APPLICATION NO.14 OF 2017 (SZ)

**JOINT COMMITTEE SITE INSPECTION REPORT BY THE OFFICIALS OF REGIONAL OFFICE OF THE MINISTRY OF ENVIRONMENT, FOREST AND CLIMATE CHANGE (MOEF&CC), CHENNAI, DEPARTMENT OF FISHERIES, TAMIL NADU AND TAMIL NADU POLLUTION CONTROL BOARD (TNPCB) IN COMPLIANCE TO THE ORDER OF THE HON'BLE NATIONAL GREEN TRIBUNAL, SOUTHERN ZONE, CHENNAI DATED 08/01/2020 IN APPLICATION NOS 14, 16, 38 & 40 OF 2017.**

This refers to the spillage of oil occurred due to the collision of inbound vessel MT Dawn Kancheepuram with outbound vessel BW Maple at Ennore near fairway buoy of Kamarajar port on 28.01.2017 and subsequent damage caused to environment due to oil spillage in sea shore area.

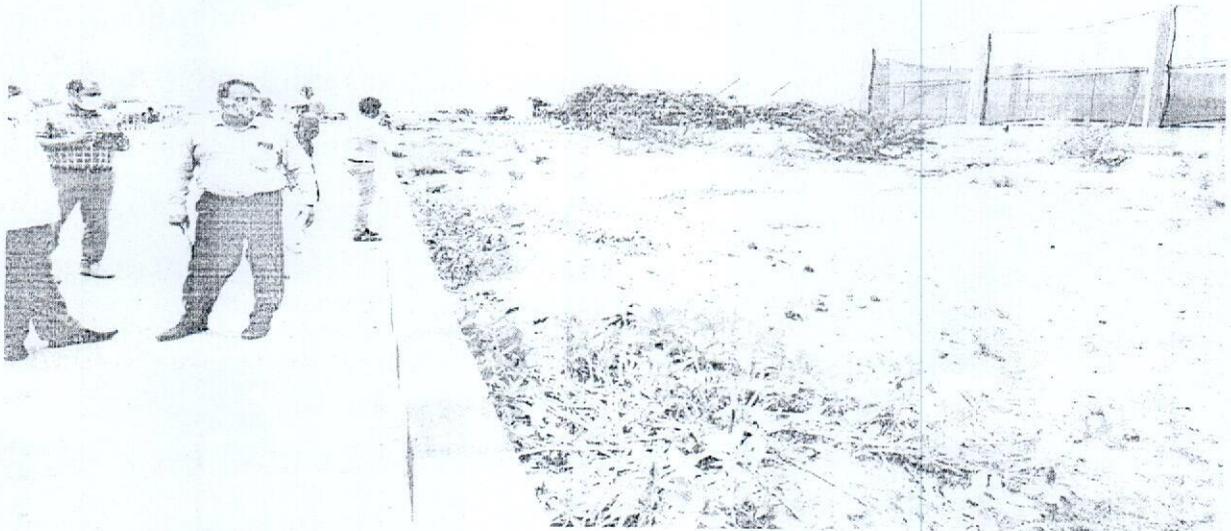
Photo of the 1st phase bioremediation site is as below.(Fig-1)

Figure-I: The site of First phase bioremediation site. Now the soil is stabilized and it is evident that there are growing plants normally

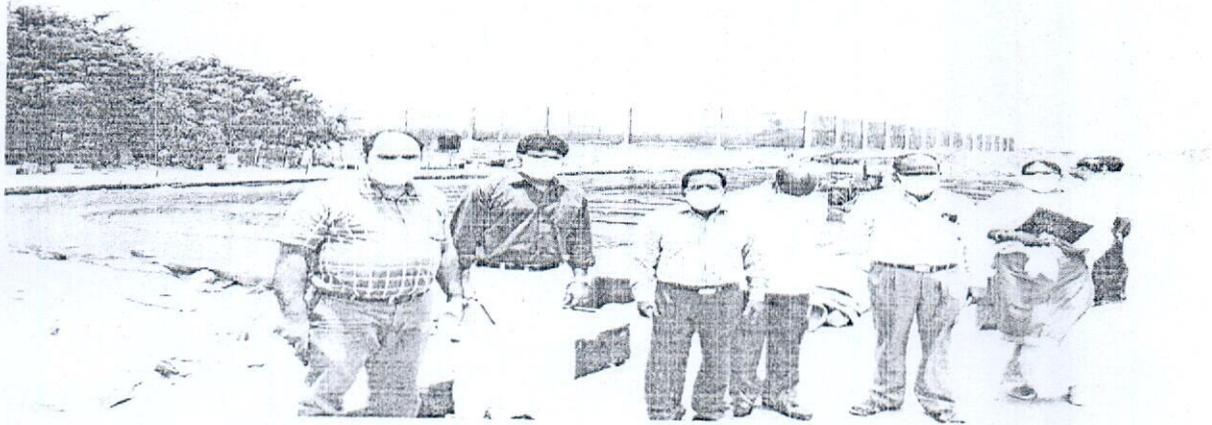
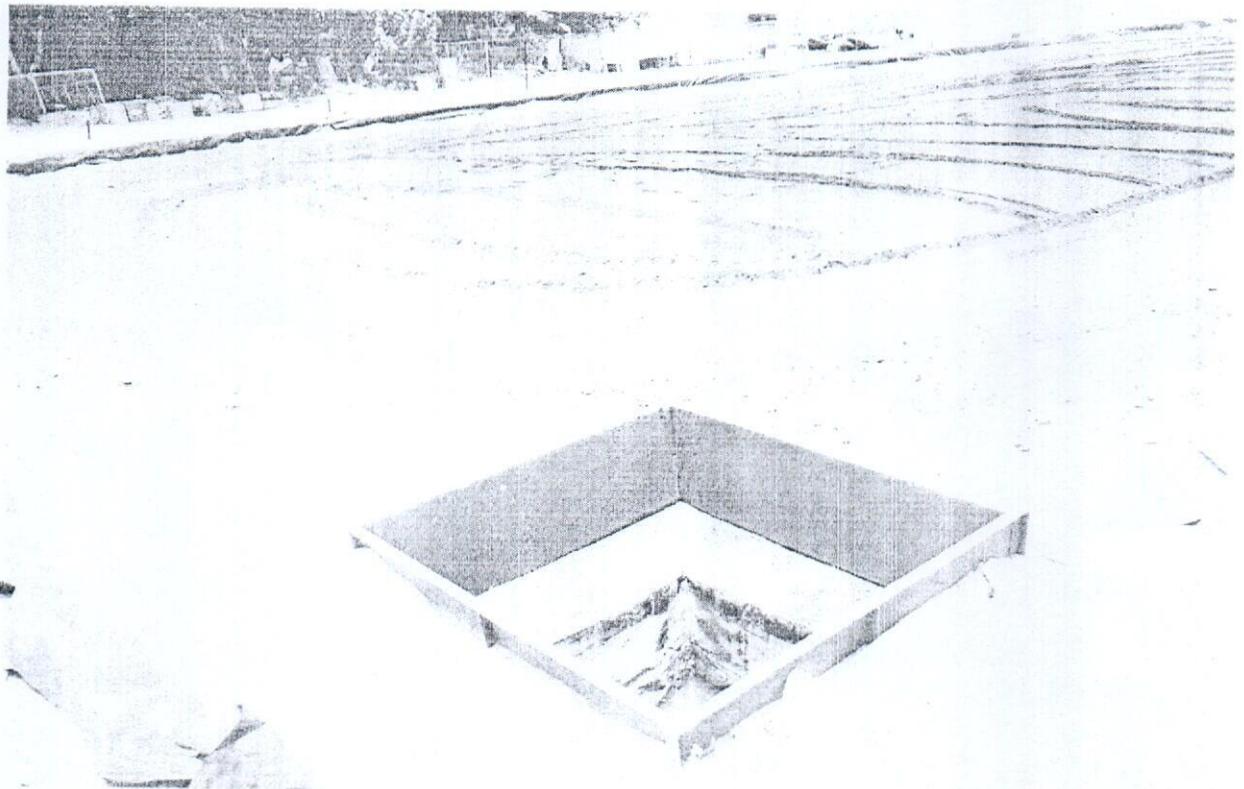
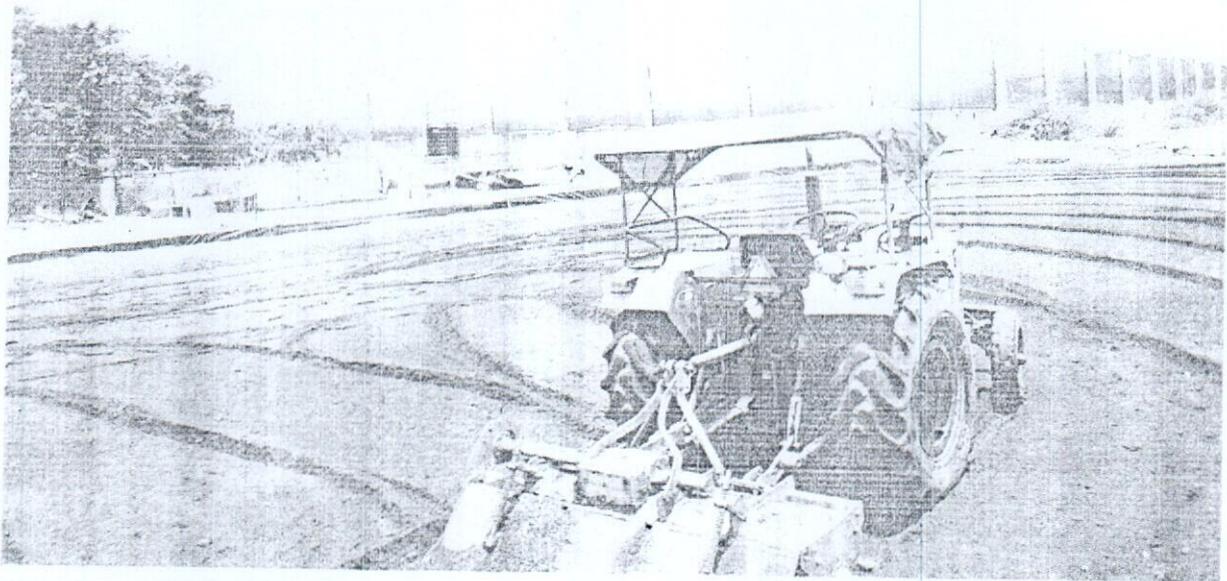
Photo of the 2nd phase bioremediation site is as below (Fig-2 to Fig-4).

The present committee members carried out the inspection at 1<sup>st</sup> and 2<sup>nd</sup> phase of Bioremedial site in M/s Kamarajar Port Limited and the shoreline stretch of Ennore in Tiruvallur District. It is also observed that the parameters are within the limit and therefore no evidence of seepage of oil from the bioremediation site to the surrounding area. A detailed report submitted by the Kamaraj Port Ltd regarding the progress in bioremediation process is at Annexure-IV

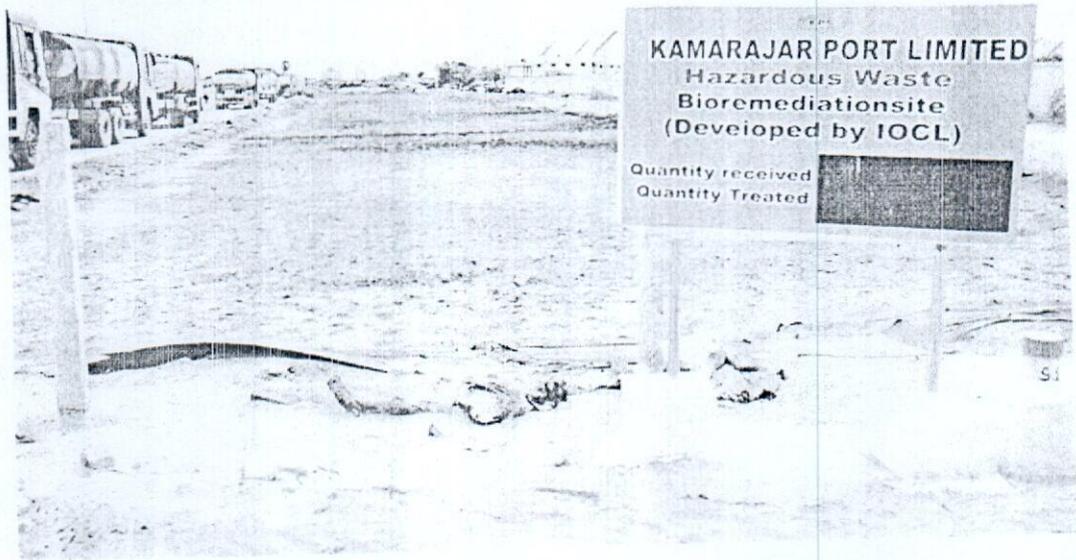
During inspection, it is observed that M/s KPL has provided a bio-remediation pit of dimension 172 meters x 16.5 meters for remediation of oil sludge and oil contaminated sand. It is noted that the bio-remediation site is provided with poly-ethylene liners. Lay out map of the bio-remediation site indicating its dimension and locations of 16 piezometric wells is enclosed as **Annexure -I**. The details regarding receipt and treatment of oily sludge and oil contaminated sand as per the records produced by the representatives of M/s KPL is as follows:

Figure 1: Bio-remediation site of M/s KPL

- i. Authorization under the provisions of Hazardous Wastes (Management, Handling and Transboundary) Rules, 2016 needs to be obtained from TNPCB for the bio-remediating oil contaminated sand.

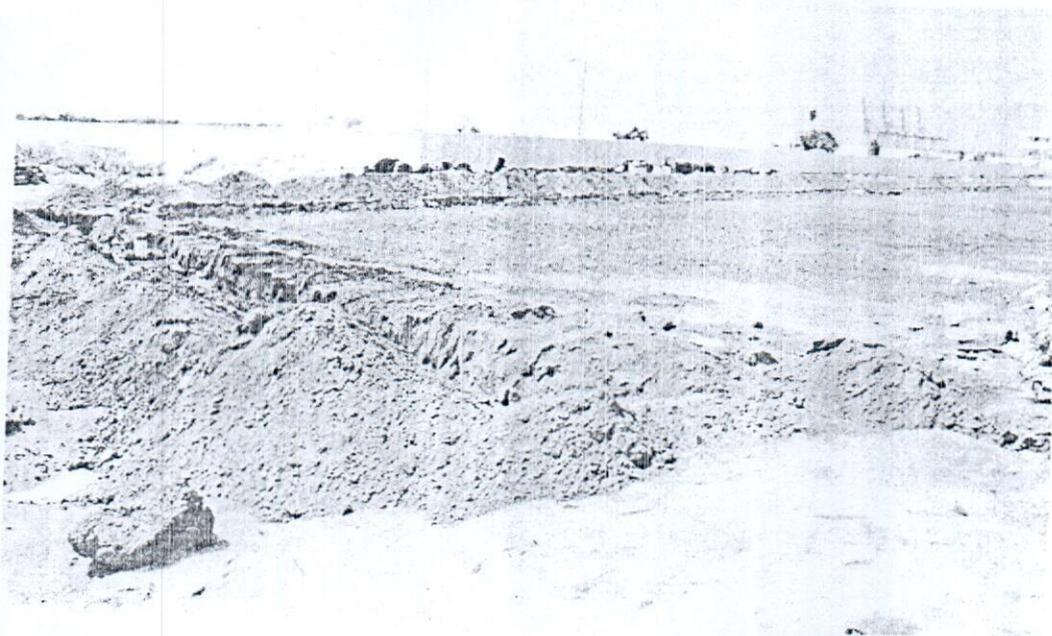
Figure 2: Kreb wall construction around the bio-remediation site

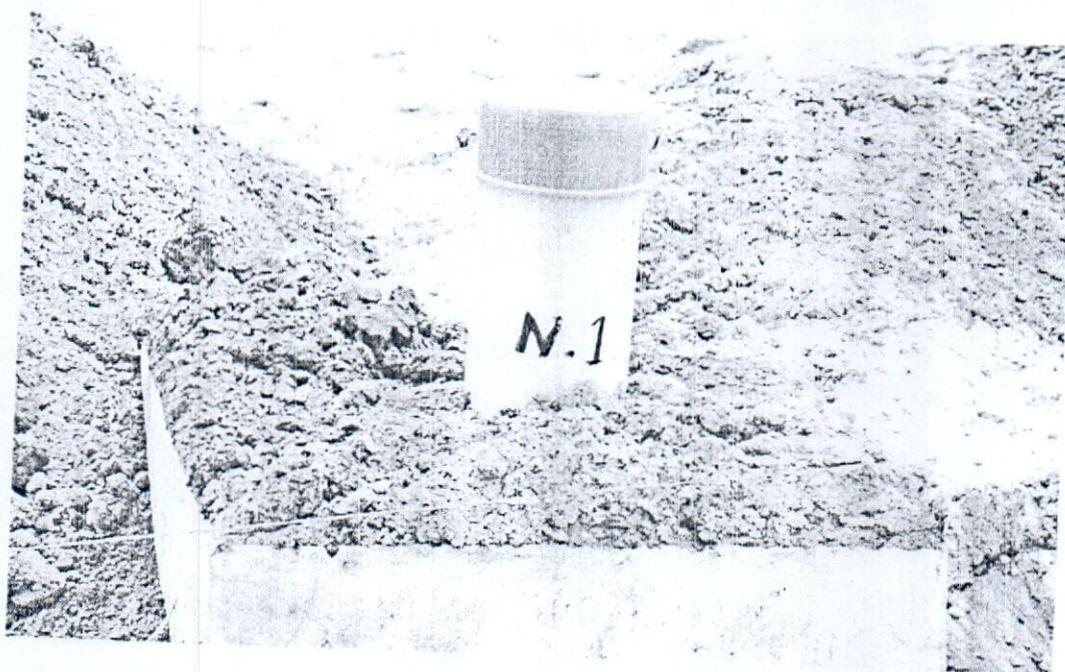
Figure 3: Piezometric well established around the bio-remediation site

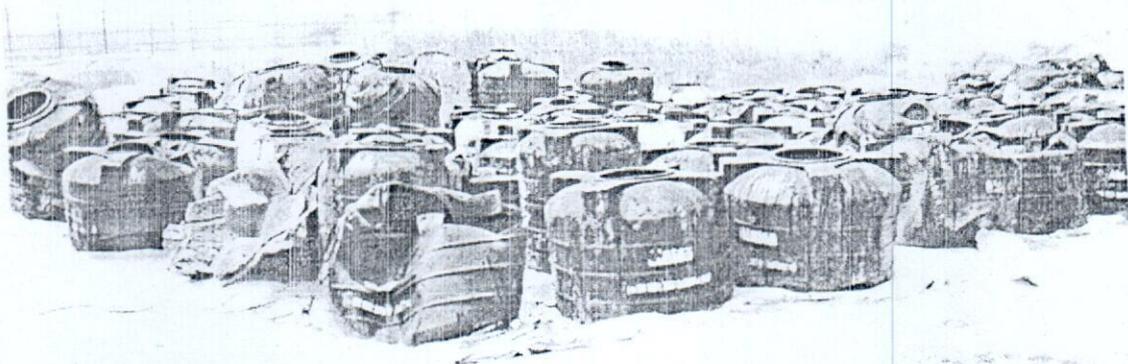
Figure 4: Open storage of empty sintex tanks at the bio-remediation site

After detailed deliberations, the team noted that following environmental safeguards shall be adopted for the bio-remediation site.

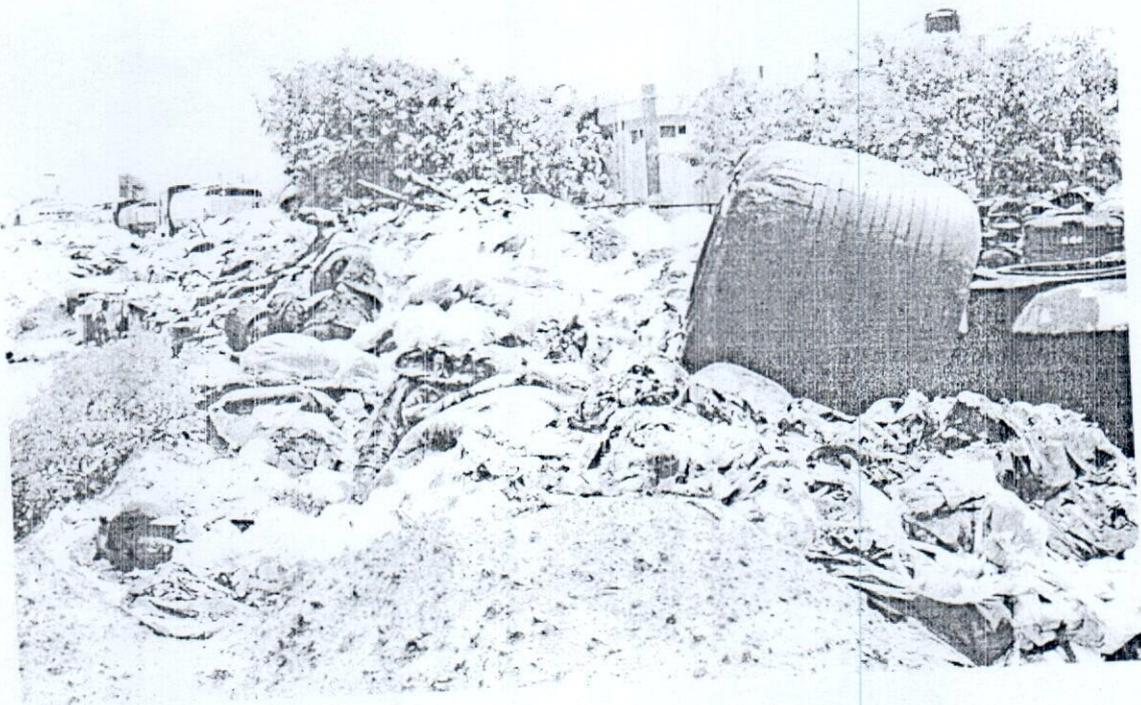
Figure 5: Open storage of oil contaminated materials at the site

- As directed by the Committee, dedicated closed shed with impervious lining was provided for the storage of oil contaminated sand. The oily sludge was stored in leak proof plastic barrels of various sizes and the same were kept covered with plastic sheets and placed on concrete surface. Regular monitoring of the barrels was carried out. The bio-remediation pit and the shed are located adjacent to KPL fire station, where fire tender, fire extinguishers and crew are available round the clock. Personnel are deployed to continuously monitor the bioremediation site on regular basis. The oil contaminated sand stored in the shed and the oily sludge stored in the barrels are put in a pit and is being treated by bioremediation process, and the shed was now dismantled and removed,

sintex tanks used for collection of oily sludge, sand contaminated with oil residues, HDPE bags, gunny bags soiled with oily residues, used gum boots & other oil contaminated personnel protective equipment, oil contaminated absorbent booms/ absorbent pads and fishing nets with oily deposits are to be considered as Hazardous Wastes and authorization has to be obtained at the earliest and the waste needs to be disposed immediately. Further, Dedicated closed sheds with impervious concrete lining shall be provided for storage of these materials

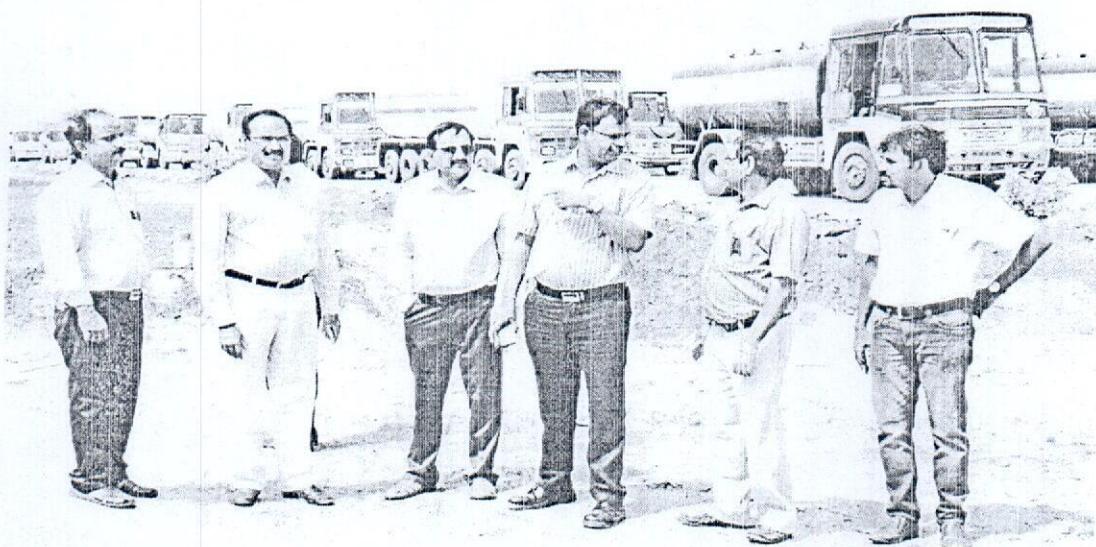
Figure 6: Joint inspection by the team at the bio-remediation site

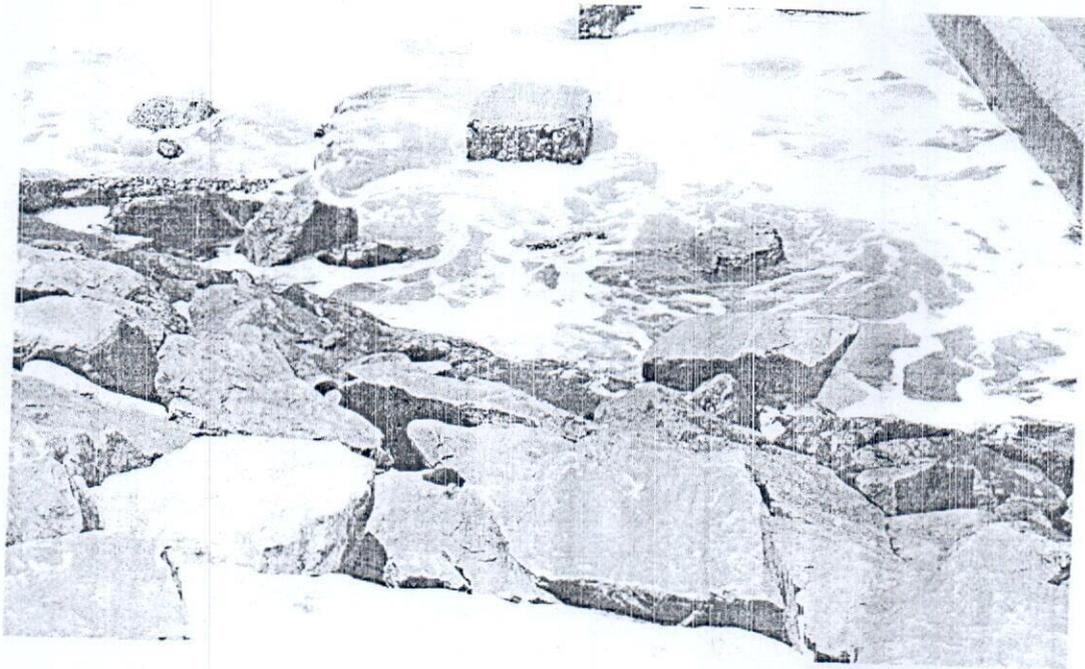
Figure 8: Photograph depicting rocks at ETPS old bay

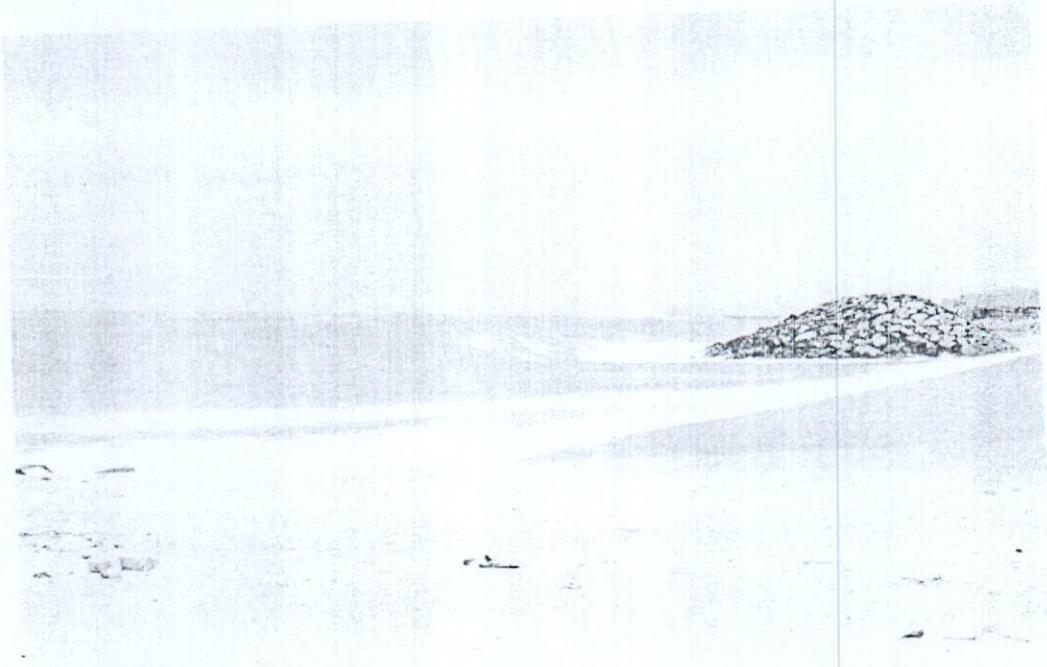
Ernavur Kuppam was inspected on 29.6.2017. The shore line was found to be clean and no fresh deposits of oil residues or Tar balls were noticed on the beaches as well as on the rocks laid for shore protection. The surface of the rocks which were taken up for clean-up is found to be free of oil deposit.

Figure 9: Photograph depicting Ernavur Kuppam

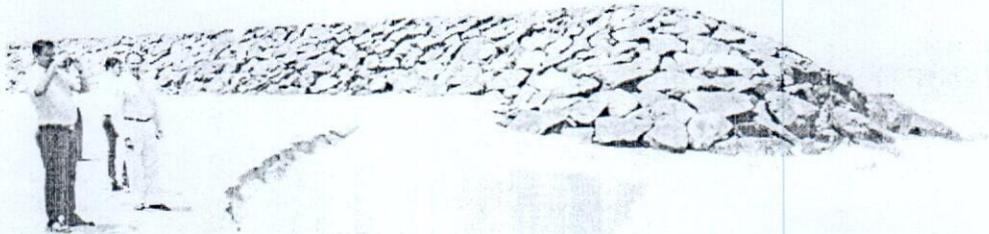
Figure 10: Photograph depicting rocks at Ernavur Kuppam

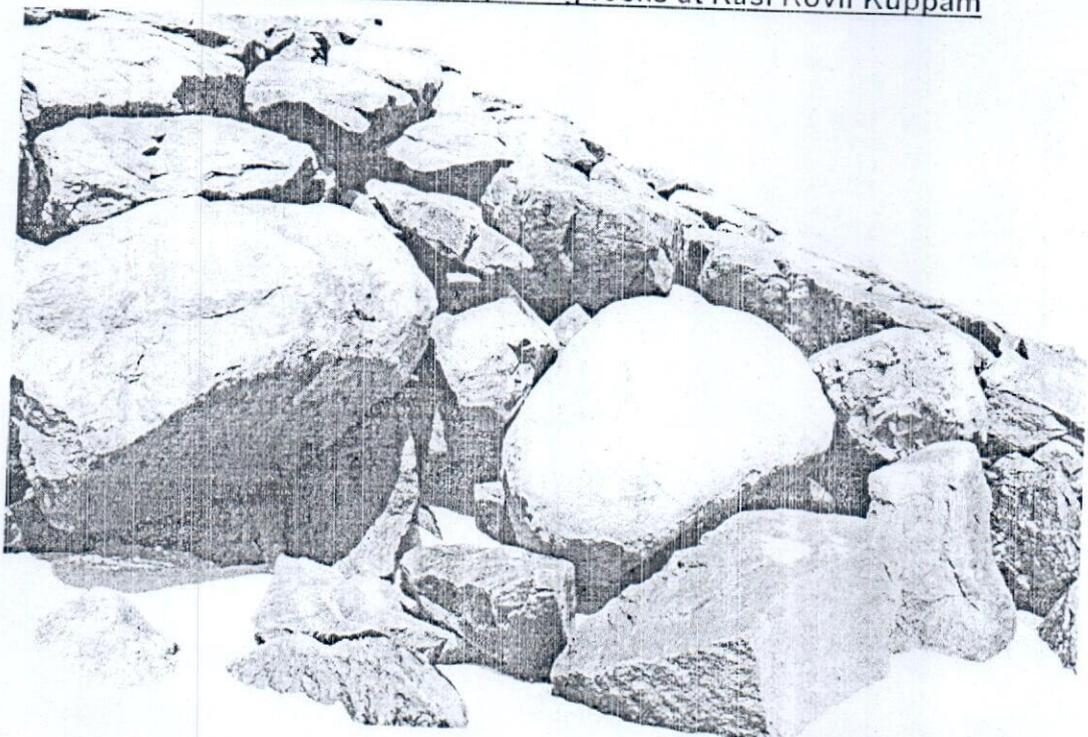
Figure 12: Photograph depicting rocks at Kasi Kovil Kuppam

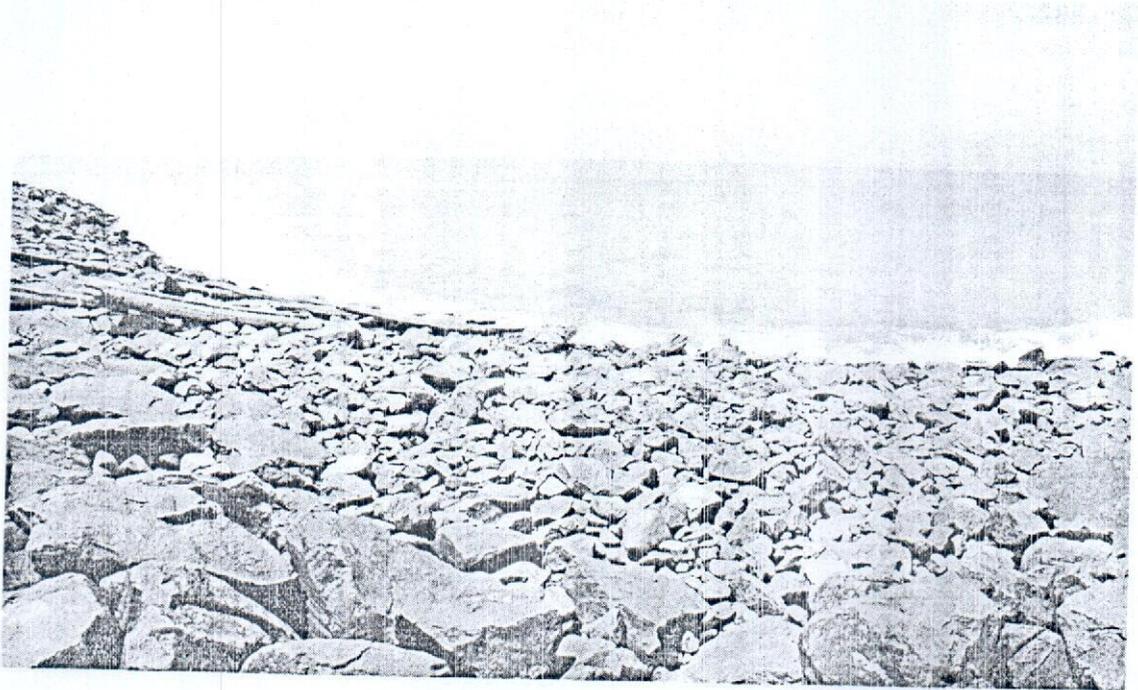
This site was most affected during the oil slick. At present, no oil deposits were found on the surface of the rocks and it's appears to be clean. Fresh sand was found to be deposited on the crevices between the rocks. Few catamarans were found to be parked on the boulders. In the adjacent beach, few mechanized boats were berthed on shore and no oil sediments (or) tar balls were found to be deposited.

Figure 15: Photograph depicting Ernavur

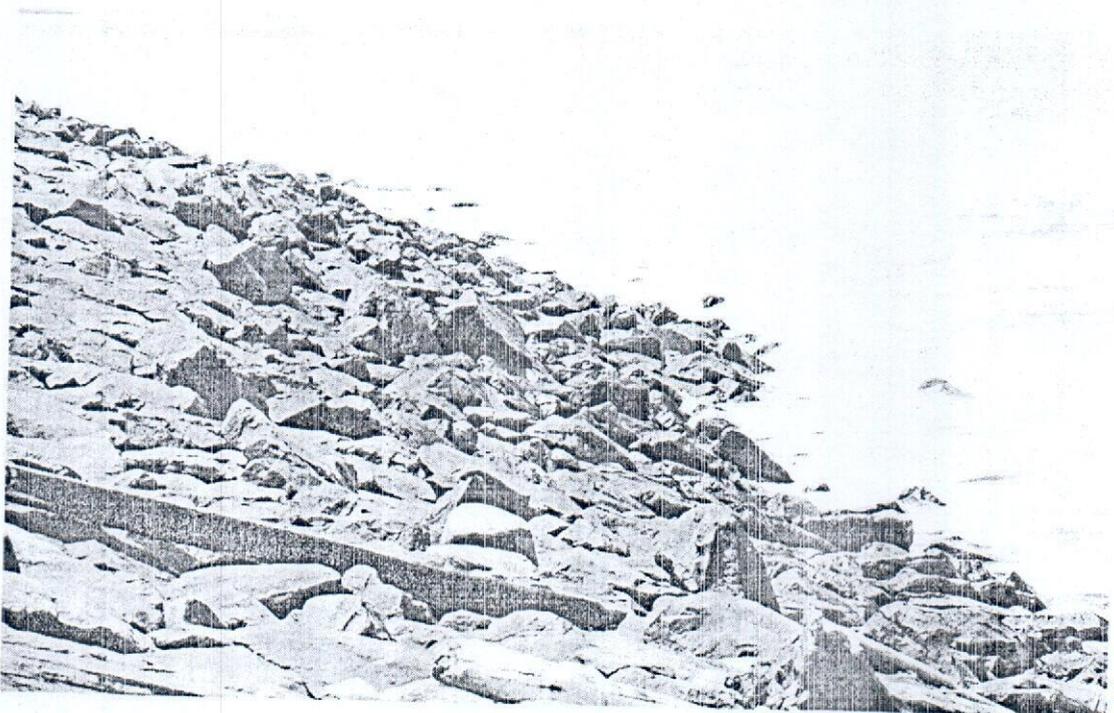
Figure 16: Photograph depicting rocks at Ernavur

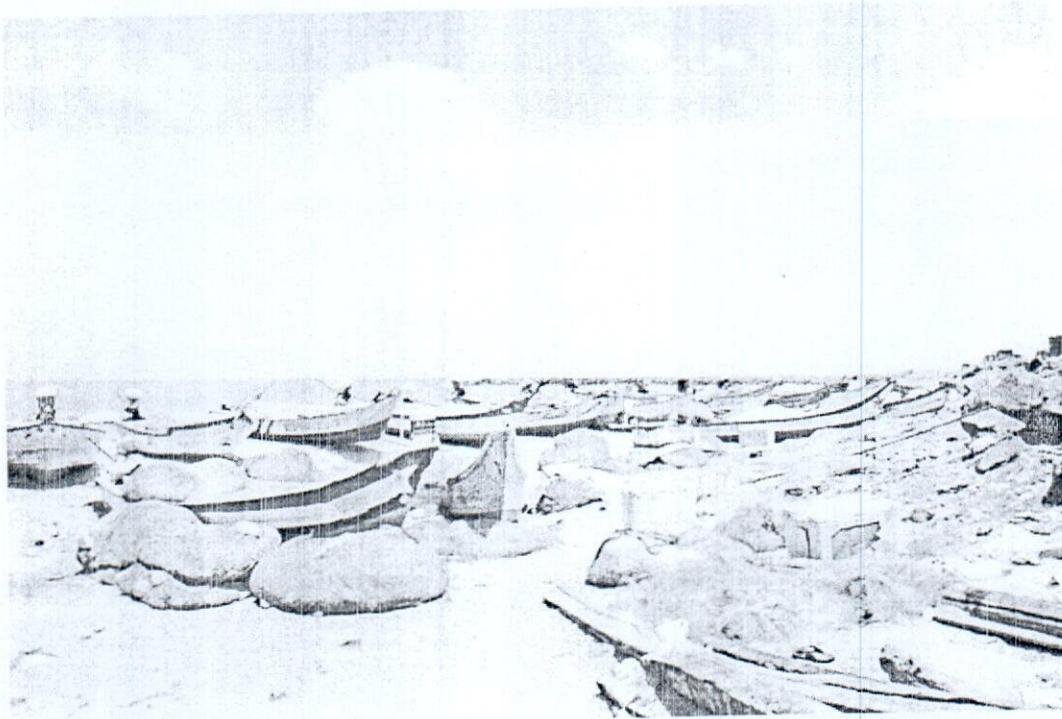
Figure 17: Photograph depicting boats and fishing nets at Ernavur

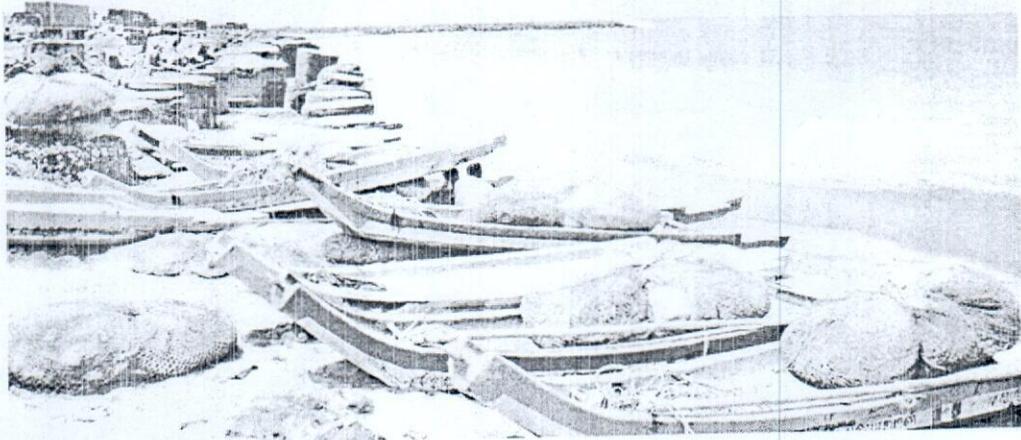
Ramakrishna Nagar Part II was inspected on 29.6.2017. No deposits of oil residues or Tar balls were noticed on the surface of the rocks.

Figure 18: Photograph depicting Ramakrishna Nagar Part II

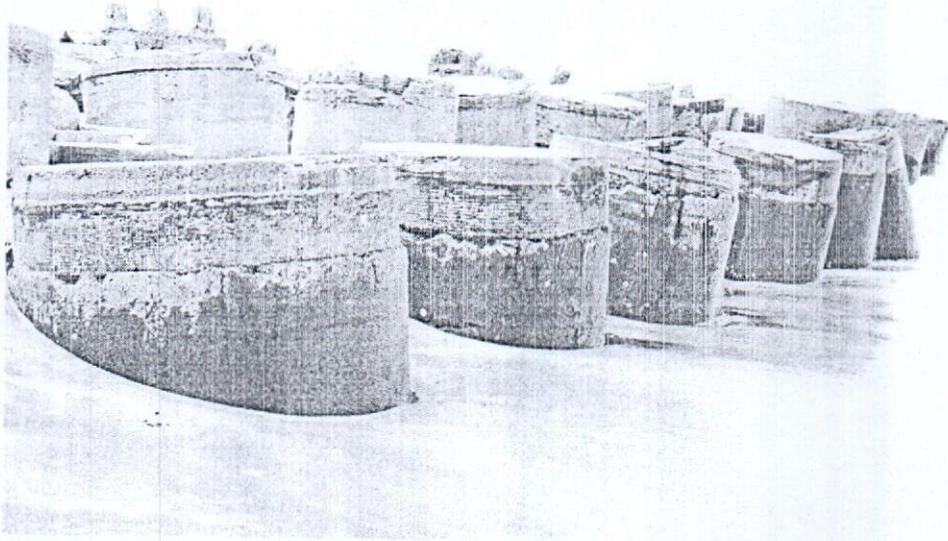
Figure 19: Photograph depicting boulders at Ramakrishna Nagar Part II

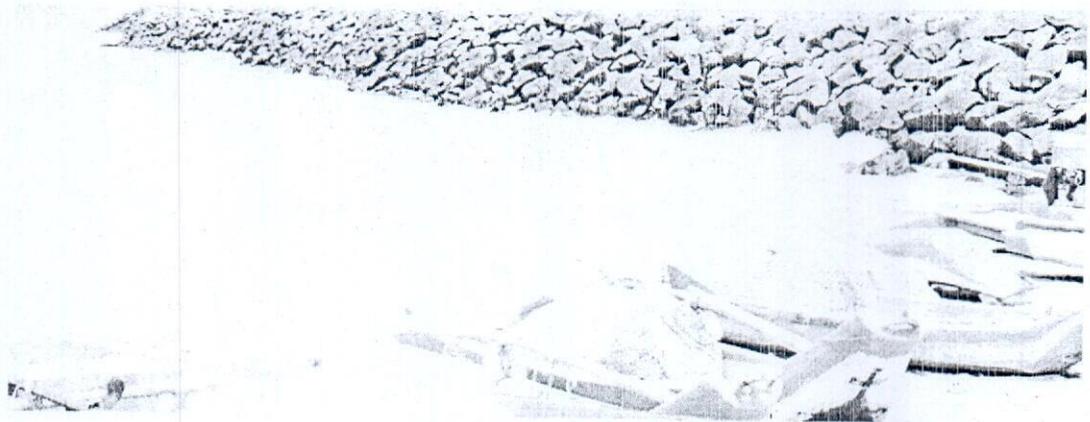
After post clean-up operations, the shoreline near KVK Kuppam was found to be clean and no oil sediments or tar balls were found on the surface of the rocks.

Figure 20: Photograph depicting KVK Kuppam

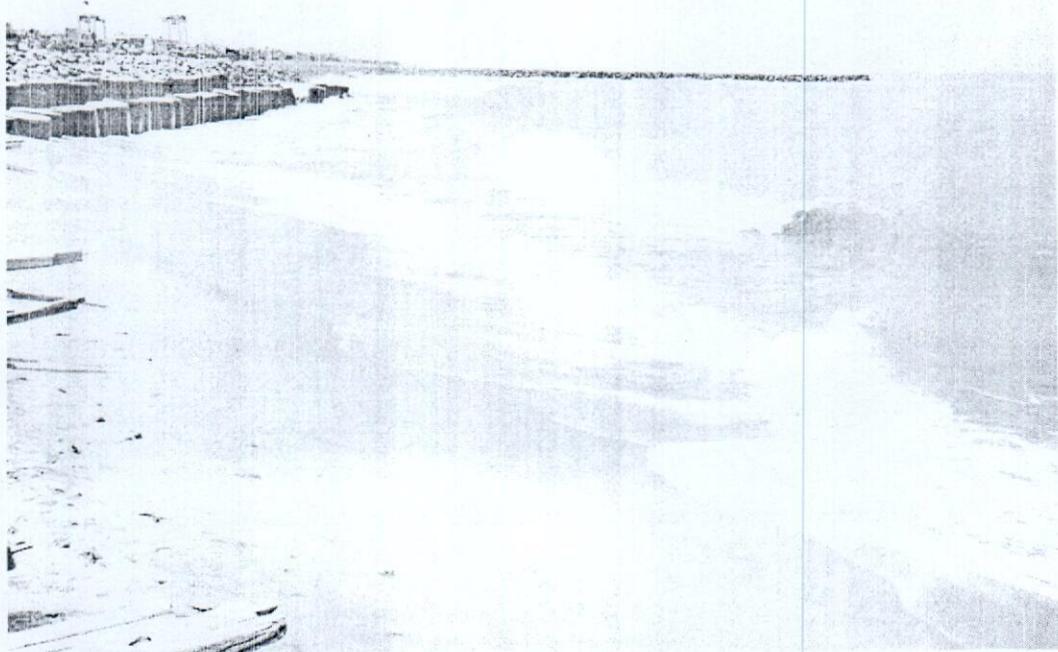
After post clean-up operations, the shoreline near Palagai Thotti Kuppam was found to be clean and no oil sediments or tar balls were found.

Figure 22: Photograph depicting Palagai Thotti Kuppam

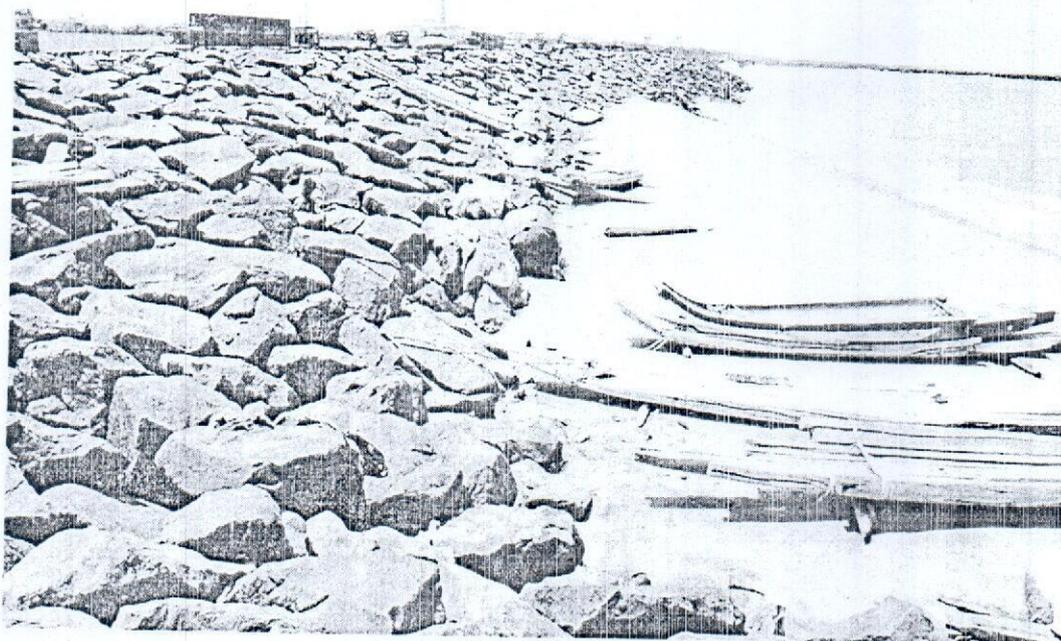
Masthankoil I was inspected on 29.6.2017. The shore line was found to be clean and no deposits of oil residues or Tar balls were noticed.

Figure 24: Photograph depicting Masthankoil I

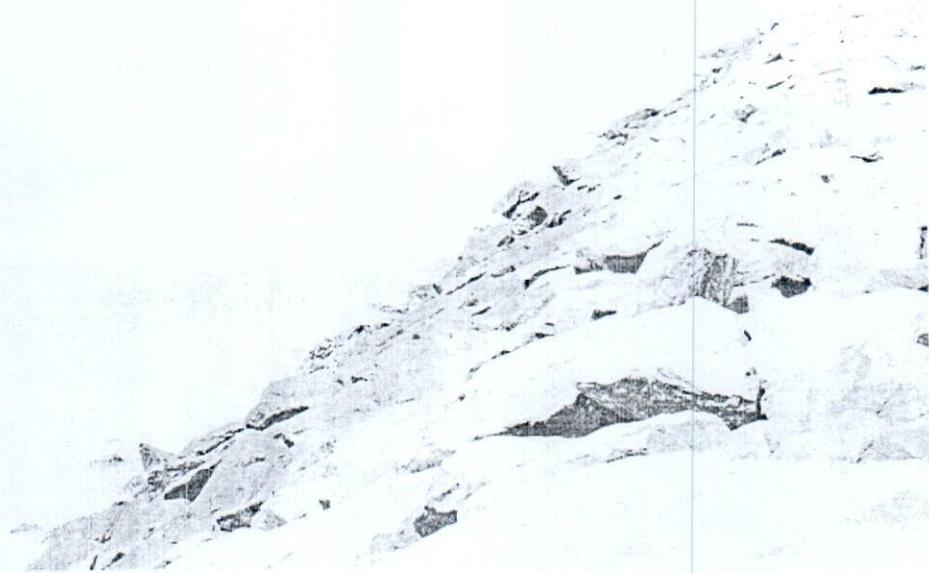
Figure 25: Photograph depicting rocks at Masthankoil I

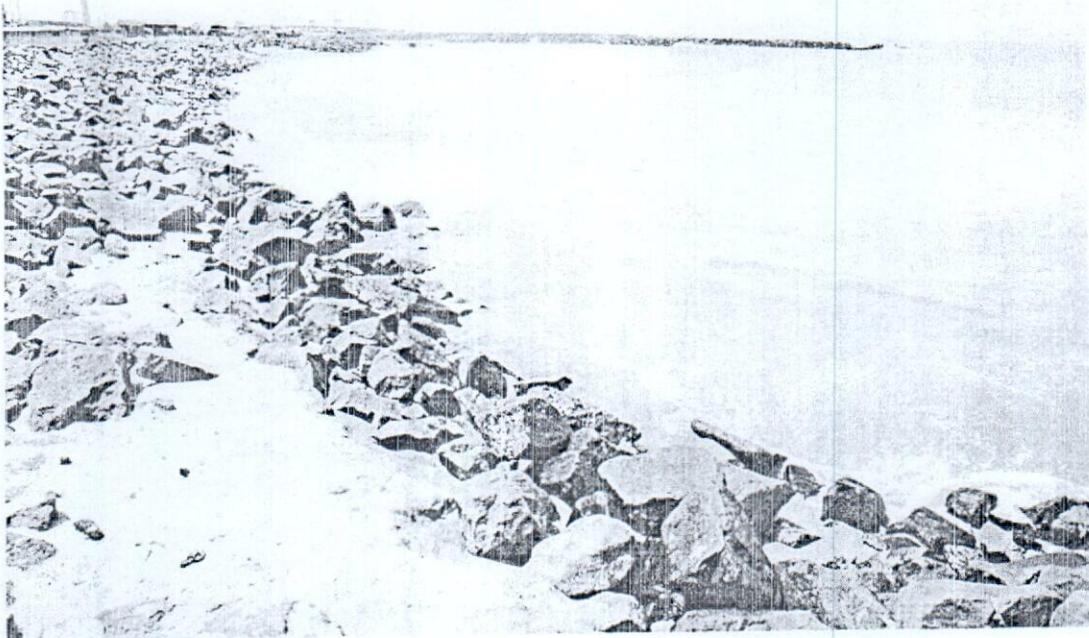
Masthankoil II was inspected on 29.6.2017. The shore line was found to be clean and no deposits of oil residues or Tar balls were noticed.

Figure 26: Photograph depicting Masthankoil II

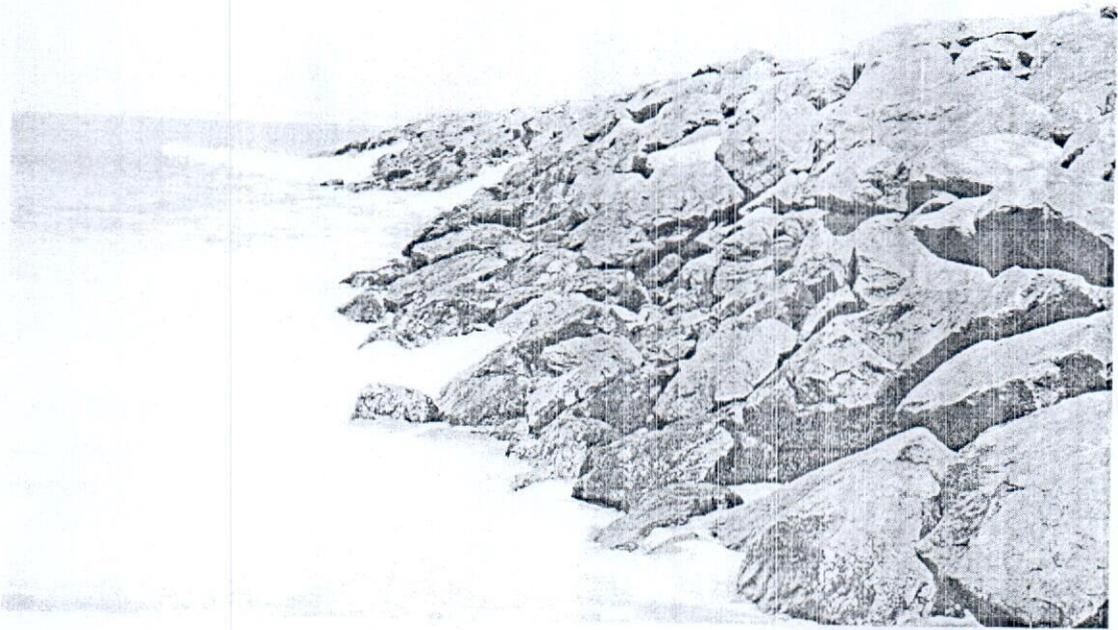
Figure 27: Photograph depicting Masthankoil II

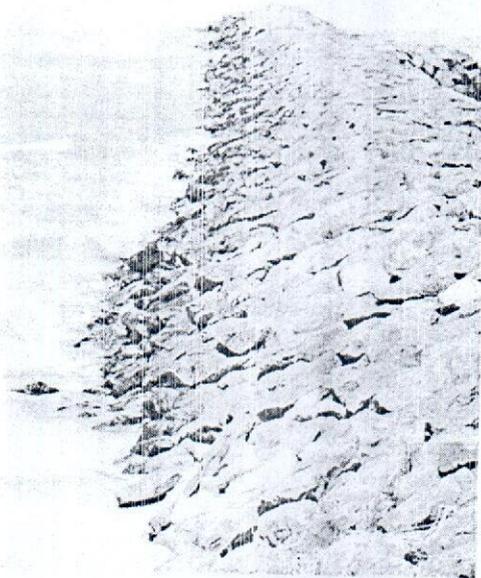
After post clean-up operations, the shoreline near Thiruchinar Kuppam was found to be clean and no oil sediments or tar balls were found.

Figure 32: Photograph depicting Thiruchinar Kuppam

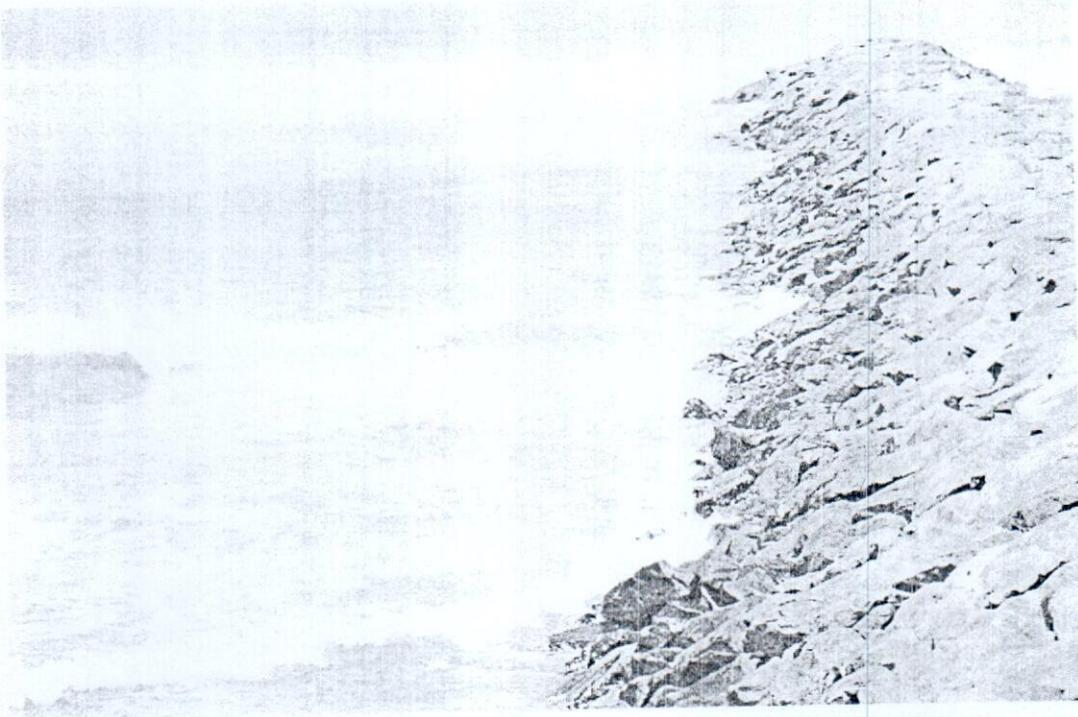
Figure 33: Photograph depicting rocks at Thiruchinar Kuppam

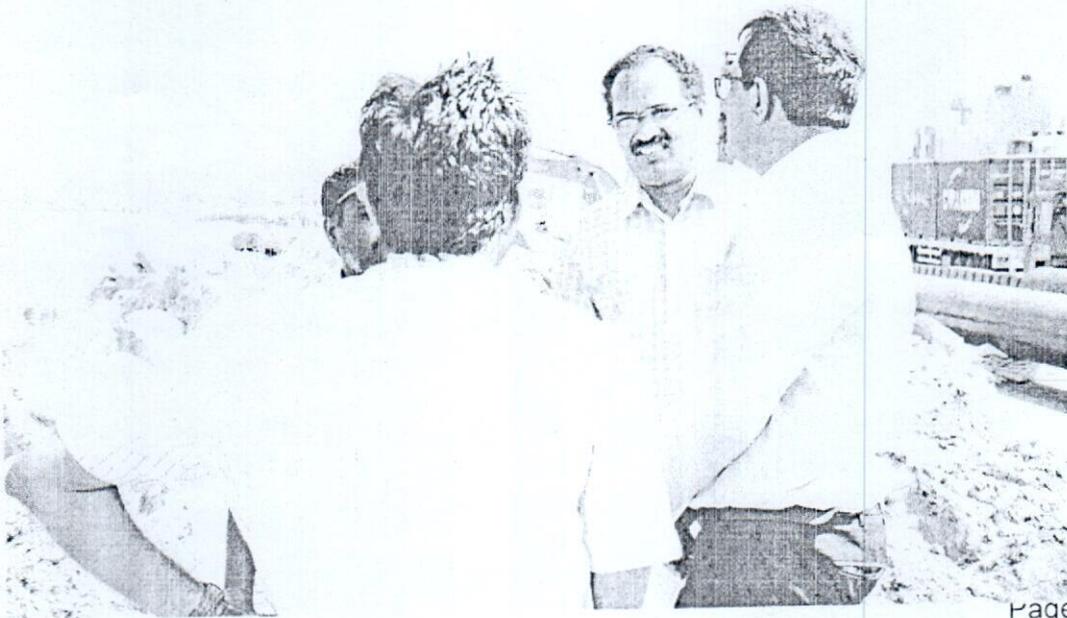
Tollgate – New Washermenpet was inspected on 29.6.2017. The shore line was found to be clean and no deposits of oil residues or Tar balls were noticed.

Figure 34: Photograph depicting Tollgate -New Washermenpet

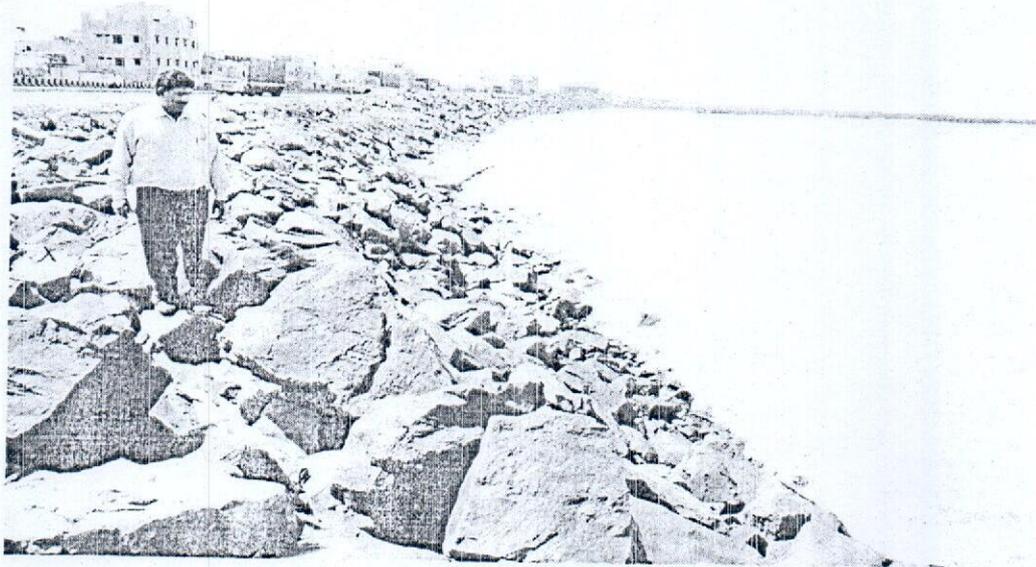
After post clean-up operations, the shoreline near Anna Nagar Beach was found to be clean and no oil sediments or tar balls were found.

**Figure 35: Photograph depicting Anna Nagar Beach**

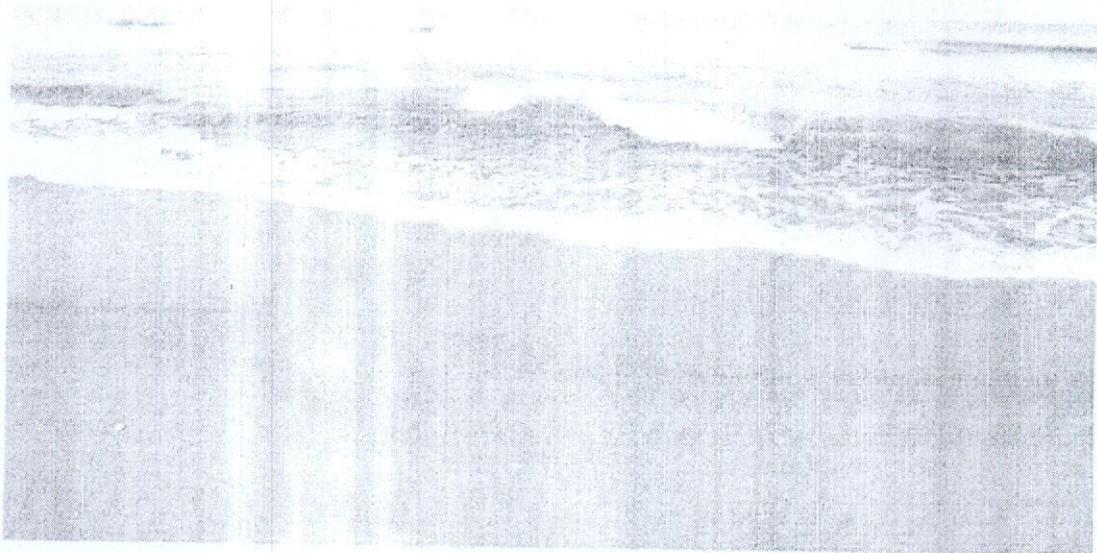
Srinivasapuram Beach was inspected on 29.6.2017. The shore line was found to be clean and no deposits of oil residues or Tar balls were noticed.

**Figure 40: Photograph depicting Srinivasapuram Beach**

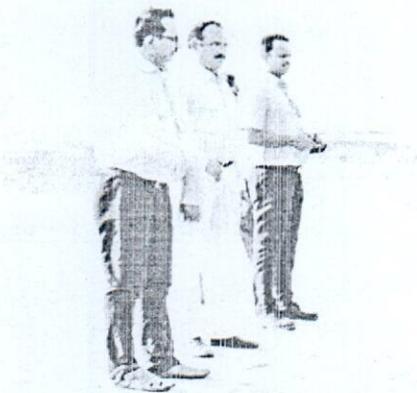
Elliot's Beach was inspected on 29.6.2017. The shore line was found to be clean and no deposits of oil residues or Tar balls were noticed.

Figure 42: Photograph depicting Elliot's Beach

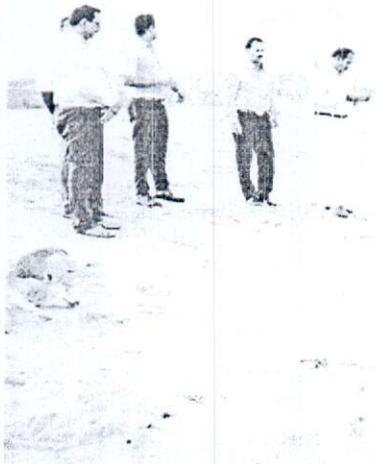
Thiruvanmiyur Beach was inspected on 29.6.2017. The shore line was found to be clean and no deposits of oil residues or Tar balls were noticed.

Figure 44: Photograph depicting Thiruvanmiyur Beach

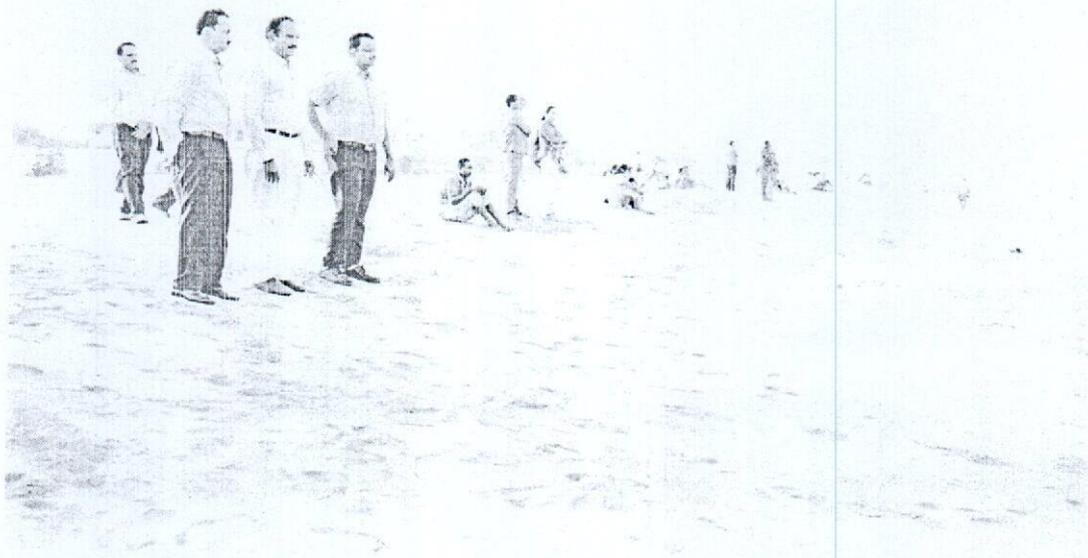
Kottivakam Beach was inspected on 29.6.2017. The shore line was found to be clean and no deposits of oil residues or Tar balls were noticed.

Figure 46: Photograph depicting Kottivakam Beach

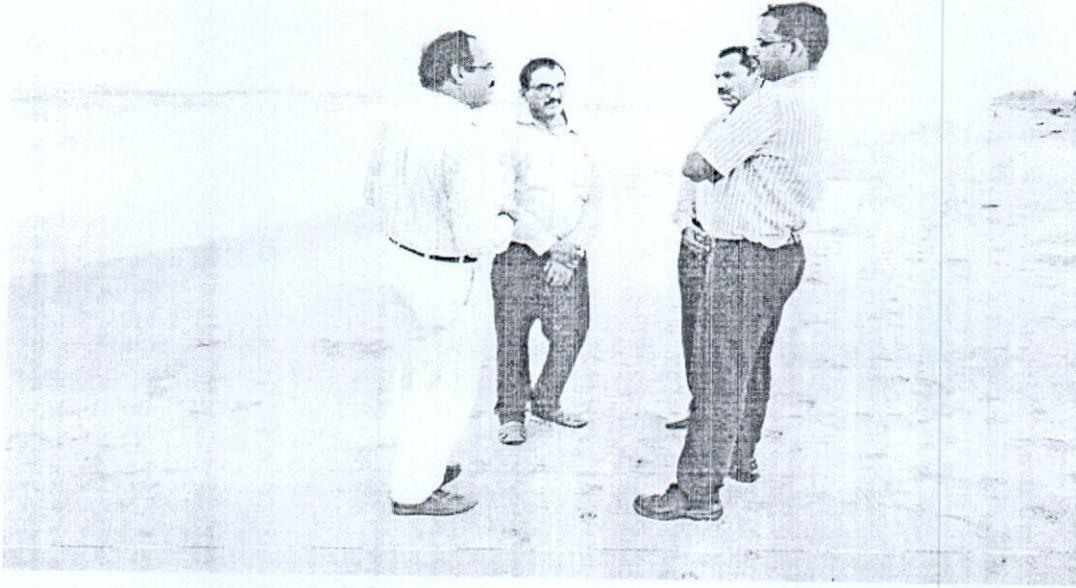
Kanathur Beach was inspected on 29.6.2017. The shore line was found to be clean and no deposits of oil residues or Tar balls were noticed.

**Figure 49: Photograph depicting Kanathur Beach**
