APPLICATION NO.14 OF 2017 (SZ)

**JOINT COMMITTEE SITE INSPECTION REPORT BY THE OFFICIALS OF REGIONAL OFFICE OF THE MINISTRY OF ENVIRONMENT, FOREST AND CLIMATE CHANGE (MOEF&CC), CHENNAI, DEPARTMENT OF FISHERIES, TAMIL NADU AND TAMIL NADU POLLUTION CONTROL BOARD (TNPCB) IN COMPLIANCE TO THE ORDER OF THE HON'BLE NATIONAL GREEN TRIBUNAL, SOUTHERN ZONE, CHENNAI DATED 08/01/2020 IN APPLICATION NOS 14, 16, 38 & 40 OF 2017.**

This refers to the spillage of oil occurred due to the collision of inbound vessel MT Dawn Kancheepuram with outbound vessel BW Maple at Ennore near fairway buoy of Kamarajar port on 28.01.2017 and subsequent damage caused to environment due to oil spillage in sea shore area.

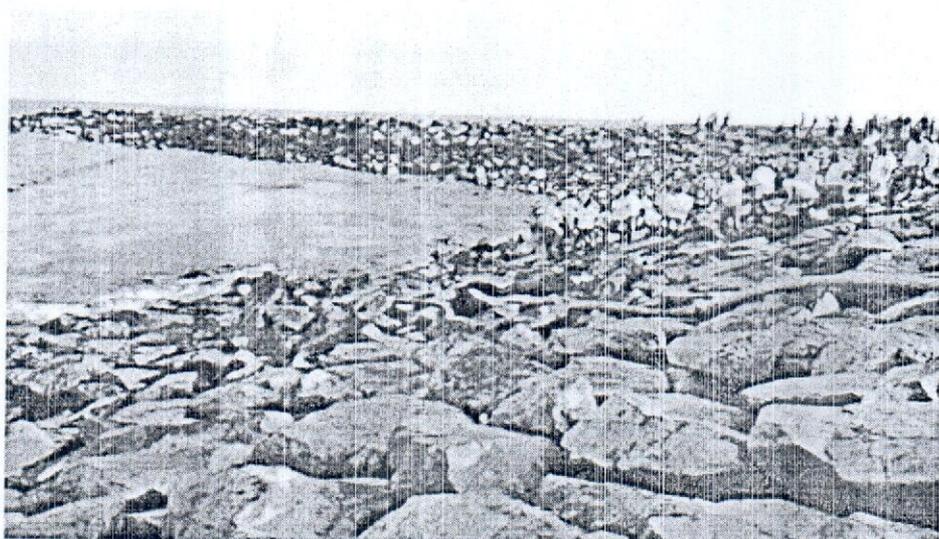
On January 28, 2017, two cargo ships, the Maple, having offloaded LPG, and on its way out, and the Dawn Kanchipuram, with heavy furnace or bunker oil, and coming in, collided at Ennore port in Chennai causing bunker oil to spill into the sea (**Figure-1**). The spilled oil reached to the beaches with waves contaminating the soil. The spilled oil sludge was collected along with contaminated soil and its disposal in environment friendly manner was an issue.

**Figure 1: Oil spill at Ennore beach**

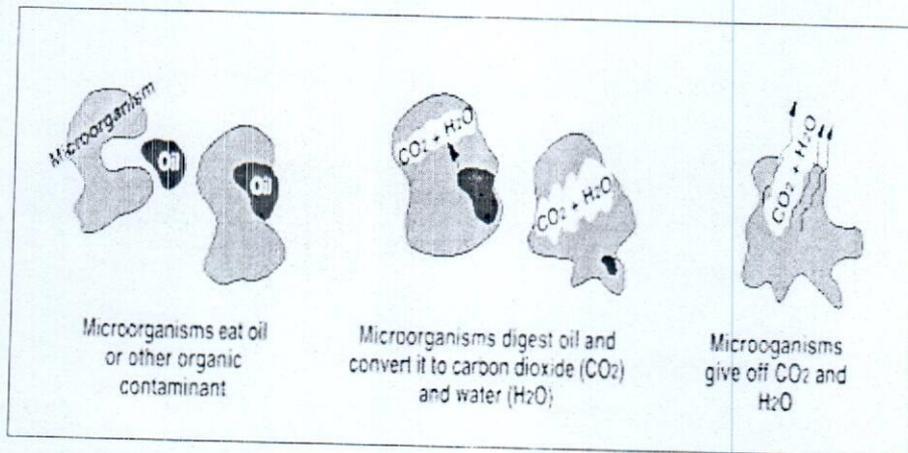
Bioremediation consists of using naturally occurring living organisms (usually bacteria, fungi, actinomycetes, cyanobacteria and to a lesser extent, plants) to reduce or eliminate toxic pollutants. These organisms may be naturally occurring or laboratory cultivated. The microorganisms break down, or degrade, hazardous substances into less toxic or nontoxic substances. Microorganisms, just like humans, eat and digest organic substances for nutrients and energy. The microorganisms break down the organic contaminants into harmless products—mainly carbon dioxide and water (Figure-2).

Figure 2: Schematic Diagram of Aerobic Biodegradation in Soil

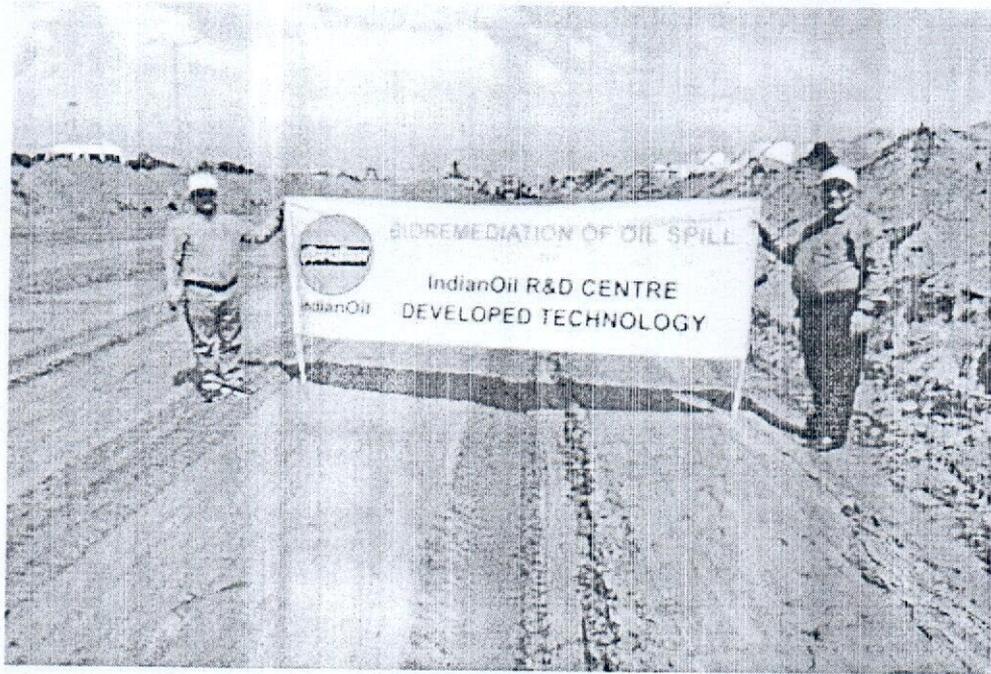
Accordingly, bioremediation site was prepared by removing the grass and stones and adding soils in the form of a single block. A pit of 200x15 meter size and one foot deep was prepared (Figure-4) and HDPE sheets were laid down in the pit to avoid any percolation of oil in the ground below the pit (Figure-5). Layer of normal soil was spread on the HDPE sheet and 184 MT of oil sludge and oil-contaminated soil was mixed with normal soil in the pit (Figure-6). Soil and oil were mixed properly with around 400 Kg of R&D developed bio-inoculum/nutrient (Figure-7). The site was barricaded and identified properly. Tiling and watering of bioremediation site is being done once in a week by IOC (M).

Figure 4: Pit prepared for Bioremediation Process

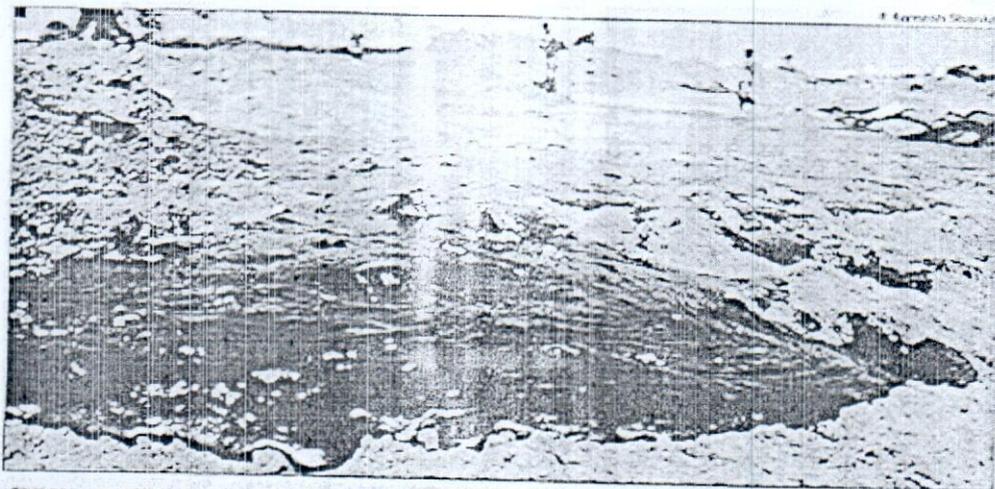
Figure 5: Safeguarding from percolation of sludge to soil using HDPE sheets

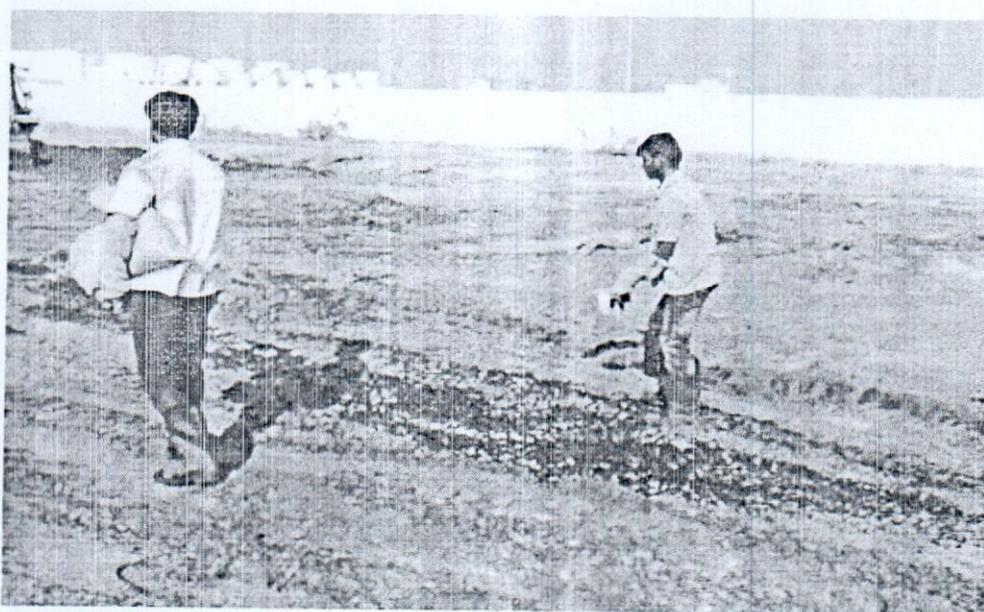
**Figure 6: Mixing of Sludge from the Oil Spill and Normal Soil**

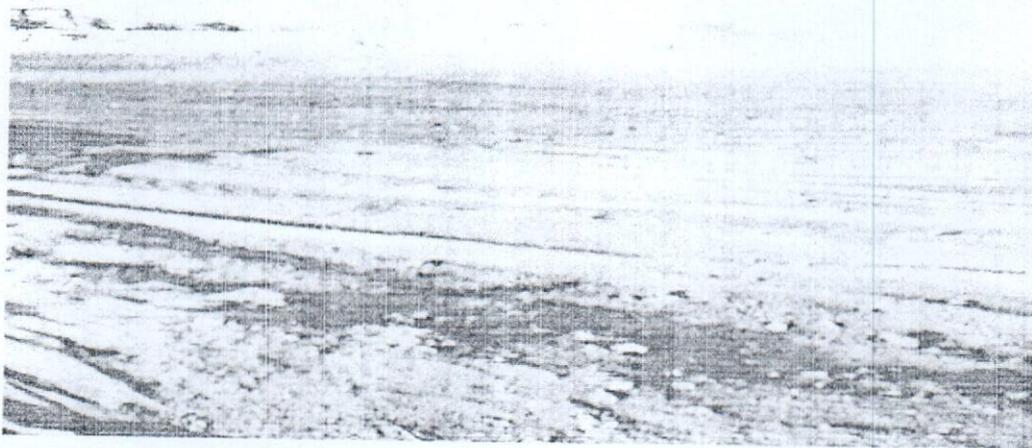
The photographs of site taken at different time intervals from site are depicted as Figure-09, 10, 11, 12, 13, 14, 15, 16 and 17 respectively.

Figure 9: Photograph of the bioremediation site at Zero day. (Dark site colour)

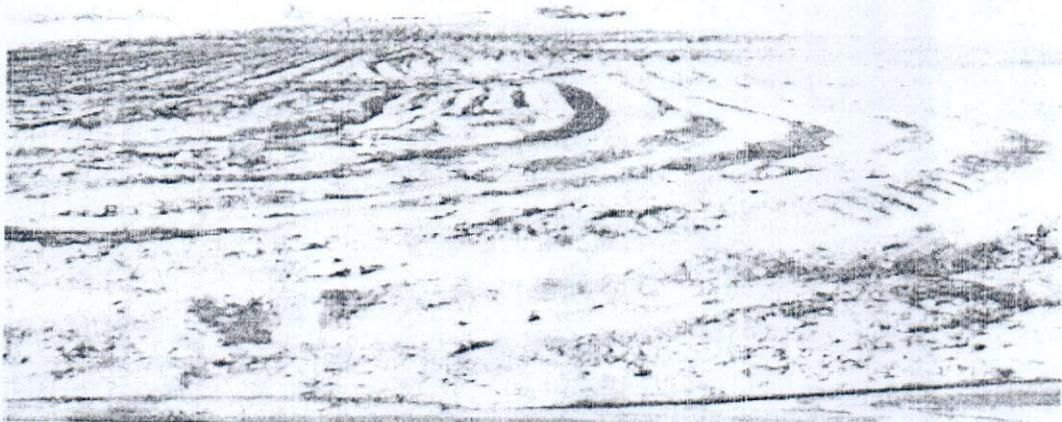
Figure 11: Photograph of the bioremediation site on 45<sup>th</sup> day

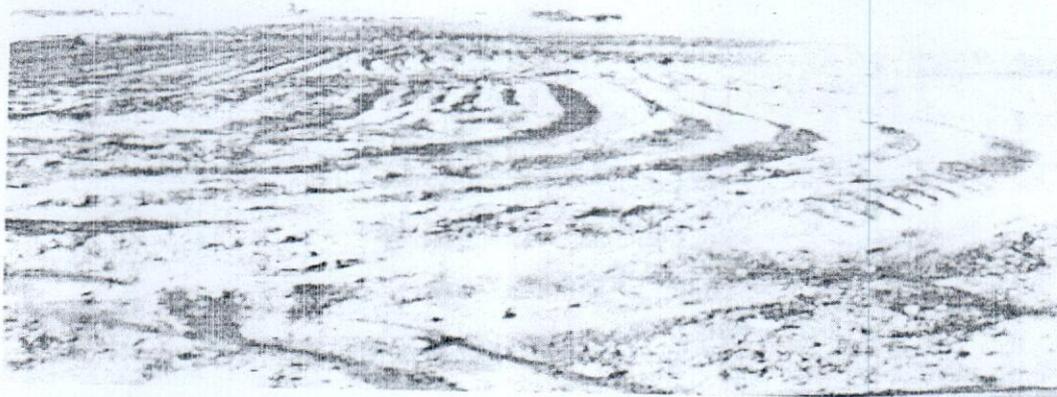
Figure 12: Photograph of the bioremediation site on 75<sup>th</sup> day

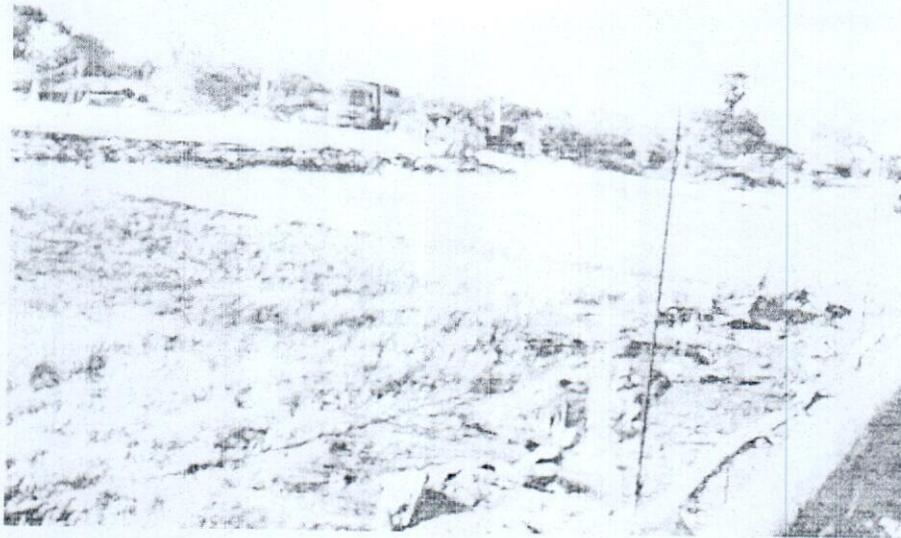
Figure 16: Photograph of the bioremediation site on 200<sup>th</sup> day

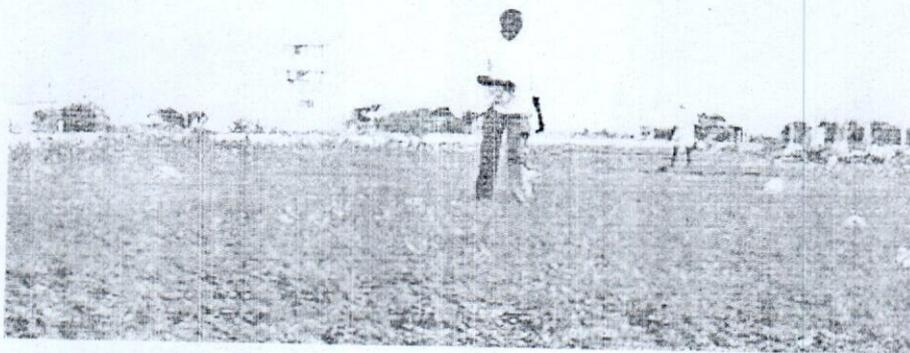
Figure 17: Photograph of the bioremediation site on 230<sup>th</sup> day (Green land with full grown vegetation)

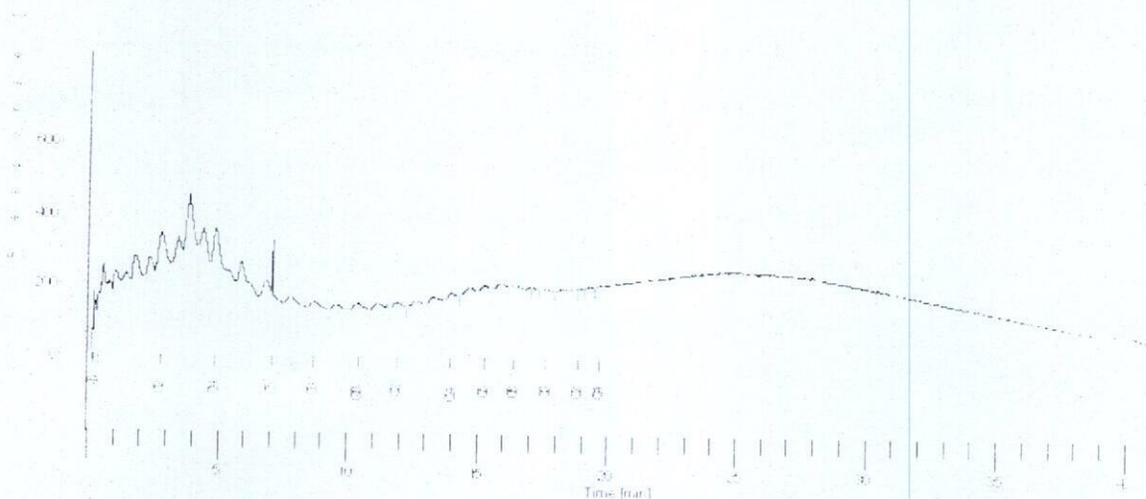
that sample after 15 days contains hydrocarbon in the range of C6 to C34, while the sample after 60 days contains the hydrocarbon in the range of C6 to C30. The reduction of hydrocarbons concentration after 121 days was observed about 79%. The hydrocarbon carbon type present in the TPH samples after 230 days was having distribution in the range of C6 to C20 with the hydrocarbon reduction of more than 96% as compare to the TPH sample after 15 days. However, when the analysis was repeated as per the method No. 9071B of EPA SW-846, the reduction of hydrocarbons concentration after 121 days was observed about 88 % and further reduced to more than 98% having distribution in the range of C6 to C20. The change in carbon number distribution further corroborates time dependent decrease in hydrocarbons content in bioremediation site.

Figure-18a: Gas chromatograph of TPH extracted after 15 days from the bioremediation site

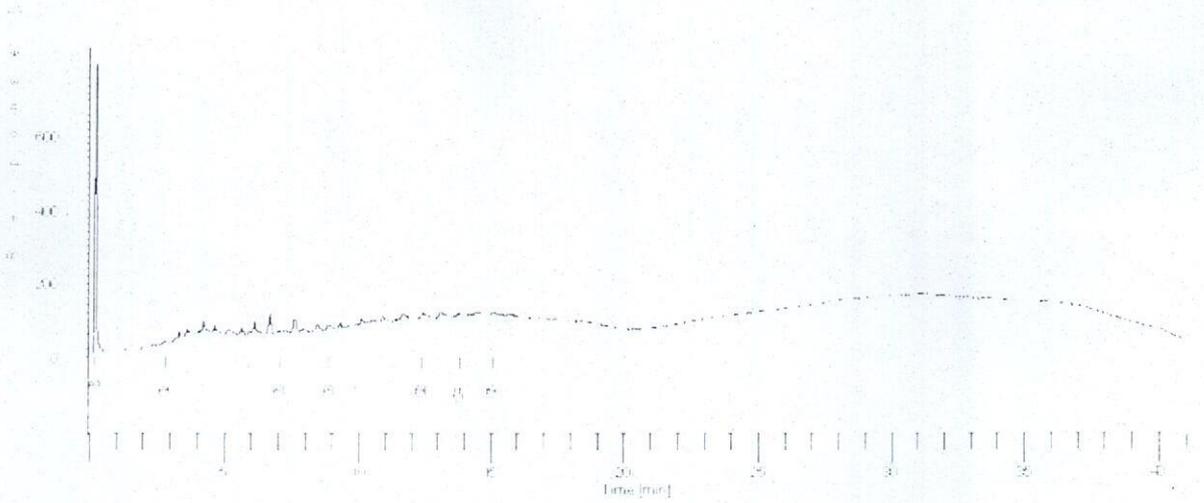
Figure-18 b: Gas chromatograph of TPH extracted after 121 days from the bioremediation site

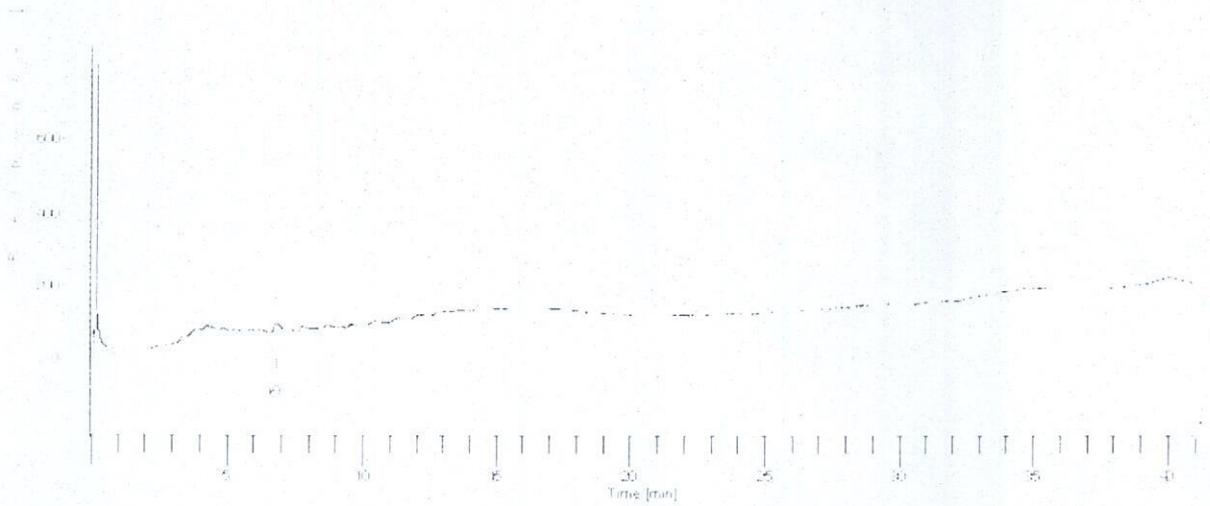
Figure 18c: Gas chromatograph of TPH extracted after 230 days from the bioremediation site

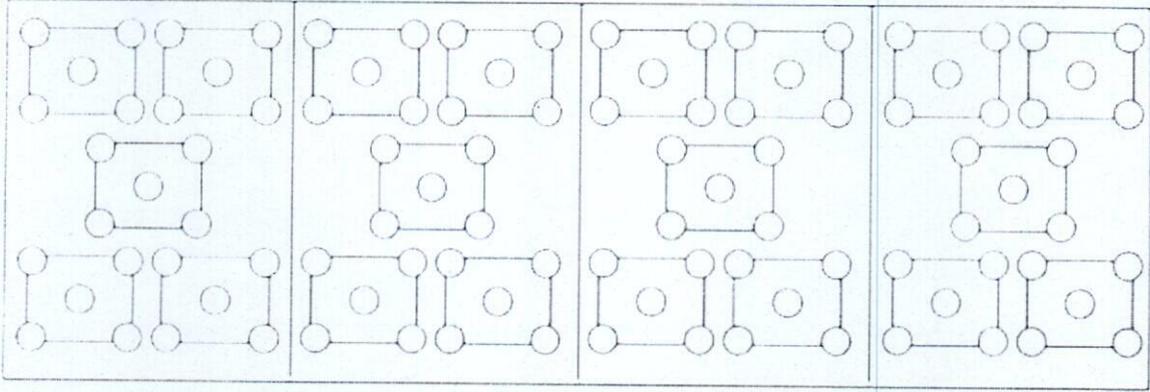
- The plot to be divided into four equal blocks.
- From each block five samples to be collected (as shown in below figure).
- To take sample from each point, select at least five equidistant points from center of the (01 at center + 04) and collect around 500gms of a homogenous/uniform sample from each point.

- The soil sample from all depth (30-45 cm) should be collected.
- Mix the samples to make a composite sample and dispatch around 1kg of this sample for analysis.
- The sample should be collected at the time of the start of the bioremediation and at every month interval.
