**REPORT OF THE JOINT COMMITTEE IN THE MATTER OF OA 143/2021 REGARDING SUO MOTU MOTION TAKEN UP BY HON'BLE TRIBUNAL BASED ON THE NEWS ITEM IN THE EENADU NEWSPAPER, EDITION DATED: 12TH JUNE 2021, "DREDGING ALONG THE EMBANKMENTS OF KRISHNA RIVER TO BE STOPPED"**

**V Committee inspection: Observations made by the committee during visits and by using satellite images**

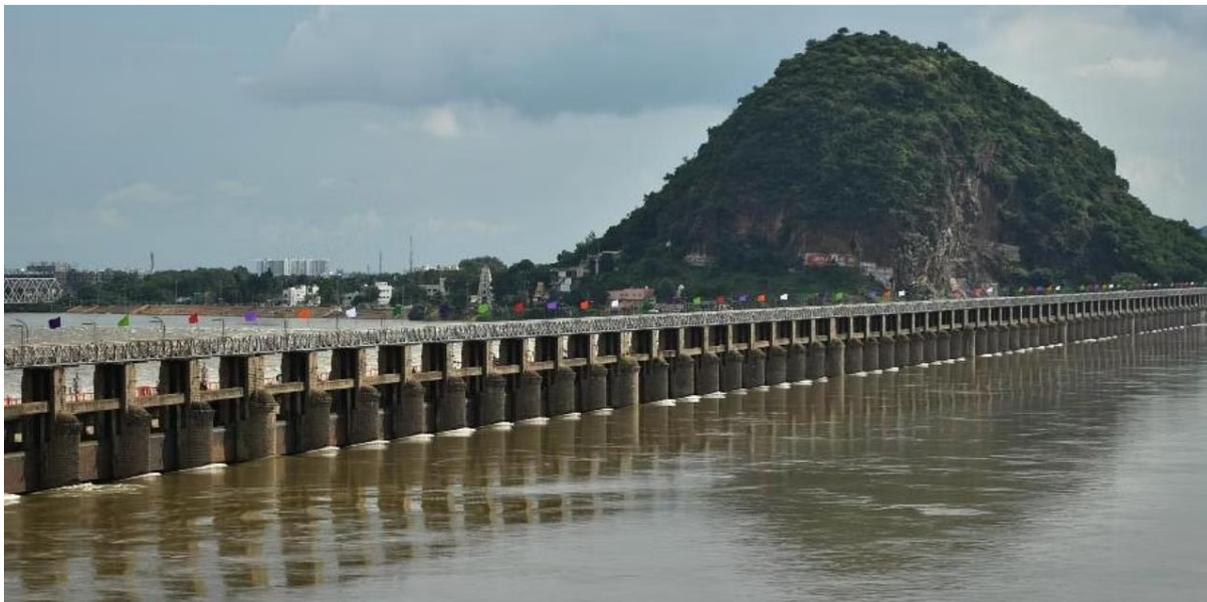
The committee carried out the site visit on 11.05.2022 along with Deputy Director Mines, Guntur and officials from Water Resource Department, GoAP & SEIAA AP. Prakasam Barrage was constructed upstream of River Krishna during 1957 and total length of barrage is 1232.92 m.

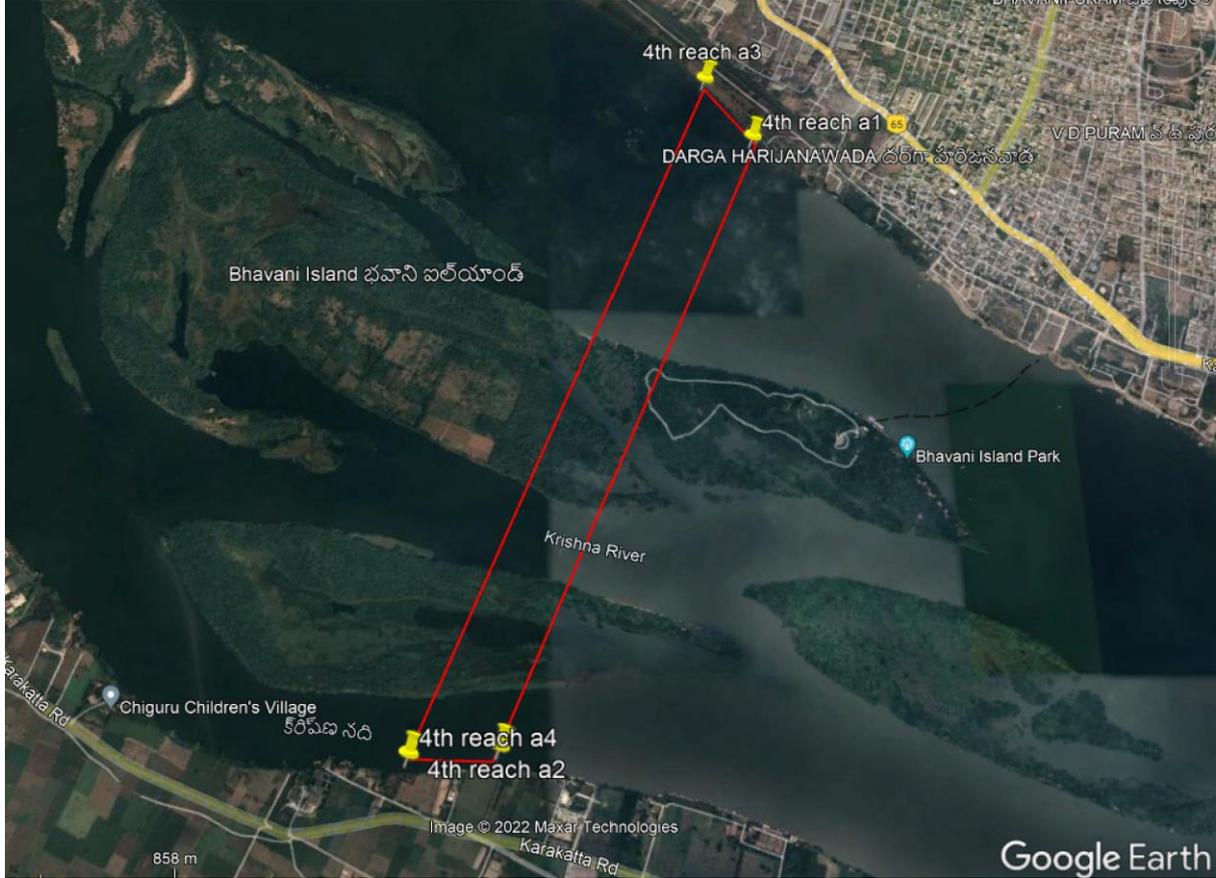
Figure: Satellite image of 4<sup>th</sup> reach

From the satellite image it is observed that the total area allotted for sand extraction is 68.46 hectares. The reach is passing through Bhavani islands. Depth upto which dredging is carried out is not stipulated. WRD has not restricted on the depth of dredging. Stockyard is surrounded

by agricultural land on one side. Proper arrangements were not made in stockyard for the water to drain back into the river. From satellite image it can be observed that the activities in the stockyard have started from November, 2021 onwards. The river width described in the approval and river width as per satellite image is varying.

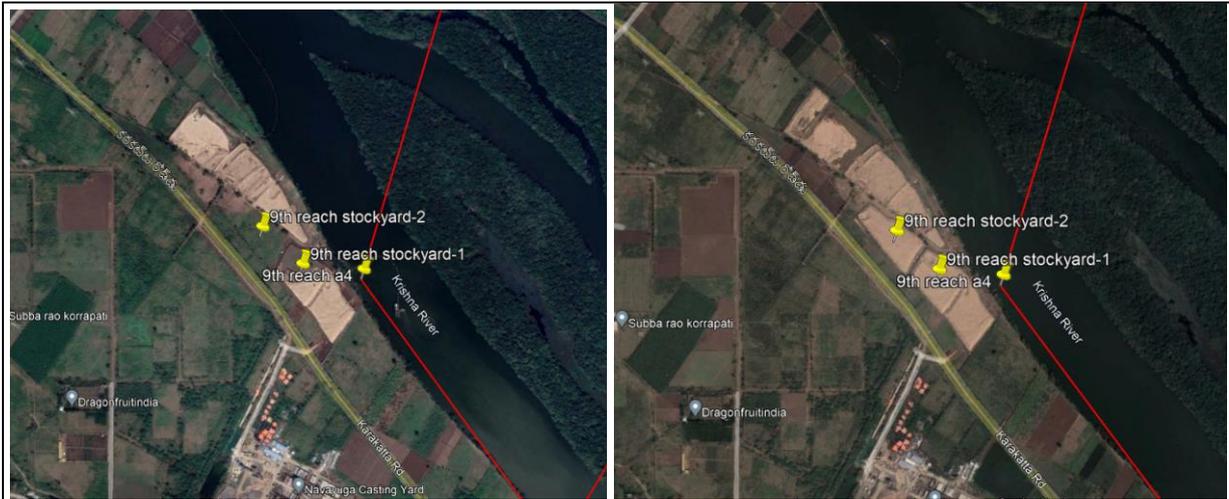
Fig: satellite image of two stockyards during 12/2021 and 2/2022

1	9 <sup>th</sup> reach tank 1	3.0 acres	16°31'52.14"N 80°32'34.57"E	03- 12- 21	05- 01- 22	110000 Cum	100m to 150m	APCRDA land	Lease period 1 yr
2	9 <sup>th</sup> reach tank 2	3.0 acres	16°31'55.06"N 80°32'31.24"E	06- 01- 22	04- 02- 22	105000 Cum	150m to 200m	APCRDA land	Lease period 1 yr

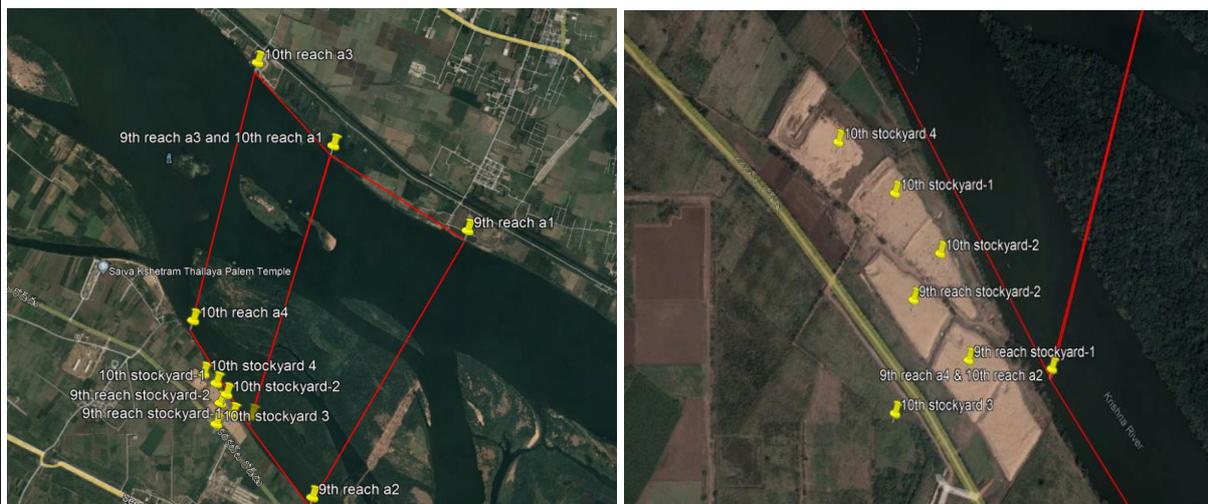
Figure: Satellite image of 10<sup>th</sup> reach adjoin to 9<sup>th</sup> reach. Figure: Stockyard of 10<sup>th</sup> reach

The total area of the reach is 156 hectares. 9<sup>th</sup> reach and 10<sup>th</sup> reach are sharing common boundary on one side. The geo-coordinates of stockyard-3 and the actual location are different. Due care is not taken while establishing stockyard-3 for 10<sup>th</sup> reach.

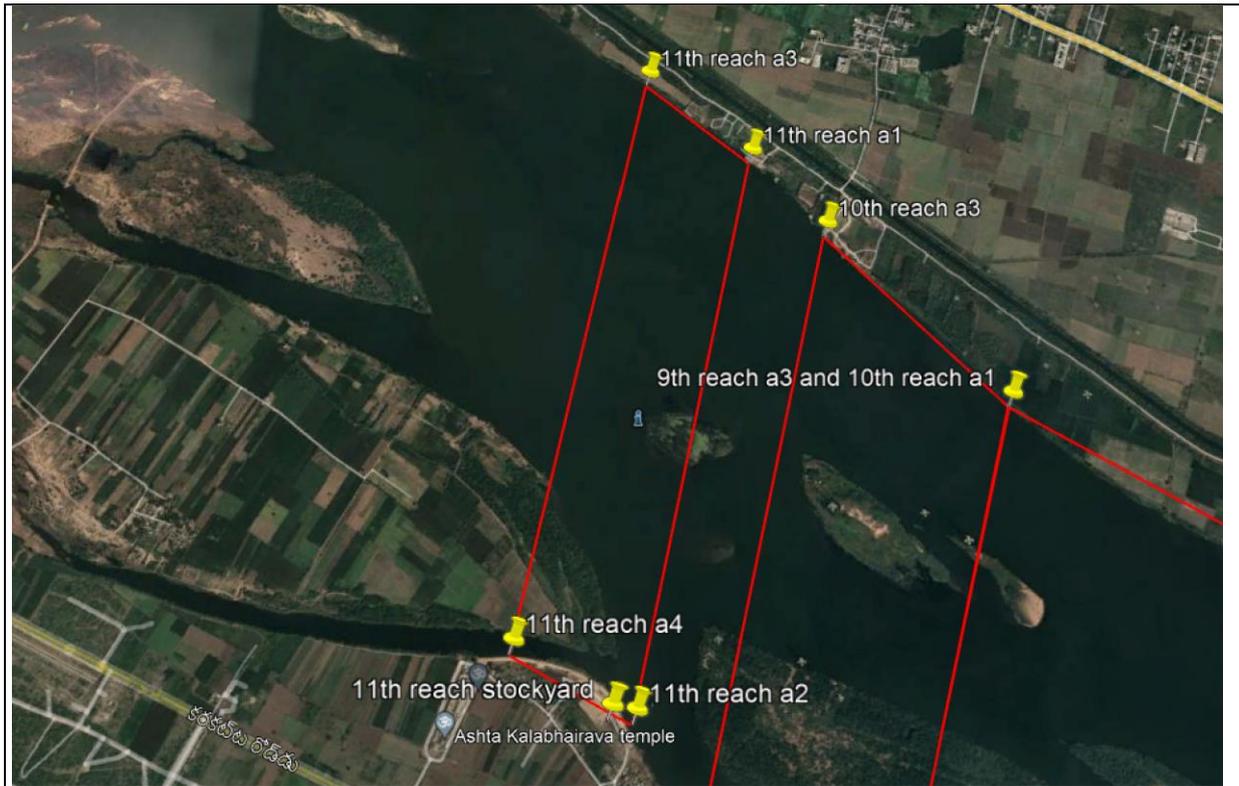
Figure: satellite image of 11<sup>th</sup> reach

The total area allotted for sand extraction is 93.86 hectares. Though as per records the stacking of sand started from 08-01-2022 in stockyard but from satellite images it is noticed that sand is stacked from December, 2021 onwards which also implies that production has started prior to allotted date.
