Report of the Joint Committee as per the direction of the Hon'ble NGT south zone
Case filed in Hon'ble NGT South Zone
O.A. No. 155/2020
Shri Vijeesh Kumar Vs. U.O.I and others

November 2020

State Environmental Impact Assessment Authority
Ministry of Environment, Forest and Climate Change
National Centre for Earth Science Studies
Kerala State Pollution Control Board
Department of Mining and Geology

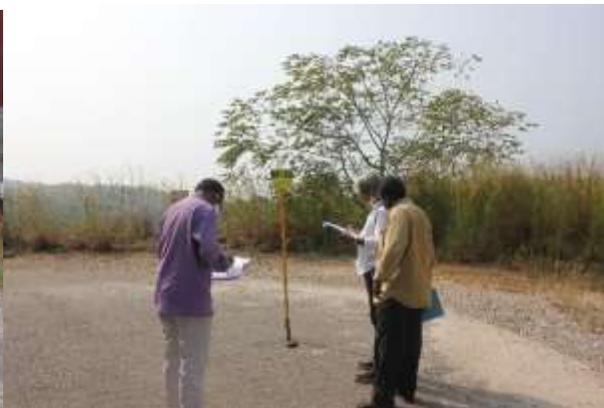
Fig 4 Boundary pillar on the black topped road

BP 12	N8° 38' 54.9"	E76° 57' 16.1"	Encroachment to outside lease area, No buffer
BP 13	N8° 38' 54.9"	E76° 57' 17.3"	Vegetated area
BP 14	N8° 38' 53.9"	E76° 57' 17.7"	BP located in steep and bush area
BP 15 missing	N8° 38' 53.4"	E76° 57' 18.5"	Verified mining seen side lease area. BP
BP 16	N8° 38' 54.3"	E76° 57' 19.2"	Verified No garland canal
BP 17	N8° 38' 55.2"	E76° 57' 18.5"	Verified No garland canal
BP 18	N8° 38' 55.4"	E76° 57' 17.7"	Verified , No garland canal , No Buffer
BP 19	N8° 38' 58.3"	E76° 57' 18.4"	Near Canal. Verified
BP 20	N8° 38' 58.5"	E76° 57' 16.2"	On the road. Not concreted Verified and found correct (Fig.4)

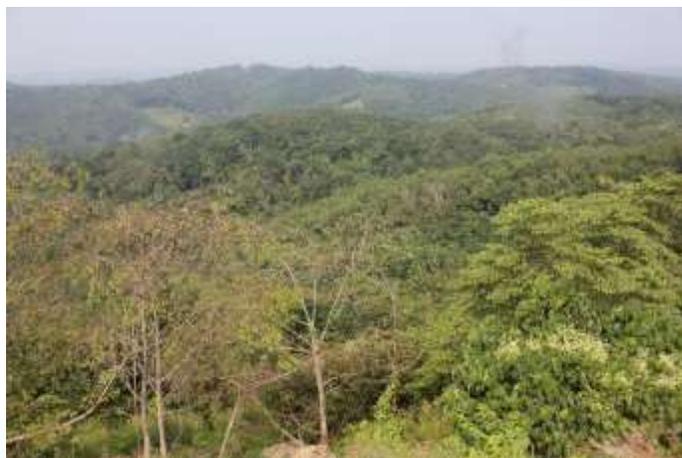
Fig 6 Debris mantle slope on the western side of the quarry. Not quarried

Complied. The Fig. 6 indicates the actual ground condition of the boundary pillars which were given the approved mining plan. In the Specific condition the mining was prohibited in the debris mantle slope on the western side on the lease area . BP 25, 26 , 27 and 1 cover this area. At the time of visit the area is fully vegetated and undisturbed.(Fig 6and 7)

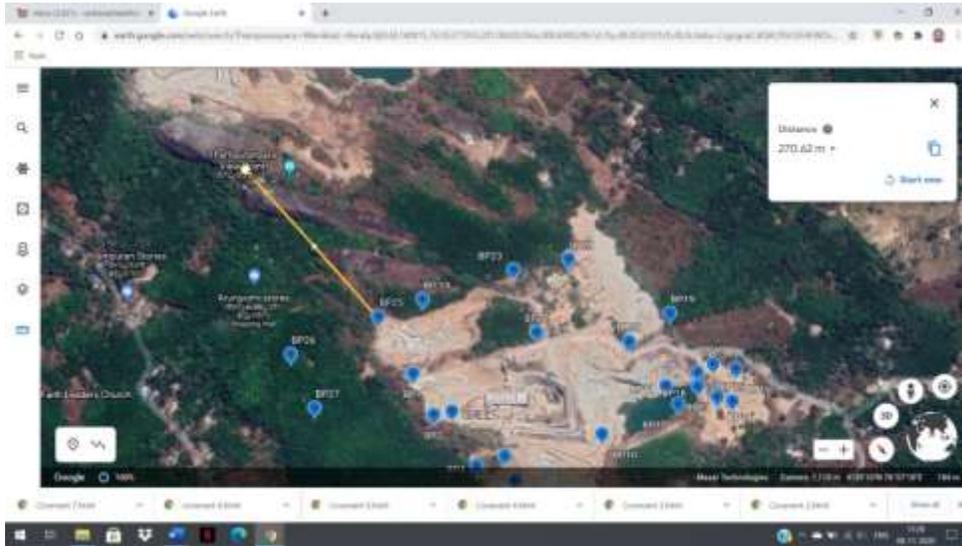
Fig.8. Distance of Thampurapara from the nearest BP in the north is observed.

Complied . There is an aerial distance of approx. 270m from BP 25 to Thampurana para. The distance was measured using tools available in Google earth. (Fig.8). BP 25 BP geo coordinates were verified on the field. So the distance criterion is maintained. At this spot encroached mining

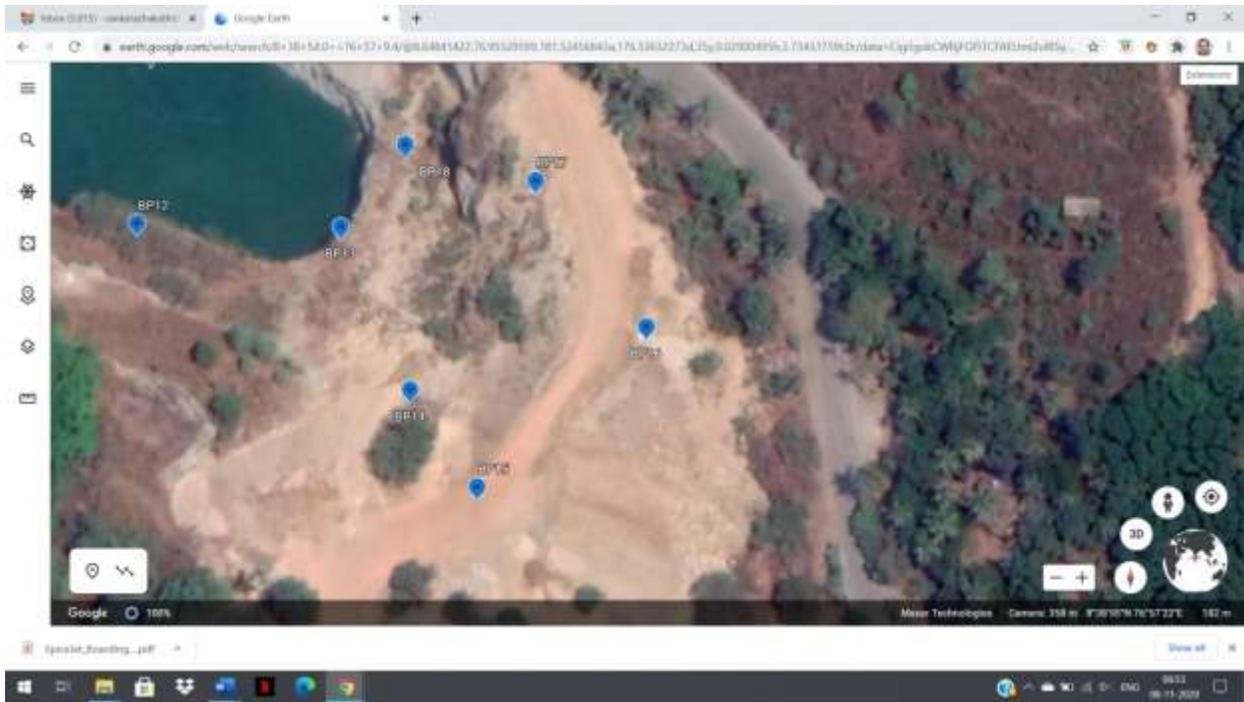
Fig.9 Google image with BP 16, 15, 14, 13, 12 indicates mining was carried out outside the lease area.

Not Complied. The Boundary Pillars with the geocordinates numbering BP1 to BP27 mentioned in the approved mine plan covers the lease area in the sy nos 470.472/41, 474/1, 474/1-1, 474 ½, 472/5, 472/6, 469/4/3/4, 469/4/3/3, 469/4/2, 469/4/1/1, 469/4/1/2,469/4/1/3 and 469/4 at the Manickal village, Nedumangad taluk, Thiruvananthapuram district, Kerala. Field verification and GIS interpretation (i.e. Superimposition of Geocordinates of BP in the Satellite image) it is evident that mining has encroached into the areas beyond the sy.nos mentioned in the environmental clearance. Most affected areas are in the south and southwestern areas. The Department of Mining and Geology (DMG) has carried out an extensive field based survey to find out excessive mining carried out by the Company. DMG have also confirmed that mining was encroached to outside lease area.

In Fig.9, Fig 10 and Fig.11 It is noticed that the boundary pillars are located not on the borders but inside the mining area, indicating that encroachment has taken place.

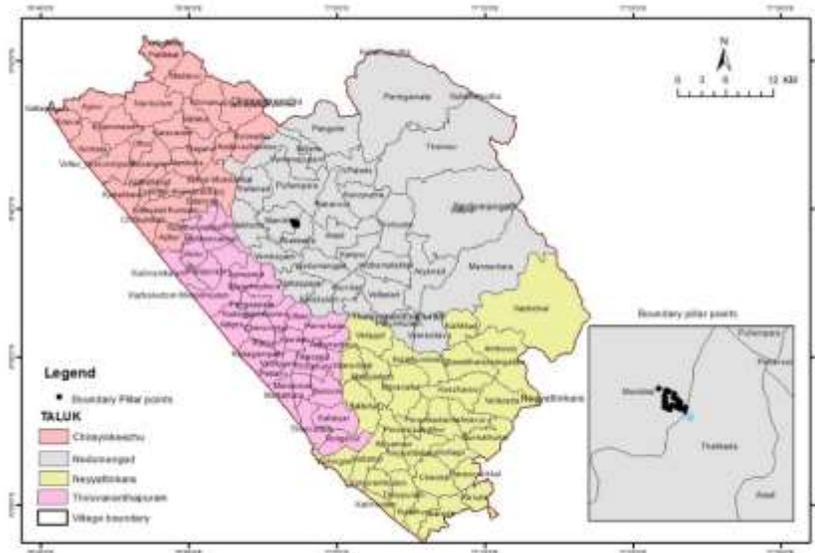
Fig.12 Map showing Taluks and Villages in Thiruvananthapuram district with BP of the quarry

Complied . Cross checked in the field as well as using GIS / satellite image . The Boundary points were plotted on the map (Fig.12) shows that there is buffer maintained from the taluk boundary. The position of the Boundary Pillars near the Taluk boundary are also verified in the field.

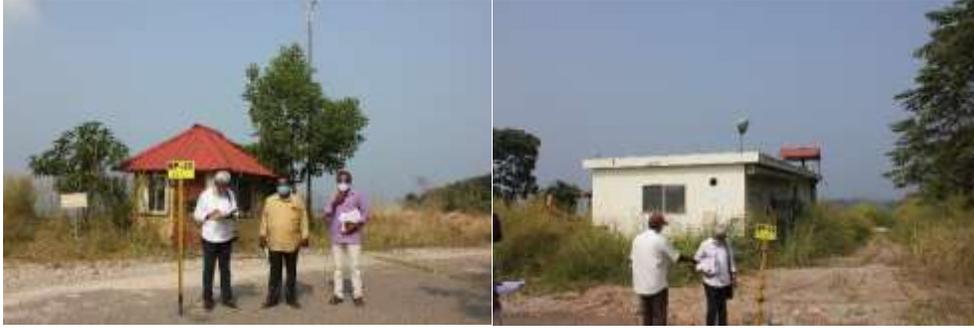
Fig.13. Removable BP in the middle of the road

Boundary pillars are not maintained properly. In couple of places it is either missing or dilapidated. This BP is located on an asphalted road leading to the site (Fig13) . Another one is

also found located in the middle of the road (BP 14) . Both these BP are metallic and removable. This is not permissible for quarrying operations. Mining projects are long term projects and the BP should not degrade with time. Since BP are located in open, metallic poles will be subjected to rusting. So concrete pillars or stone pillars concreted to the base are envisaged in a mining project. At one locality two BP boundary pillars are seen (Fig 15) .

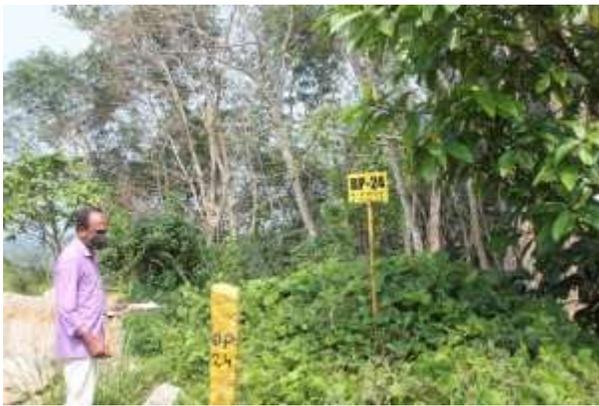
Fig.15 Two boundary pillars are seen near BP 24.

There are two boundary pillars (Fig 15) seen near BP 24 one stone pillar painted as BP24 and the other metallic one with BP24 sticker. The metallic pole is the correct one and the stone pillar with same number is found inside the lease area. This indicates the negligence of the management in maintaining the Boundary pillars (BP). BP 23 is found missing in the spot where it should have located as per the geo coordinates. Few BP are located in steep inaccessible location and could not be verified physically. Their position was checked using GIS / satellite image (Google earth)

(The metallic pole with coordinate gave the correct values)

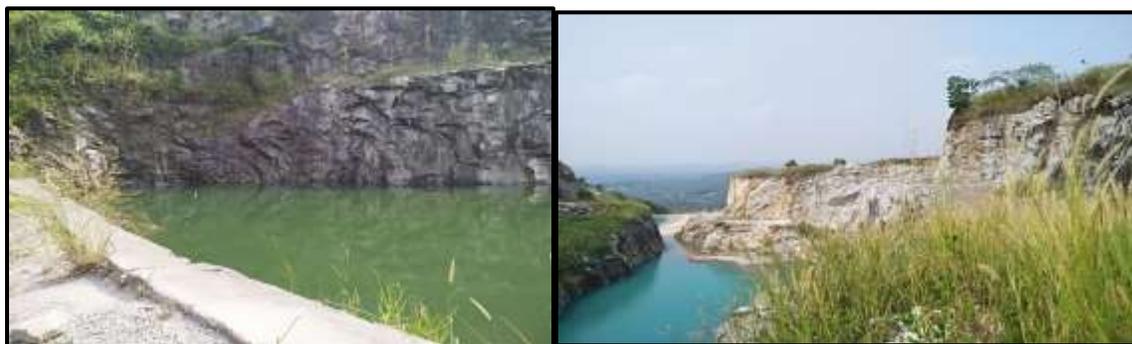
Fig 16. Rainwater harvesting at old mining pits. Fig 17 Rain harvesting pond

Complied. It was noted that PA has made arrangement for collection of rainwater in two ponds. (Fig16 and Fig17). PA has informed that the water is used for sprinkling on haulage road for dust suppression and also for the plantation.

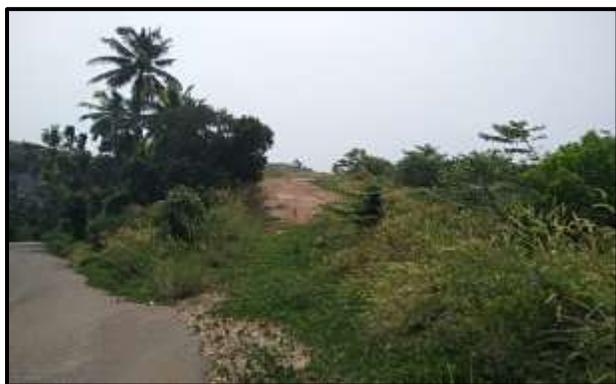
Fig18. Overburden dump area.

Partly Complied. PA has retained old mining pit as a water storage area. However, plantation carried out only at very less area in overburden dump areas.(Fig.18)

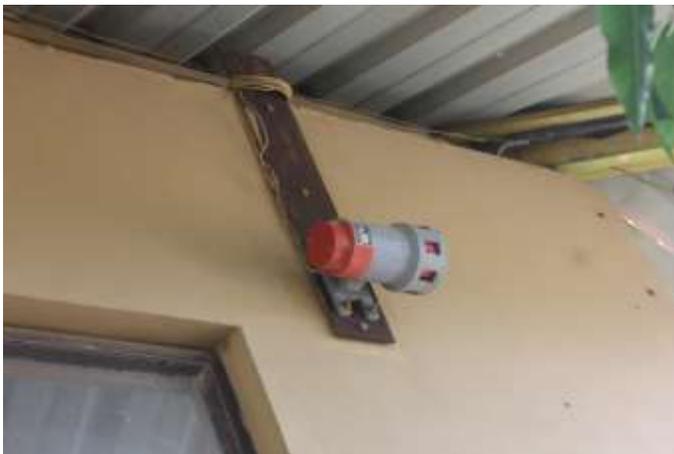
Fig.21 Siren fixed to give warning alarm at the time of blasting

Complied.

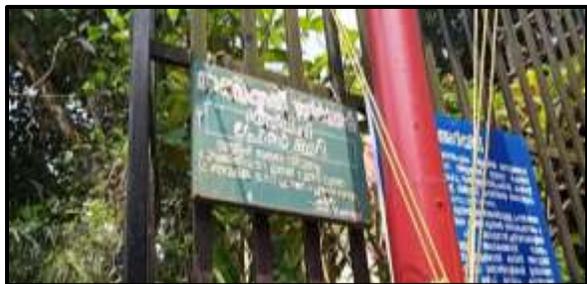
Fig.22 Blasting time board.

Complied. Signage erected at strategic points.

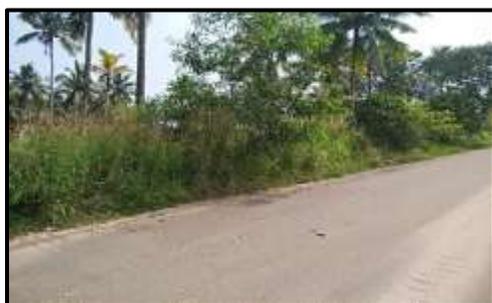
Fig23 . The main access road in Quarry area.

Complied. The main road (Fig.23) is a tarred (black topped) road. The small roads branching from main road is not tarred (Fig.24)

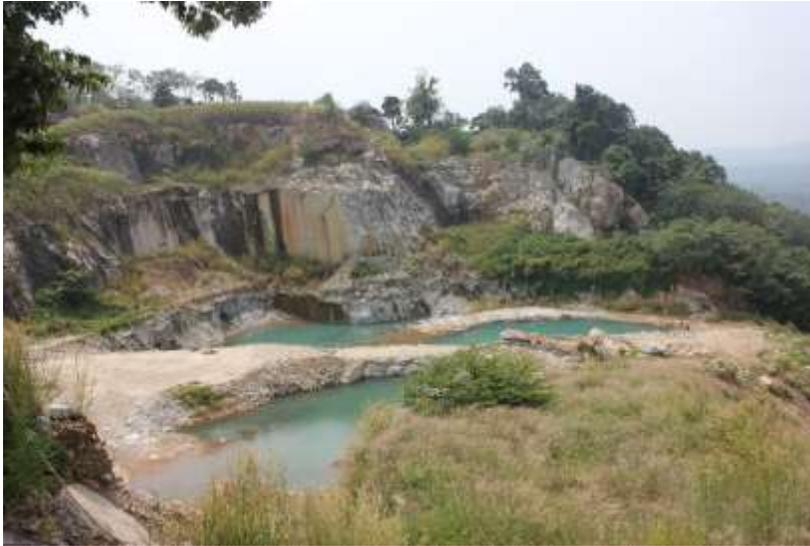
Fig. 25 5m x 5m benching method is not adopted here

Not complied. Height and width of benches not maintained (Fig25) as per EC conditions. All benches are mined out to extract more materials.

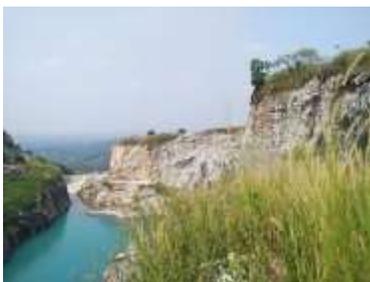
Fig.26 Mining depth exceeded 10m

3.2219 General Condition 19
level at site shall not exceed 10m
 Not complied (Fig.26)

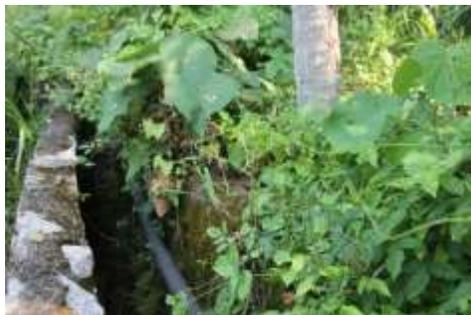
Fig. 27 The Garland canal is located near BP 19 .

Not complied. There is one canal (Fig.27) going for a short distance without any silt traps near BP19. This drain is now being used as a duct for cables and it not maintained properly. The garland drain is being used to drain mine drainage. It should be located between the benches and the buffer. The rain water falling on the benches should drain through these garland canals and the silt should deposit in the silt traps provided in these canals before joining the common public drainage system. Such an arrangement is not adopted here.

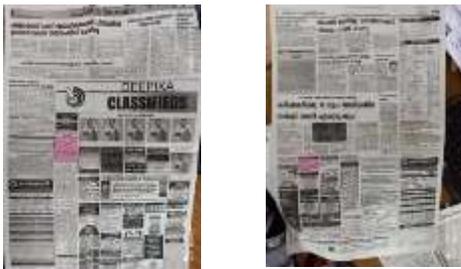
Fig. 28 Advertisement in Deepika and Mangalam daily

Complied.(Fig 28).

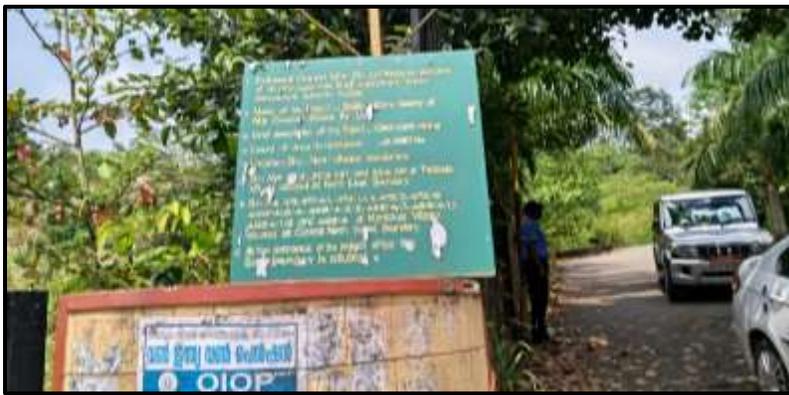
Fig.29 EC display board at entrance.

Complied. PA has provided display board (Fig.29) at the entrance of the quarry for public.

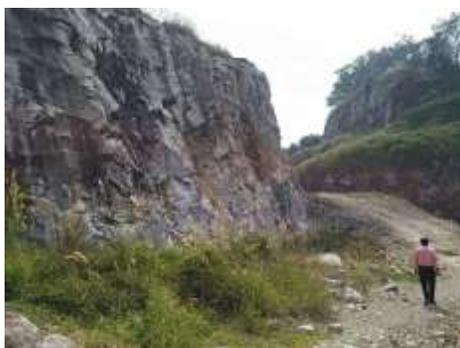
Fig.30 Benches and buffer area mined out

According to the DMG Geologist's report "The Dimension stone lease area was inspected on 06.11.2020 with the taluk surveyor . it was observed that the lease holder had extracted Granute Dimension stone far in excess of the permitted quantity in the lease . In that case a show cause case notice had served to the lease holder on 12.11.2020 only on receipt of explanation proper legal steps will be initiated to reliaise the loss sustained to the Government." (Annexure 4)

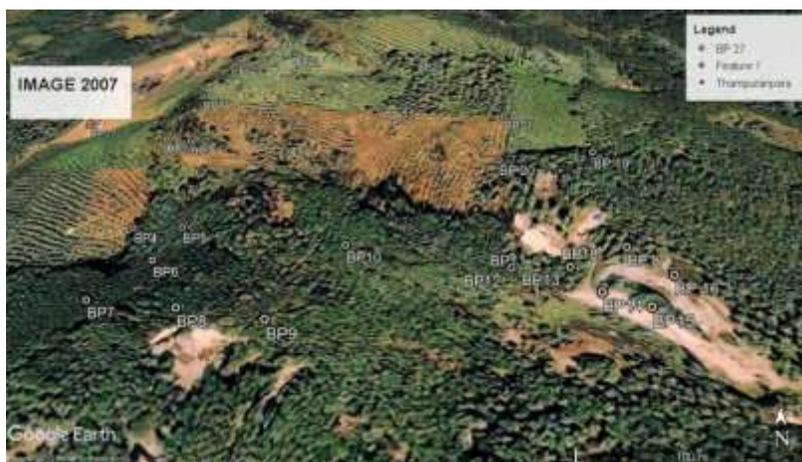
Fig.32 Google map of the lease area in 2007. quarrying activity seen near BP8,14, 16, 17,18. 14

Fig. 31 to Fig. 38 indicates the changes that have happened to the lease area of the Covenant quarry from 2003 to 2020. Before starting full scale quarrying in 2015 , quarrying activity was noticed in 2003 itself (Fig. 31) . Fig 32, 33 and 34 indicates quarrying activity near BP 7 and 8
