ACTION TAKEN REPORT OF JOINT COMMITTEE
CONSTITUTED AS PER THE ORDER OF THE HON'BLE
NGT (SZ), CHENNAI

ORIGINAL APPLICATION NO 164 of 2017 (SZ)

ACTION TAKEN REPORT OF JOINT COMMITTEE SUBMITTED BEFORE THE HON'BLE NATIONAL GREEN TRIBUNAL, SOUTHERN ZONE, CHENNAI IN THE MATTER OF ORIGINAL APPLICATION NO. 164 OF 2017 (SZ), M. DHAMOTHARAN Vs THE SECRETARY TO GOVERNMENT, ENVIRONMENT & FOREST DEPARTMENT, GOVERNMENT OF TAMILANDU, AS PER ORDER DATED 16thFEBRUARY, 2021

2. Status of Action taken to improve the water quality of Nallaru Odai and Nanjarayan Lake;

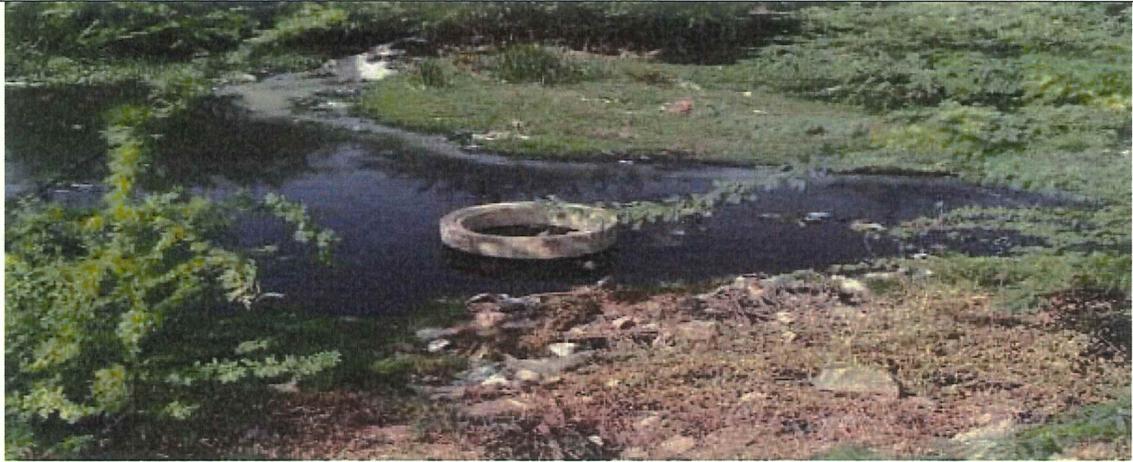
Online TDS Monitoring Station in Nallaru Odai in the Downstream of Park CETP member units

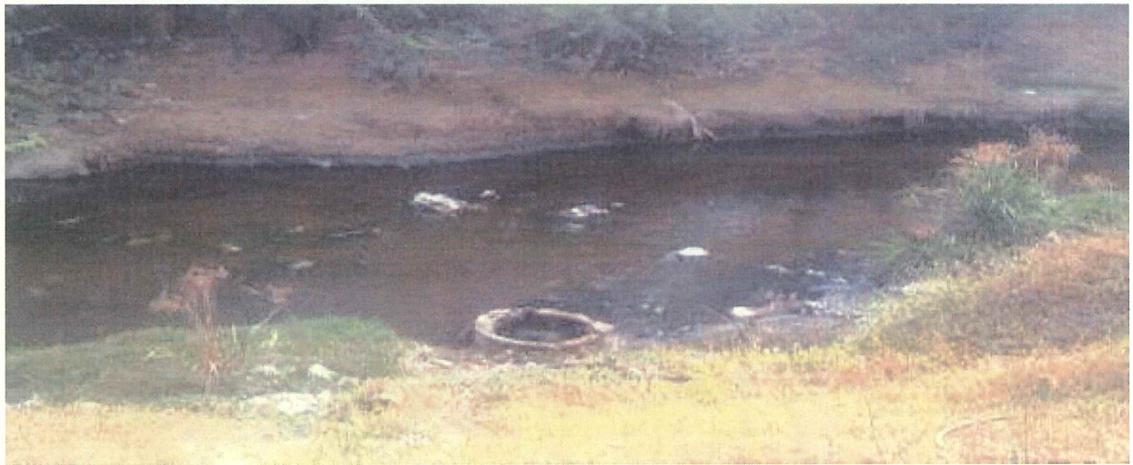
Online TDS Monitoring Station in Nallaru Odai—in the Downstream of Angeripalayam CETP & its Member units

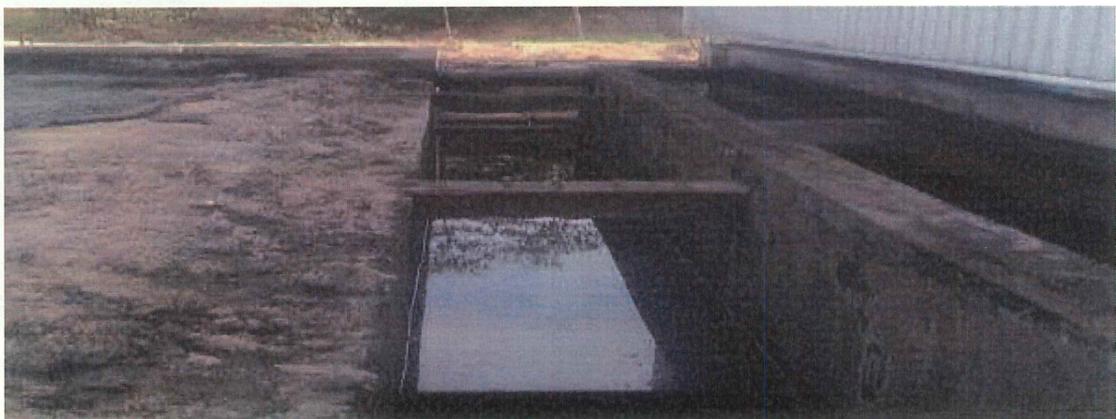
Online TDS Monitoring Station in Storm Water drain inside the Angeripalayam CETP premises

- The CETP has provided online monitoring system (pH, EC, TDS) in the Storm Water drain located within the CETP premises.
- The CETP has removed the solar evaporation pans area of 1884 Sq.M as per the instructions of committee and the details of the same are as mentioned below:

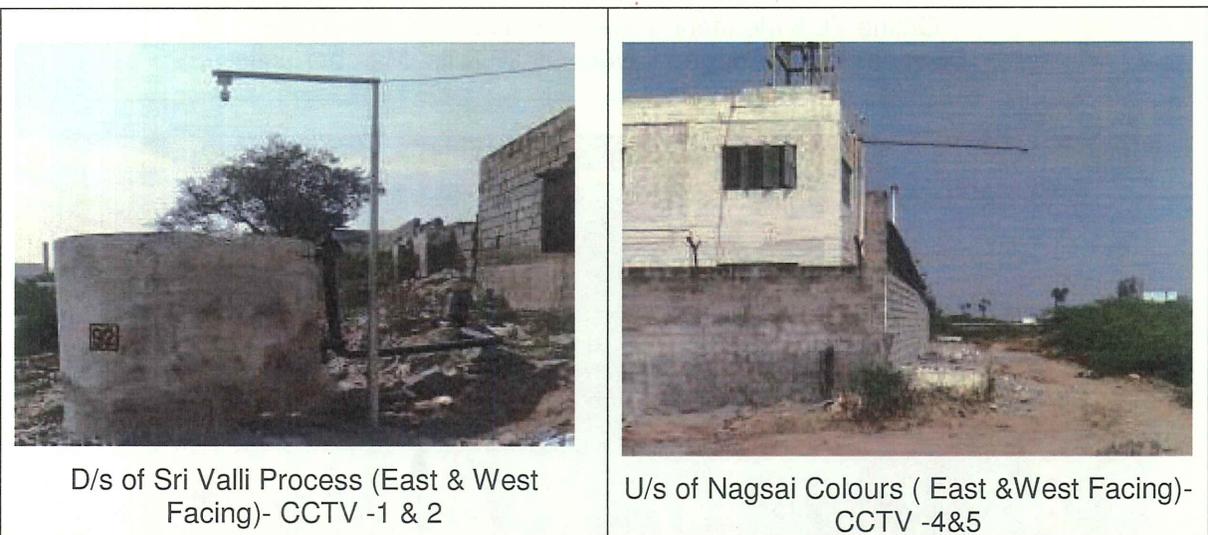
D/s of Sri Valli Process (East & West Facing)- CCTV -1 & 2

U/s of Nagsai Colours (East &West Facing)- CCTV -4&5

Angeripalayam CETP has installed 6nos of surveillance CCTV cameras to monitor the pipe line and manhole for leakages if any in six following locations:

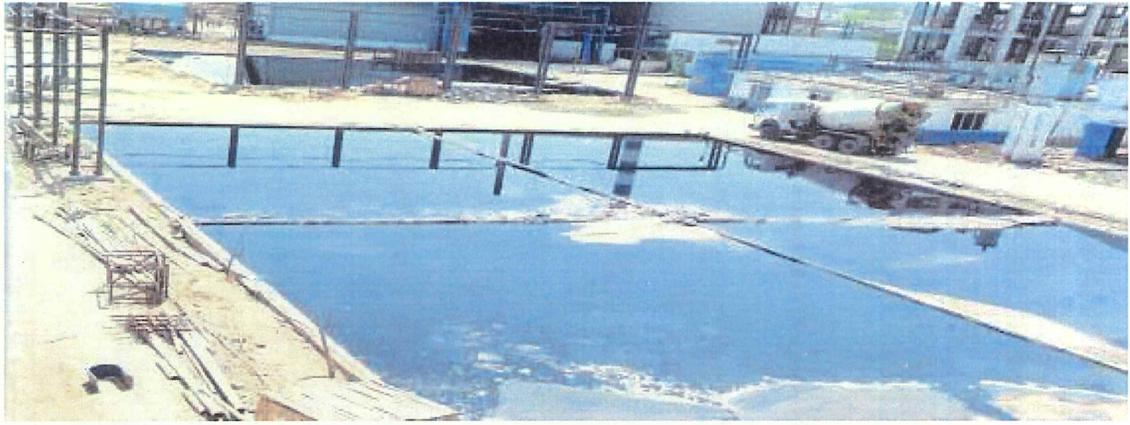
Before Dismantling of Solar Evaporation Pans

- a) The CETP has removed the salt from these solar evaporation pans which was noticed by the committee during earlier inspection and the same is stored safely under covered shed.

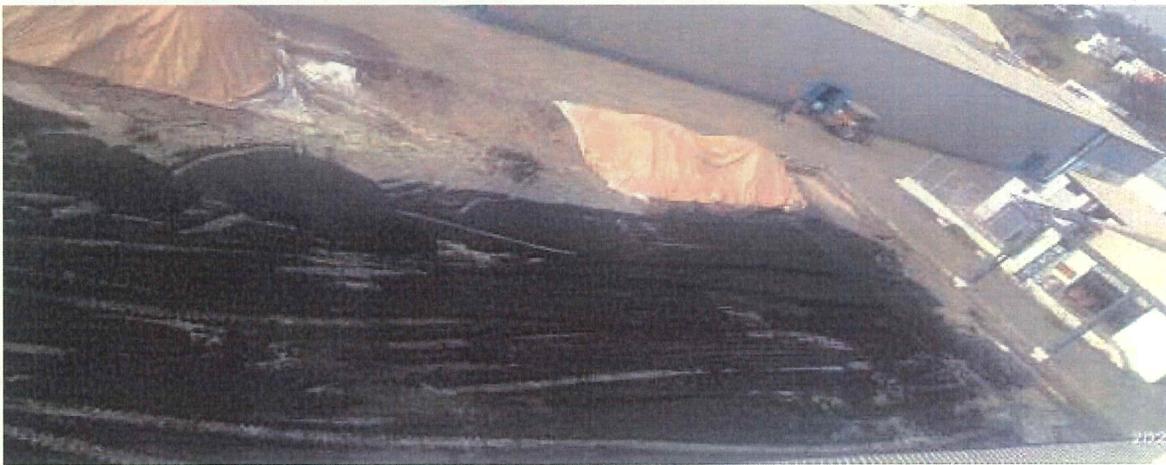
After Dismantling of Solar Evaporation Pans used for Bio Sludge drying

- b) The CETP has converted the solar evaporation pans area I part of 466.sq.M as chemical sludge storage shed.
 - c) The CETP has converted the solar evaporation pans area II part of 466.sq.M as Bio sludge storage shed.

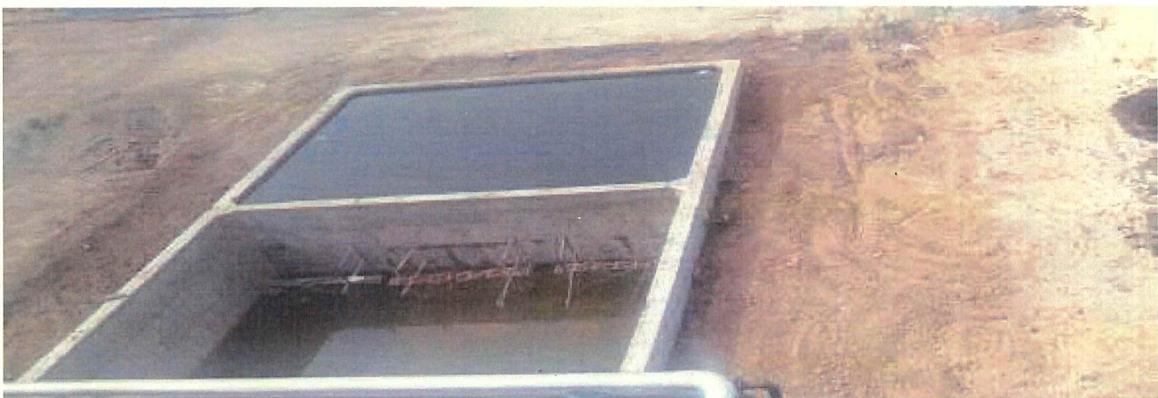
Previous Solar Evaporation Pan area utilized for MEE CIP drain tank

- d) The CETP has converted the solar evaporation pans area III part of 466.sq.M as Multiple Effect Evaporator -III Clean In Place Drain tank
 - e) Balance 486 Sq.m area of solar evaporation pan is utilized as bio sludge drying yard with polycarbonate roofing (Construction under progress).

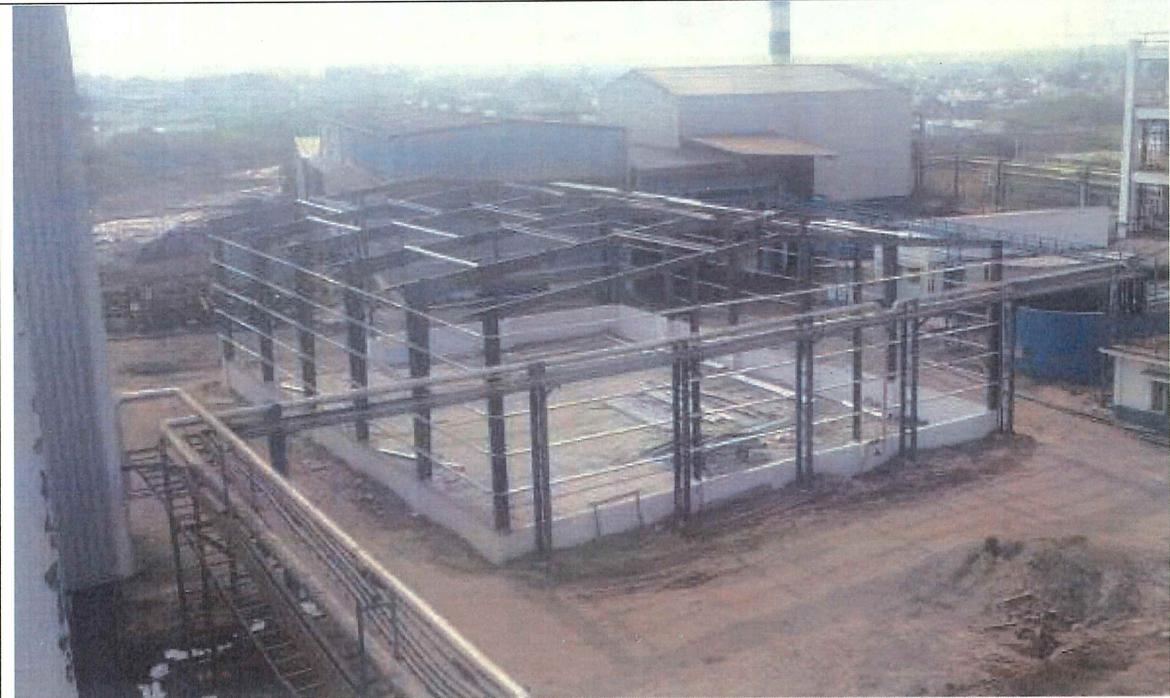
Bio Sludge drying shed to be covered with polycarbonate sheet

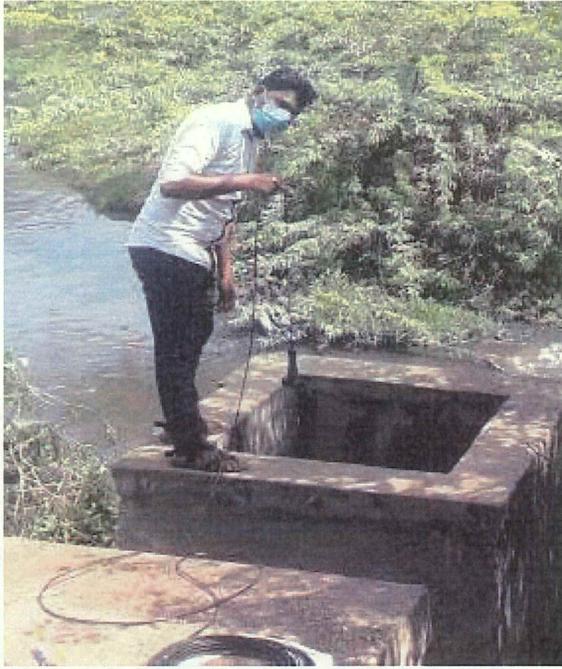
Online TDS Monitoring Station in Nallaru Odai in the Upstream of Member units of Park CETP View -I

- ❖ **Installation of online TDS:** Park CETP has installed online TDS monitoring station in Nallaru Odai in the upstream of Park CETP member units.

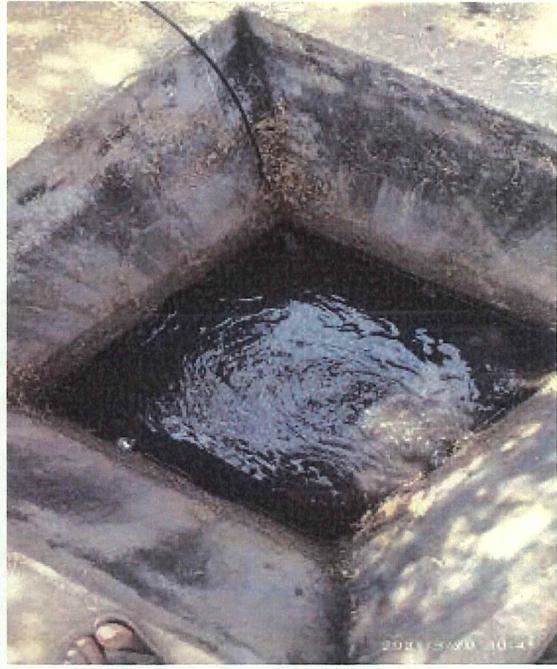
Online TDS Monitoring Station in Nallaru Odai in the Upstream of Member units of Park CETP View-II

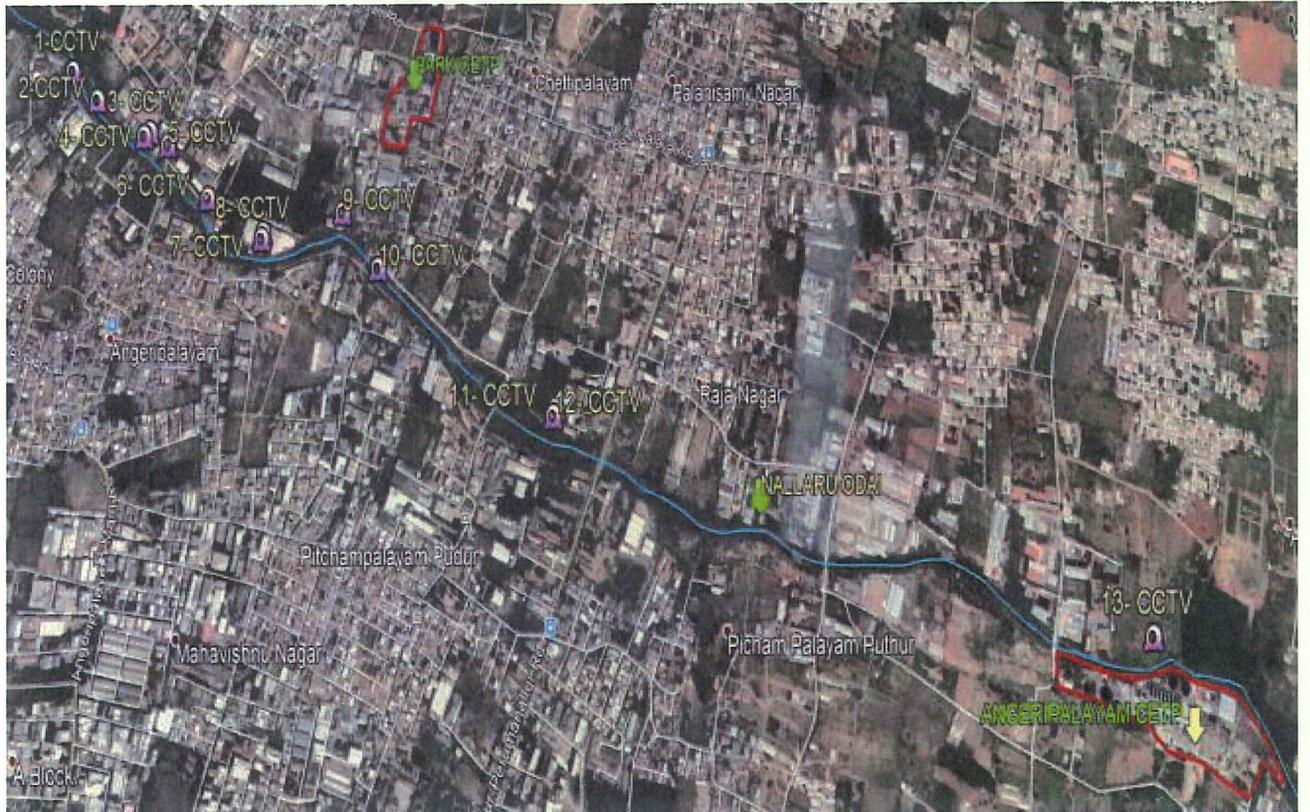
Google earth map showing the locations of CCTV fixed by Angeripalayam CETP and Park CETP to monitor the manholes and pile lines along Nallaru Odai

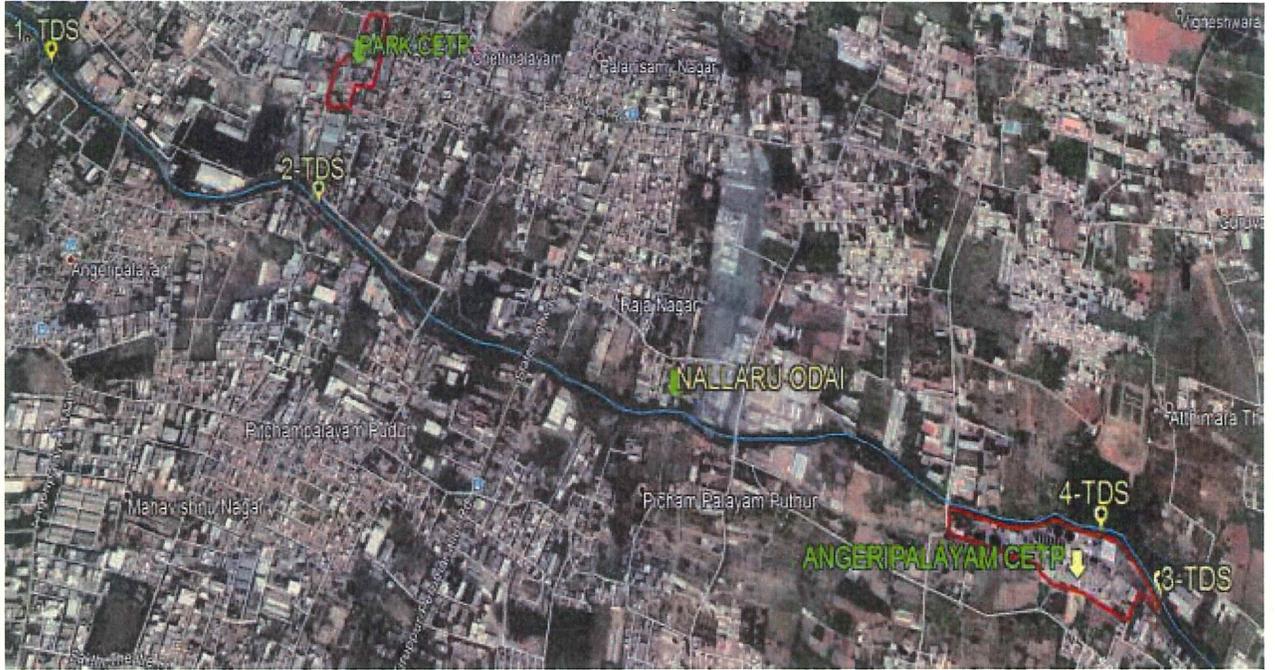
Google earth map showing the locations of Online TDS Meter fixed by Angeripalayam CETP and Park CETP to monitor the TDS in Nallaru Odai

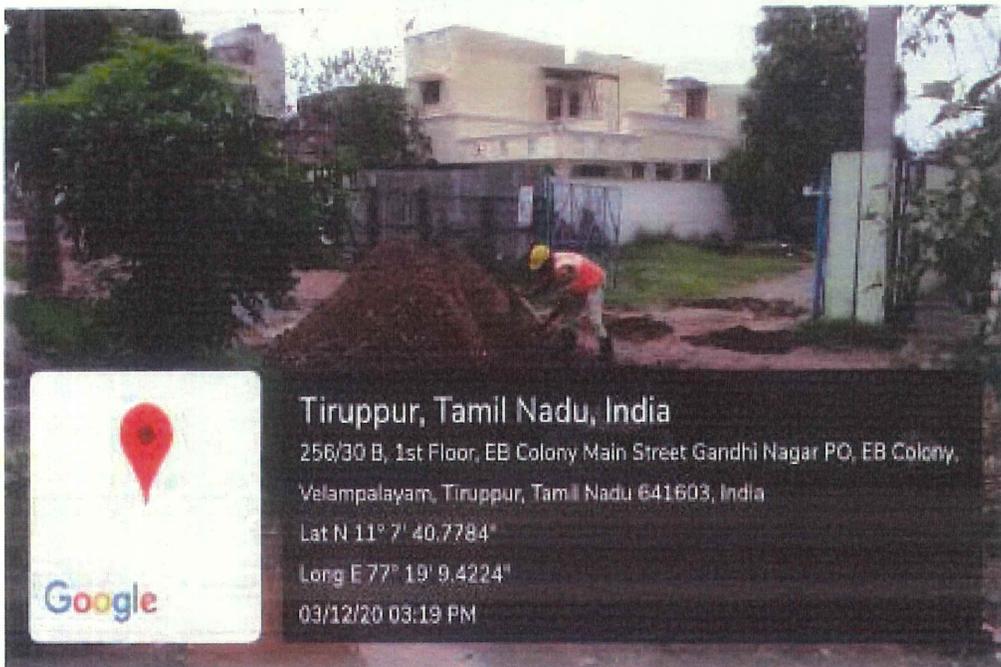
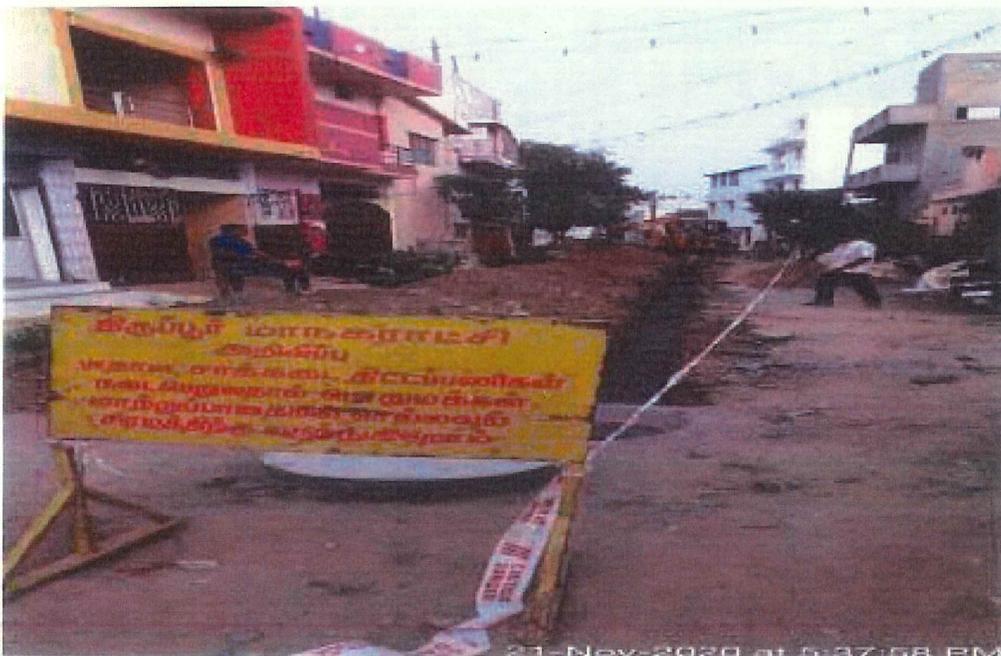
Manhole Erection & Collection System laying Works at EB Colony main road

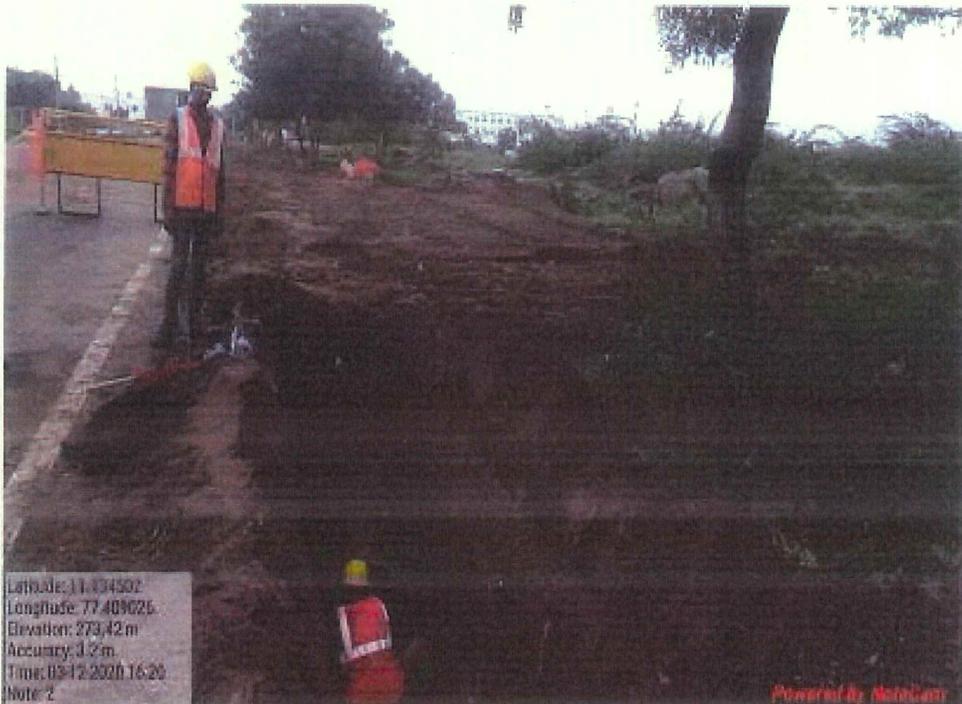
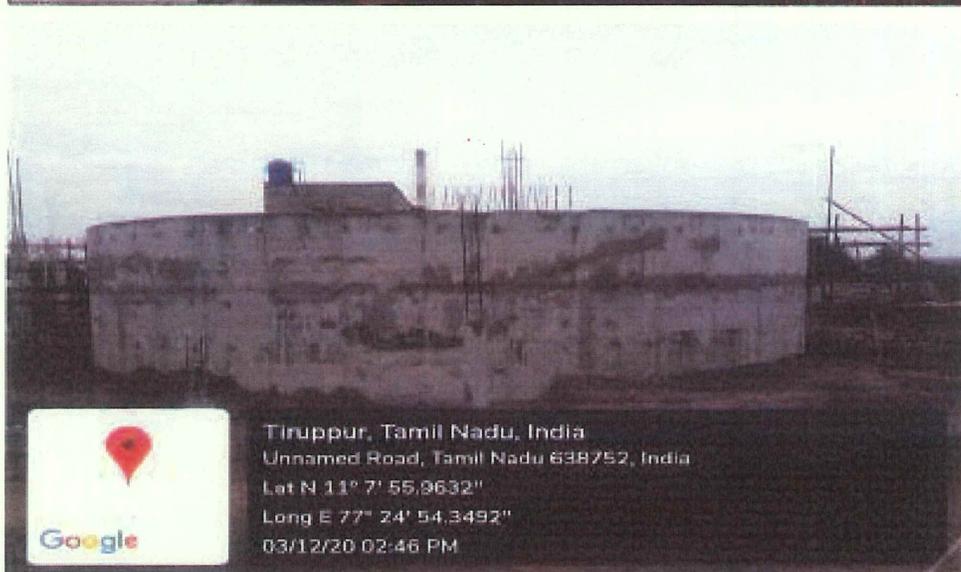
Pumping Main 600mm CI-Pipe laying at Uthukulmain road & 36 MLD STP Work
