ORIGINAL APPLICATION NO. 120/2023/EZ

AFFIDAVIT FILED BY THE WEST BENGAL
POLLUTION CONTROL BOARD.

Inspection Report

Photographs taken during inspection of M/s Ridhi Sidhi Construction Materials on 22.01.2024

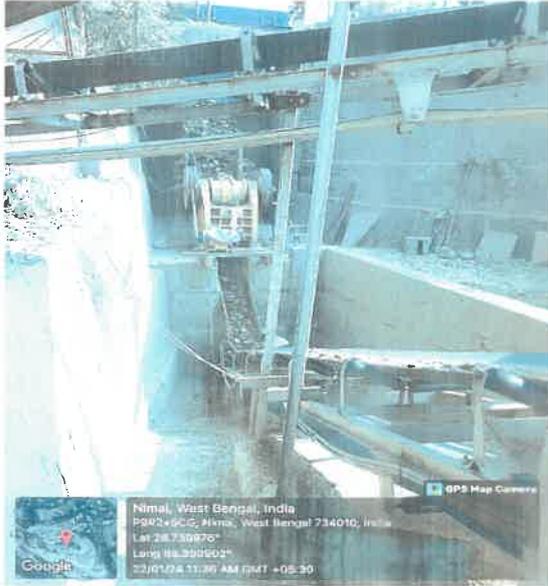
Sl no	Fugitive Emission Source	Present status of the unit
01	Unloading area of raw material, primary crusher, screener, conveyor belts and transfer points	Raw Material handling area: - Water sprinkling system available in the unloading area of raw material. Primary Crusher: - Two nos. of primary crusher was available. Out of which one of them was under maintenance. The primary crushers were not covered with GI/MS sheet. However, screener was covered with GI/MS sheet. Water sprinkling system with designed nozzle was available and operational for the primary crusher and screeners. (Pic. - 1)
02	Covering of conveyor belts from node to node with a thick sheet of suitable material	Conveyor belts were uncovered. (Pic. - 2)

Primary Crusher
(Pic. – 1)

1. The primary crushers were not covered with GI/MS sheet.
2. Conveyor belts were uncovered.
3. Secondary crushers were not equipped with dry extraction cum bag filter followed by cyclone.

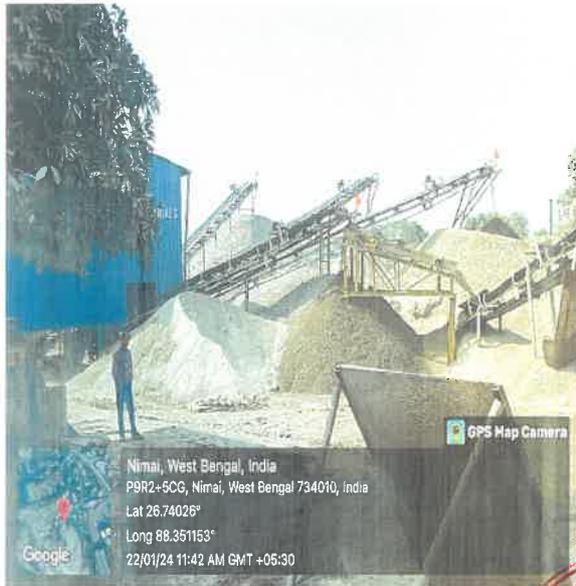
Conveyor Belts were uncovered
Flexible chutes not found at all the final
discharge points
(Pic. – 2, 3)

4. Flexible telescopic chutes were not installed at the discharge points of all conveyor belts upto ground level.
5. GI/MS/Brick wind breaking walls were not provided around the periphery of crusher mill.

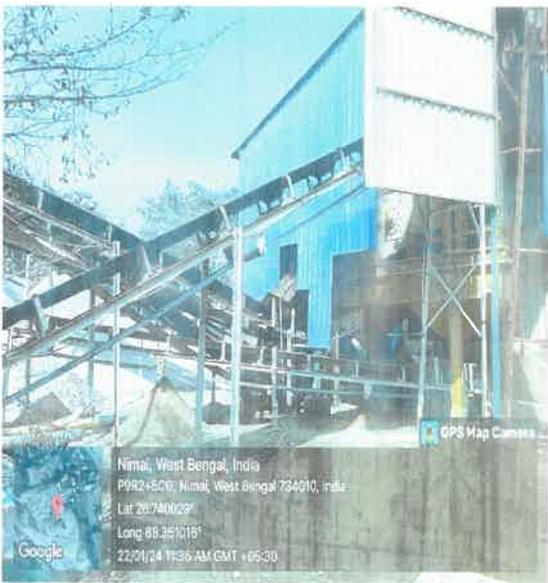
03.	Secondary, Tertiary crushers and screeners shall be equipped with dry extraction cum bag filter followed by cyclone	The unit had total 5 nos. of secondary crushers. The crushers were covered with GI/MS sheet. Water sprinkling system with designed nozzle was available and operational. (Pic. - 3) However, they were not equipped with dry extraction cum bag filter followed by cyclone.
03	At discharge points flexible telescopic chute from top of discharge points to the ground level	Flexible telescopic chutes were not available at the discharge points . (Pic. - 4)
04	GI/MS/Brick wind breaking wall of 3ft more than the highest node of the crusher along the periphery of the crusher	Wind breaking walls were not provided around the periphery of crusher mill. (Pic. - 5)
05	Metalled/Concrete roads within the premises. Ramps and the entire ground area inside the premises should also be metalled	Road within the premises is of earth work. No metalled roads available within the premises and ramps. Dust suspension & Waterlogging in the premises was seen. (Pic. 6)

Secondary crusher covered with GI/MS sheet
(Pic. – 4)

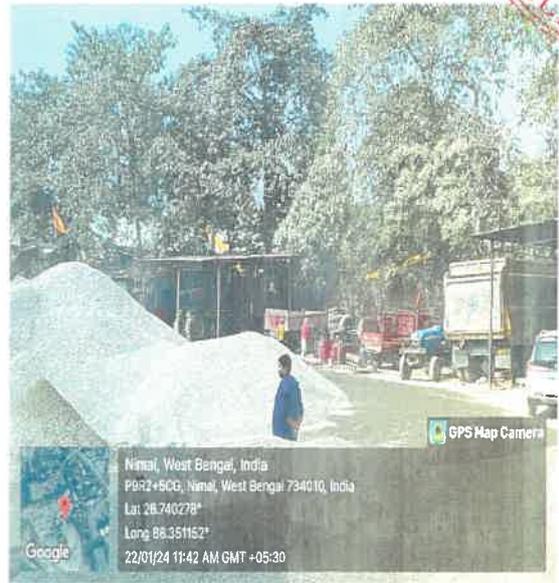
No wind breaking wall around the periphery
of the crusher mill!
(Pic. – 5)

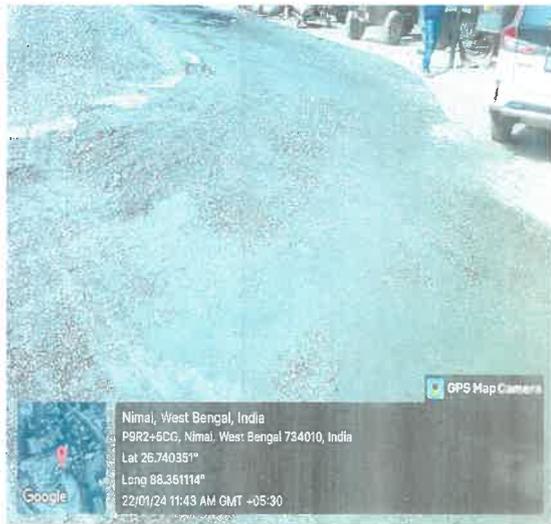
Unmetalled Road
(Pic. - 6)

6. No metalled roads available within the unit premises.
7. No enclosed stone dust storage room was installed. Stone dust was found to be stored within open area.

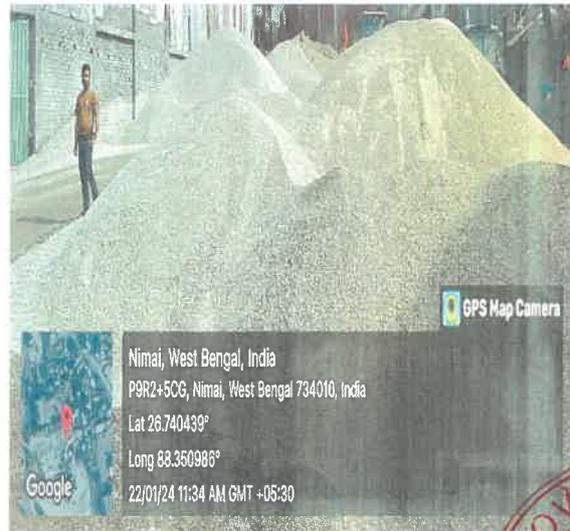
Other Observations: -	
01. Dust Storage	The occupier of the stone crusher had not provided dust room. At Present huge quantity of stone dust was laying on the stone crusher area (Pic. - 7)
02. Provision for recycling of wastewater generated during dust suspension and crushers	No settling tank was available for recycling of the wastewater generated during dust suppression and from the crusher. Waterlogging within the premises was seen.
03. National Park/ Wildlife Sanctuary/ Eco-sensitive zone as per the list of Department of Forest, Govt. of WB	The unit does not fall in any notified National Park/ Wildlife Sanctuary/ Eco-sensitive zone (ESZ) as per the list of Department of Forest, Govt. of WB. The Distance of the stone crushing site from the ESZ boundary of Mahananda Wildlife Sanctuary on the basis of geo-coordinates is approx. 7.62 Km as measured on google map. (Distance map enclosed)

No Dust storage room provided
(Pic. - 7)
