BEFORE THE NATIONAL GREEN TRIBUNAL  
EASTERN ZONE BENCH, KOLKATA

Original Application No. 150/2022/EZ

INSPECTION REPORT

THE COMMITTEE CONSTITUTED BY THE HON'BLE NGT IN O.A. NO. 150/2022/EZ IN THE MATTER OF PI VANRAMCHHUANGI VS UNION OF INDIA & ORS ON THE 6 (SIX) STONE QUARRIES INSIDE THE TLAWNG HNAR RESERVED FOREST CARRIED OUT ON 1<sup>ST</sup> MAY, 2024

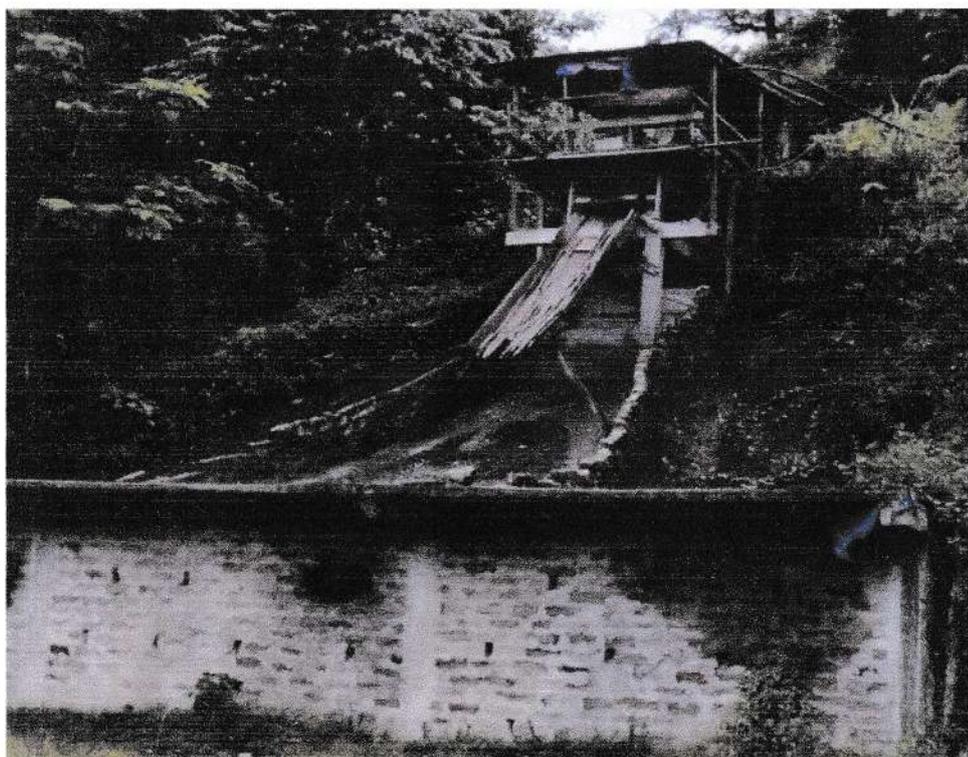
**6. i. Report on the Stone Crusher & Stone Quarry of Shri Raymond Zonunsanga:** The Committee started its inspection on the stone crusher and quarry of Shri Raymond Zonunsanga which is located near the District Park, Lunglei. The GPS co-ordinates of the Stone Crusher Unit is N 22°50'55.9" E 092°48'51.7" Elevation: 3607 ft. The crusher is 64 mtrs away from NH-54 and distance from Tlawng RRF is 26.7mtrs (Photo 1). The GPS co-ordinates of the Stone Quarry are N 22°50'53" E 092°48'49". The Stone Quarry is 143.92 mtrs away from NH-54 and distance from Tlawng RRF is 116.71 mtrs (Photo 2). The site is located within the boundary of the Tlawng Hnar Reserved Forest (RF). The Committee observed that both the stone crusher and stone quarry are not in operation and natural growth of vegetation in the periphery of the stone quarry have already started.

**Photo 1. Stone Crusher of Shri Raymond Zonunsanga**

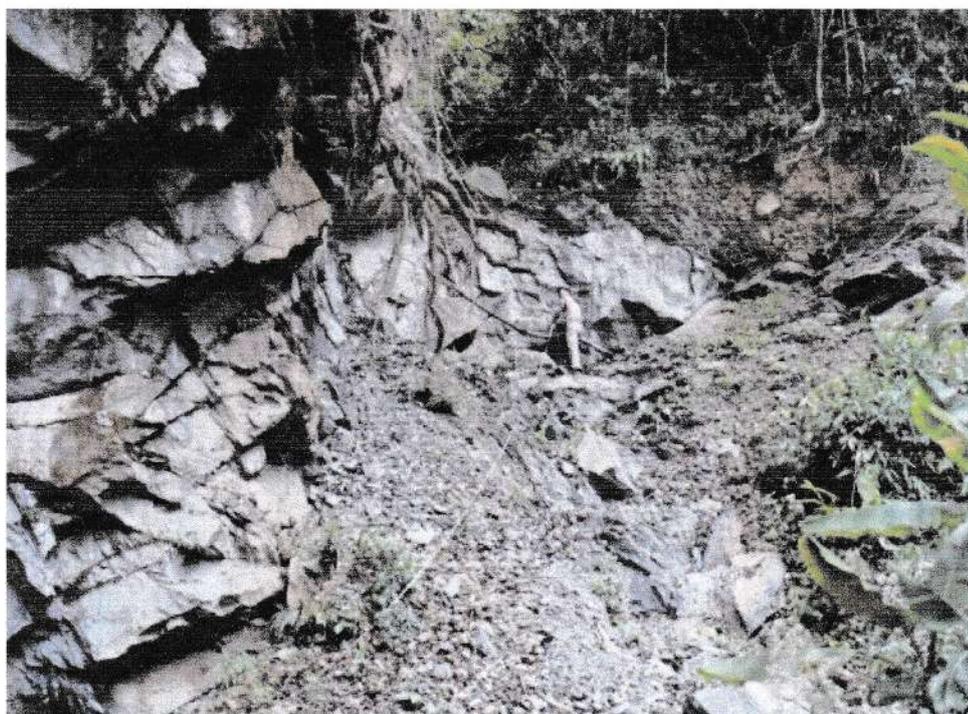
The Committee takes measurement of the damaged/broken portion of the mining area belonging to Shri Raymond Zonunsanga (stone quarry) and recorded as under:

- ✓ Length= 13.6 mtrs, Breadth= 7.17 mtrs and Height= 4.25 mtrs
- ✓ Hence the Volume of extracted stoned/mined stone=414.426 m<sup>3</sup> (13.6 × 7.17 × 4.25)

**Photo 2. Stone Quarry of Shri Raymond Zonunsanga**

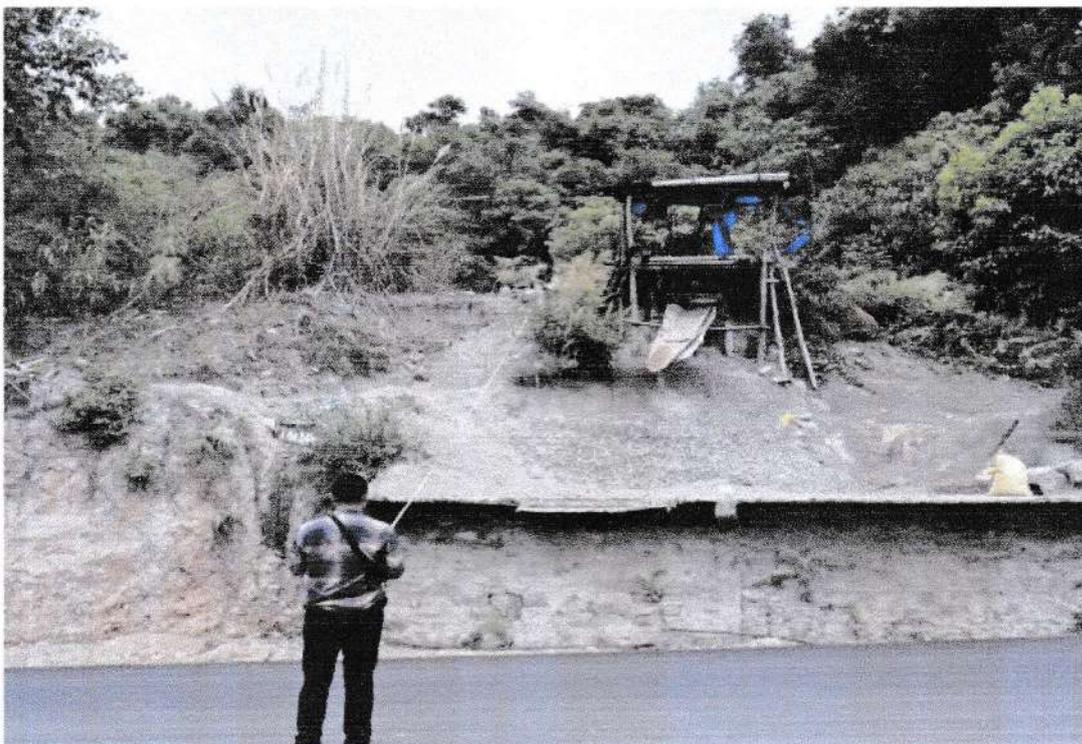
**6. ii. Inspection on the Stone Crusher & Stone Quarry of Shri Thanchhuma:** The next inspection was done on the Stone Crusher and Stone Quarry of Shri Thanchhuma which is located adjacent to NH-54. The GPS co-ordinates of the Stone Crusher Unit are N22°51'00.1" E092°48'38.3" Elevation is 3674 ft. The Stone Crusher is located 16 mtrs away from NH-54 and distance from Tlawng RRF is 72.13 mtrs (Photo 3). The GPS co-ordinates of the Stone Quarry are N 22°51'00" E 092°48'38". The Stone Quarry is 38 mtrs away from NH-54 and distance from Tlawng RRF is 86.88 mtrs (Photo 4). The site is located within the boundary of the Tlawng Hnar Reserved Forest (RF). The Committee observed that both the Crusher and Quarry are not in operational and thick growth of natural vegetation in the periphery of the stone quarry had already developed.

**Photo 3. Stone Crusher of Shri Thanchhuma**

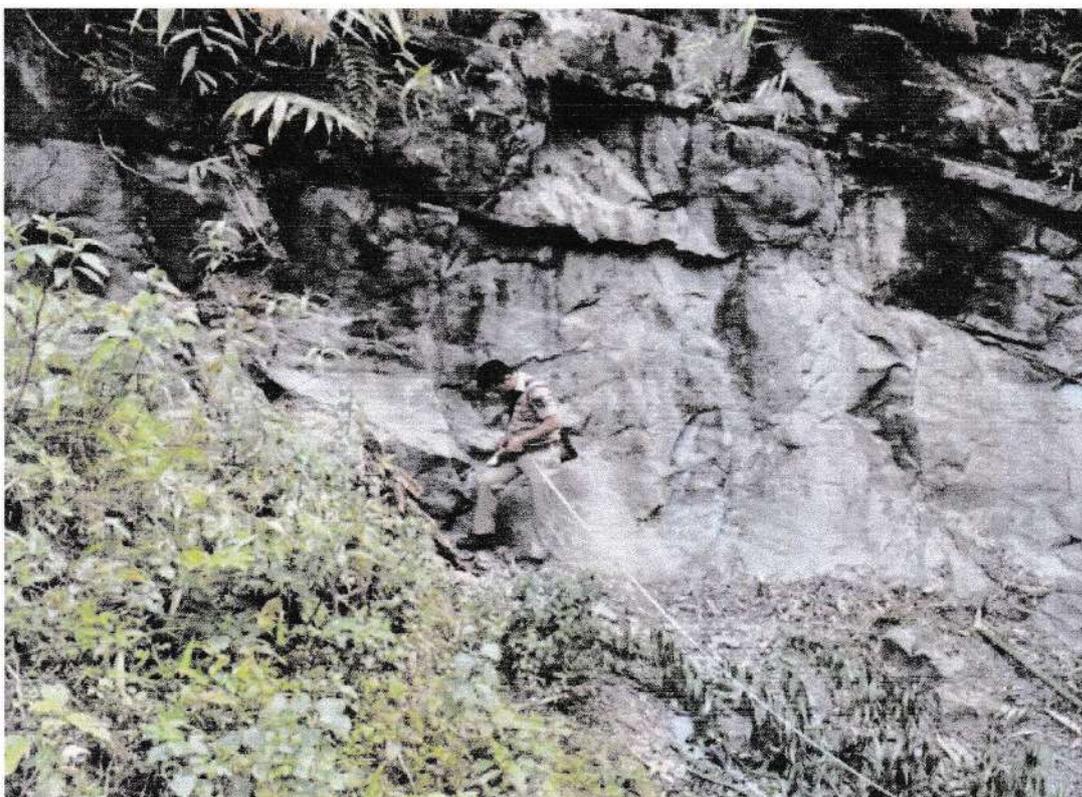
The Committee takes measurement of the damaged/broken portion of the mining area belonging to Shri Thanchhuma (stone quarry) and recorded as under:

- ✓ Length= 10.64mtrs, Breadth= 11mtrs and Height= 7.036mtrs
- ✓ Hence the Volume of extracted stoned/mined stone = 823.494m<sup>3</sup> (10.64 × 11 × 7.036)

**Photo 4. Stone Quarry of Shri Thanchhuma**

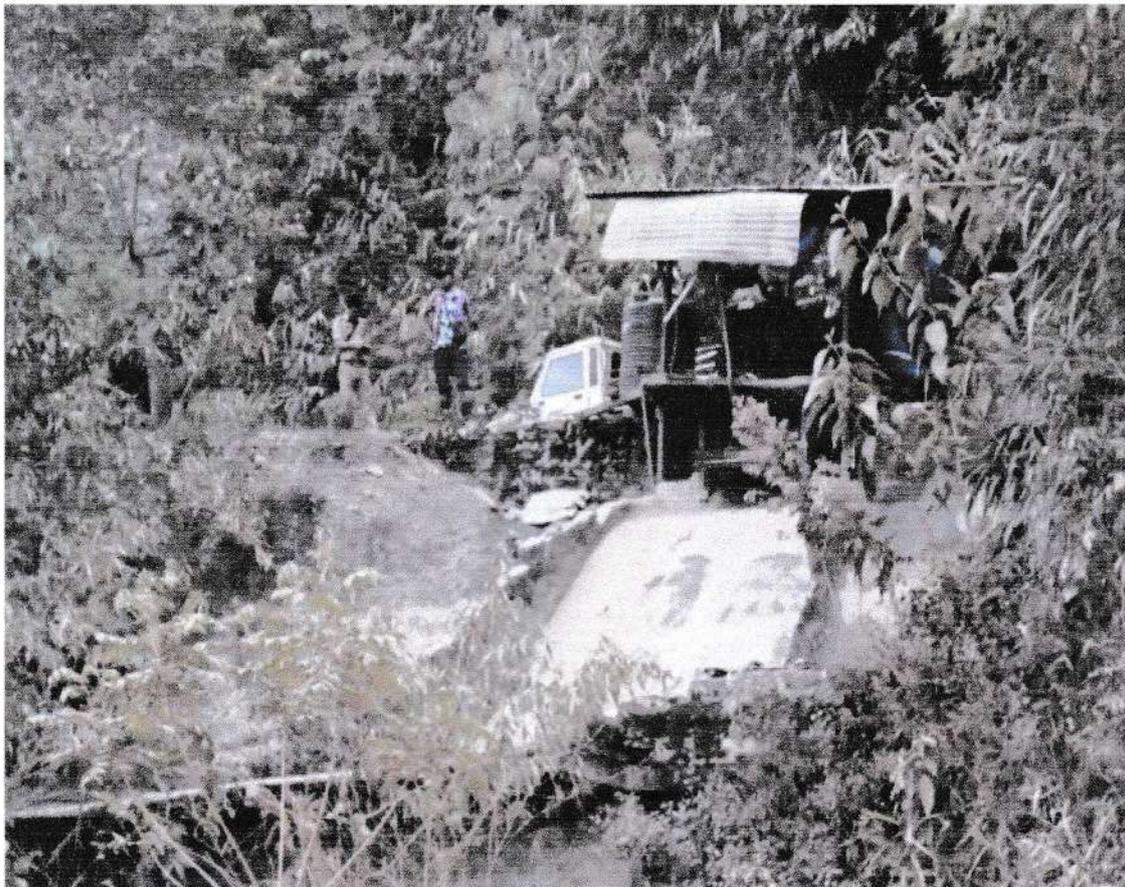
**6. iii. Inspection on the Stone Crusher & Stone Quarry of Shri Thanmawia Chawngthu:** The next inspection was done on the Stone Crusher and Stone Quarry of Shri Thanmawia Chawngthu which is located around 42 mtrs away from NH-54. The GPS co-ordinates of the Stone Crusher Unit is 22°50'56.3" E 092°48'34.6". The Crusher is 42 mtrs away from NH-54 and distance from Tlawng RRF is 233.8 mtrs (Photo 5). The GPS co-ordinates of the Mining/Stone Quarry are N 22°50'53" E 092°48'37". The Mining/Stone Quarry is 125.5mtrs away from NH-54 and distance from Tlawng RRF is 288 mtrs (Photo 6). The site is located within the boundary of the Tlawng Hnar Reserved Forest (RF). The Committee observed that both the Crusher and Quarry are not in operational and natural growth of vegetation in the periphery of the stone quarry had already started.

**Photo 5. Stone Crusher of Shri Thanmawia Chawngthu**

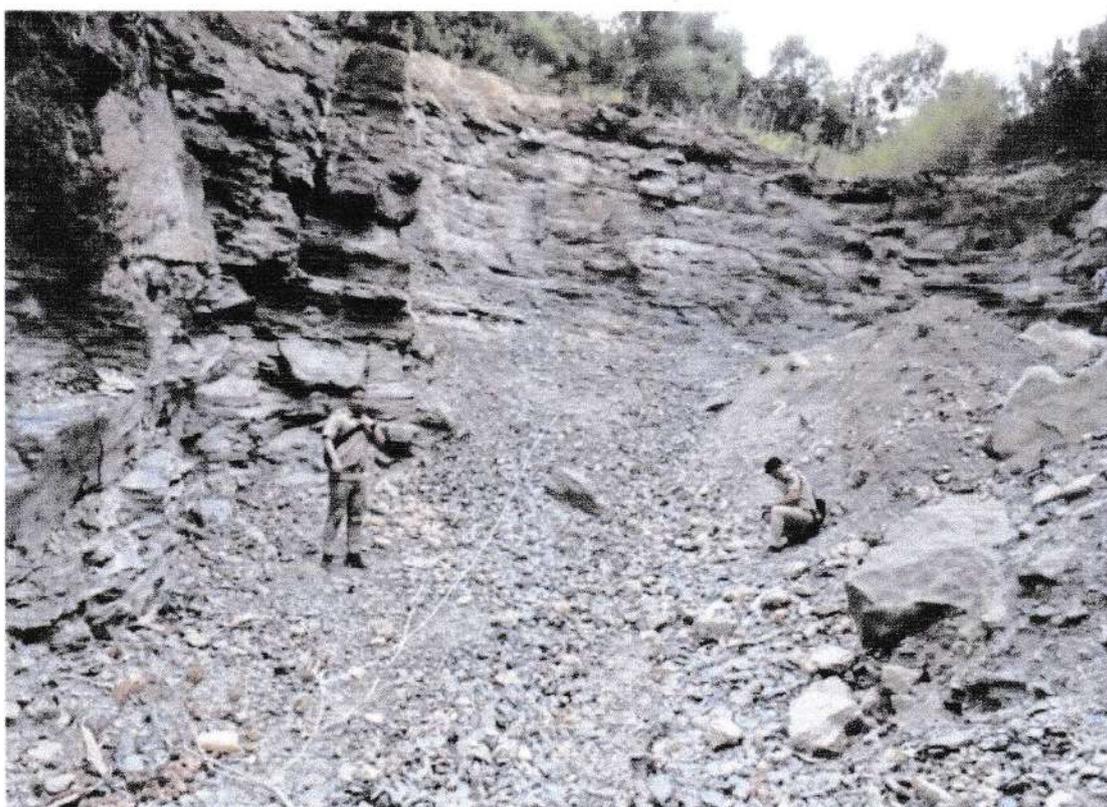
Photo 7. Stone Crusher of Shri Malsawma Murray

**6. iv. Inspection on the Stone Crusher & Stone Quarry of Shri Malsawma Murray:** The next inspection was done on the stone crusher and quarry of Shri Malsawma Murray which is located inside the encroached Lungpuizawl Village of Tlawng Hnar RF. The GPS co-ordinates of the Stone Crusher is N22°50'50.2" E092°48'24.8". The Crusher is 183.04 mtrs away from NH-54 and distance from Tlawng RRF is 529.7mtrs (Photo 7). The GPS co-ordinates of the Stone Quarry are N 22°50'46.2" E 092°48'28.5". The Stone Quarry is 347.7 mtrs away from NH-54 and distance from Tlawng RRF is 583.17mtrs (Photo 8). The Committee observed that both the Stone Crusher and Stone Quarry are in operation at the time of site visit. The Committee also observed that small mines of about 20 (twenty) in number are operated in this mining area. Local miners belonging to Lungpuizawl village are operating these quarries. Local villagers present during the inspection stated that these stone quarries are the only source of their livelihood. The Committee observed that the mines have been operated at the foot of the hill and the area is very fragile. The Committee opined that if illegal mining operation continues in the area, there is a possibility that the hill may collapsed or caused landslides which may pose serious danger to the villagers living in Lungpuizawl village.

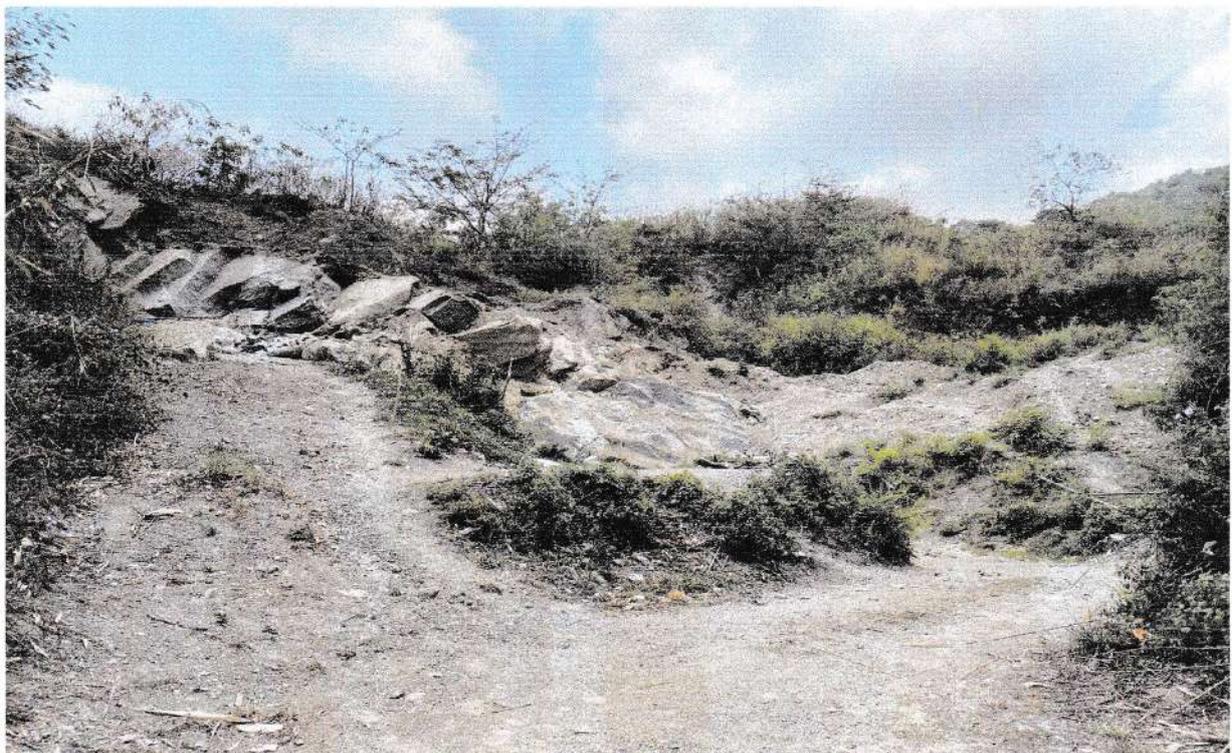
The Committee takes measurement of the damaged/broken portion of all the mining areas belonging to Shri Malsawma Murray (stone quarry) and recorded as under:

- ✓ Total length= 21.3mtrs, total breadth= 9.4 mtrs and total height= 7.5 mtrs
- ✓ Hence the Volume of extracted stoned/mined stone =  $1501.65 \text{ m}^3$  ( $21.3 \times 9.4 \times 7.5$ )

iii. The Committee observed that small quarry of about 20 (twenty) in number are still operated in mining area by Shri Malsawma Murray. The Committee also observed that the quarries have been operated at foot of the hill and the area is very fragile. The Committee opined that if illegal mining operation continues in the area, there is a possibility that the hill may collapsed or caused landslides which may pose serious danger to villagers lived in Lungpuizawl village. The Committee also discussed the issue with District Magistrate(DM), Lunglei. DM, Lunglei assured that administration will take necessary preventive measures as and when report is received.

Photo 8: Stone Quarry of Shri Malsawma Murray

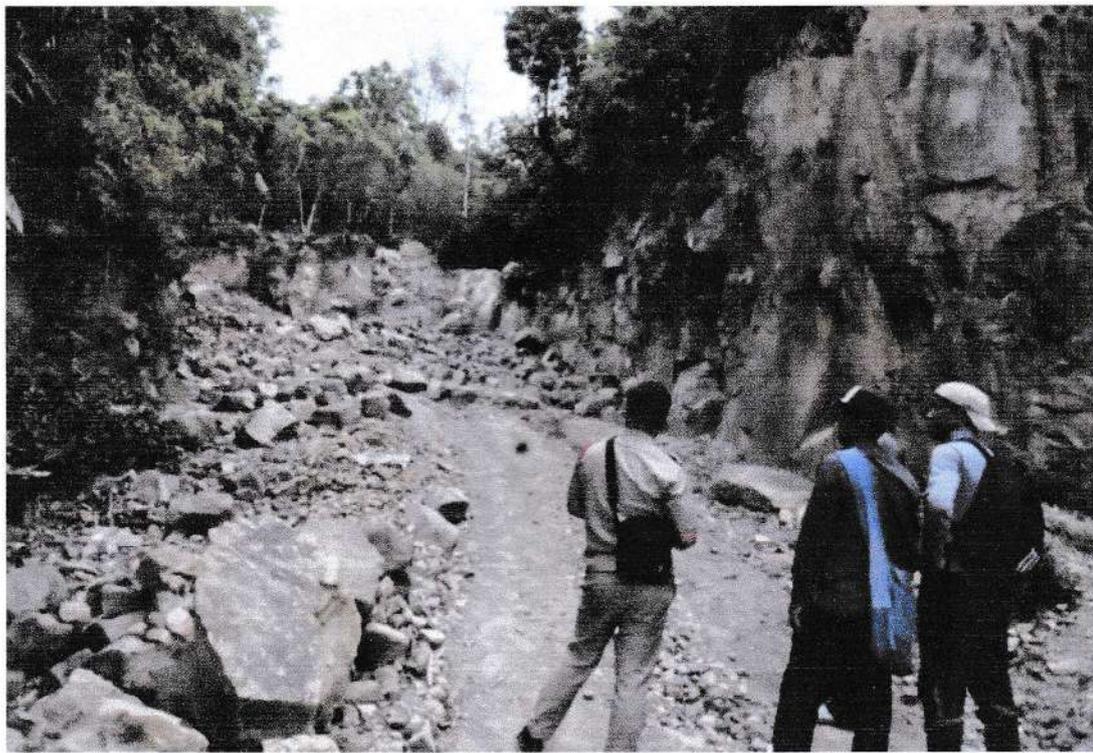
**6. v. Inspection on the Stone Crusher & Stone Quarry of Shri V. Malsawma:** The next inspection was done on the stone quarry of Shri V. Malsawma which is located about 469.37mtrs away from NH54. The Committee observed that no stone crusher has been set up in this mine. The GPS co-ordinates of the Stone Quarry are N 22°50'41.6" E 092°48'19.1" (Photo 9). However, the mine owner claims that his Mining/Stone Quarry falls outside the boundary of the Tlawng Hnar RF.

- ✓ Length= 23.22 mtrs, Breadth= 6.57 mtrs and Height= 3mtrs
- ✓ Hence the Volume of extracted stoned/mined stone =  $457.67\text{m}^3$  ( $23.22 \times 6.57 \times 3$ )

**Photo 9: Stone Quarry of Shri V. Malsawma**

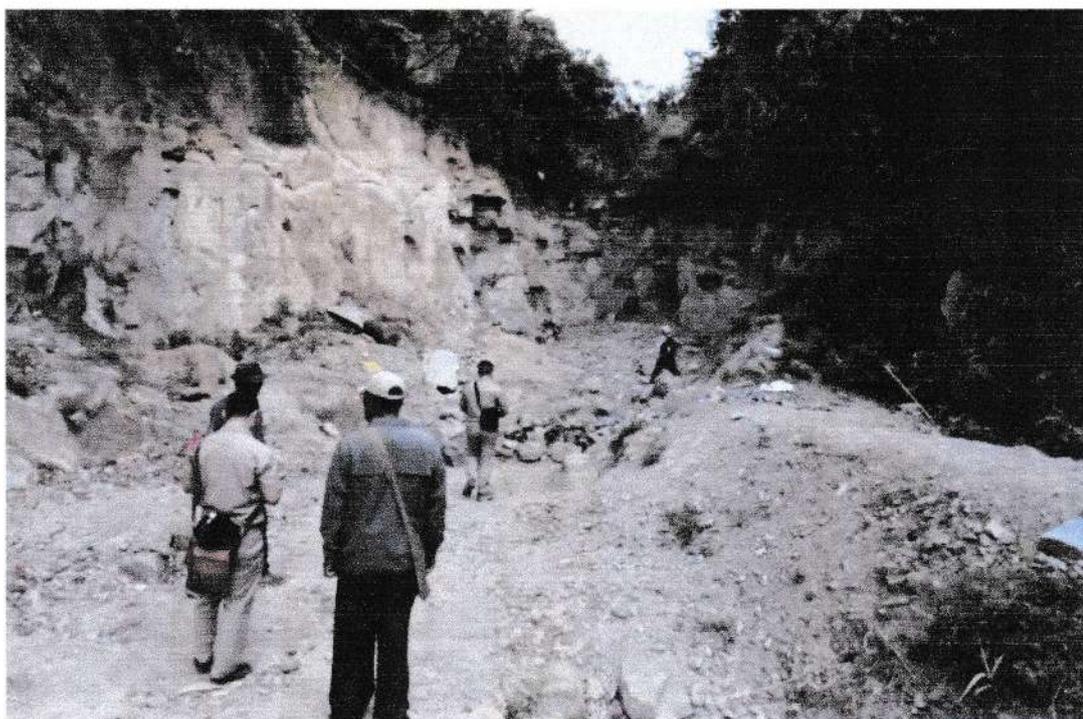
The last inspection was done on the stone quarry of Shri V. Lalbiakluanga. The Committee observed that no stone crusher has been set up in this mine. However, the Committee 2 (two) stone quarries were operated by the owner referred in this report as Point-1 and Point-2. Point-1 Stone Quarry is located about 467.3 mtrs away from NH54 and the distance from the Tlawng RRF is 805 mtrs. The GPS co-ordinates of Point-1 Stone Quarry are N 22°50'43.4" E 092°48'18.1". (Photo 10) and Point-2 Stone Quarry is located about 365.61mtrs away from NH54 and the distance from the Tlawng RRF is 761.09 mtrs. The GPS co-ordinates of Point-2 Stone Quarry are N 22°50'44.6" E 092°48'19.5" (Photo 11). The Committee observed that only Point-1 mine is in operation.

- ✓ Length= 16.05mtrs, Breadth= 8.45 mtrs and Height= 4 mtrs
- ✓ Hence the Volume of extracted stoned/mined stone =  $542.49\text{ m}^3$  ( $16.05 \times 8.45 \times 4$ )

**Photo 10, Point 1 Stone Quarry of Shri V.LALBIAKTLUANGA**

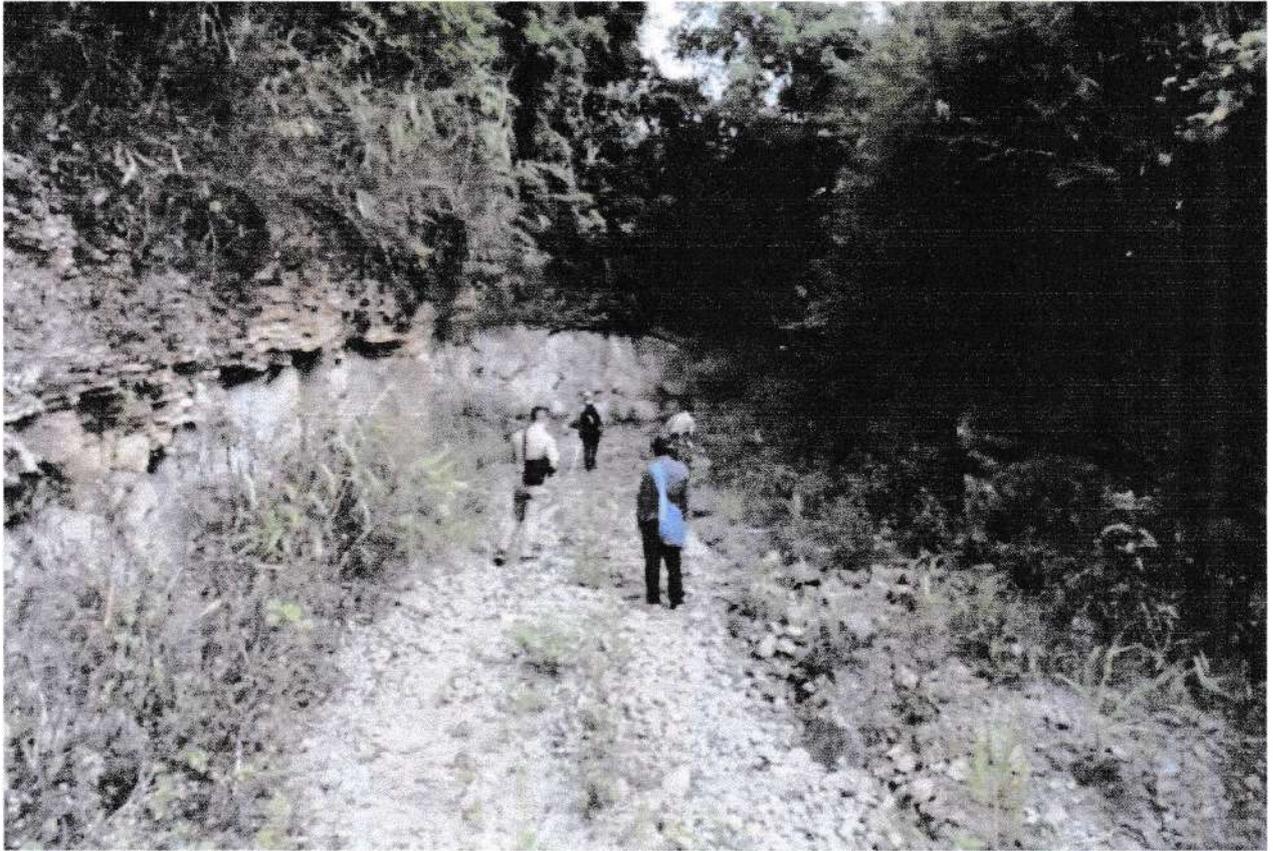
- ✓ Length= 23.2 mtrs, Breadth= 7.4 mtrs and Height= 5 mtrs
- ✓ Hence the Volume of extracted stoned/mined stone =  $858.4\text{ m}^3$  ( $23.2 \times 7.4 \times 5$ )
- ✓ Total Volume:  $1,400.89\text{ m}^3$

**Photo 11: Point 2-Stone Quarry of Shri V. LALBIAKTLUANGA**

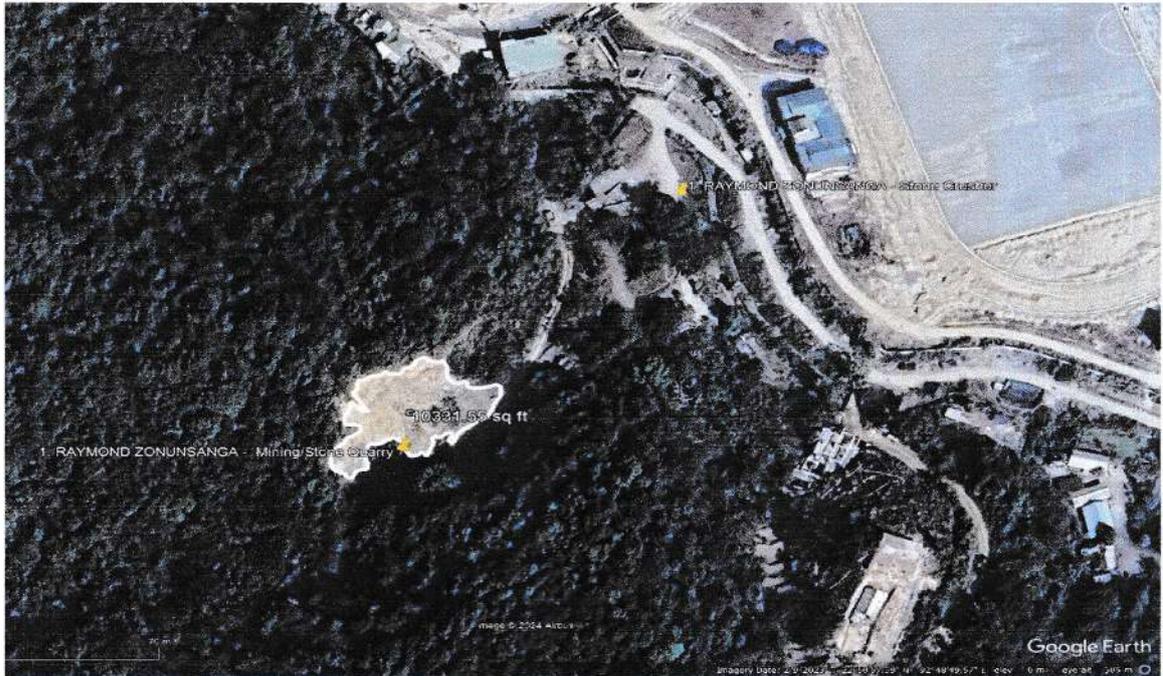
Furthermore, based on field data and analysis utilizing GIS software (ArcMap), the area of the damaged/broken portion of Shri Raymond Zonunsanga mining area has been recorded to be 10331.552 square feet (Figure 1).

*Figure 1. Google Earth Imagery- 2.9.23, of Shri Raymond Zonunsanga Quarry (Area=10331.552 sqft).*

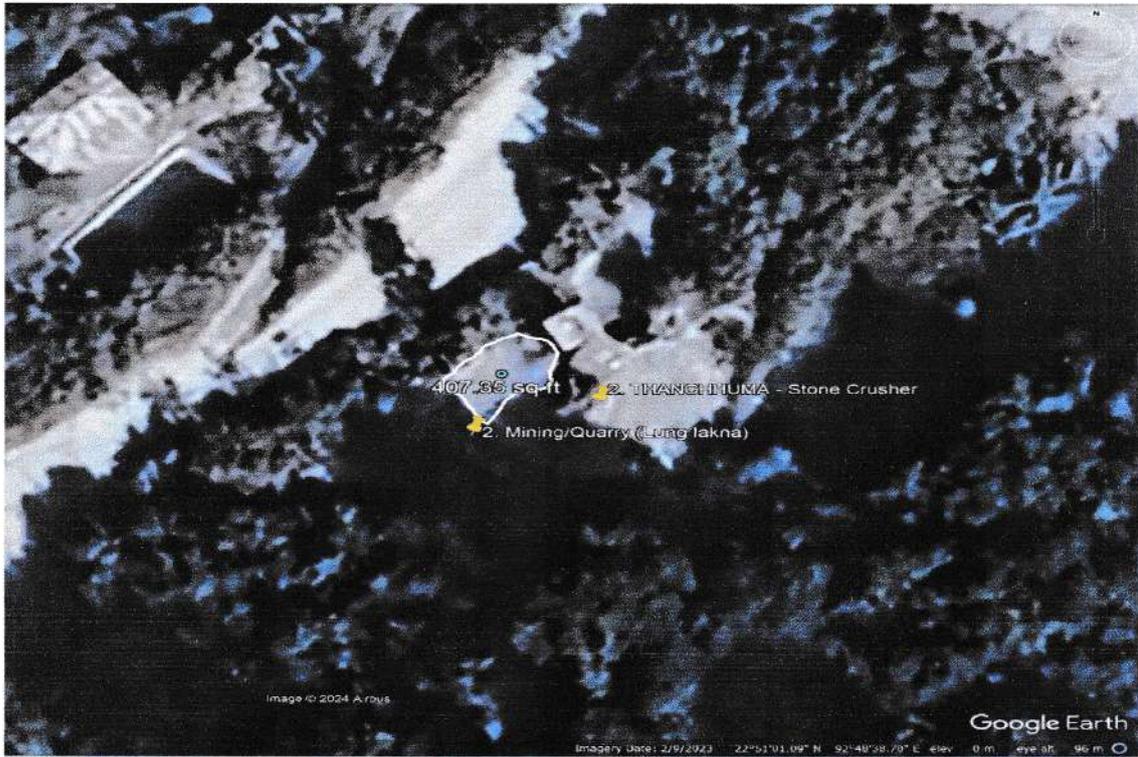
Furthermore, based on field data and analysis utilizing GIS software (ArcMap), the area of the damaged/broken portion of mine belonging to Shri Thanchhuma has been recorded to be 407.355 square feet (Figure 2).

Figure 2 -- Google Earth Imagery – 2.9.23, of Shri Thanchhuma Quarry (Area– 407.355 sqft.)

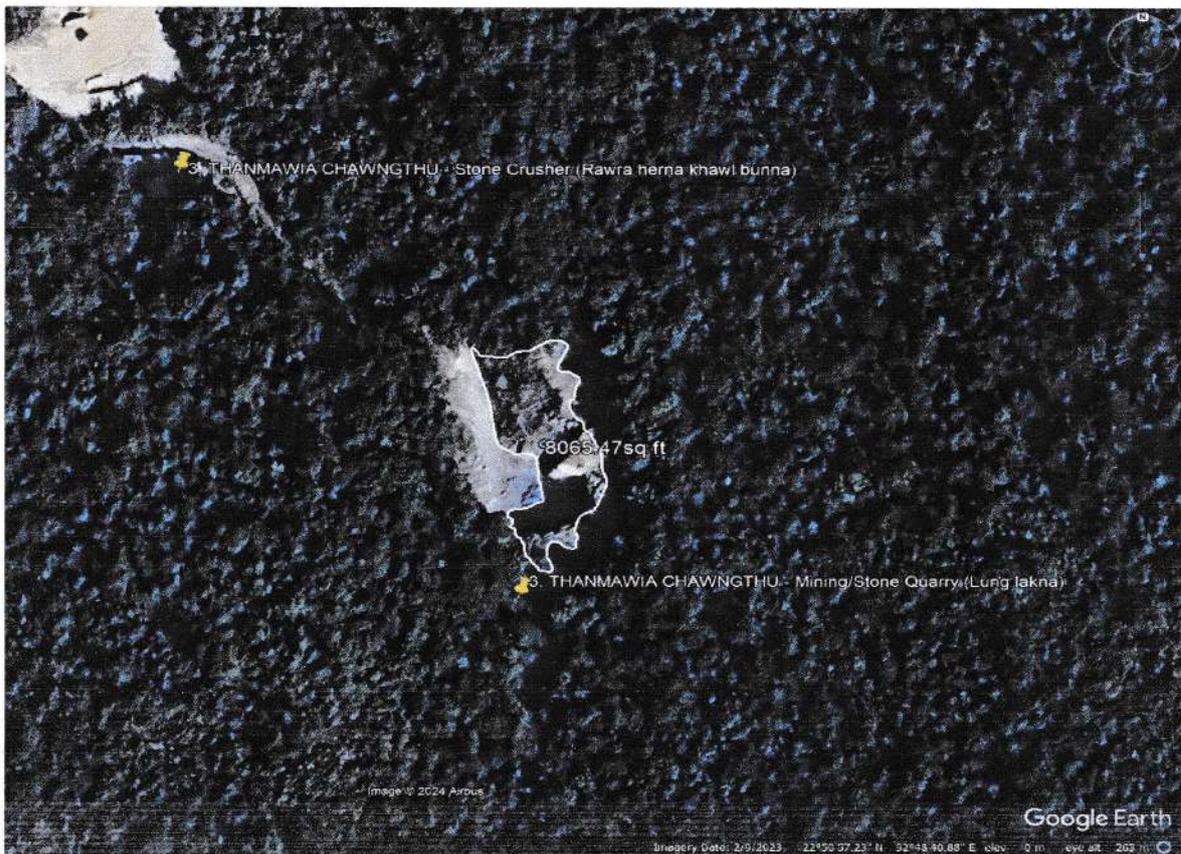
Furthermore, based on field data and analysis utilizing GIS software (ArcMap), the area of the damaged/broken portion of Shri Thanmawia Chawngthu mining area has been recorded to be 8065.479 square feet (Figure 3).

Figure 3: Google Earth Imagery-2.9.23, of Shri Thanmawia Chawngthu Quarry (Area-8065.479 sqft.)

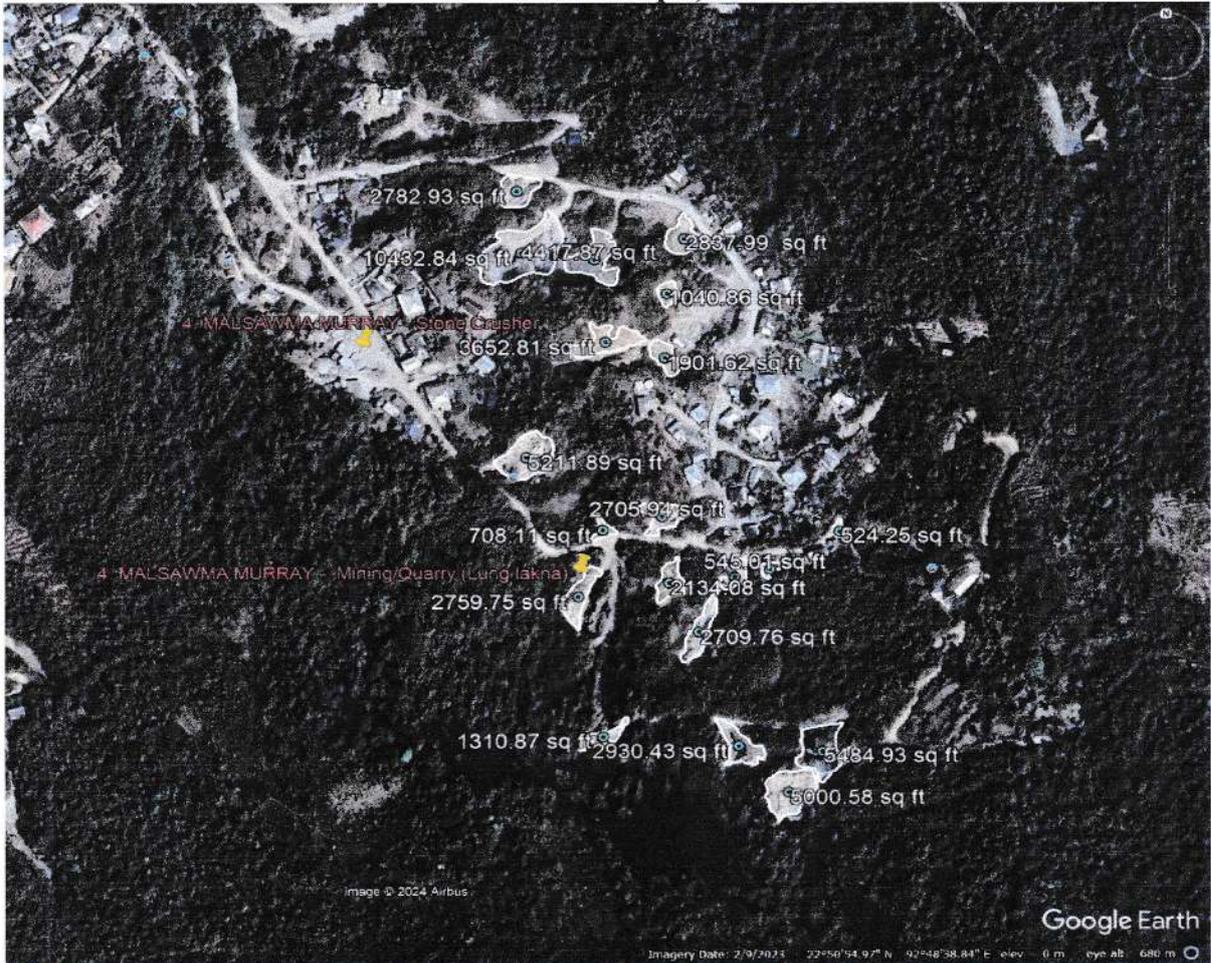
Furthermore, based on field data and analysis utilizing GIS software (ArcMap), the total area of the damaged/broken portion of Shri Malsawma Murray mining areas have been recorded to be 60192.277 square feet (Figure 4).

Figure 3: Google Earth Imagery-2.9.23, of Shri Malsawma Murray Mining Quarry (Total area-60192.277 sqft).

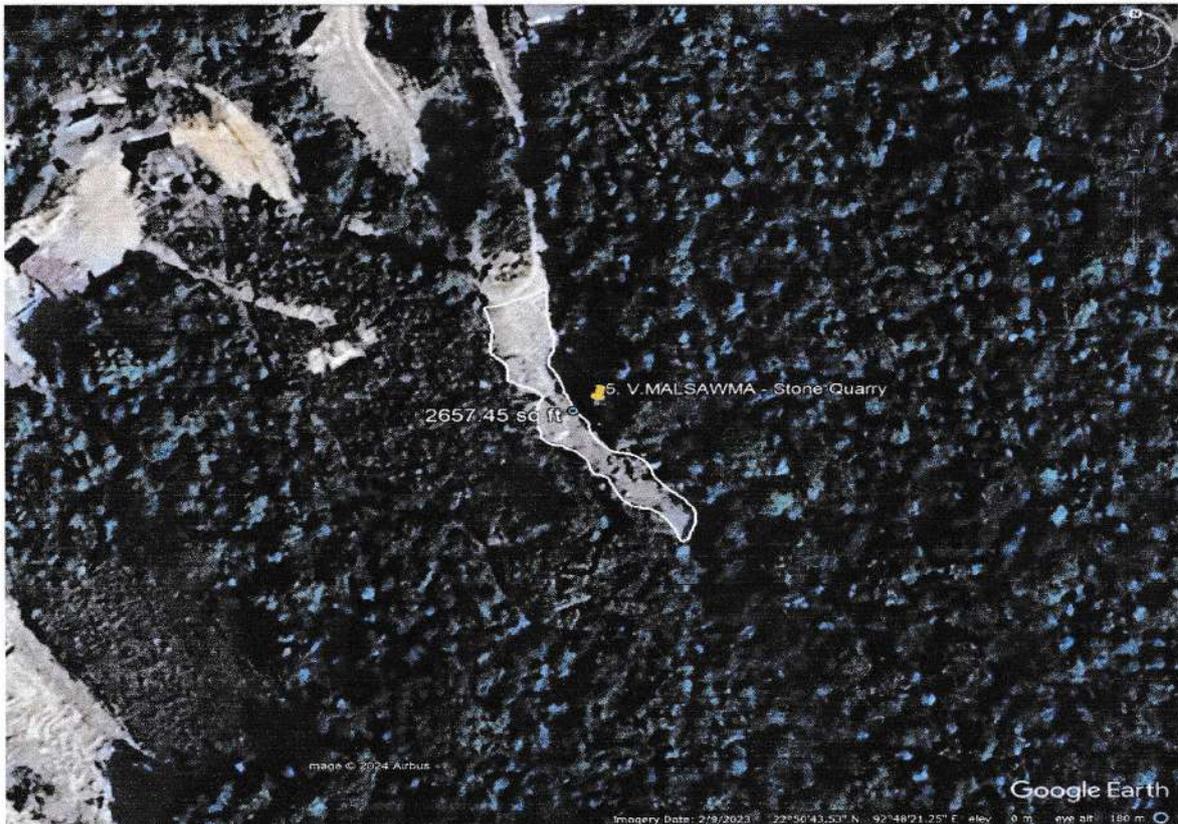
Furthermore, based on field data and analysis utilizing GIS software (ArcMap), the area of the damaged/broken portion of Shri V. Malsawma mining area has been recorded to be 2657.457 square feet (Figure 5).

Figure 4: Google Earth Imagery-2.9.23, of Shri V.Malsawma Quarry  
(Area – 2657.457 sqft).

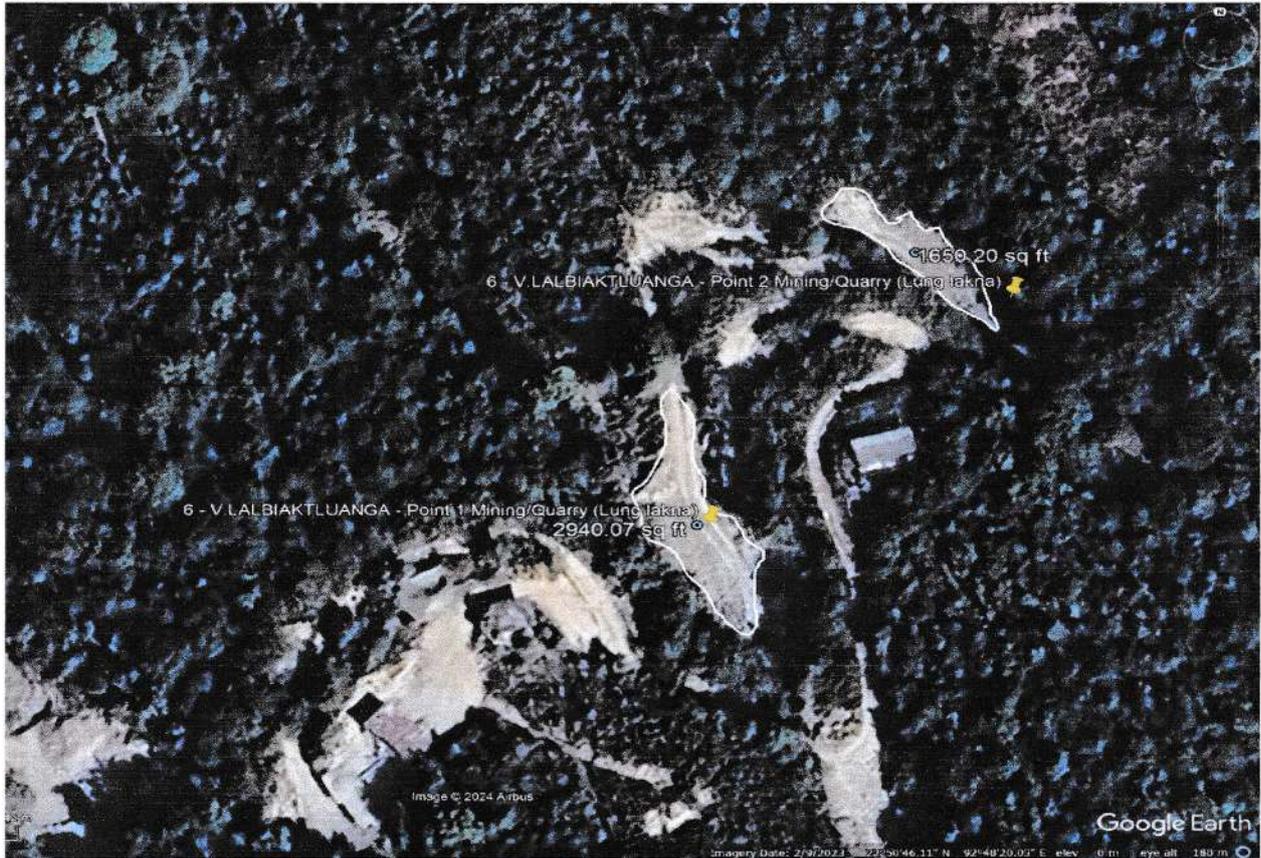
Furthermore, based on field data and analysis utilizing GIS software (ArcMap), the area of the damaged/broken portion of Shri V. Lalbiakluanga mining area has been recorded to be Point 1= 2940.077 square feet and Point 2 = 1650.203 (Figure 6).

Figure 5 - Google Earth Imagery – 2.9.23, of Shri V.Lalbiaktluanga Point 1 Area –  
2940.077 sqft & Point 2 Area – 1650.203 sq. ft.
