**BEFORE THE HON'BLE NATIONAL GREEN TRIBUNAL
EASTERN ZONE BENCH, KOLKATA
ORIGINAL APPLICATION NO. 28 OF 2022 / EZ**

**AFFIDAVIT ON BEHALF OF STATE POLLUTION
CONTROL BOARD, ODISHA, R.NO.9.**

A field inspection was conducted on 08.04.2022 in pursuance of the order of Hon'ble NGT, EZB, Kolkata Dtd. 16.03.2022 passed in OA No. 28/2022/EZ to verify the correctness of the allegations made about pollution of Gobari river and to suggest remedial measures if non-compliances are found.

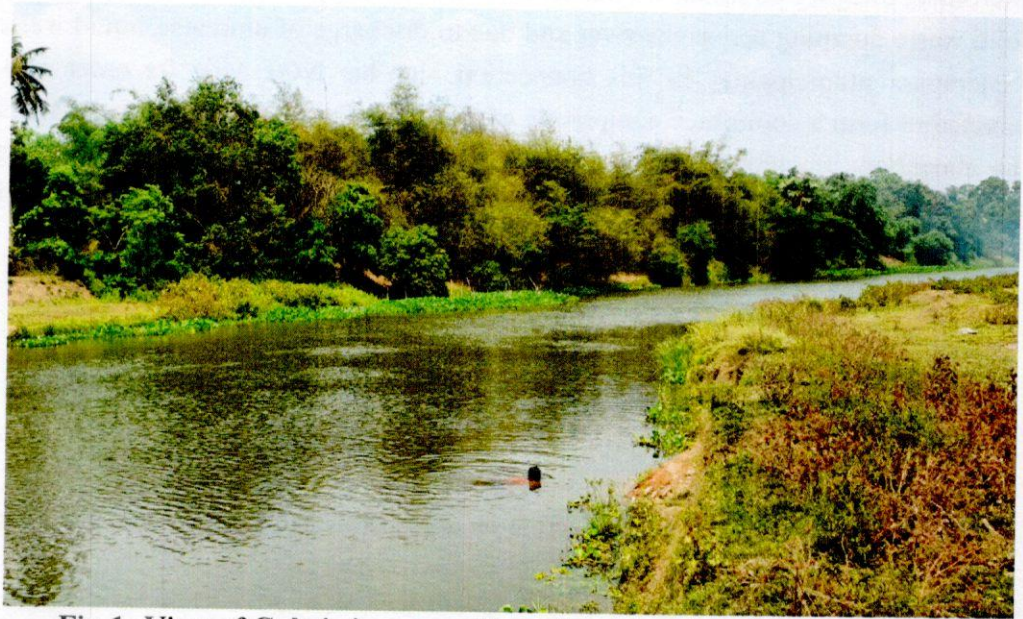
Fig-1- View of Gobri river near Hajaribagicha dumping site in the downstream of Kendrapara municipality

- (a) Solid waste disposal is continuing at a designated place at Hajaribagicha. There is a blacktopped road from the town to the same site. Solid waste dumping site is at one side of the road and Gobari river flows in the opposite side of the road. The present water flow is about 40/50 m away from the road. No evidence of any dumping of solid waste along the roadside or towards the river side was found during the inspection. No deposition of any waste along the river bank due to any flow from the dump area was seen. A photograph of Gobari river near Hajaribagicha dump site indicated normal flow of water as shown in Fig-1.

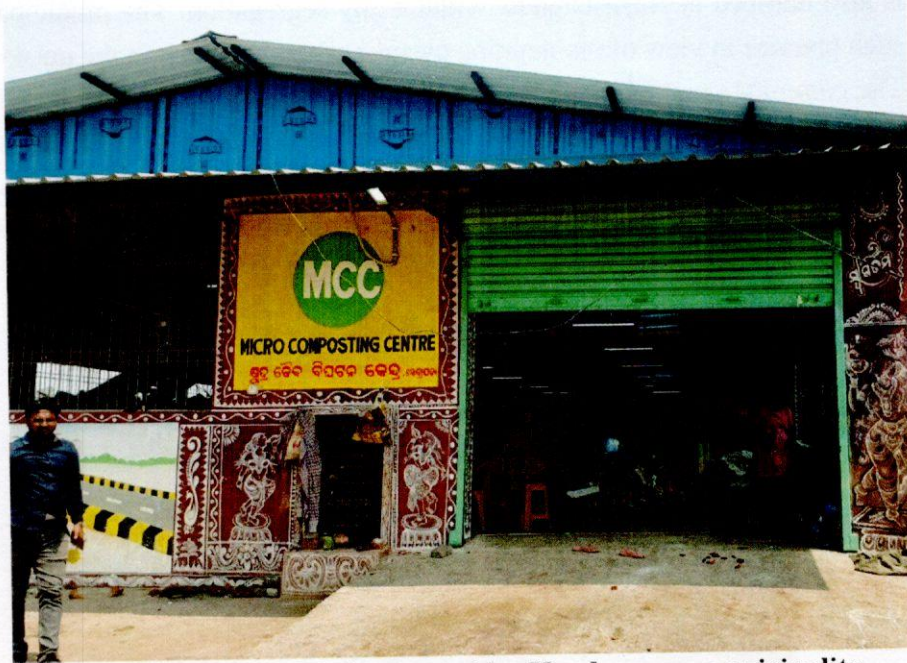
Fig.-2- A view of MCC-1 operated by Kendrapara municipality

forest departments under 'Mo Khata Yojana of State Government' and the scheme is working well. However, the municipality is constructing another MCC of 3TPD capacity at Odisso (Ward No.7) for future use and better capacity utilization of both the MCCs. The second MCC is scheduled to operate within another one month. A photograph of MCC-1 is shown at Fig.-2 for reference.

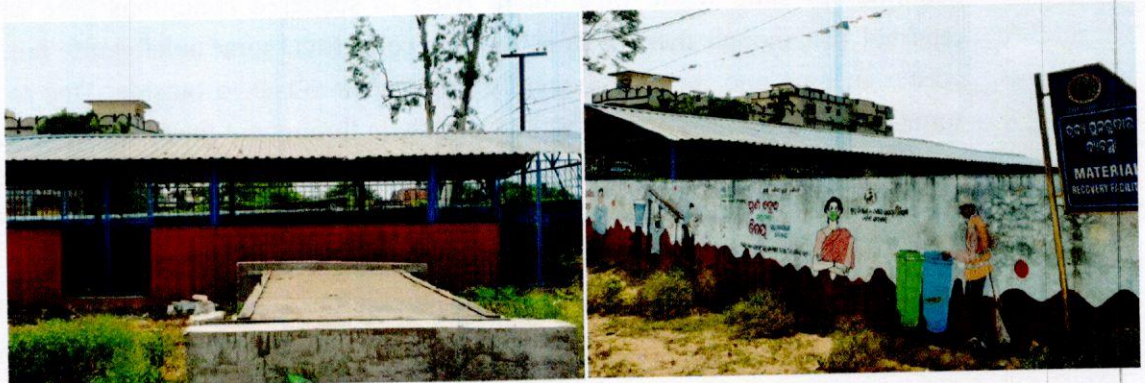
Fig.-3- Photographs of MRF-1 operated by Kendrapara Municipality

(e) One Material Recovery Facility (MRF) of 5 TPD capacity has been provided at Hazaribagicha area (Ward No.12) as seen in the photographs. It was not in operation during the visit of the committee due to some modification/upgradation work continuing. It was reported that a weigh bridge is under installation inside the MRF. Dry waste collected from the municipal area was found to be kept inside both the MRF and MCC area. Another MRF of 5 TPD capacity was found to be under construction at Kajala (Ward No. 21). As dry solid waste generation is 7 TPD, operation of both the MRFs will be sufficient to cater to the requirement. Photograph of MRF-1 is placed at Fig.-3.

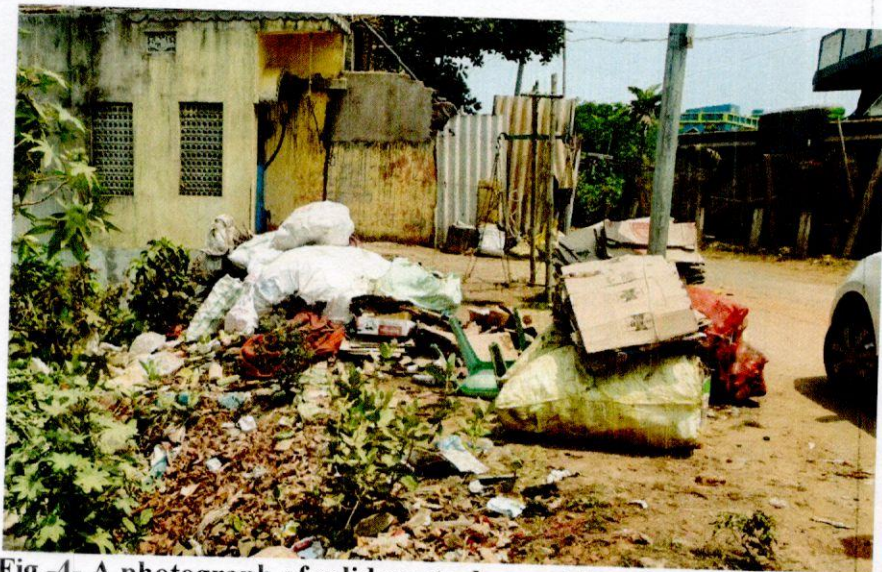
Fig.-4- A photograph of solid waste dumped by a kawadiwala near Jayapura area of Kendrapara Municipality

- (g) The committee moved along the road adjacent to Gobari river. No specific solid waste dump site was found anywhere in places like Khadianga, Jayapura, Sunaelo, Ekanakhandi and Naya Idgah. However, in Jayapura area, some solid dry wastes were found in bagged condition near to the house of a Kawadiwala as in Fig-4. However, its impact on Gobari river was not physically visible.

- (h) Though no designated solid waste dump site exists anywhere other than Hajaribagicha, small quantities of solid waste were found lying in scattered conditions here and there. It was reported that though there is door to door collection, some inhabitants fail to deliver their wastes in time and they subsequently throw their waste to outside. Due to such activities, some solid waste was found lying here and there throughout the town. It was reported that the same waste is being lifted intermittently. However, people litter the area again. Such littering of waste was probably causing threat to Gobari river earlier during rain. However, this has reduced after fixation of bar screens in the drains.
- (i) Kendrapara Municipality does not have valid authorization under Solid Waste Management Rules, 2016. However it has applied for grant of authorization to SPCB head office.

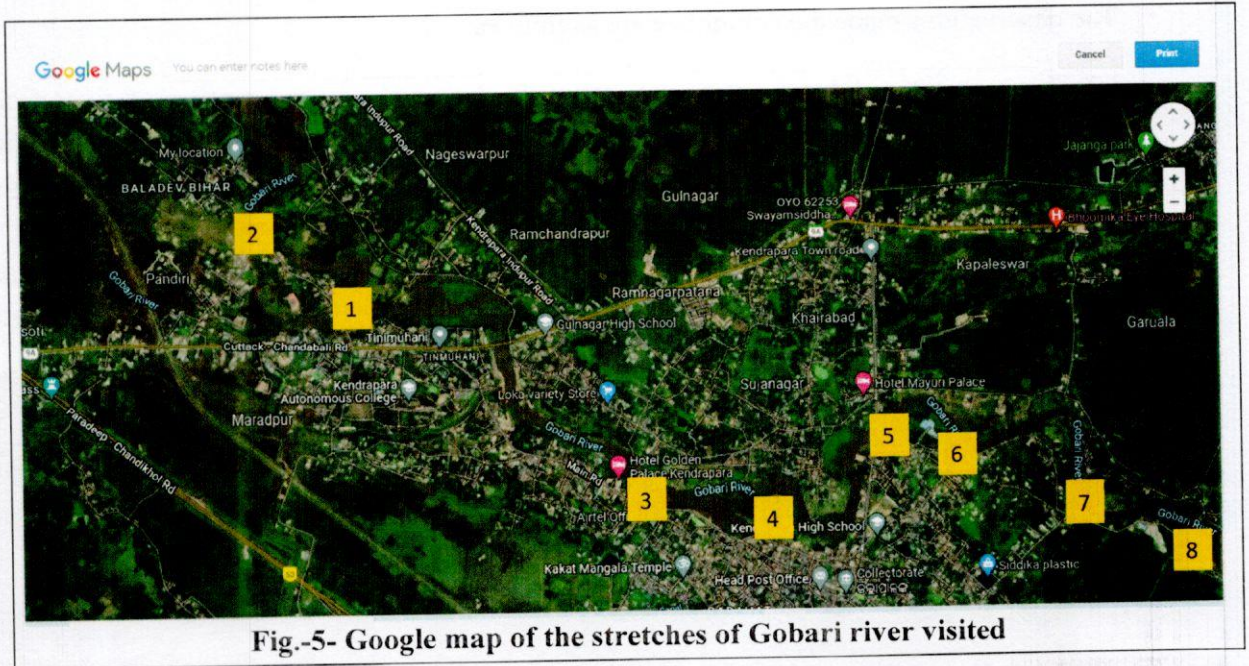
Fig.-5- Google map of the stretches of Gobari river visited

It has been alleged that domestic wastewater/sewage of Kendrapara municipality is directly discharged into Gobari river and entire Gobari river is polluted and its water is not usable. The committee visited the entire stretch of Gobari river flowing near Kendrapara municipality area to verify the allegations. The inspection was started from upstream of Kendrapara municipality and its outskirts (Udaynagar in Derabish block) and ended at the downstream of Municipal area (Nagapura in Kendrapara block) covering eight points. A Google map showing the points visited is placed at Fig.-5. Details of the locations are placed in Table-1.

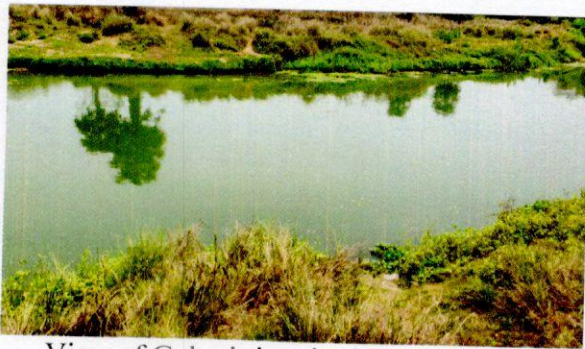
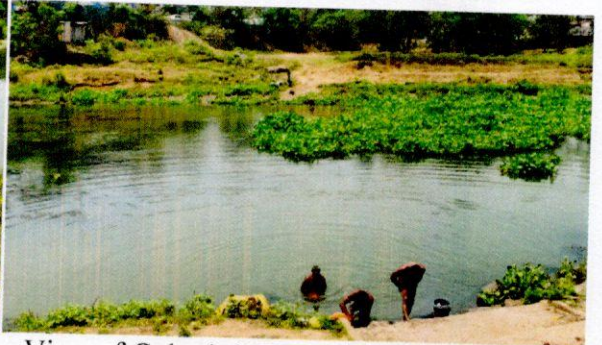
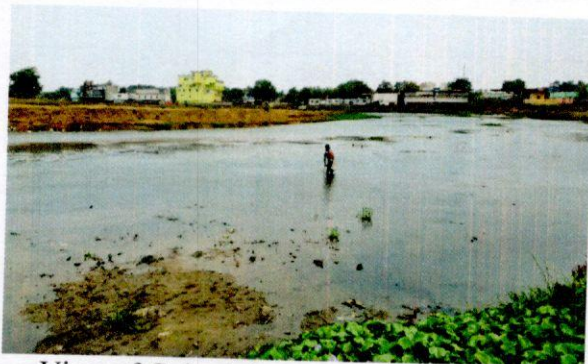
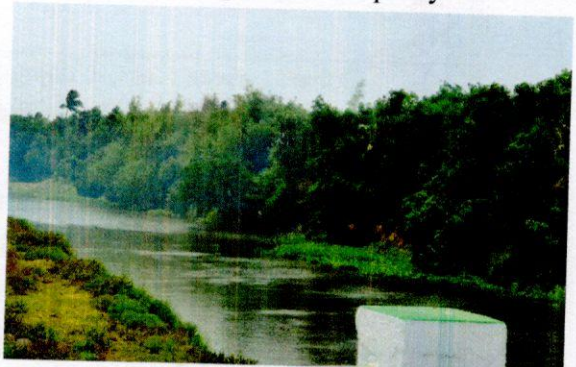
Fig.-6 – View of Gobari river at various places of Kendrapara Municipality

- (a) The committee did not notice any seriously damaged or dead portion of river Gobari as alleged in the OA. There was usual flow in the river and people were using the river for bathing and washing purposes. Siltation was observed at some patches of the river near Naya Idgah. Growth of hyacinth was also observed at some places near the town area, which indicated organic load input to the river. Photographs of the river at the upstream and downstream of Kendrapara municipality and inside the town is placed in Fig.-6 for reference.

View of Gobari river in the upstream of Kendrapara Municipality

View of Gobari river near new bus stand of Kendrapara Municipality

View of Gobari river near Naya Idgah of Kendrapara Municipality

View of Gobari river in the downstream of Kendrapara Municipality

- Dredging is required to remove siltation observed in river Gobari and to maintain the health of the river.

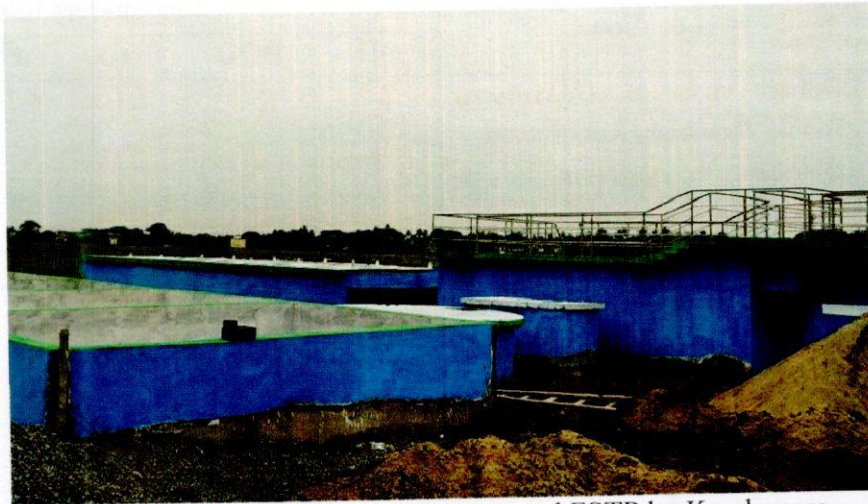
Fig.-7- A view of the newly constructed FSTP by Kendrapara Municipality

- (c) Kendrapara municipality is a 153 year old municipality and the roads inside the main town are very narrow. Therefore, construction of any sewerage system has not been possible as reported. Most of the households have their own septic tank-soak pit system to handle the sewage. The municipality has recently completed construction of a FSTP (20 KLD capacity) for treatment of the wastewater collected from the septic tanks through cesspool vehicles as seen in Fig.-7. Construction of such FSTPs for all ULBs except Municipal Corporations of the State have been recommended by the State Government as reported. For operation of FSTP, it has already obtained CTO from SPCB. Once its operation is started, the sewage from septic tanks will be taken care of.

- (d) As the FSTP system has not been operational so far, sewage collected from the septic tanks through cesspool vehicles is disposed off inside an earmarked pit near Hajaribagicha.

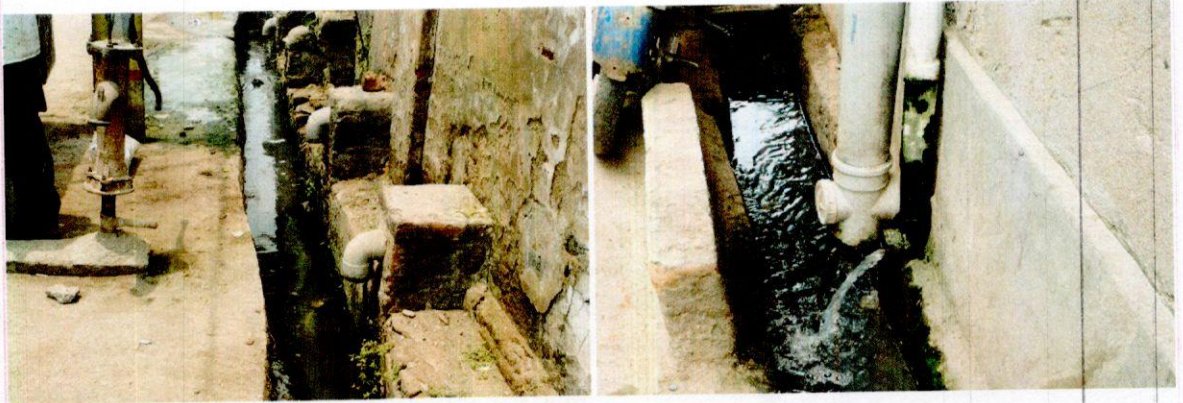
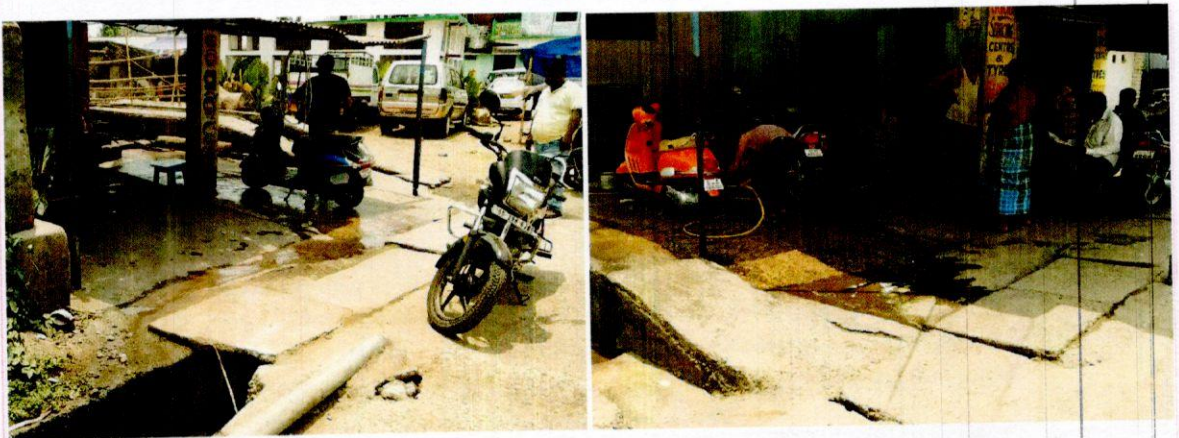
Fig.-7- Configuration of domestic wastewater in Naya Idgah Drain

- (a) The nominal discharge of domestic wastewater was again observed near New bus stand. It was only from bus stand area covering shops and small restaurants/eateries and thus it is not raw sewage.
- (b) The drain near Naya Idgah collects domestic wastewater from Ward no. 14 and 15 and it covers about 3000 people as reported. The entire area was covered by walking and all the drains of the area were inspected. It was found that most of the household have connected their wastewater outlets from bath room and kitchen to the municipality drains. Besides, there are vehicle washing stations (two numbers) which also discharge their wash water into the same drain. People were found taking bath in open and the same was also entering into the drain. All the mixed wastewater was found flowing into Gobari river. Some of the photographs taken are placed in Fig.-7 for reference.

Views of domestic wastewater drains connected with the municipal drain at Naya Idgah

Views of operating vehicle washing stations discharging wastewater into municipal drain at Naya Idgah

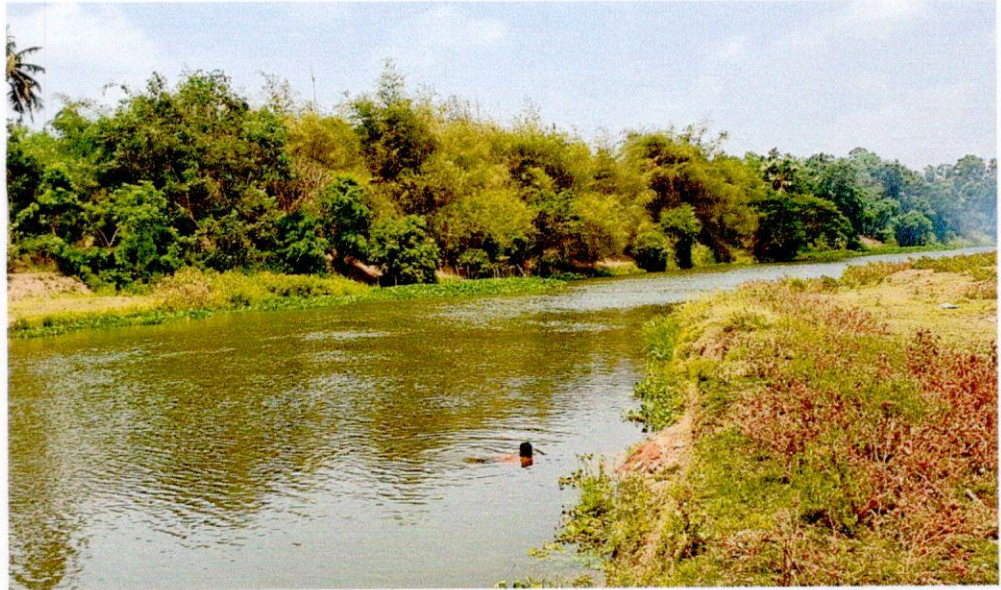
Fig-1- View of Gobari River near Hajaribagicha dumping site in the downstream of Kendrapara municipality

- (a) Solid waste disposal is continuing at a designated place at Hajaribagicha. There is a blacktopped road from the town to the same site. Solid waste dumping site is at one side of the road and Gobari river flows in the opposite side of the road. The present water flow is about 40/50 m away from the road. No evidence of any dumping of solid waste along the roadside or towards the river side was found during the inspection. No deposition of any waste along the river bank due to any flow from the dump area was seen. A photograph of Gobari River near Hajaribagicha dump site indicated normal flow of water as shown in Fig-1.

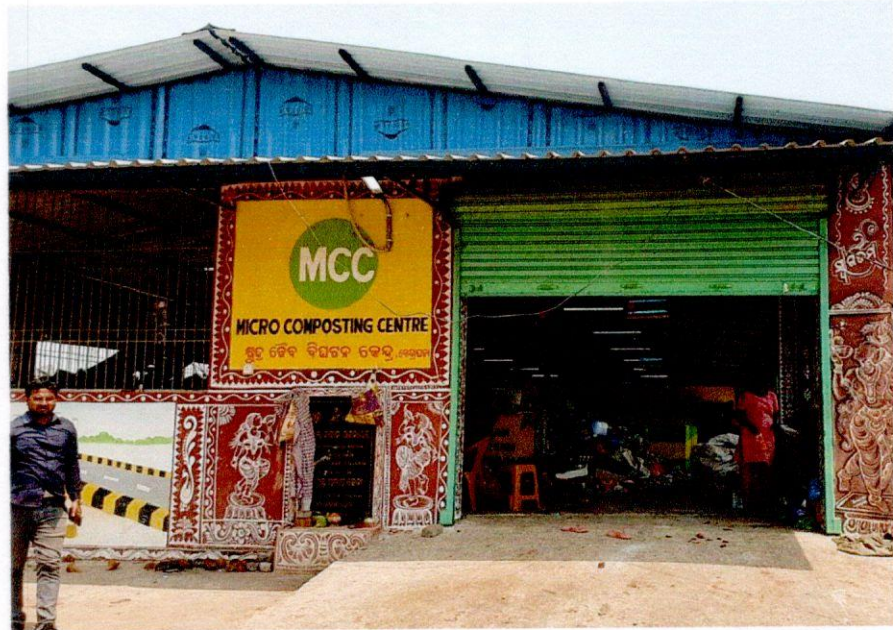
Fig.-2- A view of MCC-1 operated by Kendrapara municipality

another MCC of 3TPD capacity at Odisso (Ward No.7) for future use and better capacity utilization of both the MCCs. The second MCC is scheduled to operate within another one month. A photograph of MCC-1 is shown at Fig.-2 for reference.

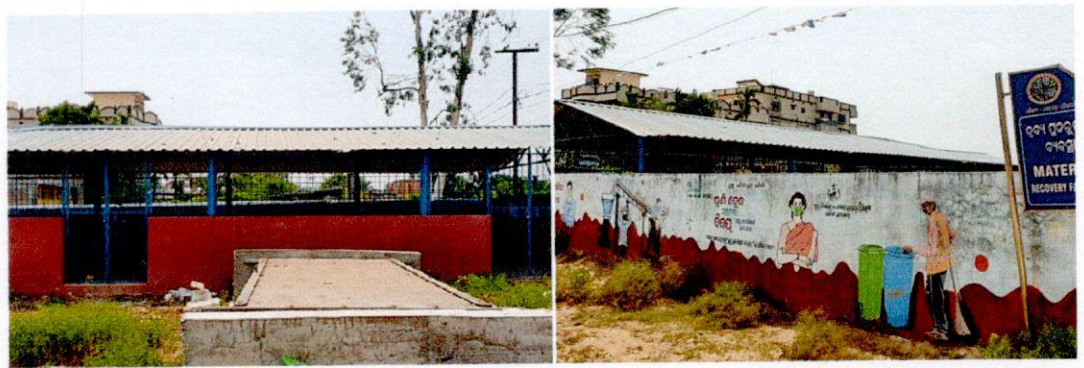
Fig.-3- Photographs of MRF-1 operated by Kendrapara Municipality

- (e) One Material Recovery Facility (MRF) of 5 TPD capacity has been provided at Hazaribagicha area (Ward No.12) as seen in the photographs. It was not in operation during the visit of the committee due to some modification/upgradation work continuing. It was reported that a weigh bridge is under installation inside the MRF. Dry waste collected from the municipal area was found to be kept inside both the MRF and MCC area. Another MRF of 5 TPD capacity was found to be under construction at Kajala (Ward No. 21). As dry solid waste generation is 7 TPD, operation of both the MRFs will be sufficient to cater to the requirement. Photograph of MRF-1 is placed at Fig.-3.

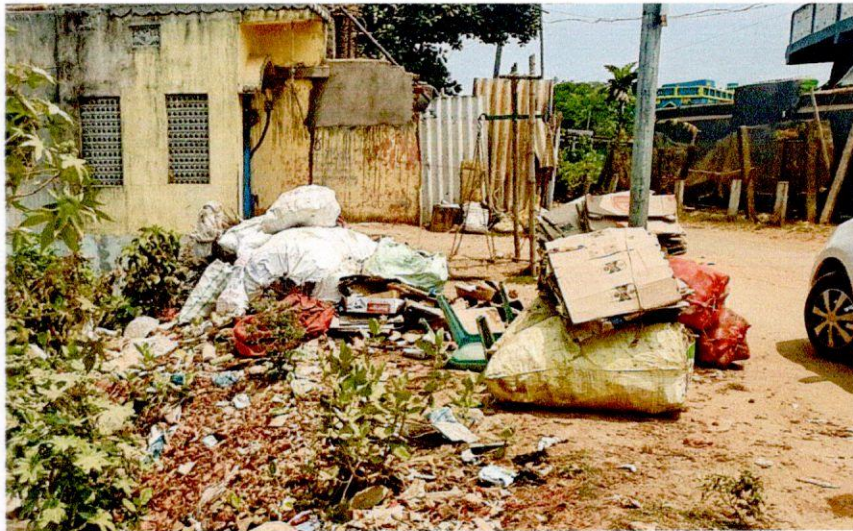
Fig.-4- A photograph of solid waste dumped by a Kawadiwala near Jayapura area of Kendrapara Municipality

- (g) The committee moved along the road adjacent to Gobari river. No specific solid waste dump site was found anywhere in places like Khadianga, Jayapura, Sunaelo, Ekanakhandi and Naya Idgah. However, in Jayapura area, some solid dry wastes were found in bagged condition near to the house of a Kawadiwala as in Fig-4. However, its impact on Gobari river was not physically visible.

- (h) Though no designated solid waste dump site exists anywhere other than Hajaribagicha, small quantities of solid waste were found lying in scattered conditions here and there. It was reported that though there is door to door collection, some inhabitants fail to deliver their wastes in time and they subsequently throw their waste to outside. Due to such activities, some solid waste was found lying here and there throughout the town. It was reported that the same waste is being lifted intermittently. However, people litter the area again. Such littering of waste was probably causing threat to Gobari river earlier during rain. However, this has reduced after fixation of bar screens in the drains.
- (i) Kendrapara Municipality does not have valid authorization under Solid Waste Management Rules, 2016. However it has applied for grant of authorization to SPCB head office.

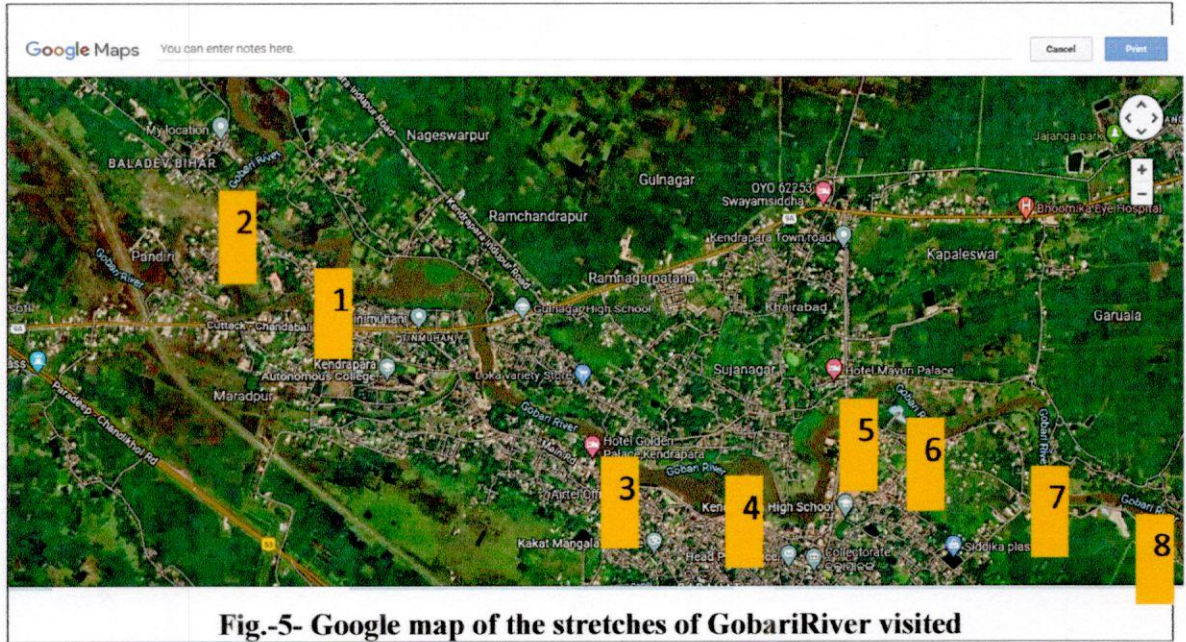
Fig.-5- Google map of the stretches of GobarRiver visited

Municipal area (Nagapura in KendraparaBlock) covering eight points. A Google map showing the points visited is placed at Fig.-5. Details of the locations are placed in Table-1.

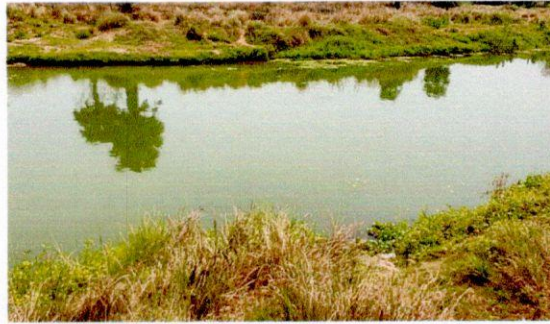
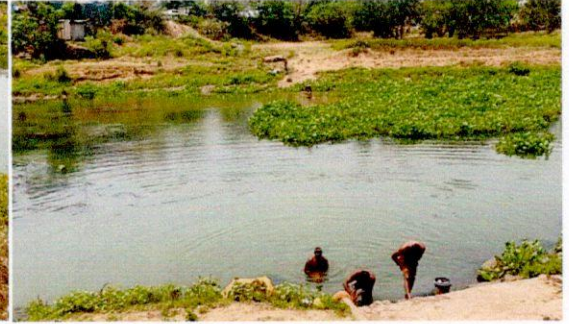
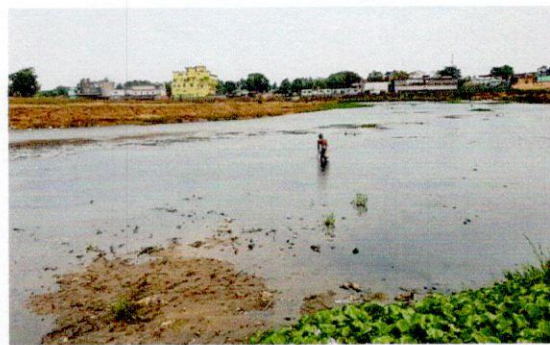
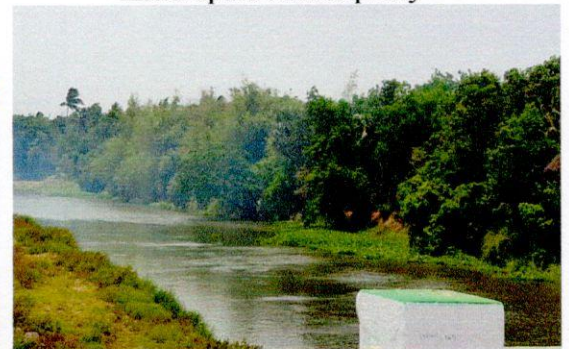
Fig.-6 – View of Gobari River at various places of Kendrapara Municipality

- (a) The Committee did not notice any seriously damaged or dead portion of river Gobari as alleged in the OA. There was usual flow in the river and people were using the river for bathing and washing purposes. Siltation was observed at some patches of the river near

Naya Idgah. Growth of hyacinth was also observed at some places near the town area, which indicated organic load input to the river. Photographs of the river at the upstream and downstream of Kendrapara Municipality and inside the town is placed in Fig.-6 for reference.

View of Gobari River in the upstream of Kendrapara Municipality

View of Gobari River near new bus stand of Kendrapara Municipality

View of Gobari River near Naya Idgah of Kendrapara Municipality

View of Gobari River in the downstream of Kendrapara Municipality

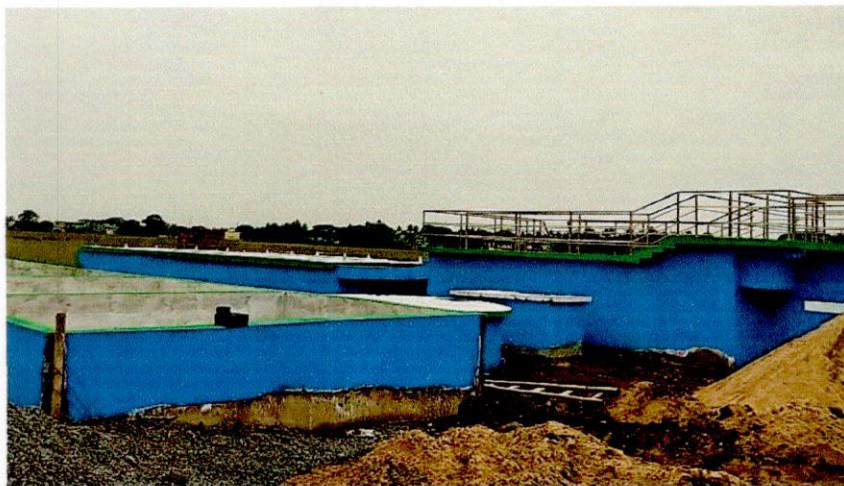
Fig.-7- A view of the newly constructed FSTP by Kendrapara Municipality

- (c) Kendrapara Municipality is a 153 year old municipality and the roads inside the main town are very narrow. Therefore, construction of any sewerage system has not been possible as reported. Most of the households have their own septic tank-soak pit system to handle the sewage. The municipality has recently completed construction of a FSTP (20 KLD capacity) for treatment of the wastewater collected from the septic tanks through cesspool vehicles as seen in Fig.-7. Construction of such FSTPs for all ULBs except Municipal Corporations of the State have been recommended by the State Government as reported. For operation of FSTP, it has already obtained CTO from SPCB. Once its operation is started, the sewage from septic tanks will be taken care of.

- (d) As the FSTP system has not been operational so far, sewage collected from the septic tanks through cesspool vehicles is disposed off inside an earmarked pit near Hajaribagicha.

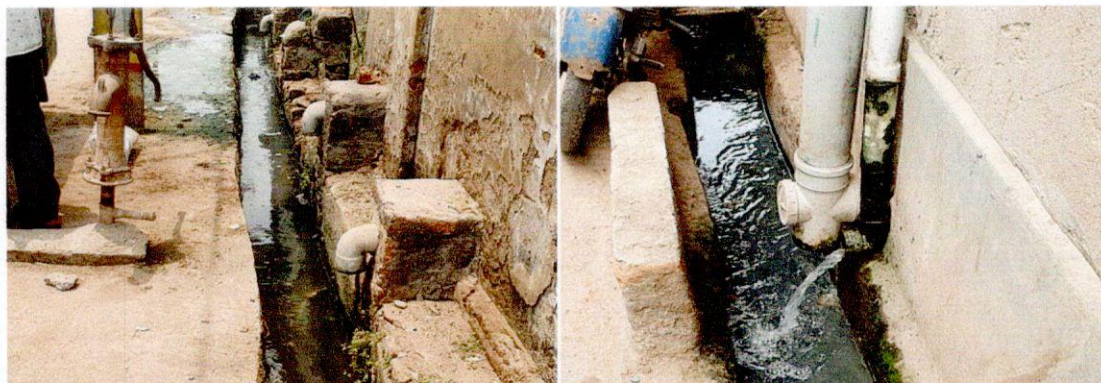
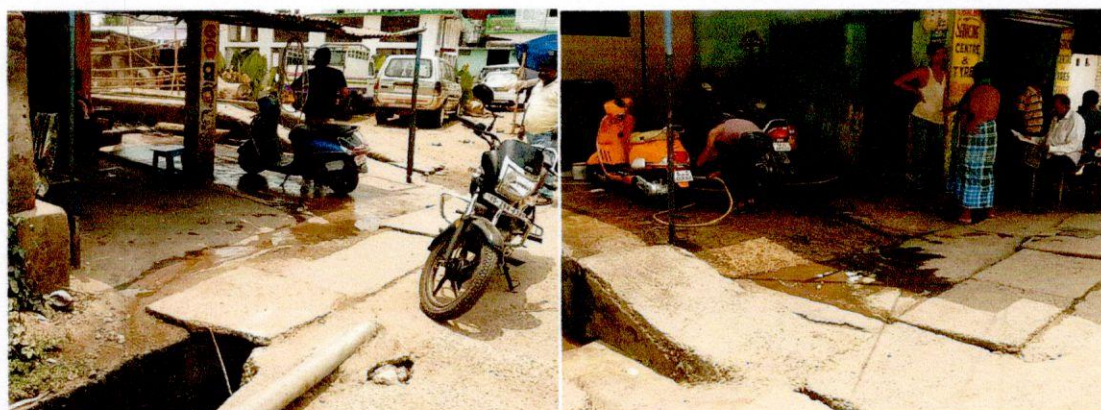
Fig.-7- Configuration of domestic wastewater in Naya Idgah Drain

- (a) The nominal discharge of domestic wastewater was again observed near New bus stand. It was only from bus stand area covering shops and small restaurants/eateries and thus it is not raw sewage.
- (b) The drain near Naya Idgah collects domestic wastewater from Ward no. 14 and 15 and it covers about 3000 people as reported. The entire area was covered by walking and all the drains of the area were inspected. It was found that most of the household have connected their wastewater outlets from bath room and kitchen to the municipality

drains. Besides, there are vehicle washing stations (two numbers) which also discharge their wash water into the same drain. People were found taking bath in open and the same was also entering into the drain. All the mixed wastewater was found flowing into GobariRiver. Some of the photographs taken are placed in Fig.-7 for reference.

Views of domestic wastewater drains connected with the municipal drain at Naya Idgah

Views of operating vehicle washing stations discharging wastewater into municipal drain at Naya Idgah
