**BEFORE THE NATIONAL GREEN TRIBUNAL  
EASTERN ZONE BENCH, KOLKATA**

**ORIGINAL APPLICATION NO. 217 OF 2024 (EZ)**

NEWS ITEM TITLED "CAG FAULTS CITY'S WASTE PROCESSING" APPEARING IN THE SHILLONG TIMES DATED 16.09.2024.

**REPLY AFFIDAVIT ON BEHALF OF RESPONDENT NO.1 -  
MEGHALAYA POLLUTION CONTROL BOARD**

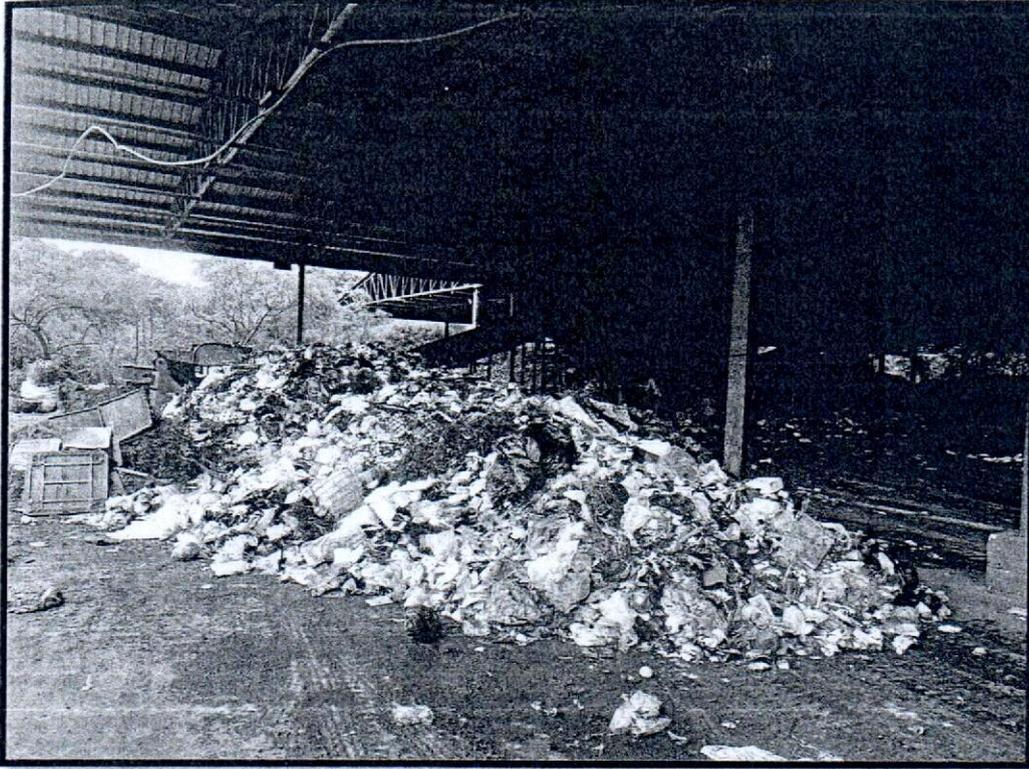
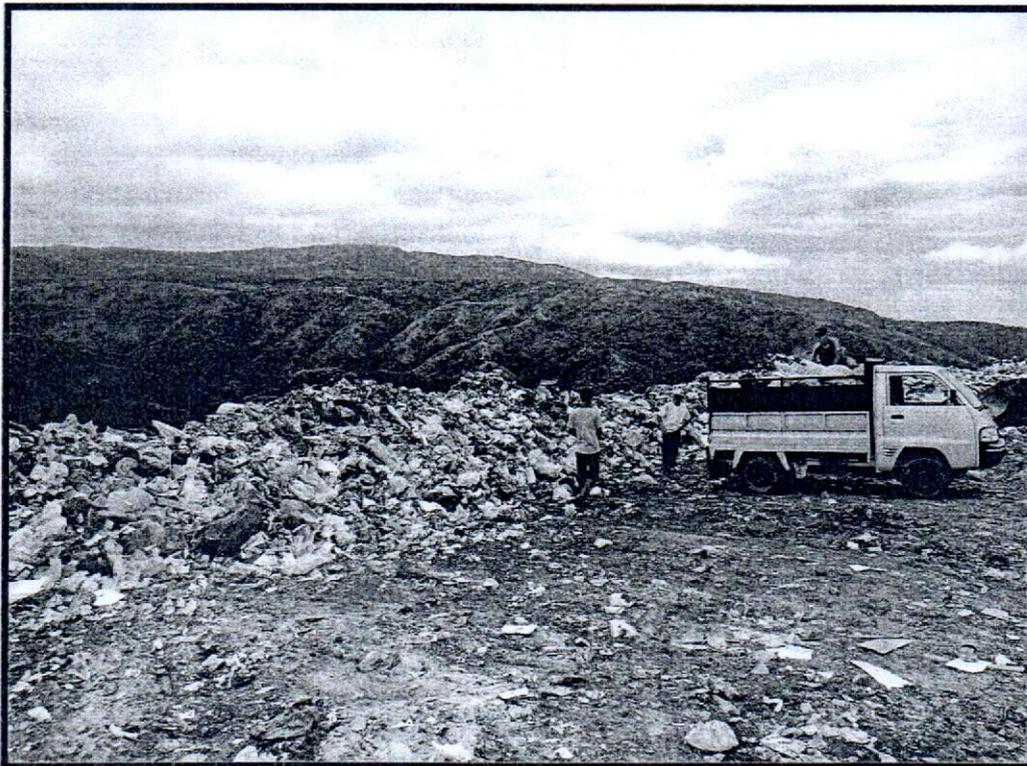
1. Total waste received at the facility is around 150 ton per day.
2. No segregation of solid waste, the solid waste both biodegradable waste & non-biodegradable waste were dumped. When enquired, the person present at site informed that 50% of the mixed waste i.e. 75 TPA approx is dumped and further treated in the composting plant and remaining 50% is dumped directly in the landfill site (Pic. enclosed as Plate –I).

Plate – I (Showing mixed solid waste dumped in the Sanitary Landfill and Composting area)

**In this connection, you are also hereby directed to take immediate necessary steps to address the above issues and submit the Action Taken Report to this office within 15 (fifteen) days from the date of issue of this letter failure which environmental Compensation will be impose for non-compliance.**

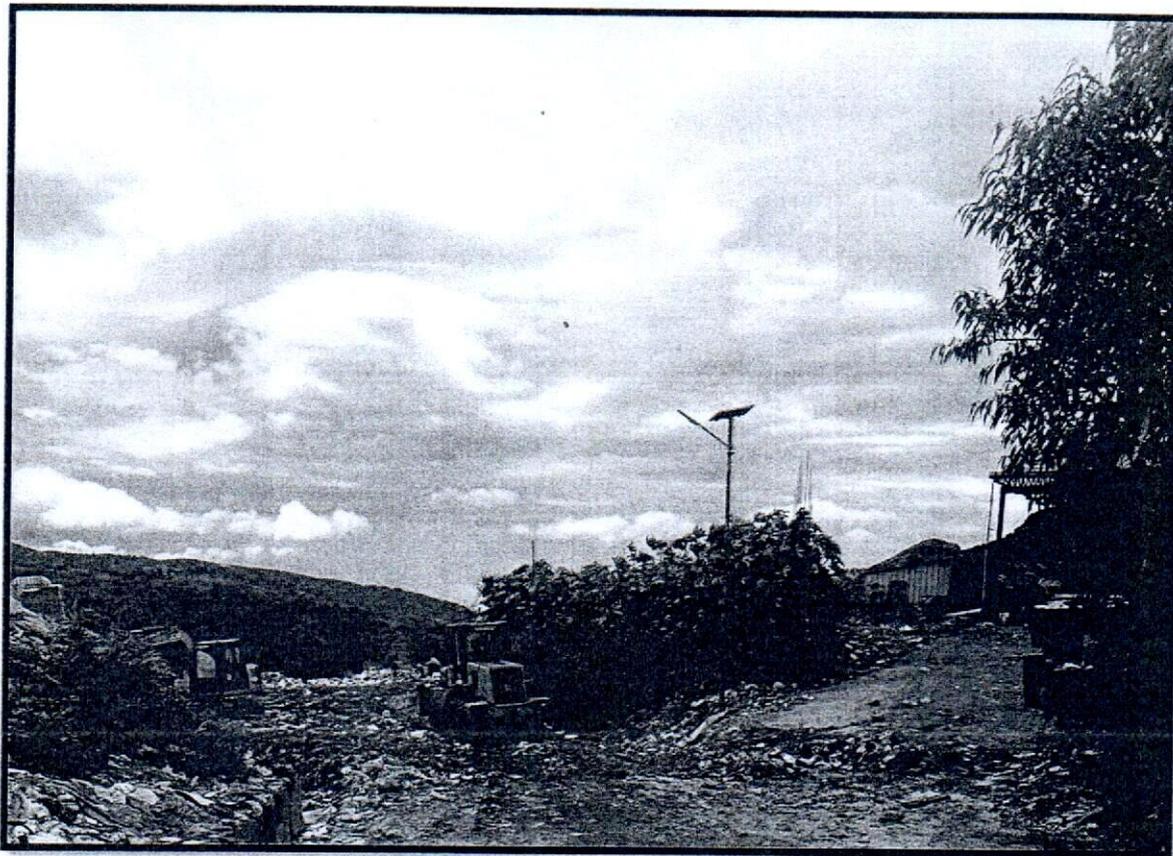
3. Road leading to the areas where all mixed waste were dumped is in deteriorated condition (Pic. enclosed as Plate –II).
4. Solid waste were observed littering around the approach road.

Plate – II (Showing the deterioration of approach road to the Landfill)

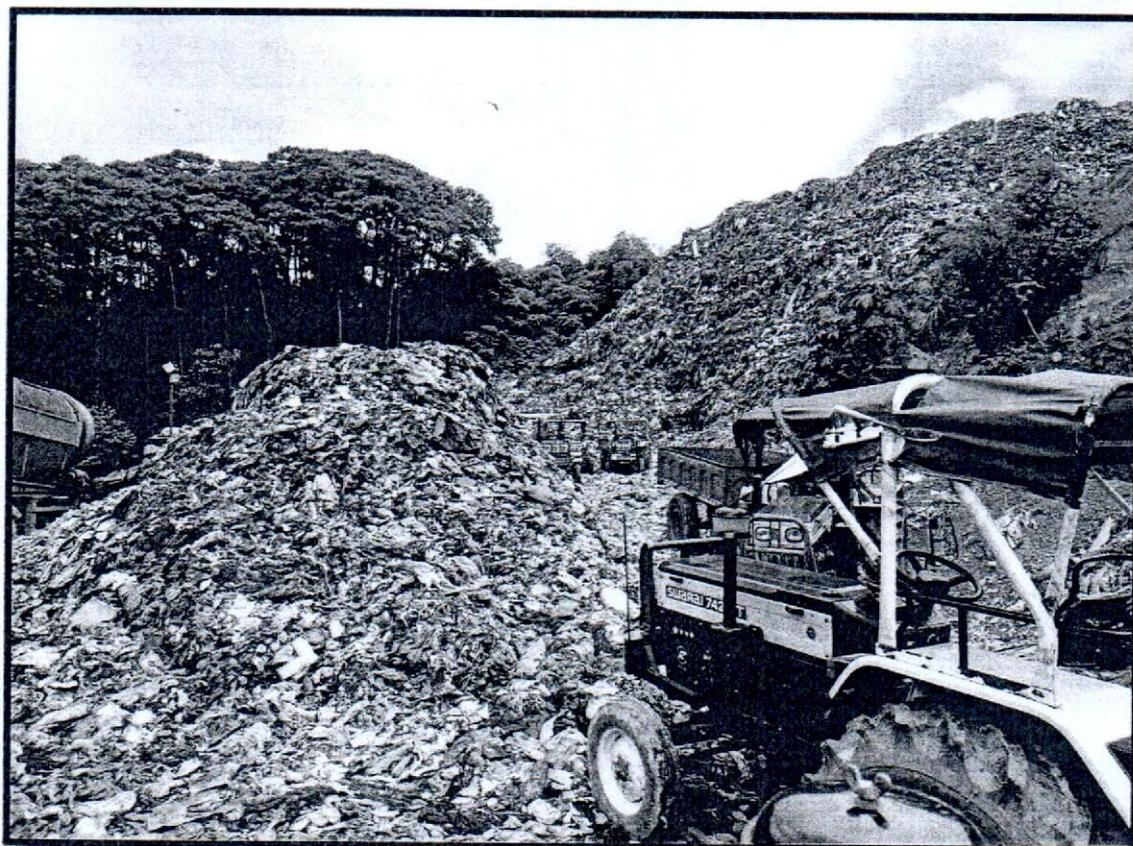
7. Clearing of Legacy waste through excavator has started since June,2024. One trommel machine installed for segregation of legacy waste (Pic. enclosed as Plate –III). Trucks were seen waiting in line for loading of the segregated plastic waste. Authorization yet to be obtained.

Plate – III (Showing clearing of Legacy waste from Phase-I of landfill site )

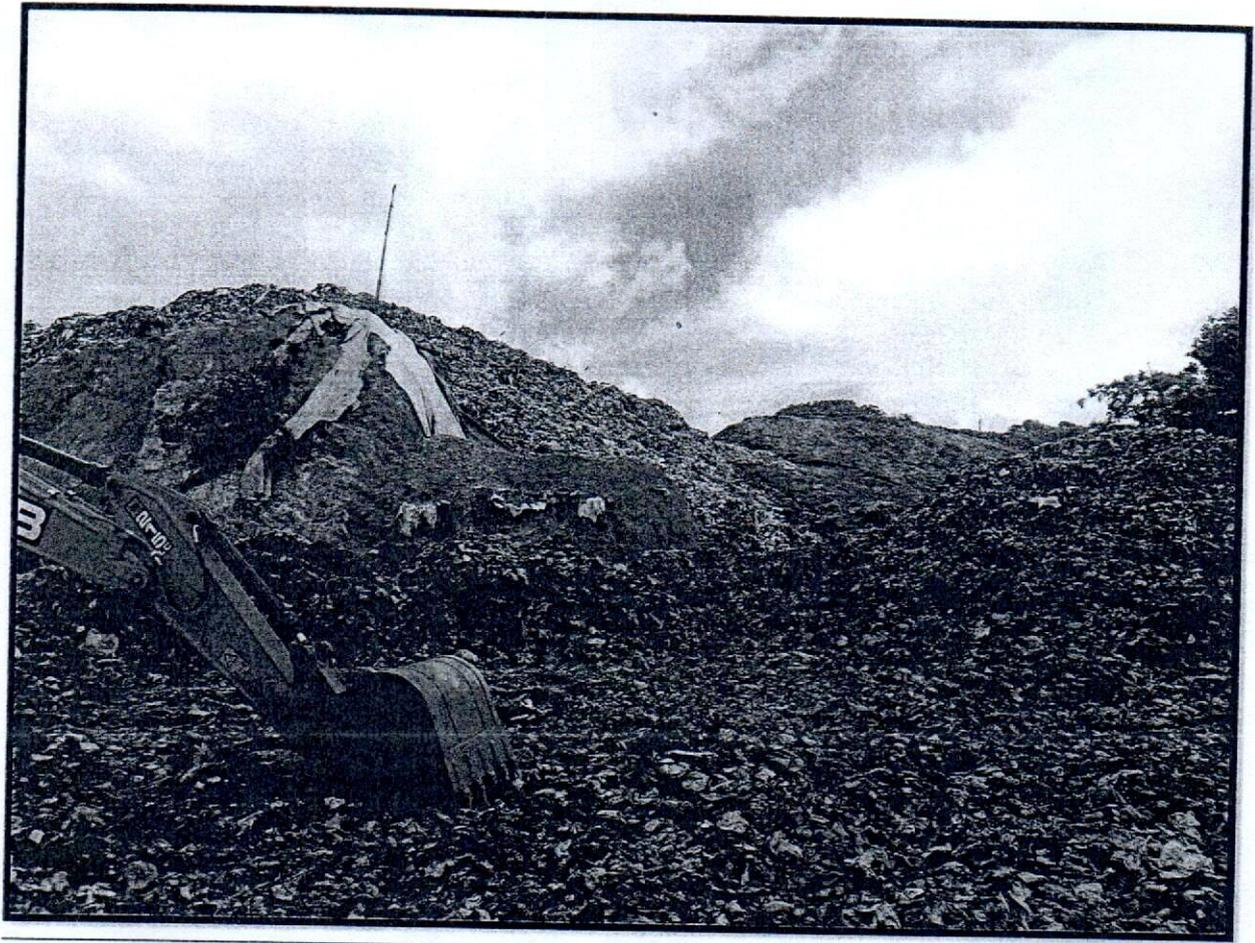
8. The geo thermal lining is all peeled off and in deteriorated condition, due to which it is most likely possible for leachate to find ways penetrating into the ground (Pic enclosed as Plate - IV)

Plate - IV (Showing geo thermal lining has been peeled off )

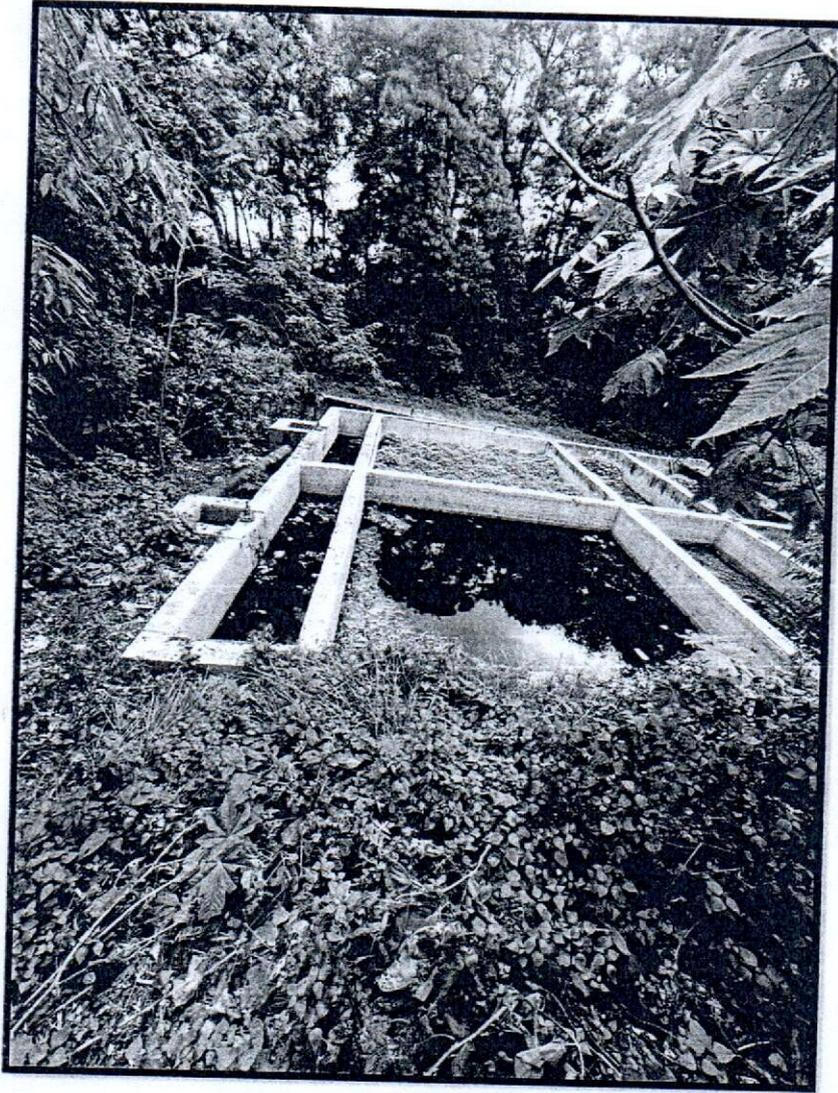
9. The drainage system and leachate treatment plant constructed is not at all being maintained. The leachate is observed discharging directly without proper treatment (Pic enclosed as Plate - V).

Plate - V (Showing the leachate treatment plant left abandoned )

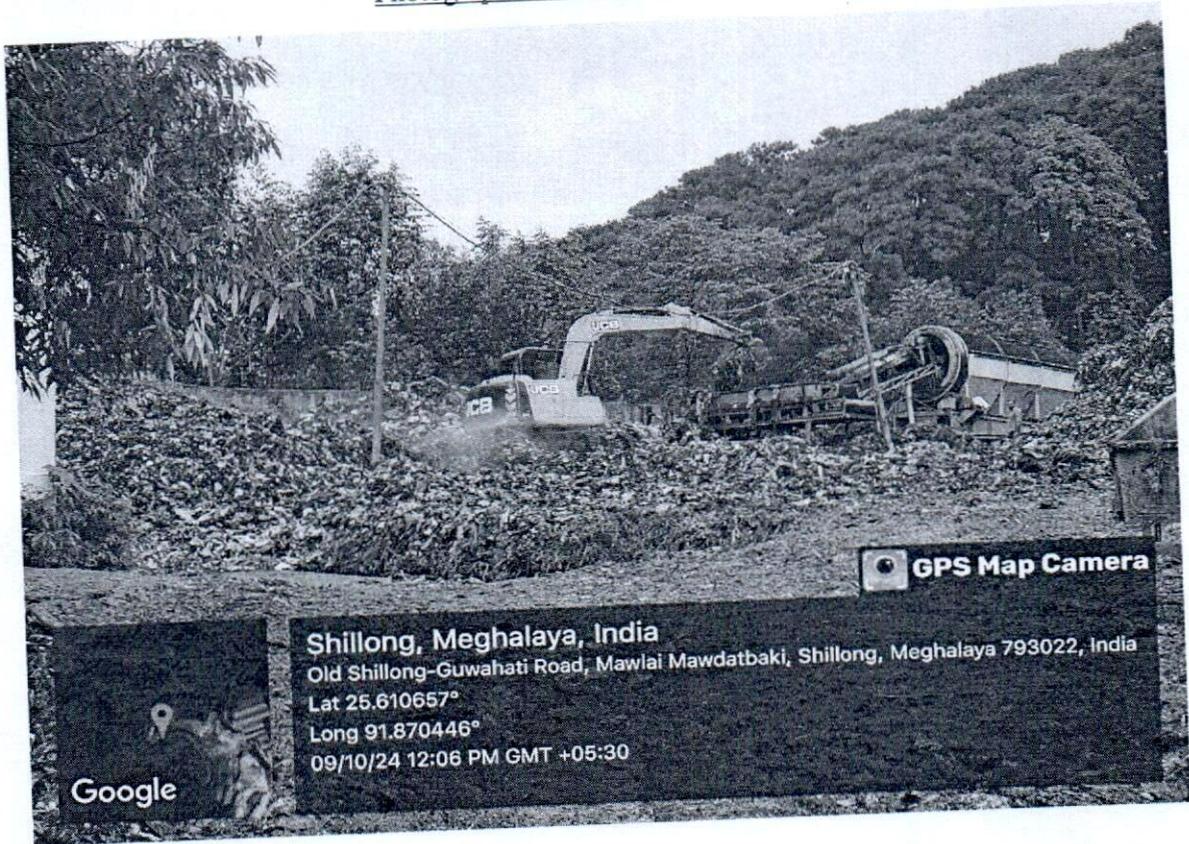
Phase-I of Shillong Land-fill Facility

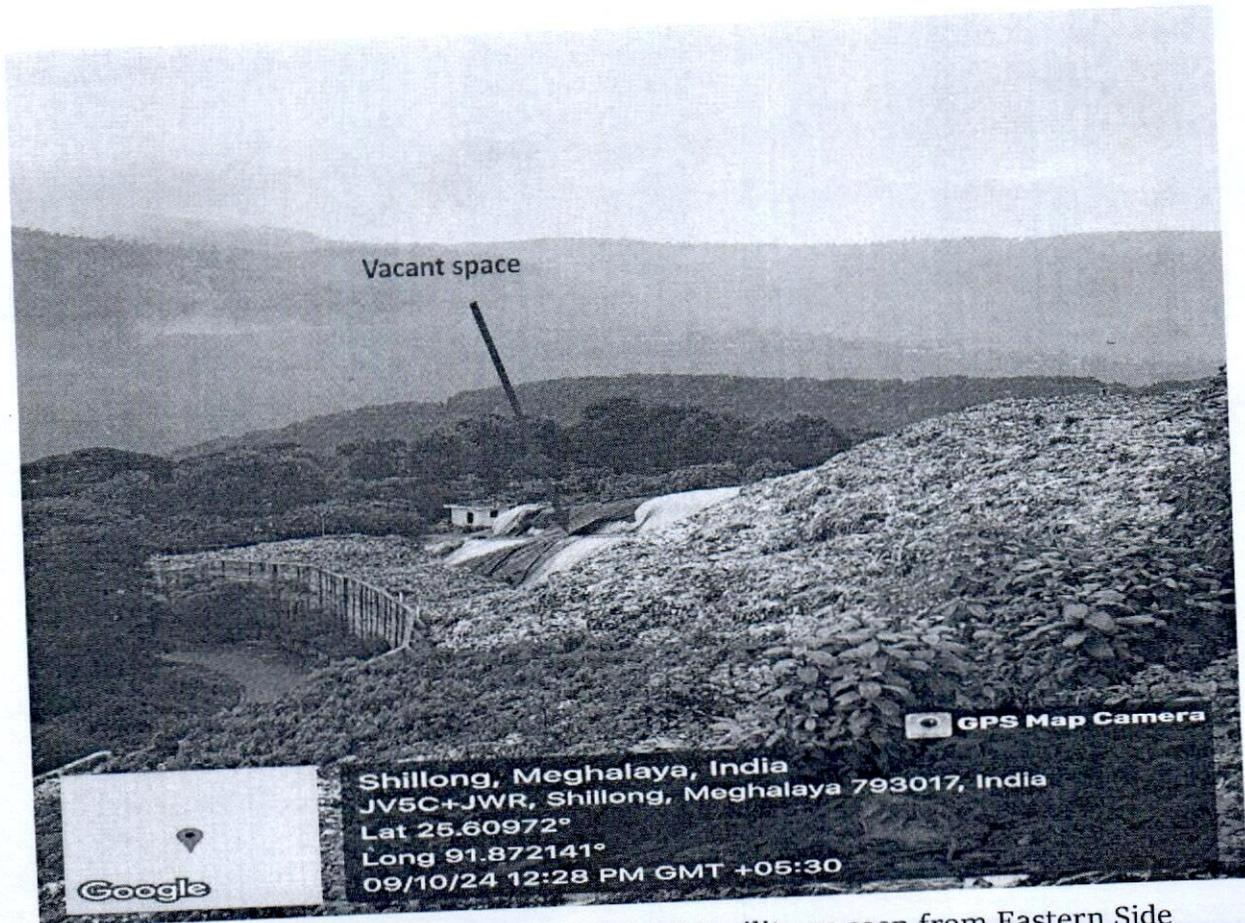
Phase-II of the SLF was found to be covered with non-permeable HDPE linings system at the base (photographs attached). Leachate collection and treatment system was seen in the field (Photographs attached). However, it seems that the leachate treatment facility may not be operated regularly. Moreover, there is no system observed for diversion of storm water to minimize leachate generation and to avoid flooding/water logging as per CPCB guidelines.

Phase-II of Shillong Land-fill Facility as seen from Eastern Side

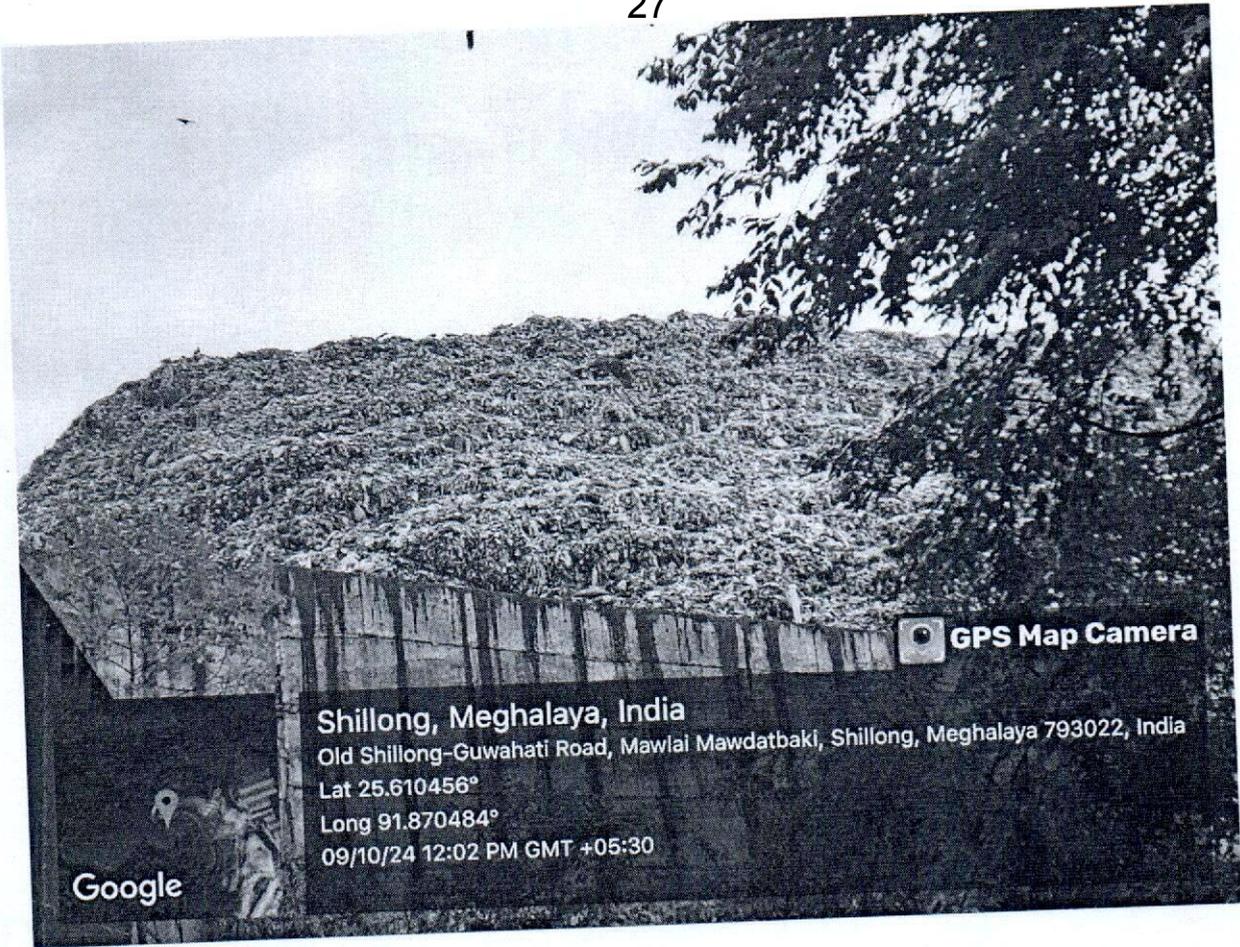
Phase-II of Shillong Land-fill Facility as seen from North-Western Side

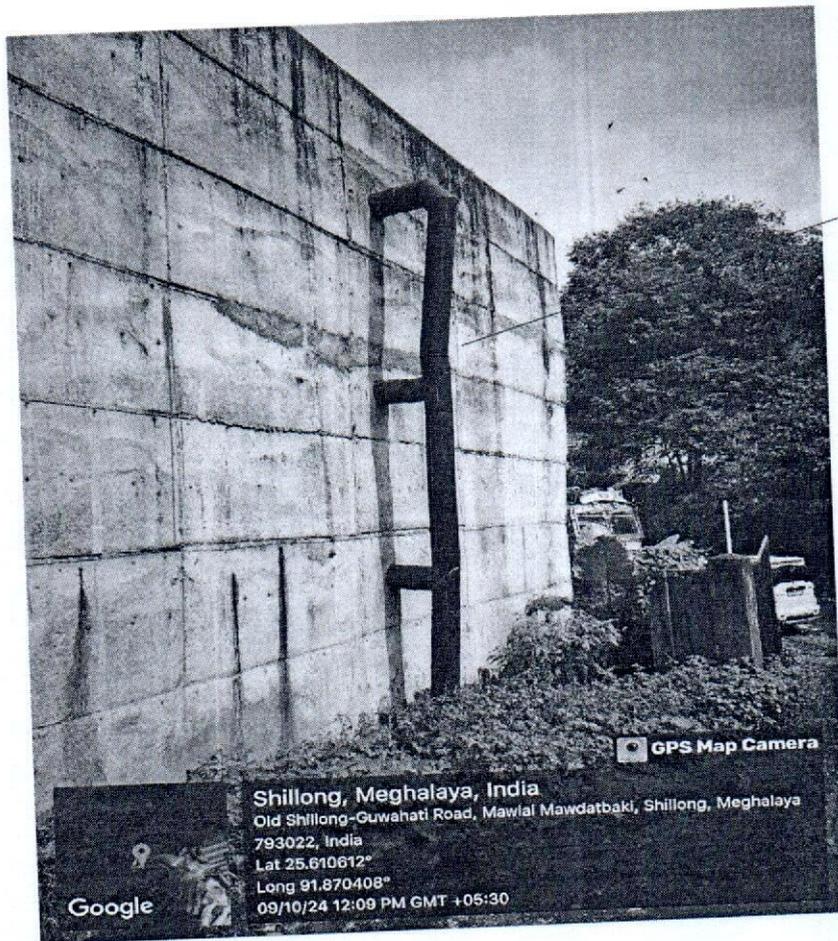
Leachate collection system at Shillong Land-fill Facility

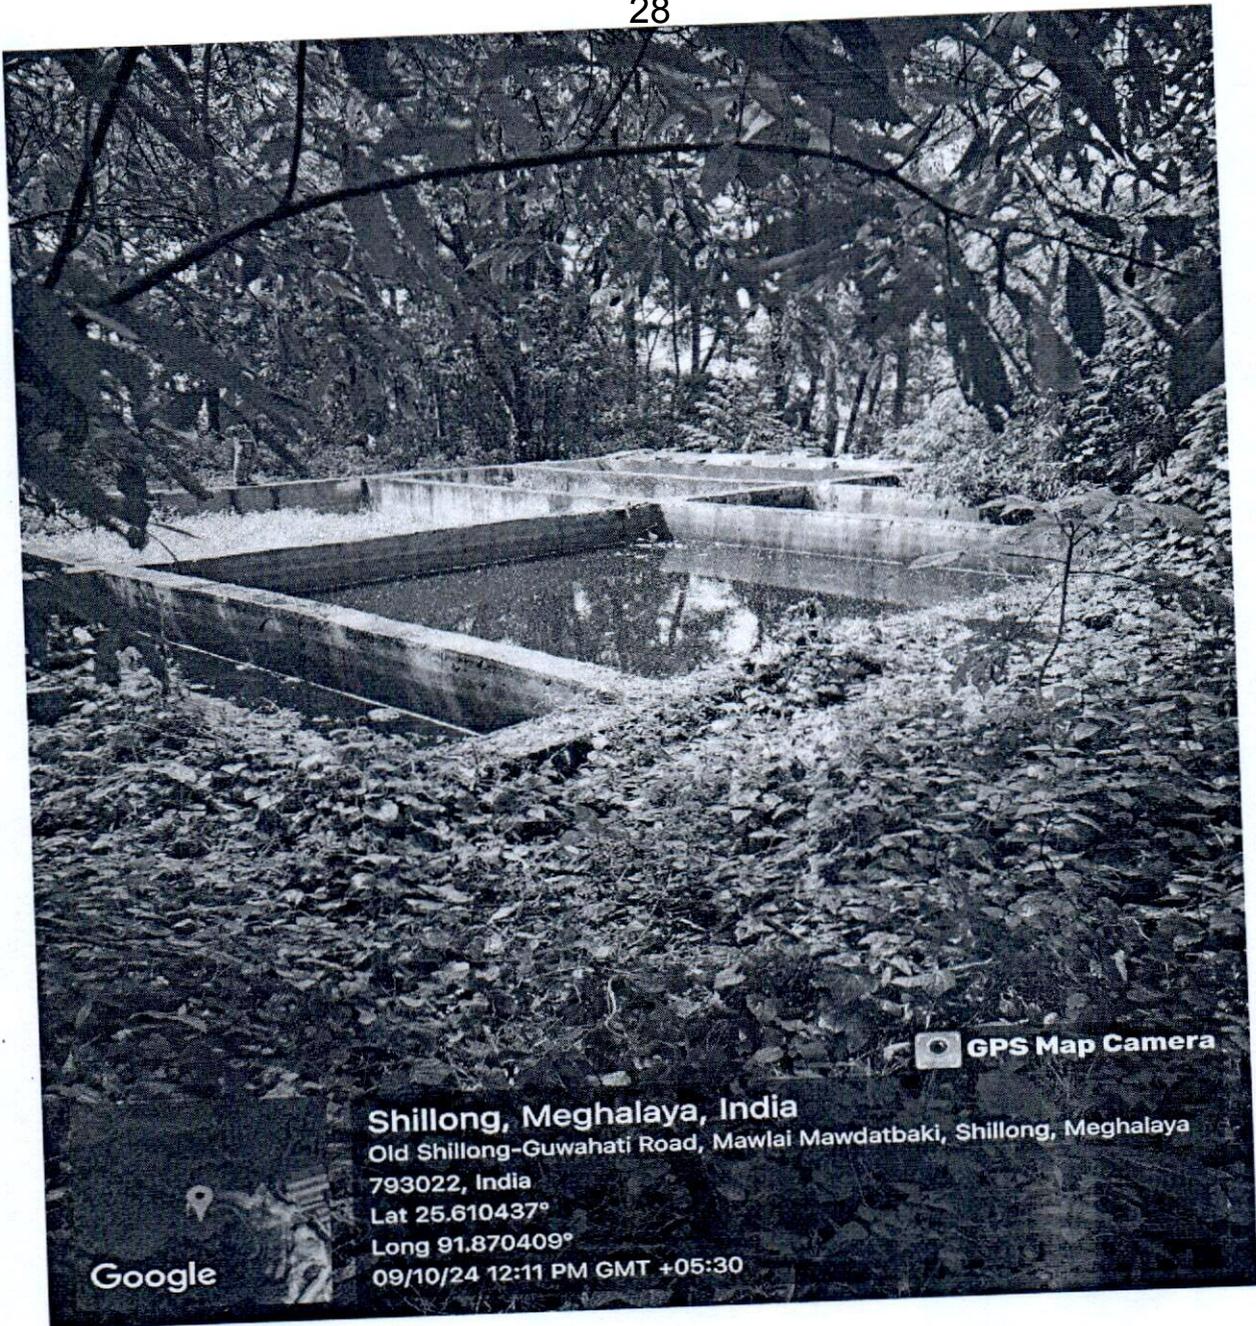
Sand filter is the only treatment media as observed in the leachate treatment plant and the treated effluent is discharged into outside drain as reported by the SMB representative. No log-book was found to be maintained.

Leachate Treatment Plant at Shillong Land-fill Facility
