BEFORE THE NATIONAL GREEN TRIBUNAL (SZ), SITTING AT CHENNAI
(Under Section 18(1) read with S.14 & 15 of NGT Act, 2010)
ORIGINAL APPLICATION No. 180 OF 2023

Sub: TNPCB, O/o.JCEE, Chennai –Report on the suspected oil leak into
Buckingham canal consequently reaching the Ennore Creek – Regarding

MINUTES OF THE MEETING RELATED TO SUSPECTED OIL LEAK INTO BUCKINGHAM CANAL ON 08.12.2023 AT 5.00 PM TO DECIDE ON THE ACTION TO BE TAKEN

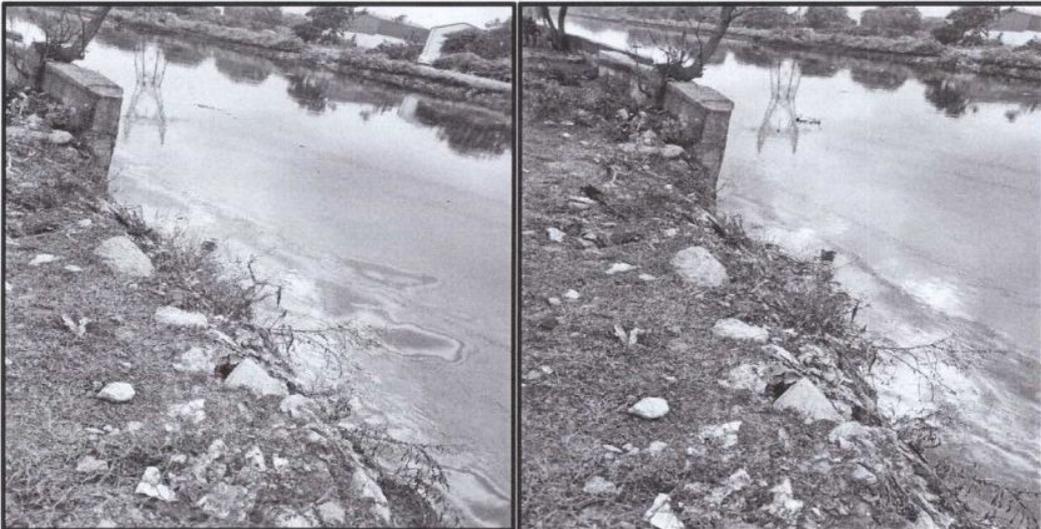
Based on the above information, a team of officials of Tamil Nadu Pollution Control Board inspected the said area. The Team initially visited the Buckingham Canal stretch from Kargil Nagar bridge up to Kodungaiyur. During the inspection, the team observed traces of oil in the Buckingham Canal mainly on the banks. It was observed that the ingress of oil mainly occurred from the stormwater drain from the Manali industrial area confluence with Buckingham canal.

Oil Traces found in Buckingham Canal

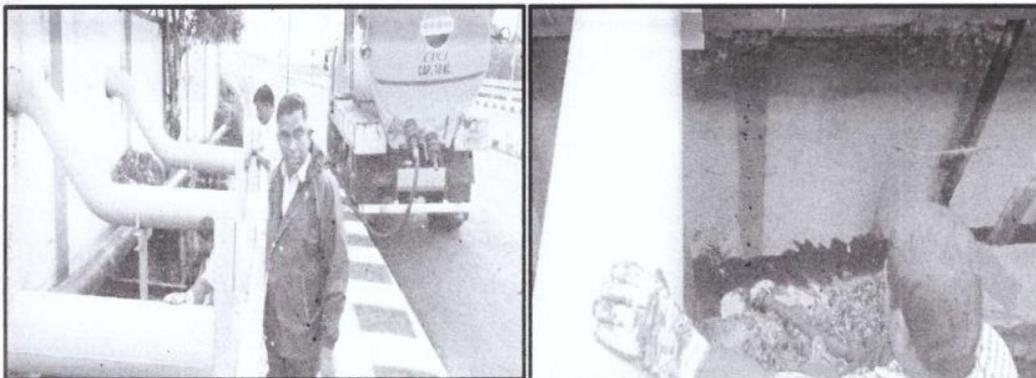
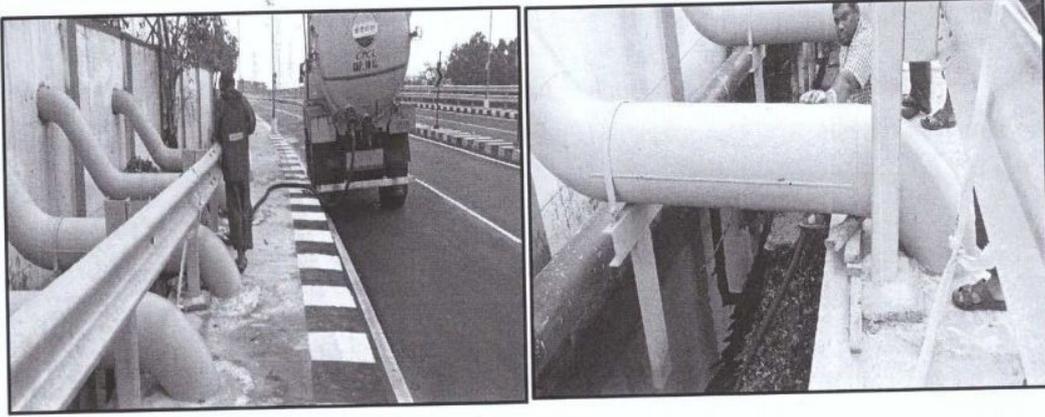
At this juncture, the team attempted to find out the source of the oil and found that, there was some stagnant storm water along with oil, adjoining the storm outlet near South Gate of Chennai Petroleum Corporation Limited, which slowly contributed to oil traces. However, it was observed that during inspection the stormwater coming out of the Chennai Petroleum Corporation Limited premises on the southern side was not found to have oil.

It is observed that the said stagnant oil reaches the Buckingham canal through the culvert slowly, results in oil traces in the water of Buckingham Canal. CPCL authorities are instructed to remove the said floating oil using gully sucker and they immediately carried out the same. They assured to repeat the process tomorrow morning also. The storm water containing oil is taken back for further processing along with crude oil.

Stagnated oil with storm water removal using Gully sucker

Further, the CPCL authorities are also instructed to provide boomer arrangement at the location where the storm water is reaching the drain, leading to Buckingham canal. The representative of industry present assured to formulate a concrete proposal in this regard and to furnish the same for approval before execution.

It is submitted that the action of removal of stagnated storm containing oil, through Gully Sucker near the South gate, would eliminate the oil traces reaching Buckingham Canal, thereby makes the water in Buckingham canal, free of oil.

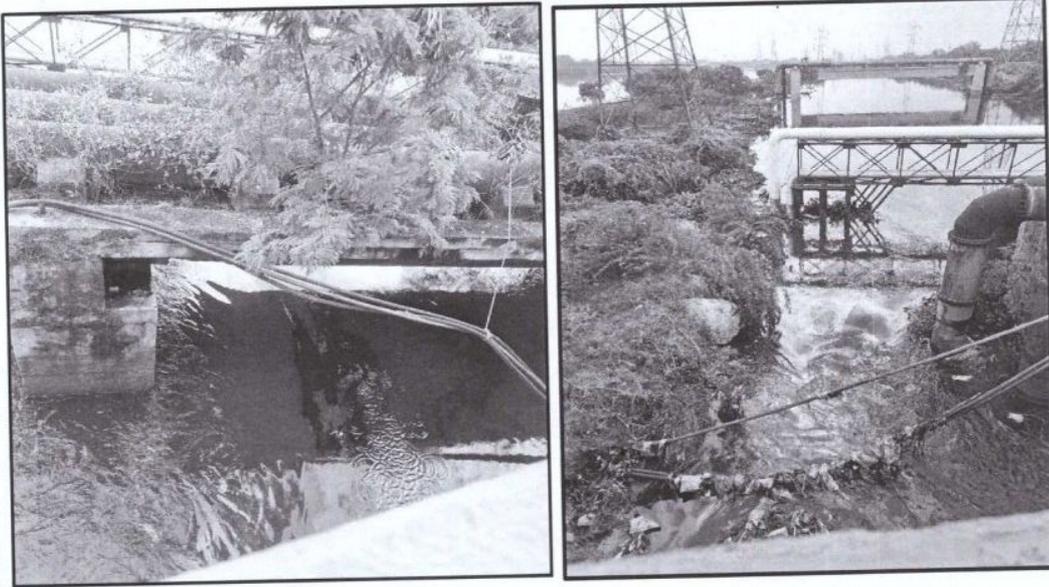
However, the inspecting team found that slight traces of oil is also found coming from the upstream of the Chennai Petroleum Corporation Limited from Kodungaiyur / Tondiarpet areas from Indian Oil Corporation Limited, Tondiarpet Terminal and container Terminal located along the Buckingham Canal at Korrukupet and Kodungaiyur areas.

Oil traces in the upstream of Buckingham canal

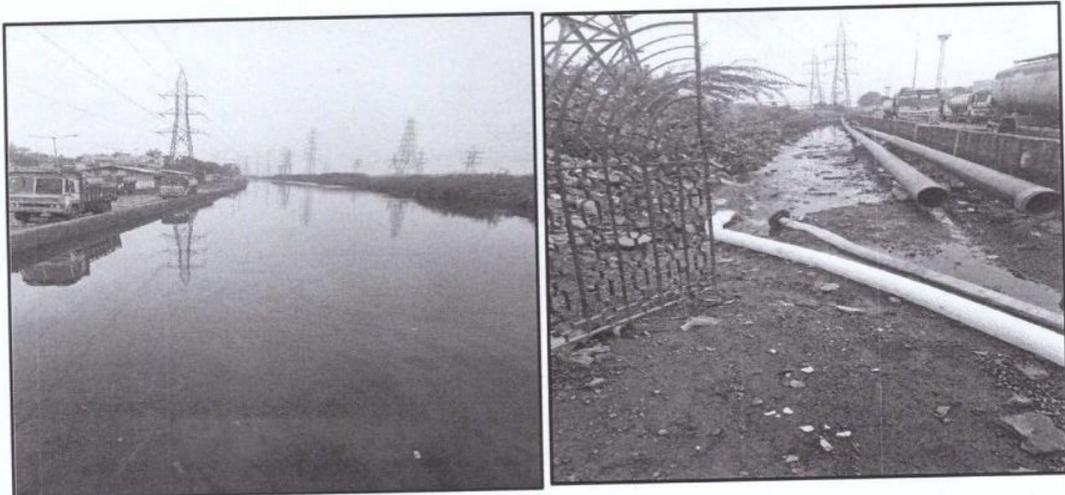
Oil traces near Kodungaiyur IOCL, Container Terminal facility
