**BEFORE THE NATIONAL GREEN TRIBUNAL
SOUTHERN ZONE, CHENNAI
OA No. 180 of 2023 (SZ)**

**STATUS REPORT FILED BY M/s. CHENNAI PETROLEUM
CORPORATION LIMITED , THE 7TH RESPONDENT (21.12.2023)**

Field Observation Report

Site visit report of oil spill at Ennore Creek

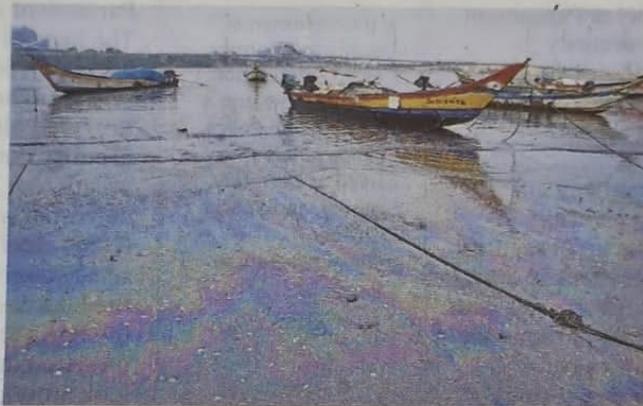
Done and dusted: The team reviewed work on Buckingham Canal, Kosasthalaiyar river and Ennore creek area. B. JOTHI RAMALINGAM
