**BEFORE THE NATIONAL GREEN TRIBUNAL SOUTHERN ZONE BENCH AT
CHENNAI**

APPLICATION No. 195 of 2023 (SZ)

Tribunal on its own motion- Suo Motu Based on the
News Item published in The Express News Newspaper,
Tamil Nadu, Chennai District,
Dated 27.12.2023,
"Ammonia Gas Leak from fertilizer
Manufacturing unit triggers panic
In Chennai's Ennore"

AFFIDAVIT/ REPORT FILED BY THE 7th RESPONDENT

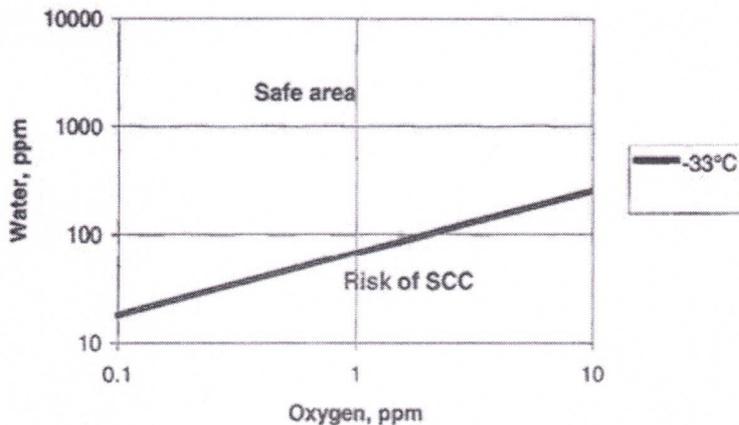
Figure: Relation between water and oxygen concentration in ammonia and risk of SCC

The dependency of SCC on water content and oxygen concentration in ammonia is shown in Figure

The initial cracking potential has been considered as "LOW" with the above listed points and also as per the operational history provided. It is to be noted that SCC is the main internal degradation mechanism which needs to be taken into consideration when planning and executing an inspection

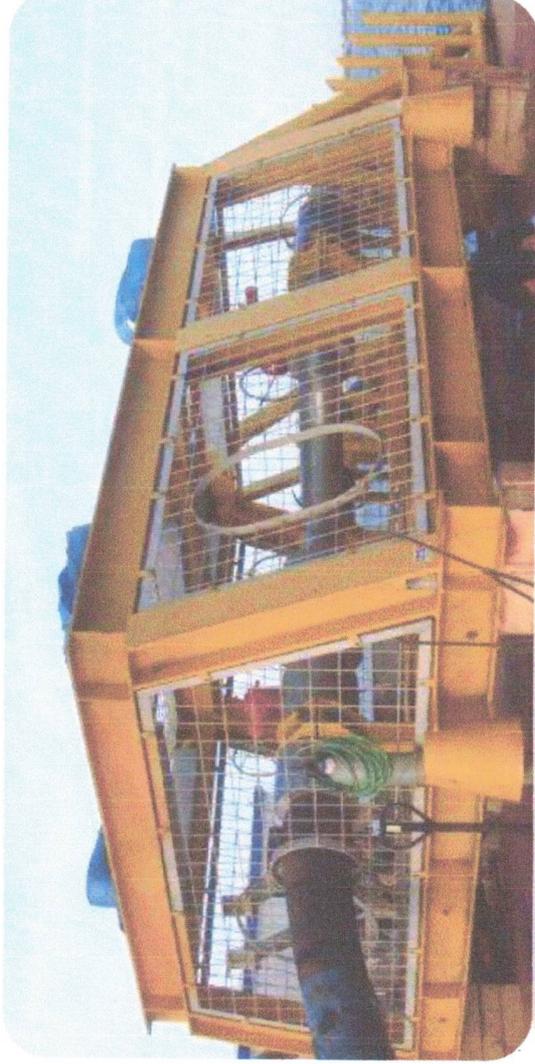
PLEM Assembly

- ❖ Steel Foundation with Steel skirt – Gravity foundation
- ❖ Connected with NKT - Valves – 2 No. 8” Ball Valves
- ❖ Connected with Unloading Hose with 10” Butterfly Valve with NRV

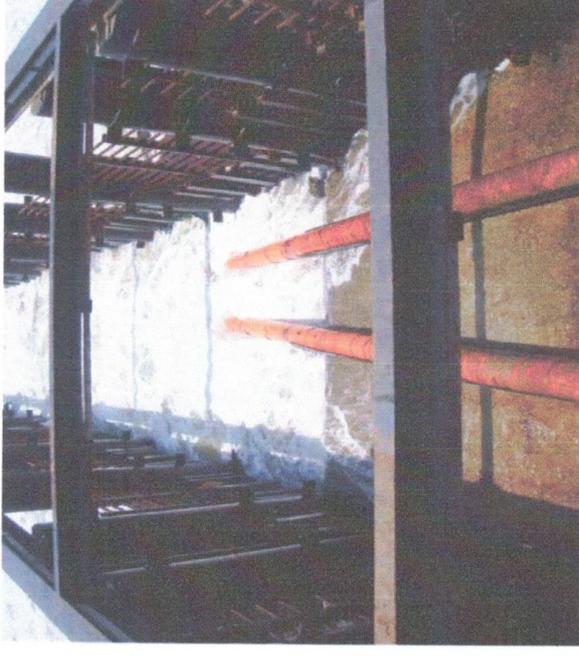
NKT Subsea Pipeline

- The Pipeline was designed and commissioned by **M/s NKT Flexibles, Denmark.**
- The pipeline is made of **steel wire impregnated, multi layered (11 layers) polyurethane pipe.**
- At the time of installation, the coastal line profile at Ennore, was with **50 m of beach.** Pipeline laid in the coastal sand bed.
- The pipeline is designed for **25 kg/cm² against the operating pressure of 6 kg/cm².**
- The manufacturer has given **average life expectancy of the pipeline for 50 years.**
- The pipeline is designed for the worst case of **burst pressure of 131 kg/cm².**

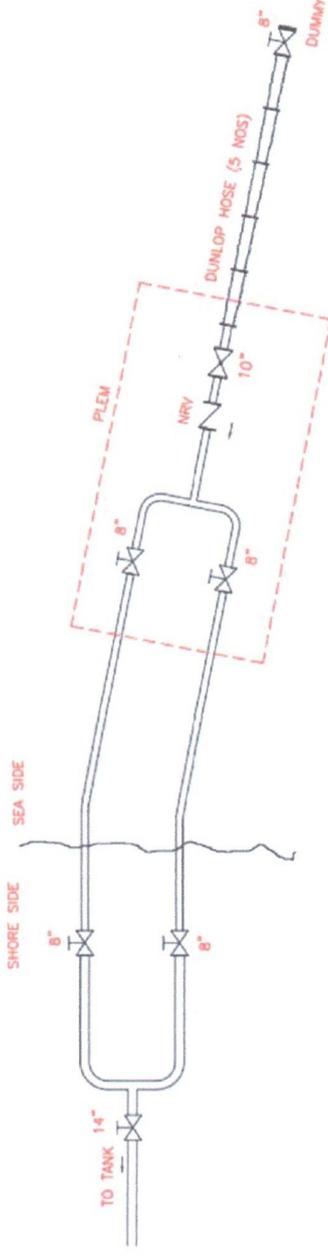
Ammonia Ship Unloading Operation

- Since the ammonia is **cryogenic fluid**, it should be operated in **negative Temperature (-33 Deg.C)**
- it is mandatory to reduce the pipeline temperature near to -33 Deg.C to have a control on vaporisation rate.
- The process of reducing the pipeline temperature near to -33 Deg.C is called **Precooling Operation**.

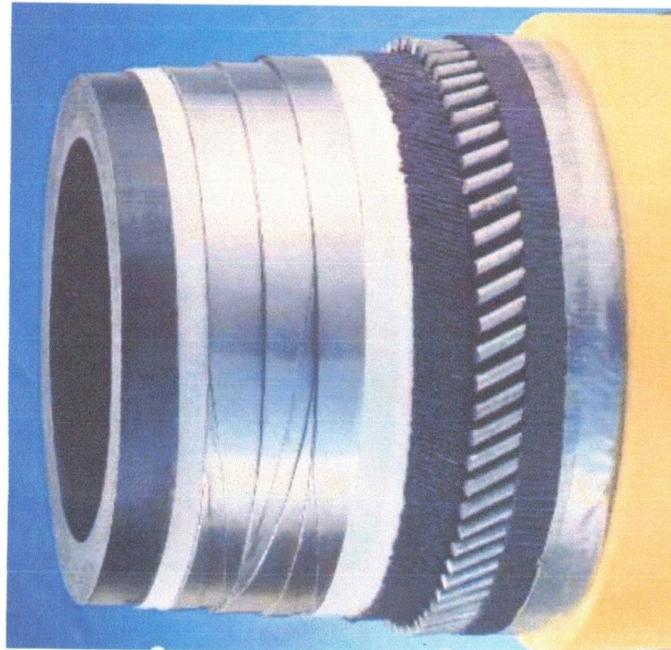
NKT Subsea Pipeline - Layers

Cross Section View

S.No	Item	Material	Layer Thickness, mm	Outer Diameter, mm
1	Pipe Inner	HDPE	18.0	220.0
2	Bedding tape	Polyester	0.3	220.5
3	6" steel tapes	Fine grain	4.8	230.1
4	PVC - tape	PVC	0.6	231.3
5	PP - Yarn	PP	1.5	234.3
6	72 Steel wire 6.00	St 34	6.0	246.3
7	Asphalt	Asphalt	0.0	246.4
8	Bedding tape	Crepe tape	0.5	247.4
9	Bedding tape	Polyester	0.1	247.5
10	Outer Sheath	MDPE	7.0	261.5

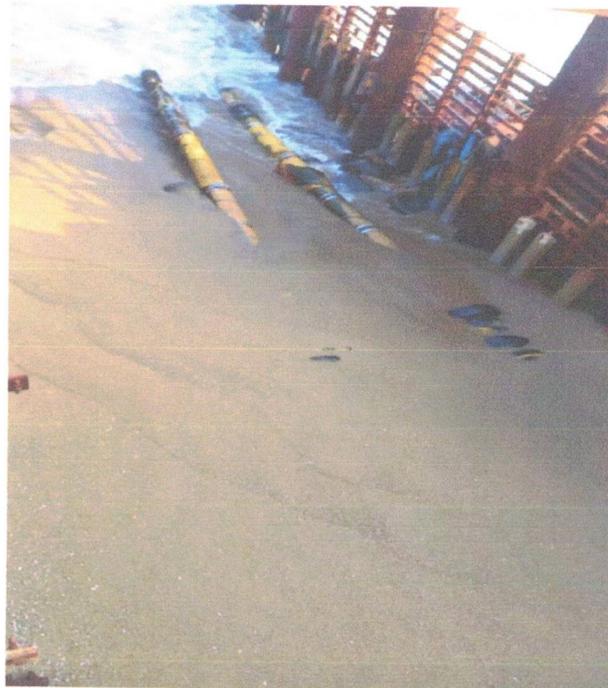
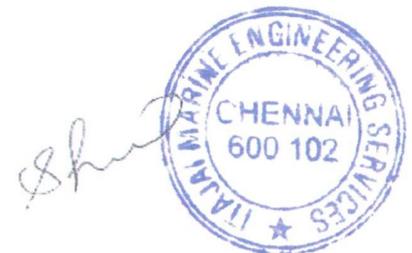
The post cyclone inspection of NKT corridor area was carried out on 13th December 2023. The observations have been listed below.

- i. The boulders & debris found near the NKT corridor area were cleared manually.
- ii. All anodes fixed on the beams observed before the cyclone were found intact.
- iii. No major beam or metal structure damages when compared to pre-cyclone inspection were observed.
- iv. The NKT pipeline was observed to be covered with sand till 6th Pile from the road.
- v. The distance between both NKT pipelines observed over the visible portion till splash zone remains the same.

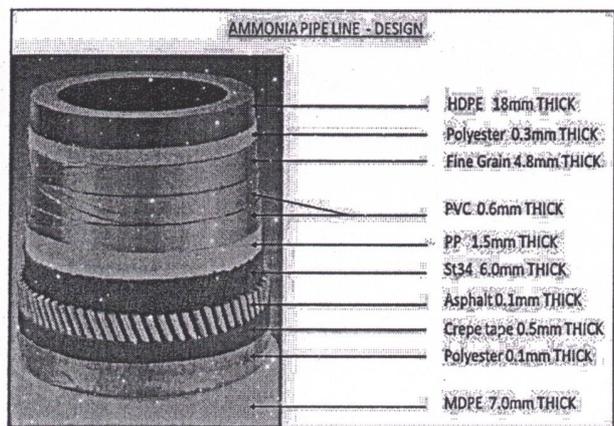
- a) Pre-Cooling Lines (3" & 4"): Design Pressure 22.5 kg/cm2g, MOC: LTCS
- b) Sub Sea Pipeline (8" x 2 Nos): Design Pressure 25 kg/cm2g, MOC: HDPE armoured with several layers of steel tapes and steel wires. Refer sketch below for cross section of subsea flexible hose.

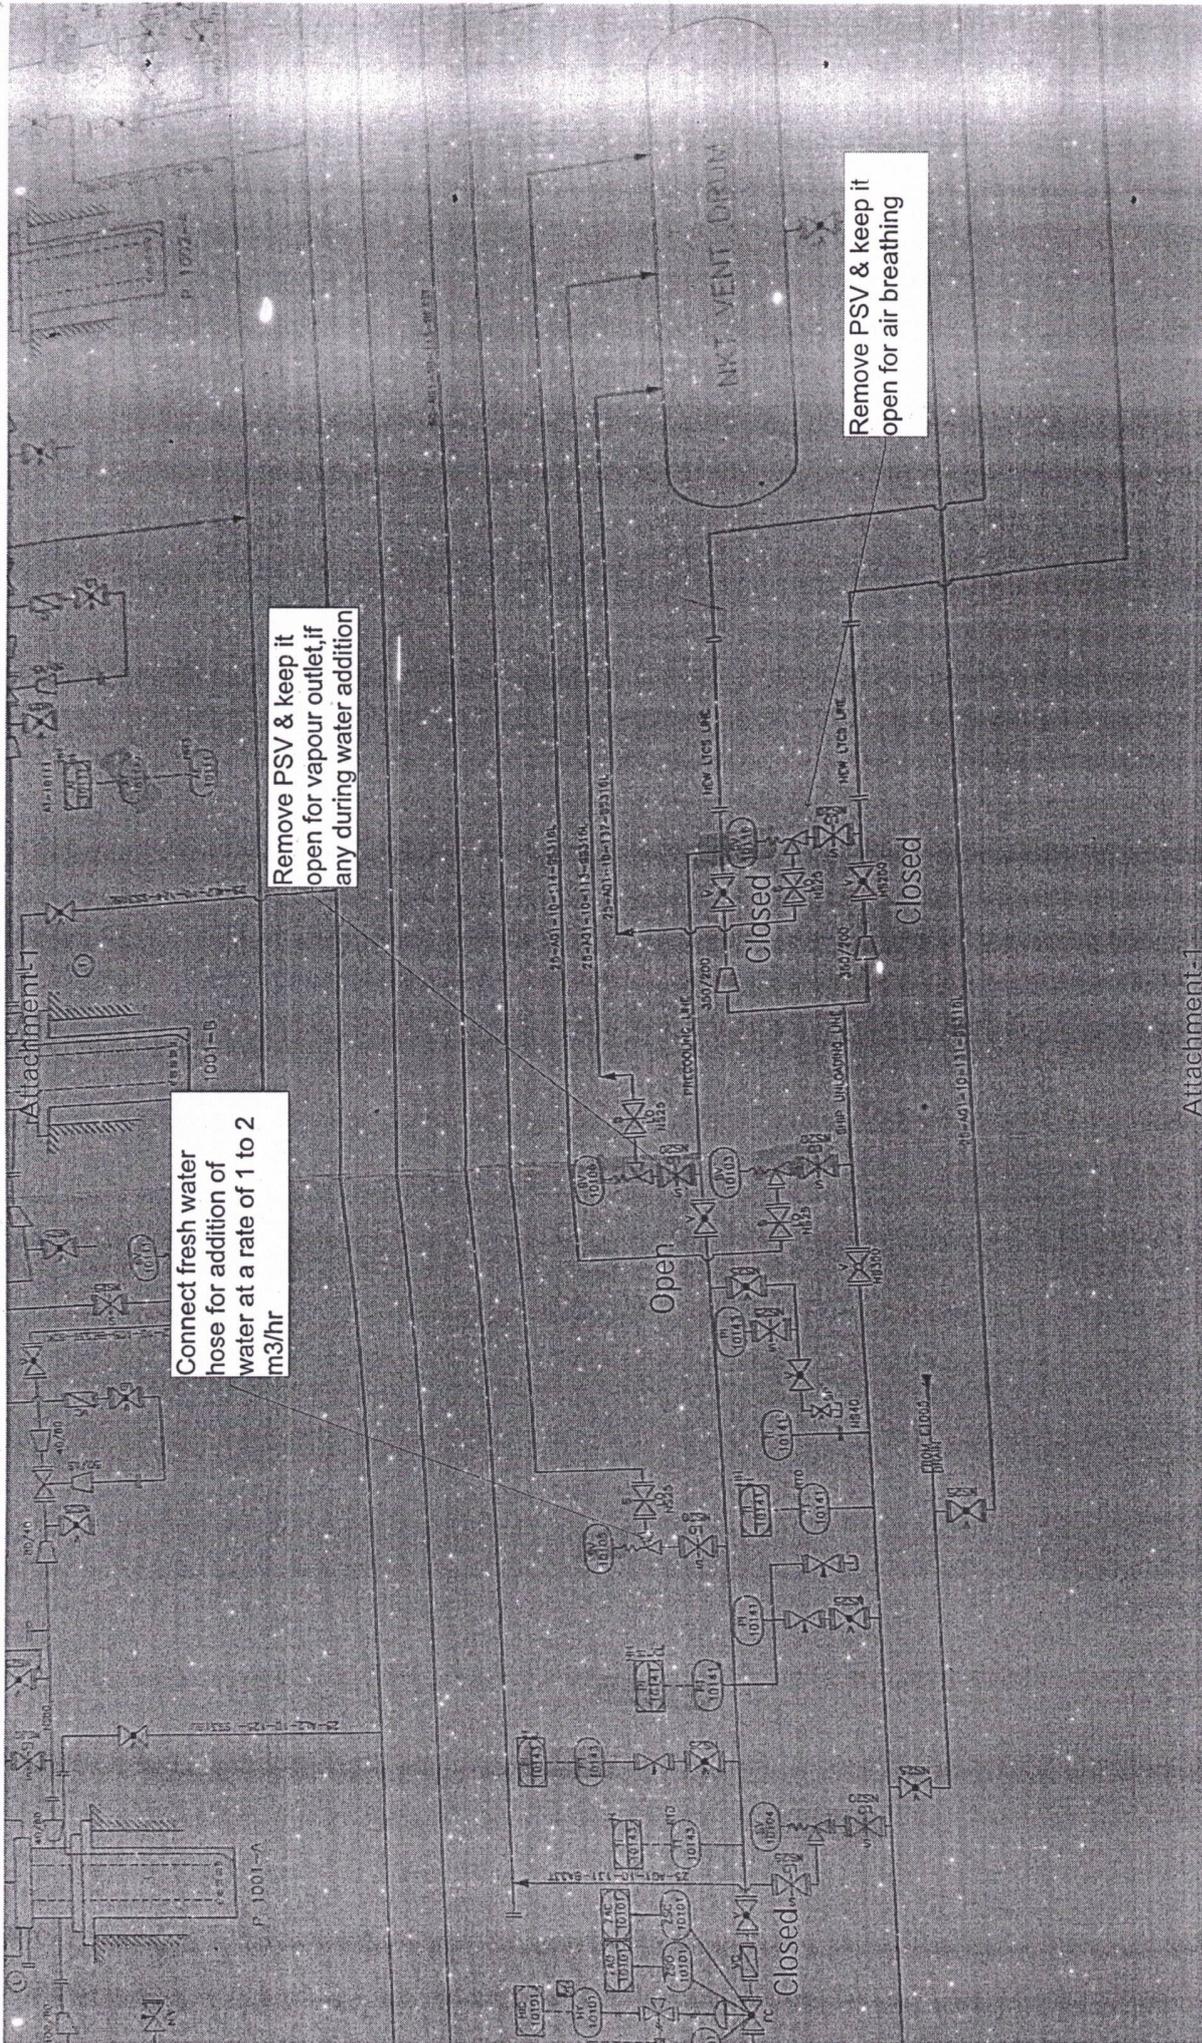
Attachment-1

Connect fresh water hose for addition of water at a rate of 1 to 2 m3/hr

Remove PSV & keep it open for vapour outlet, if any during water addition

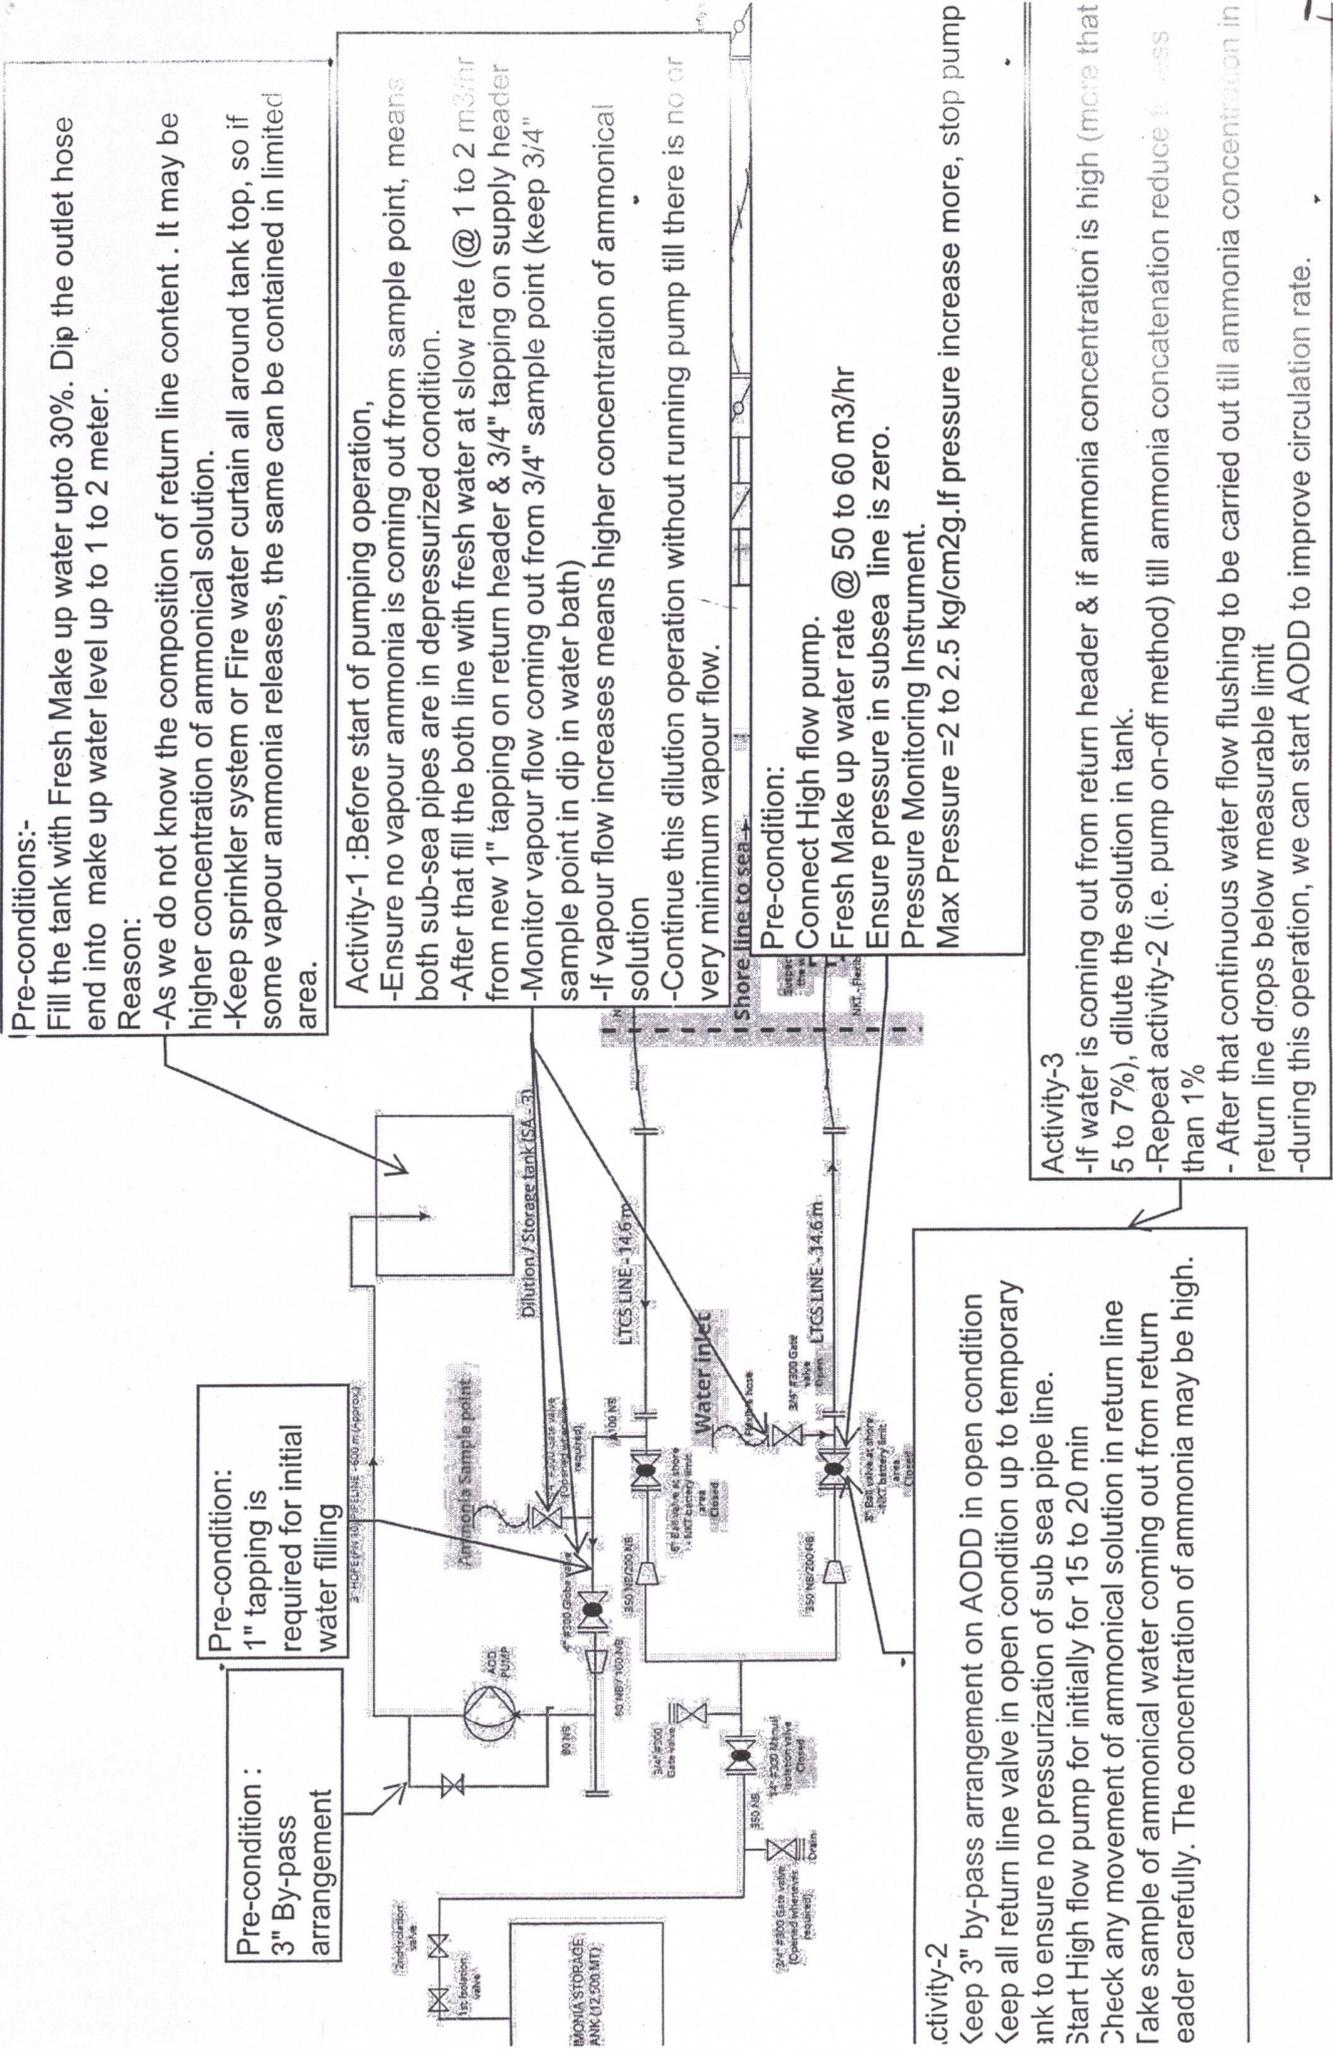
Attachment-2

Pre-conditions:-
 Fill the tank with Fresh Make up water upto 30%. Dip the outlet hose end into make up water level up to 1 to 2 meter.

Reason:
 -As we do not know the composition of return line content . It may be higher concentration of ammonical solution.
 -Keep sprinkler system or Fire water curtain all around tank top, so if some vapour ammonia releases, the same can be contained in limited area.
