Original Application No.148 of 2022 (SZ)

**REPORT OF
TAMIL NADU POLLUTION CONTROL BOARD
AS PER THE HON'BLE NATIONAL GREEN
TRIBUNAL(SZ),CHENNAI
ORDER DATED 18/05/2023 IN
O.A.NO.148 OF 2022.**

**Submitted to
Hon'ble National Green Tribunal (SZ), Chennai
AUGUST 2023**

In order to comply with the Hon'ble NGT order dated 18.05.2023, the following respondent units were inspected by the Joint Chief Environmental Engineer (Monitoring), Tamil Nadu Pollution Control Board, Salem along with officials of TNPCB on 07.07.2023.

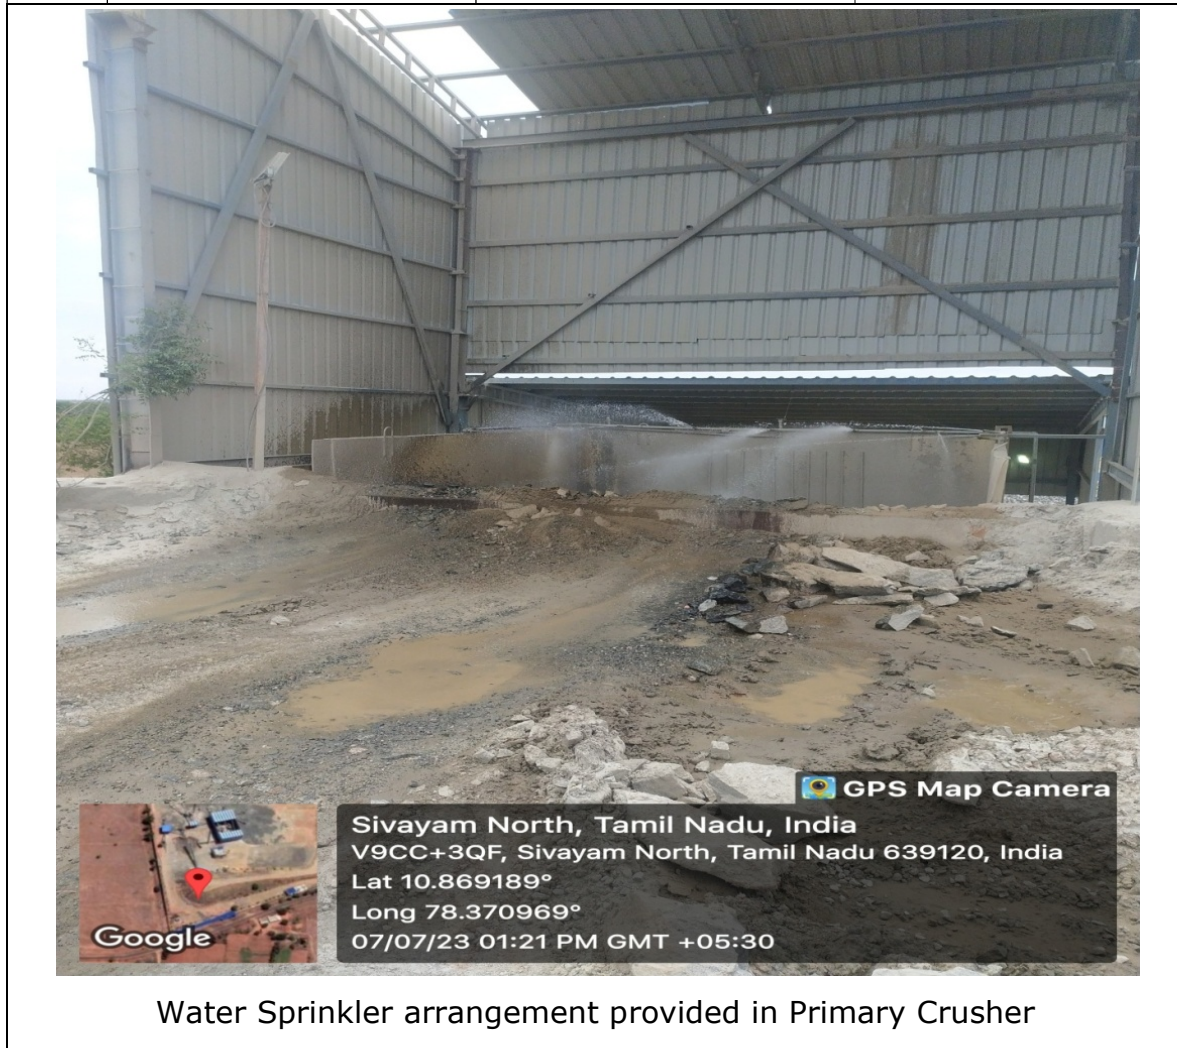
SI No	Emission Source Machinery installed	Pollution Control Measures provided	Remarks
1	Primary Crusher-1No	Water Sprinklers	In operable condition as depicted below

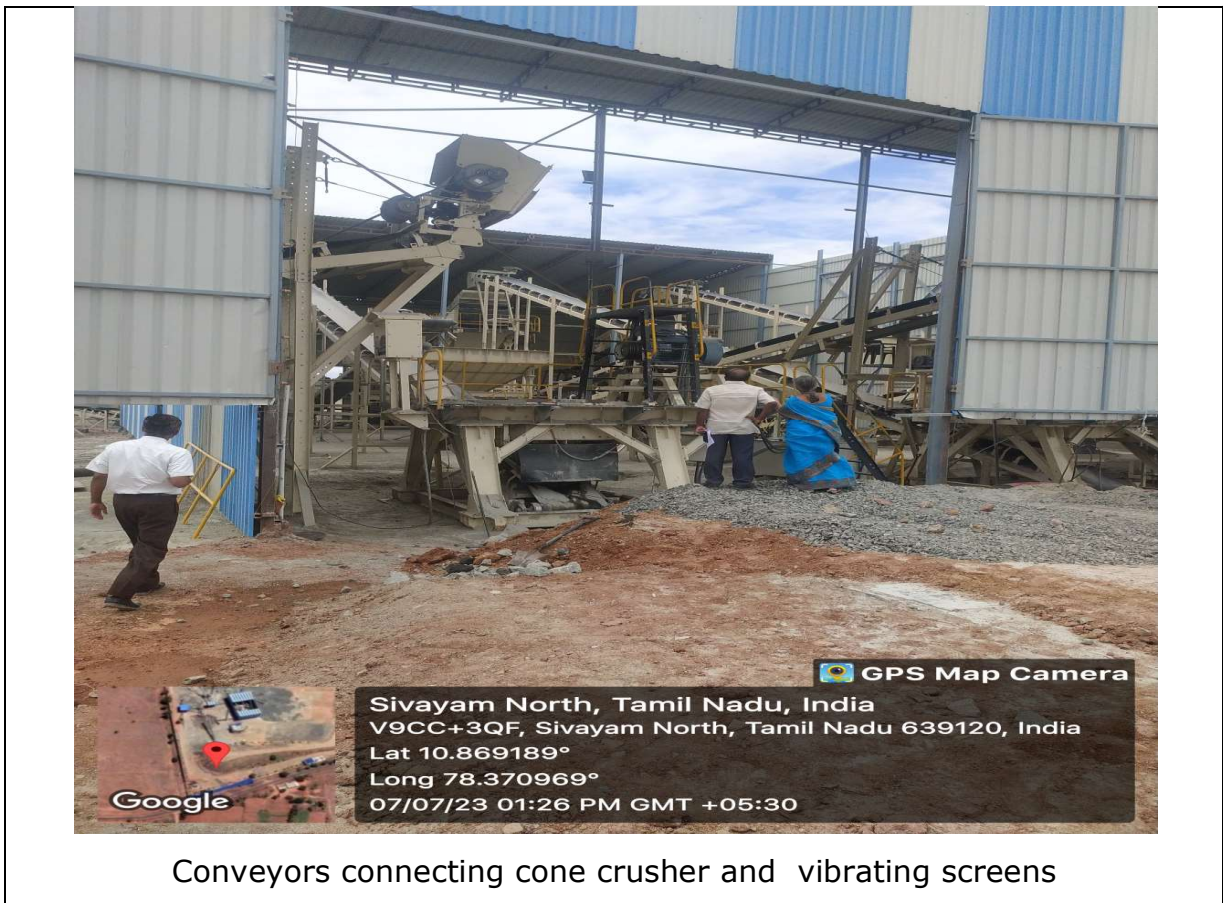
2	Cone Crusher -2 Nos with conveyors leading to vibrating screen (AVC series)	Cone crushers, Conveyers and Vibrating screens are placed inside the partially closed shed.	1 No of cone crusher is not in operational condition since the unit has removed the impact or chamber (Crusher). However, the conveyor connecting Cone Crusher and vibrating screen was present as depicted below.
---	---	---	--

3. The unit had installed 2 Nos of Cone crusher and 1 No of VSI Crusher as against the consented machinery of 1 No. Of Cone Crusher and 1 No of VSI Crusher for the production of blue metal of various sizes. During the time of inspection, it was found that the unit has removed 1 No of Cone Crusher. Though the unit has removed 1 No of impactor (Crushing chamber) attached to the Cone crusher, the conveyors connecting to the Cone crusher structural base, motor arrangements & vibrating screen were present.
4. The unit had also installed an additional Cone crusher, Conveyer, Vibrating screen and collection chamber arrangements for the production of 40mm metals. Though the unit has removed the impactor

(Crushing chamber) attached to the Cone crusher, the conveyors connecting to the Cone crusher, structural base, vibrating screen were present.

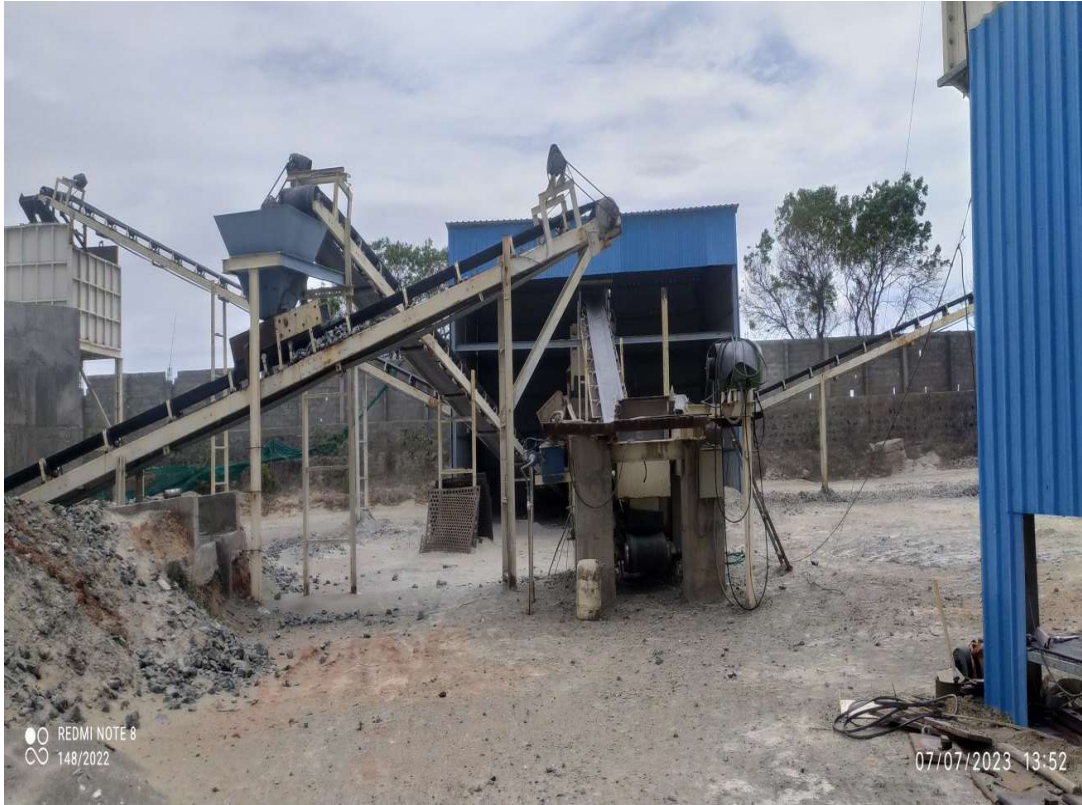
3	VSI Crusher - (Fine chamber) (SM 250)	VSI Crusher, Conveyers and Vibrating screens are placed inside the partially closed shed. Water sprinklers are provided at the conveyor ahead of the VSI Crusher.	In operable condition.
4	Vibrating Screens - 3 Nos	Vibrating screens are placed inside the partially closed shed. Water sprinklers are provided at the conveyor ahead of the Vibrating Screens.	In operable condition.
5	Powder Collection Tank	Metal Sheet Covered shed provided.	Metal Sheet Covered shed provided.
6	Sand washing machine-2 Nos	-	-
7	Cone crusher, Conveyer, Vibrating screen and collection chamber arrangements for the production of 40mm metals. • Not in operation	No APC measures for cone crusher and provided closed shed for vibrating screen	The unit has removed the impactor Chamber (Crusher) for the production of 40mm metals. However, the conveyors connecting cone crusher, vibrating screen and structural base for the Impactor and conveyor connecting collection chamber

& cone crusher were present as depicted below.

Conveyor connecting cone crusher and vibrating screen

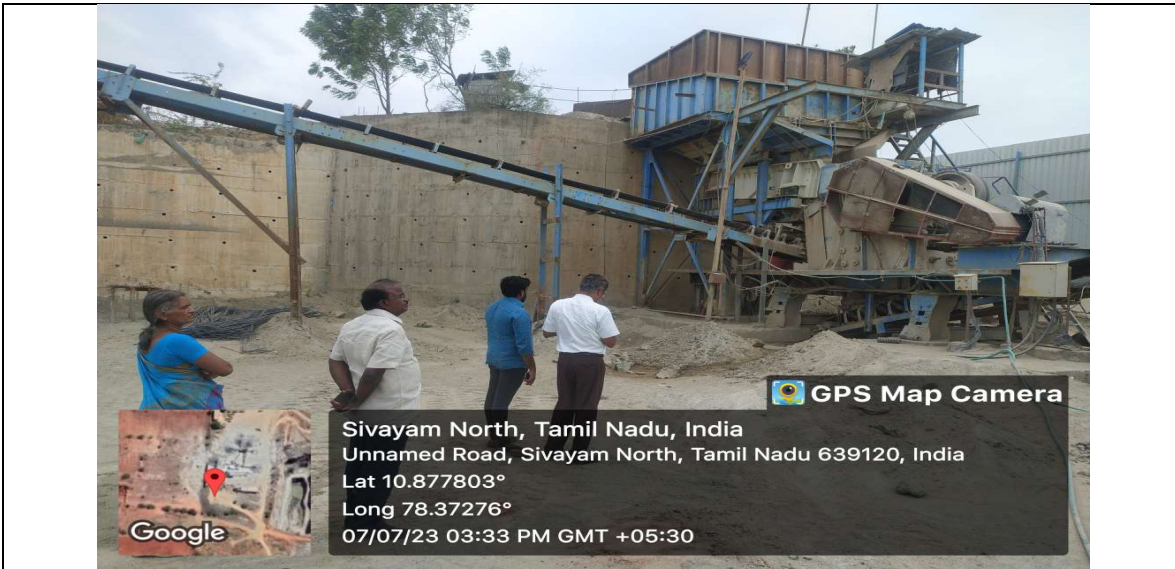
SI No	Emission Source machinery installed.	Pollution Control measures provided	Remarks
1	Primary Crusher-1 No	Water Sprinklers	In Operable condition as depicted below

Water Sprinkler arrangement provided in Primary Crusher

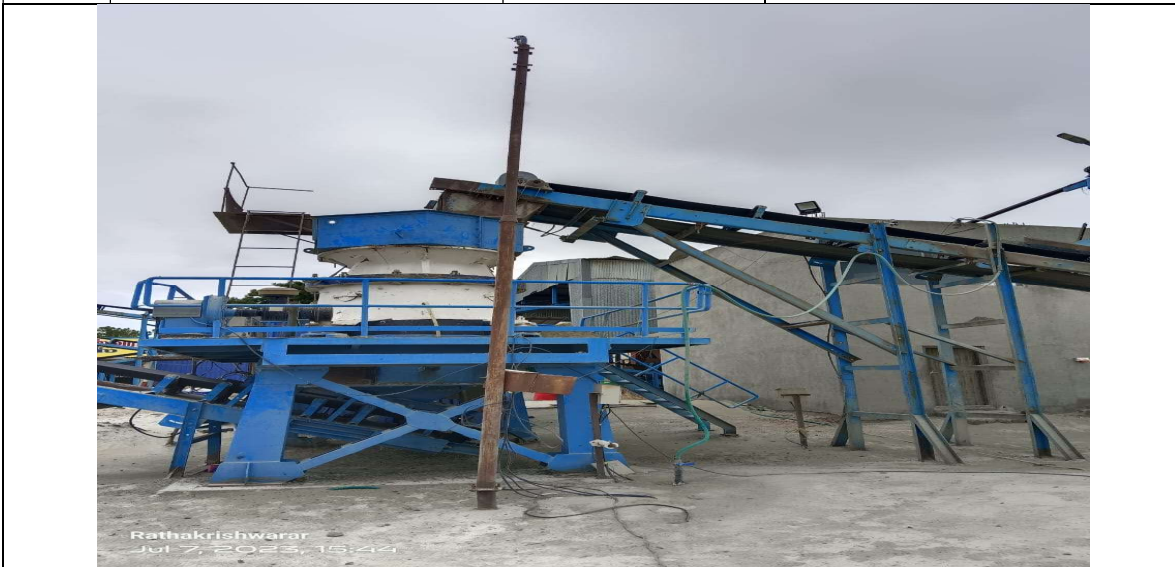
2	Cone Crusher -1 No	Water Sprinklers	Not covered with GI sheet enclosures as depicted below
---	--------------------	------------------	--

Cone crusher without GI Sheet Covered shed

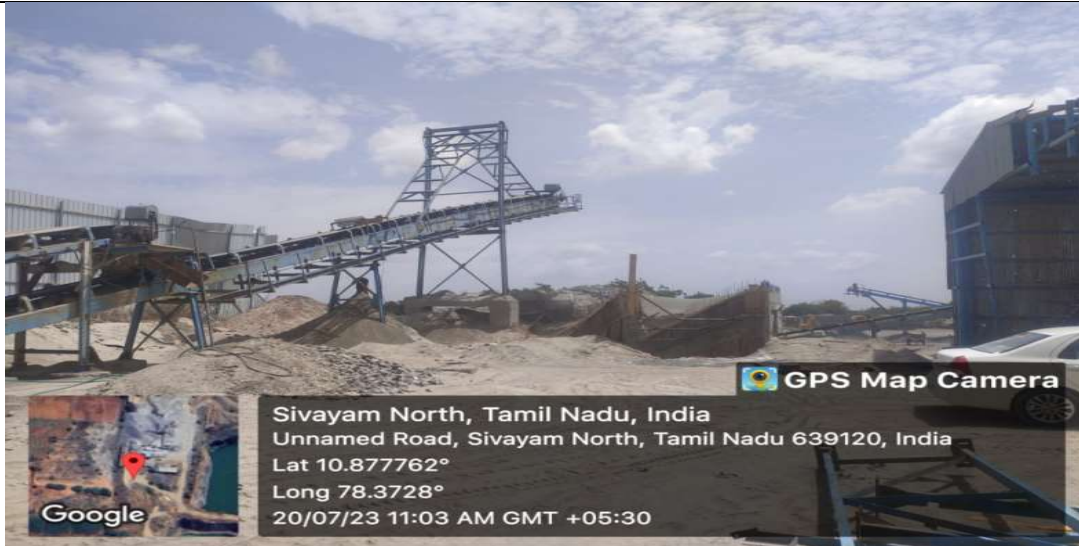
3	Secondary Crusher-1 No along with Vibrating Screen and Conveyor arrangements	Partially covered with Metal Sheet	The conveyor connecting the secondary crusher and primary crusher is disconnected by removing the conveyor connecting the primary crusher and secondary crusher as depicted below
---	--	------------------------------------	---

Conveyor removed connecting primary crusher and secondary crusher

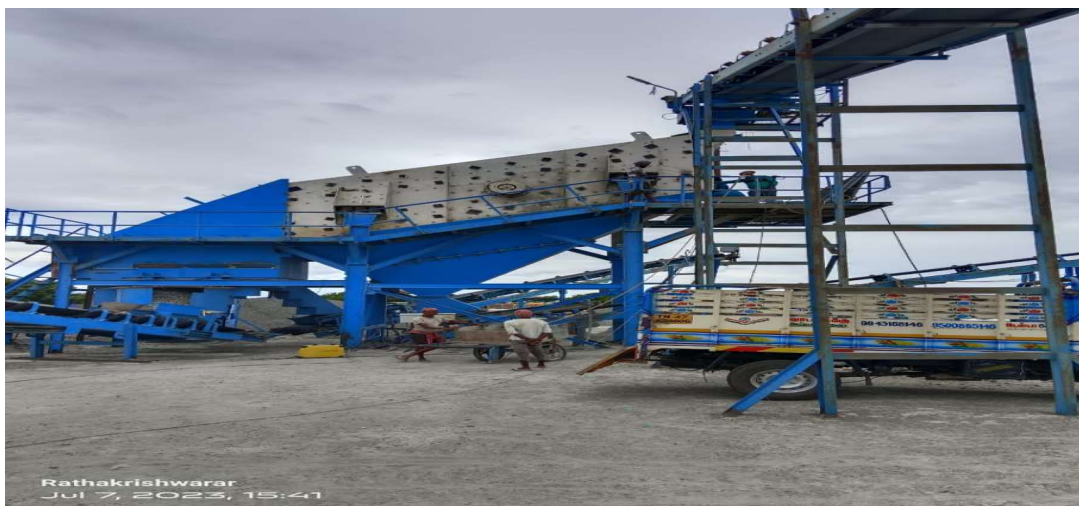
4	Vibrating Screen	Water Sprinkler	Vibrating screen and conveyors were not covered with metal sheets. as depicted below
---	------------------	-----------------	--

Vibrating screen without metal sheet cover

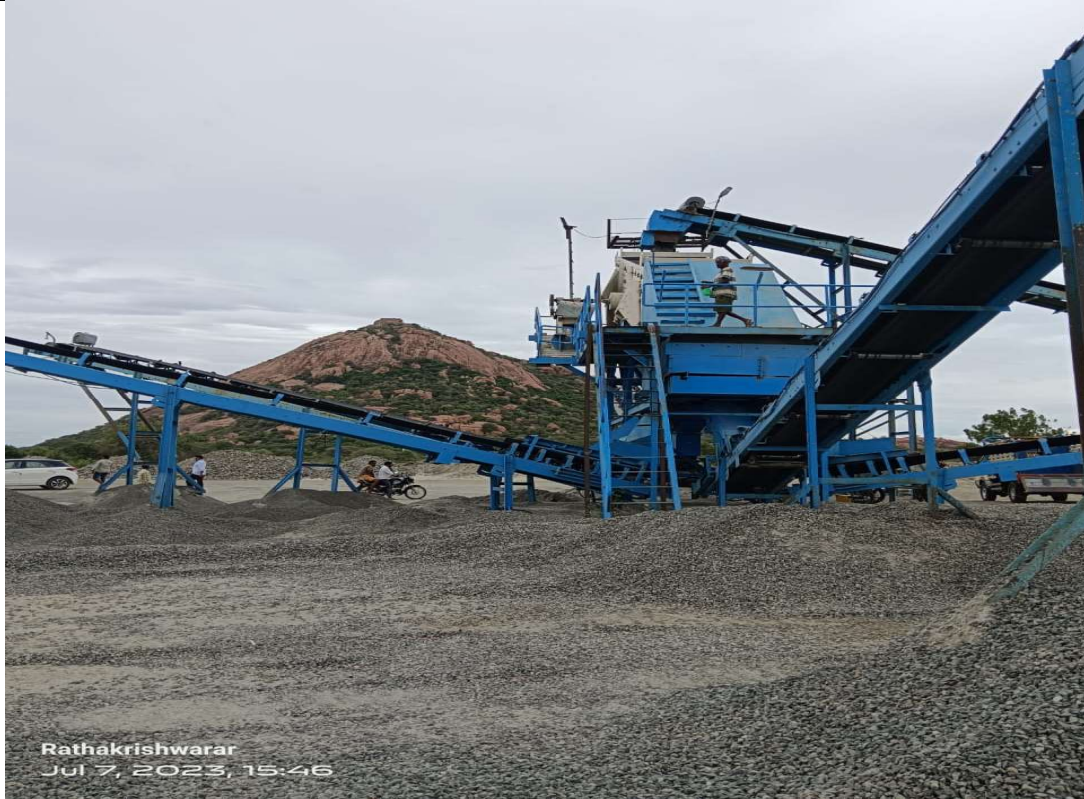
5	Conveyor connecting the Cone crusher with vibrating screen	Water Sprinkler	Vibrating screen and Conveyors were not covered with metal sheets as depicted below
---	--	-----------------	---

Vibrating screen and Conveyors without metal sheet cover

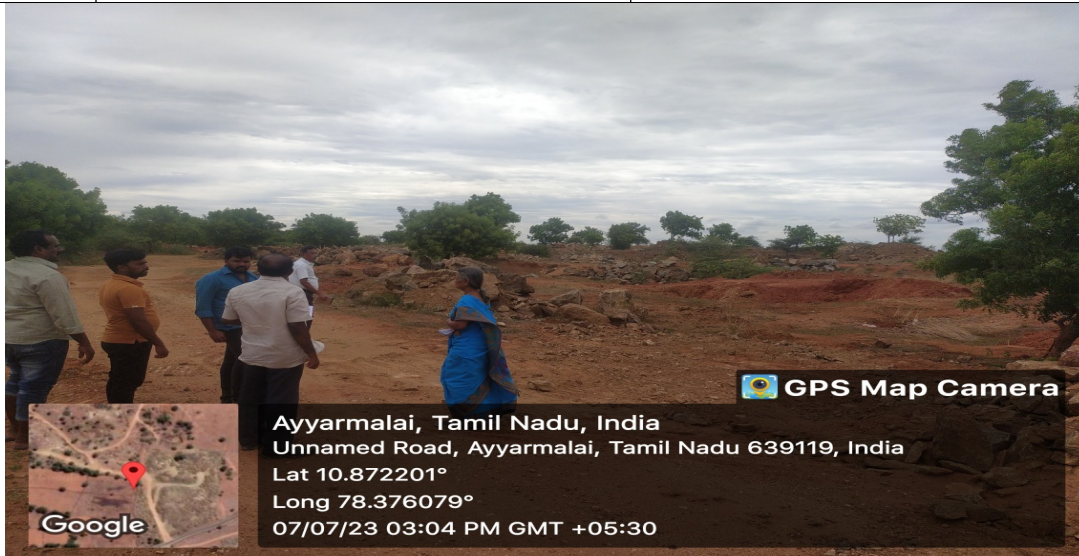
(ii)	Environmental Clearance/ Lease and if so, the validity of the same.	<p>TN/F.No.6993/SEAC/TOR-761/2020 dated 24.9.2020 with validity upto 3 years from the date of issue, for submission of EIA Report with Public Hearing. The Public Hearing was conducted on 21.06.2023 by the DEE, Karur and the approved minutes of the Public Hearing was submitted to SEIAA, Chennai through TNPC Board.</p> <ul style="list-style-type: none"> The unit is yet to obtain Environmental Clearance from Competent Authority.
Vide Para 5 (iii)	If they had operated in excess, whether the same has been found out and any compensation has been levied by the appropriate authority.	During the time of inspection, no quarrying activity was carried out. Preparatory work (leveling the site) was under progress as depicted below

Preparatory work for quarry site under progress.

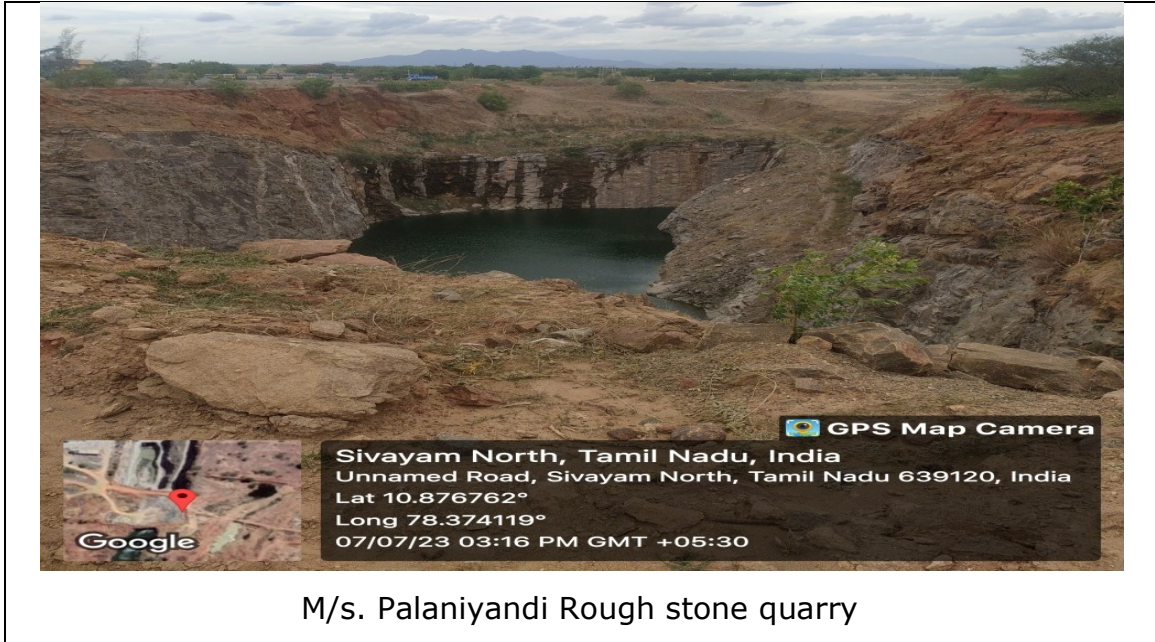
1. Quarry was not in operation and rain water was stagnated in the quarry pit as depicted below,

M/s. Palaniyandi Rough stone quarry

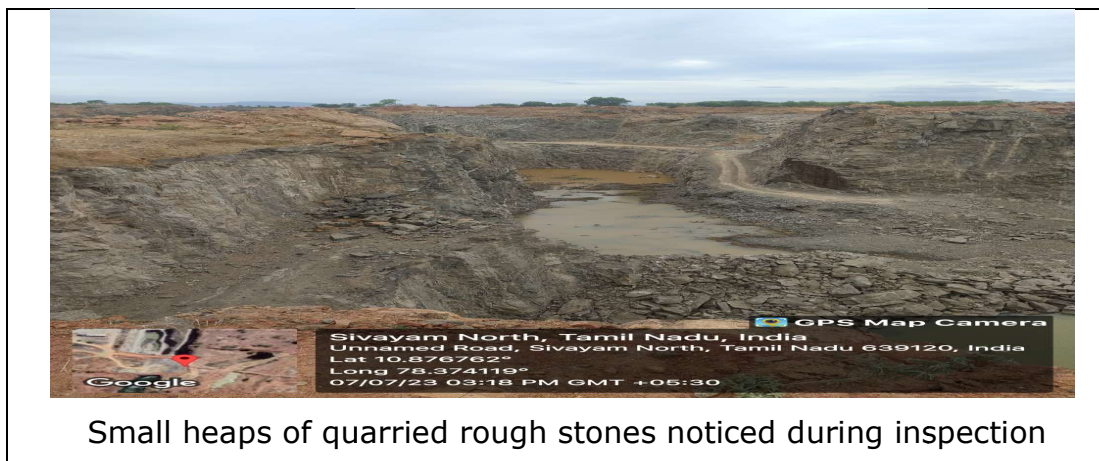
1. Quarry was not in operation. It was informed that the rough stone quarry is presently purchased by Thiru. Silambarasan.
2. The traces for the quarrying activities carried out in the rough stone quarry were noticed. Small heaps of quarried rough stones were present in the quarry pit, as depicted below.
