**Original Application No.20 of 2022**

**JOINT COMMITTEE REPORT SUBMITTED BEFORE THE HON'BLE NATIONAL GREEN TRIBUNAL (SOUTHERN ZONE), CHENNAI IN THE MATTER OF ORIGINAL APPLICATION No. 20 of 2022 (SZ), FILED BY THIRU S. EASWARAMOORTHY, TIRUPUR DISTRICT Vs THE TAMILNADU POLLUTION CONTROL BOARD CHENNAI AND OTHERS, AS PER ORDER DATED 11<sup>th</sup> MAY 2022.**

The committee members have inspected the unit of M/s. United Carbon Solutions Private Limited, Vattamalai Village, Kangeyam Taluk, Tiruppur District and the Applicant Thiru S. Easwaramoorthy's Agriculture land and house on 29.03.2022. During the committee visit, the unit was under operation and manufacturing of Activated Carbon. Further, the committee briefly discussed about the scope as per the Hon'ble Tribunal order for compliance.

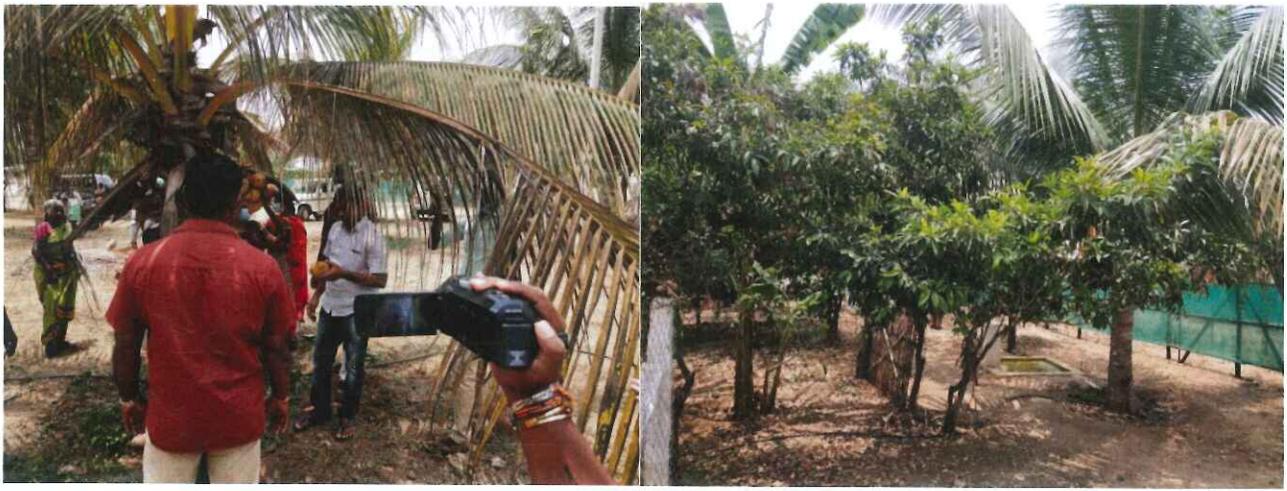
6. There is no black deposit observed on top of the leaves, whereas bottom leaves in some of the coconut trees found with black deposit. This black deposit is due to Black Fungus and indicates that no carbon particle deposit from the unit. Coconut trees of most varieties are most susceptible to many diseases, Disorders and insect infestations. Coconut trees are commonly affected by "Black Fungus". In the tree leaves fully covered looks like Black soot and initially it was observed in the bottom of the leaves, at the severe stages it appears in upper side of the leaves also. During the visit, such black deposit was not observed in other crops planted in the applicant land. Same is shown in below photographs.

Further, the member of Agricultural Department has confirmed that it is a fungal effect on the coconut trees based on physical observation.

As per the study conducted w.r.t Ambient air, Ground Water and soil, it is found that no impact/damage observed on ambient air, Ground water and soil due to operation/activity of the unit. The agriculture department report says that natural deficiency of nutrient in the soil and black fungus formation caused unhealthy appearance of coconut tree leaves in the applicant land.

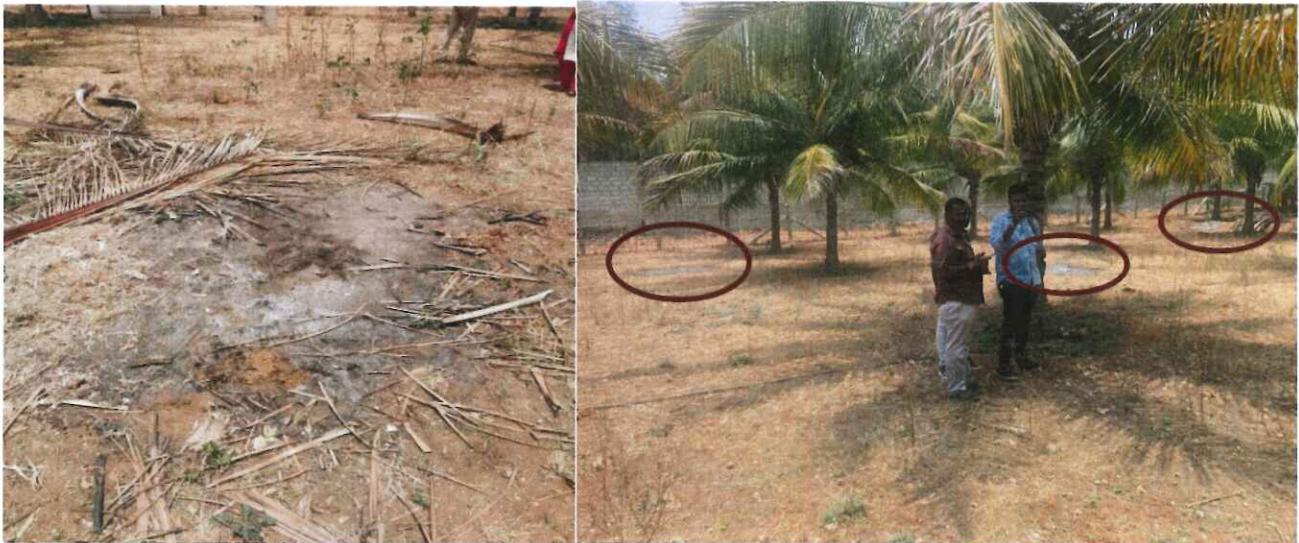
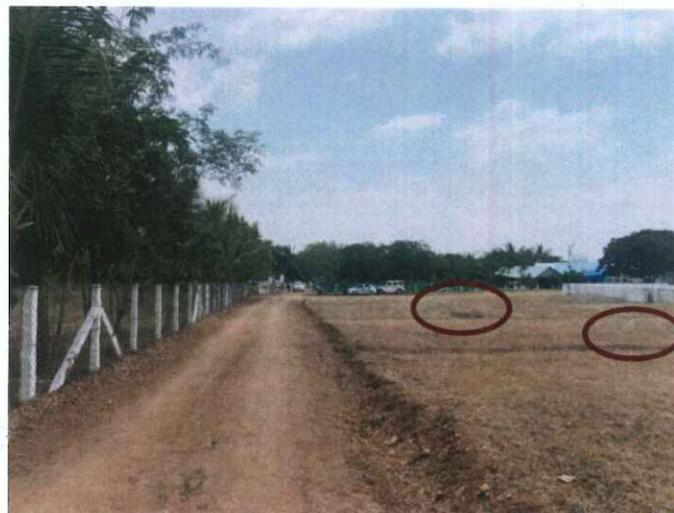
7. In the entire coconut farm & open land of the applicant, around 20 locations burned patches & traces of coconut leaves & shells was observed. This activity was carried out by the applicant. It seems that the burning was done before the committee visit, which is shown in below photographs

Further, it is submitted that based on the visit, it is observed that the applicant carried out burning of leaves/stems to show the carbon black deposit as stated in the report.

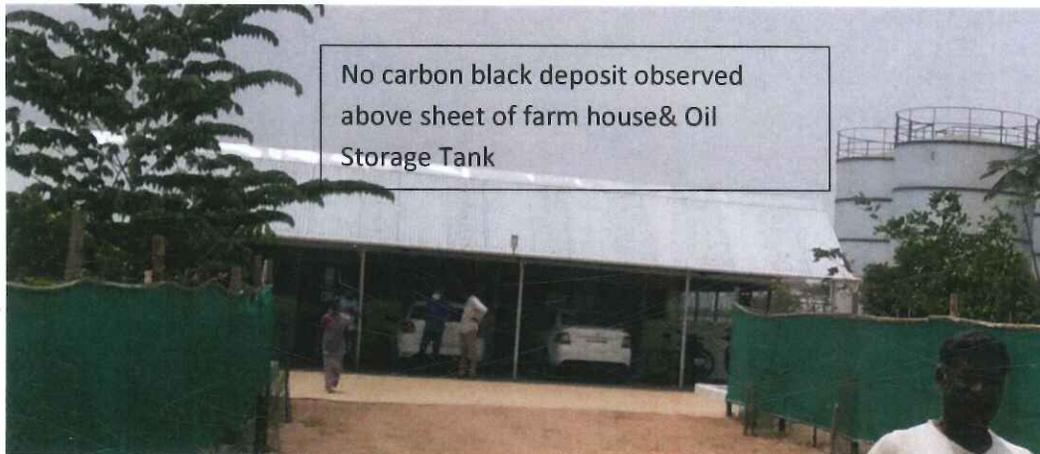
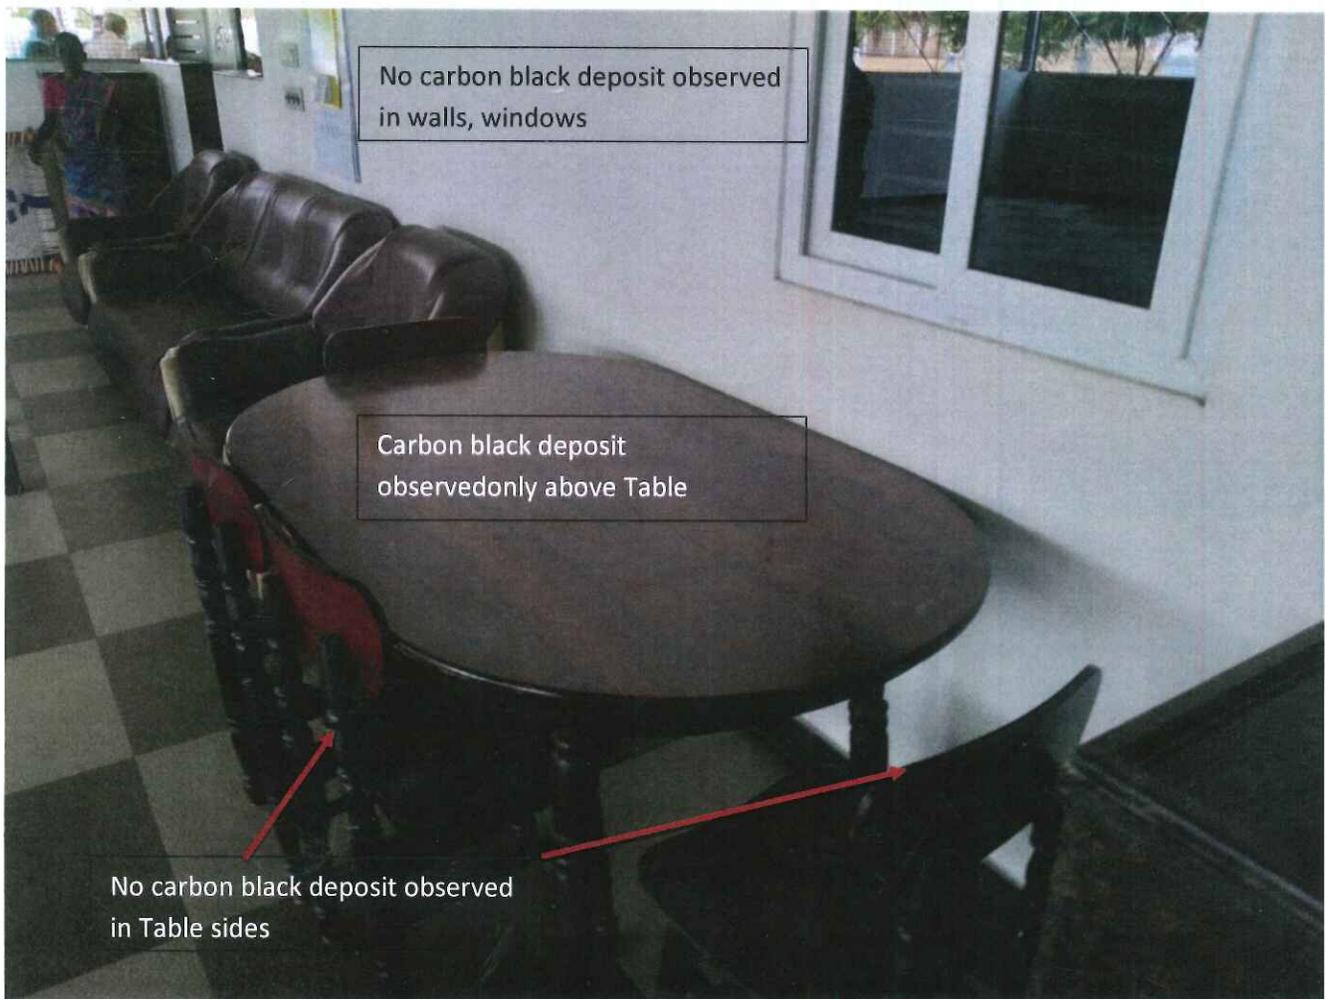
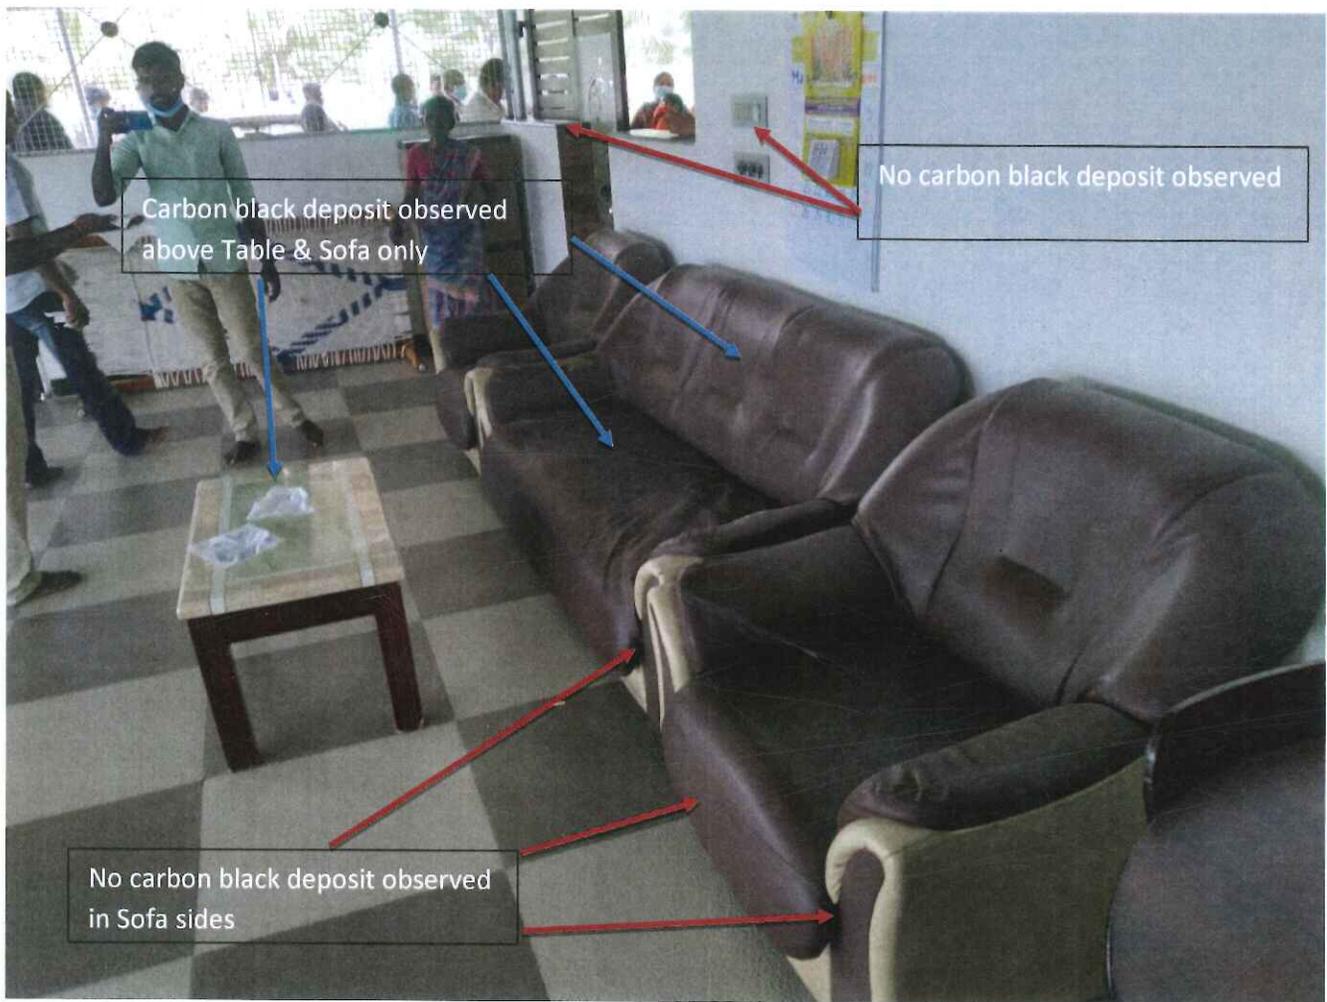
8. Moreover, the committee visited applicant`s farm house also. Applicant showed the carbon deposit to the committee above the solar panel installed in the farm land, above the sofa & table inside the house.

10. The applicant farm house is painted in white color inside & outside. The marks of carbon deposit are not found on the walls, windows, electrical panels etc. as well as above the asbestos sheet. Whereas applicant showed black deposited above the table & sofa, but no deposit observed in beading & sides of the sofa & table. The same is shown in below photographs

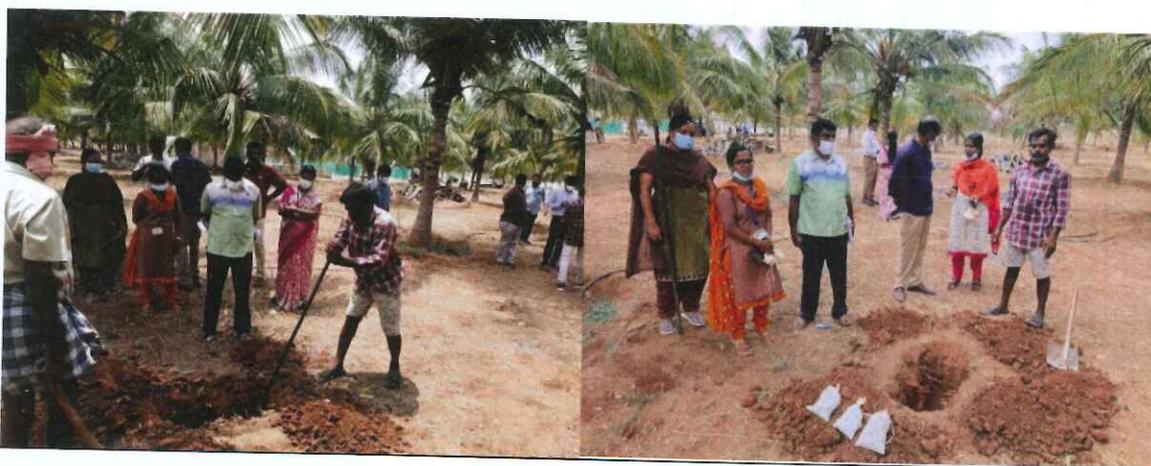
**Collection of Soil samples by Joint Director In-charge, Agriculture Department, Tiruppur in the Applicant Thiru S. Easwaramoorthy's Coconut Farm**

The soil samples at a depth of 30, 60 and 90 cm below ground level in the applicant's coconut farm were collected by the Joint Director, Agriculture Department, Tiruppur on 29.03.2022 for analysis of 12 Nos. of parameters such as pH, Electrical conductivity, Macro and micro nutrient were analyzed in the Mobile Soil Testing Centre, Tamil Nadu Agriculture Department, Palladam. The test results are as follows:

The Mobile Soil Testing Centre, Palladam, Tamil Nadu Agriculture Department has concluded that the soil is suitable for coconut cultivation. The soil has calcareous in nature. To reclaim the soil, organic manure application and cultivation of green manure crops is important. To improve the soil health status and yield, Soil test based fertilizer application and continuous application of organic manuring is important.

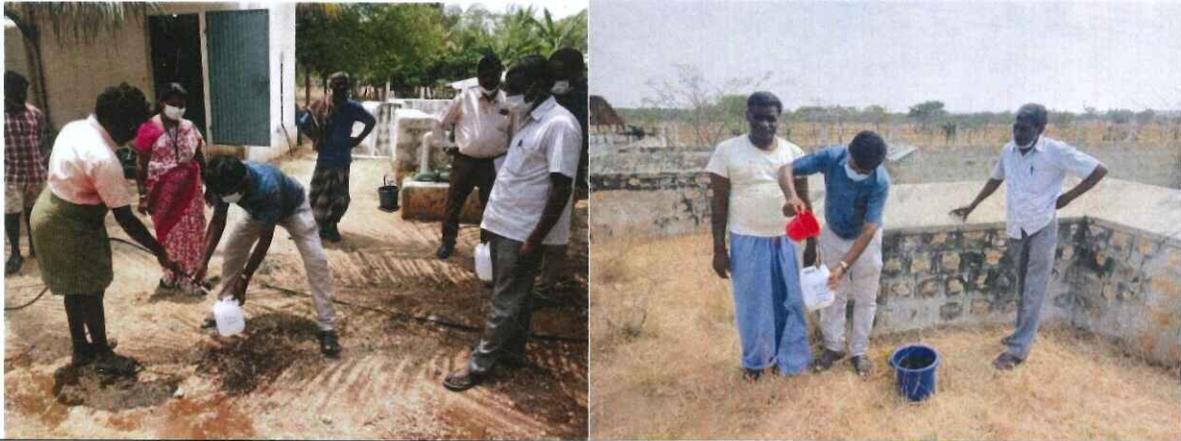
**Collection of Open well and Bore well water located in the Applicant`s land & Vivid Thottam**

The ground water samples of 6 Nos. were collected in & around the unit premises including the complainant's well. The samples collected are analyzed at TNPCB District Environmental Laboratory, Tiruupur. The sampling locations are given below;

The analysis report reveals that; no impact in ground water due to operation of the industries. The TDS in the ground water found to be more in that area naturally and less water level more than 800 ft. deep. The analysis report of the ground water is shown in the below table;

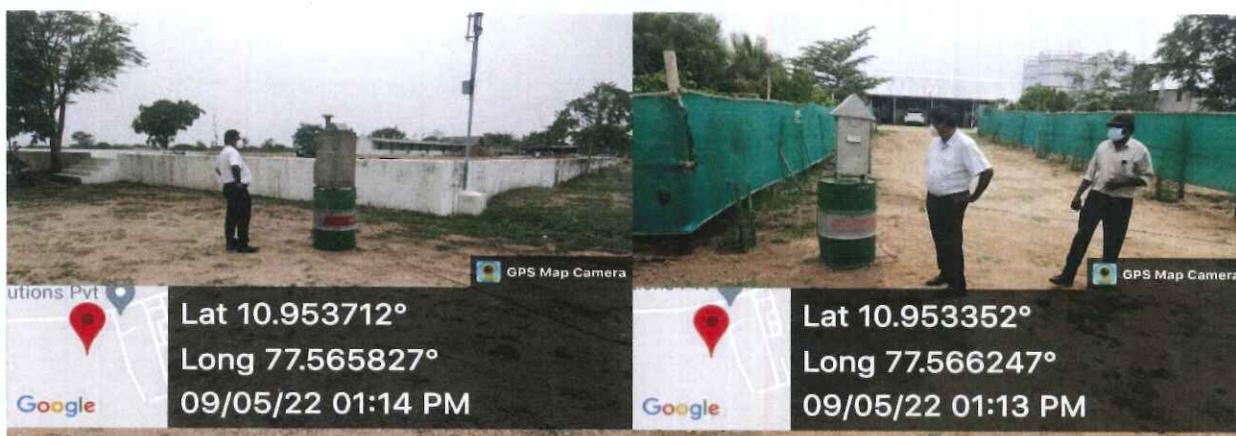
**AAQ Survey using High Volume Sampler in the Application Coconut Farm and House**

Ambient Air Quality monitoring for the parameters PM 10, PM2.5, SOx&NOx was carried out by District Environmental Lab, Tamilnadu Pollution Control Board, Tiruppur. PM10 was monitored by the High Volume Sampler using RDS. The other Parameters SPM & Heavy Metal monitoring & analysis carried out by the M/s. ECO Green Solution System Pvt Ltd, Bangalore (EPA recognized & NABL Accredited lab) using High volume sampler for Suspended Particulate Matter. The ambient air quality monitoring was carried out for 24 hrs during the period 09.05.2022 to 10.05.2022 at three locations 1. Western side of the unit (Complainant farm house), 2. Eastern Side of the unit (Unit's Storage Yard) & 3. South East Side of the unit (Near STP of the unit).

The analysis results of the ambient air quality reveals that all parameters are within the notified norms. The analysis result is given in the below table;

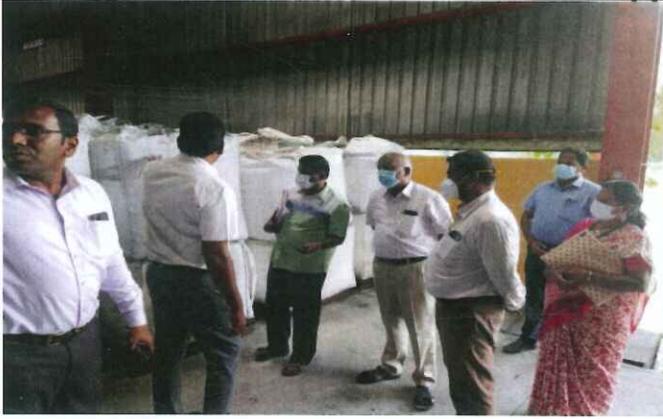
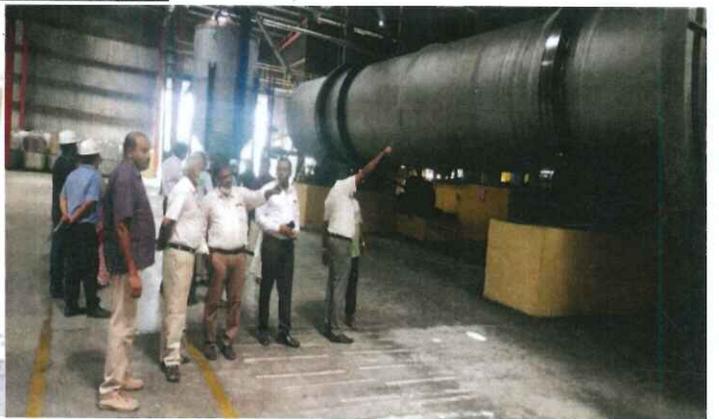
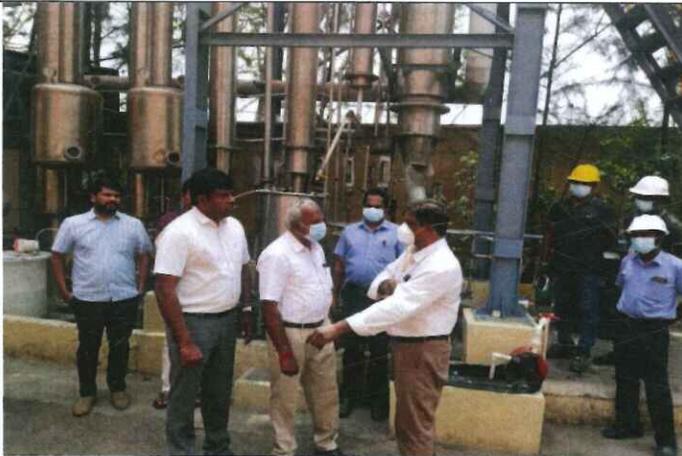
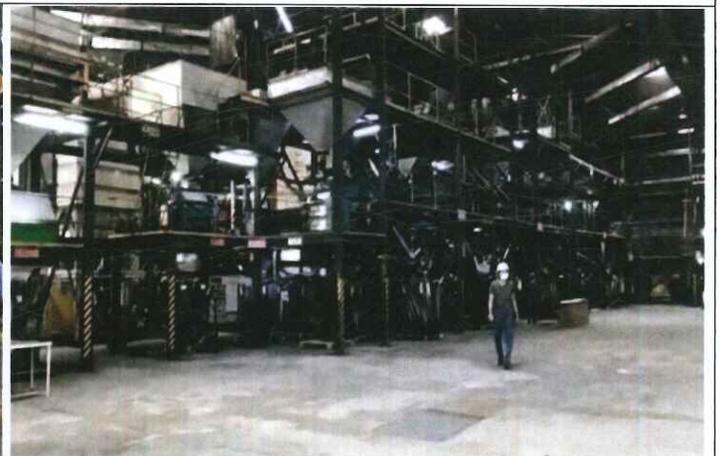
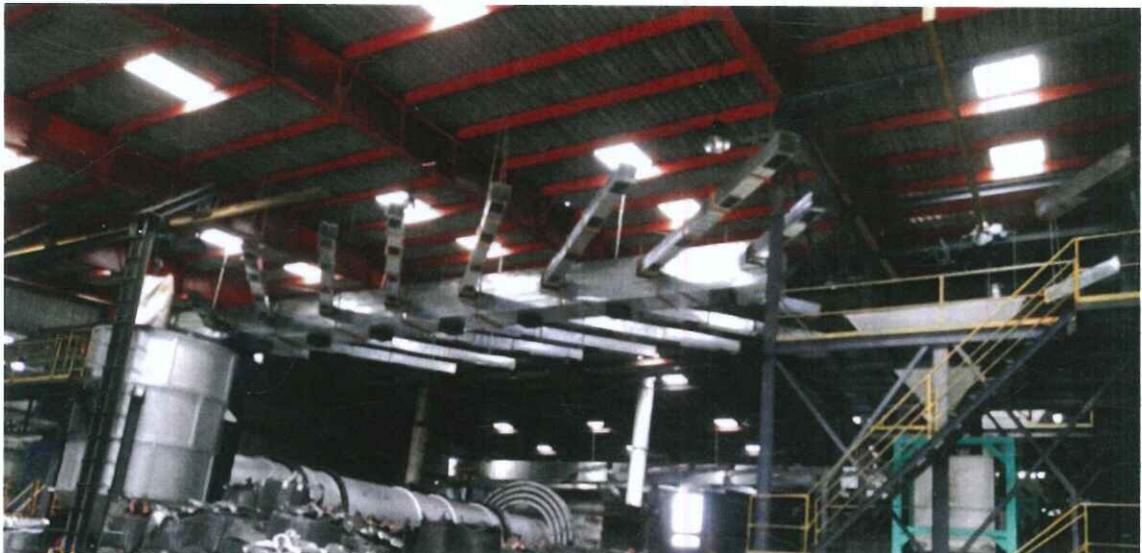
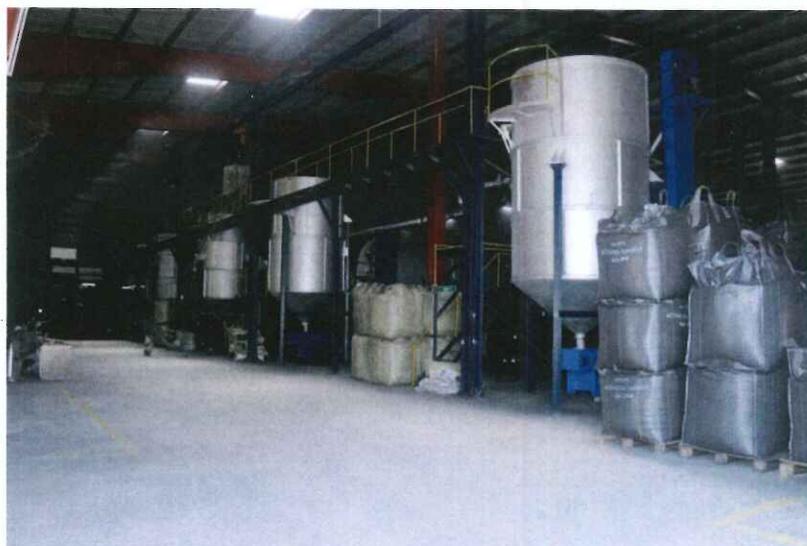
**M/s. United Carbon Solutions Private Limited, Vattamalai Village, Kangeyam Taluk, Tiruppur District**

The unit has provided greenish plantation inside the unit premises. No deposition of carbon dust particles on the leaf of the trees and on land was observed during inspection.

The unit has provided adequate air pollution control device for control of source & fugitive emission from the process. The sources emission analysis results also found within the prescribed limit.

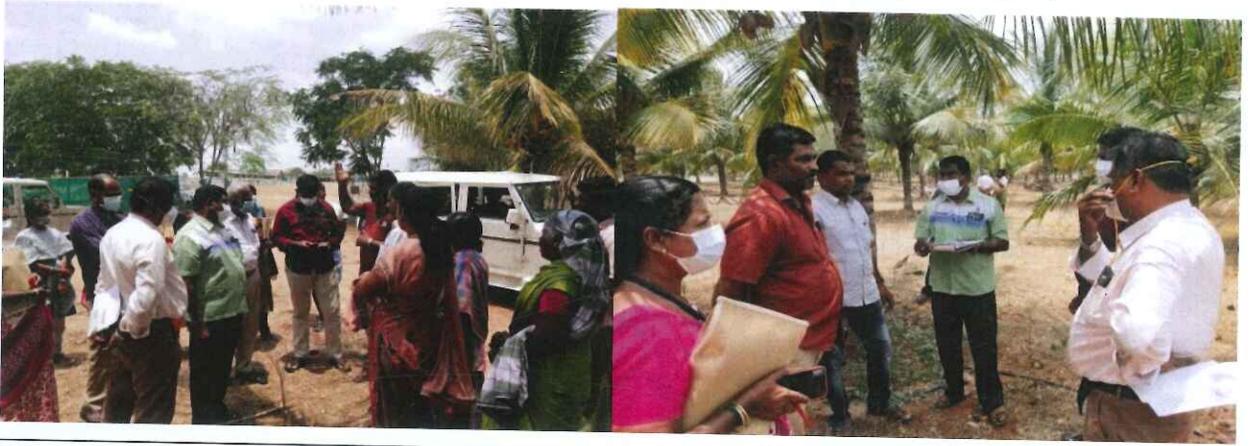
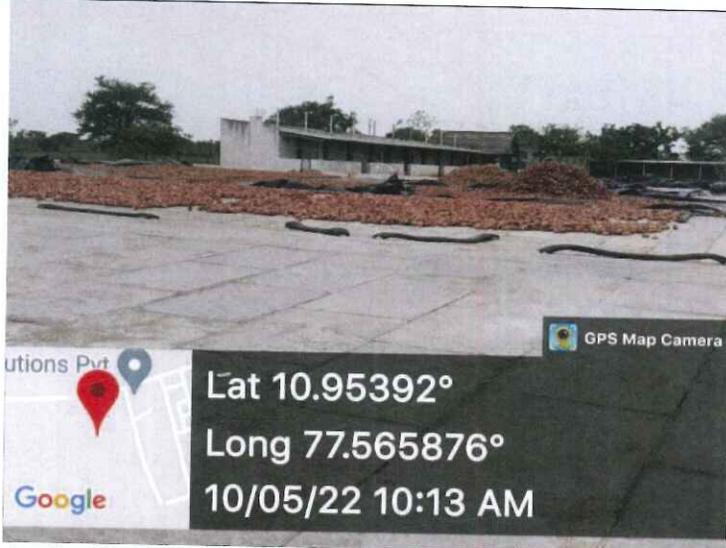
**Applicant Thiru S. Easwaramoorthy `s Coconut Farm**

**Coconut Shell Drying Yard in the Applicant `s House**
