JOINT COMMITTEE REPORT IN RESPECT OF O.A NO.248 OF 2020 TAKEN UP SUO MOTU BASED ON THE NEWS ITEM IN TIMES OF INDIA NEWSPAPER DATED 9.11.2020, CHENNAI SUPPLEMENTARY " CHOKED BUCKINGHAM CANAL MAY KEEP STREETS FLOODED DURING HEAVY RAINFALL" BY THE HON'BLE NATIONAL GREEN TRIBUNAL(SZ)

Accordingly in due compliance of the orders of the Hon'ble National Green Tribunal, the Joint Committee is constituted and has conducted the inspection on 29.1.2021 and the water samples from the North Buckingham Canal were taken by the Tamil Nadu Pollution Control Board in order to ascertain the water quality of the canal.

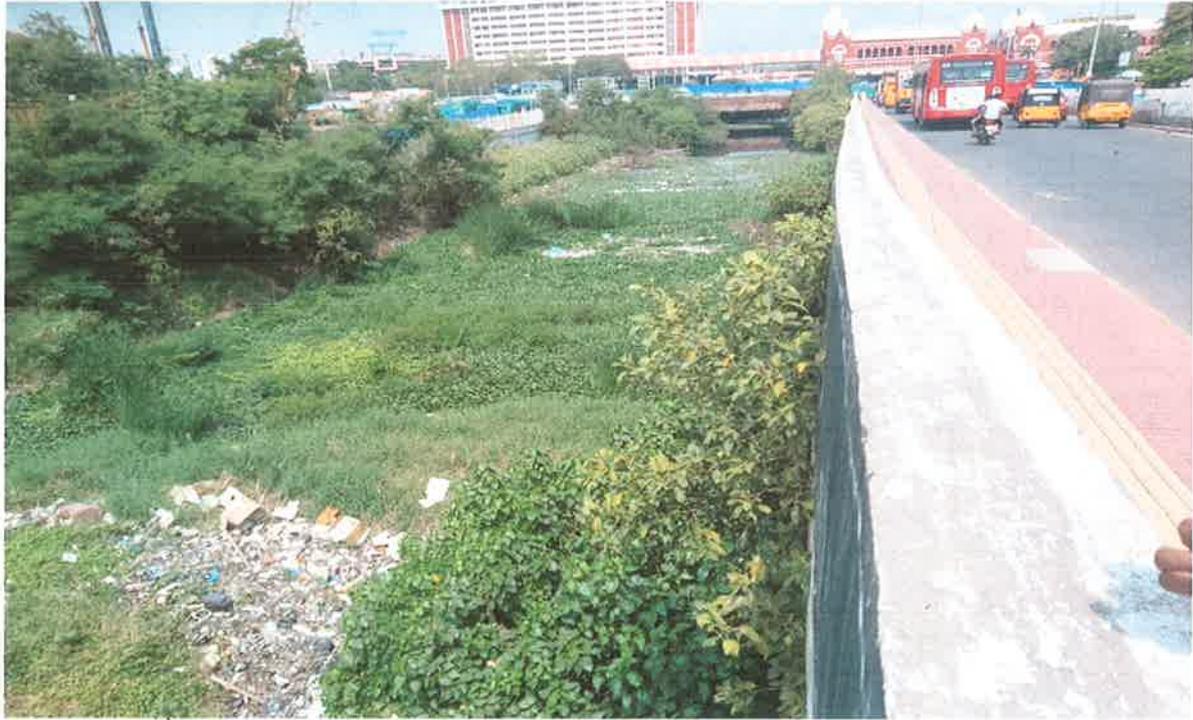
It is alleged in the newspaper report that that mounds of garbage especially plastic waste were seen floating, impeding the flow of water in the canal just outside the Chennai Central Railway Station. Due to unauthorized dumping of garbage and other things, free flow of water in that area has been affected. So, it is apprehended by the reporter that there is a possibility of flood being caused on account of this unauthorized blockage of flow of water in Buckingham Canal due to the unlawful dumping of garbage and other wastes.

The disputed area is the North Buckingham Canal just downstream side of Poonamallee Road Bridge. At this stretch, the North Buckingham Canal is surrounded by Chennai Metro Rail Limited (CMRL) Central Square on the West side, PallavanSaalai Bridge on the Eastside, Poonamallee Road Bridge on the North side and Railway lines (Chennai Park to Chennai Fort route) on the South side. As there is no approach for deployment of heavy machineries in order to clean the floating wastes and vegetations in the North Buckingham Canal. The CMRL has been addressed by the PWD and GCC to provide approach for the deployment of heavy machineries in the Canal and they have assured to provide approach for clearing the obstructions in the Canal. Accordingly, CMRL has removed the grills abutting the western bank of the North Buckingham Canal facilitating the approach

**NORTH BUCKINGHAM CANAL- D/S OF POONAMALLEE ROAD BRIDGE-
BEFORE EXECUTION**

for the movement of heavy machineries into the North Buckingham Canal. The Greater Chennai Corporation deployed Amphibian Robotic Excavator & Amphibian Multipurpose Watermaster Dredger and totally removed the obstructions such as vegetations & floating solid wastes thereby facilitating the free flow in the Canal. The photos taken before and after the execution of the work have been attached which depicts all the obstructions impeding the free flow in the canal have been completely removed which is the major issue alleged in the newspaper report. However, due to the torrential rain of 2020 which hampered the Chennai city, there was no report of out flank of flood from Buckingham Canal. Although there were floating material on its surface, the canal experienced a good sub surface flow and the flood receded quickly without causing inundation by a large.

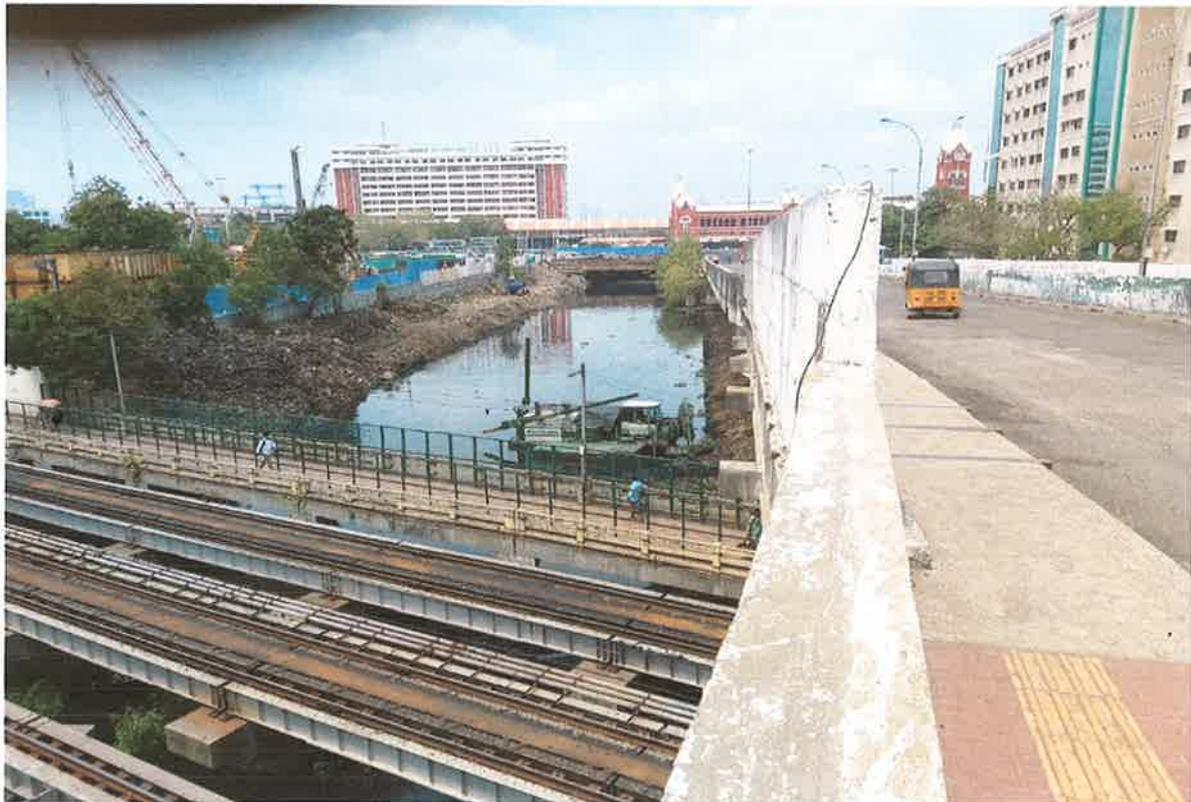
**NORTH BUCKINGHAM CANAL- D/S OF POONAMALLEE ROAD BRIDGE-
AFTER EXECUTION**
