**BEFORE THE HON'BLE NATIONAL GREEN TRIBUNAL  
SOUTHERN ZONE, CHENNAI**

**ORIGINAL APPLICATION NO. 43 of 2017**

**REPORT ON FIRE INCIDENT AT IMAGE, THE CBWTF AT PALAKKAD, IN JAN 2022**

Fire Accident at IMAGE, on 16-01-2022 - Photos

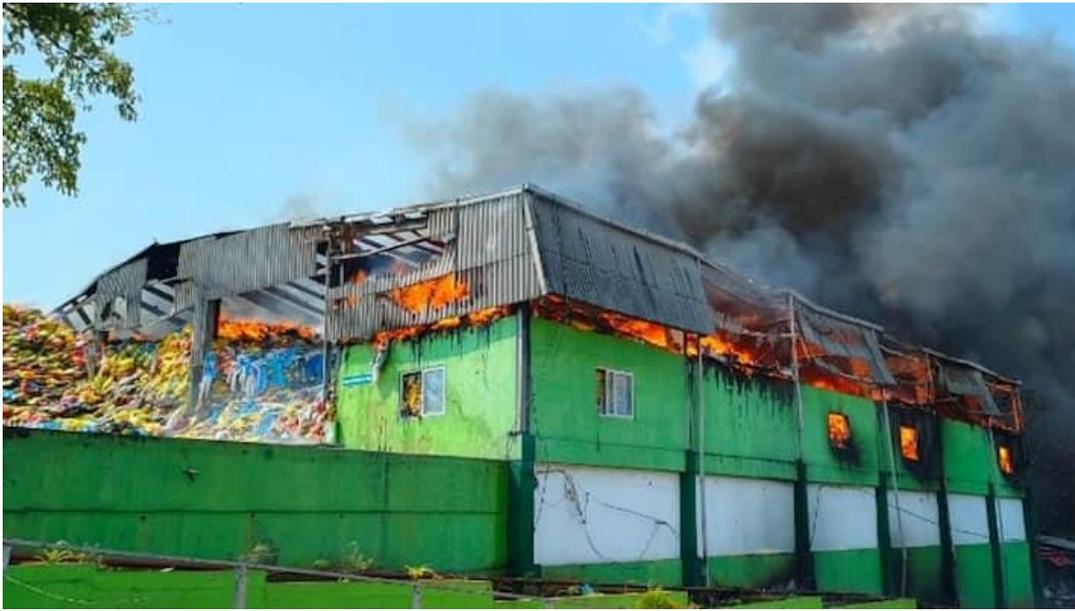
Waste storage shed when fire started \_16-01-2022

1. The size of the storage shed which caught fire is 35m x 40m. The Bio-Medical Waste has been stacked inside the shed with an average height of 4.5m. Thus the total volume of the Bio-Medical Waste is 6300m<sup>3</sup>. The unit weight of the Bio-Medical Waste was calculated using a vehicle and weigh bridge in the plant itself and it was obtained as 0.3 tons/ m<sup>3</sup>. Based on this, total quantity of the Bio-Medical Waste which caught fire was estimated to be 2000 tons. Bio-Medical Waste was also stacked outside, abutting the building. It was reported by the IMAGE that the Bio-Medical Waste accumulated inside the building and abutting the building were being taken for incineration everyday and the backlog was being reduced day by day until the day of fire incident.

2. The entire Bio-Medical Waste that caught fire is of Yellow type as per the Rules. During the peak Covid pandemic and continuing days, the Covid Bio-Medical Waste was given preference and it was being incinerated on the day itself. The non-Covid Bio-Medical Waste- Yellow- was being stacked like this.

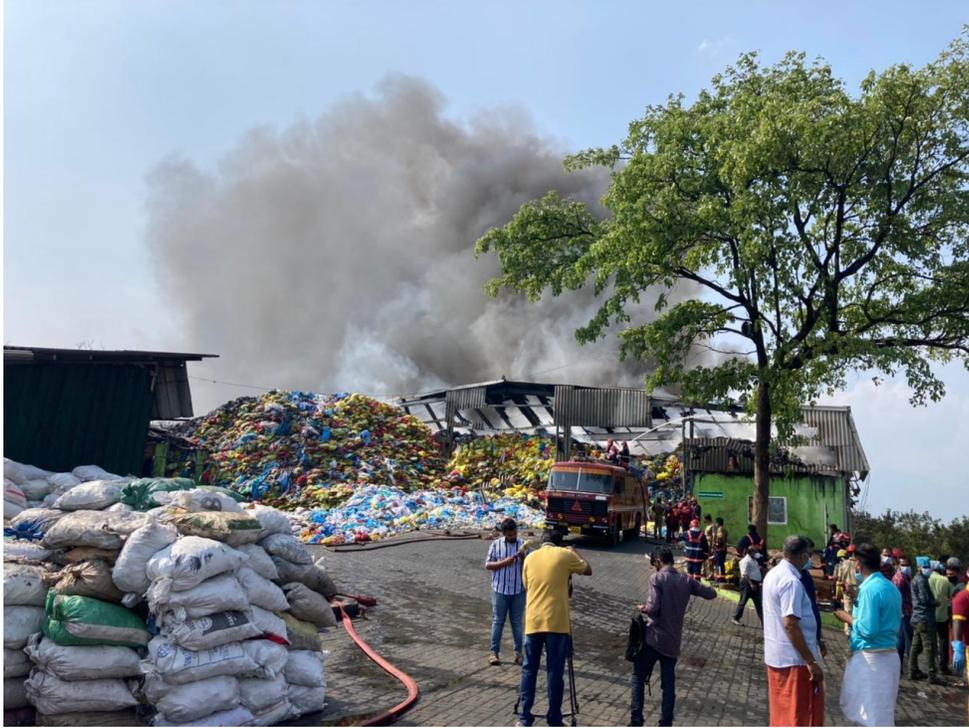
Initial hours of fire \_ 16-01-2022

Board Officials reached the site within an hour of the incident. A storage shed was filled with Bio-Medical Waste. The waste was under fire. The Fire Force was spraying water on the heap, but the fire was not subsiding. They could only prevent the spread of fire outside that building to other parts of the plant. No other part of the plant including buildings housing incinerators, autoclaves, Effluent Treatment Plant, sorting – sheds, administrative buildings etc. did come into contact with fire. The Bio-Medical Waste being in plastic bags was burning without any respite even after continuous spraying of water.

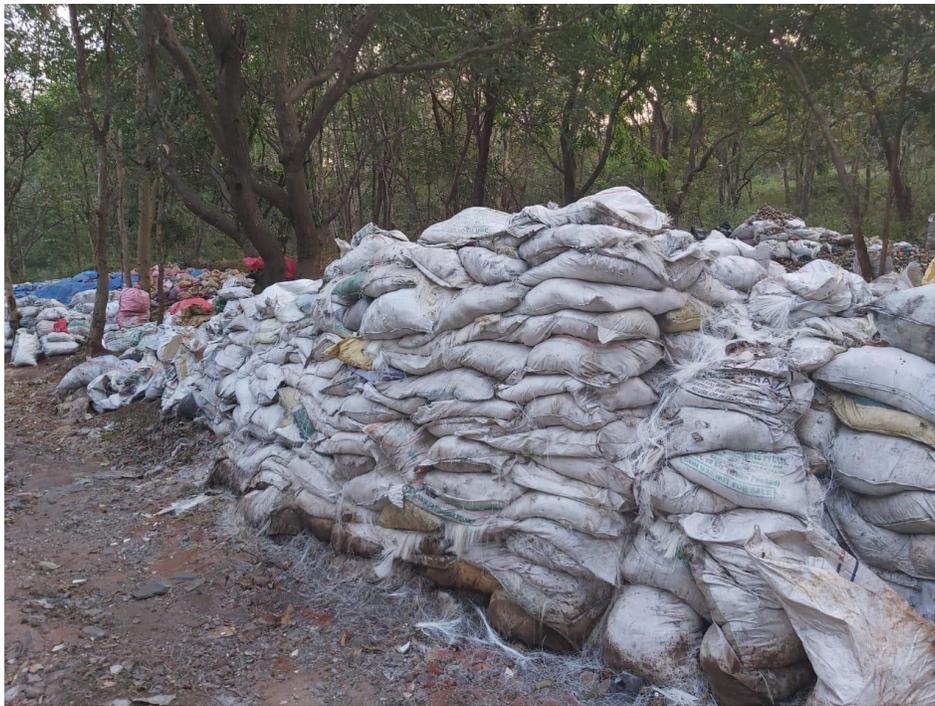
Disinfected and sorted BMW stored for transportation to recyclers, not affected by fire\_16-01-2022

The autoclaved recyclable waste after segregation is packed in white coloured plastic bags. This will be loaded into vehicles and handed over to authorized recyclers. During the period after the pandemic as well there has been certain delay in transporting out the autoclaved waste. This resulted in a small backlog of autoclaved waste as well, which were to be handled over to recyclers.

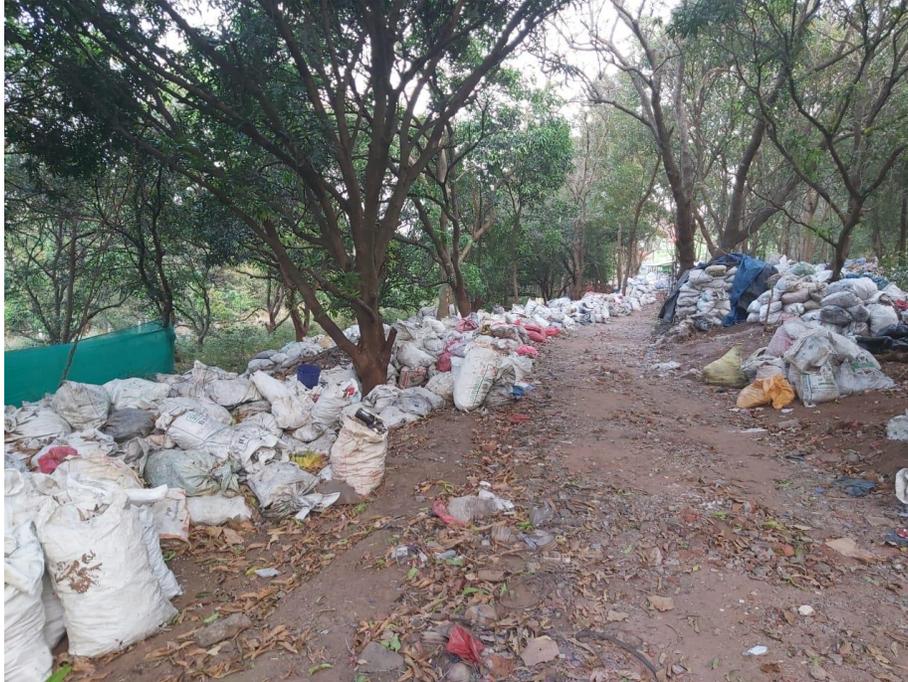
Disinfected BMW stored in open due to backlog of waste to be transported to recyclers\_16-01-2022

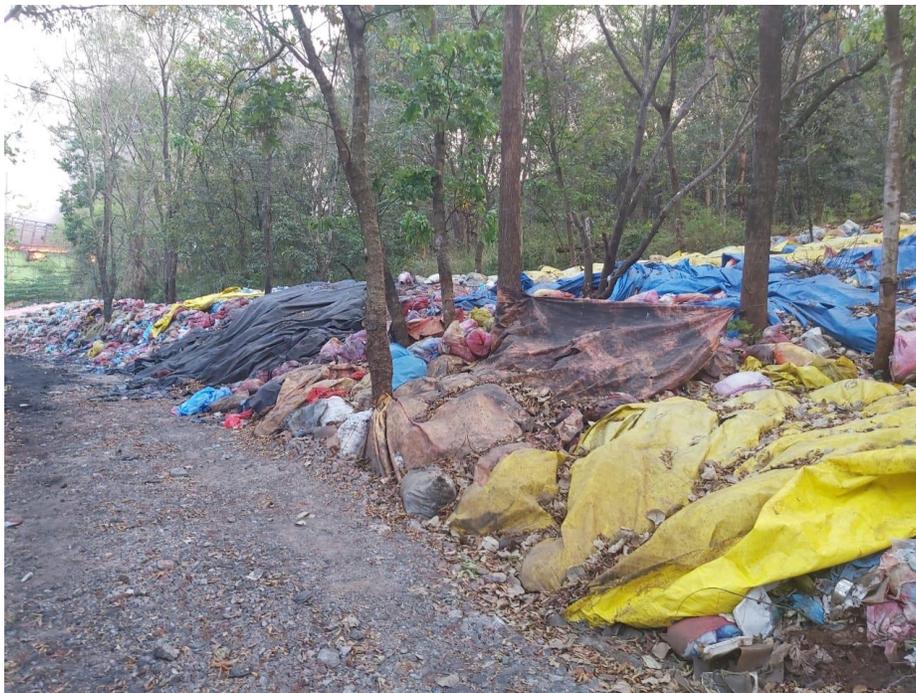
Disinfected BMW in open, faulty sorting during peak Covid pandemic, contains both recyclables and non recyclables\_16-01-2022

3. Outside the sheds, near the autoclaving sheds, some stacks of autoclaved / disinfected Bio-Medical Waste could be seen in open. These are Bio-Medical Waste packets taken out and stored after autoclaving. During the pandemic period, as well as after that, many hospitals were doing faulty segregation of Bio-Medical Waste. So even in red packets, many incinerable waste were coming. Such dry incinerable waste which came in red packets were autoclaved, separated manually, put in new packets and was being stored in this region. So these Bio-Medical Waste was also being taken day by day and the volume was getting reduced until the day of fire incident. Adjacent to that many autoclaved/recyclable waste also seen stocked.

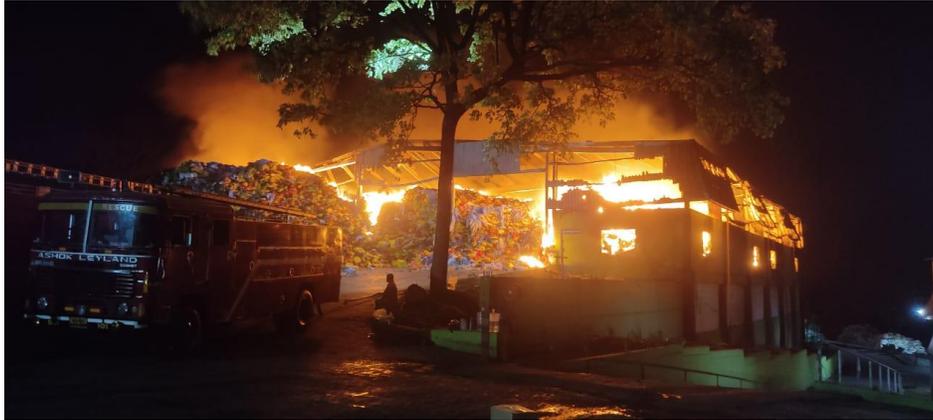
Fire continuing in night\_16-01-2022

The burning waste was sprayed with enormous quantity of water by the fire department. But the waste being in highly combustible nature, due to the presence of plastic inside and in the form of packets the fire was not getting subsided. The fumes generated in the burning were getting transported in approximately westward direction. Adjacent to the plant in westward direction it is forest land. Beyond that also it is uninhabited areas for about 2 km radial distance. So human inhabitations was not affected by the fumes.

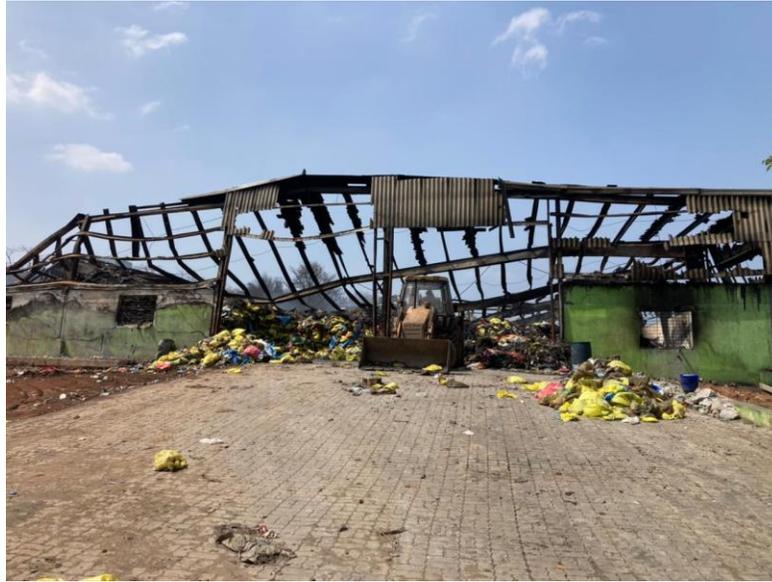
After all fire and smoldering had subsided, ash removal progressing\_29-01-2022

The fire and the consequential smoldering subsided fully only after 10 days only. The site was inspected finally on 29<sup>th</sup> January and it was found that even generation of smoke had subsided. The entire ash generated during the fire has been transferred to ash storage area, for transfer to TSDF.

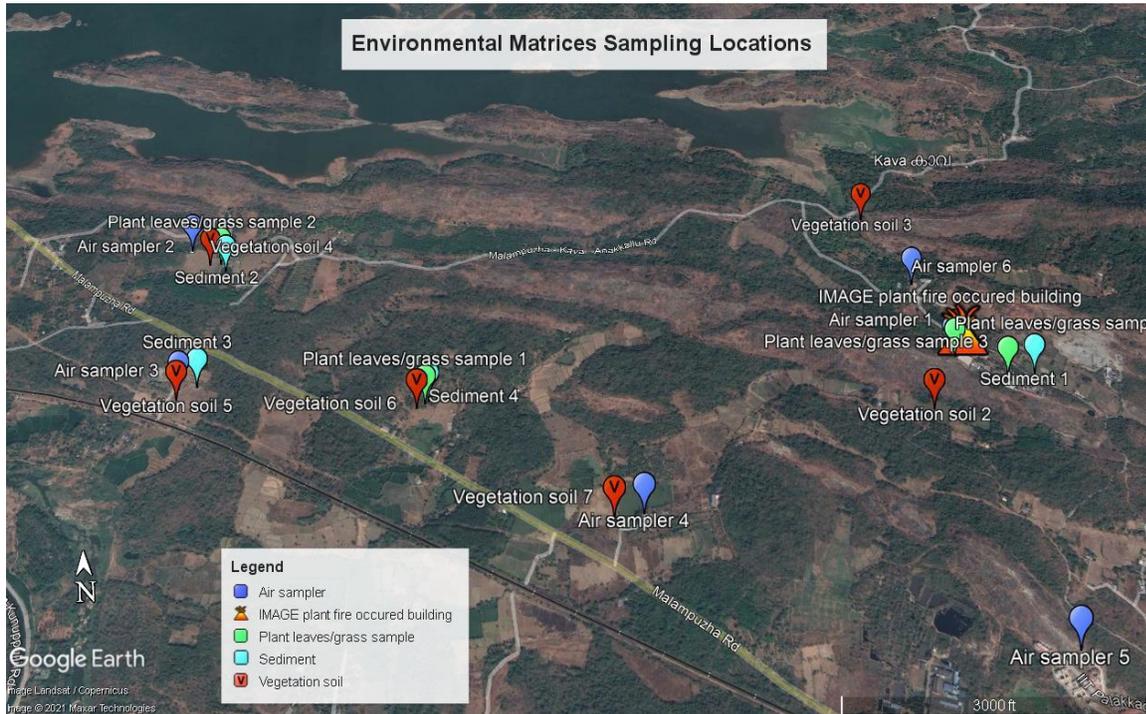
Environmental matrices sampling locations- monitoring by NIIST – 19-01-2022

Immediately, from 19.01.19 onwards, Board started a detailed monitoring for the presence of dioxins and furans in the ambient air, soil, vegetation etc. The fire was still burning during the monitoring. The sampling and analysis are being done by the NIIST, Thiruvananthapuram, one of the few laboratories in the Govt. sector with facilities for monitoring and analysing dioxins and furans. The following samples were collected and analysis is progressing

- Assessment of ambient air levels of dioxins-like POPs (PCDD/F/dl-PCBs) and heavy metals in selected sites in and around the CBWTF plant.
- Quantification of dioxin-like POPs and heavy metals in the burned residues and fly ash depositions from the fire occurred zone.
- Assessment of dioxin-like POPs levels and heavy metals in the vegetation, surface soil and sediments in and around the fire-occurred building.
