Original Application No. 448 of 2022

**In re: News item published in Hindustan Times dated 03.06.2022 titled
"178 Women workers fall ill after gas leak in Andhra's
Visakhapatnam"**

**2nd Interim Report
of the Joint Committee
Appointed by the National Green Tribunal
in the matter of
O.A. No.448 of 2022**

2nd Interim Report on the Incidents occurred on 03.06.2022 and 02.08.2022 at M/s Brandix Intimate India Pvt. Ltd., (formerly M/s Seeds Intimate Apparel India Pvt. Ltd.) located in the premises of M/s. Brandix India Apparel City Pvt., Ltd, SEZ, Atchuthapuram, Anakapalli District, Andhra Pradesh.

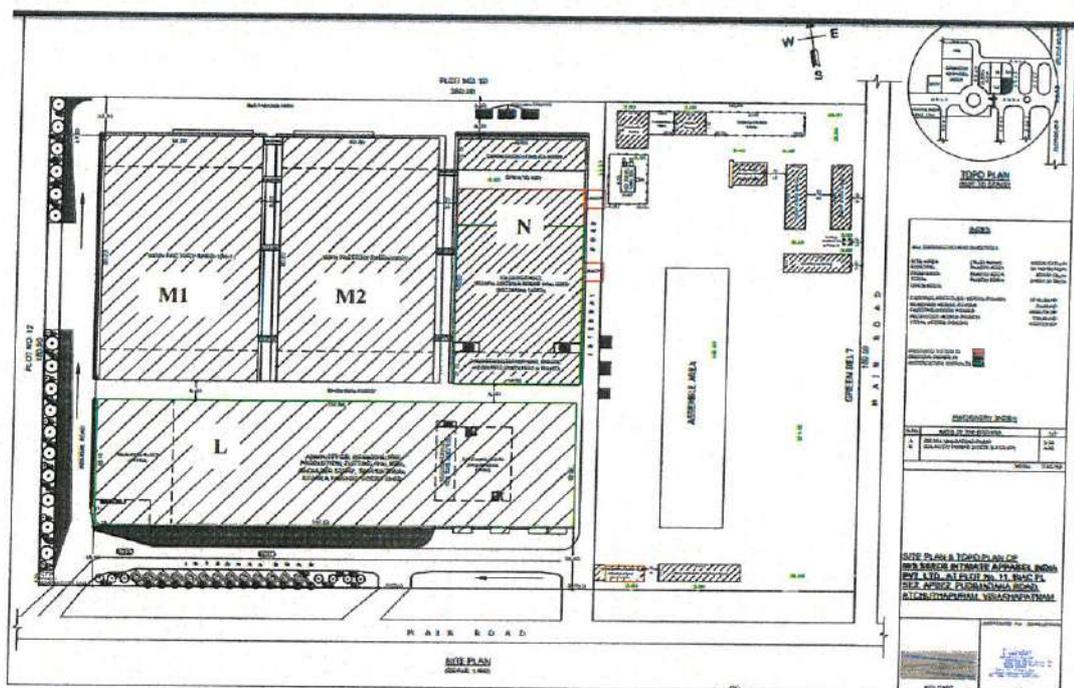
Figure 1: The layout of the M/s. Brandix Intimate India (P) Ltd., Unit in Brandix India Apparel City (P) Ltd.,

M/s. BIIL has four building blocks namely M1, M2, L and N blocks and open space /areas. The layout of the unit is shown in Figure 1.

The two manufacturing blocks are designated as M1 and M2, whereas the L block houses the administration office, moulding, preproduction, cutting, and warehouse for storage of raw material and finished apparel product. The Block N is meant for utilities including a medical room and canteen. There is a separate room in N block, which is designated as

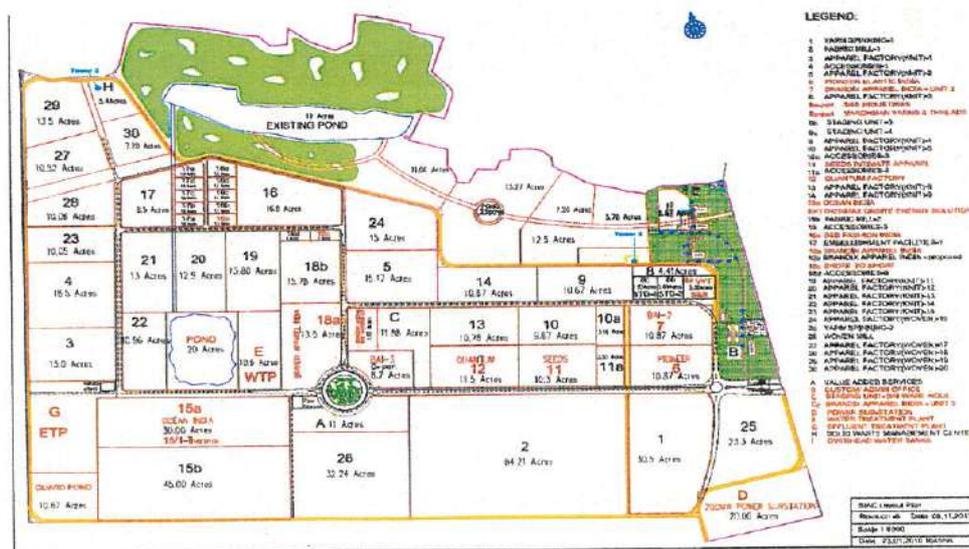
Figure - 2: Layout of Brandix India Apparel City Pvt., Ltd, SEZ,

The Layout of M/s Brandix India Apparel City Pvt., Ltd, and the Google map indicating location of BIIL are shown in figure 2 & 3 respectively.

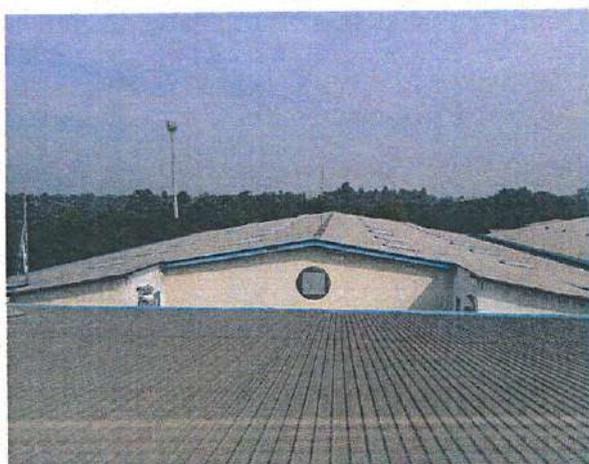
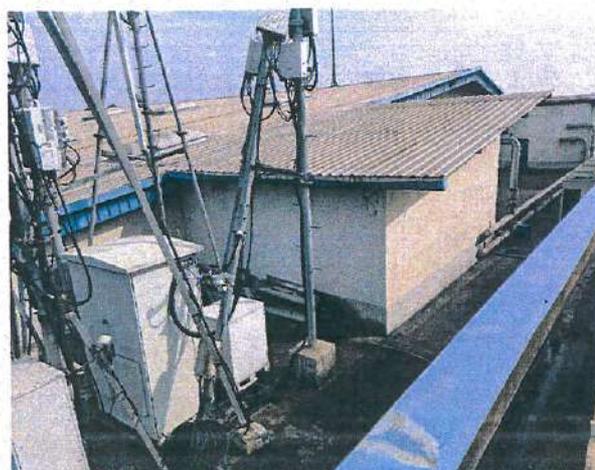
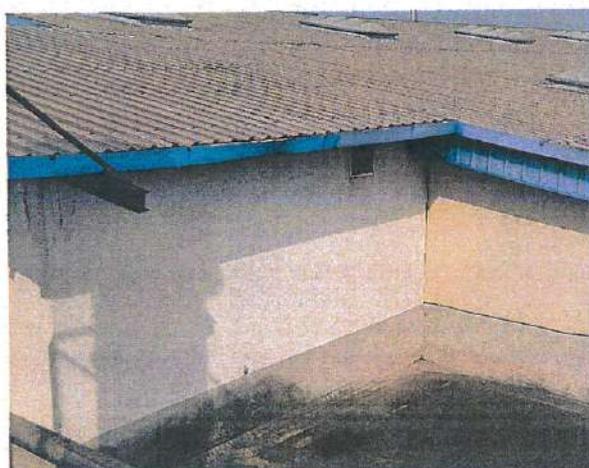
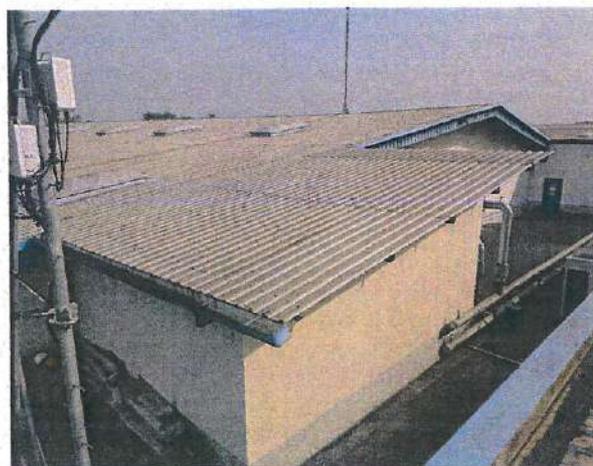
The Air conditioning facility provided is chilled water HVAC system consists of a central chilling unit outside the building as shown in Figure 1. There are total eight Air Handling Units (AHU) catering the air – conditioning needs of both M1 (4 AHUs for M1) and M2 (4 AHUs for M2) blocks. The AHUs are located on the roof top of M1 and M2 buildings. The each of the AHUs provide fresh air inlet to draw outside air. The fresh air drawn through these inlets is mixed with the chilled air and circulated in the air conditioning system.

- Chilling room has one chilling plant and three No. of compressors in N block.
- 4 number of Air Handling Units (AHUs) are provided for each of the M1 and M2 blocks (two 75 TR AHUs are located at North side and the other two 80 TR AHUs are at south side of the blocks).
- Capacity of AHUs for each block is 80 TR AHUs (2 Nos.) – 34,400 CFM; 70TR AHUs (2 Nos) – 28,000 CFM.
- The lines numbered as 1,3,5,7,9,11,21,22 in the manufacturing blocks are connected to AHUs – 3 at South West side of M1.

- The lines bearing numbers 2,4,6,8,10,12 are connected to AHU – 4 at South East side of M1.
- The lines 13,15,17,19,23 are connected to AHU-2 at North East side of M1.
- The lines 14,16,18,20,24 are connected to AHU- 1 at North West side of M1.
- The AHU room size is 20.9ft x 16 ft.
- Fresh air damper of AHU size is 20 inch x 16 inch.
- AHU No.3 & 4 were installed on terrace slab of M1 building at South side at a distance of 5m from corridor lean to roof.

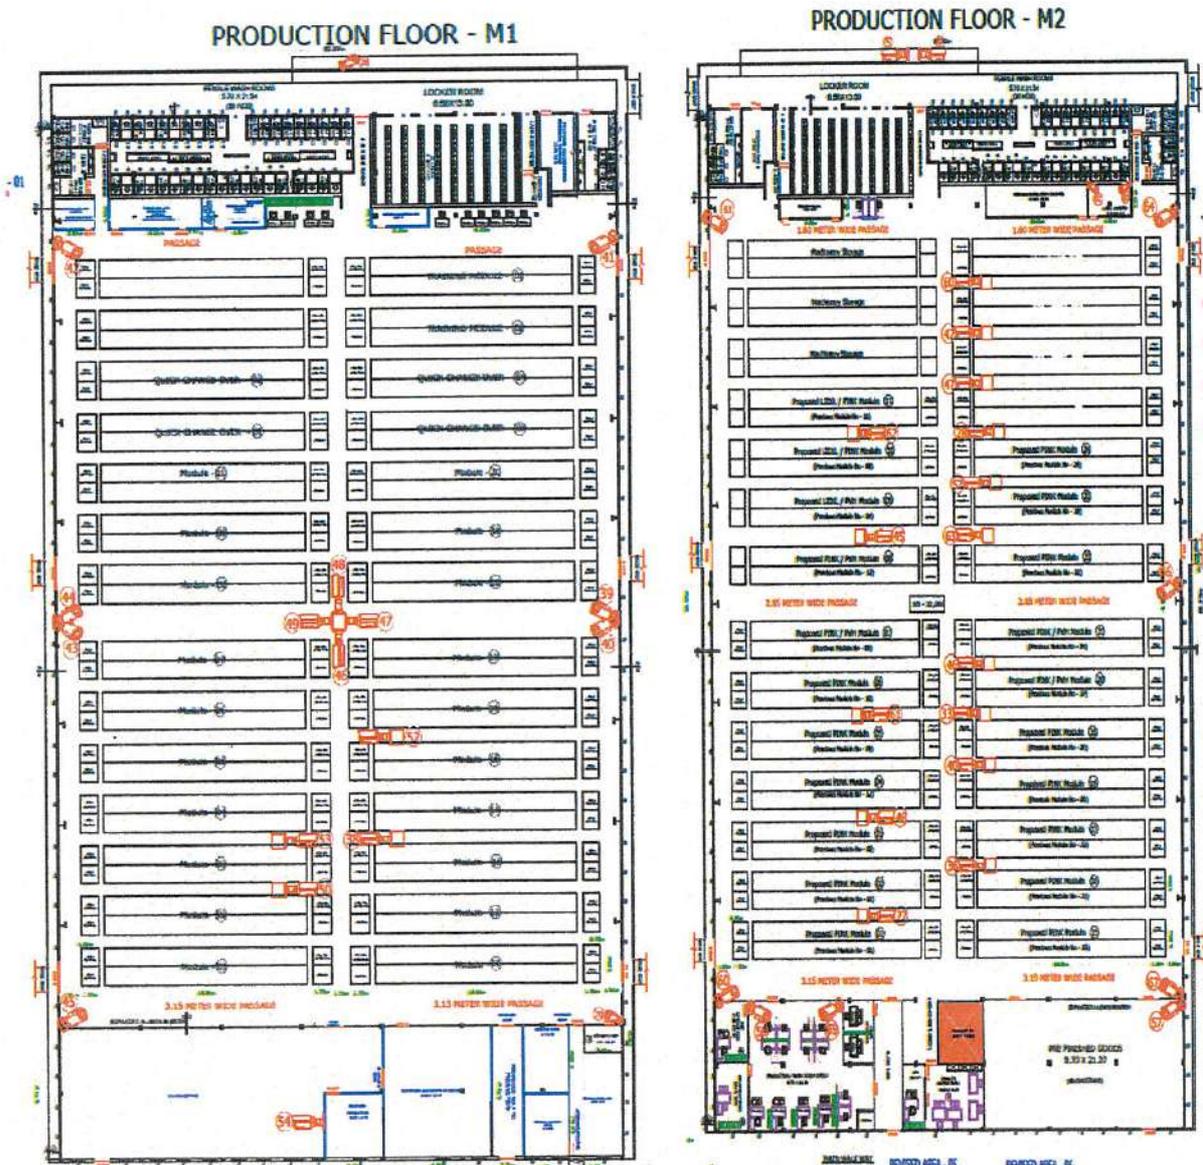
Figure 2: Production floor layout of the M1 and M2 blocks

eaves. The M1 and M2 blocks are centrally air-conditioned blocks where the temperature and humidity are maintained in the range of 25^o C – 26^o C and 55% - 60% respectively. The noise levels are measured during the field visit and the average noise level is 65 dB. The staff working in these blocks is exposed to these conditions for duration of approximately 7.5 hours in a working day. The production floor layout of the M1 and M2 blocks is shown in Figure 2.

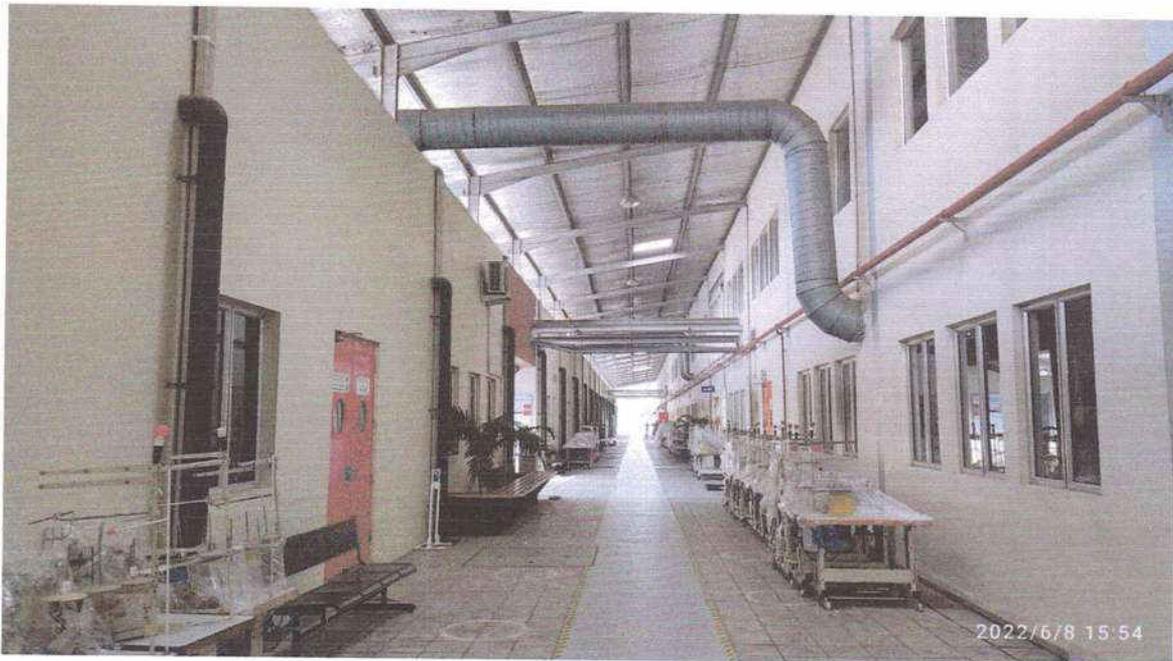
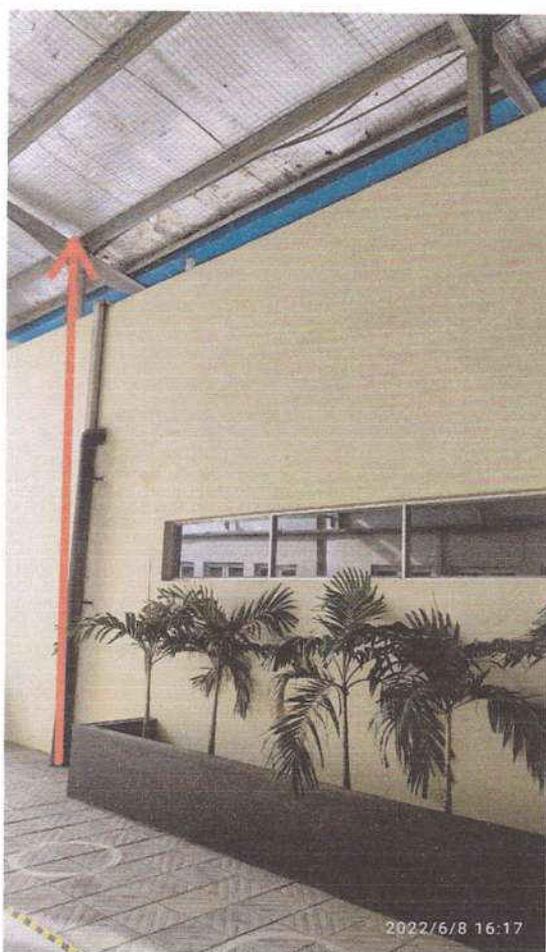
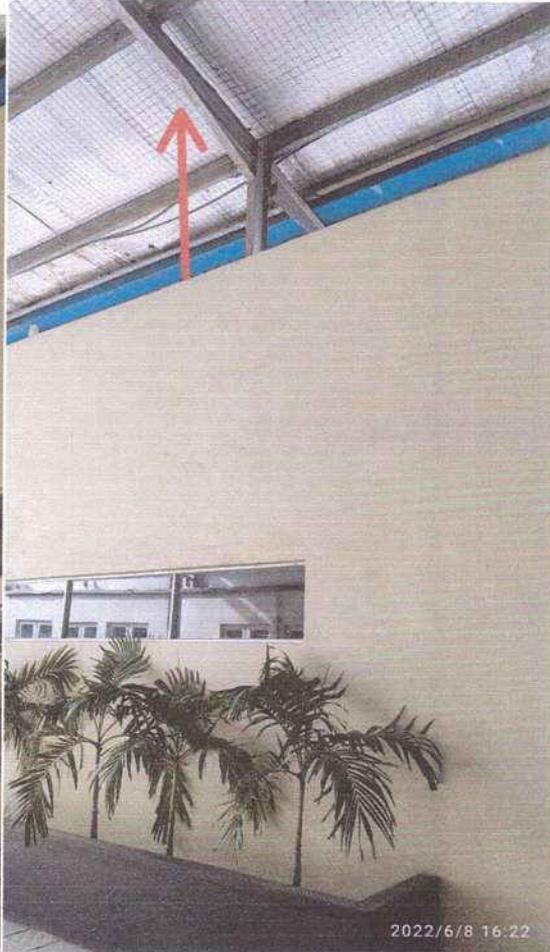
Lean to roof of GI Sheet found that the eaves are on M1, M2 & N blocks and leading from L (Admin. Building), leaving a gap of 6 meters between M1, M2 & N blocks and L (Admin Building).

- viii. There is a lean to roof of GI sheet found on the slabs of M1, M2 & N blocks L block there is 6 m wide corridor between M1, M2 & N blocks and L building. The pest control operator usually spraying along the walls of L Block and return along the walls of M1, M2 & N blocks, As the 6 meters corridor with the length of about 150 meters is sprayed twice and the entire gases/vapour generated from the spray is accumulated at lean to roof from there the accumulated gases passed through the gap between the roof and walls of M1, M2 & N blocks.

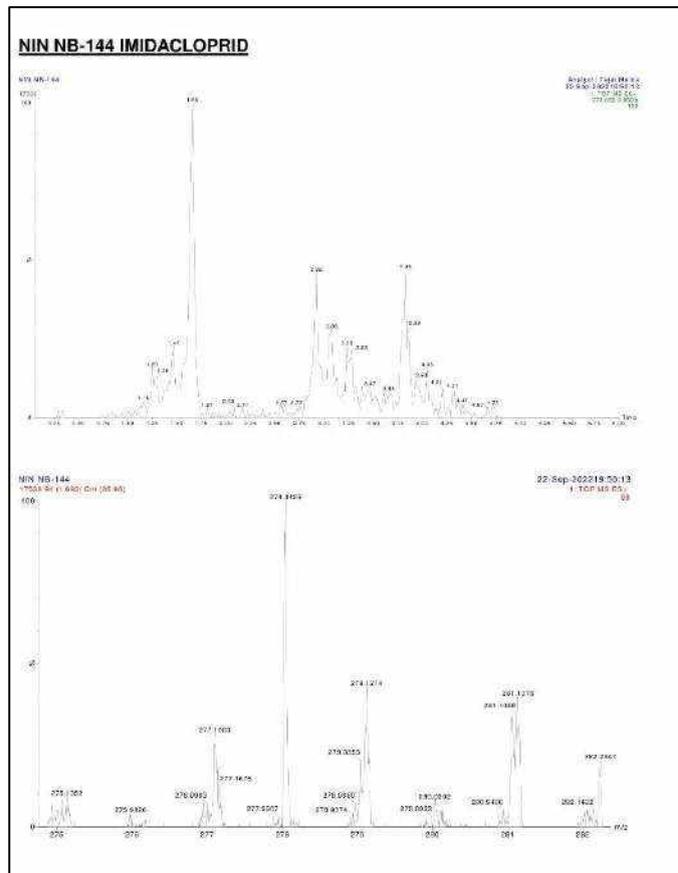
Figure 10: chromatogram of Imidacloprid In Blood sample of Case

The clinical picture and epidemic pattern are characteristic of a single exposure outbreak. The acute clinical signs and symptoms were suggestive of inhalation of organophosphate insecticide. The biomarker of Imidacloprid, an Insecticide, were found in four samples among the exposed.
