BEFORE THE HON'BLE NATIONAL GREEN TRIBUNAL, (SZ), CHENNAI
M.A.No. 03/2021

**A geotechnical note on the proposed lift at Jonnalaboguda Balancing Reservoir
(stage II) under Kalwakurthi Lift Irrigation Scheme, Mahaboobnagar District,
Andhra Pradesh.**

Note on geotechnical assessment of the foundation of surge pool – MGKLIS-II

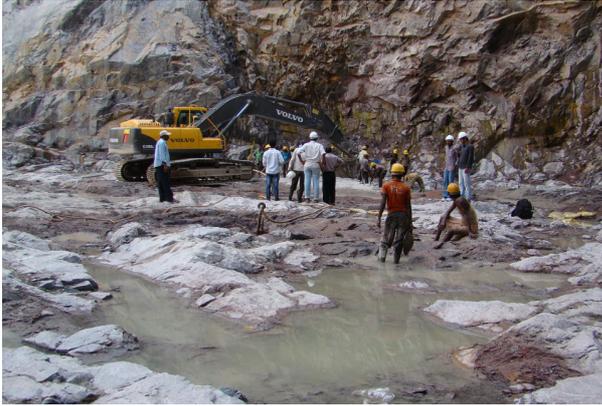
Plate 1. Cleaning the foundation level of Surge Pool

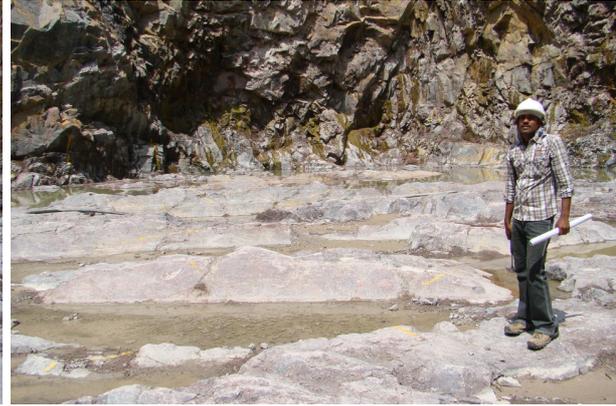
Plate 2. Marking of grids on the foundation level

Grids were prepared for mapping the surge pool floor area. The size of the grid is 2 m X 2 m, which was decided based on the mapping accuracy and resolution required for such investigations. Grids for mapping were marked on the floor by NECL surveyor using elevation & chainages provided by them. Detailed examination of rock types in each grid was carried out which includes mineralogical composition, texture, classification and nomenclature and degree/grade of weathering. Fracture filling that have taken place in the study site were examined and recorded. The attitude and structure of the rocks, fractures and joint pattern present in the floor was determined for mapping. ISRM (1978), classifications for weathered rock mass was used to characterize the rock mass into different grade (Table-1). The assessment of RMR (Bieniawski, 1989) for granites rock masses, based on the rock joints and their nature and laboratory test data has been attempted.

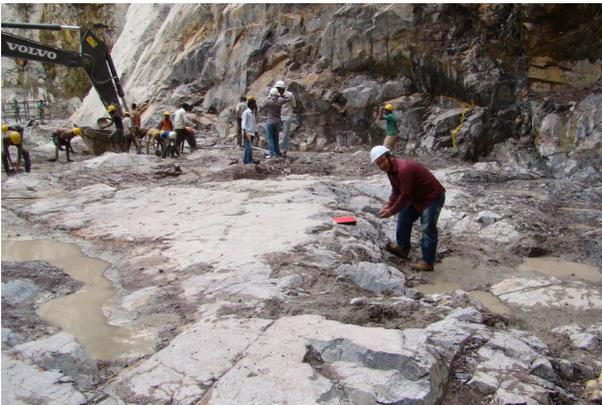
Plate 3. Collection of engineering geological data from the foundation of surge pool

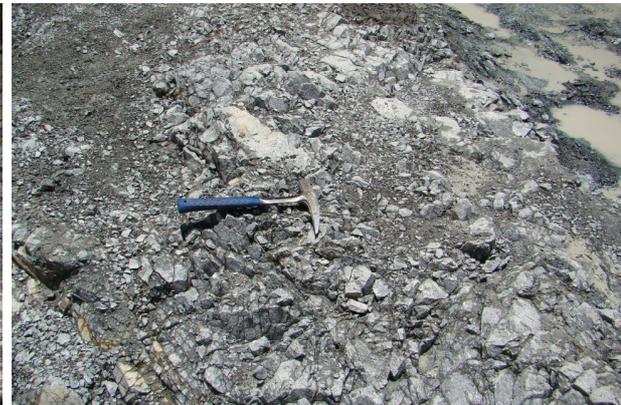
Plate 4. Highly jointed area marked as feature A in the Drawing No. NIRM/MGKLIS-II/EG1301/01

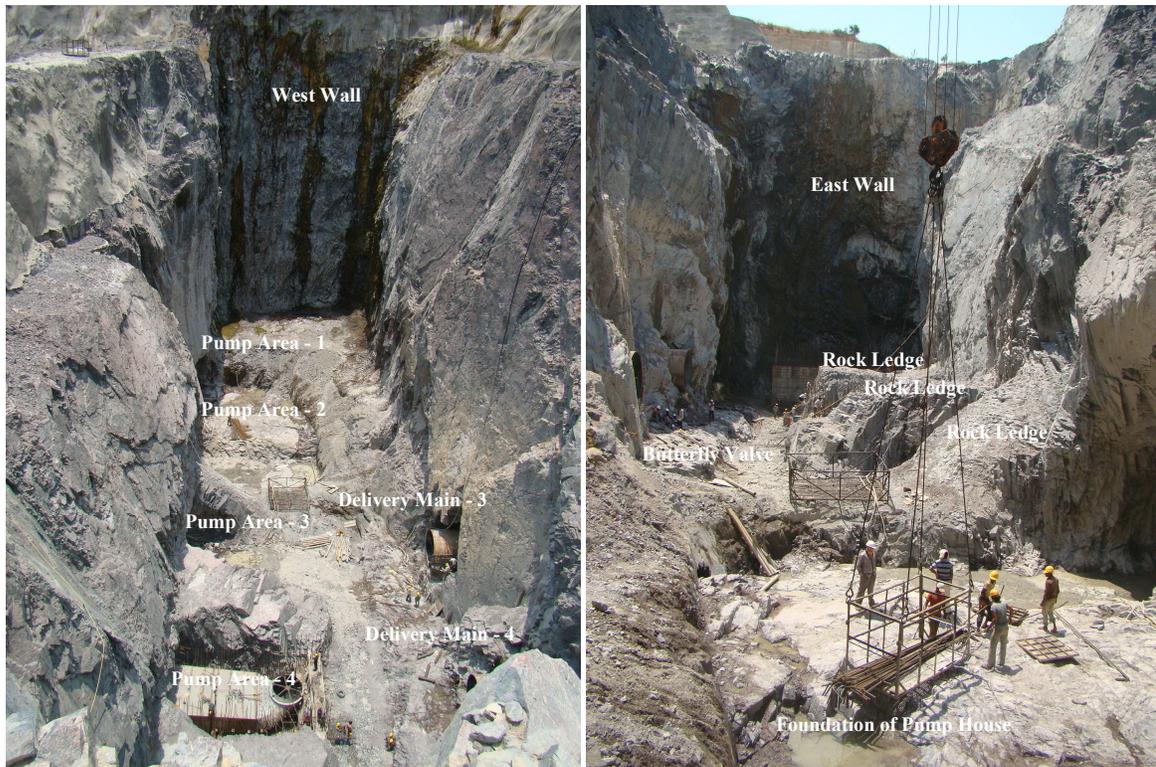
Fig. 1. Pump house area, viewing towards western direction

Fig. 2. Pump house area, viewing towards eastern direction

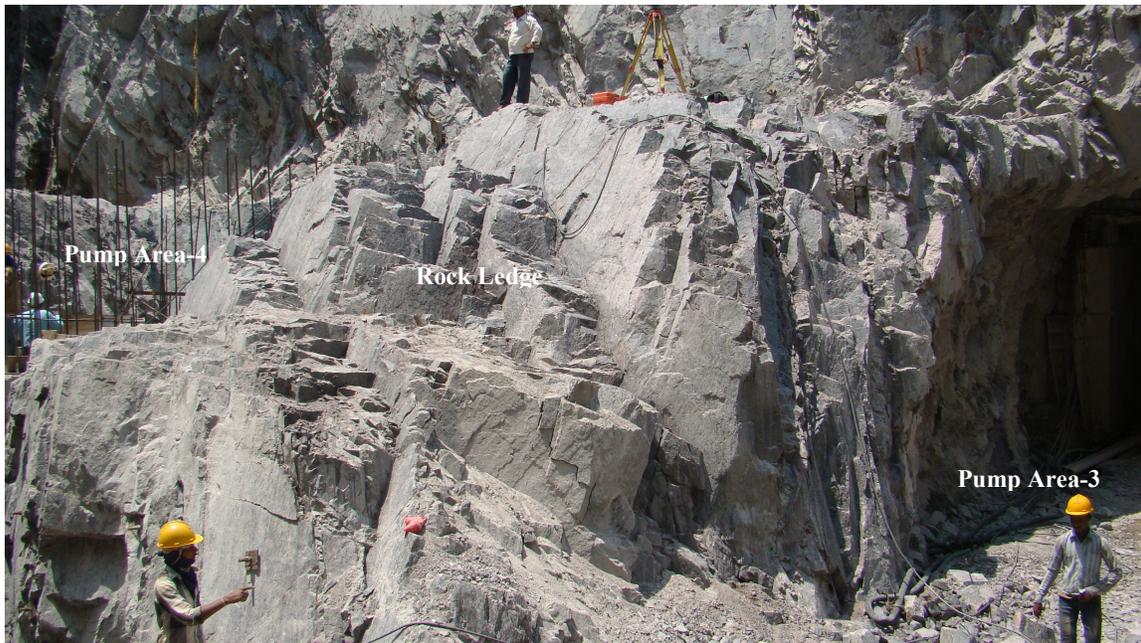
Pink granites are coarse grained, hard and jointed and shows phenocryst of alkali feldspar and quartz. Main minerals composition is alkali feldspars, quartz, mica and amphiboles. Five prominent joints set are developed and along the joint plane clay filling/coating was also recorded. Joints are irregular in pattern. Granites are generally fresh to moderately weathered (WI–WIII). At the foundation level granites are traversed by dolerite dyke (feature D1 marked in Drawing No NIRM/MGKLIS-II/EG-13-01/04). Dolerite dykes are fine grained and greenish-black in colour. The width of the dyke is up to 100 cm and strike length is more than 100 m in excavated part of pump house. Dyke is generally sheared and in D1 clay gouge was observed. Plagioclase and clinopyroxene (augite / titanaugite) are the main minerals occurring in ophitic to sub-ophitic textures in dolerite. Quartz, epidote and opaques occur as accessories. Amphibole, biotite, sericite occur as alteration products. Dyke is generally highly weathered (WIV) as per the weathering grade.

Fig. 3. Coarse grained granite exposed at the foundation of pump house

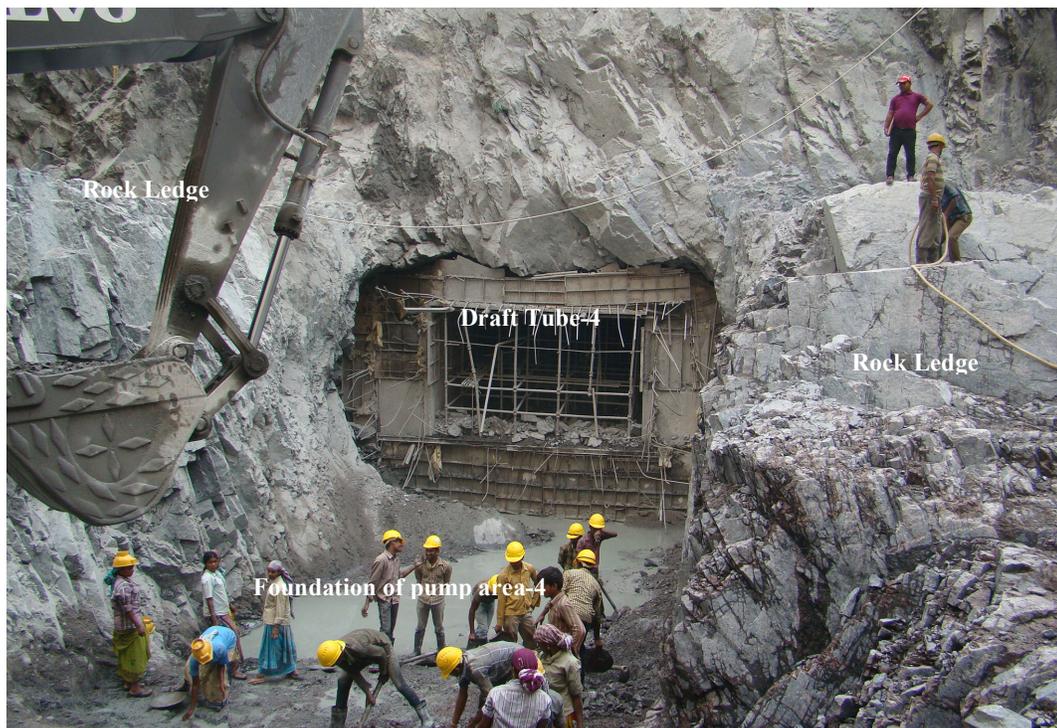
Fig. 4. Cleaning the foundation of pump area-4 before engineering geological mapping

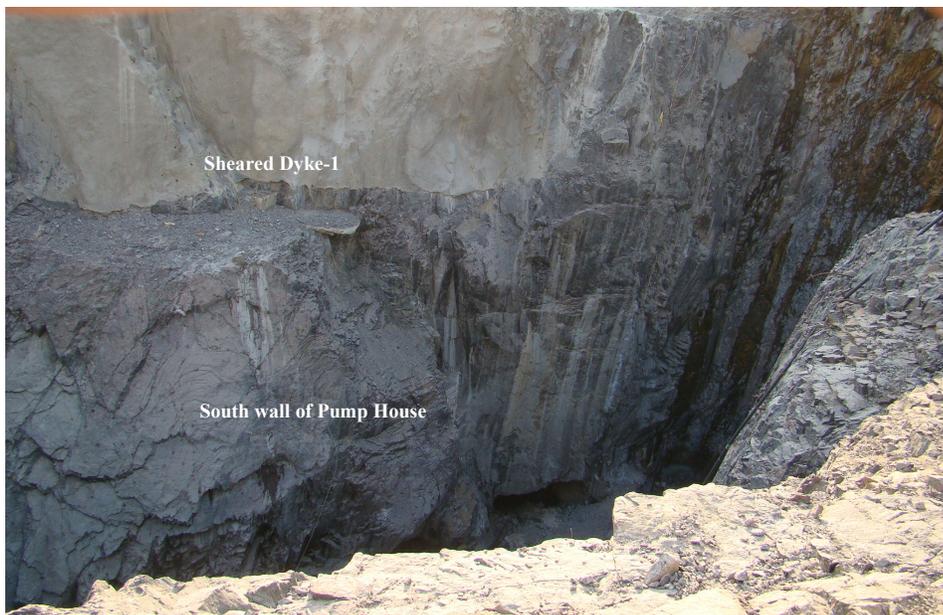
The rock mass for the south wall of pump house is classified as very poor to poor rock mass (Q 0.18 to 1.25) as per Barton's classification. The details of the Q values of south wall of pump house are given in Table 7.

Fig. 5. South wall of pump house, sheared dyke-1 is also shown

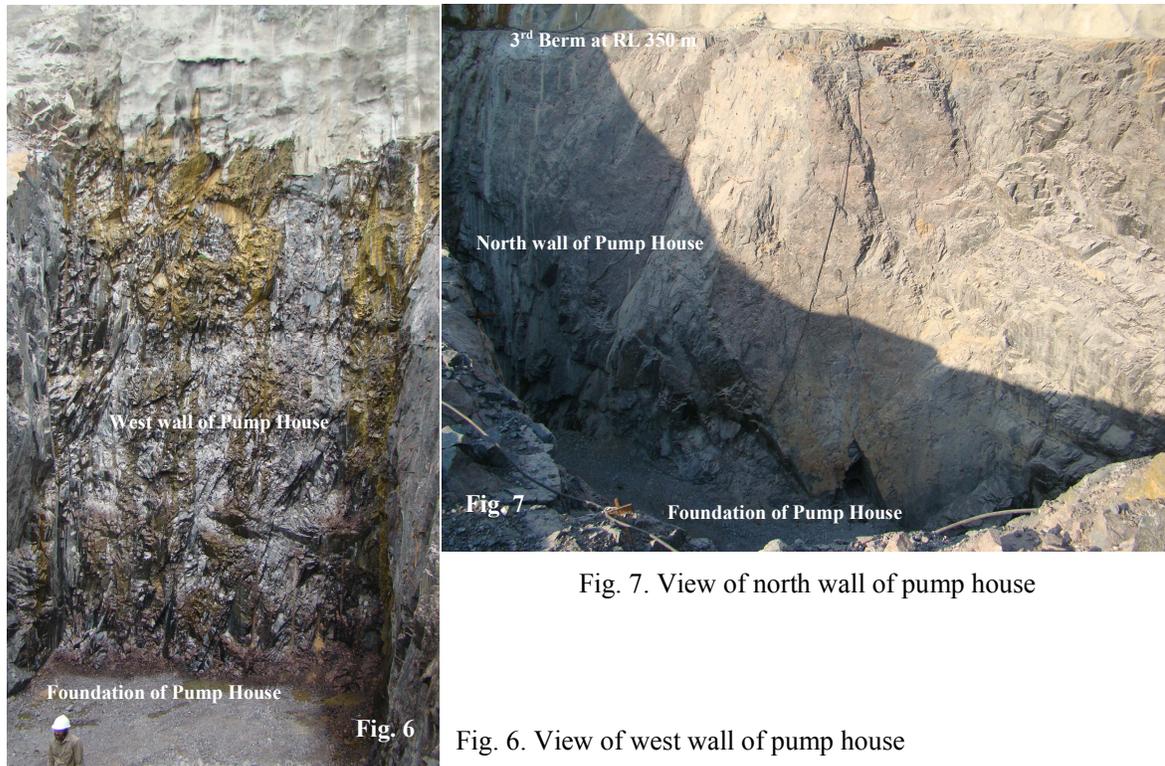
Fig. 7. View of north wall of pump house

Fig. 6. View of west wall of pump house

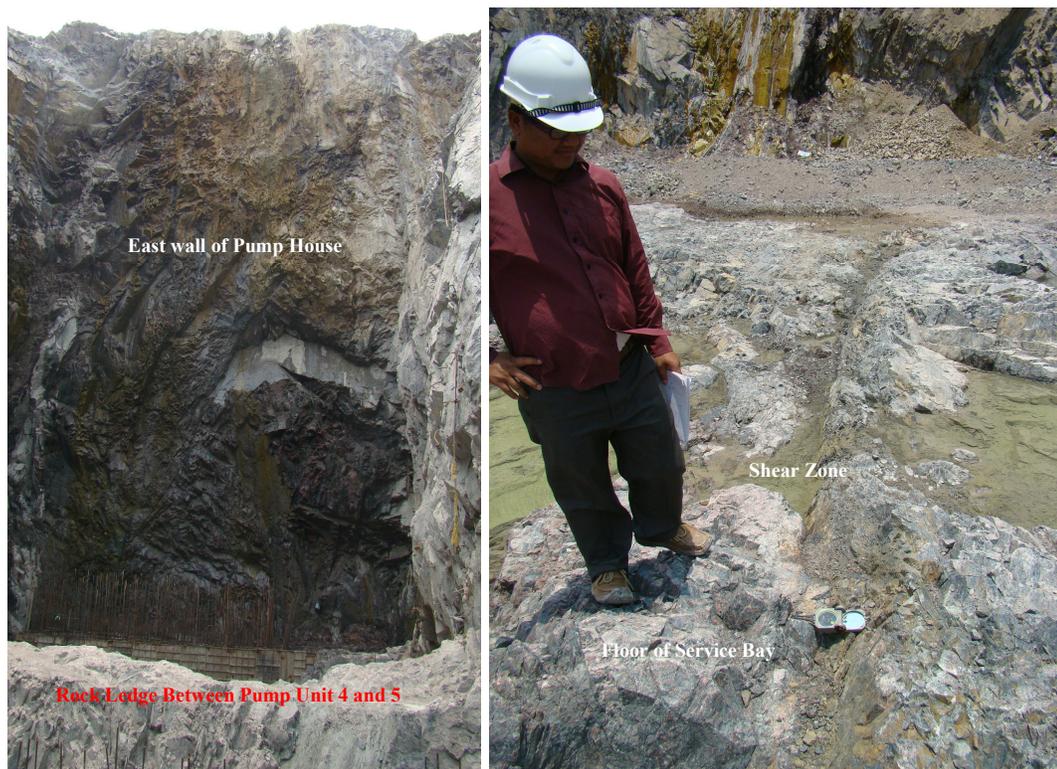
Fig. 8. View of east wall of pump house

Fig. 9. View of foundation of service bay

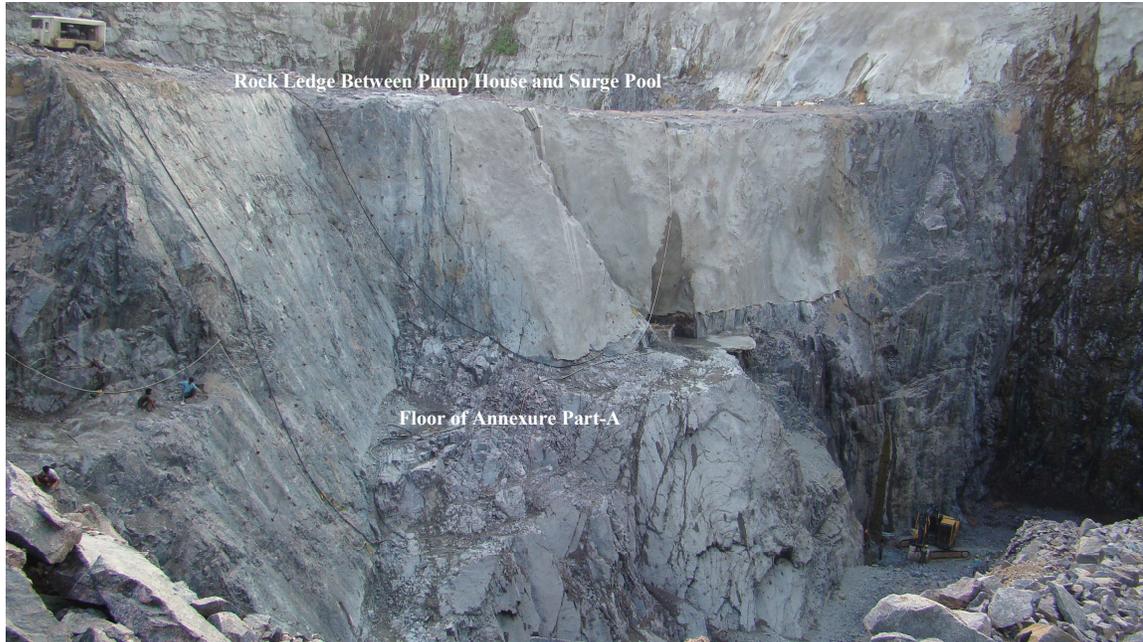
Fig. 10. View of foundation of Annexure Part-A

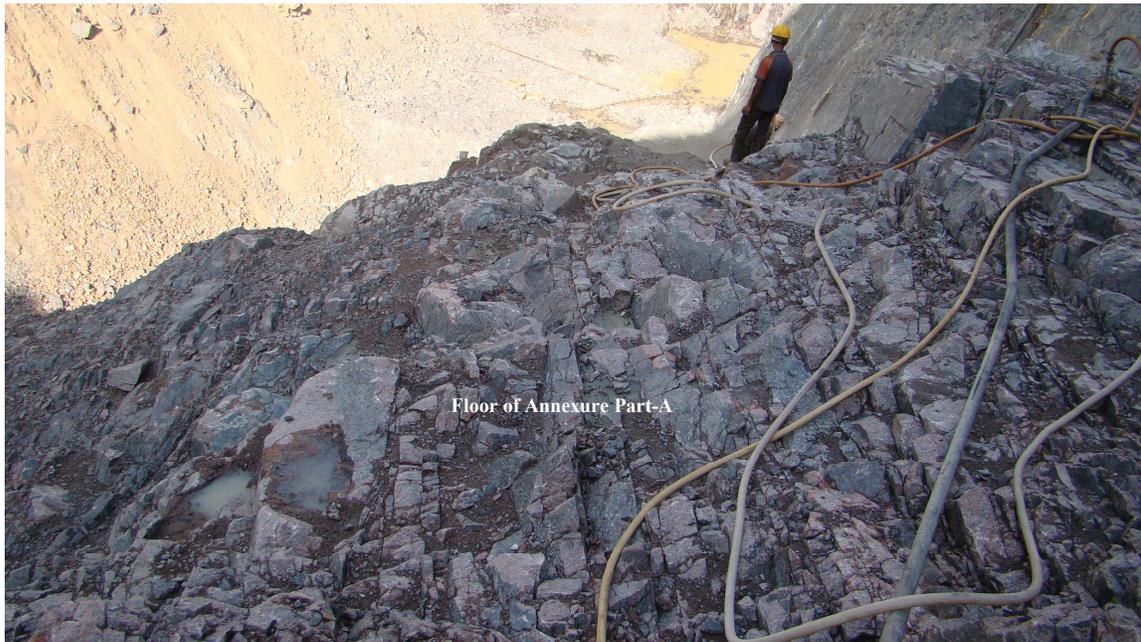
Fig. 11. Foundation of Annexure Part-A was cleaned before engineering geological mapping

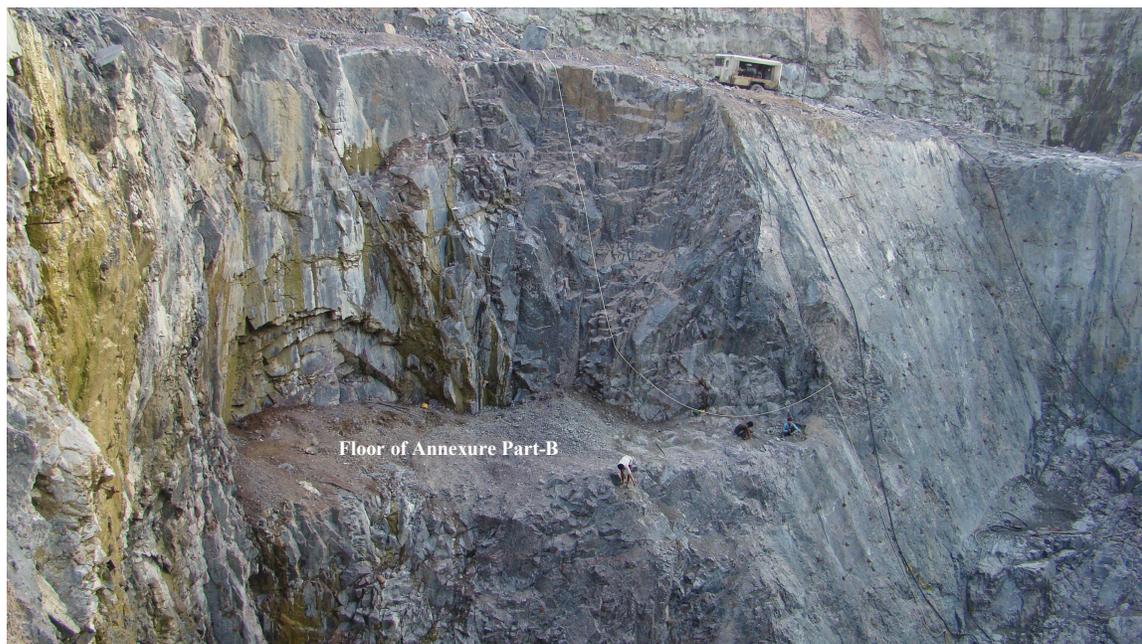
Annexure Part-B is lying on the southern side of the pump house i.e. towards eastern side of annexure part-A (Fig. 12). Annexure Part-B area is excavated up to an average RL +335 m and three columns for annexure building are provided in the design on this surface.

Fig. 12. View of foundation of Annexure Part-B

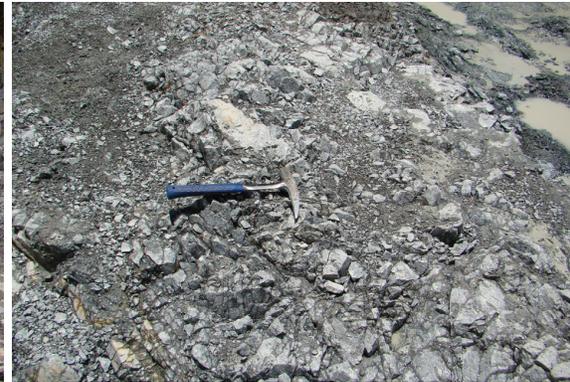
Plate 4. Highly jointed area marked as feature A in the Drawing No. NIRM/MGKLIS-II/EG1301/01

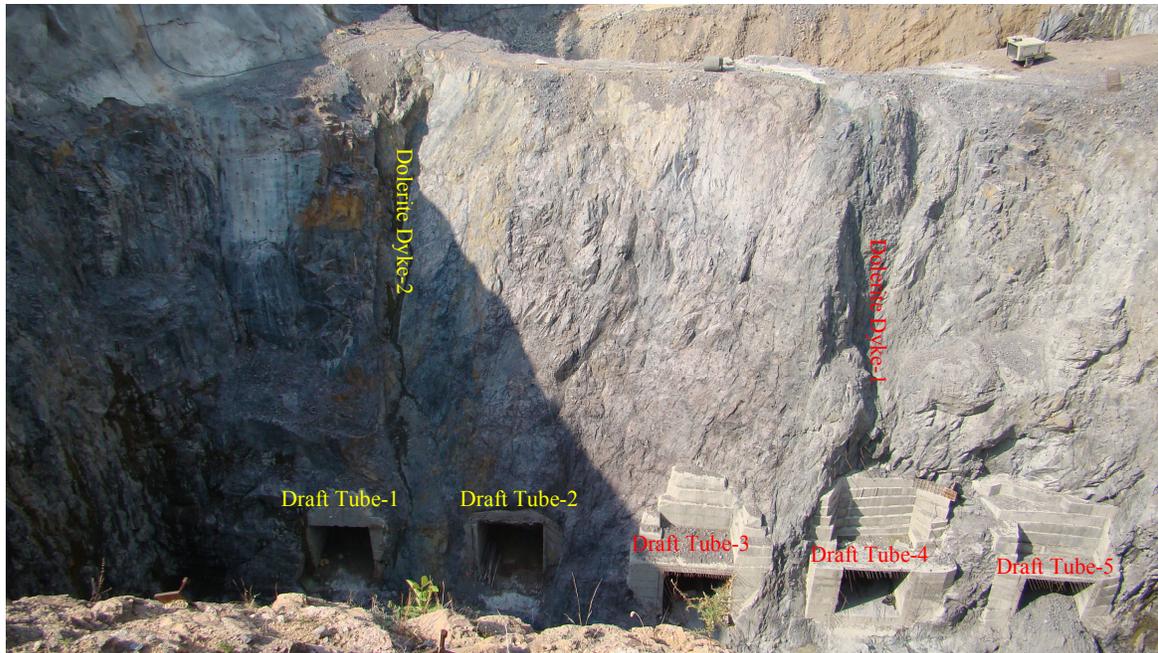
failure was due to structural wedge formation between dyke-2 (N240°/65°) & joint (N180°-190°/45°-50°) and extended to 1.5m to 2.0m depth into the excavated line of face.

Plate 1: View of north wall of surge pool; rock types are pink and grey granites intruded by dolerite dykes

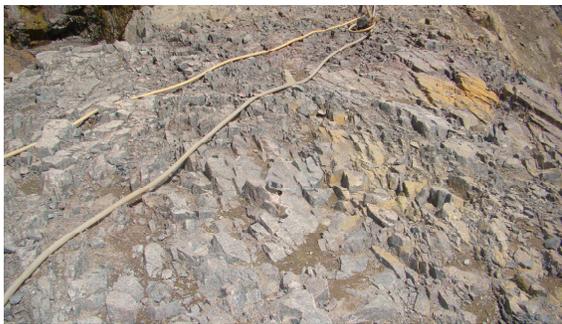
Plate 2: Fresh and jointed granite at the surface of rock ledge

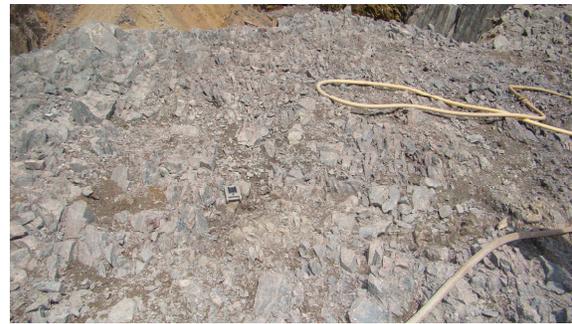
Plate 3: Slightly weathered and jointed granite at the surface of rock ledge

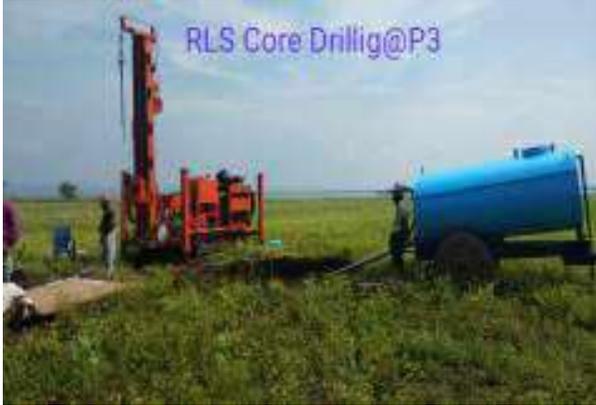
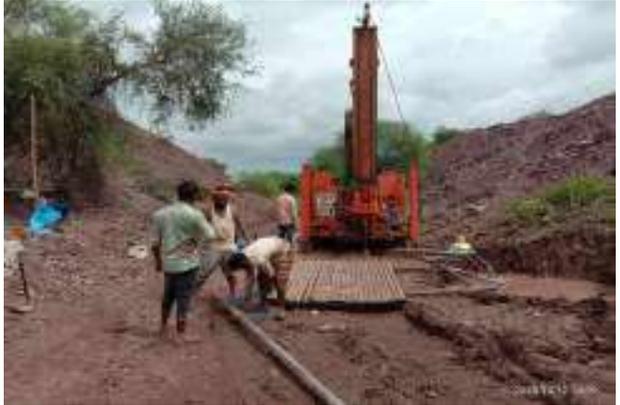
<p>1. Core Drilling in progress</p>	<p>2. Core Drilling in progress</p>

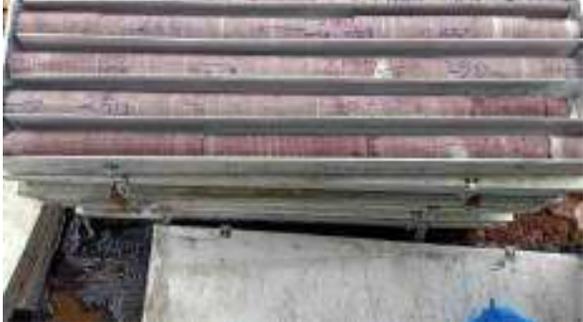
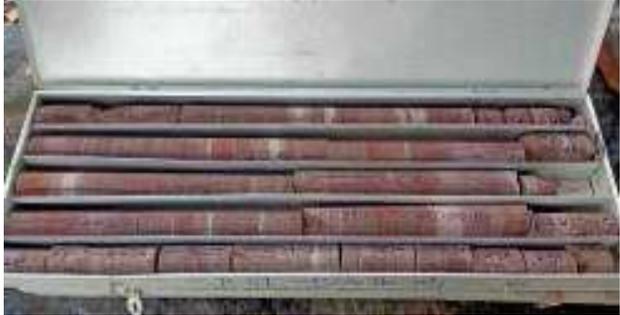
<p>3. Core Samples</p>	<p>4. Core Samples</p>
