Report of the Joint Committee on Status of Pollution in the Ramakkal
Lake in the matter of O.A.No.34 of 2024 in the Hon'ble NGT (SZ)
(Earlier O.A.No.607 of 2023 in the Hon'ble NGT (PB))

April, 2024

Original Application No.34 of 2024 in the Hon'ble NGT (SZ)
(Earlier O.A.No.607 of 2023 in the Hon'ble NGT (PB))

REPORT OF JOINT COMMITTEE ON STATUS OF POLLUTION IN THE RAMAKKAL LAKE IN THE MATTER OF ORIGINAL APPLICATION NO. 607 OF 2023 (PB) RE-NUMBERED AS O.A.NO.34 OF 2024 (SZ) “NEWS REPORT AS APPEARING IN EXPRESS NEWS SERVICE DATED 14.09.2023 TITLED “RAMAKKAL LAKE IN TN POLLUTED & EMITS FOUL SMELL, RESIDENTS DEMAND REJUVENATION”.

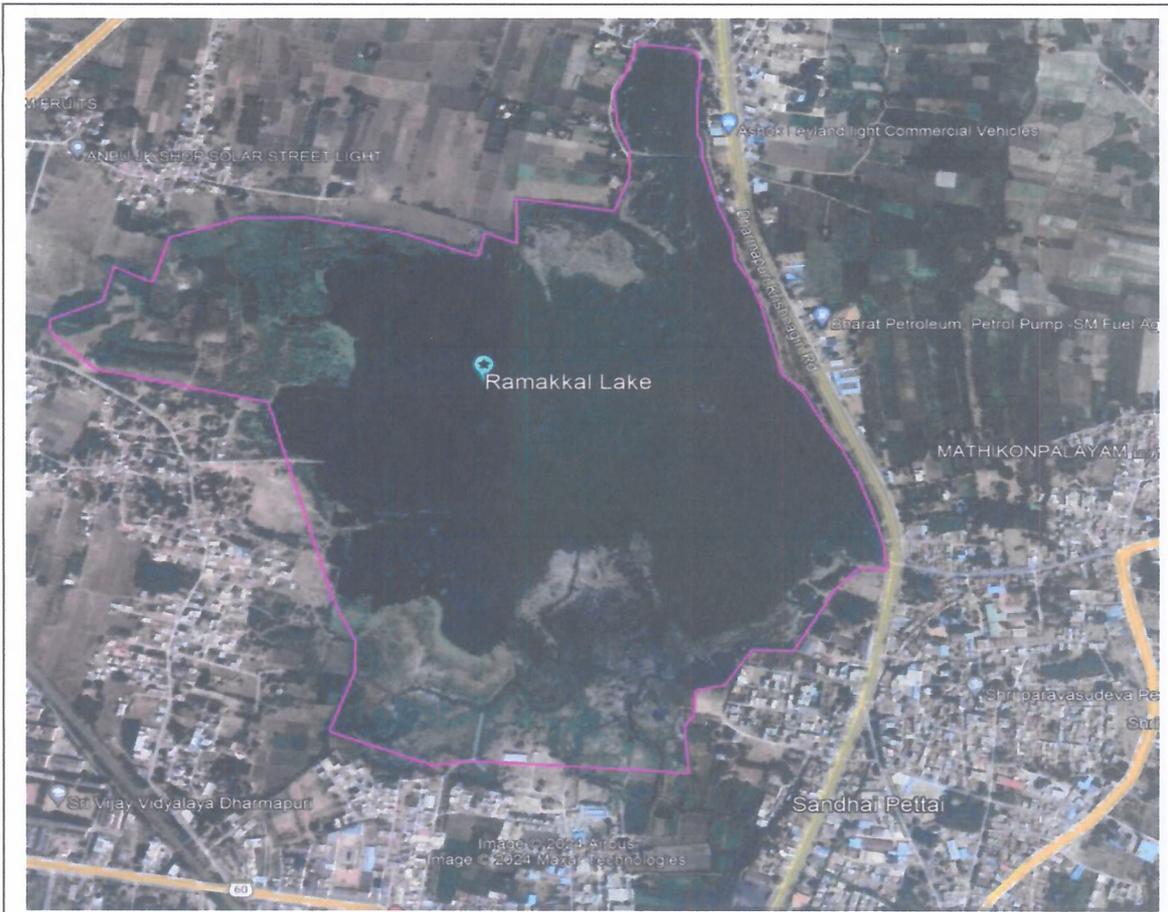
Map no. 1 : Google earth map showing Ramakkal Lake

The Ramakkal Lake is situated in Hale Dharmapuri Village in Dharmapuri Taluk of Dharmapuri District. This Tank is classified under System tank and surplus water of **Sogathur Lake** (Located at the Sogathur village, Dharmapuri Taluk & District comes under Kambainallur Sub-Basin and Pennaiyar Basin. Catchment area of sogathur lake is about 21.03 Square Kilometer. Having a bund of length 1290 m, four numbers of sluices and two numbers of weirs with an Ayacut of 347.99 acres. Discharge is about 3397 cusecs and capacity of the tank is 36.48 MCFT or 1.033MCM) and rainwater from Dharmapuri town is the main source of water inflow to the Ramakkal Lake and its natural free catchment area is about 14.01 Square Kilometer. This tank is having a bund of length 1050 m, with three numbers of sluices and two numbers of surplus weirs. This tank has an Ayacut of 107.24 acres. The discharge from the Ramakkal Lake is about 4096 cusecs and capacity of the tank is 33.51 MCFT or 0.949 MCM.

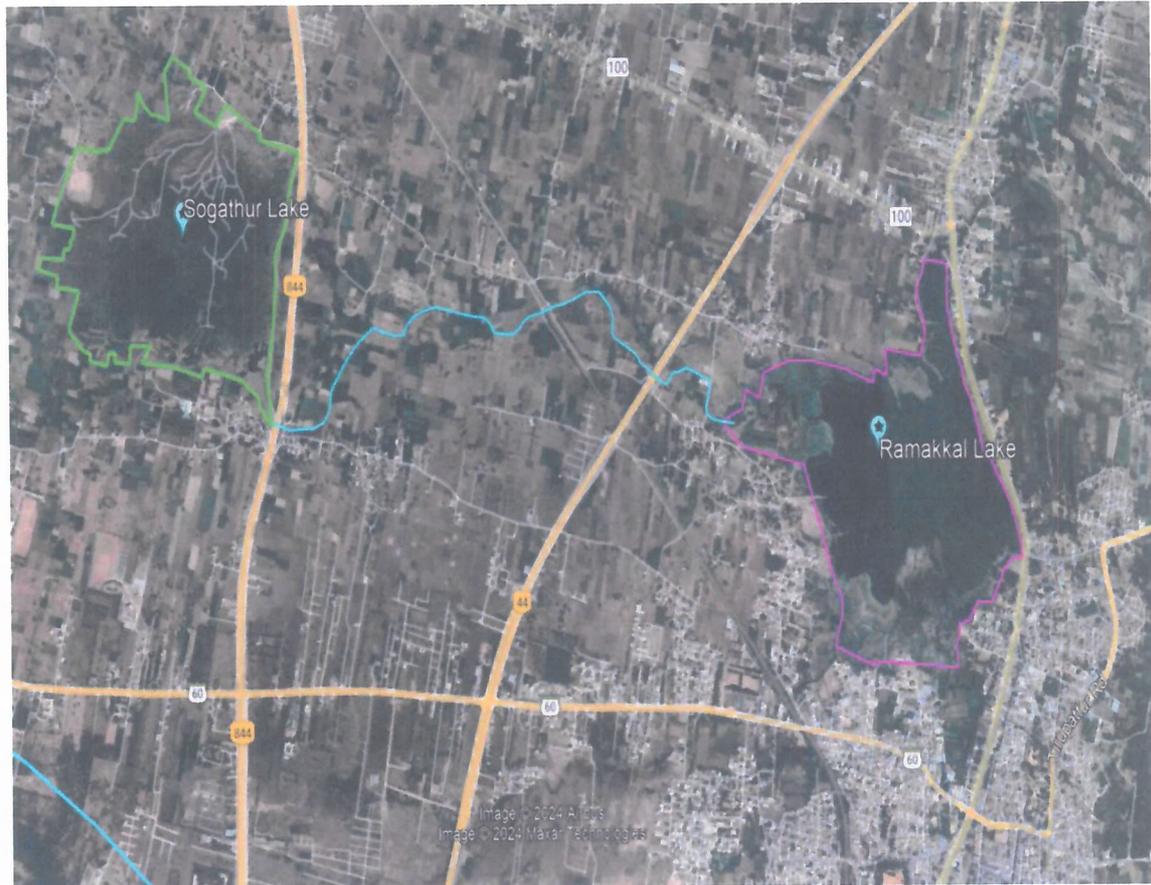
Map no 2 : Showing diagram of Sogathur lake and feeder channel to Ramakkal Lake

The surplus water of Sogathur Lake is the source to Ramakkal Lake and it is the only feeder line to Ramakkal Lake. Ramakkal Lake gets water through this feeder channel during rainy season only. Agricultural activities were carried out nearby feeder channel of Ramakkal Lake occasionally. Also sewage/sullage from nearby habitation A.Reddihalli Village is flowing into the feeder channel of the Ramakkal Lake. Other than this, four drains were also joining the Ramakkal Lake carrying domestic sewage from habitations such as Madhikonpalayam, Vattaravarchi Colony-9th ward, Kumarasampettai of Dharmapuri Municipality and Savulupatti & A.Reddihalli Village of Dharmapuri Panchayat Union. The surplus of Ramakkal Lake flows into the Sanathkumar River, which ultimately joins the River Thenpennaiyaru.

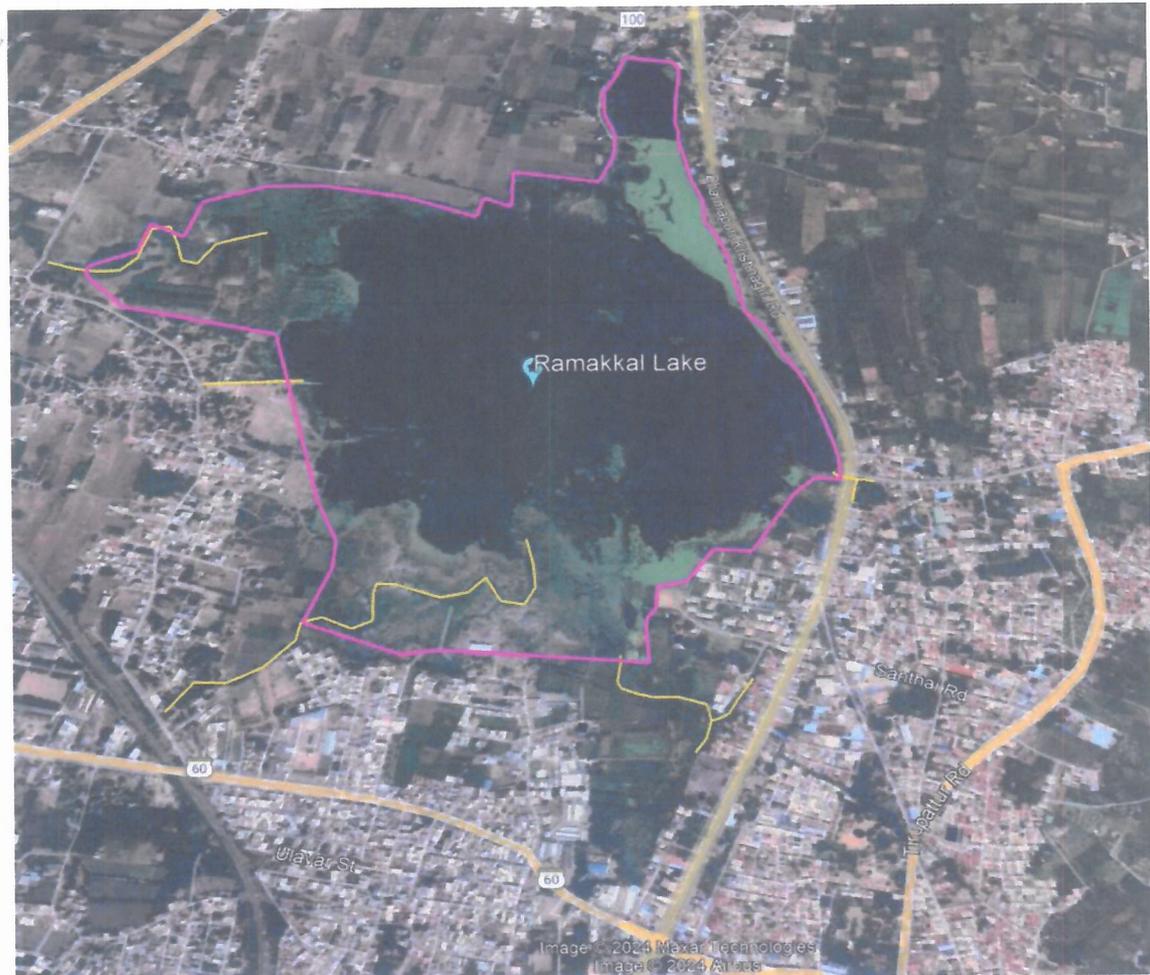
Map no. 3 : Google earth map showing the inflow of drains into Ramakkal Lake

mariamman temple) were found draining into Ramakkal lake through 5 channels which includes the sogathur surplus channel.

- ❖ The physical appearance and odour of drains into Ramakkal lake confirms the presence of domestic sewage.
- ❖ Solid wastes were found dumped on the banks of Ramakkal Lake at the Tirupathur road junction and Harichandran burial ground.

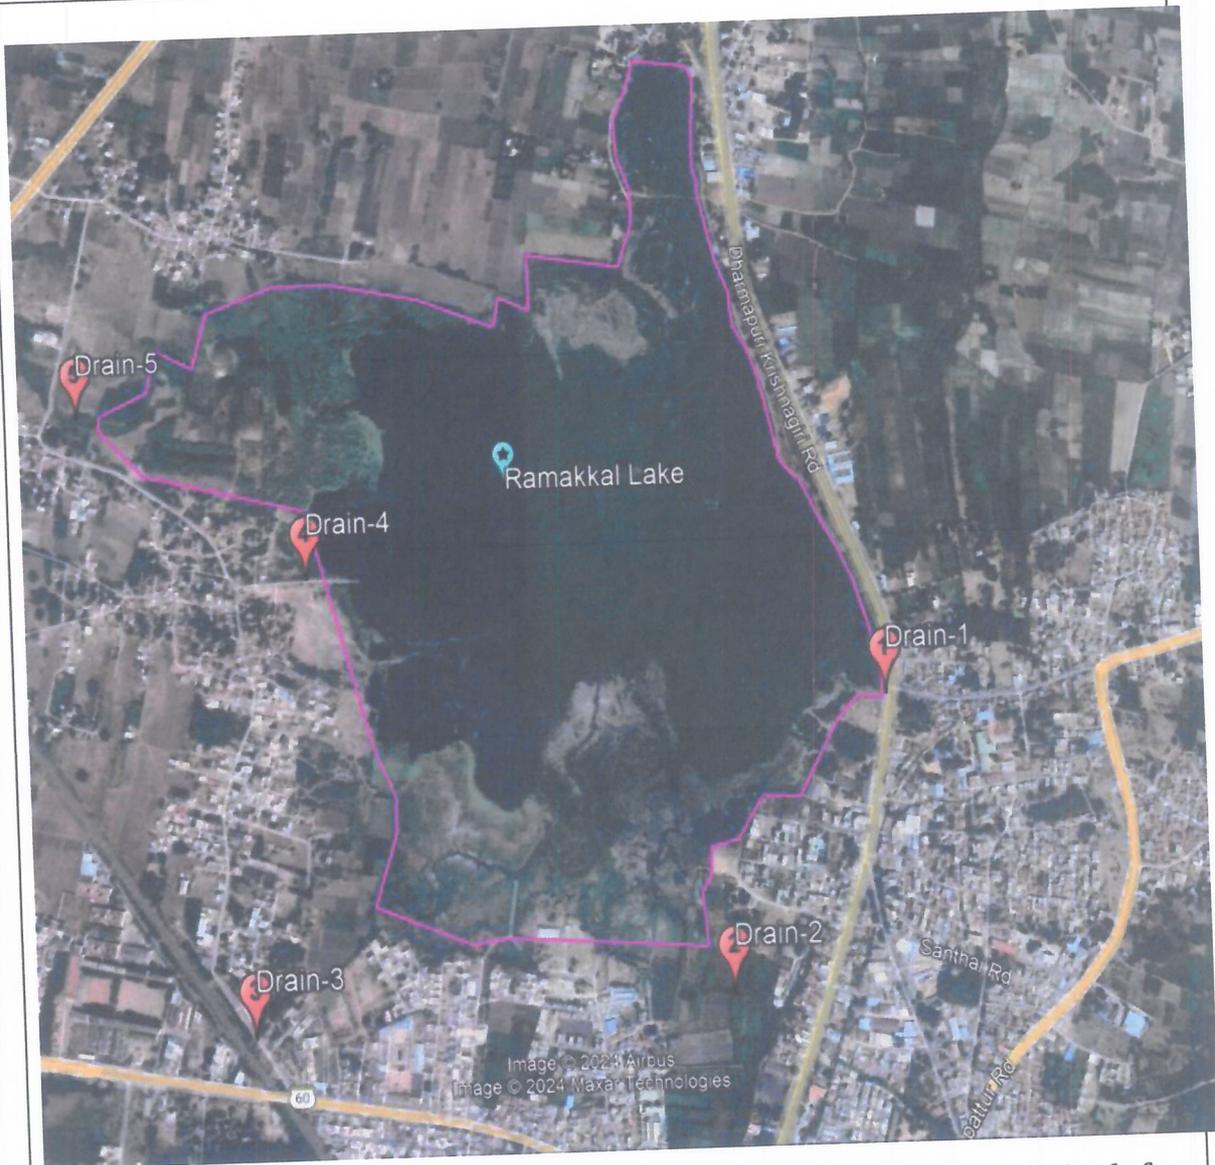
Map no. 4 : Google earth map showing the location of samples taken from drains before confluence into Ramakkal Lake

From the above report of analysis, it is ascertained that the concentration of Total Dissolve Solids (TDS) ranges from 904 - 1924 mg/L, Oil & Grease ranges from 8 - 14 mg/L, BOD ranges from 120 - 280mg/L and COD ranges from 304 - 720 mg/L.

Further, the presence of Total Coliform ranges from 1200 - 4700 MPN/100ml & Fecal Coliform ranges from 680 - 2200 MPN/100ml indicates that the drains carrying domestic sewage and confluences with the Ramakkal Lake.

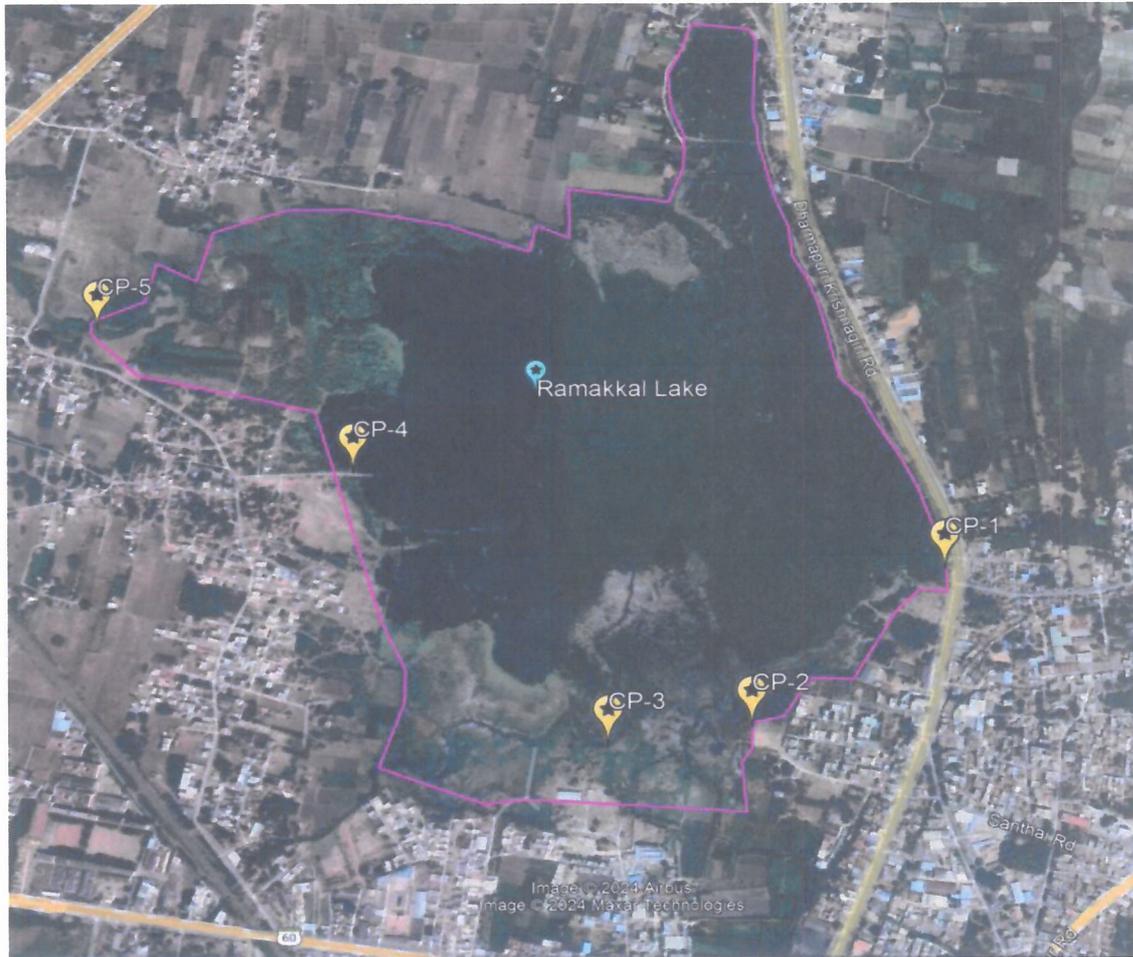
Map no. 6 : Google earth map showing the location of samples taken in the Ramakkal Lake after confluence of drains

The report of analysis of samples taken after confluence of the drain into Ramakkal Lake reveals that the concentration of TDS ranges from 1064 - 1908 mg/L, DO ranges from 4.98- 5.96 mg/L in spite of presence of BOD concentrations of 60 – 96 mg/L due to interference of Algal growth and Eutrophication.

Total Coliform of 32 - 47 MPN/100ml, Fecal Coliform of 11 - 21 MPN/100ml, Free Ammonia of 1.3664 mg/L and BOD concentration more than 30 mg/L confirms the interference of domestic sewage.

The concentration of Boron (<0.002 mg/) and Sodium Absorption Ratio (SAR) (2.47- 4.38 mg/L) are well within the irrigation water quality.

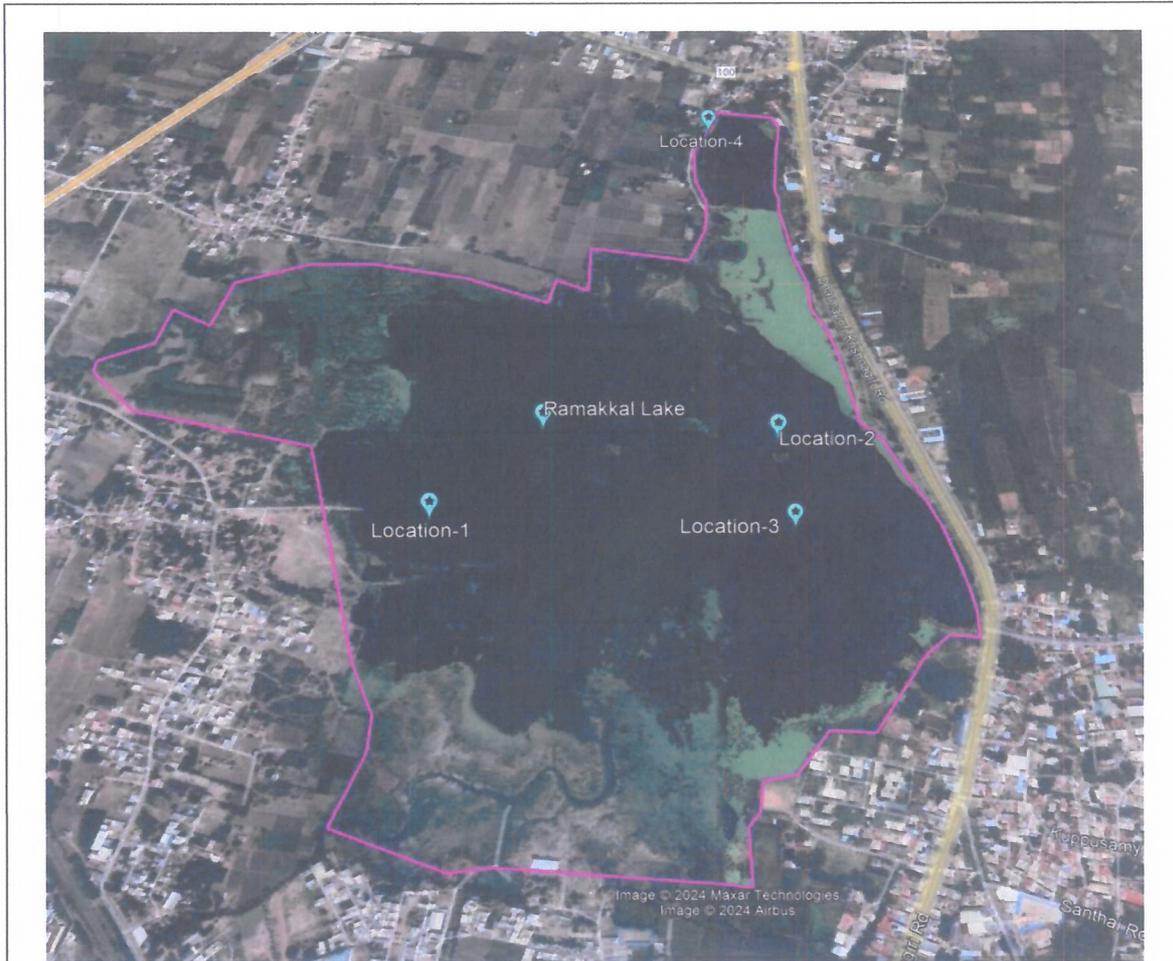
Map no. 5 : Google earth map showing the location of Samples taken in the Ramakkal Lake (Away from the Confluence point)

The report of analysis of samples taken in the Ramakkal Lake (Away from the Confluence point) reveals that the concentration of pH ranges between 8.66-8.83 Numbers, TDS ranges from 1072 -1136 mg/L, DO ranges from 6.28 - 7.10 mg/L in spite presence of BOD concentrations of 40 - 54 mg/L due to interference of Algal growth and Eutrophication

Total Coliform of 20-39 MPN/100ml, Fecal Coliform ranges from 11-20 MPN/100ml and BOD concentration more than 30 mg/L in sample taken from lake (away from the confluence of drain) confirms the interference of domestic sewage causing Eutrophication and not meeting with the designated best use water quality criteria of Class A, B & C.

The concentration of Boron (<0.002 mg/) and Sodium Absorption Ratio (SAR) (4.02- 4.39 mg/L) are well within the irrigation water quality.

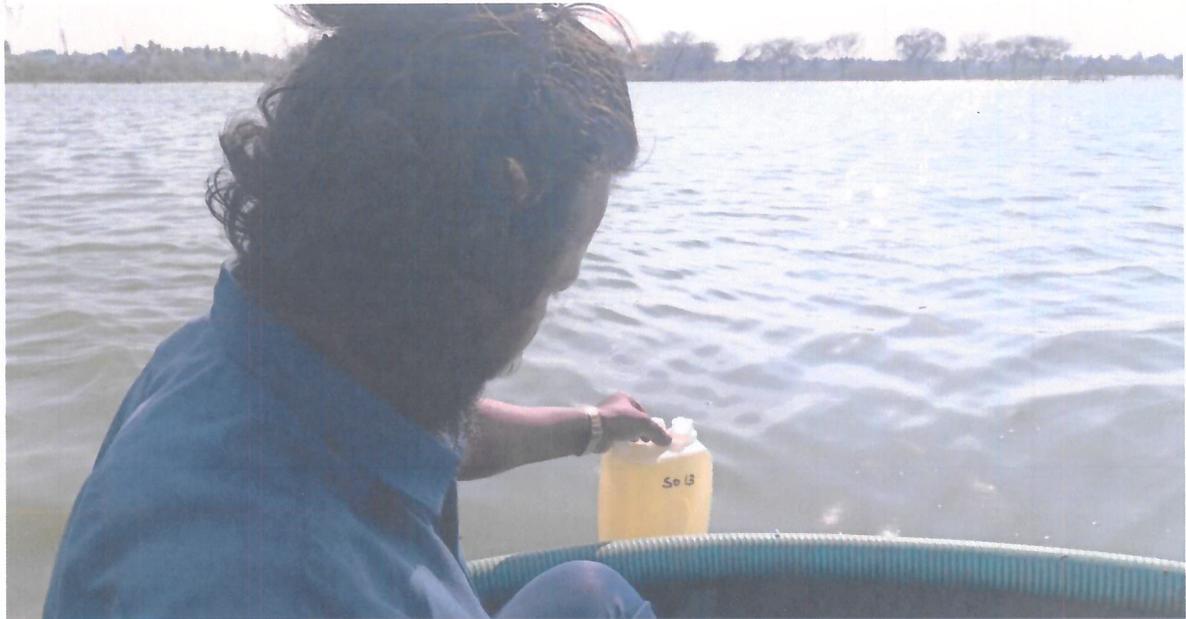
Sample collection inside the Ramakkal Lake

- (vii) As per the analysis reports of samples taken inside the lake, the presence of Total Coliform and Fecal Coliform confirms the discharge of Domestic sewage into Ramakkal Lake. However, the concentration of Boron (<0.002mg/L), Sodium Absorption Ratio (SAR) (4.02-4.39) are found well within the limit of irrigation water quality.

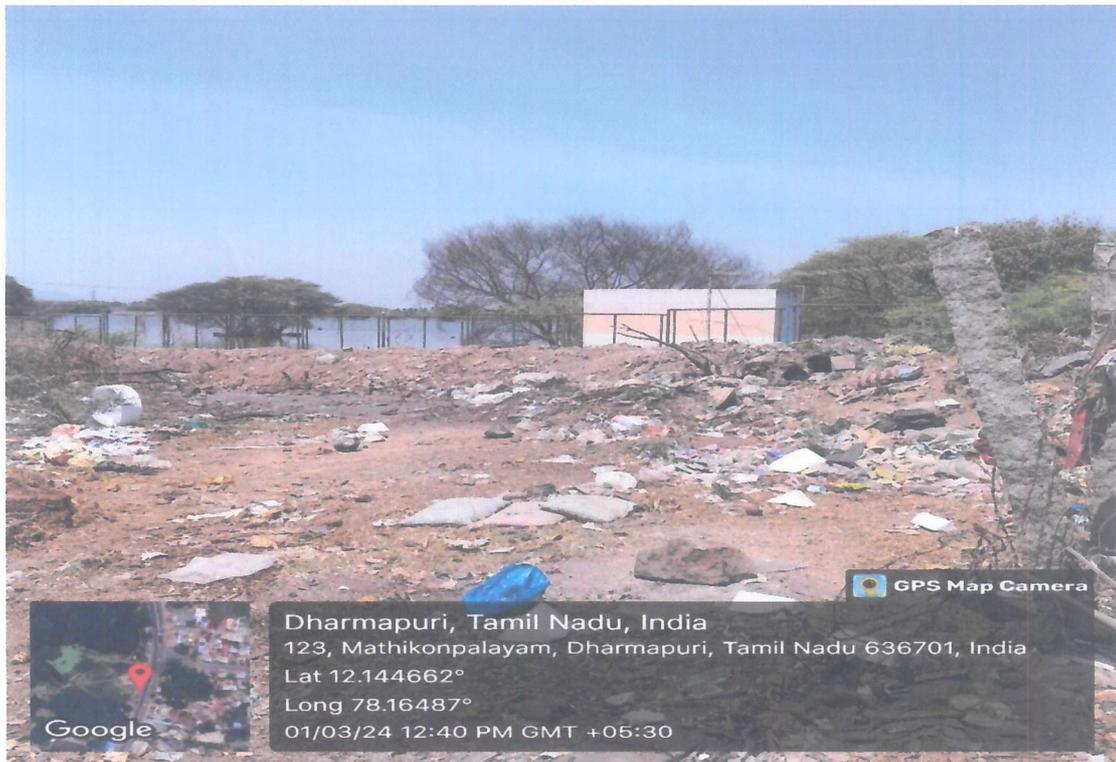
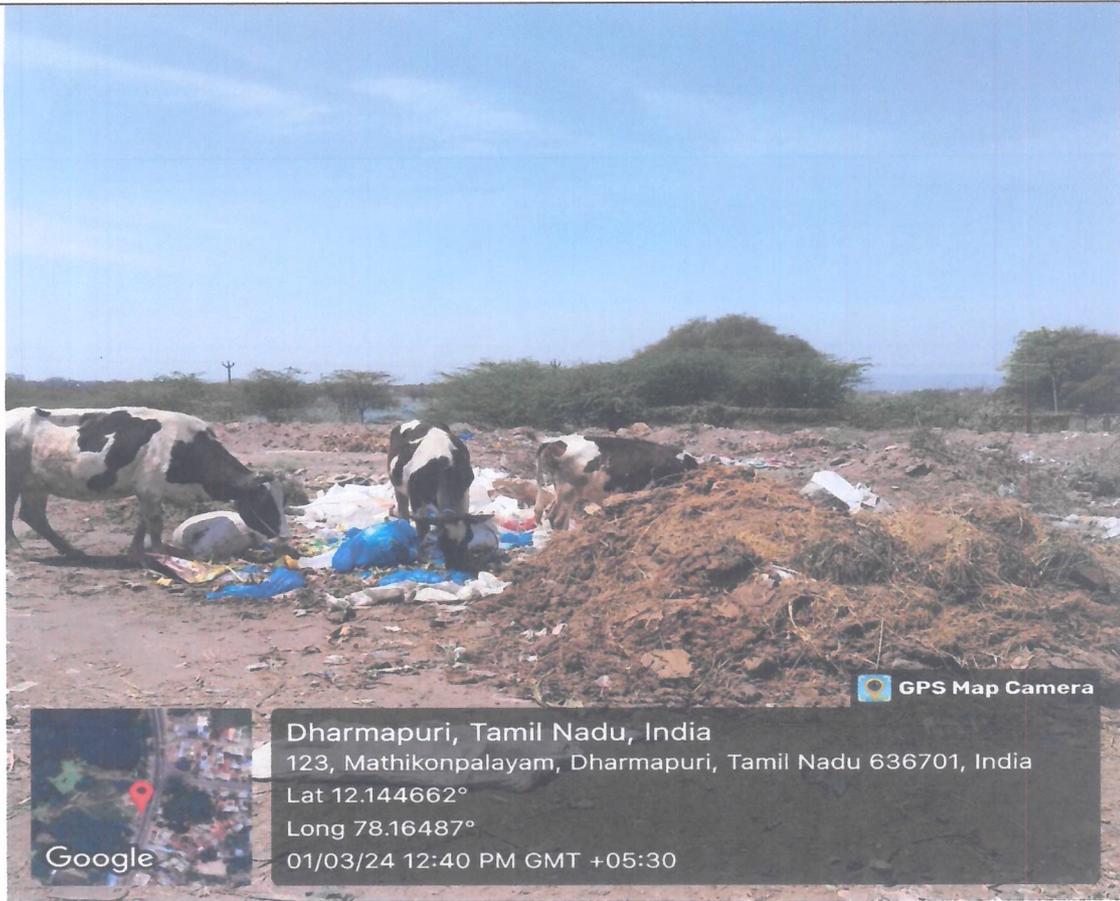
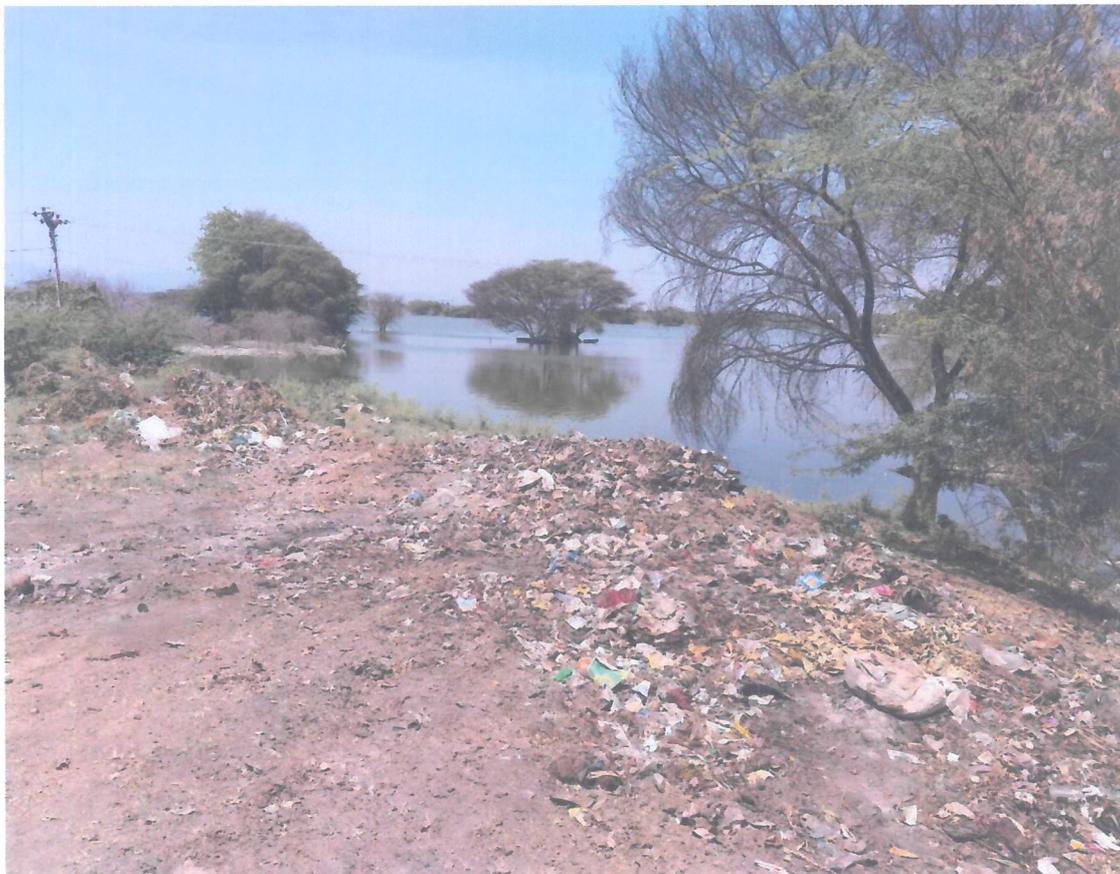
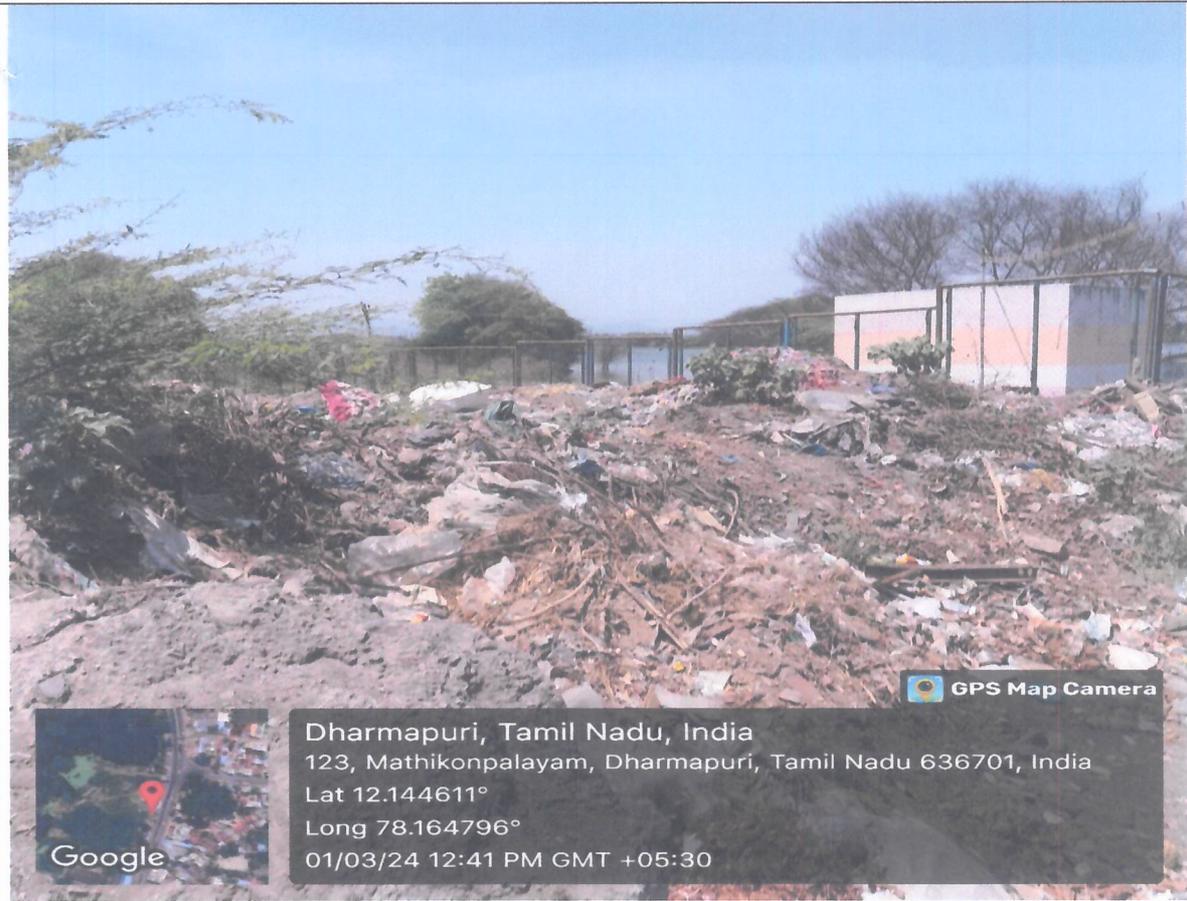
Improper Disposal of Municipal Solid Waste near Ramakkal Lake

- ❖ Improper disposal of Municipal Solid wastes on the banks of the Ramakkal Lake causes odour nuisance.
- ❖ Birds were found in the lake area which indicates the presence of fish in the Ramakkal Lake and the fishing activity is also being carried out in the Ramakkal Lake.

- (v) The solid wastes are disposed in the banks of the Ramakkal Lake at Tirupathur road junction and Harichandran Burial Ground.
- (vi) MCC is located in the bed of Ramakkal lake and solid wastes are disposed in haphazard manner outside the MCC.

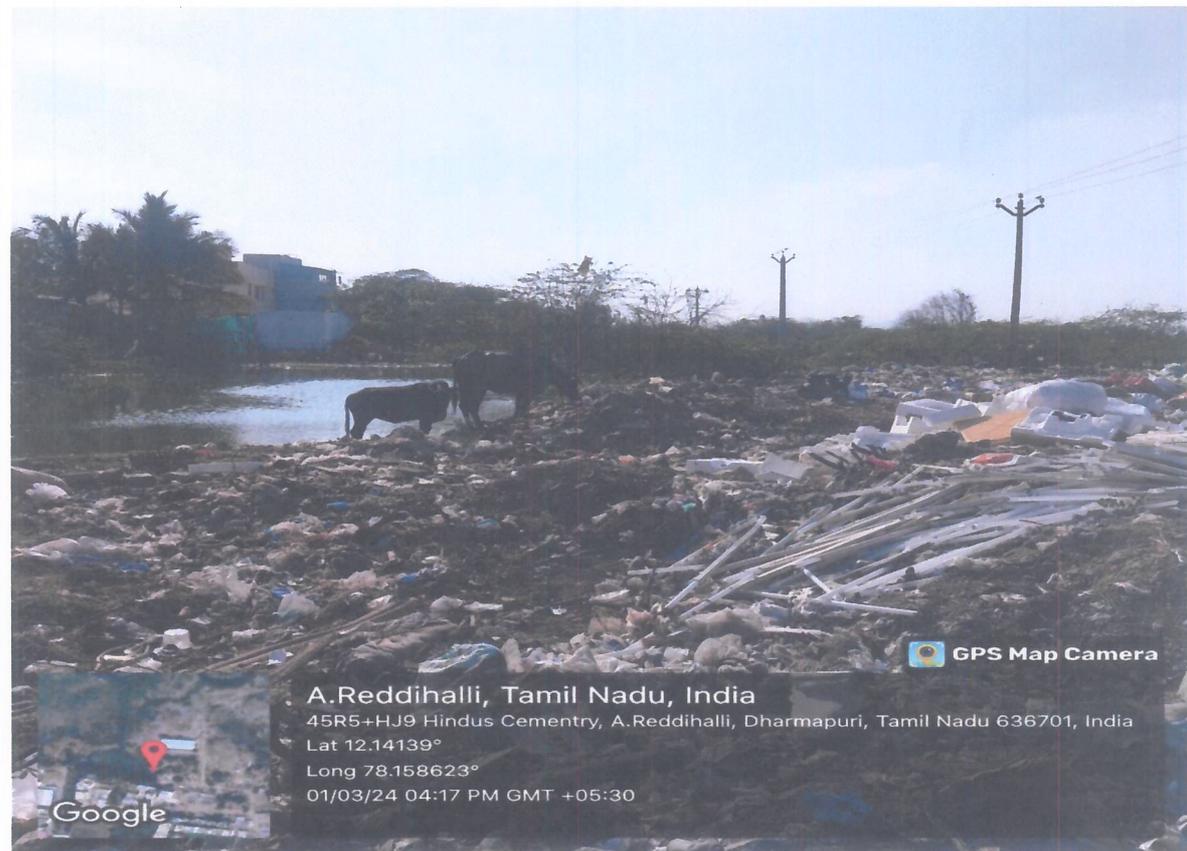
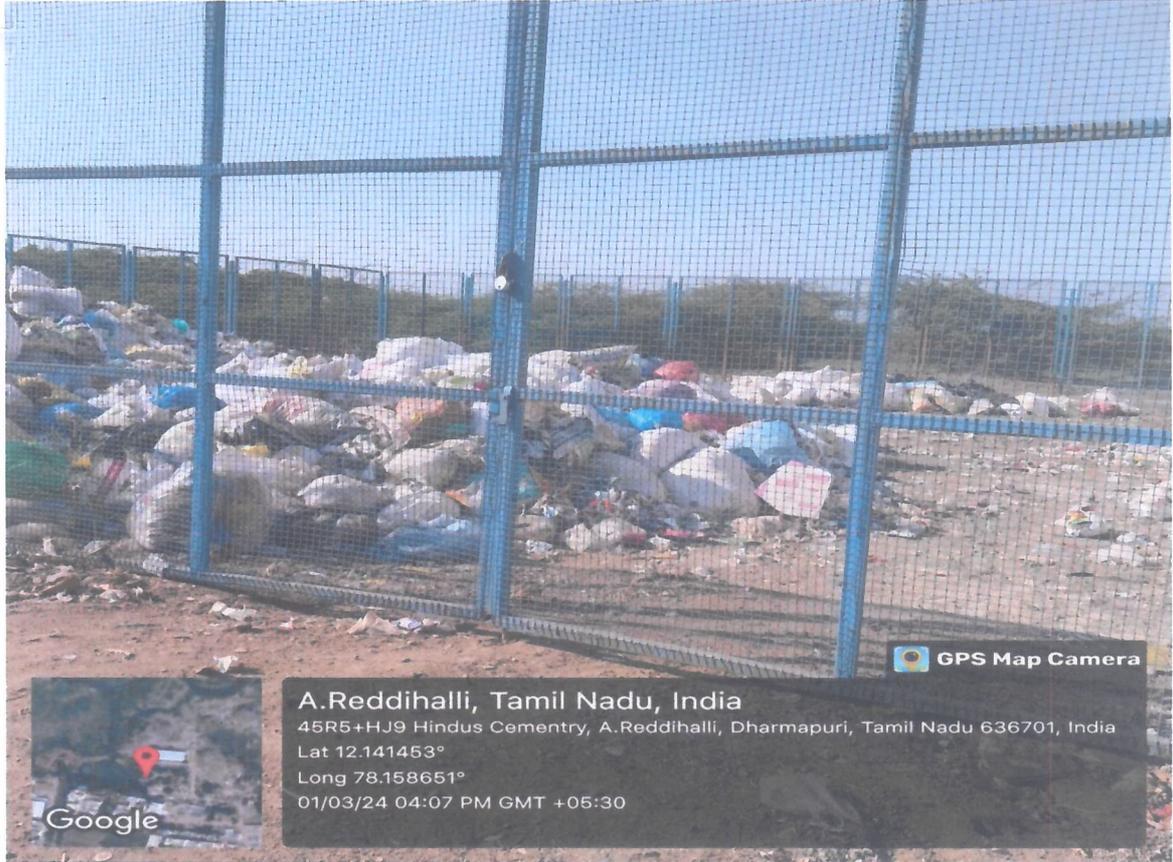
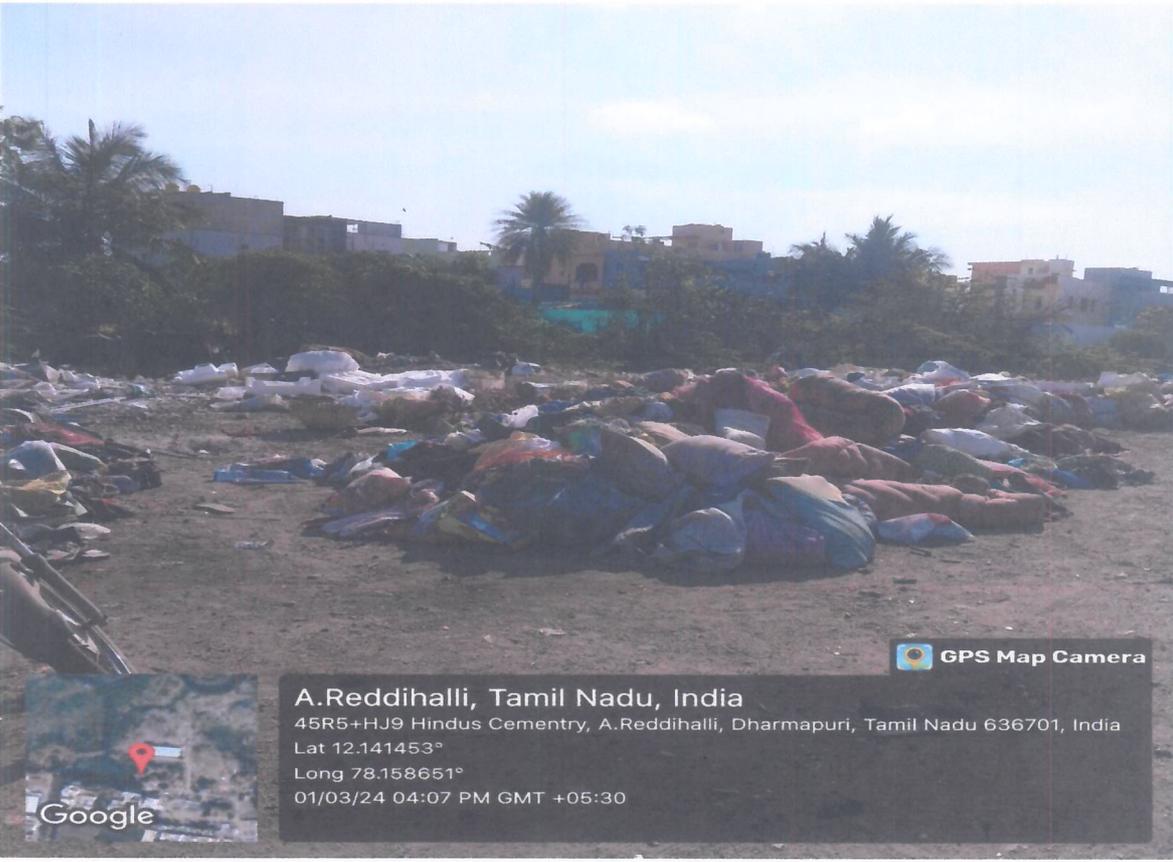
Improper Disposal of Solid Waste near Harichandran MCC in the lake bed

- ❖ There is a Micro Composting Centre functioning in Ramakkal Lake Bed at Harichandran burial ground to manage the Municipal waste from 9 to 16 wards of Dharmapuri Municipality. The dry solid wastes are not properly stored inside the closed shed of Micro Composting Centre and the same was stored/disposed near Lake bed outside the Micro Composting Centre in haphazard manner.

- Municipality Authority may be directed to process the Municipal Solid Waste inside the shed of MCC at Harichandran burial ground and shall not

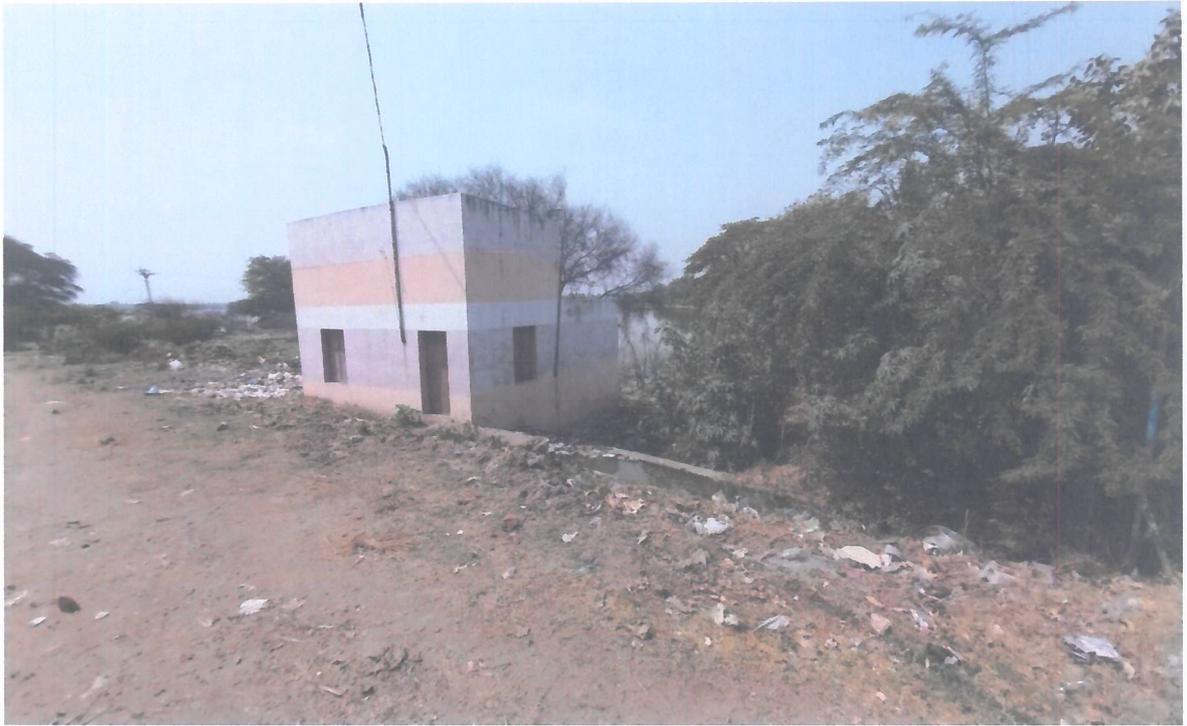
At Tirupathur Road Junction

- ❖ Filter bed structures in the channels at Tirupathur road junction and Harichandran burial ground joining the Ramakkal Lake are not in operable condition and not maintained. The Municipality authorities had informed that there are no records maintained for the same.

Filter Beds constructed across the channel (not in operable condition)
