Inspection Report of the Joint Committee
(As per Hon'ble National Green Tribunal, Southern Zone, Chennai
Order dated 20.02.2020 in O.A. No. 41/2020)

The Committee constituted by the Hon'ble National Green Tribunal has inspected the subject area on 16.02.2021.

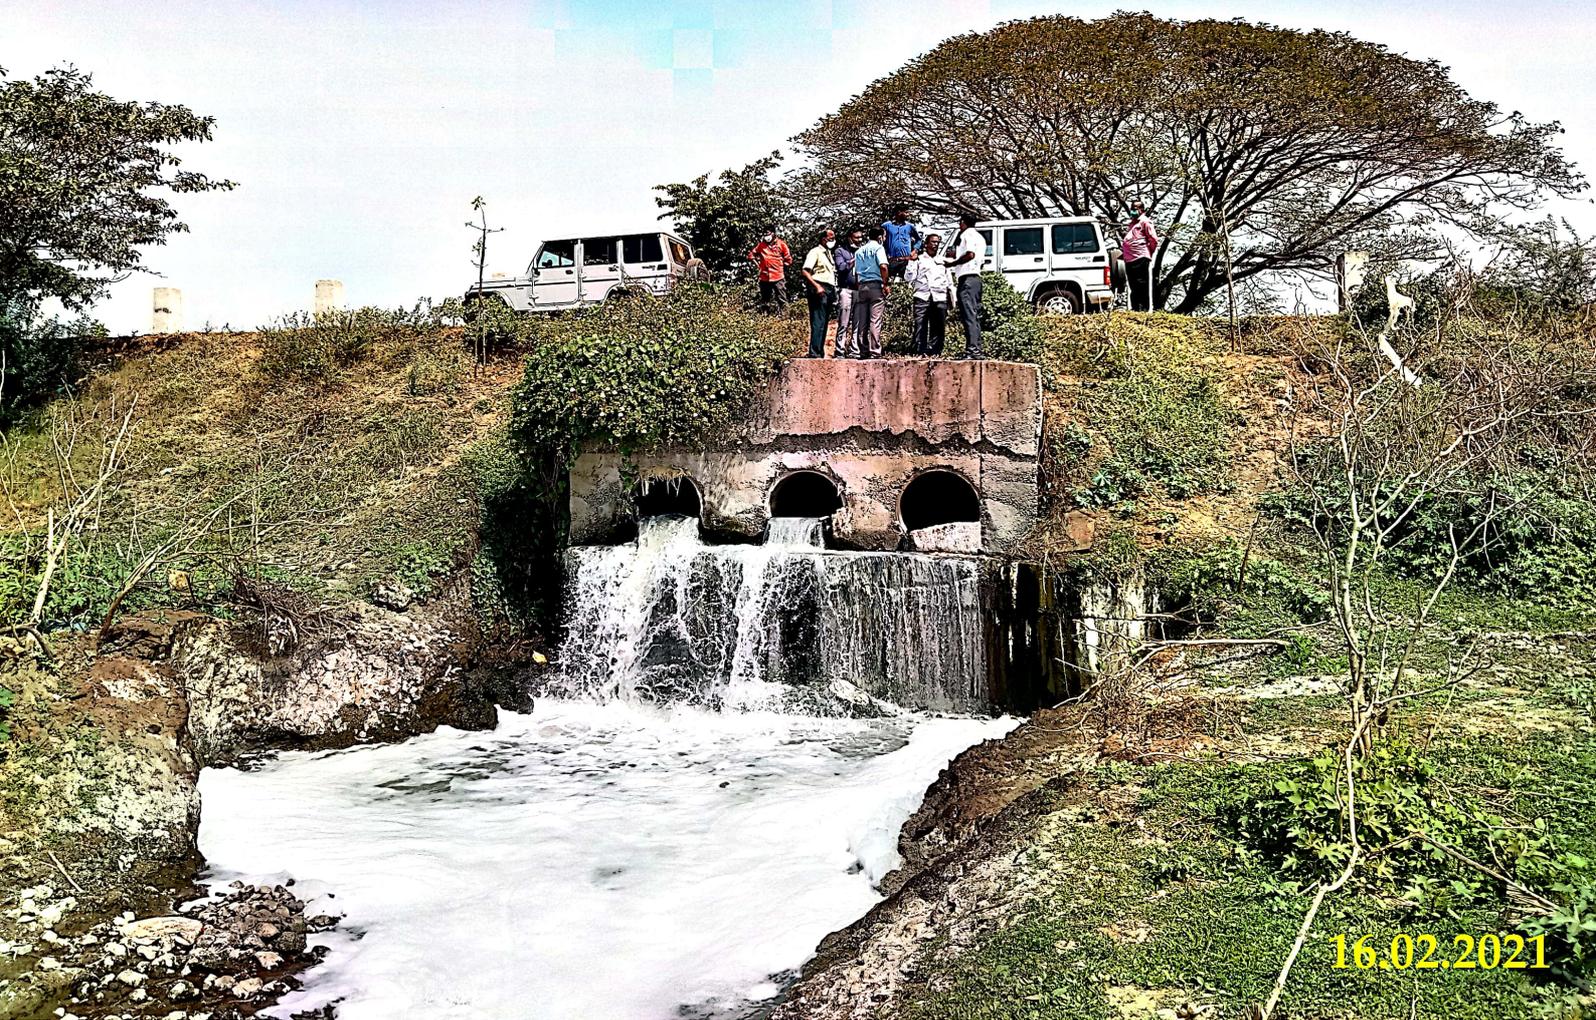
**JOINT INSPECTION FOR NGT CASE OA. NO. 41 OF 2020 IN ADAYAR RIVER
@ CONFLUNENCE POINT OF MANAPAKKAM CHANNEL**

The Manapakkam channel, which originates from sluice No.5 of Chembarampakkam Tank in Kundrathur taluk of Kancheepuram District, collects the flood surplus of the adjoining areas and discharge into Adayar River near Manapakkam village. The channel confluence into the left bank of Adayar river behind the Chennai Airport. The channel passes through thickly urbanised areas like Manapakkam, Kolapakkam and Madananthapuram. It is observed that the channel discharge the water with heavy foam formation into the Adayar river. Tamil Nadu Pollution control Board was requested to take the samples to verify whether if any hazardous chemicals present in the water due to any unauthorised industrial waste water discharge. Further, during the inspection the Manappakam channel at Manapakkam village, a private construction company let the muddy water into the channel during its construction activity. The Assistant Engineer, PWD and Tamil Nadu Pollution control Board were instructed to give notice to the construction company to stop

the muddy water immediately and take necessary legal action. It is necessary to provide adequate drainage system in the above municipal areas and underground sewage system.

SHORT TERM PLAN				
S.No.		DESCRIPTION OF WORK	DEPARTMENT	TIME SCHEDULE
1	i)	Plugging the sewage/sullage water being let into the Manapakkam channel.	Executive Engineer, Greater Chennai Corporation & Executive Engineer, CMWSSB.	3 months
	ii)	Plugging the sewage/sullage water being let into the Manickam Odai.	The Commissioner, Pammal Town Municipality & Chief Executive Officer, Cantontment Board, St.Thomas Mount Cum Pallavaram.	3 months
	iii)	Plugging the sewage/sullage water being let into the Karaima Nagar Odai.	The Commissioner, Kundrathur Town Municipality.	3 months
	iv)	Plugging the sewage/sullage water being let into the Nattu Kalvoi.	The Commissioner, Thiruneermalai Town Municipality.	3 months
2		Appropriate action on the polluting industries and impose environmental compensation.	District Environmental Engineer, TNPCB, Maraimalai Nagar and Sriperumpudur.	2 months

LONG TERM PLAN			
1	i)	Providing necessary drainage/Underground sewage System for Manapakkam, Kolapakkam, Madananthapuram areas.	The Commissioner, Pammal Town Municipality & Chief Executive Officer, Cantontment Board, St.Thomas Mount Cum Pallavaram. 2 YEARS
	ii)	Providing necessary drainage/Underground sewage System for Pallavaram and Pammal areas.	The Commissioner, Pammal Town Municipality & Chief Executive Officer, Cantontment Board, St.Thomas Mount Cum Pallavaram. 2 YEARS
	iii)	Providing necessary drainage/Underground sewage System for Kundrathur and Irandaam Kattalai areas. Necessary Effluent treatment Plant should be established.	The Commissioner, Kundrathur Town Municipality 2 YEARS
	iv)	Providing necessary drainage/Underground sewage System for Thiruneermalai areas. Necessary Effluent treatment Plant should be established.	The Commissioner, Thiruneermalai Town Municipality 2 YEARS

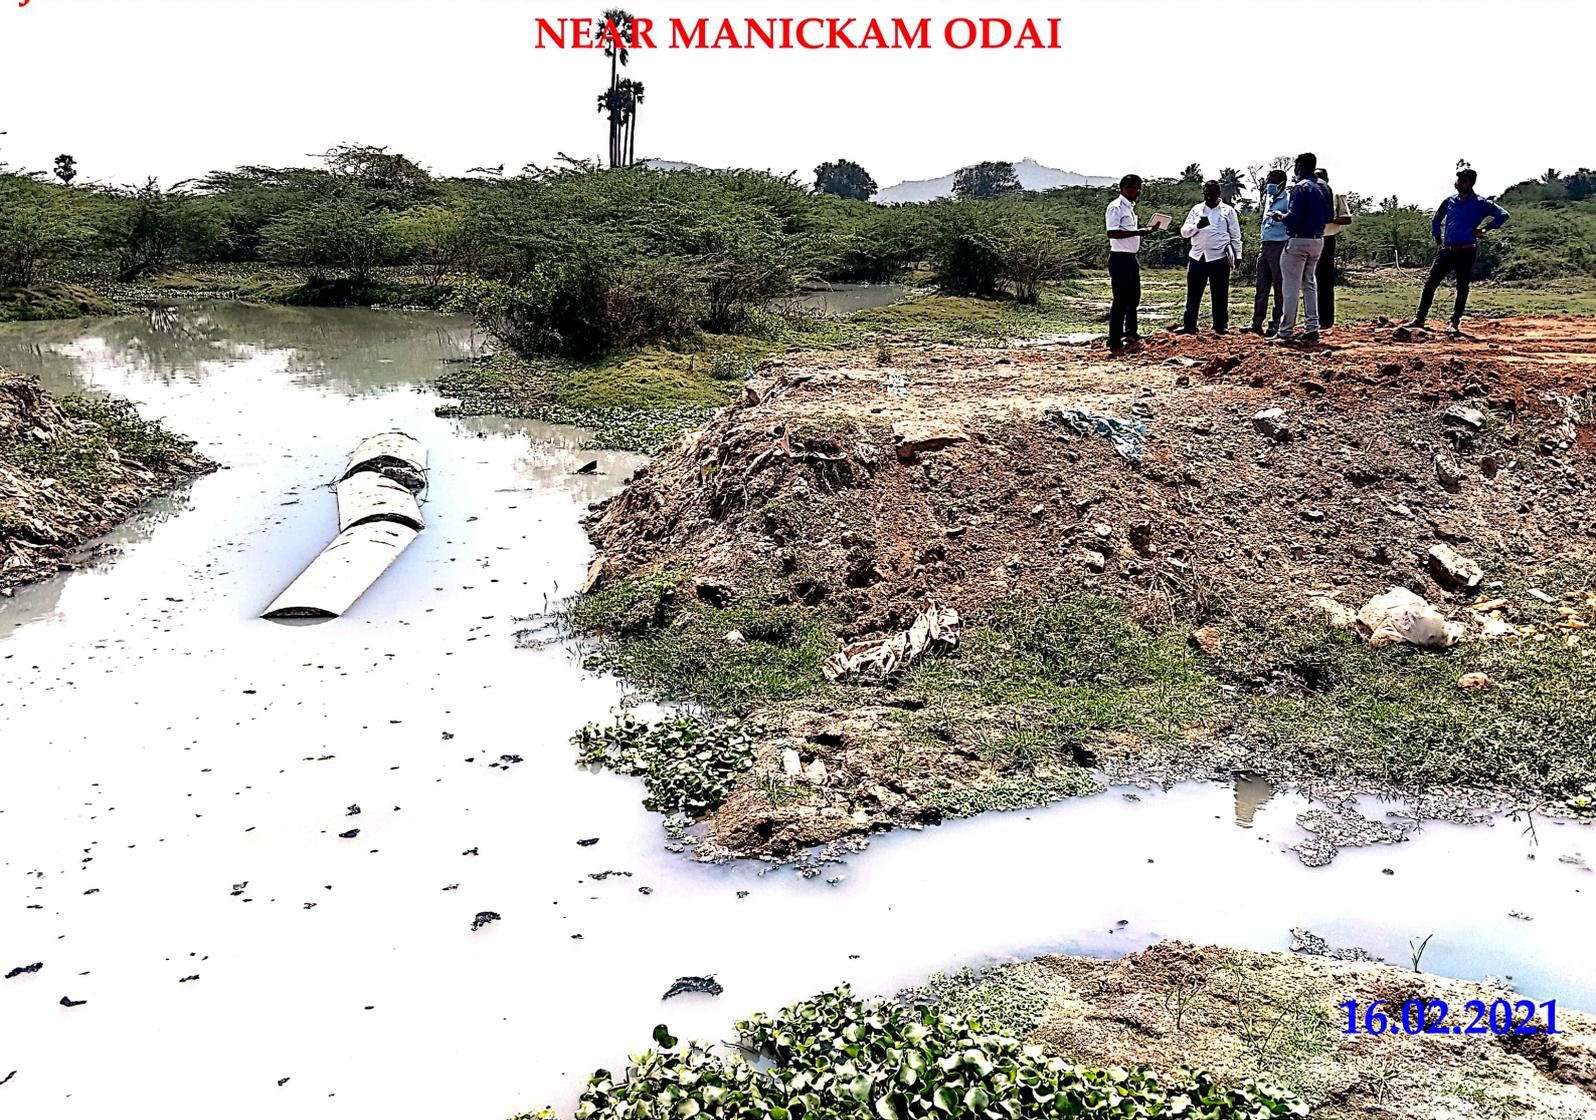
**JOINT INSPECTION FOR NGT CASE OA. NO. 41 OF 2020 IN ADAYAR RIVER
NEAR MANICKAM ODAI**

It is observed that, the sewage / sullage water and effluents from the nearby residents and small scale industries in the Pallavaram and Pammal municipality limits are being let into the Manickam Odai and confluence into Adayar river near Meenambakkam Airport compound wall in Cowl Bazaar. The water in the confluence point of Manickam Odai found contaminated and the Tamil Nadu Pollution control Board, Maraimalai Nagar was requested to take the samples for further investigation. It is necessary to provide adequate drainage system in the above municipal areas and underground sewage system.

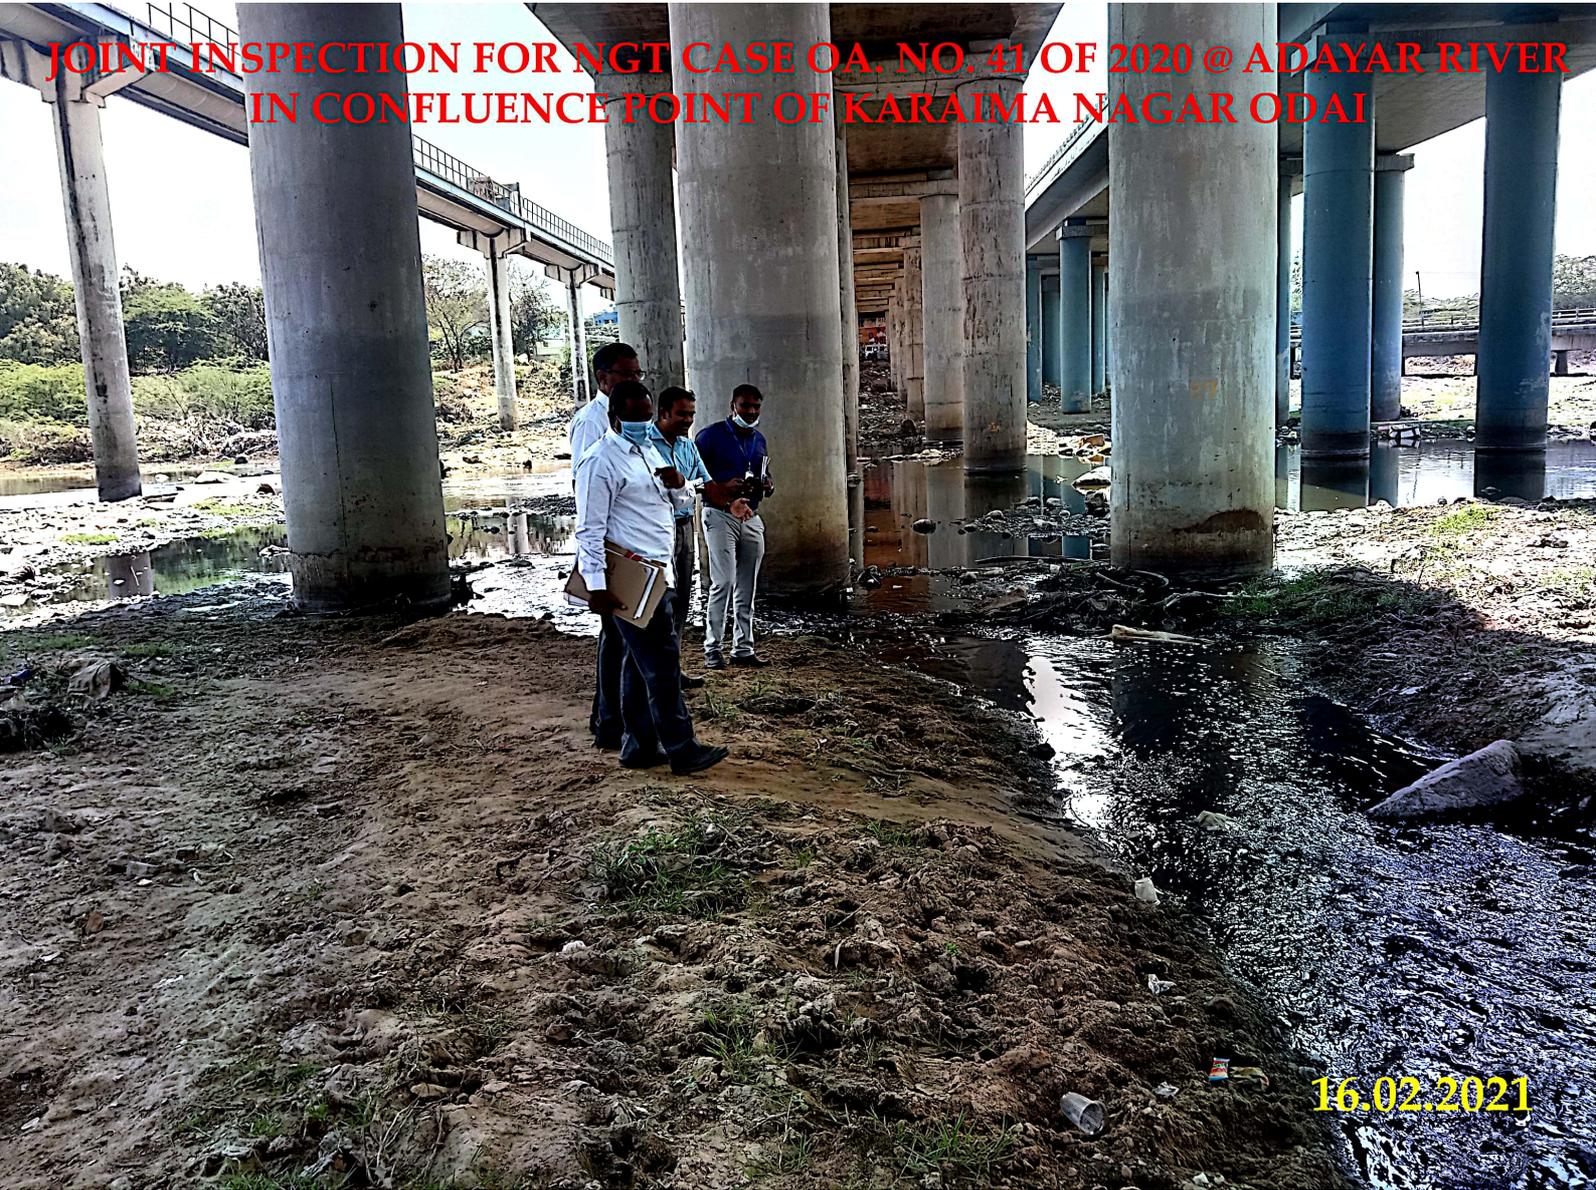
**JOINT INSPECTION FOR NGT CASE OA. NO. 41 OF 2020 @ ADAYAR RIVER
IN CONFLUENCE POINT OF KARAIMA NAGAR ODAI**

It is observed that, the sewage / sullage water and effluents from the nearby residents and small scale industries in the Kundrathur Village Town Panchayat limits are being let into the Karima Nagar odai and confluence into Adayar river near Irandaam Kattalai Village. During the inspection, the raw textile waste water from the Perla Textiles processor industry was being let into the Karima Nagar odai and the committee immediately stopped the waste water. The committee instructed the Tamil Nadu Pollution control Board, Sriperumbudur to take appropriate action on the industry and impose environmental compensation. The water in the confluence point of Karima Nagar Odai found contaminated and the Tamil Nadu Pollution control Board officials requested to take the samples for further investigation. It is necessary to provide adequate drainage system/ Effluent Treatment Plant in the above municipal areas and underground sewage system.

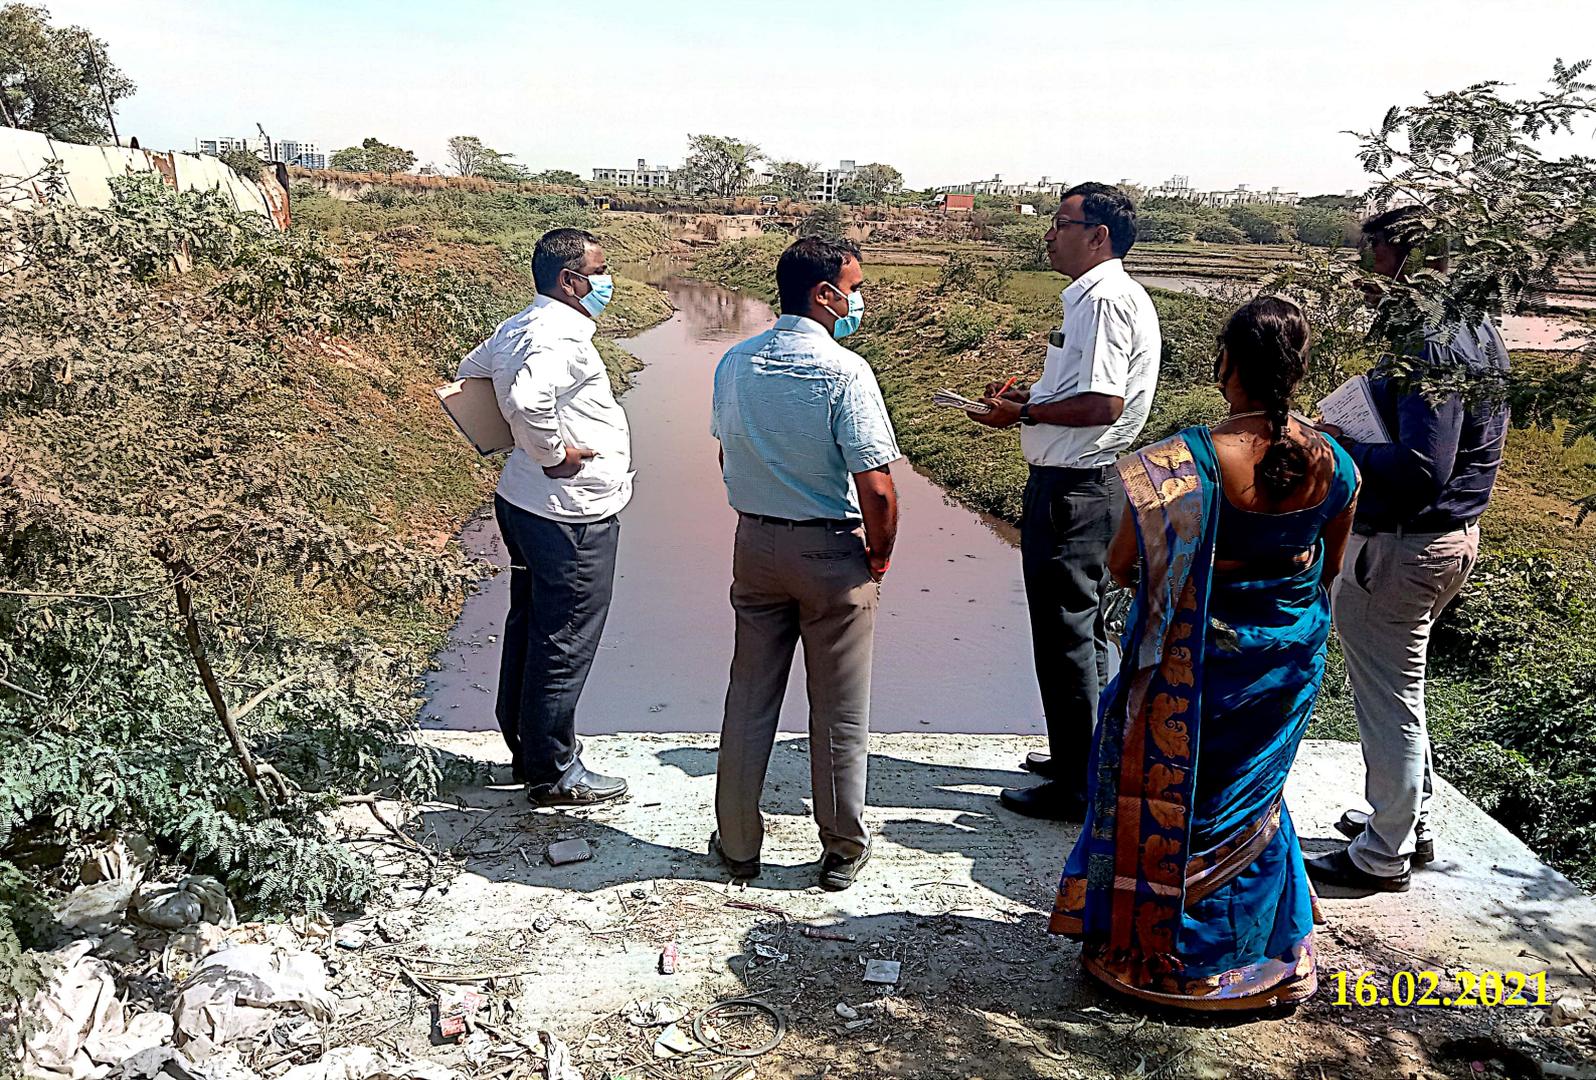
**JOINT INSPECTION FOR NGT CASE OA.NO.41 OF 2020 NEAR
NATTU KALVOY IN THIRUNEERMALAI VILLAGE**

It is observed that, the sewage / sullage water and effluents from the nearby residents and small scale industries in the Thiruneermalai Village Town Panchayat limits are being let into the Nattu Kalvoi and confluence into Adayar River near Sankar Nagar in Pammal Village. During the inspection, Tamil Nadu Pollution control Board stated that effluent generated from the leather industries in and around Naagalkeni village is being treated in the Common Effluent Treatment Plant and after treatment let into the Nattu Kalvoi. The committee instructed Tamil Nadu Pollution control Board, Maraimalai Nagar to take water samples and report whether treated effluent meets the standard. It is necessary to provide adequate

drainage system/ Effluent Treatment Plant in the above municipal areas and underground sewage system.
