**ORIGINAL APPLICATION No. 04 of 2013(SZ)**

**PAPERBOOK - I**

## **SHORELINE MANAGEMENT PLAN**

**NATIONAL INSTITUTE OF OCEAN TECHNOLOGY**

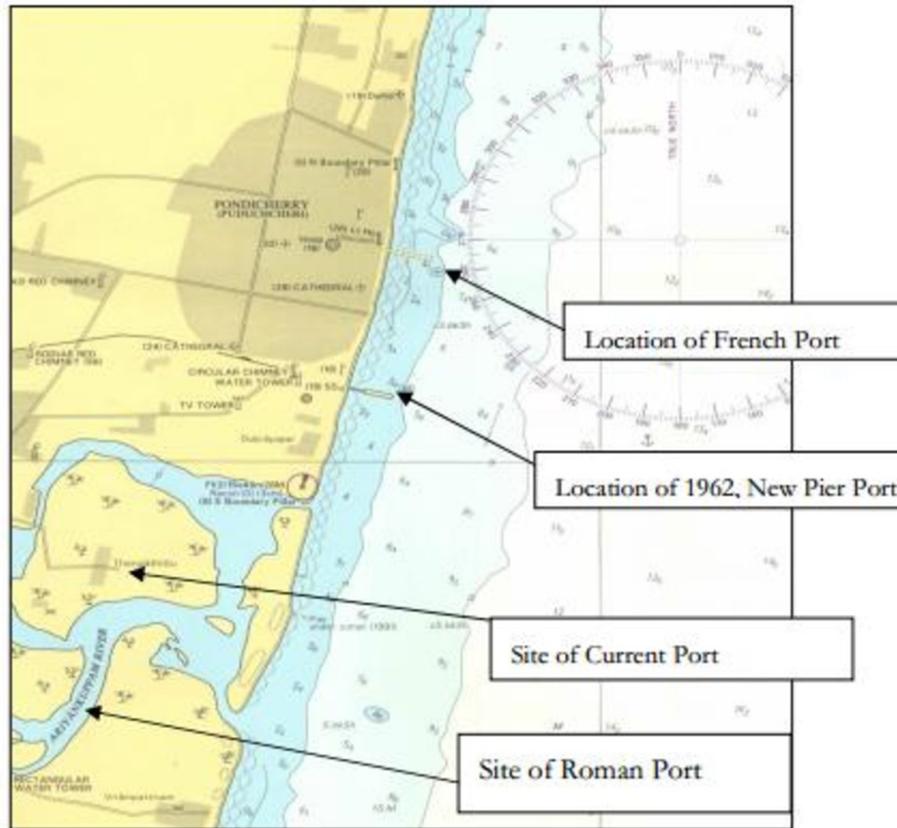
Figure 2. Locations of the past and present port

There is evidence of an ancient port town situated on the bank of Ariyankuppam river about 8km south of Pondicherry township. This port town has a history that dates back to the second century BC. An excavated ancient port town, Arikamedu had strong trade links with Rome and Greece between 100 BC and 100 AD.

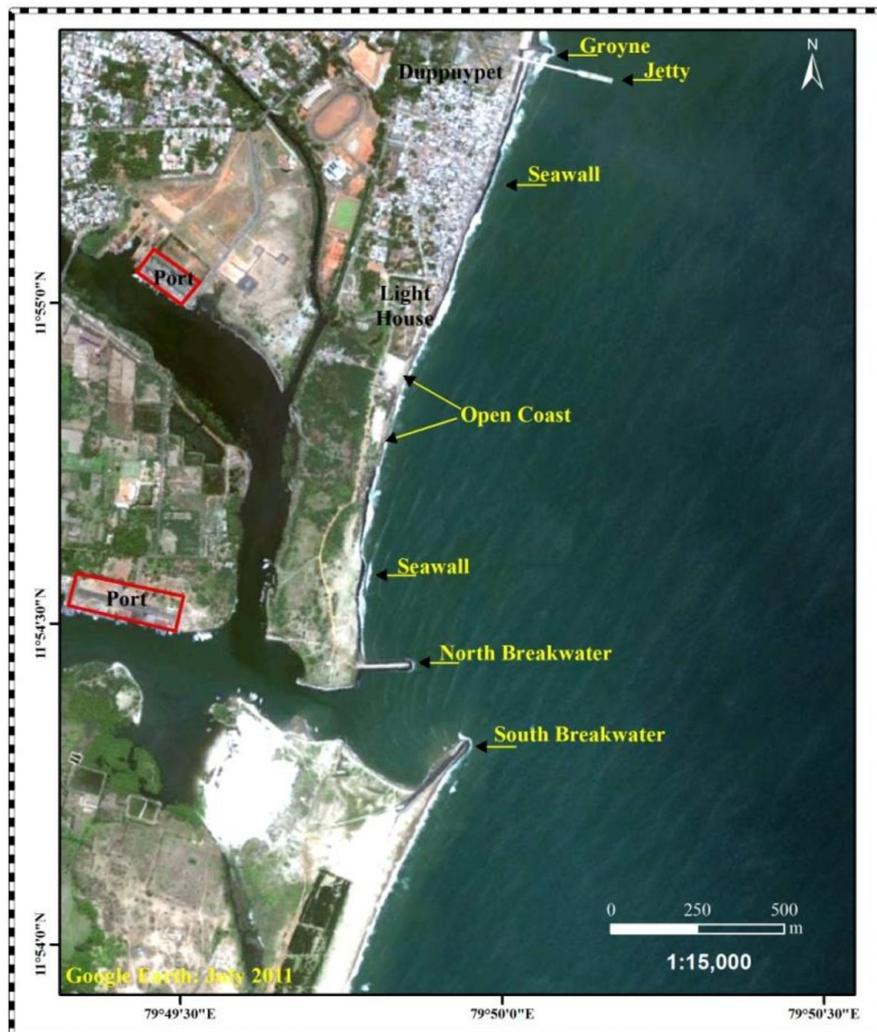
Figure 3. The Location of existing Pondicherry Port.

The current port was built south of the New Pier in the late 1980's. The shoreline is tilted approximately  $20^{\circ}$  from the North. The breakwaters of north and south are 150 m and 280 m respectively and the tip of south breakwater was originally located at a water depth of 4 m (Figure 3) but because of siltation it is presently at a depth of about 1 m. These breakwaters were constructed with the provision of a sand bypassing system with a capacity of about  $400,000 \text{ m}^3/\text{year}$ . However, the sand bypassing system has not been sufficiently or appropriately utilized. Because of this, deposition occurred on the south side of the breakwater and erosion on the north side of the northern breakwater. For protecting the shoreline against erosion, the Pondicherry/Tamil Nadu government has built riprap using boulders weighing 0.5 to 1.5 tonnes for a total length of about 8.55 km. In many places in this region, the seabed below the riprap was eroded due to severe wave action around ground subsidence.

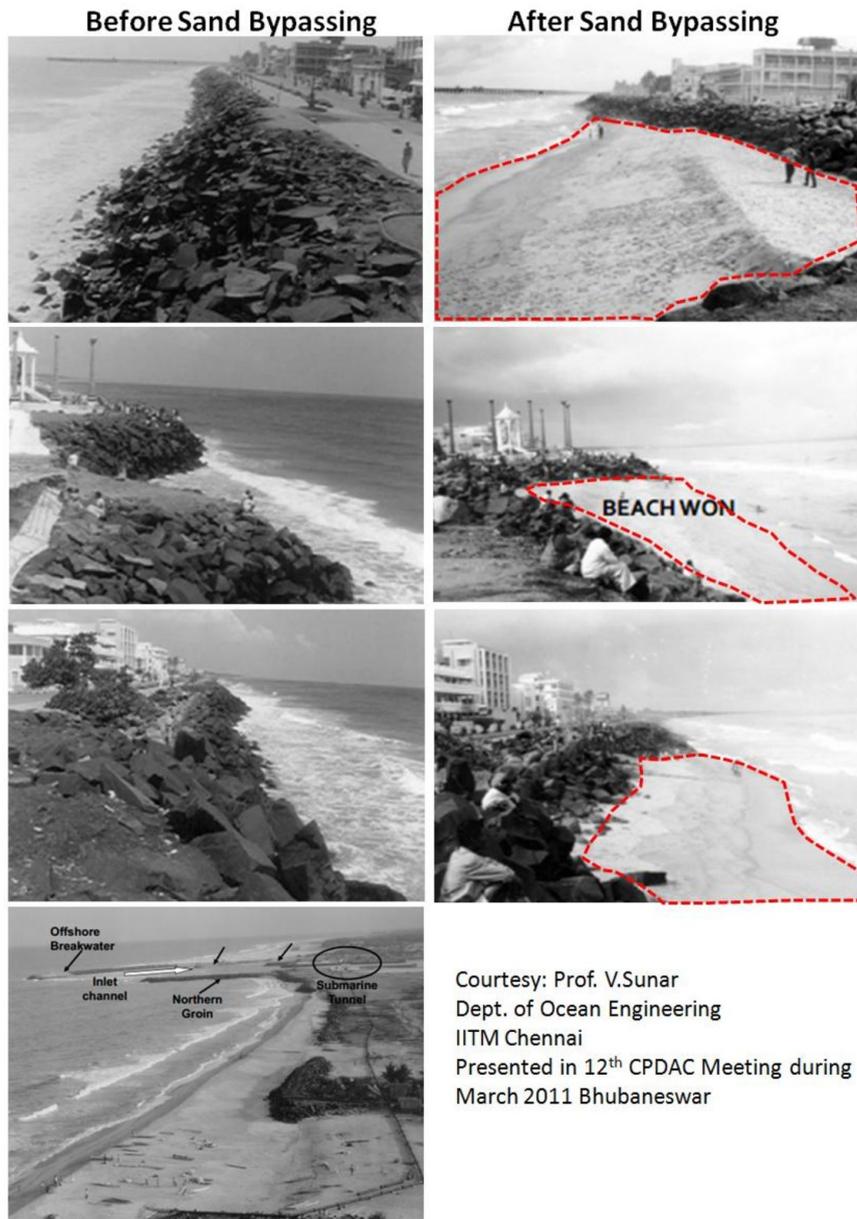
Courtesy: Prof. V.Sunar  
 Dept. of Ocean Engineering  
 IITM Chennai  
 Presented in 12<sup>th</sup> CPDAC Meeting during  
 March 2011 Bhubaneswar

The erosion and accretion estimated by Sundar et al., from 1986 to 2002 using satellite data revealed that the rate of erosion is about 4 m/yr on the northern side of port and the accretion at south of the port is 6 m/yr. The extent of erosion in the North of Northern breakwater is 31 hectares and 33 hectares of beach sand accreted with in 1.5 km on the South of the Southern breakwaters. Artificial beach nourishment which was carried out during 2002 – 2003 with the sand dredged from the Pondicherry harbour, helped in building of a beach (Figure 4).

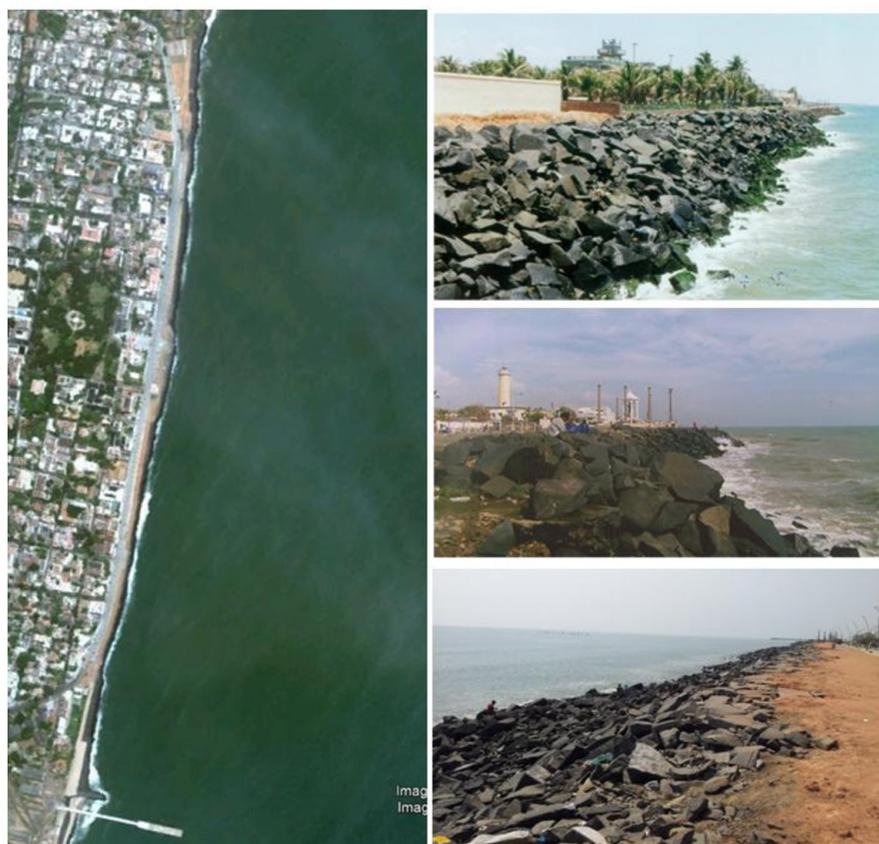
Figure 5. Constructed seawall along the Pondicherry coast

After the discontinuation of sand bypassing, the Pondicherry coast was subjected to erosion. A seawall of 6km long was built along the Pondicherry town by the Pondicherry Government during 2002 – 2003, with a estimated cost of 40 Cr resulting in the erosion of the northern coast. To protect the coast from erosion, Tamil Nadu PWD initiated protection measures by constructing a seawall of 500m length in Nadukuppam during 2003 - 2004 and 920 m in Sothanaikuppam during 2005 - 2006. These efforts continued up to Kottakuppam 820 m in 2006 - 2007 and also at Chinnamudalaiyar Chavadi. The seawall protected the coast under threat, but the foreshore became steep and the natural beaches eroded (Figure 5).

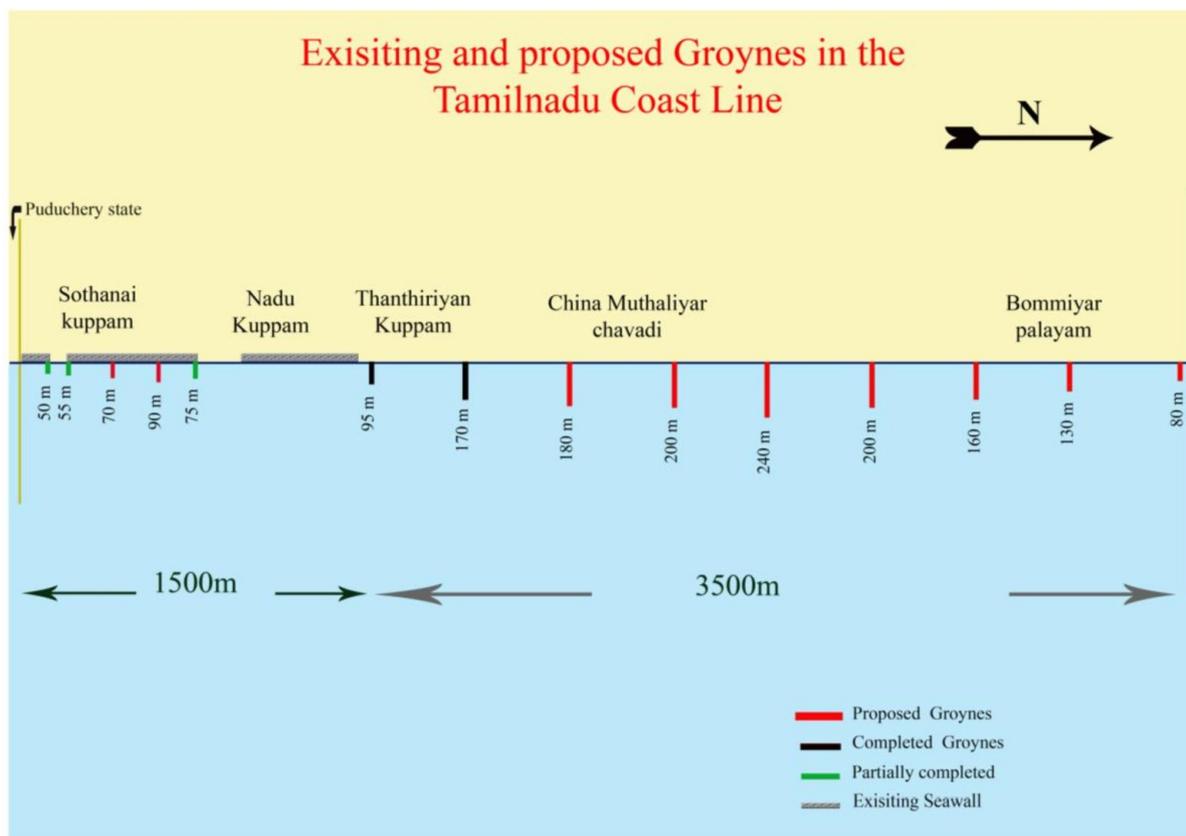
Figure 6. Existing and proposed coastal structures along the Tamil Nadu coast (Source: PWD, Tamil Nadu)

Groin construction was attempted by both the governments when the demand for a sandy beach by the fishermen intensified. This was initiated in Sothanaikuppam village with two groins (south 50m and north 55m during 2005) and which showed a moderate beach build up. Later, two more groins were constructed at Kottakuppam village with 40m length on south (during 2005) and 70m length on north. These groins trapped the sand and beach width of about 30m was formed. In 2007, two groins were built on either side of the Thanthiriyankuppam village with the length of 95m and 170m, the tip of the northern groin (170m) extended upto a depth of about 4m at time of construction. After the groin construction, the wide beach which existed on the northern side before groin construction was lost, and buildings were under threat. Further 320m of length of seawall was built by PWD, Tamil Nadu during the year 2008 - 2010 and there is a proposal to build a series of seven more groins from Chinnamudalaiyar Chavadi to Bommiyarpalayam (Figure 6).

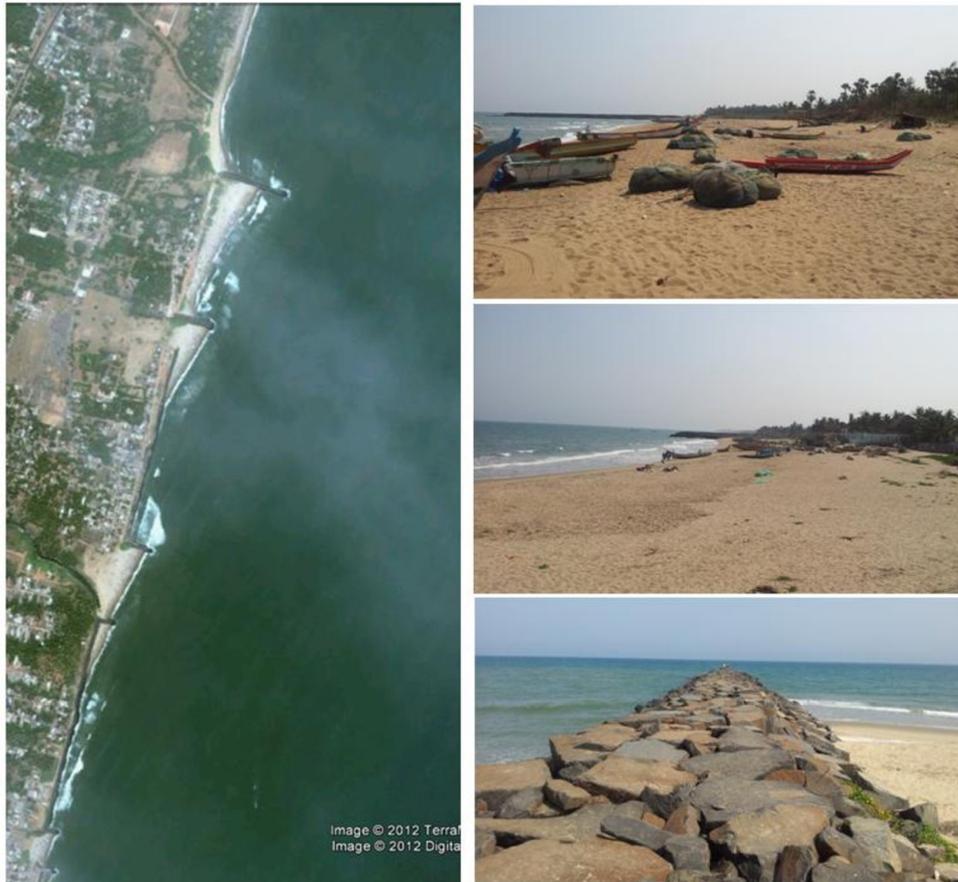
Figure 7. Construction of groins along the Pondicherry coast

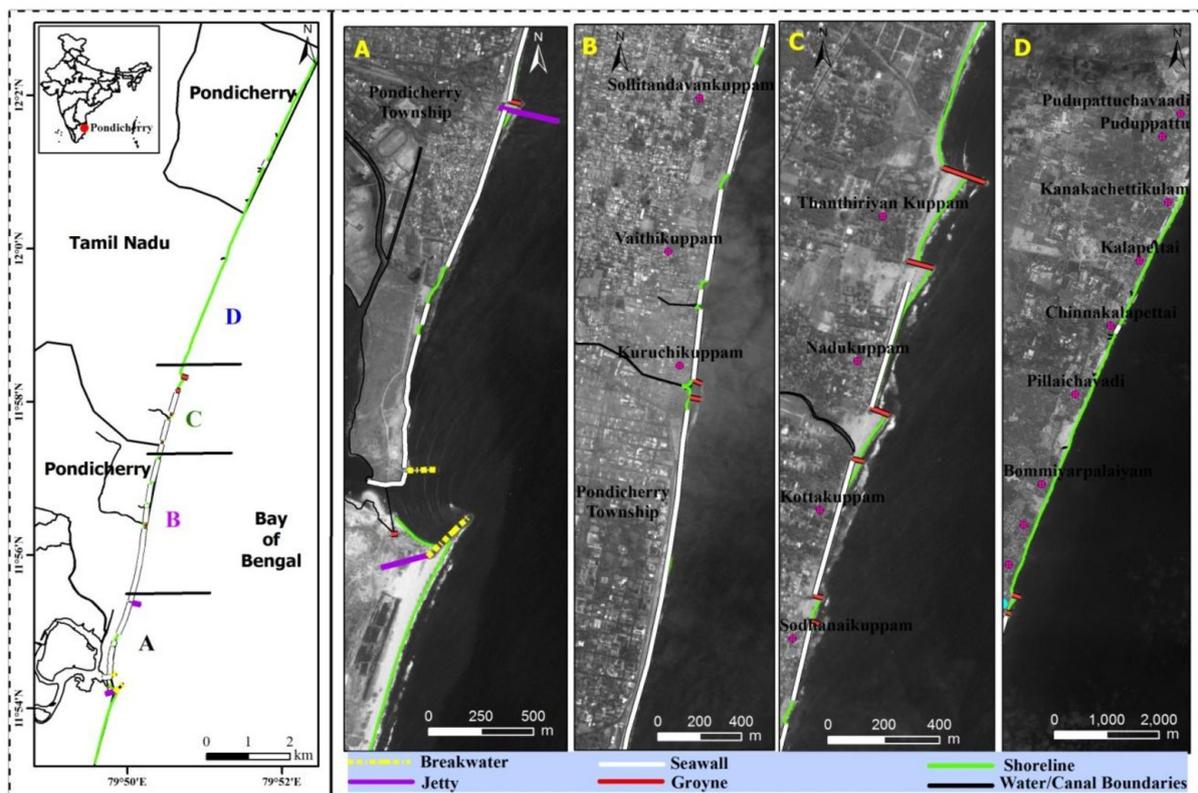
Figure 8. Classification of Pondicherry coast into zones based on structures built along the coast (A: Port Region B: Seawall region C:Groyne region D: Open Coast. (Satellite Image Source: Cartosat 2010)

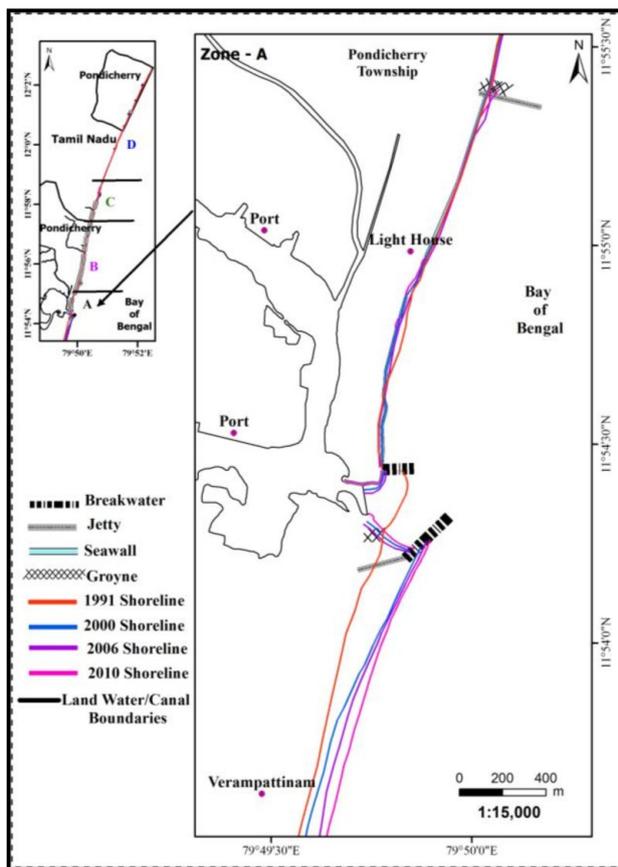
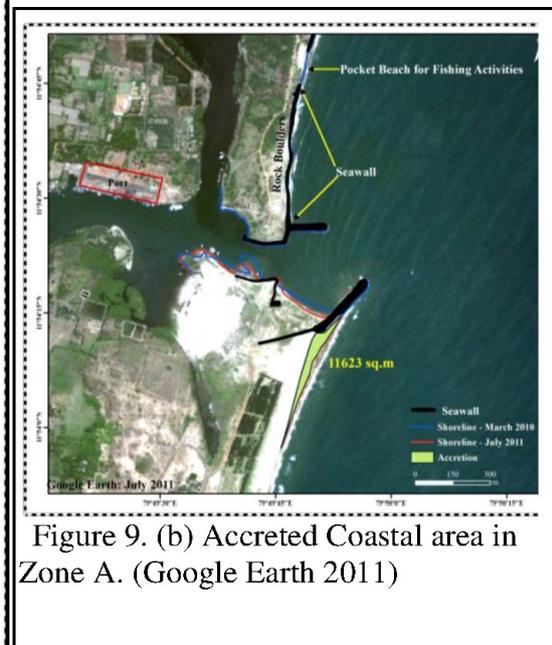
Figure 9. (b) Accreted Coastal area in Zone A. (Google Earth 2011)

Figure 9. (a) Shoreline change analysis at Zone A

A coastal stretch of 3.5km at Pondicherry harbour was analysed for its temporal changes using satellite data and field data collected during February 2012 by RTK GPS. The southern coast is accreting with maximum accretion to an extent of 180m during 1991 - 2010, while northern coast is eroding with a maximum erosion of 40m. Northern coast is protected with seawall, leaving gap of 270m for operation of fishing activities. It is observed that sediments started bypassing the southern breakwaters. (Figure 9 & 10). The decadal changes in this zone between 1991-2000 and 2000-2010 are given in Table 3, which shows maximum accretion of about 180 m at south of the breakwater.

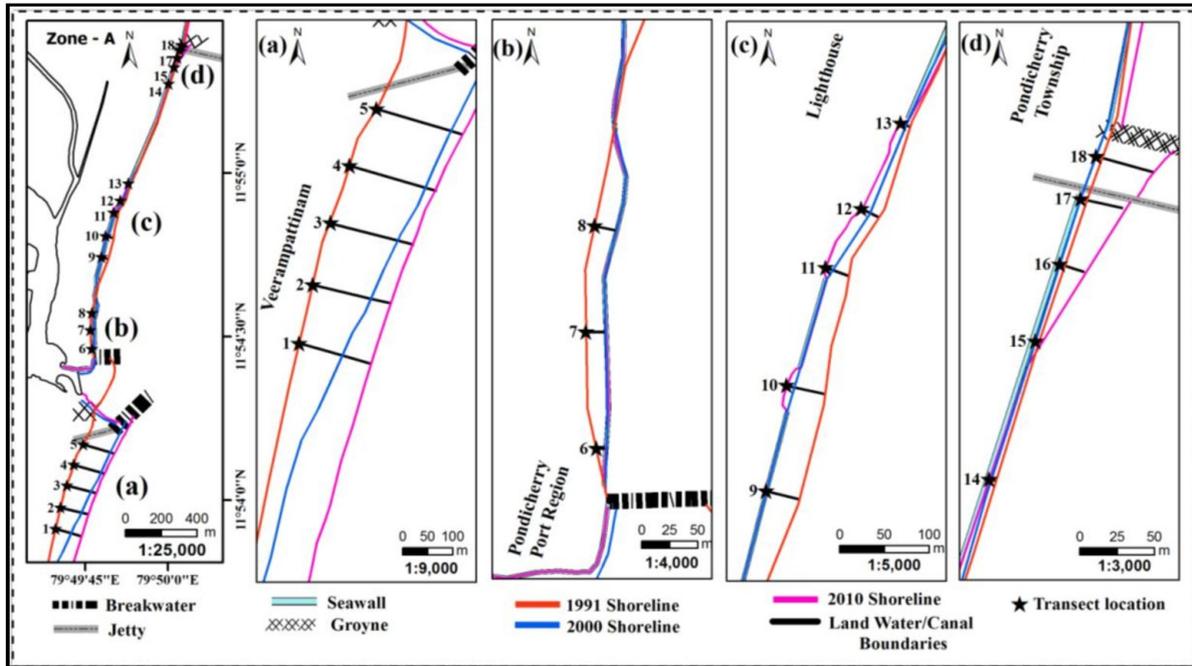
Figure 10. Temporal changes of shoreline (1991 - 2010) in Zone A

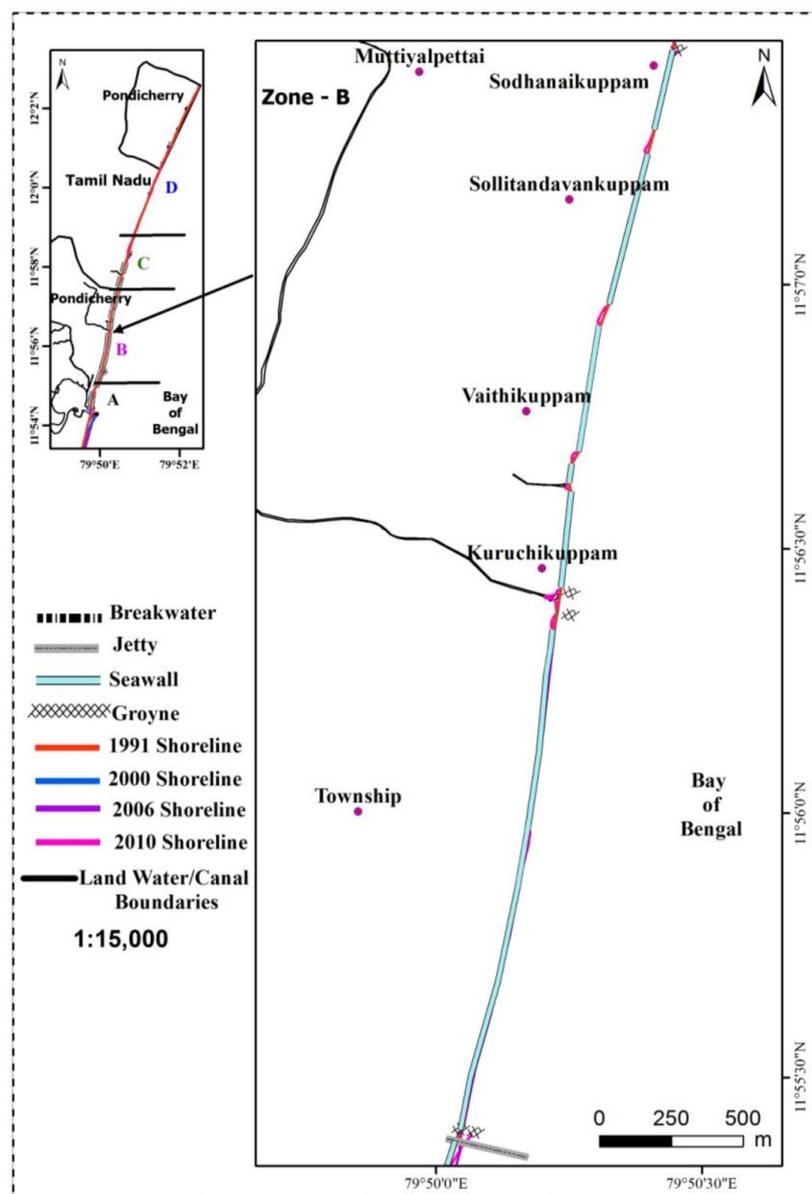
Figure 11. Shoreline changes analysis at Zone B (1991-2010)

There is no significant change in position of shoreline due to the presence of seawalls in this region. Though, the seawall protected the coast under threat, it restricted beach access to tourist and fishermen. The shoreline analysis from 1991 - 2010 (Figure 11) no significant variation in the coastline except near Kuruchikuppam channel mouth separated by 70 m apart. Two groins (50 m length) separated by 70m built at Kuruchikuppam resulted in the formation of a beach, which is used by fishermen for operation of boats. The decadal changes in this zone between 1991-2000 and 2000-2010 are given in Table 4, which shows maximum erosion of about 13 m at south of Sollitandavankuppam village.

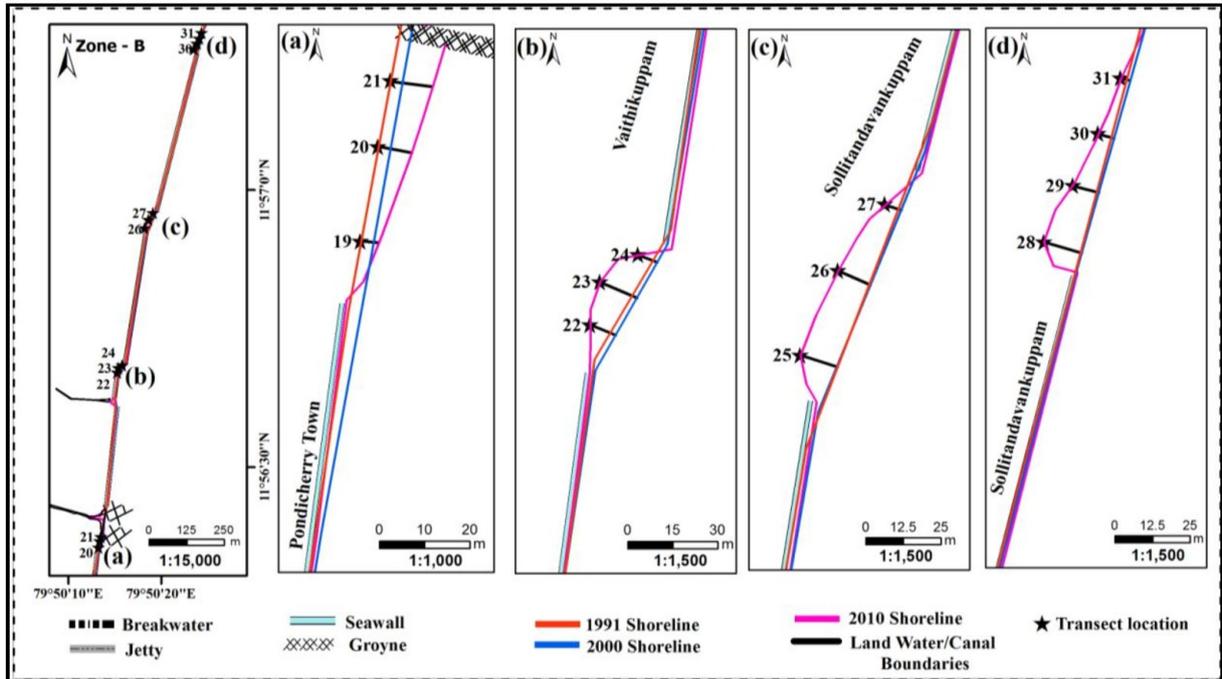
Figure 12. Temporal changes of shoreline (1991 - 2010) in Zone B

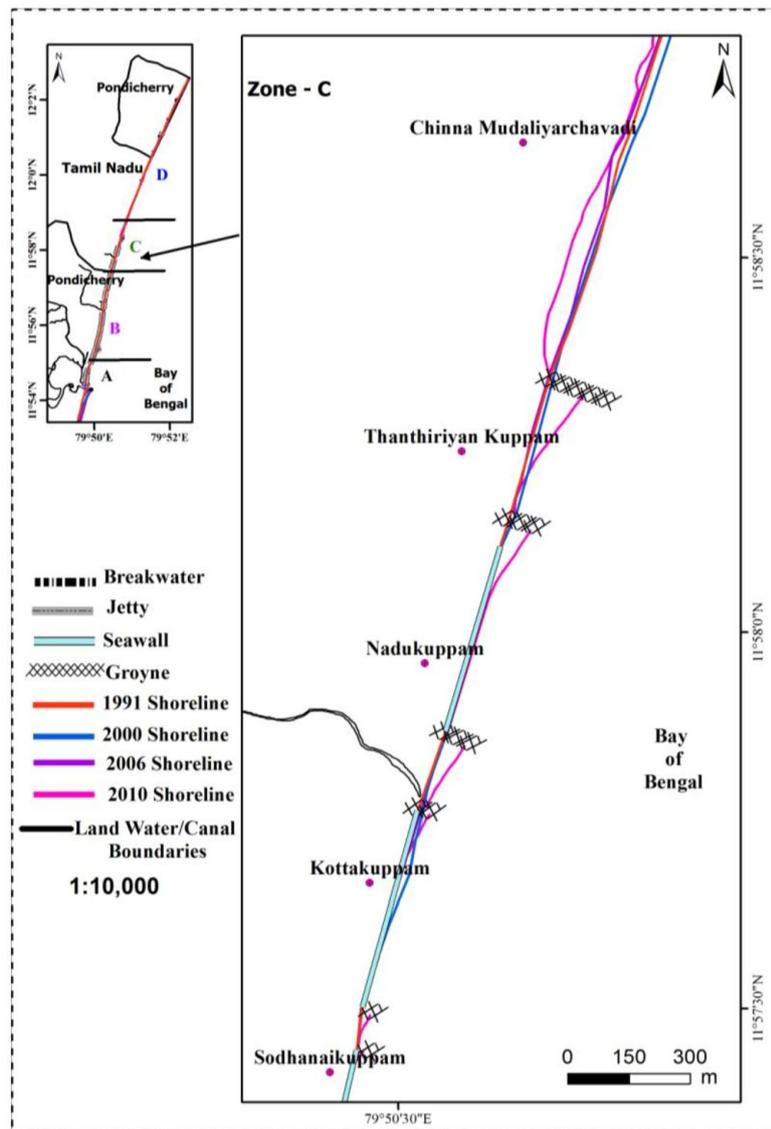
Figure 13. Shoreline change analysis at Zone C

Groin field was built to stabilize the beach in this part of coastal stretch for a length of 1.2 km (Figure 13) with six groins of varied length and spacing. It was reported that the northerly and southerly drift along Pondicherry coast is  $1.0 \times 10^6 \text{ m}^3$  and  $0.4 \times 10^6 \text{ m}^3$  respectively, resulting net northerly drift of  $0.6 \times 10^6 \text{ m}^3$  (S. Neelamani and R.Sundaravadivelu 2006). The recent analysis of shoreline change indicate these numbers are on higher side and the estimated net northerly drift would be around  $0.2$  to  $0.28 \times 10^6 \text{ m}^3$  per year. In the absence of beach nourishment, the performance of groin field and its down drift impacts depends on gross/net littoral drift rates. The decadal changes in this zone between 1991-2000 and 2000-2010 are given in Table 5, which shows maximum accretion of about 86 m at south of the longest groin at Thandirayankuppam.

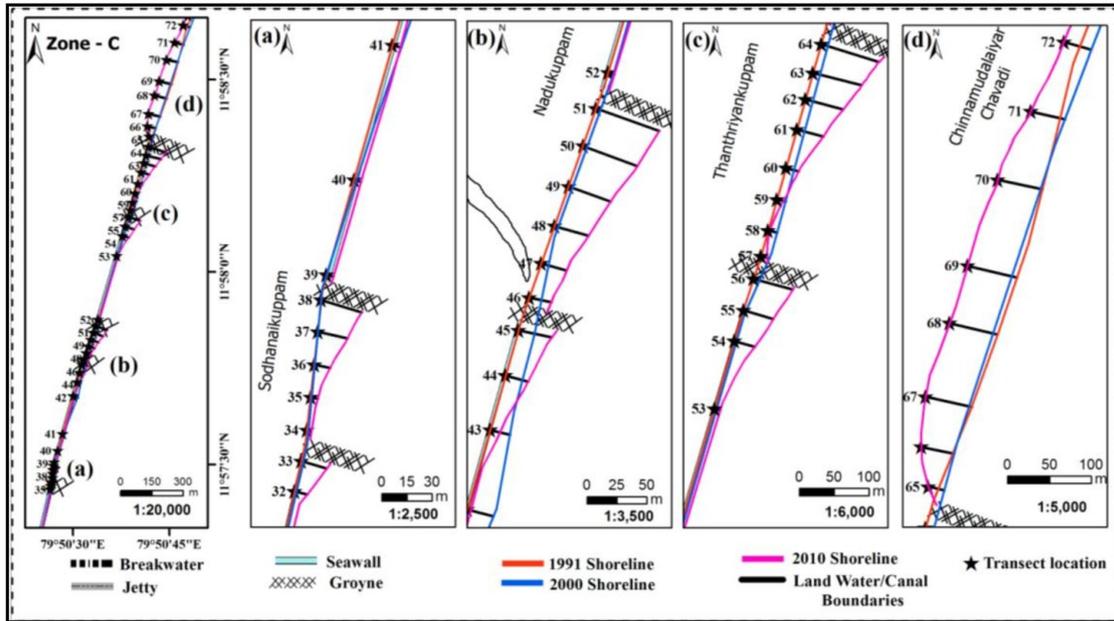
Figure 14. Temporal changes of Shoreline (1991 - 2010) in Zone C

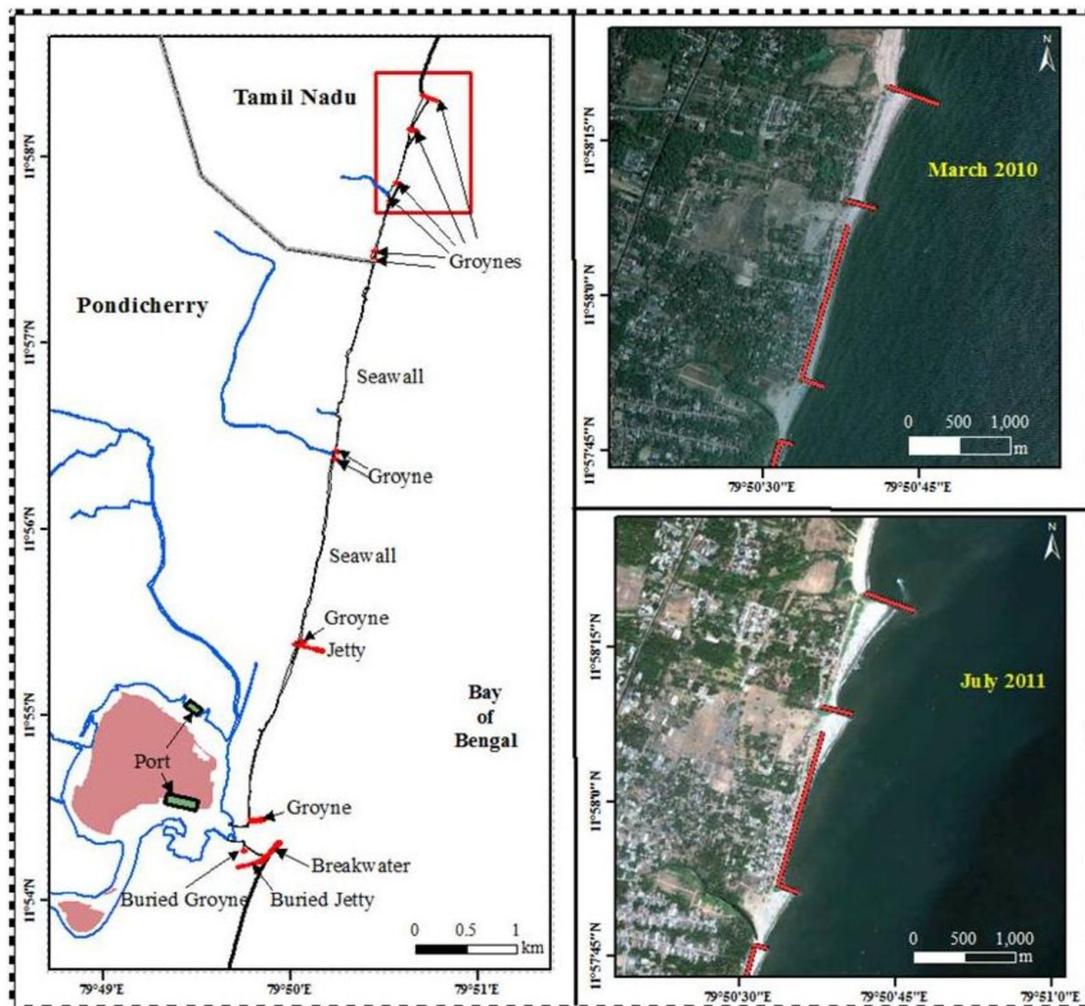
Figure 15. Short term shoreline change analysis (2010 - 2011) of groin region

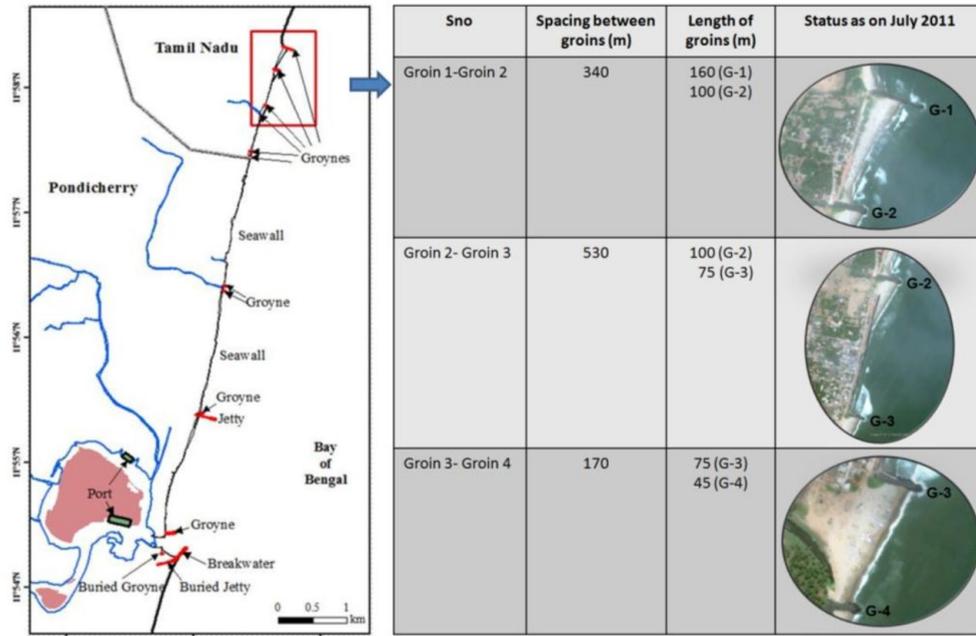
Figure 16. Performance of groin field at Thandirayankuppam village

In order to assess the functional performance of groins, 3 groin compartments (G1-G2, G2-G3 and G3-G4) of varying size were analysed as shown in Figure 16. The groin compartment G1- G2 performed well in relation to spacing and length of groin. The sand accumulation in G1-G2 compartment shows its performance, where as the increased spacing between G2 - G3 resulted in decrease in sand accumulation.

A beach area formed between G1 - G2, G2 - G3 and G3 - G4 is 1496 sq.m, 4617 sq.m and 4155 sq.m respectively. Some variation in beach formation is noticed during SW and NE monsoon, which indicates that drift during the NE monsoon is also significant. Maximum erosion is noticed north of the northern groin (G1) at Chinnamudalair Chavadi to an extent of 7678 sq.m (Figure 17).

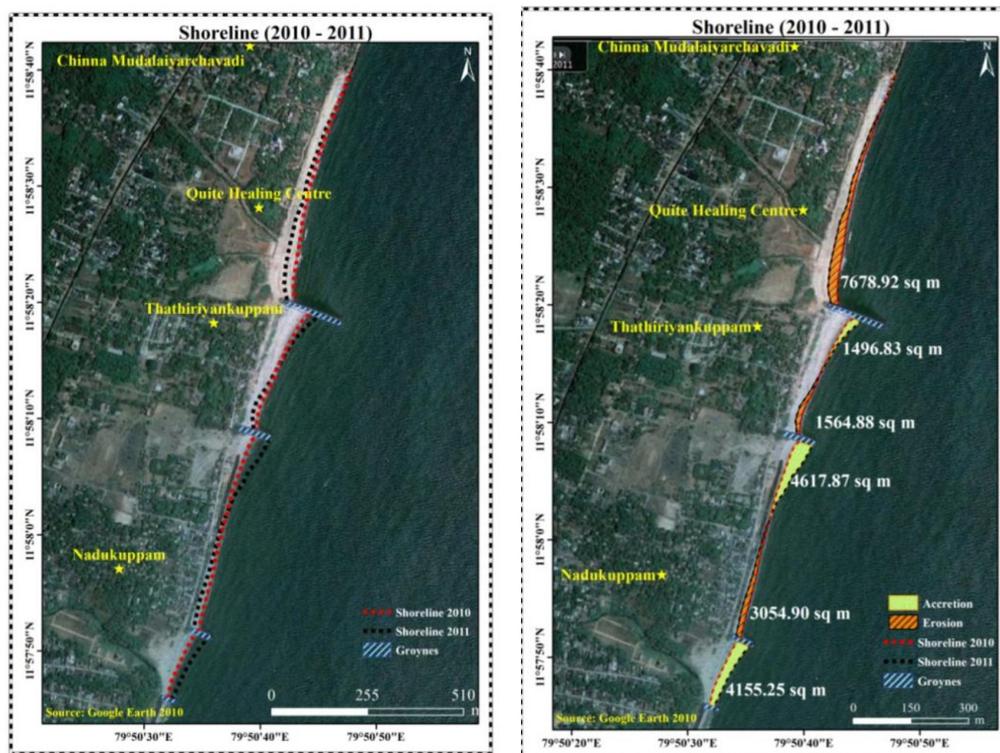
Figure 17. Eroding and accreting coast of Zone C from 2010 to 2011

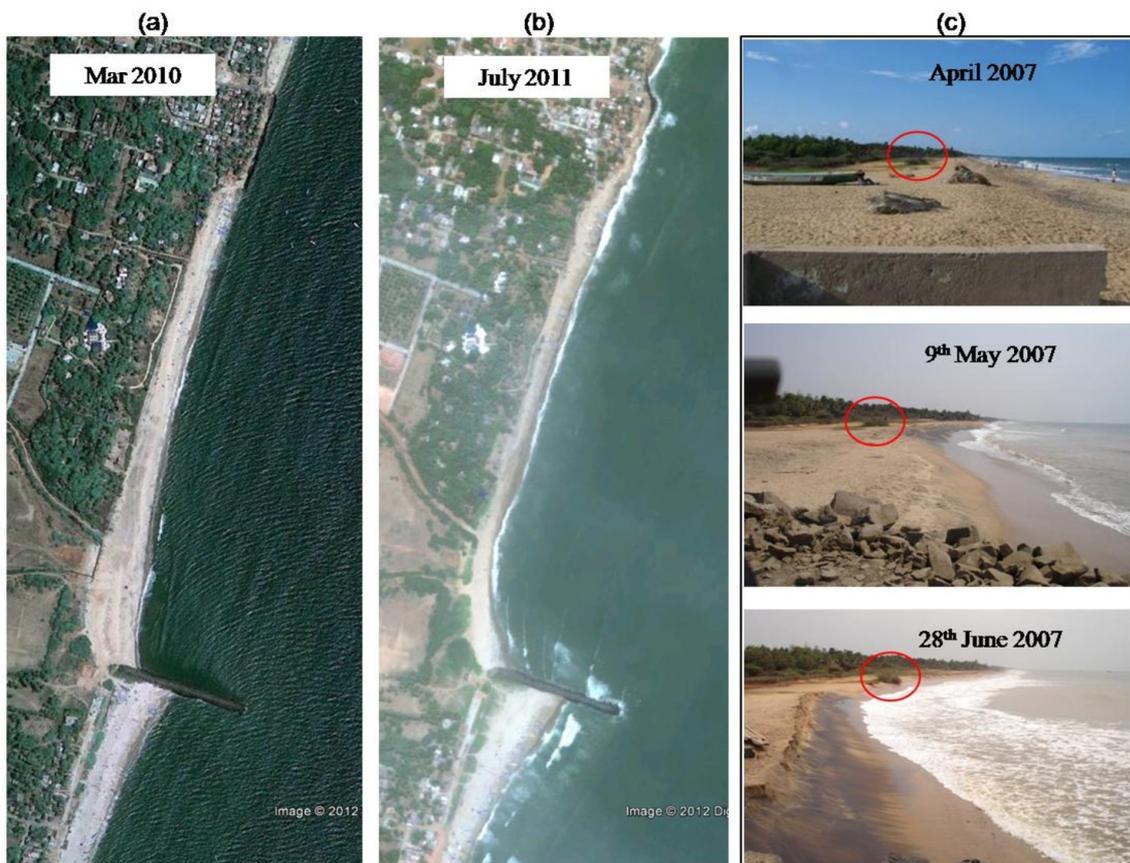
Figure 18. Shoreline changes at northernmost long groin (2007-2011)

The shoreline north of longest groin (170 m) at Thandirayankuppam indicates an erosion of 60 m in 3 months immediately after construction of groin. The erosion on north extends up to a distance of 3 km, while accretion up to 2 km during period of 2006-2011, the details are shown in Figure 18. The long groin resulted in gain of beach to an extent of 4800 m<sup>2</sup> in south and loss of beach to an order of 17,000 m<sup>2</sup> in north during period of one year. Before construction of groin, the seasonal variation of shoreline is about 11 m and it was increased to 30 m after construction of groin. In addition to seasonal and manmade shoreline changes, the episodic events like low pressure system formed during Aug/Sep, of 2007 has resulted in further increased erosion to an extent of 15 m.

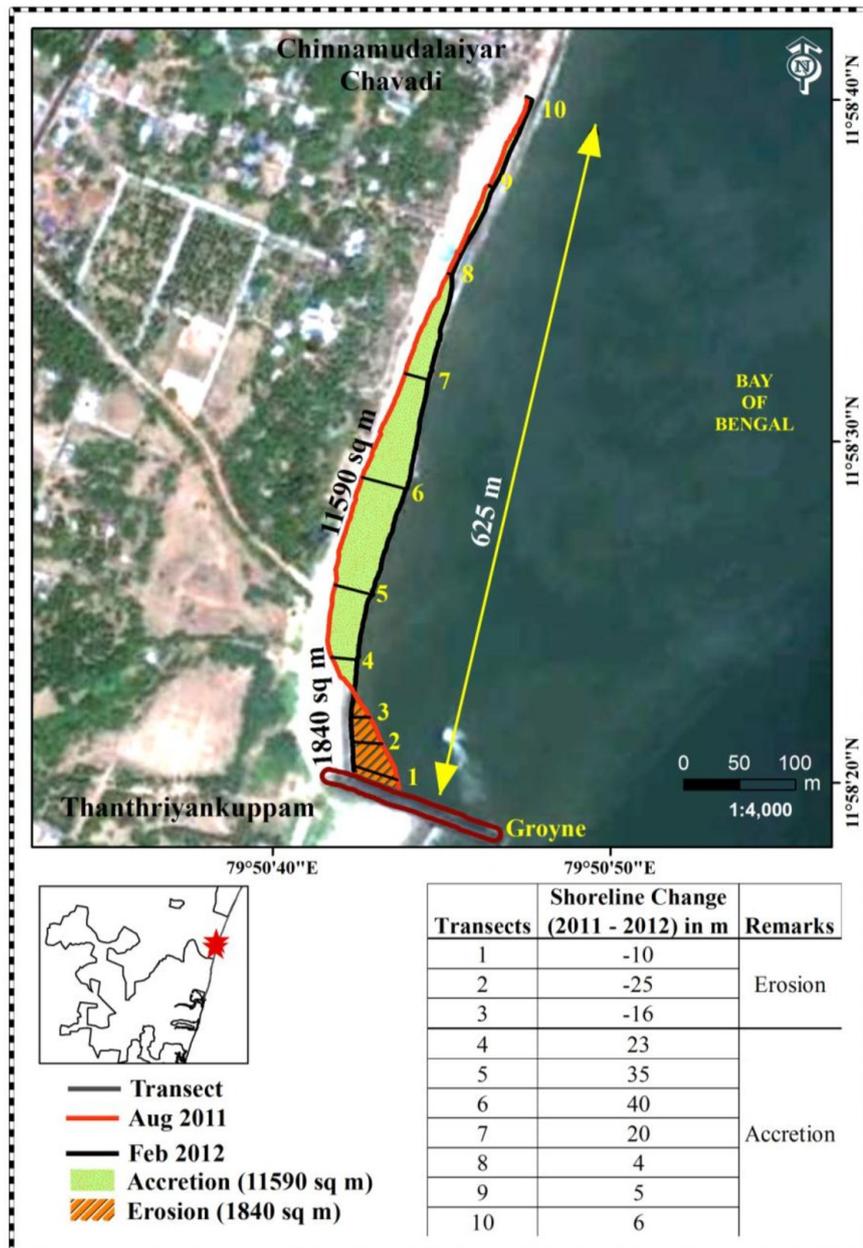
Figure 19. Chinnamudalaiyar Chavadi erosion and accretion results (2011 - 2012)

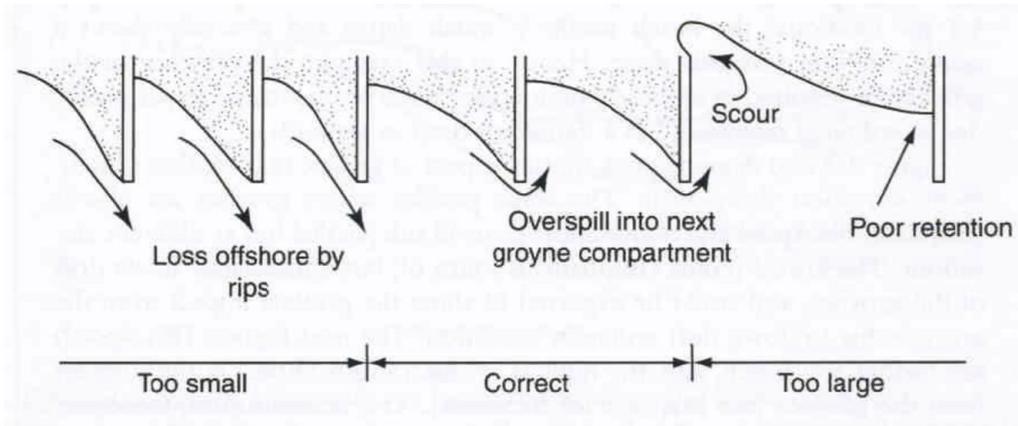
Figure 20. Functional performance of groins in relation to length and spacing

Also in the absence of seawall, possible erosion immediate north of G3 could not be ruled out to readjustment of coastline due to construction of groins as shown in Figure 20. The performance of groins to protect the coast also depends on availability of sand in littoral zone. A comparative analysis of groin field at Royapuram and Pondicherry is shown in Figure 21, which indicates Pondicherry coast is relatively better compared to Royapuram coast due to availability of sand in the littoral zone.

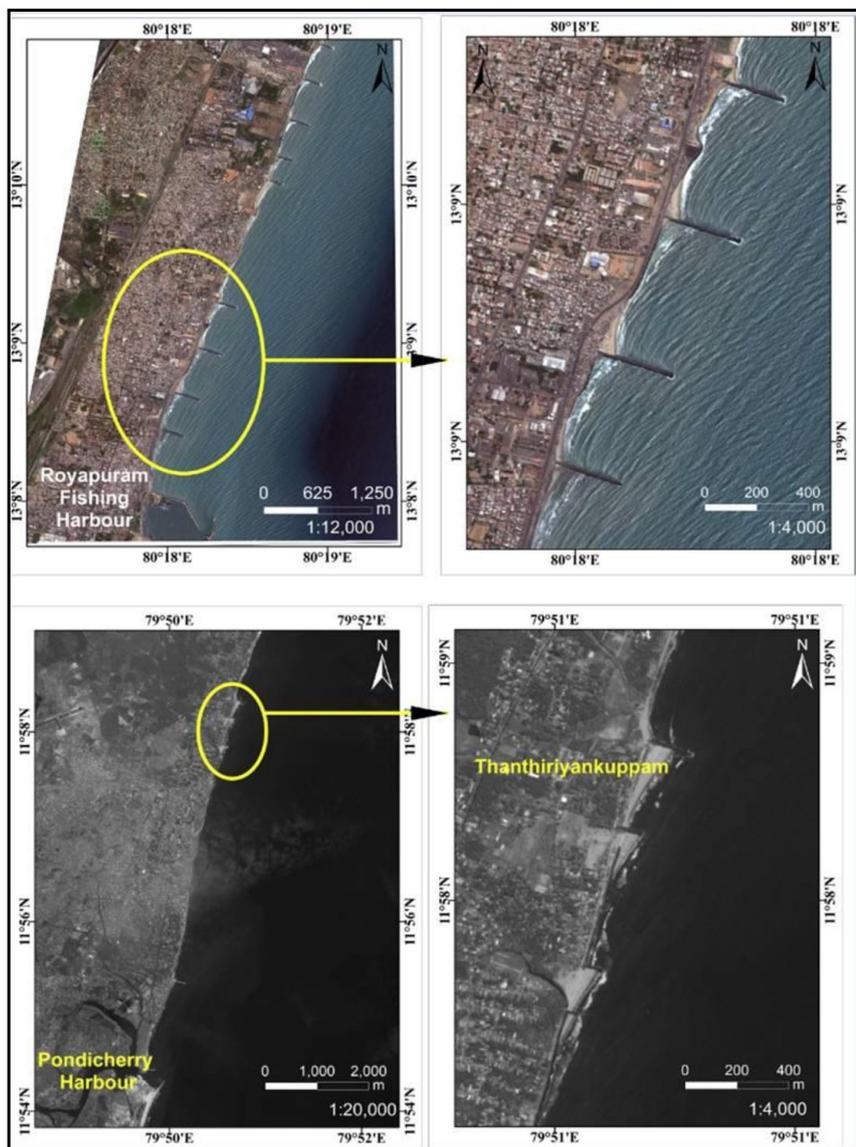
Figure 21. Performance of groin field at two independent sites - Royapuram and Pondicherry

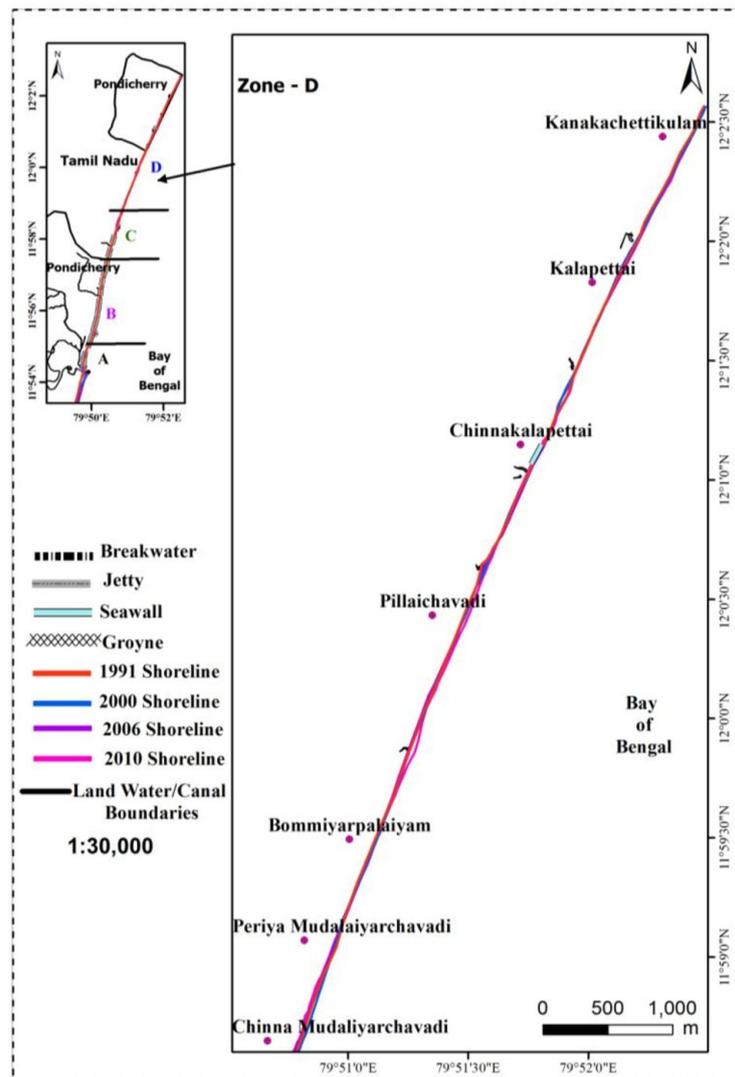
Figure 22. Shoreline change analysis at open coast (Zone: D)

This coastal stretch extends from Periyamudalaiyar Chavadi to Kanakachettikulam which is about a 8.2 km open coast with full of sandy beaches. A 165 m Rubble Mound seawall was constructed at Chinnakalapettai village during 2008. The long term shoreline analysis (1991 - 2010) shows that the maximum erosion (26 m) is observed from Periyamudalaiyar Chavadi to Bommiyarpalayam (Figure 22) , where PWD, Tamil Nadu has proposed as a protective measure a series of groins. The coast north of seawall at Chinnakalapettai village shows 16 m erosion (Figure 23). There is no significant erosion / accretion in Kalapettai and Kanakachettikulam villages (Table 6).

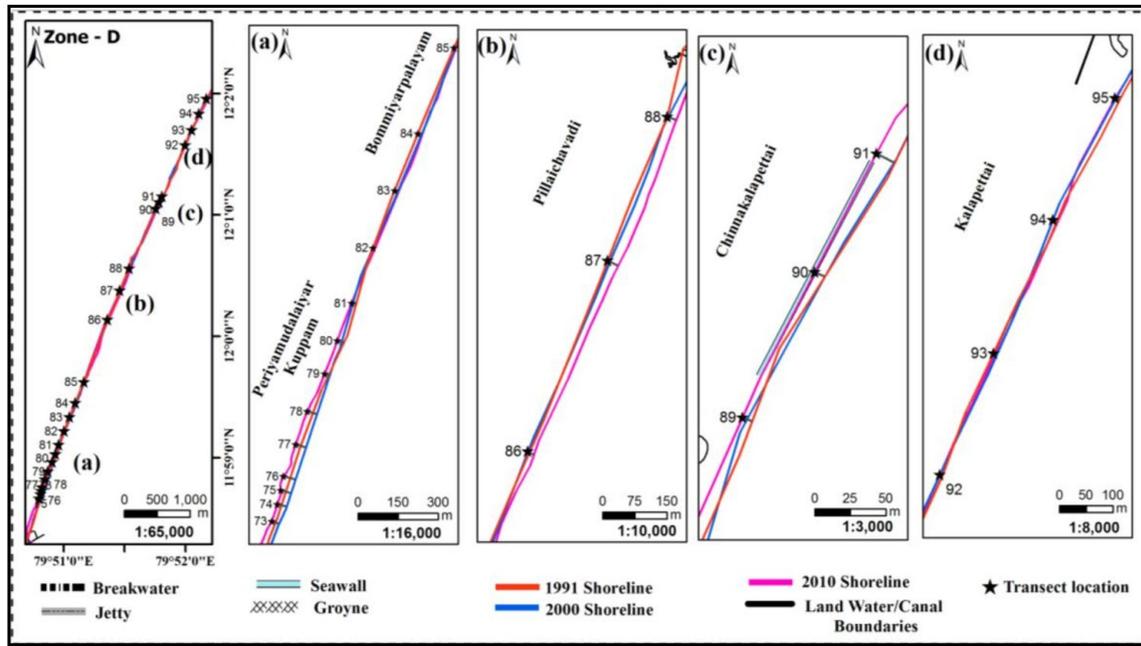
Figure 23. Temporal changes of shoreline (1991 - 2010) in Zone D

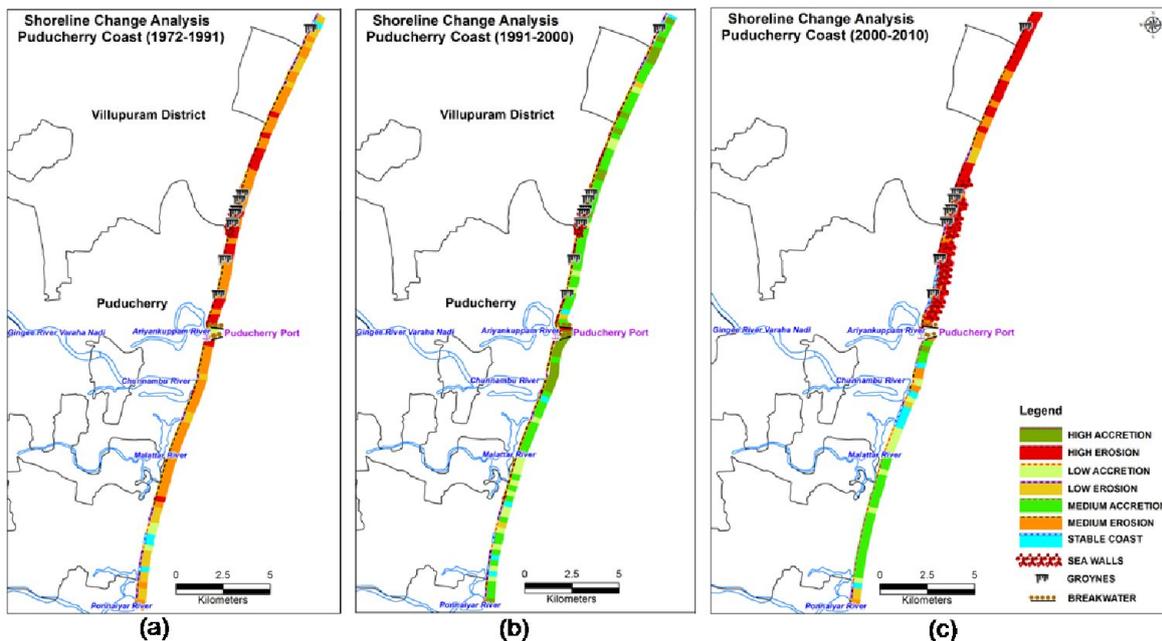
Figure 24. Long-term shoreline changes along Pondicherry and Villupuram Districts:  
(a) during 1972-1991, (b) during 1991-2000 and (c) during 2000-2010

The long-term shoreline changes were analysed using data from toposheets and satellite imageries for the period of 1972-1991, 1991-2000 and 2000-2010 to assess the decadal changes. The shoreline changes during the period 1972-1991 indicates erosion at Pondicherry port, Pondicherry township and few villages of Villupuram district (Figure 24a). During 1991-2000, medium erosion/accretion was noticed at many places along the coast (Figure 24b). But, during 2000-2010, significant erosion was noticed at many places along Pondicherry and Tamil Nadu coast and the erosion areas are extended to north of Pondicherry (Figure 24c).
