**ORIGINAL APPLICATION No. 04 of 2013(SZ)**

**PAPERBOOK - I**

## **SHORELINE MANAGEMENT PLAN**

**NATIONAL INSTITUTE OF OCEAN TECHNOLOGY**

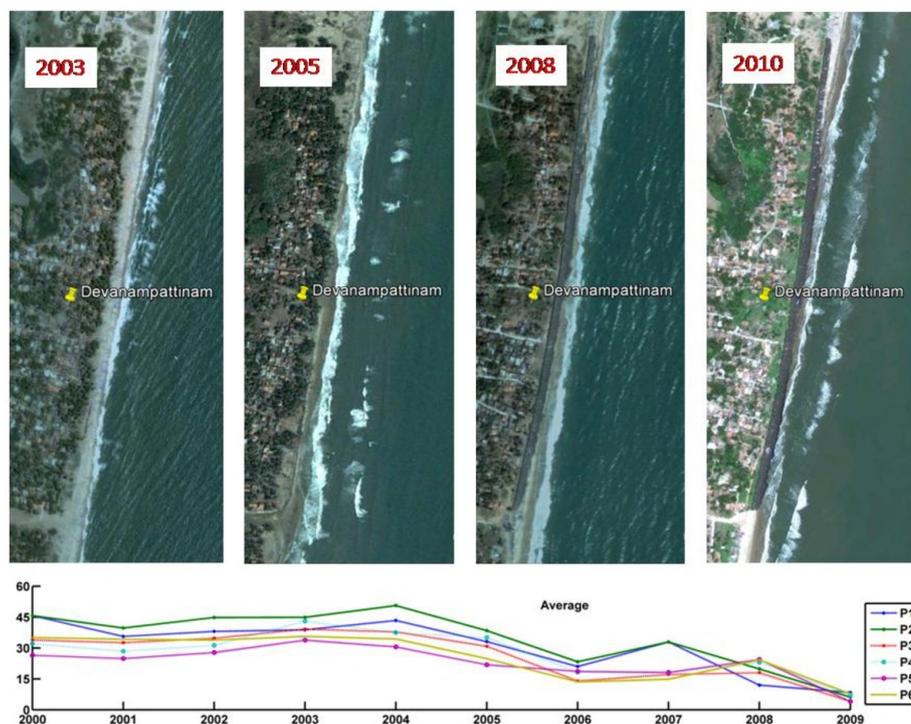
Figure 25. Shoreline oscillations at Devanampattinam based on crest of berm data (2000-2009)

The field data available at two locations, viz., Devanampattinam in south (18 km from Pondicherry port) and Oyyalikuppam in north (80 km from Pondicherry port) was used to relate remote sensing data. Though, these locations do not represent the shoreline behaviour of Pondicherry coast, it can be used as indicator for long-term shoreline change analysis. The shoreline changes at Oyyalikuppam and Devanampattinam is shown in Figures 25 & 26 respectively. The natural shoreline oscillation is about 10 m at both the stations between 2002-2007. After 2007, significant erosion noticed at Oyyalikuppam which is also observed from short-term analysis along Pondicherry coast. The data clearly suggests that Pondicherry coast experiences natural oscillation of 10 m, which can increase up to 20 m when episodic events occur due to low pressure or cyclonic storm.

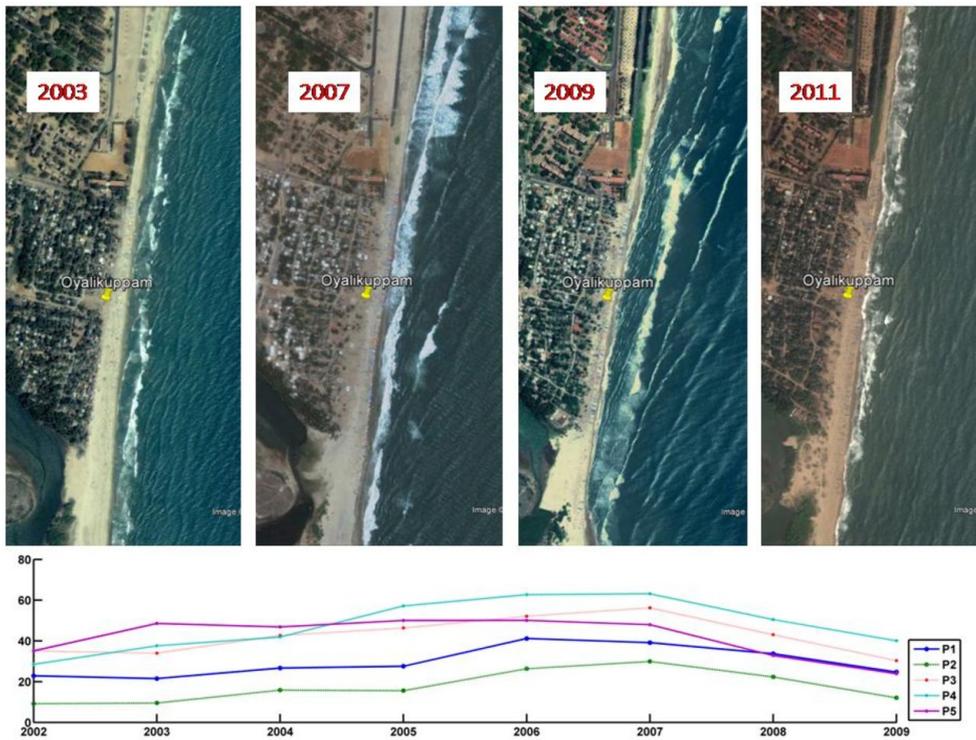
Figure 26. Shoreline oscillations at Oyyalikuppam based on crest of berm data (2002-2009)

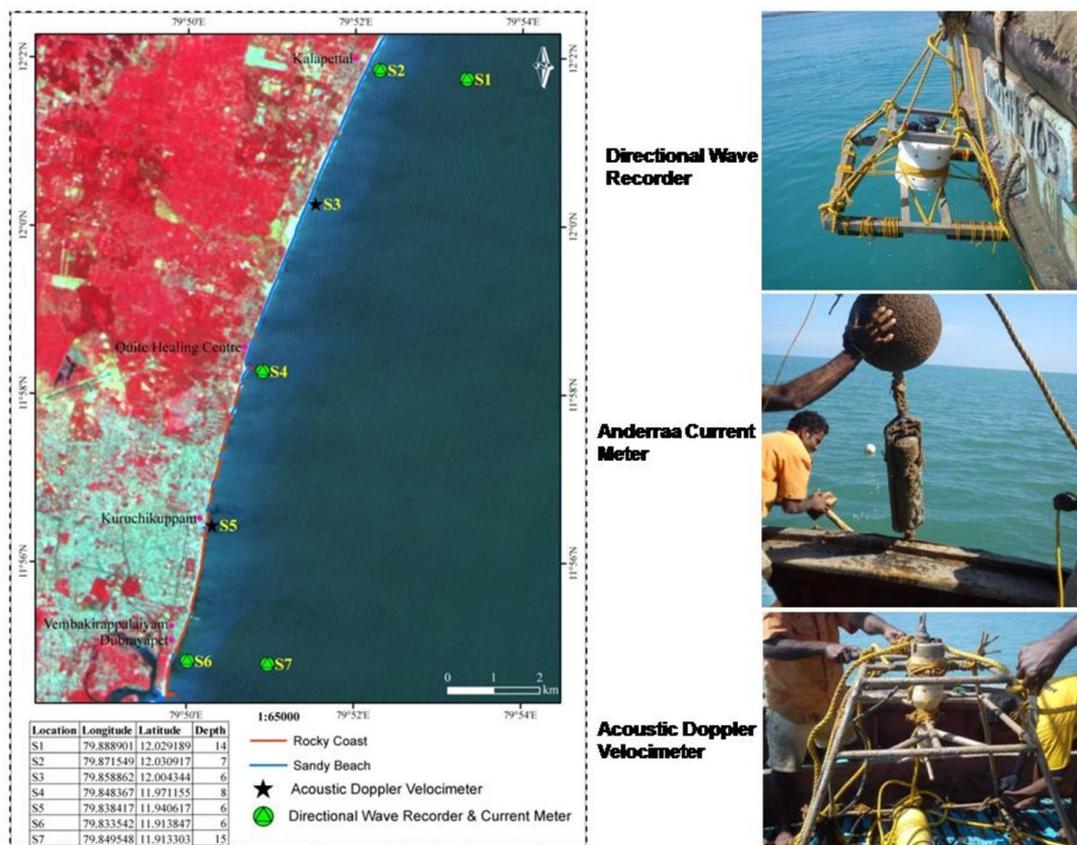
Figure 27. Locations and instruments used for observations along Pondicherry coast

Coastal processes along the Pondicherry coast were monitored to understand the dynamics of the coast, covering both the Pondicherry and Tamil Nadu regions. The measurement scheme covers a coastal stretch of length 18 km (from Pondicherry Port to Kalapettai village), where water levels, waves, coastal and nearshore currents were monitored over a period of 15 days for constructing numerical models. The location of observations is shown in Figure 27 and parameters monitored were indicated in Table 7.

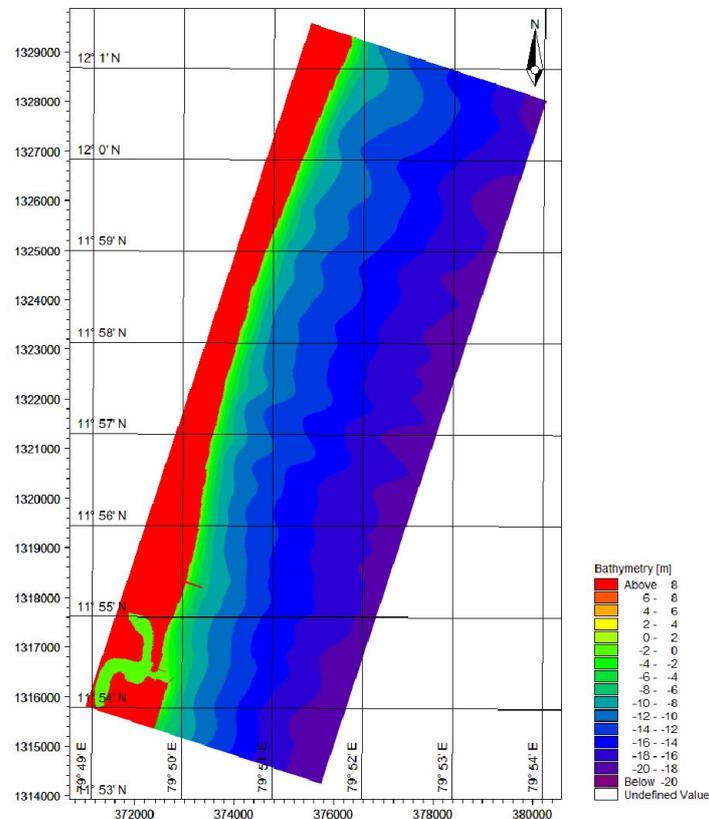
Figure 28. Surveyed bathymetry/topography along Pondicherry coast during 2011-2012

Topographic survey was carried out for the entire Pondicherry coast with 75 transects of 250 m horizontal spacing. Real Time Kinematic Global Positioning System (RTK-GPS) was used for near shore elevation data collection. RTKGPS survey is based on the use of carrier phase measurements which provides improved location accuracy, from the 15-meter nominal GPS accuracy to about 1 cm in case of the best implementations. The entire Pondicherry coast was surveyed using Trimble RTK GPS system. TRIMBLE R8 GNSS receiver used as a single reference station which provides the real-time corrections to the mobile unit TRIMBLE TSC 2. The reference base station was established at a known benchmark where the latitude, longitude and elevation were marked on the ground. The mobile unit was carried along the coast and the elevation data was recorded in the control unit. The land topography and sea bathymetry data were merged in GIS and resultant map is shown in Figure 28.

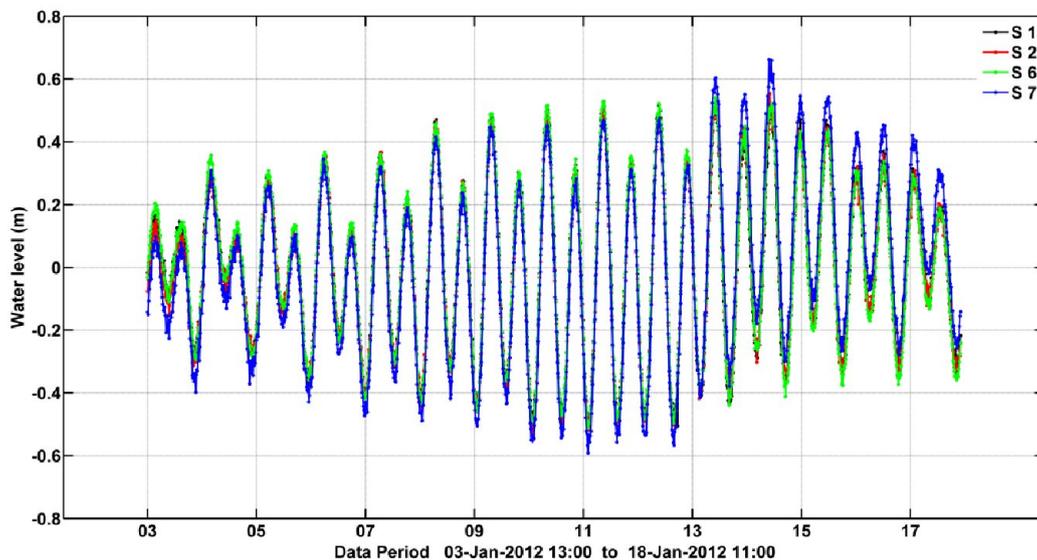
Figure 29. Observed water levels during NE monsoon at four stations of Pondicherry coast

Water levels were monitored at 4 locations (S-1, S-2, S-6 & S-7) with 15 min interval for a period of 15 days (Figure 29) to represent tide curve.

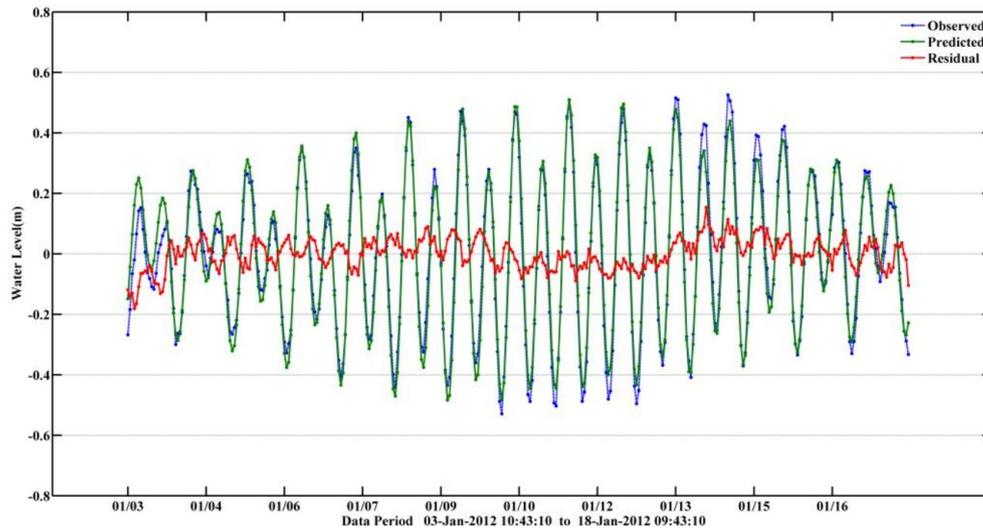
Figure 30. Observed/predicted tide along with residual at Station S-2 (Kalapettai)

measurements. In shallow waters water levels can be affected by storms at higher frequencies due local wind and barometric pressure, which result water level above tide. Following conventional practice, the data was smoothed and the non-tidal contribution was removed from the measured data using known techniques of tidal analysis (Figures 30 & 31).

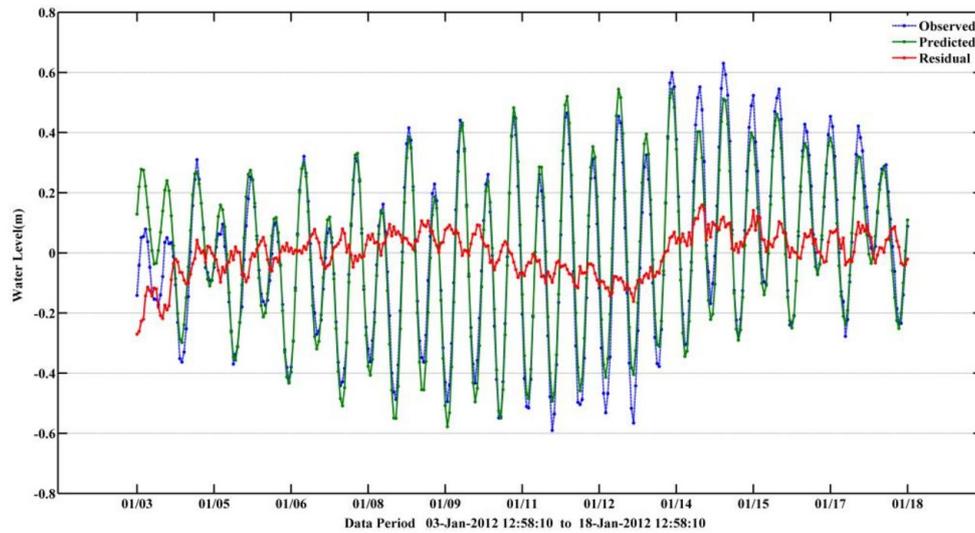
Figure 31. Observed/predicted tide along with residual at Station S-6 (Lighthouse)

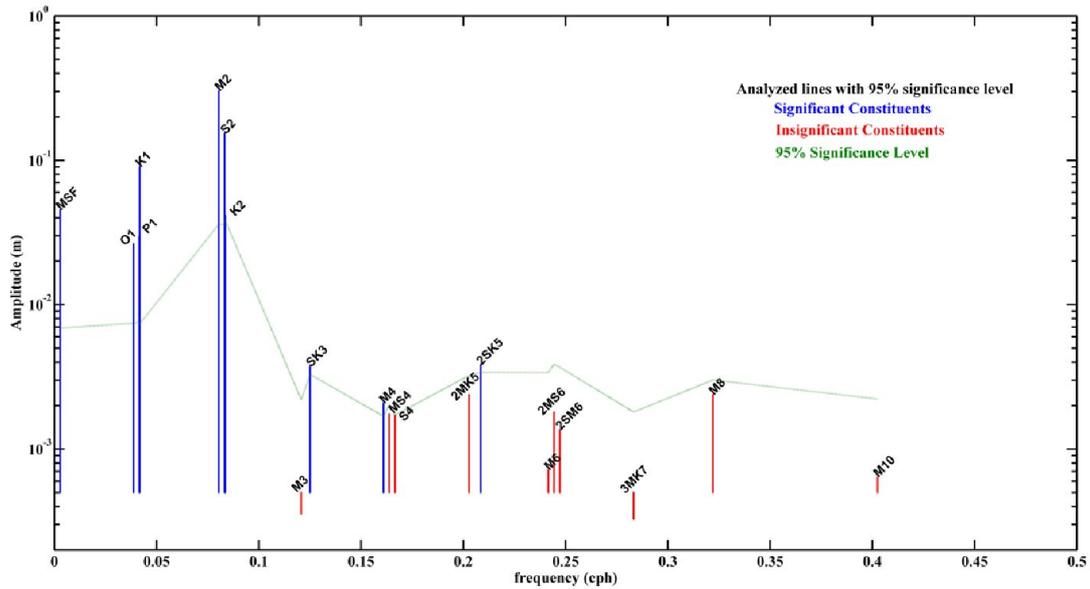
Figure 32. Amplitude and frequency spectrum of tide at station S-2 during NE monsoon

event to the first maximum of its corresponding constituent tide. It is usually expressed in degrees of one complete cosine curve ( $360^\circ$ ) of that constituent. Harmonic constants are unique to the particular station and computed constituents for Pondicherry coast is given in Table 6. The amplitude of various constituents, frequency and residuals (non-tidal component) at boundaries of study area (S2 and S6) were shown in Figures 32 & 33.

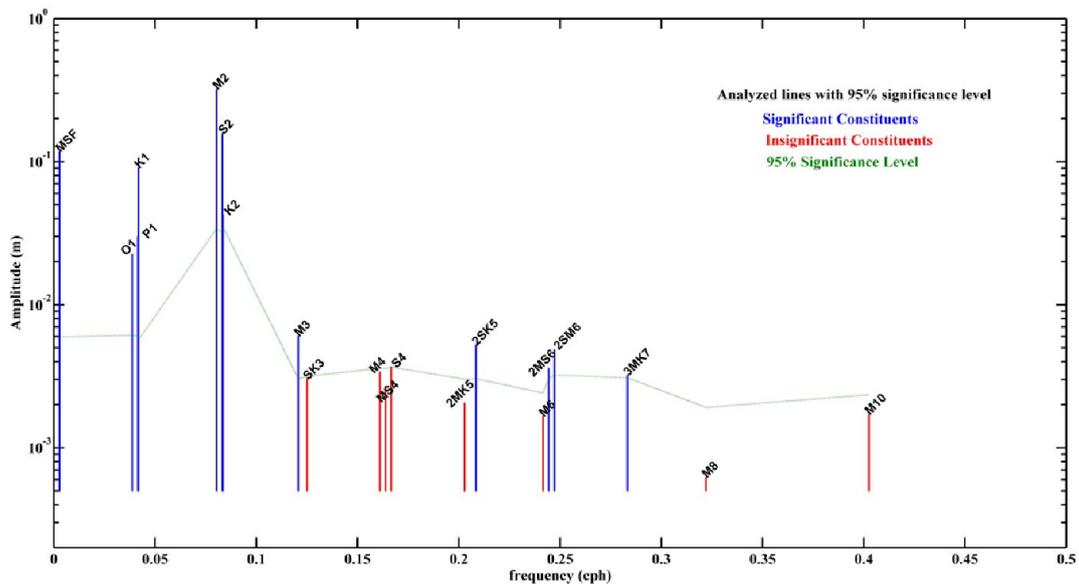
Figure 33. Amplitude and frequency spectrum of tide at station S-6 during NE monsoon

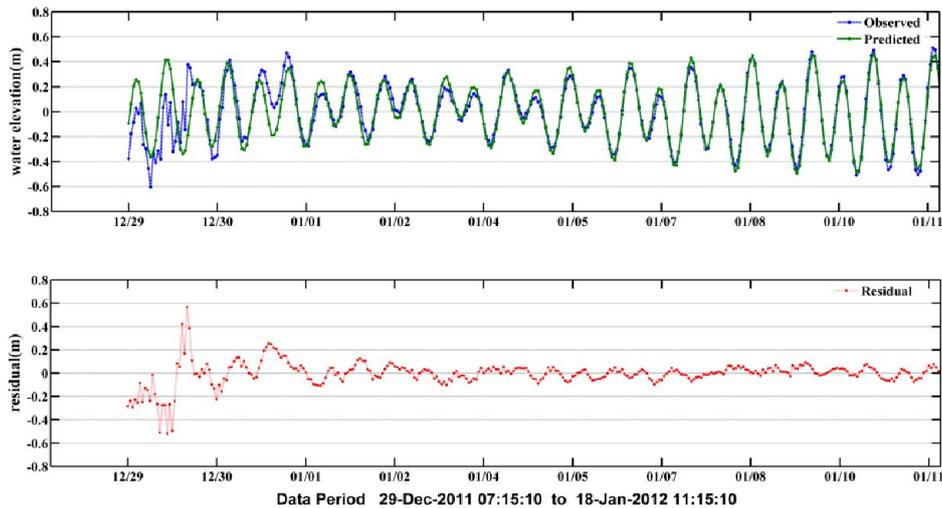
Figure 34. Measured water level at Thanthriyankuppam village (station S2) during Dec 2011 Thane cyclone

The water level gauge deployed during the period 29 December, 2011 to 17 January 2012 measured surge level during the landfall of Thane cyclone. The detided water level indicates a surge level of 0.7m at the time of cyclone crossing the coast (Figure 34). The cyclone crossing the coast during high phase of tide and hence the total measured water level is 1.3 m.

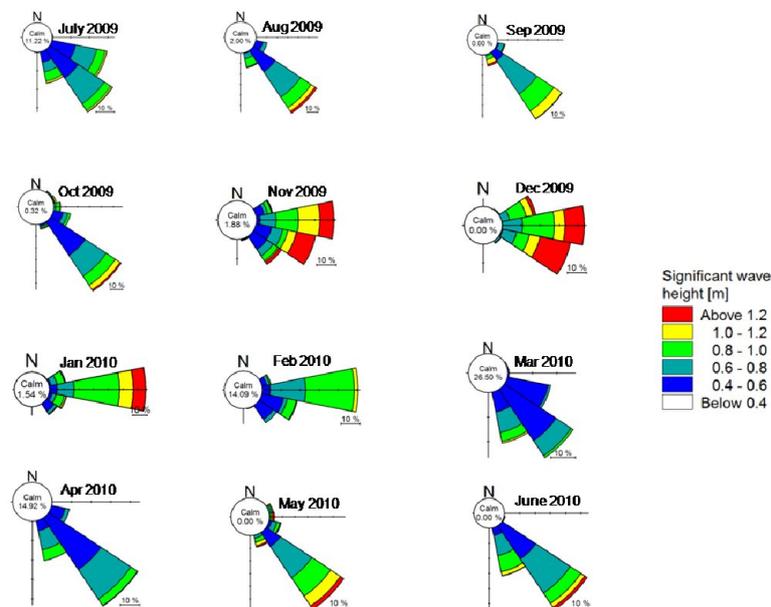
Figure 35. Monthly wave climate measured using waverider buoy at south of Pondicherry port at 30 m water depth

Wave measurements were carried out off Pondicherry coast by INCOIS, MoES during July 2009 to June 2010 using a Datawell directional waverider buoy in 30 m water depth. The data were recorded for 20 min at every 3 h interval. Frequency distribution of wave heights show that the waves are approaching from southeast by direction for about 9 months in a year and approaches from east direction for the rest of the year (Figure 35). The wave heights ranges from 0.4 m to 1.2 m during southwest monsoon with SE direction.

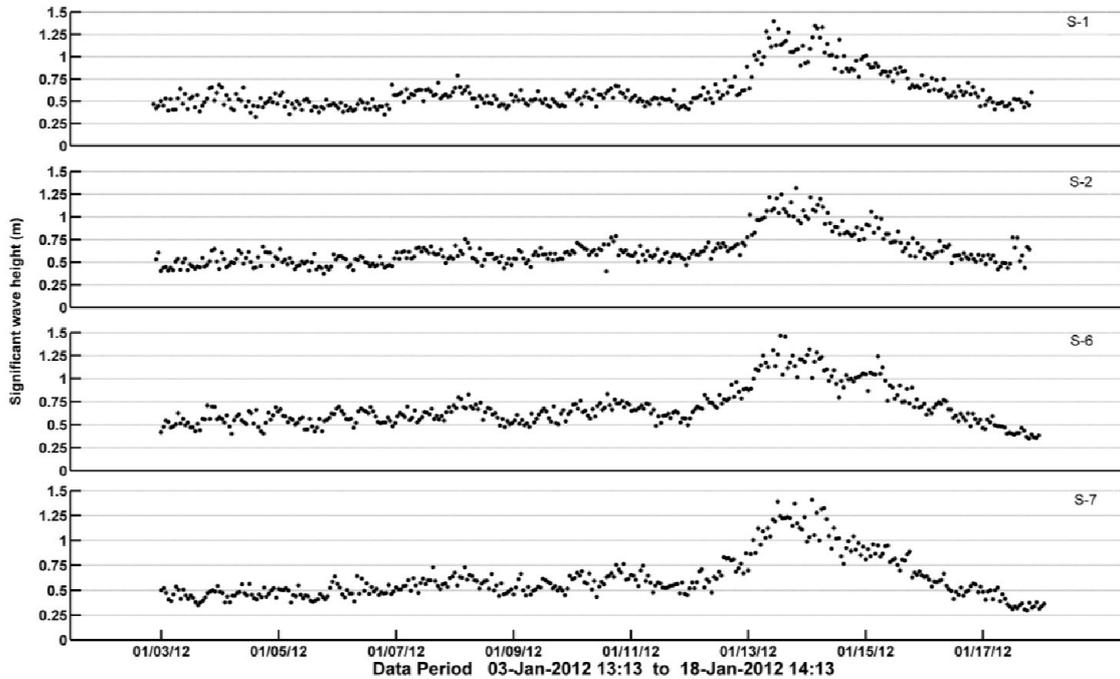
Figure 36. Significant wave height at four stations during NE monsoon

monsoon period ranges from 0.25 m to 1.50 m with an average value of 0.60 m. Frequency distributions of wave heights show that almost 50% of the significant wave heights are in the range 0.5 - 0.7 m indicating low wave activity during the observation period. The depression during 13-15 January, 2012 caused the waves to grow and the significant wave height reached up to 1.5 m on 14 January (Figure 36).

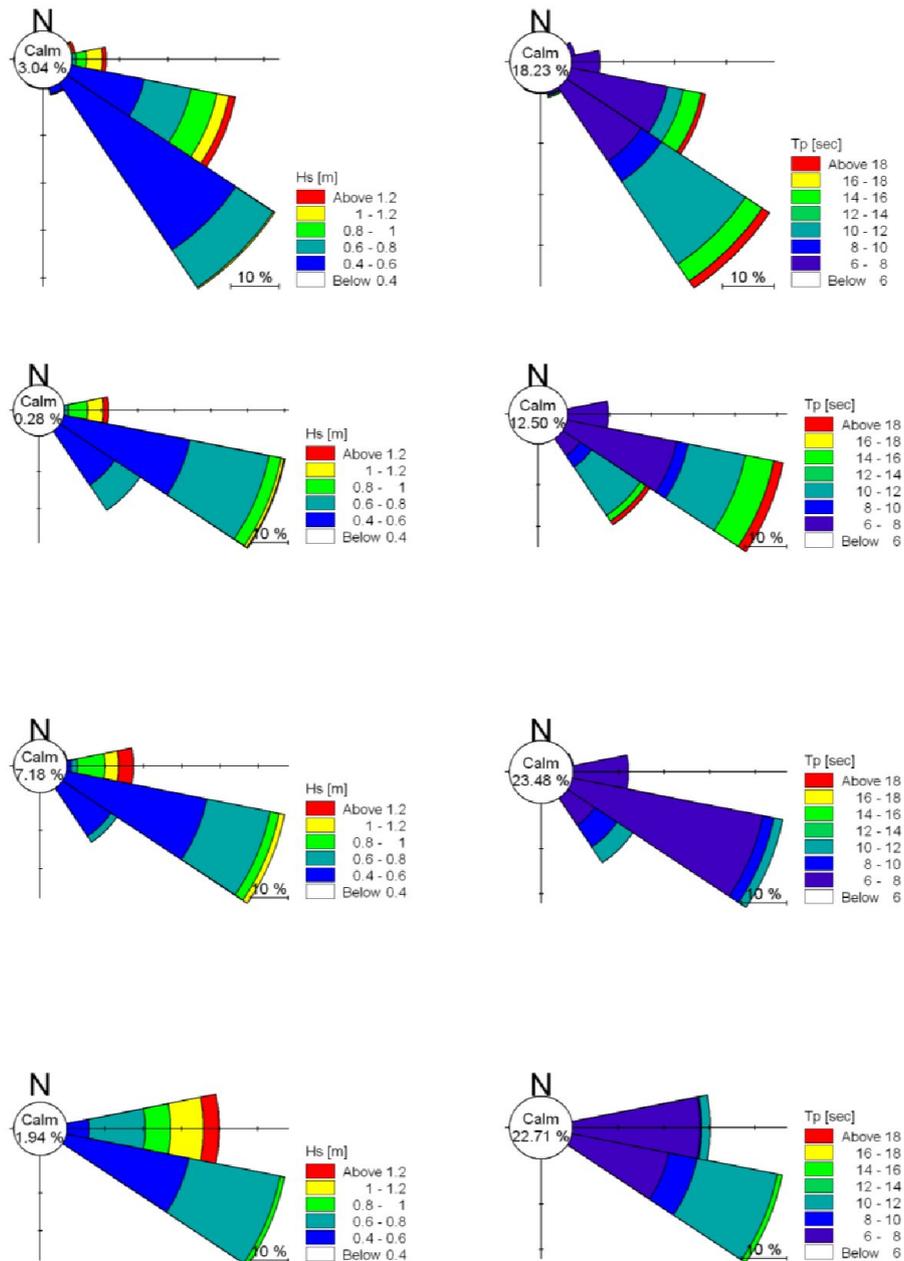
Figure 37. Wave rose diagram of the significant wave height and peak period based on measurement at four stations during the period 03-17 January 2012

The wave rose diagram shows that the wave approach as the Pondicherry from southeast with maximum significant wave height of 1.2 m at all the locations (Figure 37). The wave periods ranges between 3 - 18 sec at all the locations during northeast monsoon. The frequency distribution shows that more than 50% of the waves have  $T_z$  in the range of 8-10 sec and 15% of the waves are above 10 s during the deployment period. The wave statistics along Pondicherry coast during the observation period were shown in Table 10.

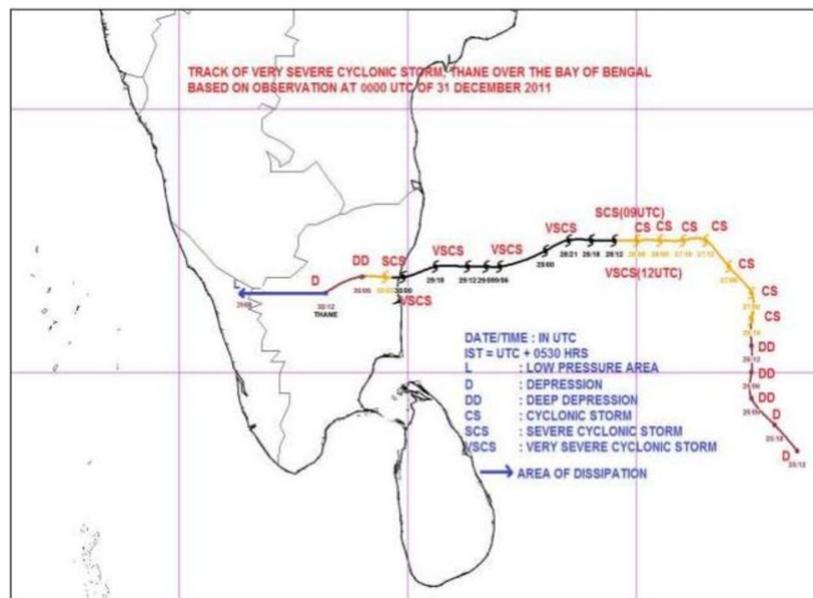
Figure 38. Track of THANE cyclone over the Bay of Bengal during December 2011

After landfall, the system rapidly weakened into a severe cyclonic storm over north coastal Tamil Nadu at 08:30 hrs IST of 30<sup>th</sup> and into a deep depression around noon and into a depression in the same evening over the north Interior Tamil Nadu. The track and associated parameters are shown in Figure 38.

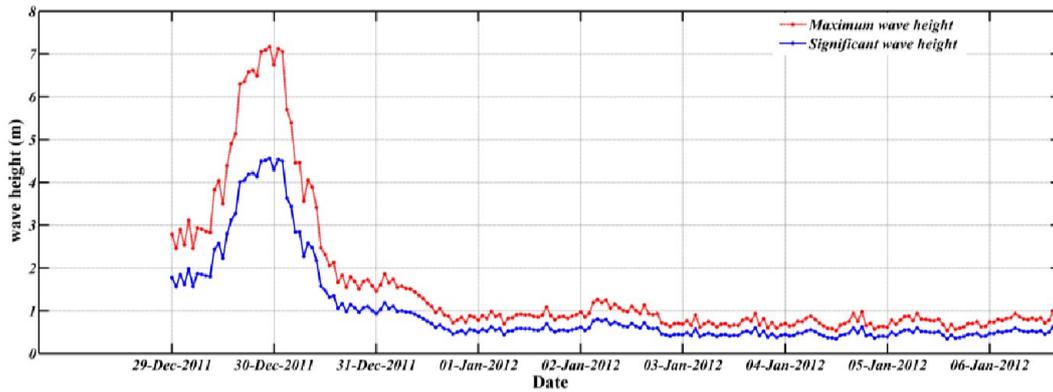
Figure 39. Maximum and significant wave height during Thane cyclone (Dec 2011)

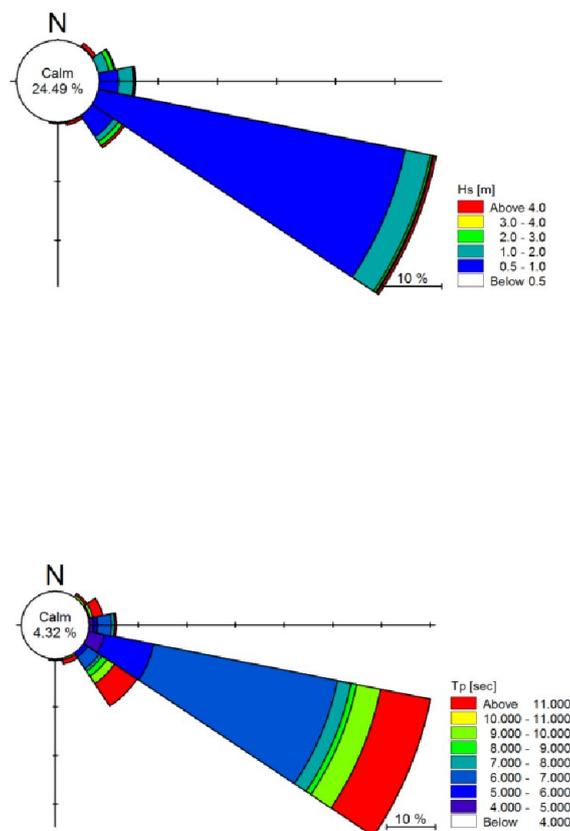
Figure 40. Wave rose plots of  $H_s$  and  $T_p$  during Thane cyclone (Dec 2011)

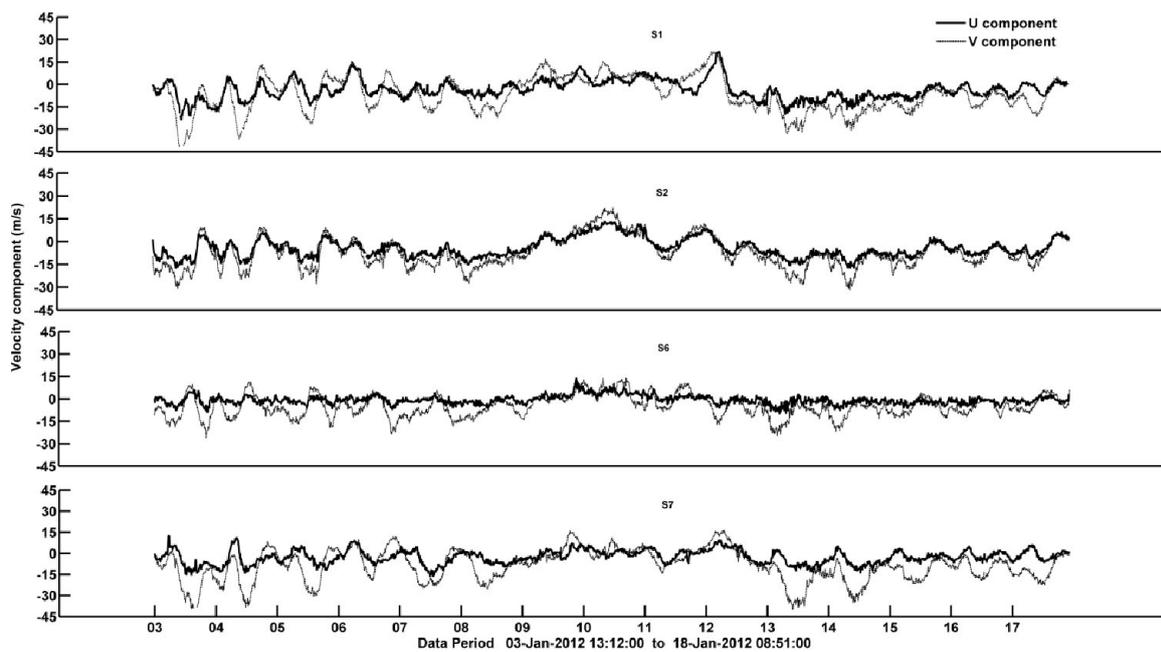
Figure 41. Measured zonal (u) and meridional (v) component of coastal currents during the period 03-17 January 2012

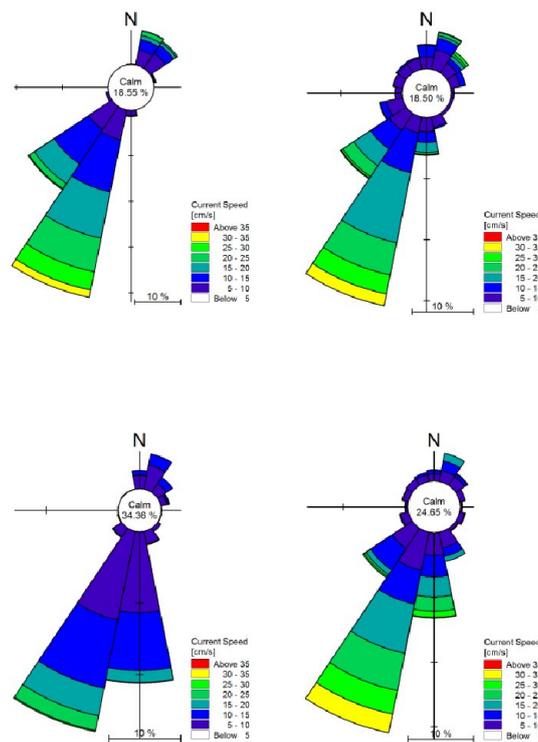
Figure 42. Rose plots of the observed currents along Pondicherry coast, NE monsoon

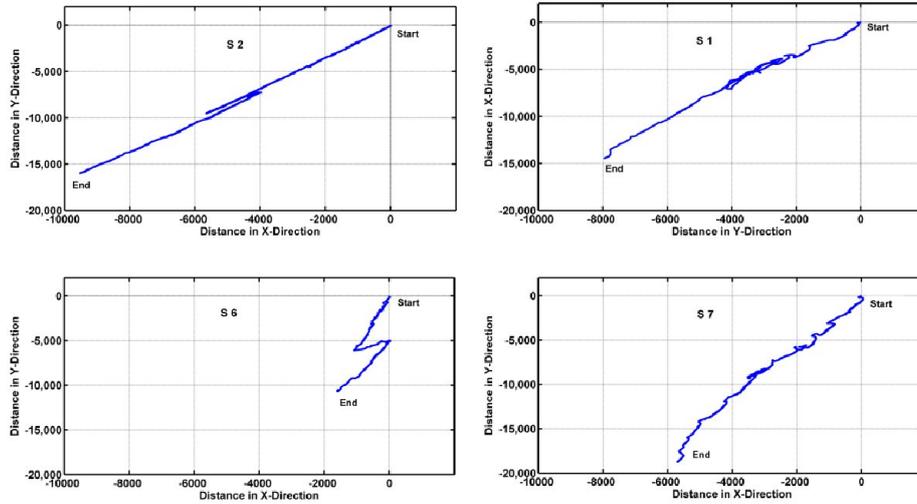
Figure 43. Progressive vector of observed currents during NE monsoon at four stations

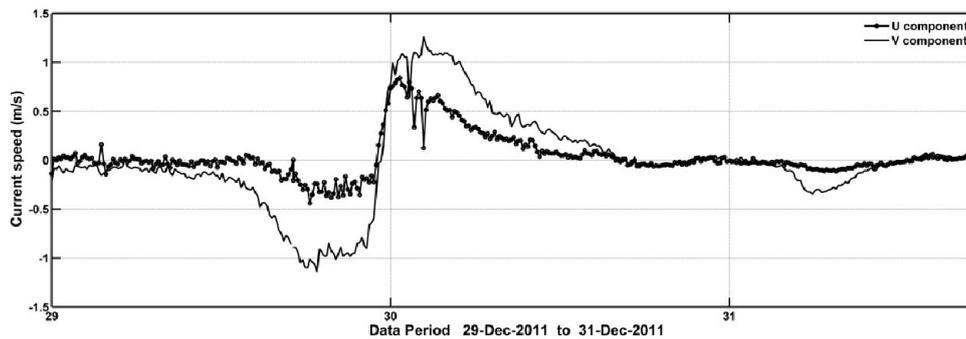
Figure 44. Maximum observed currents during December 2011 Thane cyclone

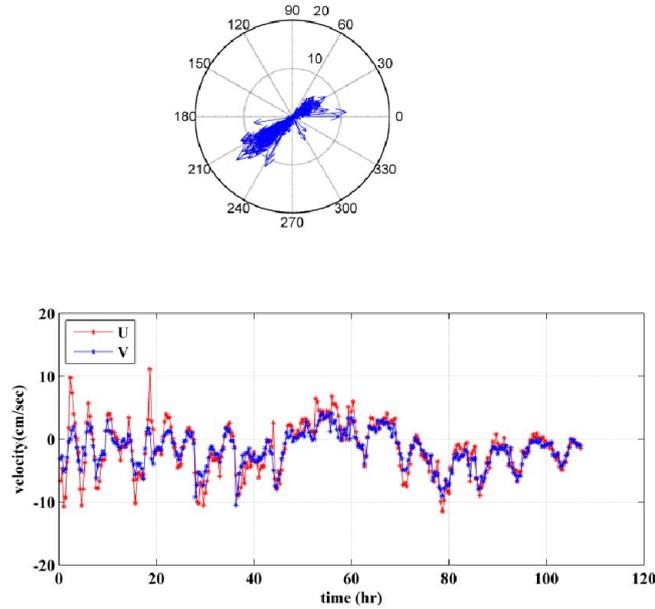
Figure 45. Observed nearshore currents at station S3 (Pillaichavadi)

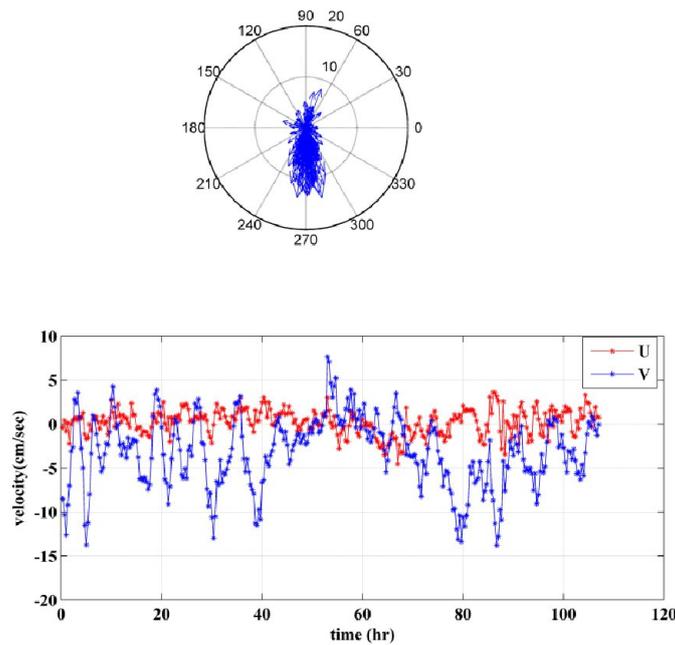
Figure 46. Observed nearshore currents at station S5 (Kuruchikuppam)

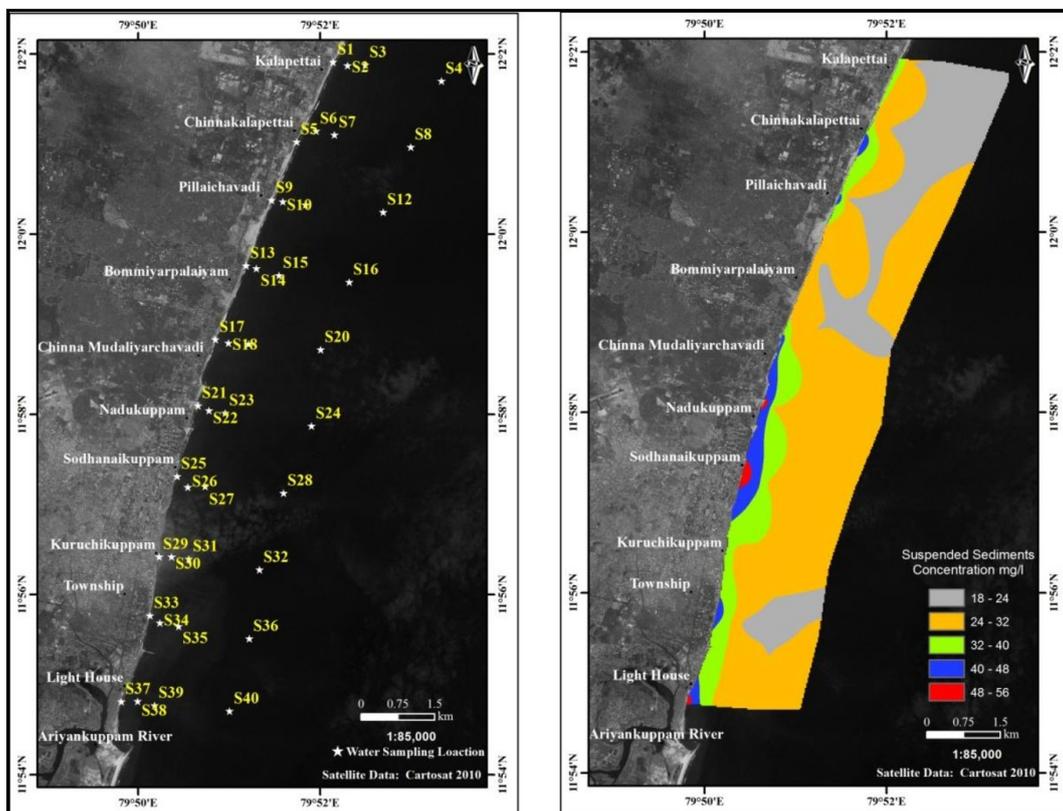
Figure 47. (a): Water Sample location and (b): Distribution of Suspended Sediments during NE monsoon period

Suspended sediment concentration was monitored from 40 stations along the Pondicherry coast during the period 03-17 January 2012 (Figure 47). During the survey, samples were collected from Pondicherry port to north of Kalapettai village using water sampler from 4 discrete depths (4 to 15 m depth). Relatively high concentration of suspended sediment (40 - 56 mg/l) was observed along the beach stations and reduced concentrations (24 mg/l) were observed in the region beyond 13 m water depth (Figure 47).

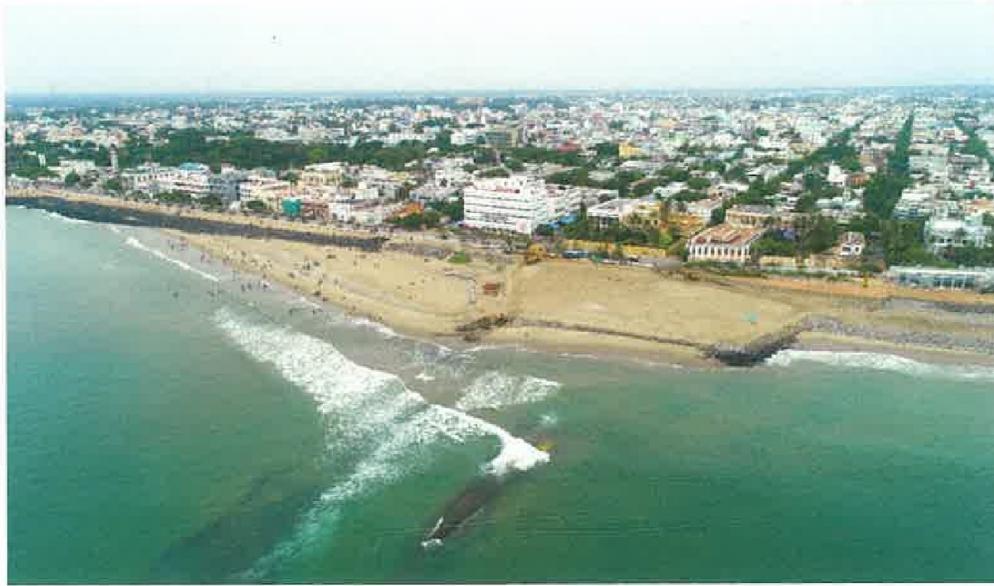
**Northern Reef Completed in October 2018**

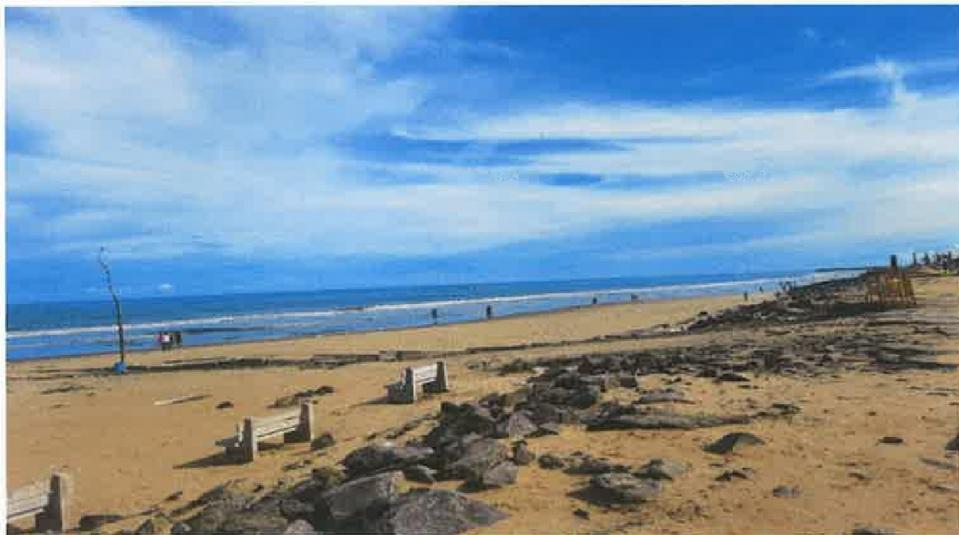
**Beach Formed October 2021**

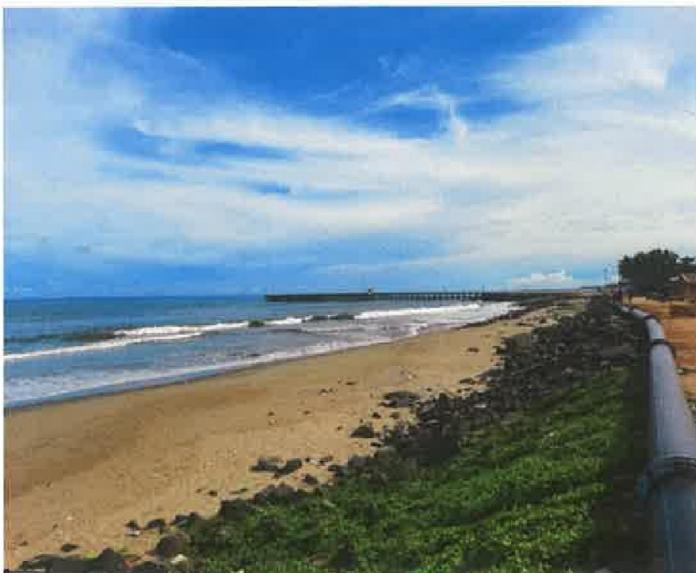
**Beach Nourishment by Dredging - October 2021**

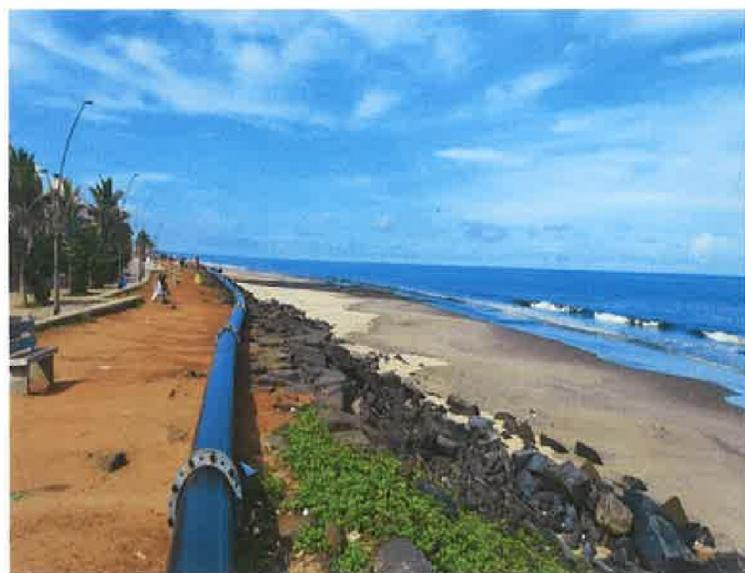
**Sand bypassing through Pipe October 2021**
