**BEFORE THE NATIONAL GREEN TRIBUNAL (SOUTHERN ZONE)
AT CHENNAI**

O.A. No. 52 of 2024

APPLICATION NO. 52 OF 2024 (SZ)

In connection with the work being executed by the Mangalore Smart City Limited (MSCL) regarding the 'Waterfront promenade development on Netravathi river bank of MangaluruThota and Jeppinamogaru village' as per the honorable NGT in order dated 30.05.2024, the project site was inspected on 30.05.2024 between 5.30 pm to 6.40 pm and photographs taken are annexed.

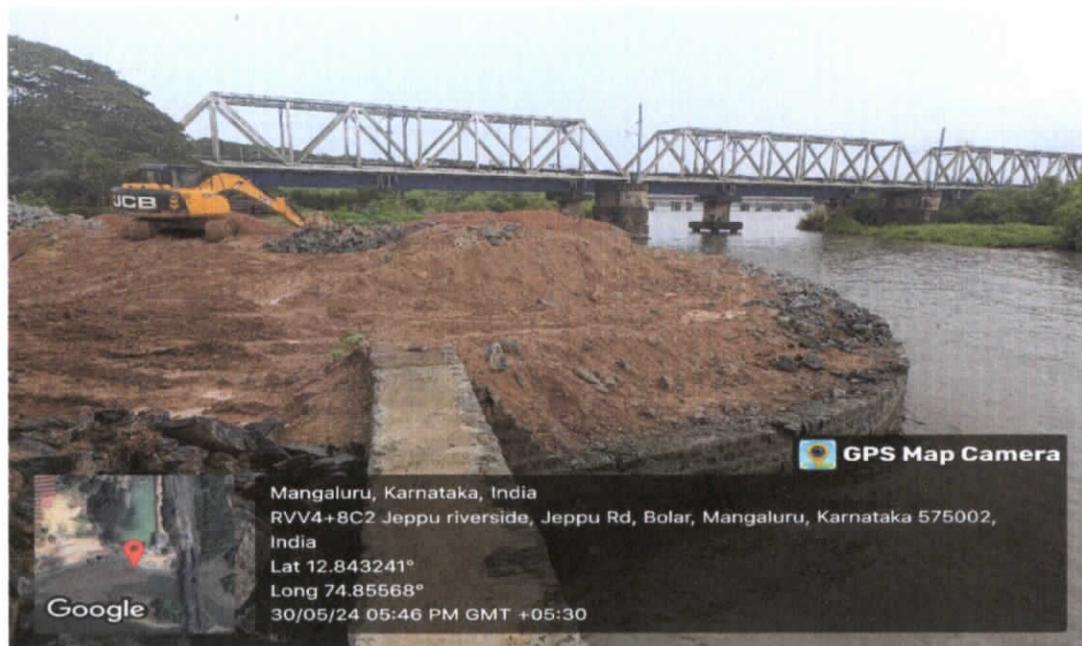
Fig.1

Site Details	Activities	CRZ Norms
Near the Nethravathi railway bridge beside the Commonwealth tile factory.	Retaining wall has been constructed in CRZ IB area and land filling has been done (Fig. 1).	This is not mentioned in the clearance issued by KSCZMA dated 07.10.2022 and hence a violation. Regarding this a letter was issued to Managing Director, MSCL on 05.02.2024 to remove the violation. The Managing Director, MSCL in their letter dated 07.02.2024 mentioned that the work in CRZ IB was done by the contractor by mistake to store the material and he has been instructed to remove the construction done. During the spot visit conducted on 30.05.2024 as per the

honorable NGT in order dated 30.5.2024, it was observed that the removal of soil and the retaining wall was in progress (Fig.1).
	In the other parts, retaining wall is constructed on the old retaining wall (Fig.2). Construction of cycle track, walking track and proposed structures was in progress (Fig. 3)	Cycle track, walking track and proposed structures are found to be on stable river bank (CRZ II) as mentioned in the NOC.
Near the TVS tyre factory abutting J.P. Morgan tile factory.	New retaining wall has been constructed on existing old retaining wall in one stretch (Fig. 4) and in another stretch new retention wall is constructed in CRZ II area (Fig. 5). Foundation for toilet blocks are being laid (Fig.6).	Retaining wall seen to be constructed in CRZ II area. Toilet blocks are being constructed on landward side of the old structures.
Near Coronation Tile factory	Concrete drainage structure have been constructed and also area for berthing of boats and steps were seen (Fig.7). Work was under progress with mud and boulders (Fig. 8)	New retaining wall is constructed above the old existing retaining wall. Work was under progress in stable CRZ II area.

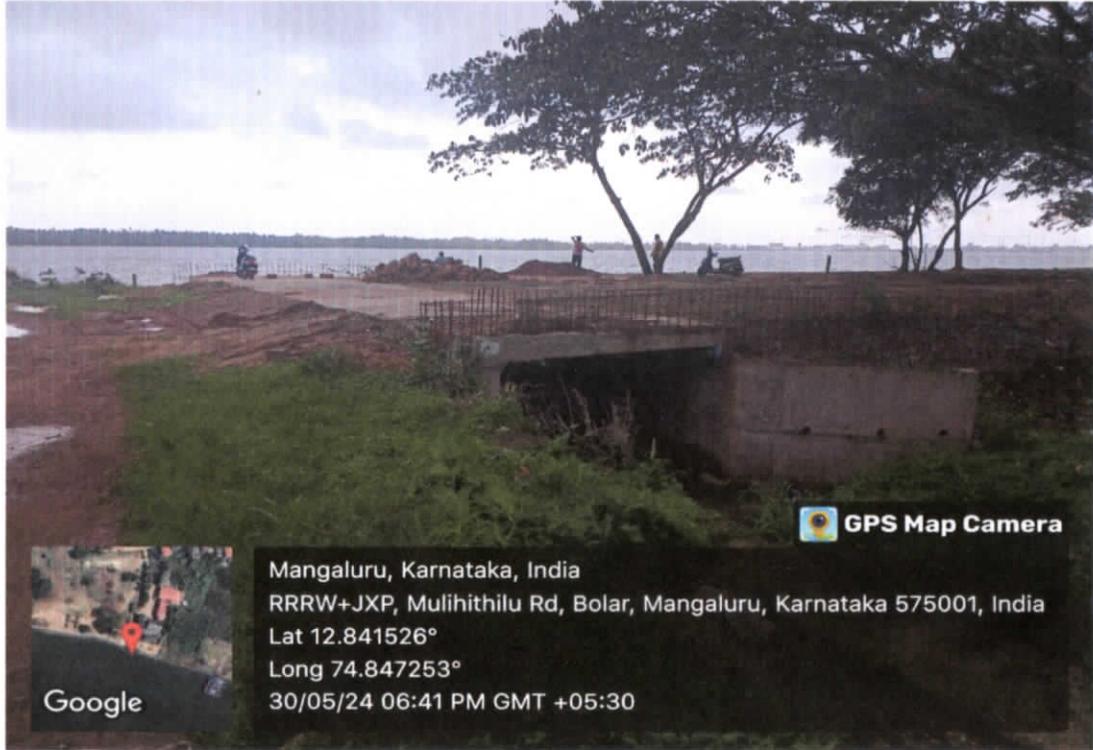
Fig. 9

Near the premises of DK and Udupi District Fish Marketing Federation, Mulihithlu area	Concrete storm water drain has been constructed (Fig. 9). The new retaining wall is constructed over the old existing retaining wall (Fig. 10). Levelling of land and soil work was seen.	In the NOC it reads "It has also been submitted that concrete structures will be avoided to the maximum possible extent". Levelling of land and soil work is in CRZ II area.
---	---	--
