**BEFORE THE NATIONAL GREEN TRIBUNAL (SZ), CHENNAI
MEMORANDUM OF APPEAL**

APPEAL No. 55 of 2022

**ADDITIONAL REJOINDER AGAINST THE COUNTER AFFIDAVIT FILED
BY THE 5TH RESPONDENT**

| SL NO. | DATES | PARTICULARS | PAGE NOS |
|---|---|--|---|
| 4. | | ANNEXURE A21: True copy of the relevant pages of Studies on land disturbances due to soil piping affecting the critical zones in Western Ghats of Kerala by NCESS | 28 - 48 |

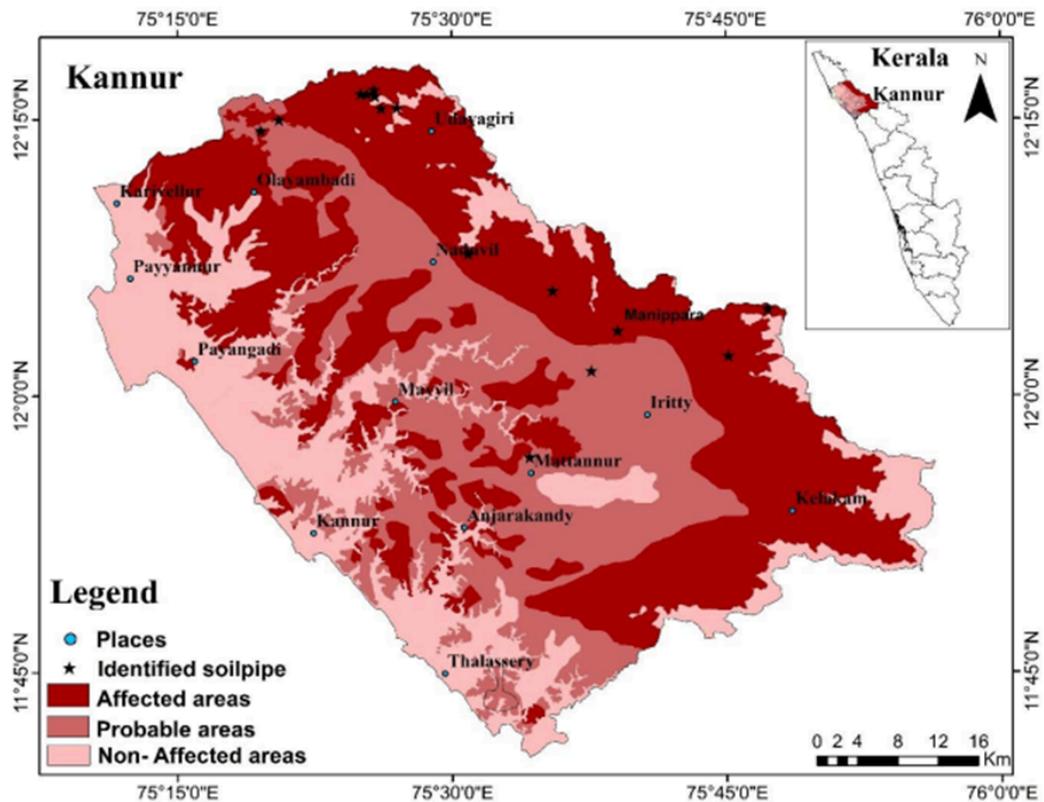
Figure 4.41: Zonation map of Kannur

“The total area of the district is 2996 square kilometres in which 1224.931 km² is falling inside the Affected zone and 993.192 km² is falling inside the Probable zone which means a good portion of the district is vulnerable.” A copy of the zonation map along with the report is reproduced below

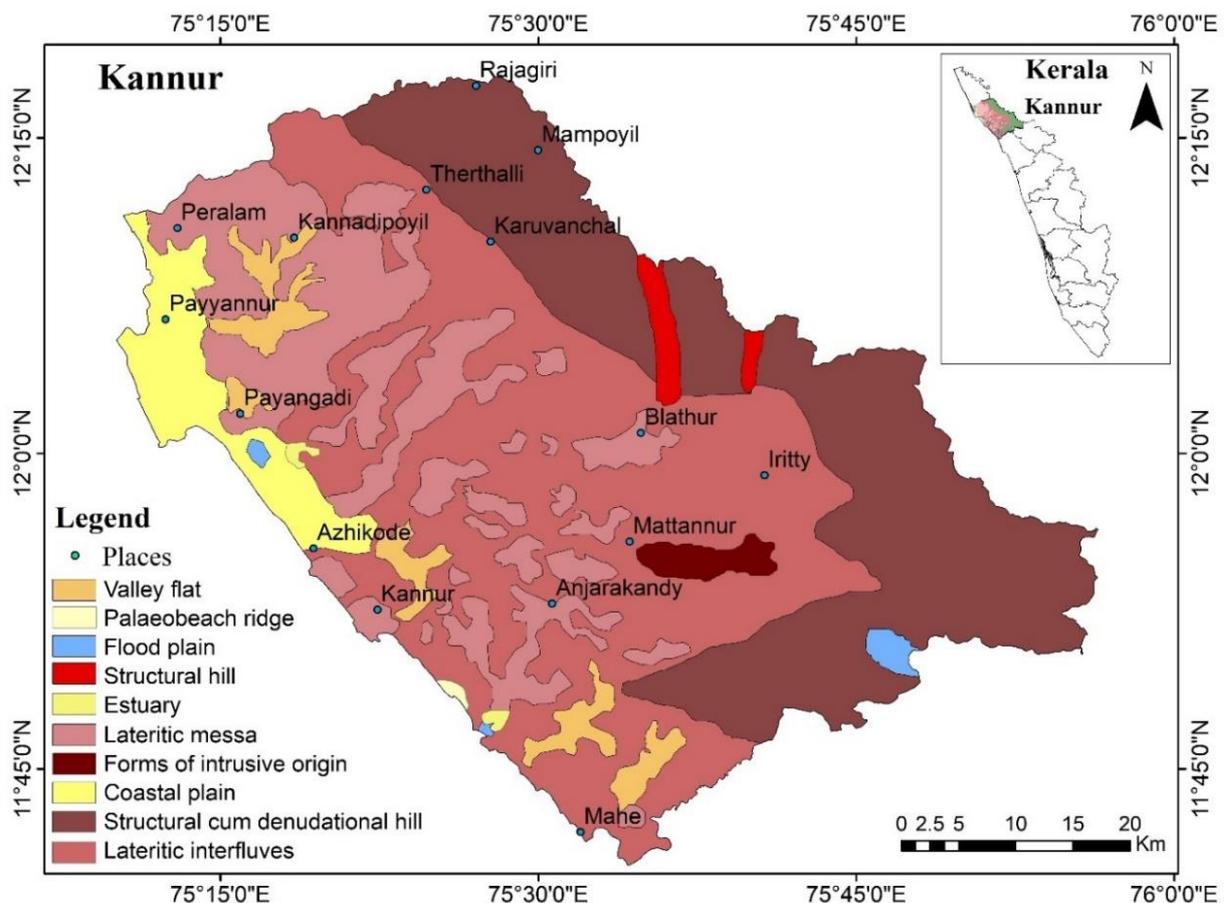
Figure 4.31: Geomorphology of Kannur District

The hilly region in the east is a structural cum denudational landforms, where the elevation is generally above 500m. Hills have very steep slopes. Landforms of intrusive origin are also noticed near Peralimala and Ezhimala. The hilly tract in the eastern part consists of highly rugged terrains. The Ezhimala peak with the characteristic N-S alignment is a distinct

physiographic unit in the coastal plains. Minor cliffs of laterite generally rising to an elevation of 50 to 60 m above mean sea level are found at Mahe, Thalasserry and Bekal coast. The midland region presents a plateau land covered by a thick cover of laterite. This is immediately to the east of the coastal strip, rising from 40 to 100 m above msl. The valleys in the plateau are gorge like and V shaped cut by youthful streams. The hilly tract along the eastern part of the district constitutes the highland region and is highly rugged. Development of bad land topography along the margins of the valley is a common feature observed in the district.

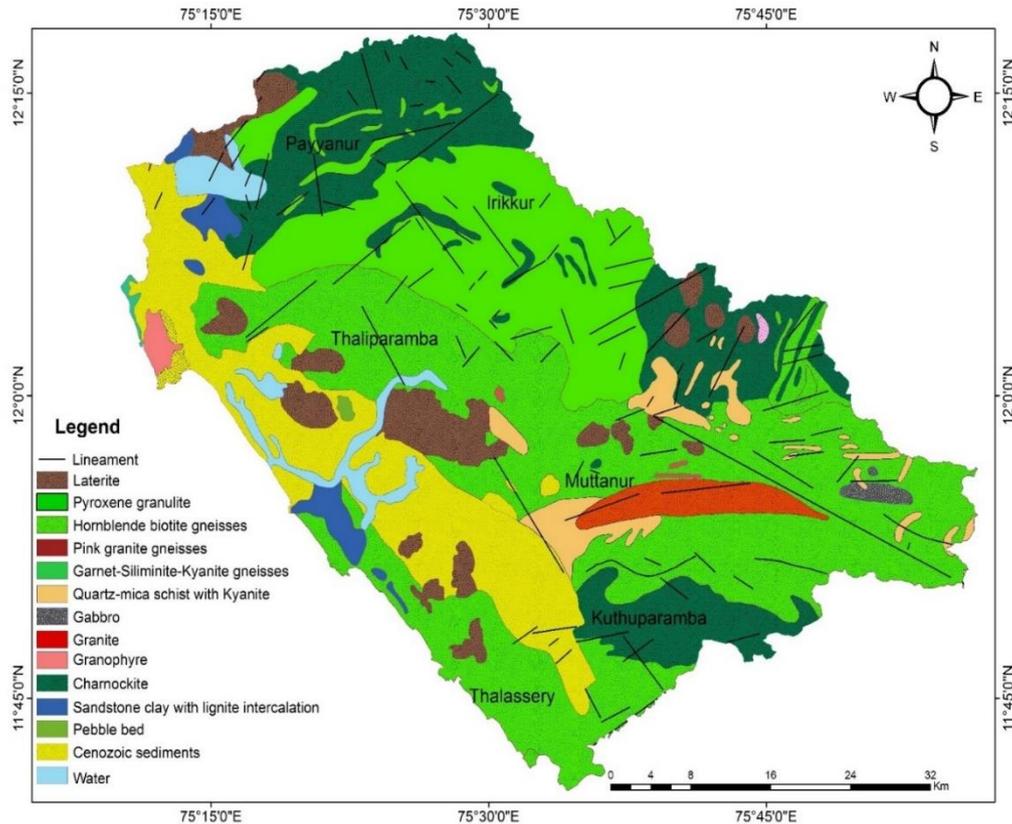
Figure 4.32: Geology of Kannur District

pyroxene granulite, charnockite (hypersthene granulite) and hornblende-diopside granulite. While hornblende granite and charnockite occupy large areas, pyroxene granulite occurs as linear bodies in the southeast. Hornblende-biotite gneiss constitutes the lithological unit of Migmatite Complex. It has a large areal extent along the coast, south of Kannur. Towards east and southeast, discrete metasedimentary and ultramafic sequences which have been designed as Wayanad Schist Complex and are considered equivalent of Sargur Group of Karnataka. They occur as isolated bands within charnockite and gneiss. Their contacts are generally discordant due to later folding, metamorphism and migmatization. The group comprises quartzite, magnetite quartzite, garnet-kyanite-sillimanite gneiss, quartz-mica-kyanite schist, quartz-sericite schist, amphibolite, kyanite-sillimanite-sericite quartzite, and metaultramafites. Garnetkyanite-sillimanite gneiss/schist is widespread in the east, whereas the other members of Wayanad Complex occur as linear bands, lensoidal bodies and vestiges to the West Peninsular Gneissic Complex, represented by hornblende-biotite gneiss comprise of a complex suite of gneisses and granites, representing the anatectic phase of migmatization of schist complex. East of Kannur extending up to Tellichery in the south, a large body of quartz-mica schist is separated from the other schistose rocks by a conglomerate horizon extending over 8km. This lithounit is known as Vengad Formation, characterised by lack of migmatization, presence of primary structures and absence of high-grade minerals, and is correlatable with rocks of Dharwar Super Group. Large bodies of anorthosite, gabbro, granite and granophyre from the post Vengad basic and acid intrusives. Dolerite dykes trending NW-SE represent the younger basic intrusives. Late Tertiary sedimentary rocks (Warkalli beds) occur as isolated patches along the coast near Kannur, Pazhayangadi and east of Payyannur. They comprise variegated clays and friable sandstone. At Kannur and Pazhayangadi, carbonaceous clay with thin seams of lignite is reported towards bottom of the sedimentary sequence. The Tertiaries as well as the basement rocks are extensively lateritised. The pebble bed, reported near Valapatnam along the bank of Valapatanam River, is considered to be of Quaternary age. Quaternary alluvial deposits occur along the coast and in the valleys.

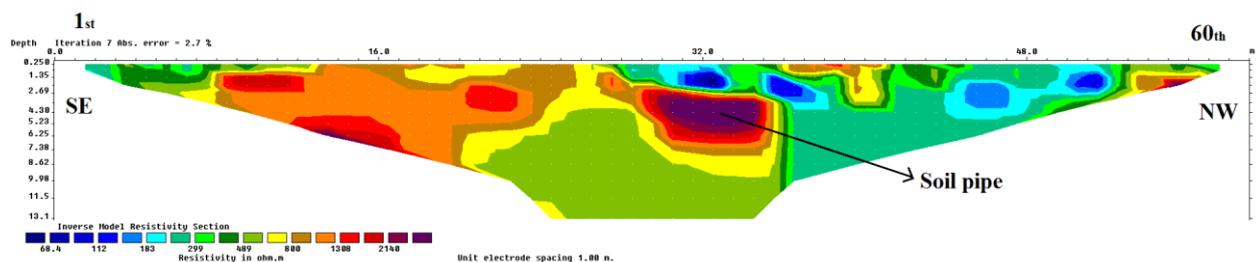
Figure 4.34: Inversion model of the ERT profile

The figure shows electrical resistivity tomographic sections of Schlumberger, array along the suspected area. This profile is laid near to the exposed part of the soil pipe. The survey line is oriented in the SE-NW direction and the depth resolution is ~16.9 m. The inverse model resistivity section, prima facie indicates a highly anisotropy in the entire section. A 3.5 m wide high resistivity zone present between 1.35 and 5.23m depth, near to the 32th electrode position.

The high resistivity in this region is may be due to the pipe. The moderate resistivity with lateral and vertical variation in between 1st and 30th electrode indicates hard resistive rock boulder with different layers of weathering condition.

The study shows that the land subsidence was due to the soil piping. Subsurface tunneling is wide spread in the affected localities and their size varies from few centimeters to couple of meters. The present pipe is a circular, with 1-foot radius. Electrical resistivity tomography has applied to know its extension and direction.

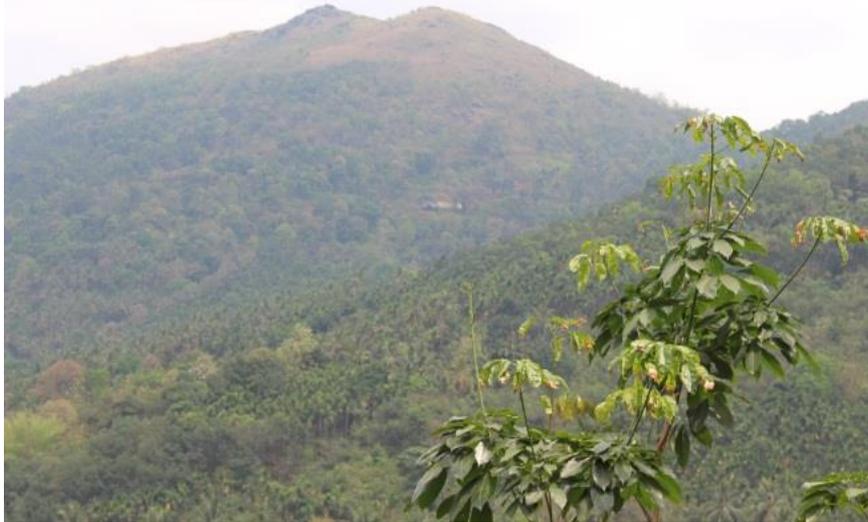
Fig.4.36: A distinct view of Kottathalachimala

The affected area located in the highland region with elevation reaching up to 830 m. The characteristic of Kottathalachimala is its anomalous slope compared to other hills, nearby area. Upper slope is about high slope ($+31^{\circ}$). where is the lower slops are about $+24^{\circ}$. Kottathalachimala is characterised by radial drainage indicating it shape? Many lower order streams originated from this hill. The hill is surrounded by Pulingom River, Thirumenichal and Ponpuzha Ar.

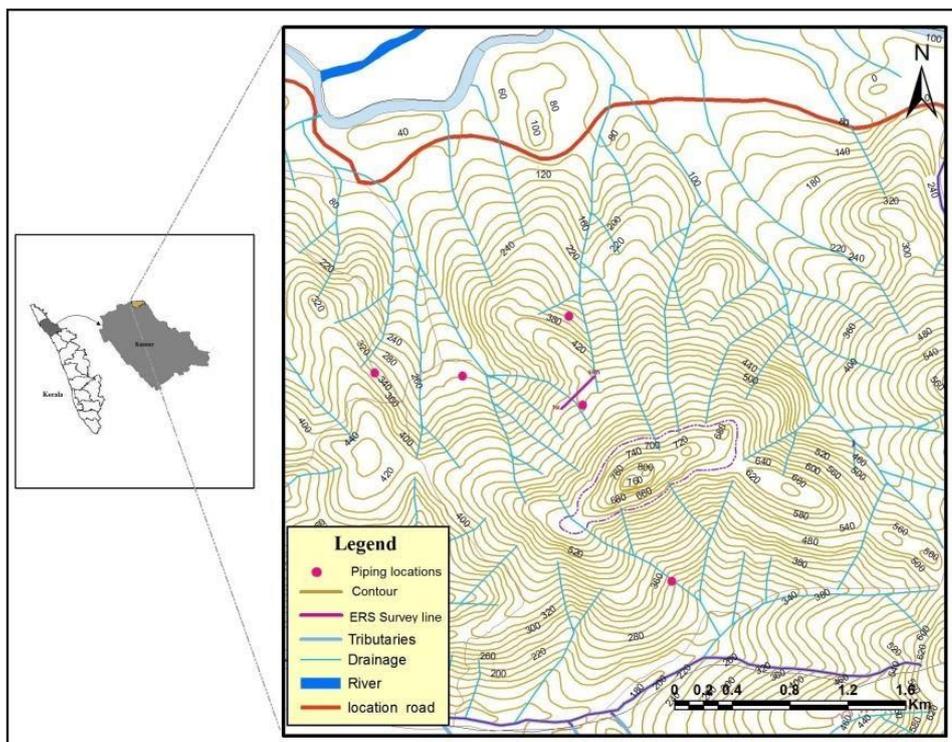
Fig 4.37: The Electrical Resistivity Survey layout in Kottathalachimala

Geophysical surveys were conducted in affected localities of Kottathalachimala, (fig 4.2.7) Taliparamba Taluk, Kannur to determine suitable method for delineation of pipes. Two resistivity profiles were laid across the alignment of soil pipes using the instrument WDJ4. The layout of these Electrical Resistivity Sounding (ERS) locations is given in figure1. A detailed description of the studies and their preliminary results are given here.

The resistivity data obtained from the ERS were retrieved to a computer and converted for interpretation by RES2DINV software (4.2.7 and 4.2.8). The interpretation of the data of each ERP carried out in specific array system provided apparent resistivity section, calculated apparent resistivity pseudo-section and inverse model resistivity section.

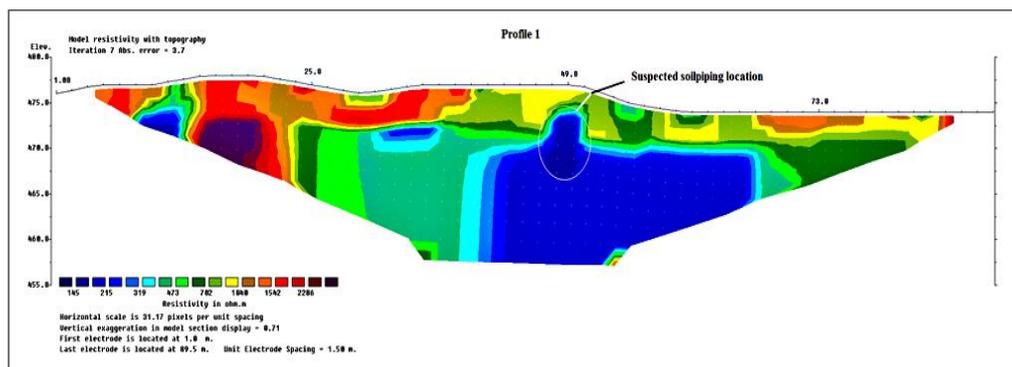
Figure 4.38: Electrical resistivity tomographic section of Schlumberger array at 1.5m electrode spacing

A profile with different electrode separation is laid across the soil pipe at 12m north of its inlet on the down slope side oriented in the EW direction. The figure 4.38 and 4.39 shows 2D electrical resistivity model of Schlumberger array with topographic correction. The corresponding resistivity with an electrode spacing of 1.5m (total profile length of 90m) and 1m (total profile length of 60m) respectively. The inverse model resistivity sections, prima-facie indicates highly anisotropic near-surface layers. There is a low resistivity zone within which a conspicuous low resistivity round-shaped feature is seen at a depth of 5m almost in the middle of the profile. Considering the apparent layout of soil pipe, resistivity values attributed to the zone and the shape of the feature, it could probably be indicative of the soil pipe.

The interpretation of the resistivity section indicates that the technique could delineate the low resistivity zones where the soil pipes are formed, subject to dimension. However, more detailed investigations with varying electrode configuration, different arrays etc. need to be attempted to get more clarity.

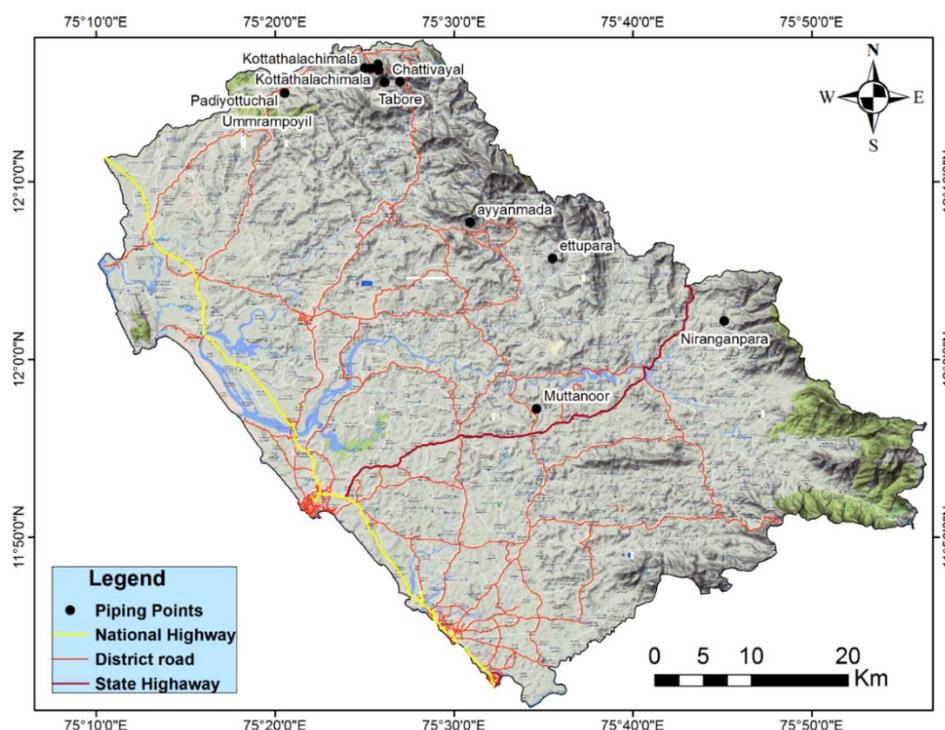
Figure 4.40: Piping location in Terrain map, Kannur

The Kannur district is prone for soil piping incidents. As the district is suspected with a total 17 number of soil pipes including minor and, major sized through stacking, scouting and geophysical investigations over the district. The geophysical, geochemical and sedimentological analyses of field data and samples collected during field investigations have given a clear idea that these pipes are occurring under certain conditions.
