**BEFORE THE NATIONAL GREEN TRIBUNAL SOUTH ZONE AT  
CHENNAI  
MEMORANDUM OF APPLICATION  
(Under Sections 14 read with 18(1) of the National Green  
Tribunal Act, 2010)**

Application No. 67 of 2022

**MEMO FILED ON BEHALF OF THE APPLICANTS**

## **Groundtruthing of CRZ violations of TANTRANSCO**

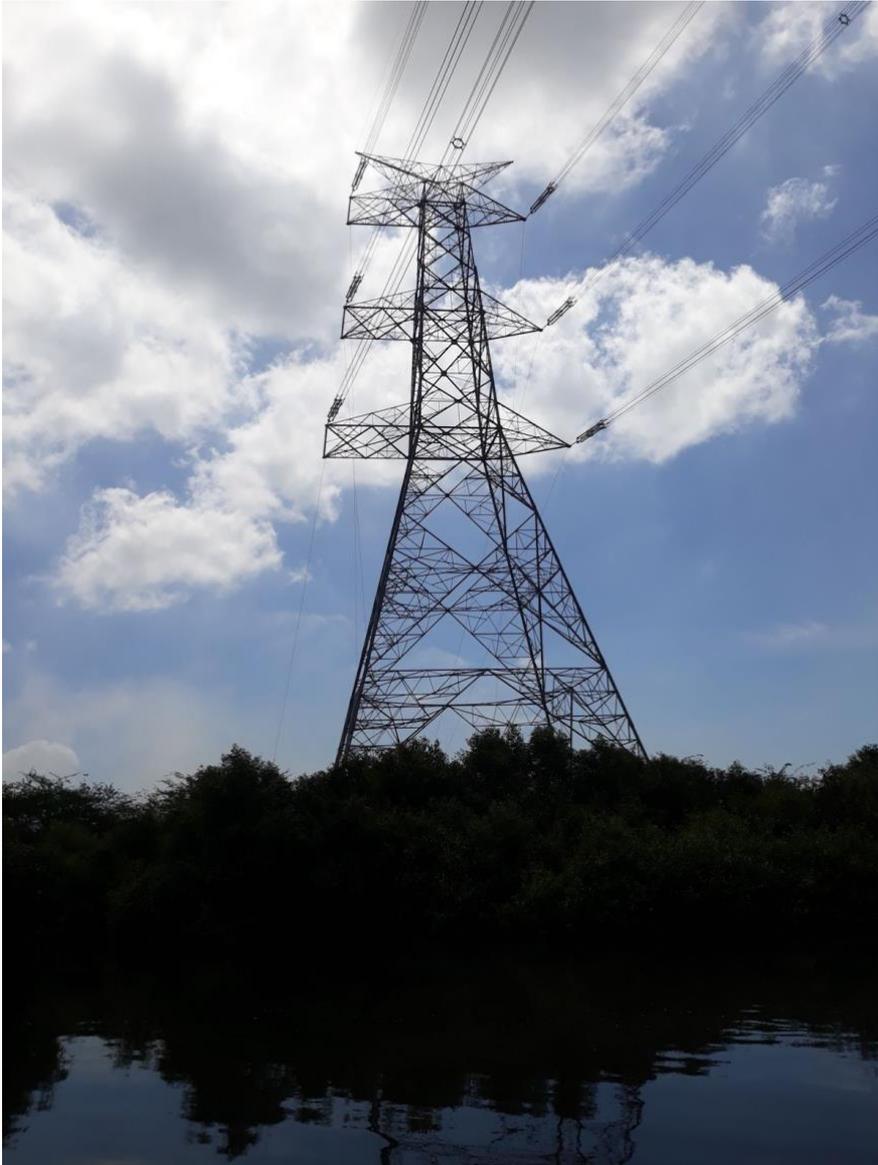
### 9. Appearance of 765kV Tower

765kV towers have 3 cross arms and V shaped peak (top structure)

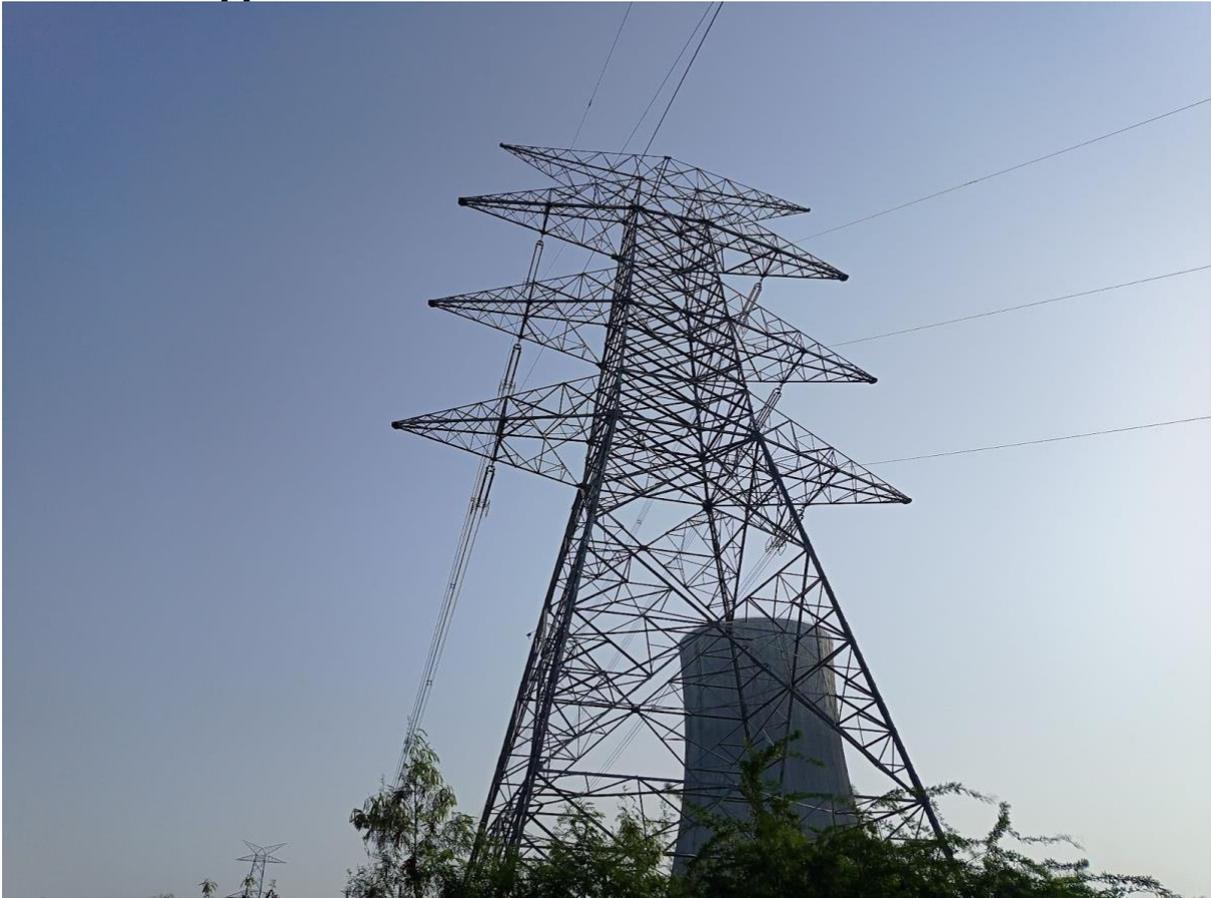
## 10. **Appearance of 400kV Tower**

400kV towers have 3 cross arms and flat shaped peak

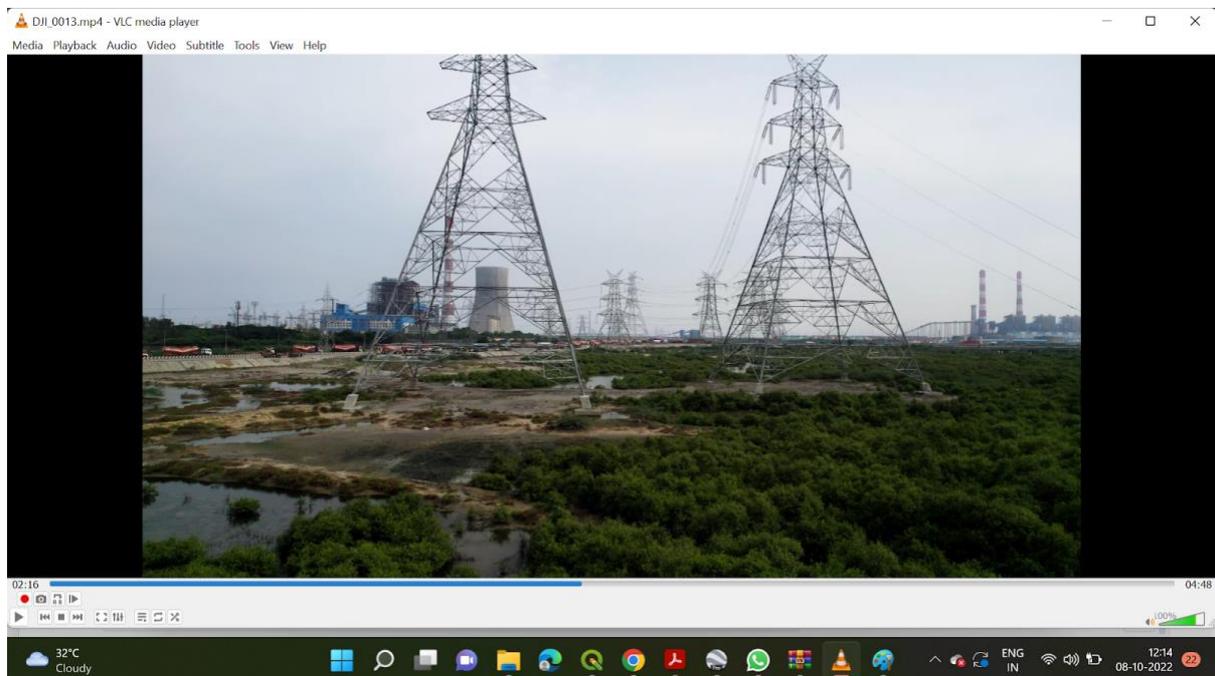
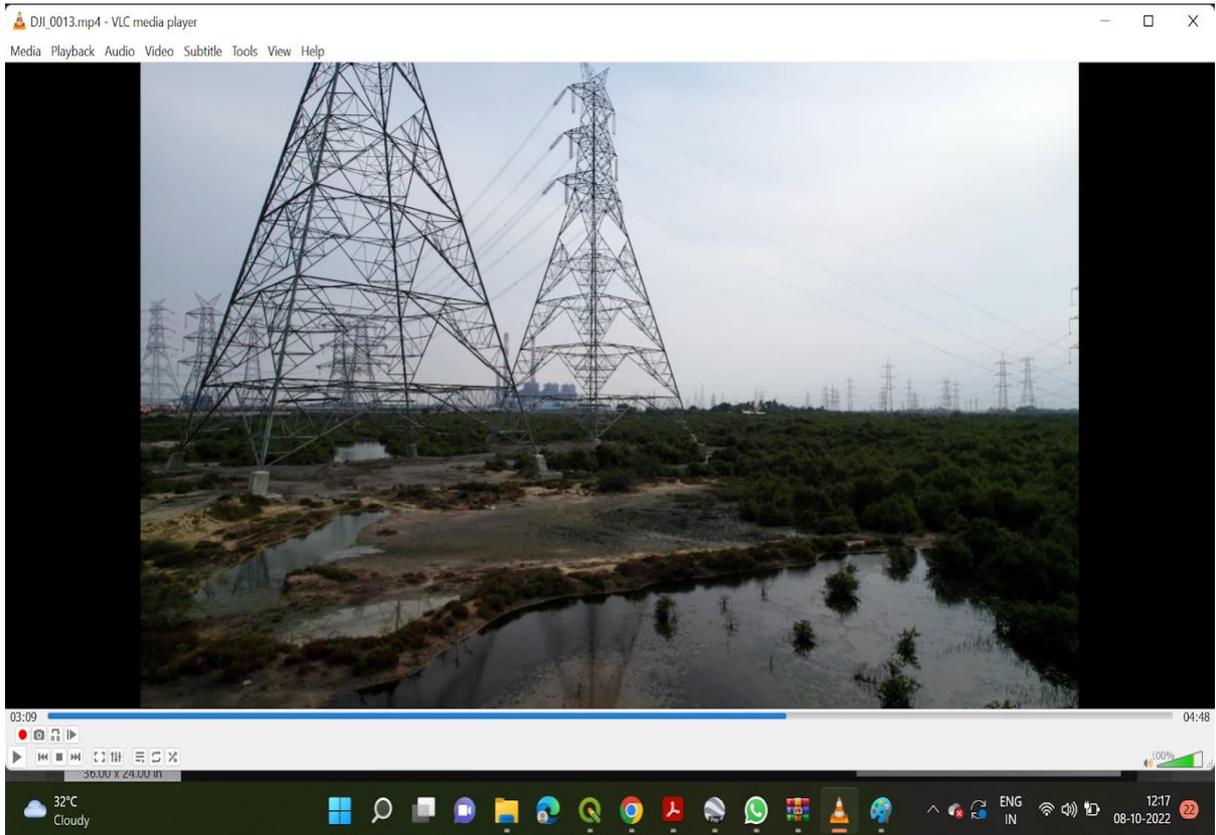
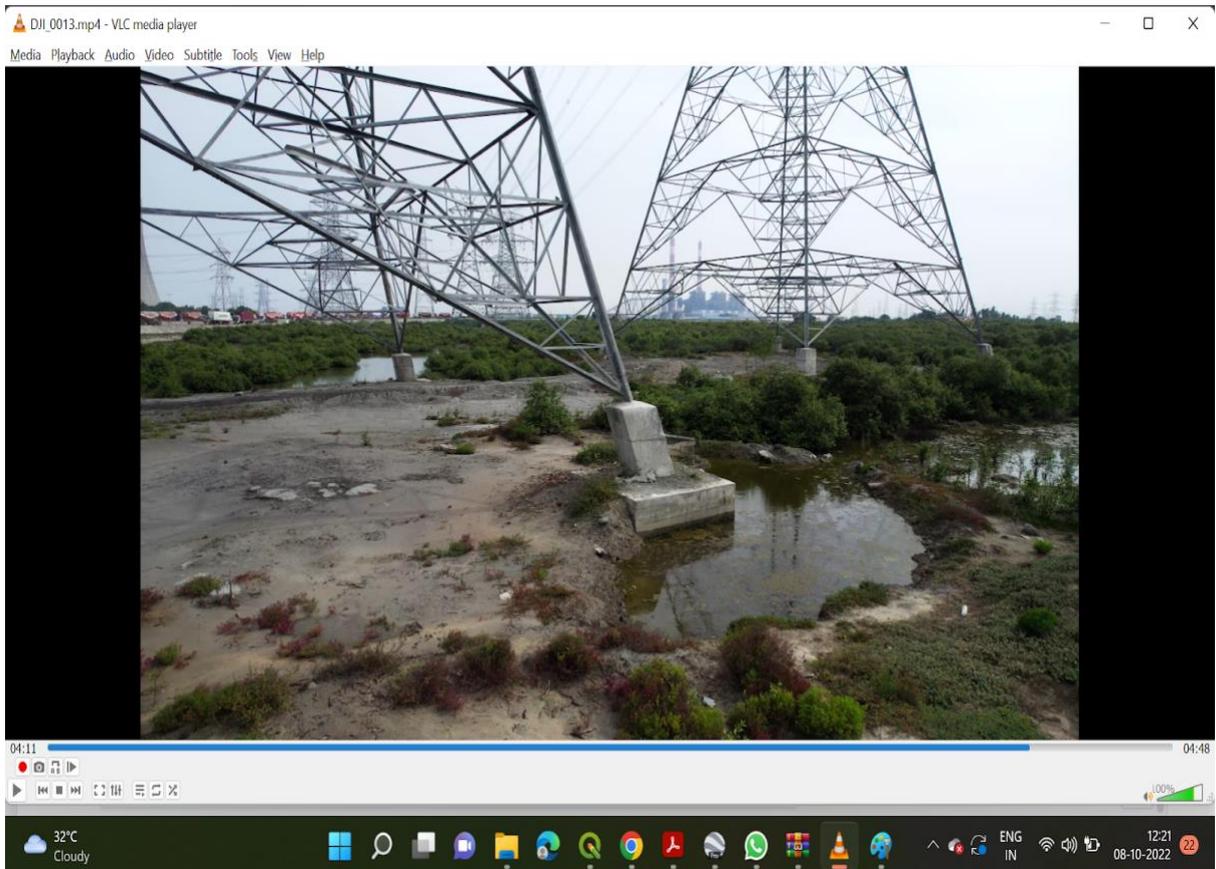
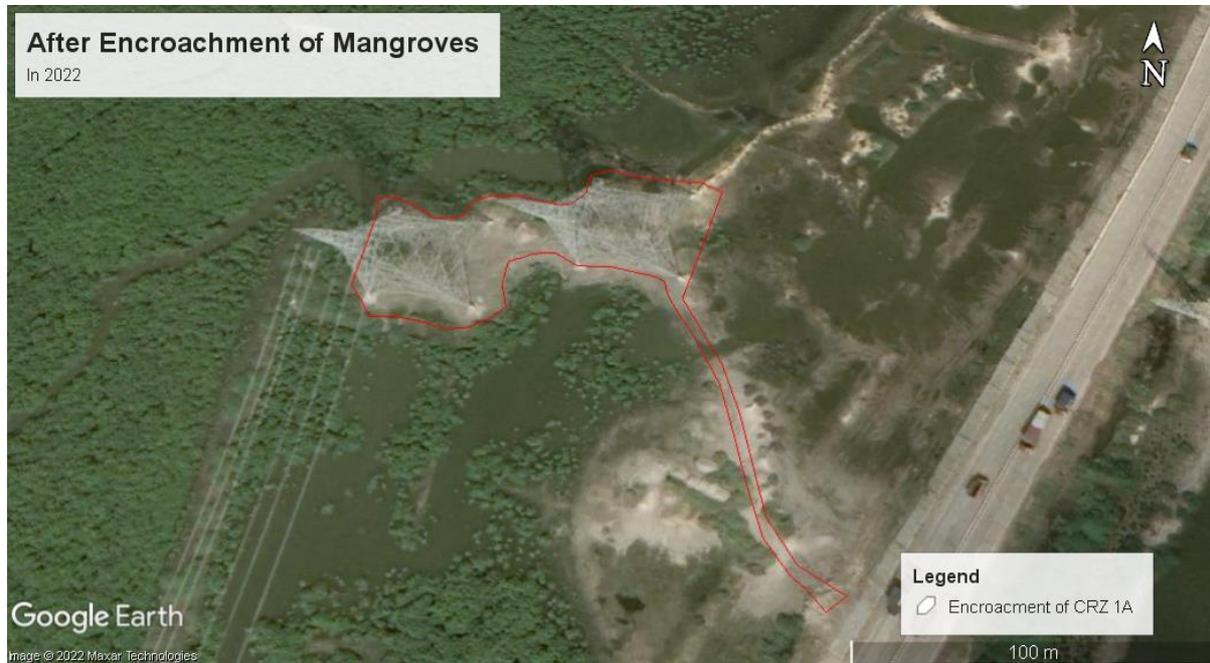
### **Destruction of Mangroves:**

20. 24 towers in total are constructed in CRZ IA areas as opposed to zero towers permitted in CRZ IA according to CRZ clearance.

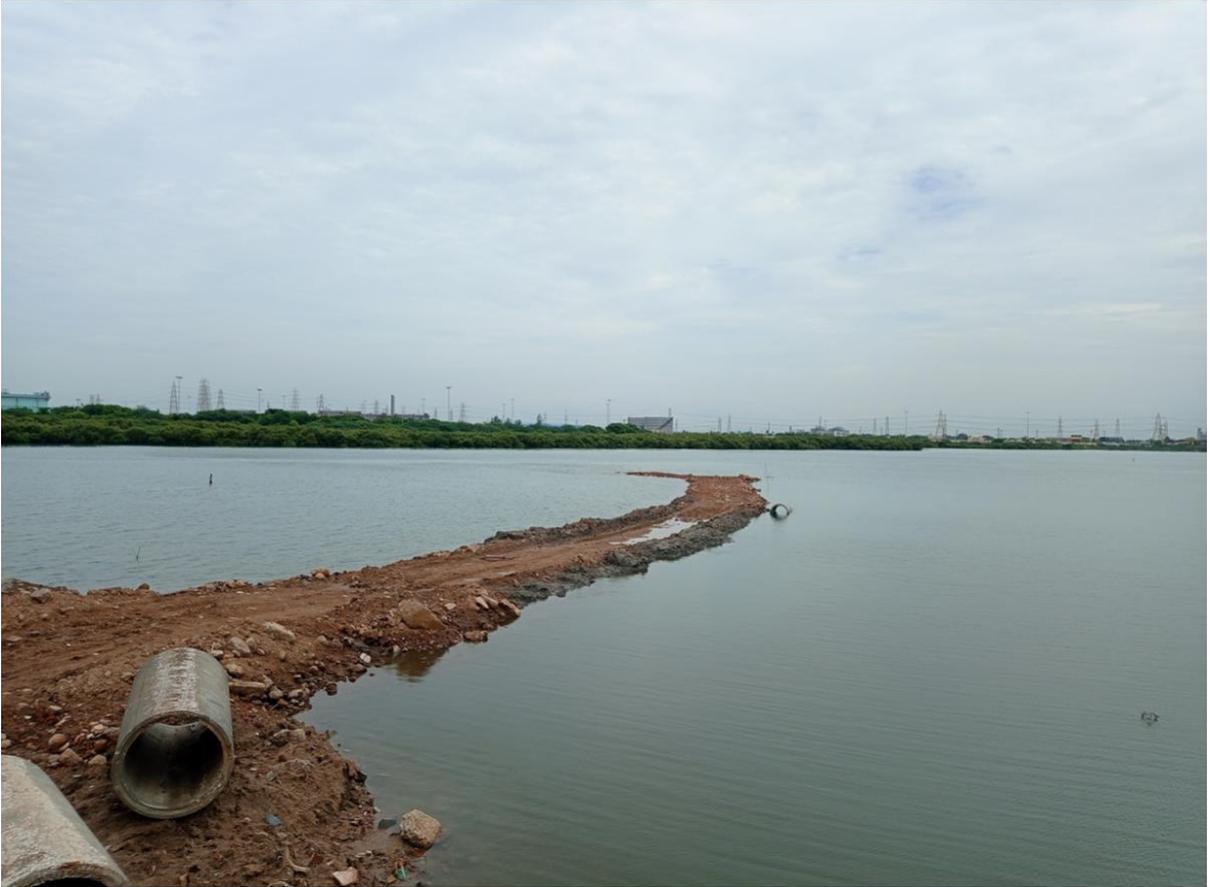
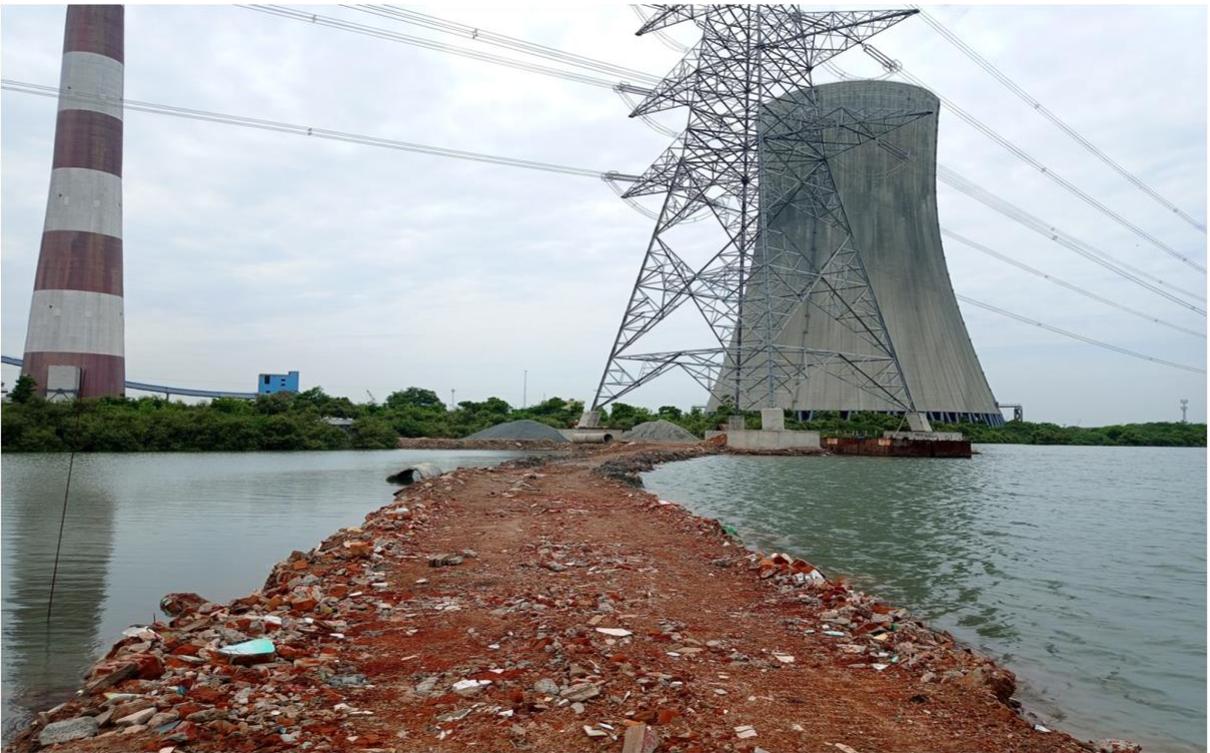
### **Physical Impact of encroachment inside waterbody:**

21. The encroachment inside Kosasthalayar opposite to the NCTPS III plant was carried out by dumping construction debris, dredged sea sand which is loose in nature. A 10 m road visible above water level will have a base of at least 20 metres on the river bed. Moreover, as more sand is dumped, the coarse particles of sand settle down and the finer particles are suspended and move with the tide and spread over a much larger proximal area. The riverbed here is altered by the deposit of fine sand. The non-removal of construction debris blocks the tidal flow and obstructs the movement of boats.

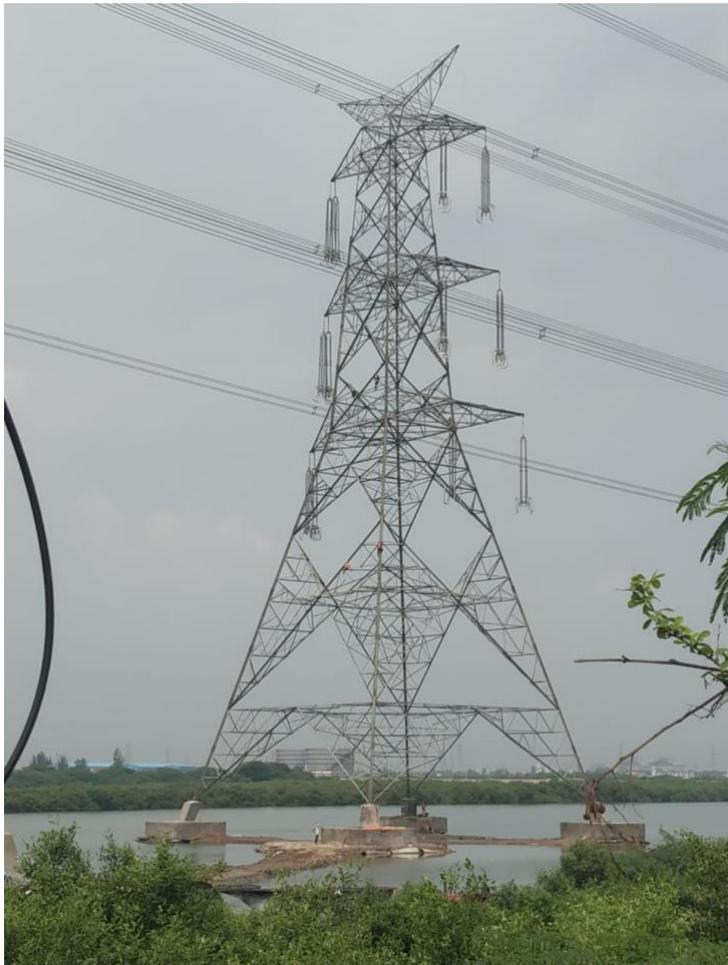
765kV Tower in violation of CRZ clearance obstructing the fishing ground.

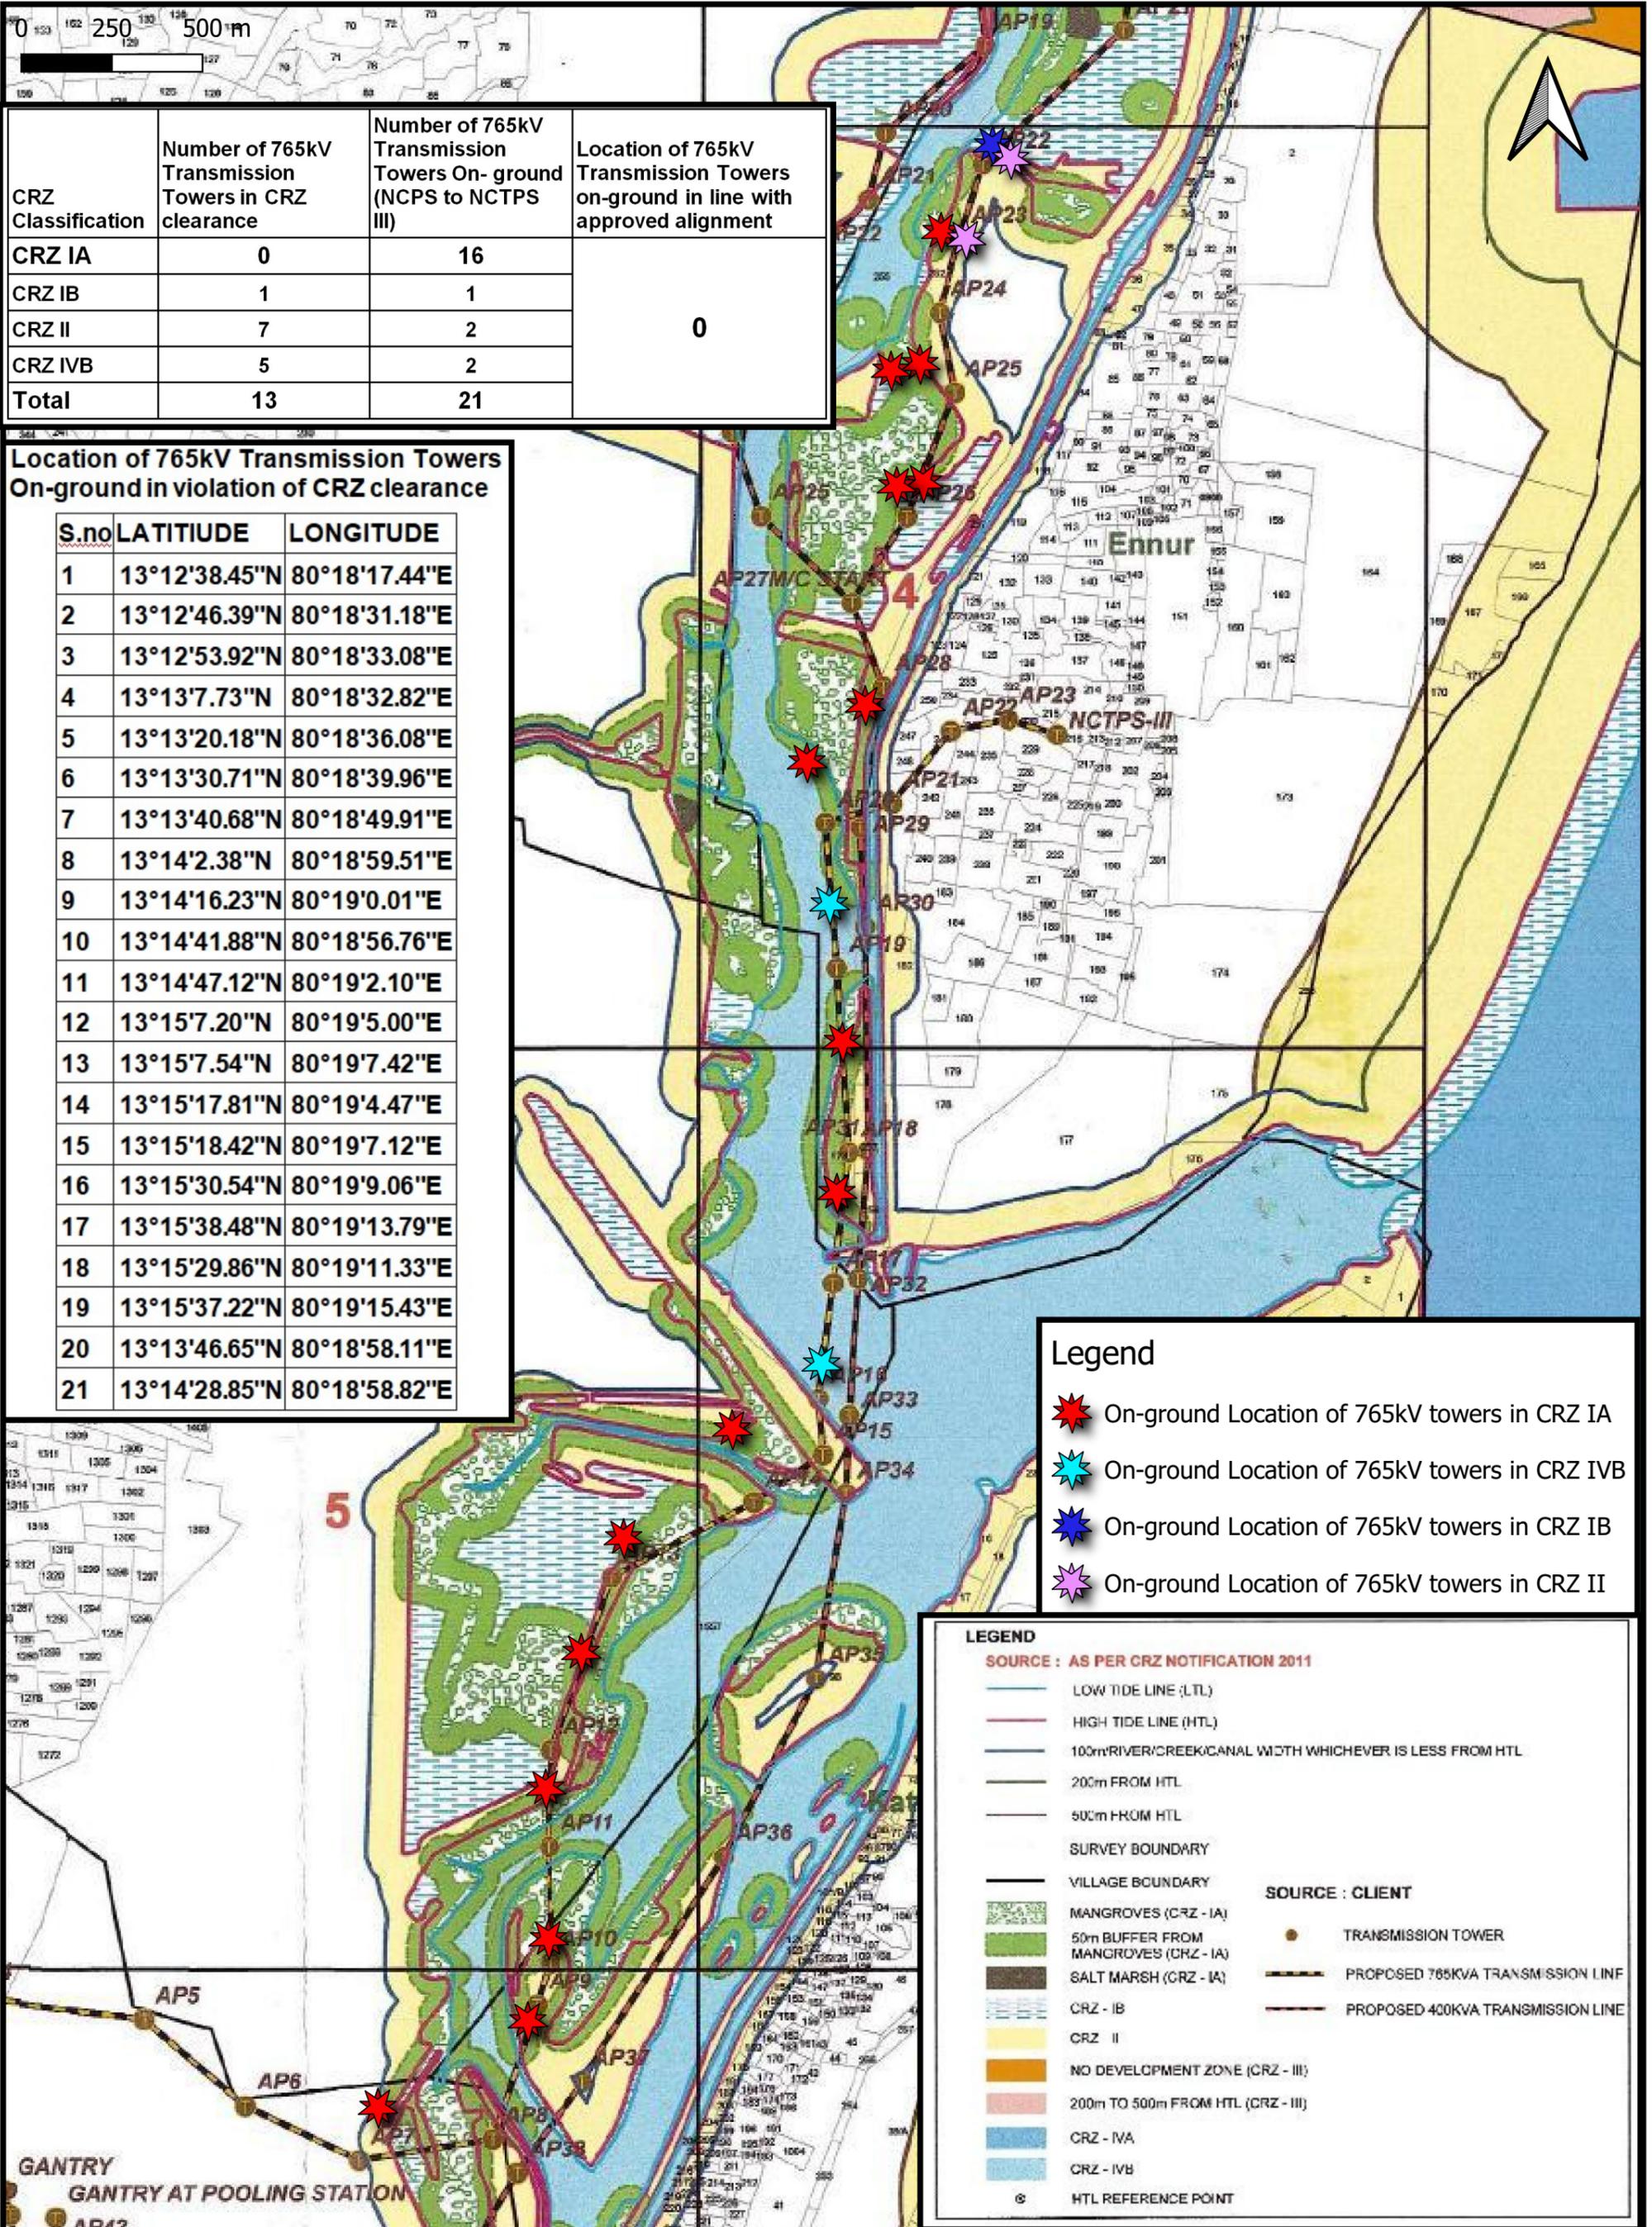
On- Ground Locations of 765kV Transmission Towers in violation of CRZ clearance overlaid on map submitted by TANTRANSCO for CRZ Clearance

17. The exact location where 765 KV towers have been constructed is marked on the approved CZMP. It is seen that these locations are falling in CRZ I A where admittedly no towers could be located.

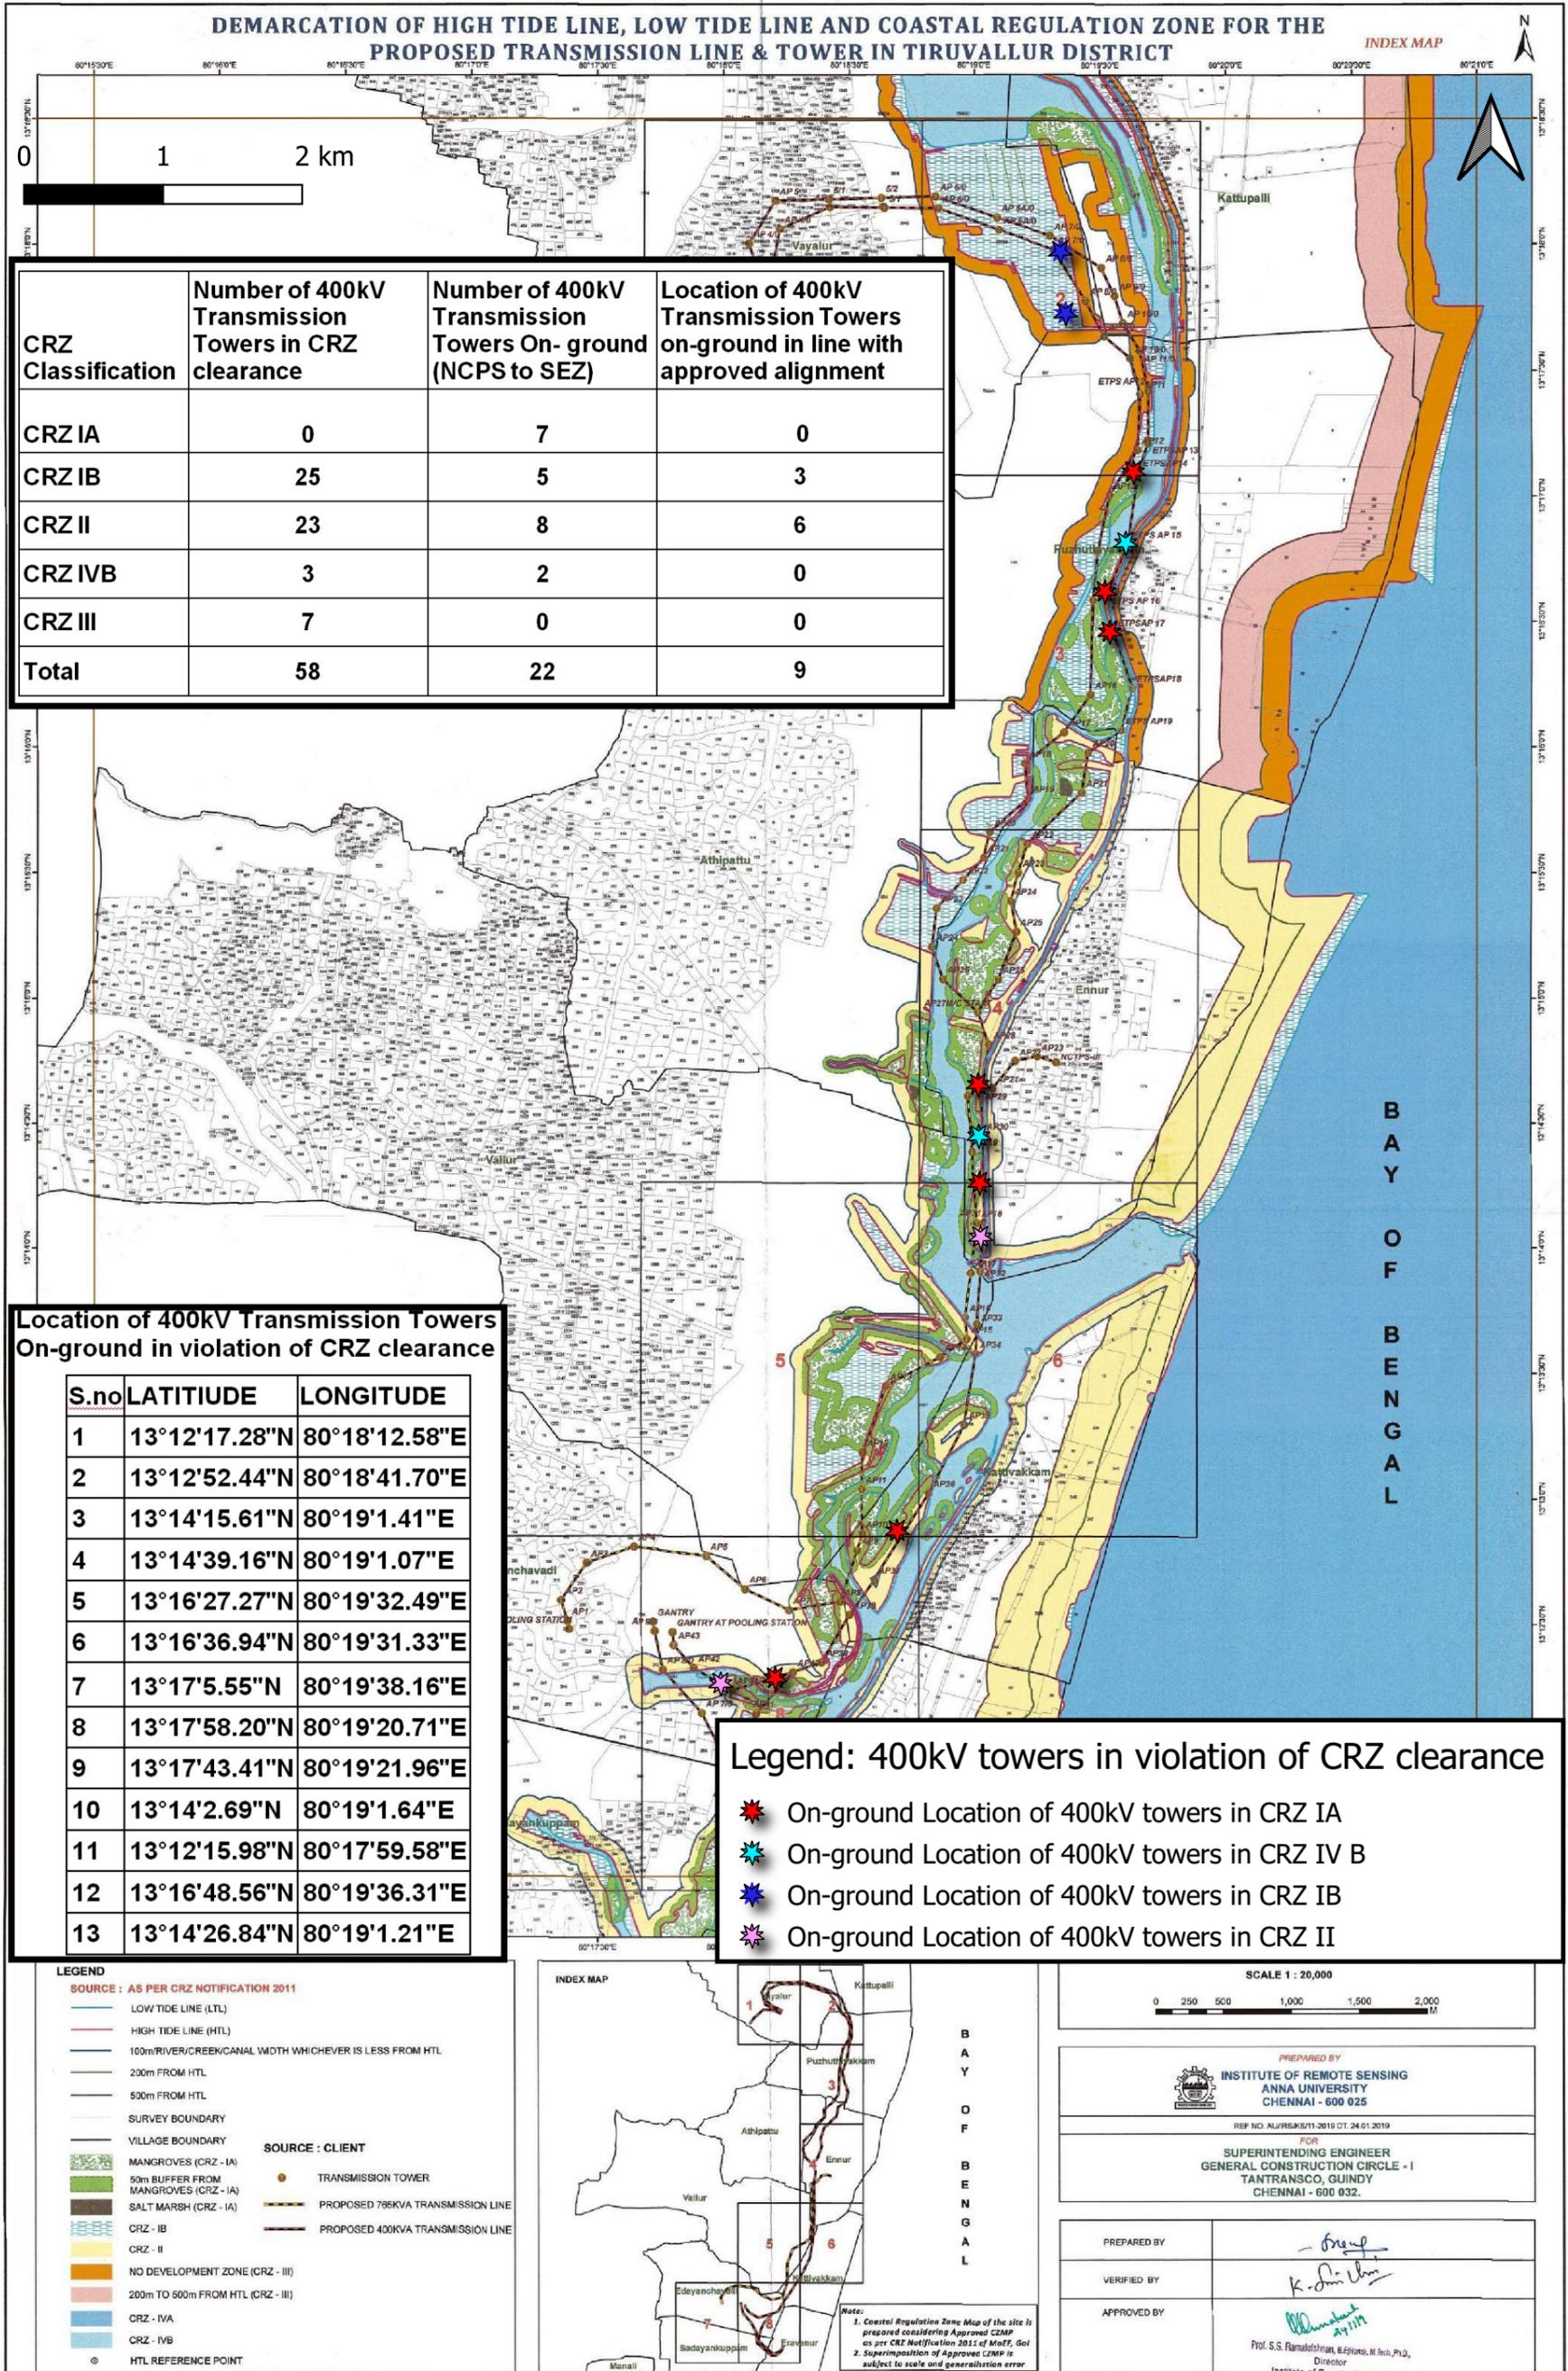
# On- Ground Locations of 400kV Transmission Towers in violation of CRZ clearance overlaid on map submitted by TANTRANSCO for CRZ Clearance

19. From the above table, it can be seen that a total of 7 numbers of 400kV towers have been constructed in CRZ IA where none are approved. Even among those towers approved in CRZ IVB areas, the two towers that have been constructed are in violation of the approved location.
