**BEFORE THE NATIONAL GREEN TRIBUNAL**

**Original Application No. 85 of 2021 (SZ)**

**SUBMISSION OF REPORT IN COMPLIANCE TO THE DIRECTIONS OF THE HON'BLE NATIONAL GREEN TRIBUNAL DATED:25.07.2023 IN ORIGINAL APPLICATION(O.A.)No.85 OF 2021 FILED BY M/s. PARISARA HITHARAKSHANA SAMITHI VERSUS UNION OF INDIA AND OTHERS IN SO FAR AS PARA 7,8 AND 9 are concerned.**

**Photographs Taken at the time of Joint inspection**

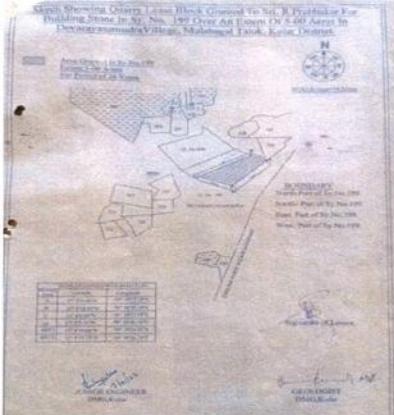
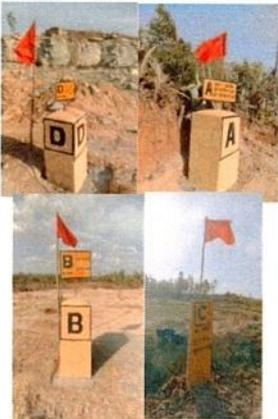
PHOTO:Lease Sketch	Boundary Pillars sketch	DGPS Co-ordinates		
		Boun dary Points	Latitude	Latitude

A	13°8' 9.48" N	78°19' 37.17' E
		B	13°8' 10.53" N	78°19' 35.10' E
		C	13°8' 6.69" N	78°19' 27.97' E
		D	13°8' 5.01" N	78°19' 32.51' E

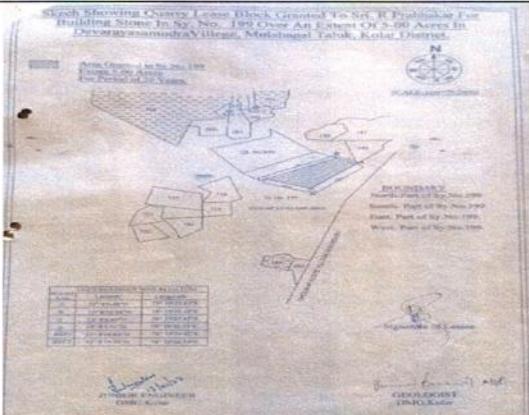
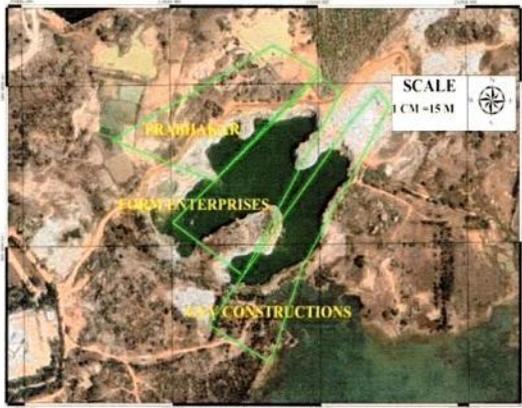
QUARRY LEASE SKETCH	Combined sketch of lease & expired block

4. The quarry lease granted over an extent of 5.00acres. The extent of quarry pit measures about 1.00 acres. photographs of the quarry lease and duringspot inspection it was found that a buffer zone of 7.5mts was maintained in three sides of quarry lease,i.e Boundary pillar B to C in the west, A to B in the north, C to D in the south. The easternboundary of quarry lease runs from point A towards D falls towards expired quarry lease No. 580 granted in favour of M/s. Form Stone Pvt Ltd over an extent of 5.26acres for a period of which came to be expired on 06.07.2009.

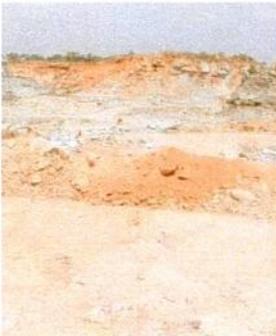
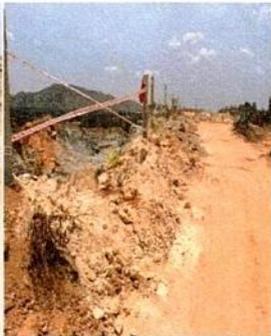
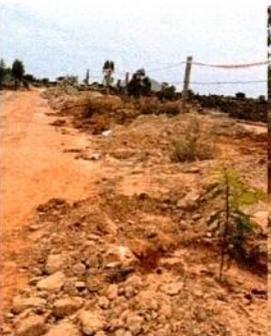
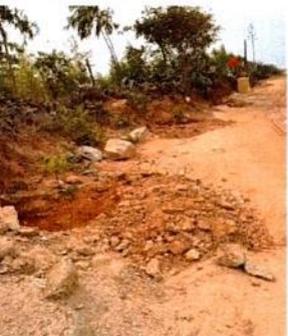
Lease fit	Approached Road	Buffer Zone	Plantation of lease

The Photographs showing- lease sketch, combined sketch, boundary pillars, Lease detail board, Buffer zone are annexed to the report.

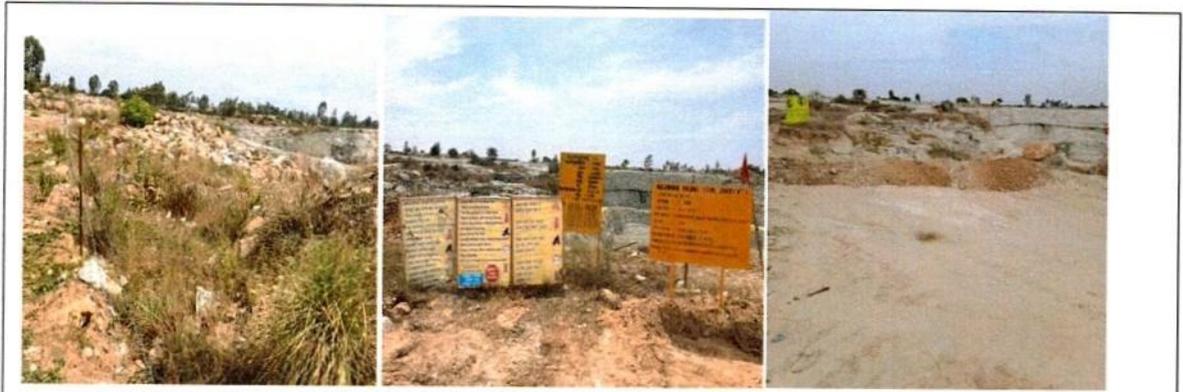
Fencing of the quarry pit

Display of Safety Board

Trench to avoid access to the quarry site

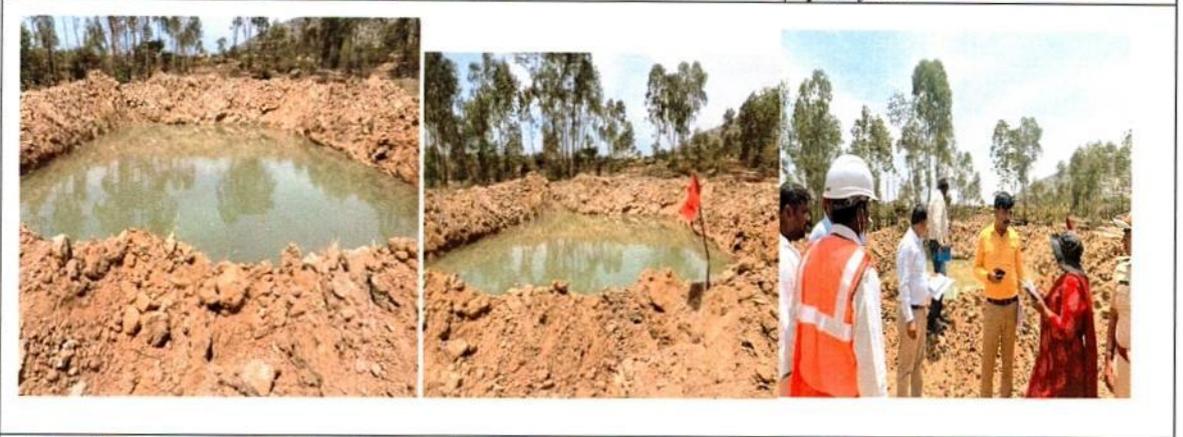
Water Tank constructed for storage of rain water

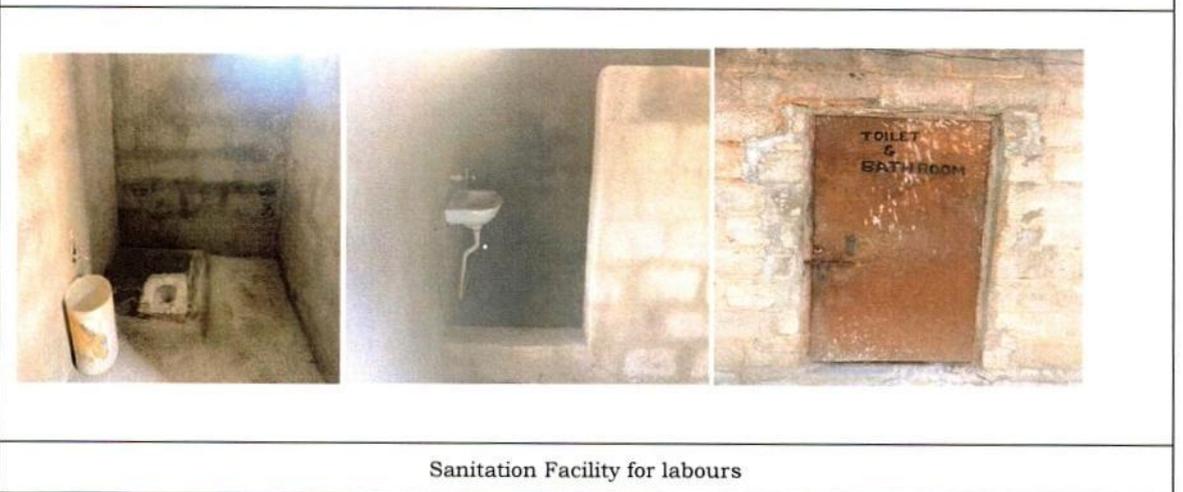
Sanitation Facility for labours

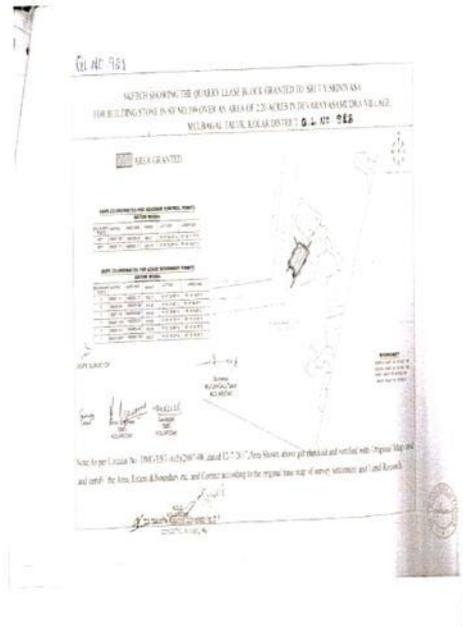
PHOTO: Lease Sketch	Boundary Pillars photos	DGPS Co-ordinates		
		Boundary Points	Latitude	Longitude

A	13°07'33.98" N	78°19'10.61' E

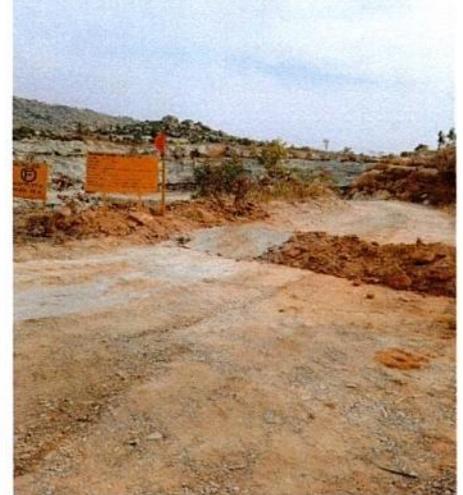
Approach Road

6. The quarry can be approached with mud road of 4mts width.

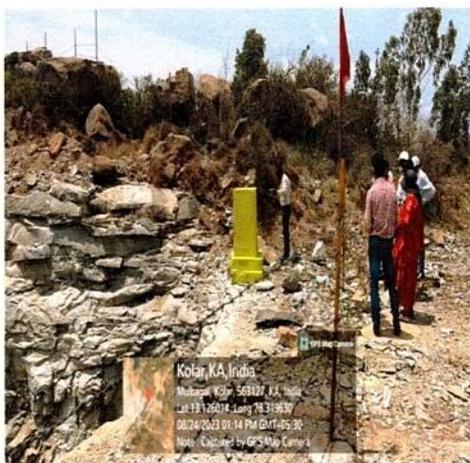
4. Safety measures such as display of safety boards all along the quarry area were found. Barbed fencing around the quarry pit is maintained.

Fencing of the quarry pit

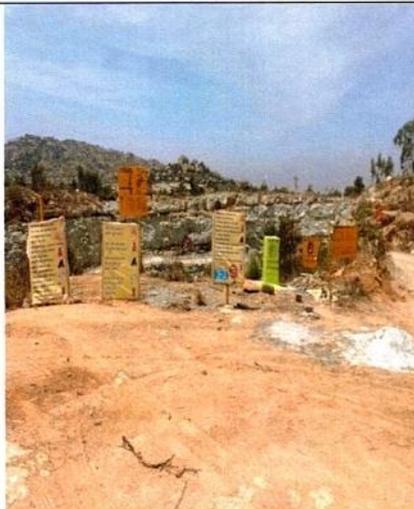
Display of Safety Board

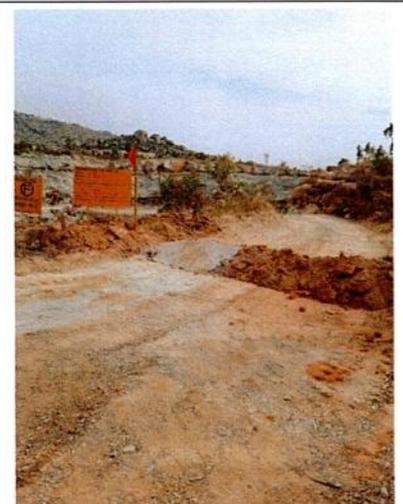
Trench to avoid access to the quarry site

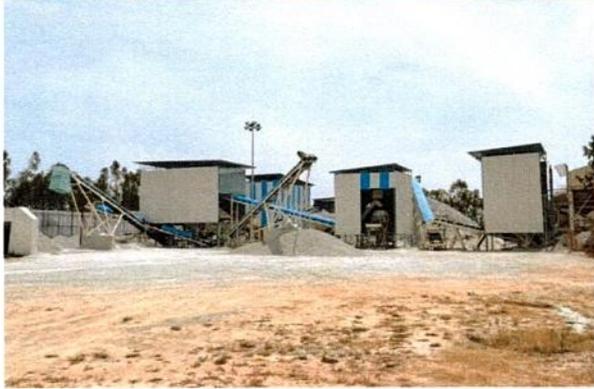
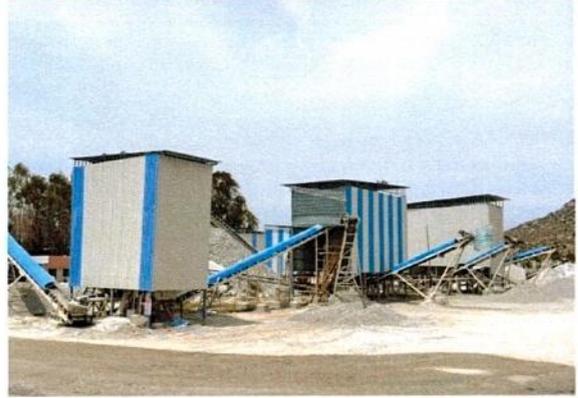
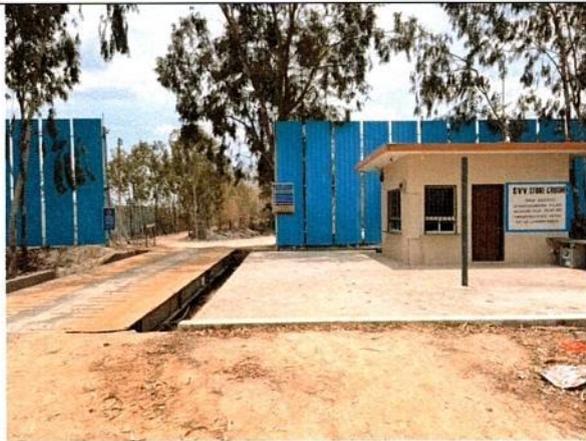
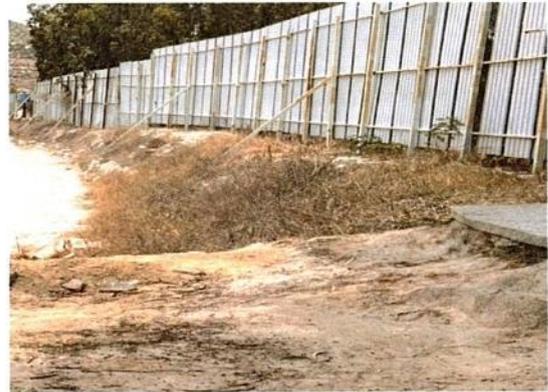
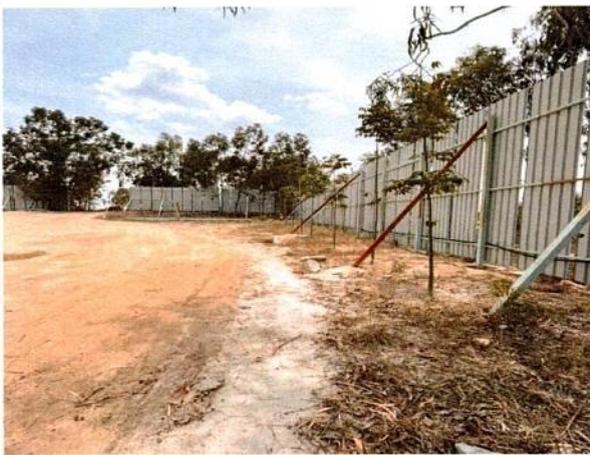
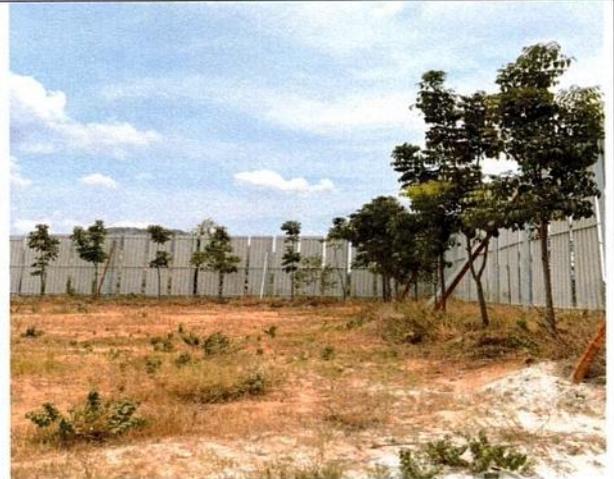
Photographs Taken at the time of Crusher Joint inspection of GVV Stone crusher

2. Extent of Crusher Licences is about 2.00 acres and 1.14 acres respectively.
3. Safety measures such as zinc sheet wall covering all along the crusher area were found.
4. The crusher can be approached with mud road of 4mts width.

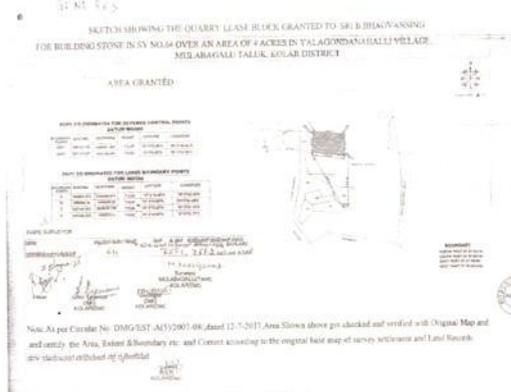
<p>SKETCH SHOWING THE QUARRY LEASE BLOCK GRANTED TO SRI. B. BHUVANASINGH FOR BUILDING STONE IN SY NO.64 OVER AN AREA OF 7 ACRES IN VELAGONDANAHALLI VILLAGE, MELABAGAL TALUK, KOLAR DISTRICT.</p> <p>AREA GRANTED:</p> <p>BOUNDARY POINTS:</p> <p>Point A: 13°5'15.7421" N, 78°17'52.6894" E</p> <p>Point B: 13°5'18.7527" N, 78°17'52.7356" E</p> <p>Point C: 13°5'18.6297" N, 78°17'58.5743" E</p> <p>Point D: 13°5'15.7025" N, 78°17'58.6244" E</p>	Boundary Points	Latitude	Longitude
	A	13°5'15.7421" N	78°17'52.6894" E
	B	13°5'18.7527" N	78°17'52.7356" E
	C	13°5'18.6297" N	78°17'58.5743" E
D	13°5'15.7025" N	78°17'58.6244" E

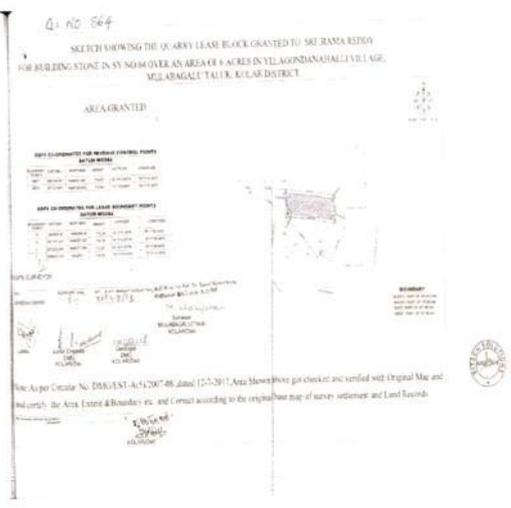
<p>SKETCH SHOWING THE QUARRY LEASE BLOCK GRANTED TO SRI RAMA REDDY FOR BUILDING STONE IN SY NO.64 OVER AN AREA OF 6 ACRES IN VELAGONDANAHALLI VILLAGE, MELABAGAL TALUK, KOLAR DISTRICT.</p> <p>AREA GRANTED:</p> <p>BOUNDARY POINTS:</p> <p>Point A: 13°5'15.7401" N, 78°17'51.2419" E</p> <p>Point B: 13°5'15.6775" N, 78°17'59.7991" E</p> <p>Point C: 13°5'12.5494" N, 78°18'00.3642" E</p> <p>Point D: 13°5'12.7419" N, 78°17'51.8068" E</p>	Boundary Points	Latitude	Longitude

A	13°5'15.7401" N	78°17'51.2419" E
	B	13°5'15.6775" N	78°17'59.7991" E
	C	13°5'12.5494" N	78°18'00.3642" E
D	13°5'12.7419" N	78°17'51.8068" E

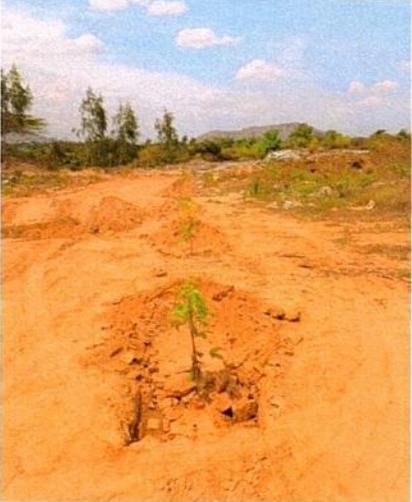
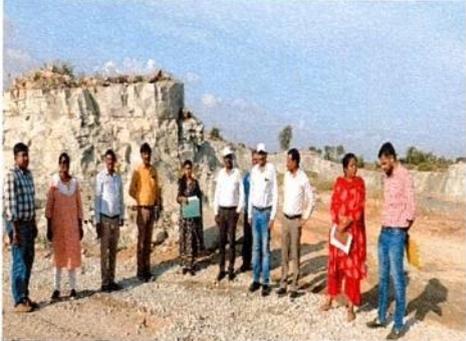
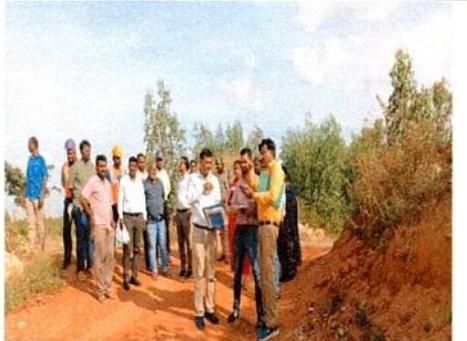
4. Safety measures such as Display of safety boards all along the quarry area were found. Barbed wire fencing around the quarry pit is maintained.
5. No Public structure, water body and wild animals were found with in a radial distance of 200mts from quarry area.
6. The quarry can be approached with mud road of 4mts width and the dust suppression controlled by sprinkling the water every day.

<p>Unnamed Road, Karnataka 563127, India</p> <p>Latitude 13.086703333333332° Longitude 78.29905000000001° Local 04:22:45 PM Altitude 800 m GMT 10:52:45 AM Thursday, 24.08.2023</p>
Plantations	Quarry pit	Approach Road

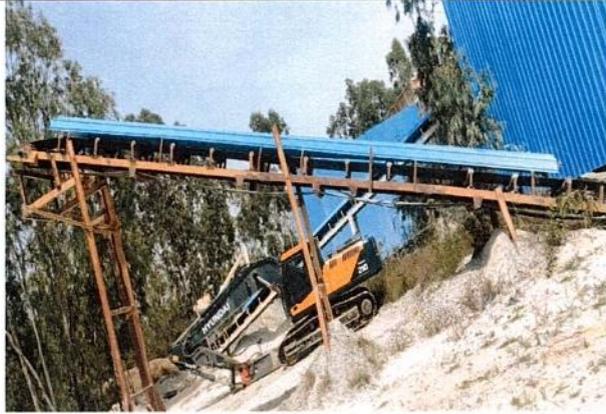
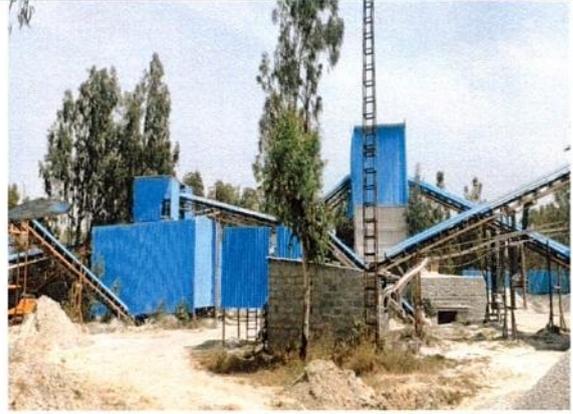
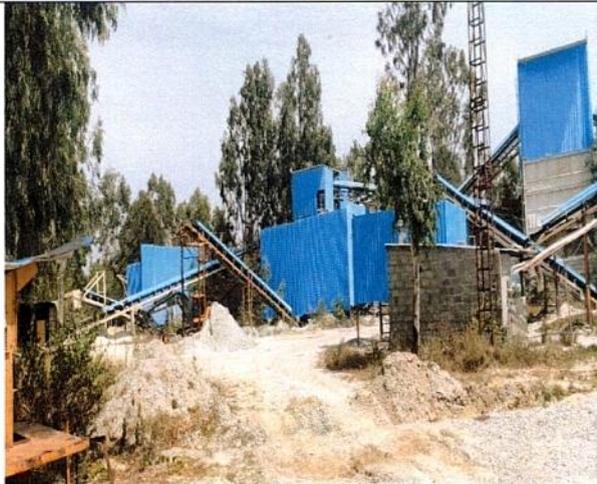
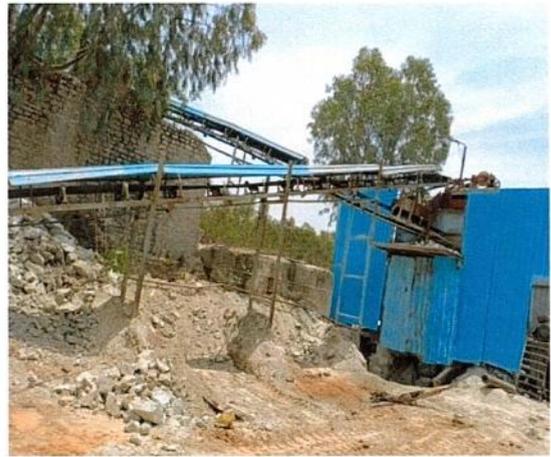
Photographs Taken at the time of Crusher Joint inspection of SVS & Associates Stone crusher

- The crusher can be approached with mud road of 4mts width and the dust suppression controlled by sprinkling the water every day.

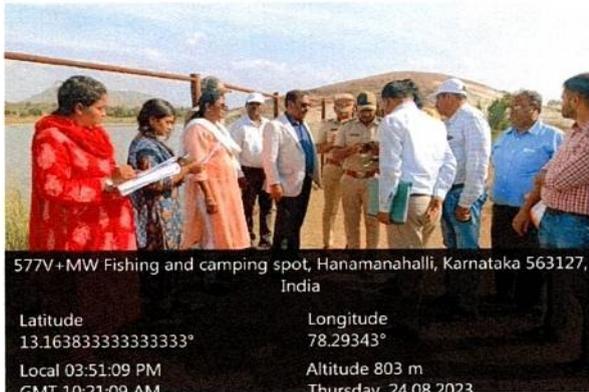
577V+MW Fishing and camping spot, Hanamanahalli, Karnataka 563127, India  
Latitude 13.163833333333333° Longitude 78.29343°  
Local 03:51:09 PM Altitude 803 m  
GMT 10:21:09 AM Thursday, 24.08.2023

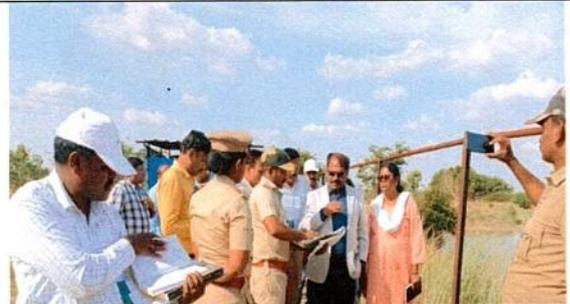
577V+MW Fishing and camping spot, Hanamanahalli, Karnataka 563127, India  
Latitude 13.163833333333333° Longitude 78.29343°  
Local 03:51:09 PM Altitude 803 m  
GMT 10:21:09 AM Thursday, 24.08.2023

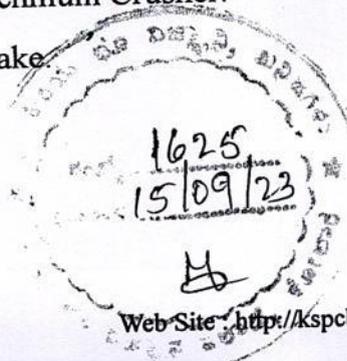
1. Pond near Millennium Crusher.
2. Cholamgunte Lake.

The samples collected on 05.09.2023 and same was handed over to the KSPCB Central Laboratory for analysis. The analysis reports of the water samples of Pond near Millennium Crusher reveals that as per CPCB standards under Class-D classification – “D” to prescribed standards with respect to Biochemical Oxygen Demand @27<sup>0</sup>C for 3 days as per Primary Water Quality Criteria-CPCB. Designated best use - Propagation of Wild Life, Fisheries and the analysis reports of the water samples of Cholamgunte Lake reveals that as per CPCB standards under Class-D classification – “D” to prescribed standards with respect to Biochemical Oxygen Demand @27<sup>0</sup>C for 3 days and Total Coliform, as per Primary Water Quality Criteria-CPCB. Designated best use - Propagation of Wild Life, Fisheries. The copies of analysis reports are herewith enclosed for your kind reference.
