**BEFORE THE NATIONAL GREEN TRIBUNAL, SOUTHERN  
ZONE, AT CHENNAI**

**ORIGINAL APPLICATION No.97 OF 2022**

**REJOINDER TO THE REPLY FILED BY THE RESPONDENT NO.2**

# GEOLOGICAL, GEOPHYSICAL AND WATER QUALITY TEST FOR UNDERSTANDING THE HYDROLOGICAL REGIME OF THE AREA

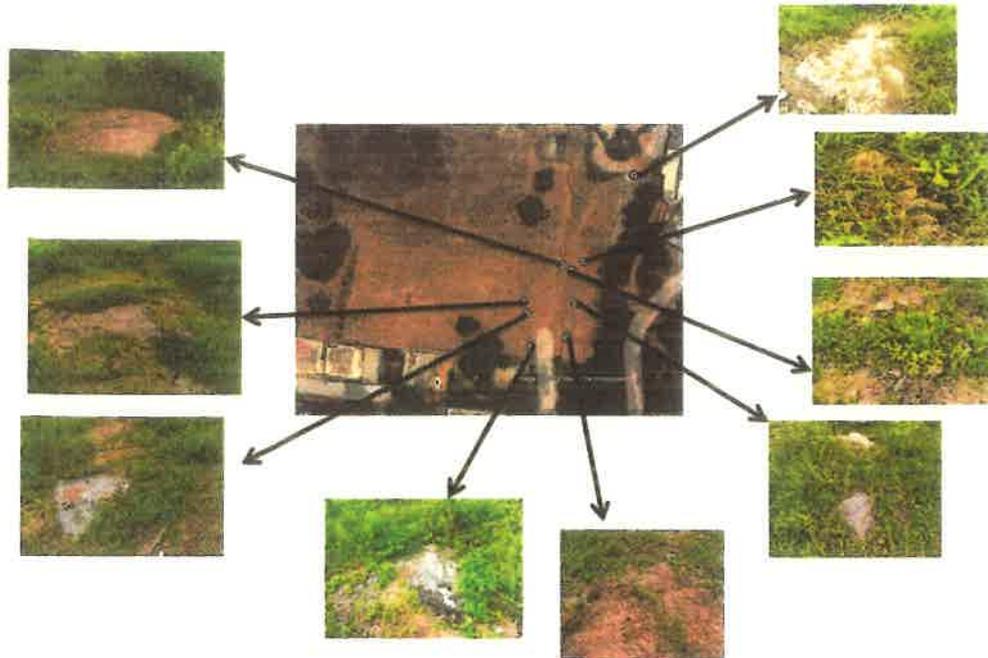
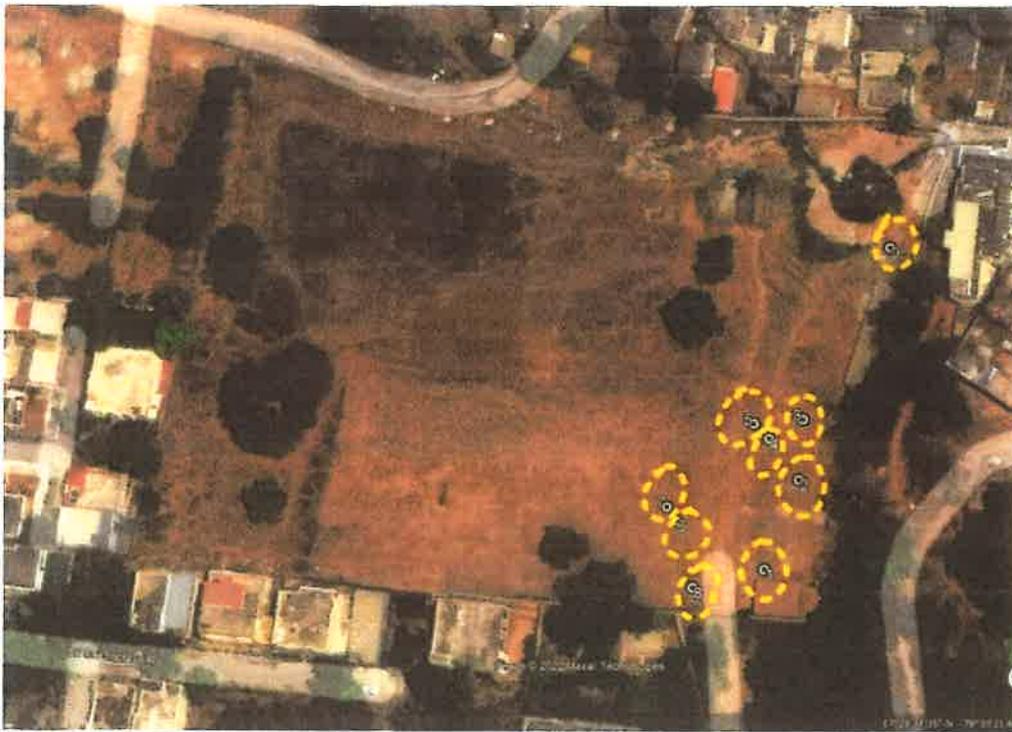
Figure 2: Rock exposures with in the study area

The study area was visited on 07-08-2022 and found that the majority of the area is occupied with exposed granitic terrain on the surface. The places where the exposed rock was observed is shown in the below figure. As per the observations, the rock exposures were identified in entire land area as isolated patches and some areas are covered with very thin weathered material. The hardness is increased as we go deep from surface was also confirmed by geophysical survey.

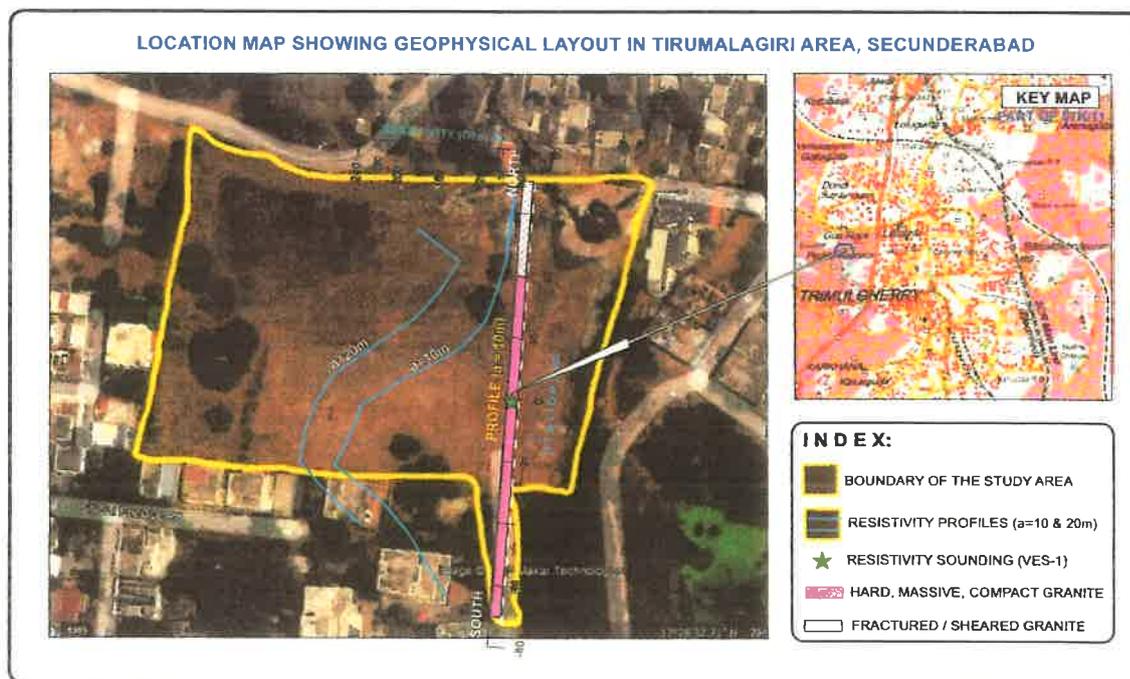
Figure 3: Geophysical survey map showing the profile and sounding location within the study area

The geophysical layout map of the Resistivity profiles with a=10 m and a= 20 m are showing in

Figure 3. The Resistivity profile with a = 10 m along the traverse, trending approximately in north-south direction (Fig.2) have brought out an overall resistivity variation of 155 Ohm.m. Resistivity highs of the order of 100 - 240 Ohm.m recorded over the central and southern parts of the profile indicating the presence of hard, massive and compact granite / shallow basement at depth. Whereas, resistivity profile with a = 20m along the same traverse have brought out a relief of 131 Ohm.m. Resistivity highs of the order of 150 - 259 Ohm. m recorded in the central and southern parts of the profile also indicating the presence of hard, massive and compact granite / shallow basement at depth.

Whereas, low resistivity's of the order of 85 - 100 Ohm.m with  $a = 10$  m and 128 - 150 Ohm.m with  $a = 20$ m respectively, noticed on northern part between stations N40 to N70 may indicating the presence of fracture / fault / shear zone trending in east-west direction, which may be favourable structure / potential zone for possible occurrence of groundwater at depth in hard rock terrain. For better understanding of the resistivity anomalies, profiles with  $a=10$ m and  $a=20$ m are overlay on Google image of the study area ( Figure 3).

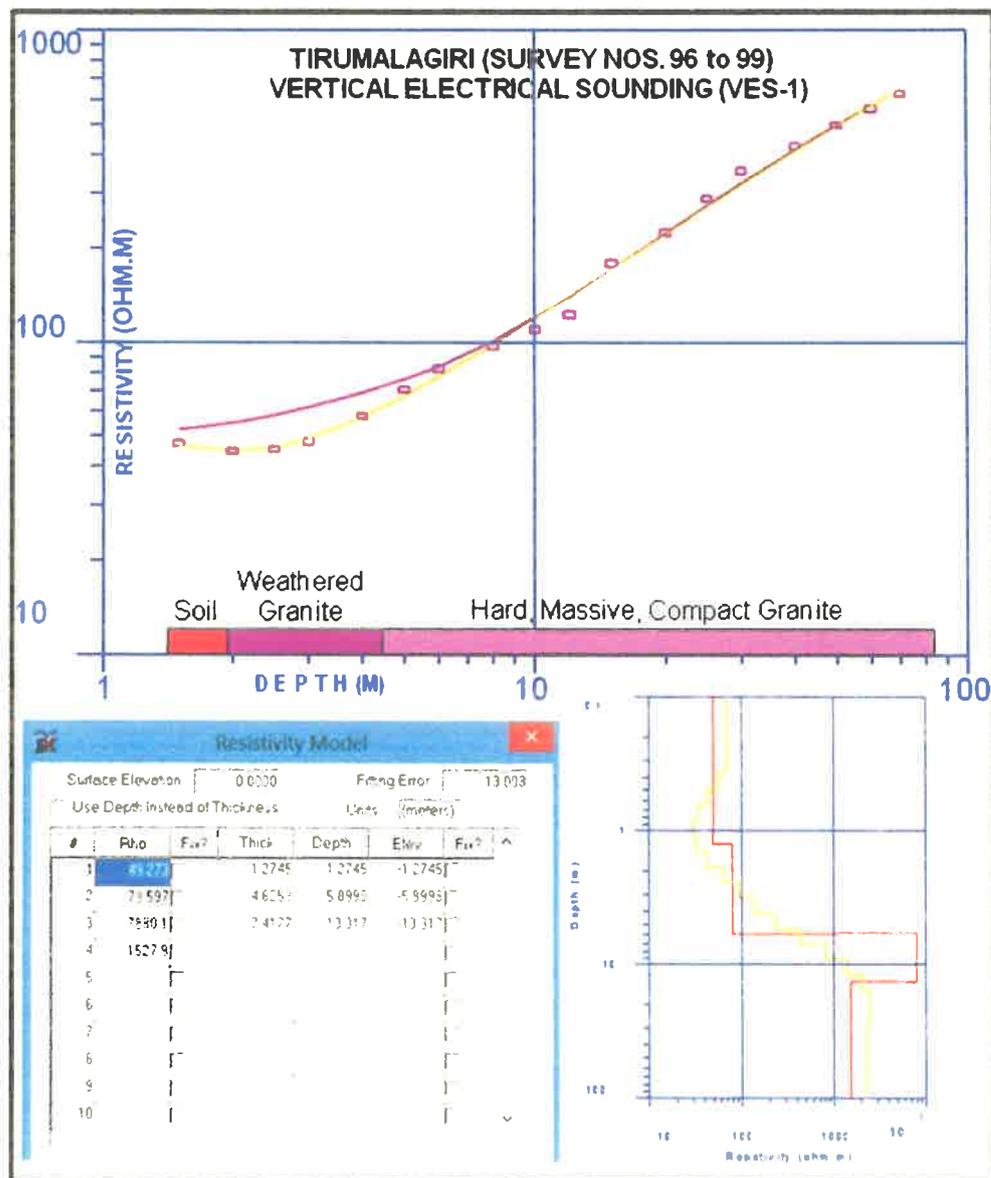
Figure 5: VES data interpretation using IXID Software

Vertical Electrical Resistivity Sounding (VES-1) with  $AB/2=70$  m was carried out in the central part at 0/0 (latitude: 17.47594911 and longitude: 78.50594699) over N-S trending traverse in the eastern part of the study area, shown in Figure 5.

The interpreted resistivity sounding with depth model using 1x1D software indicating the presence of 2 to 3 layer set up in the form of HA type curve. Intersected top brown sandy / granitic soil having a thickness of 1.27 m, with a resistivity of 43 Ohm.m, underlain by semi-weathered granite having a thickness of 4.6 m upto a depth of 5.8 m, having a resistivity of 79 Ohm.m. Followed by shallow granite basement in the form of hard, massive and compact granite or granite gneiss with high resistivity variations from 1528 to 7880 Ohm.m.

3. **Using geophysical survey, the groundwater fracture system is identified at 25 to 40 ft and 80 to 120 ft depth is well matching with the open well system.**

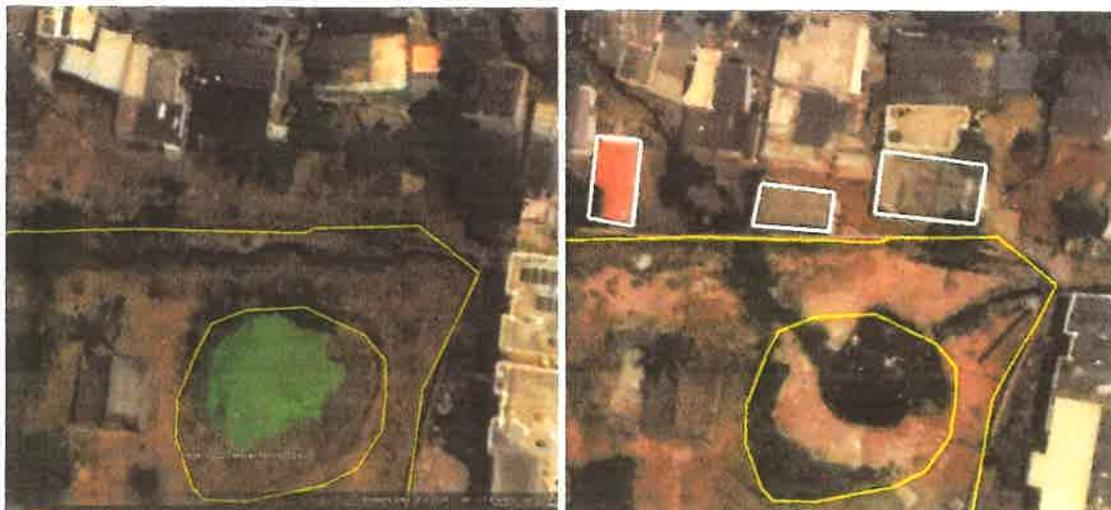
Figure 6: Satellite image of study area pertaining to 2018 (A) and 2022 (B) period

clearly marked without any sewage contamination from the northern side of the study area. **The water colour is indicating the very fresh without any contamination.** In the image of 04-2022, the well is look like with dark colour fully contaminated by sewage water entering from the North and north eastern side of the study area. Two new channels were identified on 04-2022 images which were not existed in 03-2018 images. New construction developments (encroachments) were observed in 04-2022 images shown with red colour marking which were not existed in 03-2018 images (Figure 6).

A) Image of 03-2018 (no occupations along the boundary)  
 B) Image of 04-2022 (occupations showing in white colour marking)

Observations	Image of 03-2018	Image of 04-2022	Inference
Colour of Water	Fresh water with light green colour	Polluted water with dark colour	The open well water is fully contaminated which was observed during the field visit on 07-08-2022
Development of new Sewage channels	No sewage channel is entering into the open well	Two sewage channels were entering into the open well from the northern side	The sewage channels which are fully loaded with dark colour sewage water along with faecal matter were observed from the northern western and north eastern direction are polluting the open well.
New Construction Developments beside the northern wall	No specific construction was observed beside the northern wall	New <b>three houses</b> were constructed beside the northern wall (shown in below fig. with white marking)	Due to the new house constructions, the previous water flow morphology is changed and forced to move into the clients land.

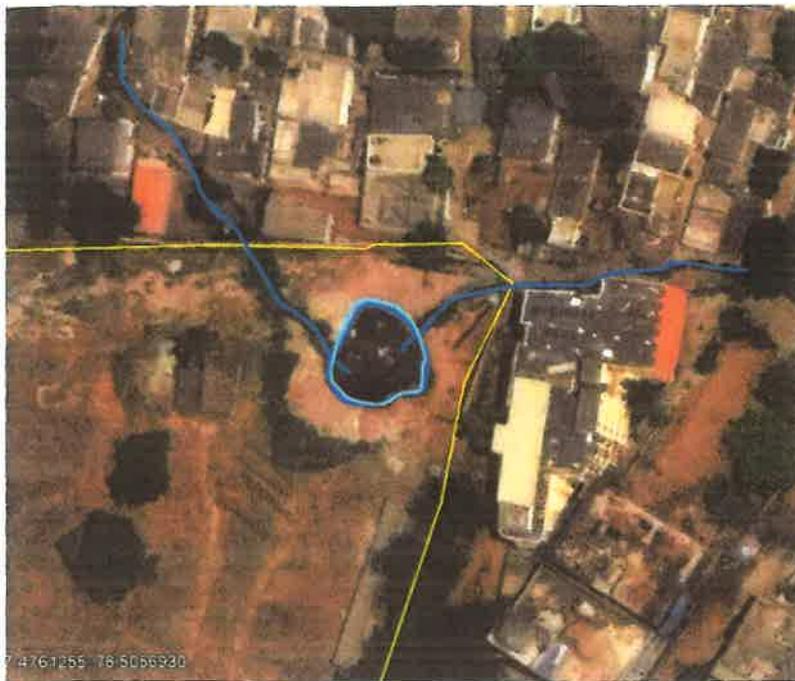
The satellite image of 04-2022 is showing the clear channelling of sewage water into the fresh water pond within the clients land.

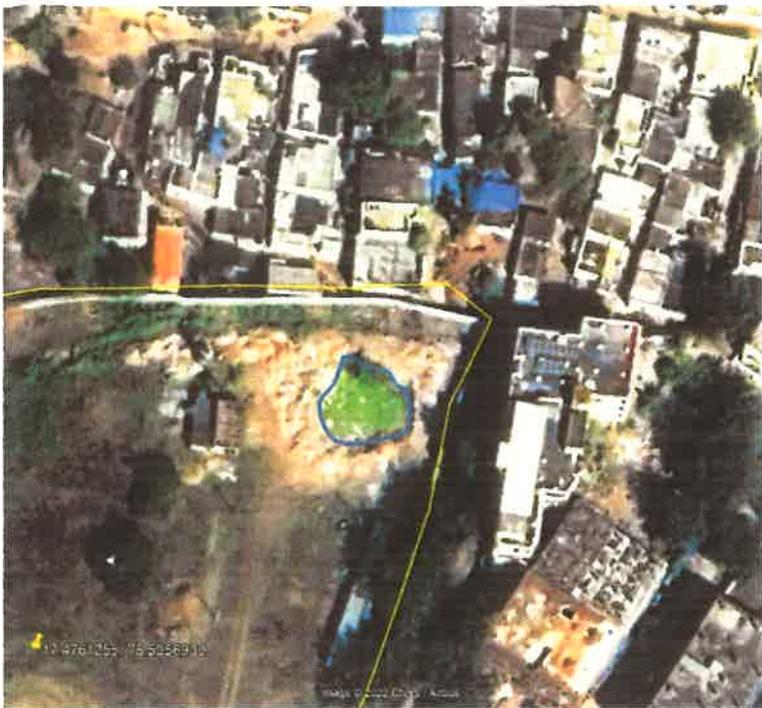
The image of 01-2022 is showing the very fresh water well (Blue Circle) with no sewage channelling into the open well (at client's premises).

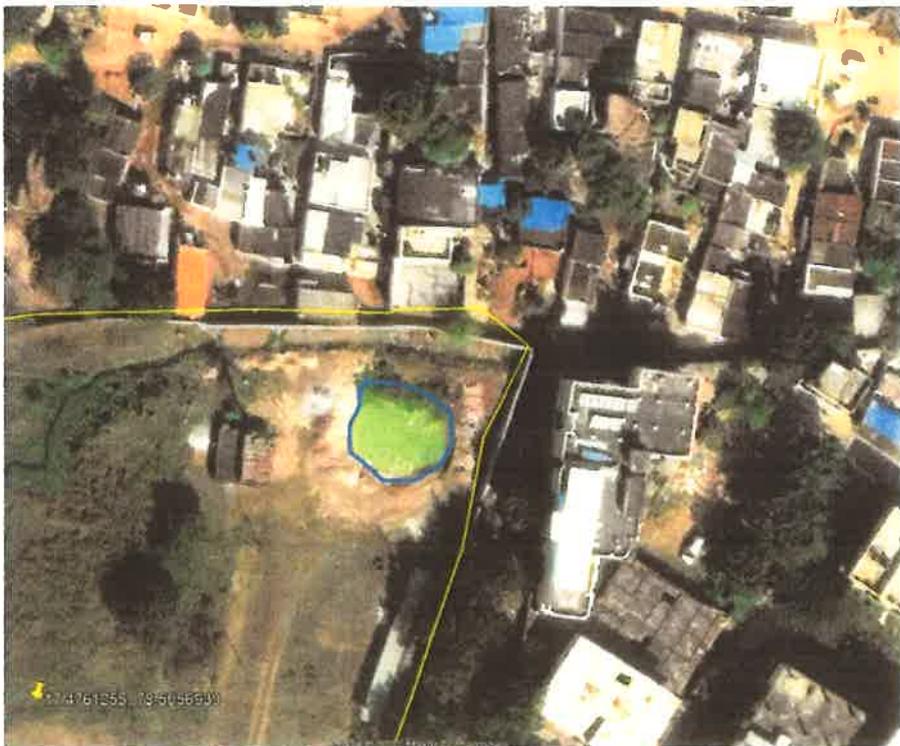
The satellite image of 12-2021 is showing the fresh water well without any sewage channelling.

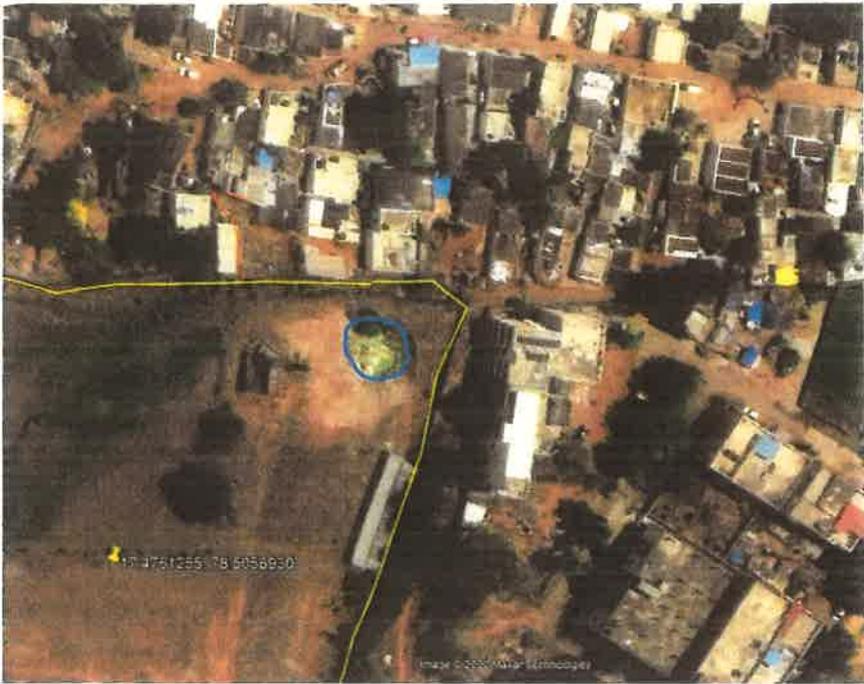
The satellite image of 05-2021 is showing the fresh water well without any sewage channelling. Also there is no waste water stagnation (orange colour marking) at North West of the well outside clients land.

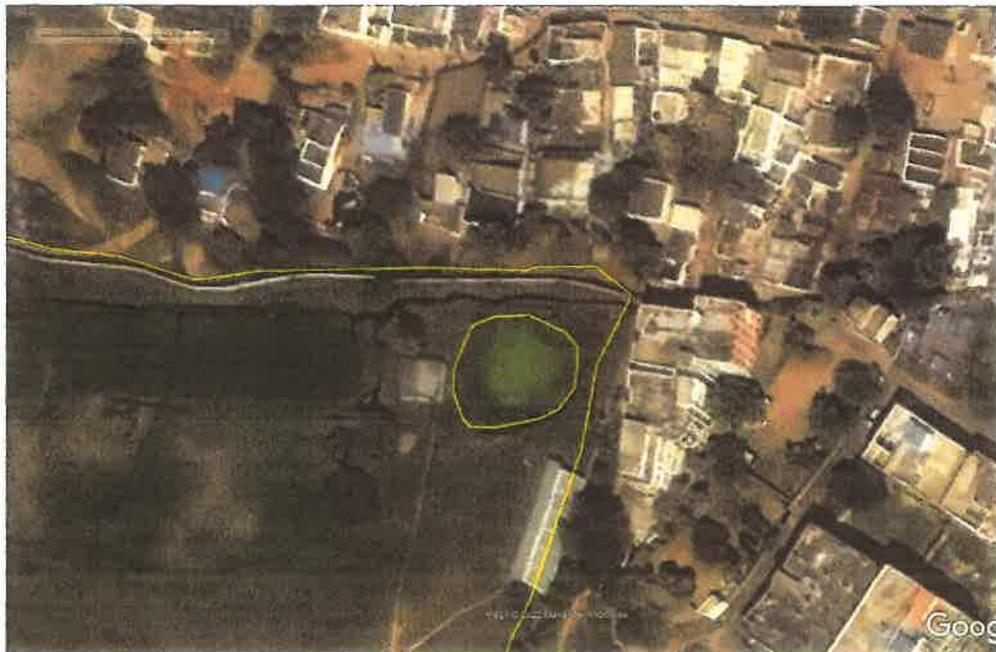
The satellite image of 10-2015 is showing the fresh water well without any sewage channelling

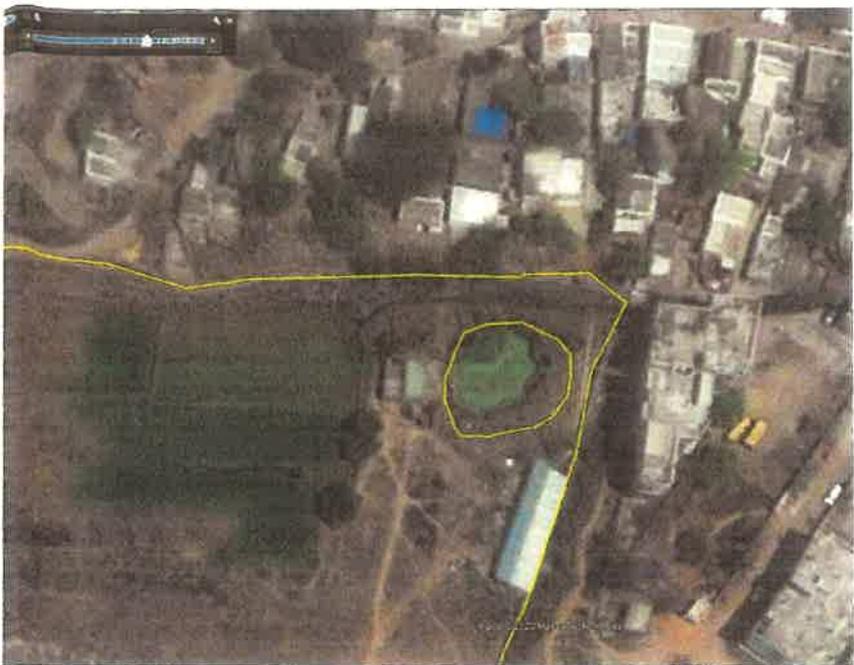
The satellite image of 04-2010 is showing the fresh water well without any sewage channelling

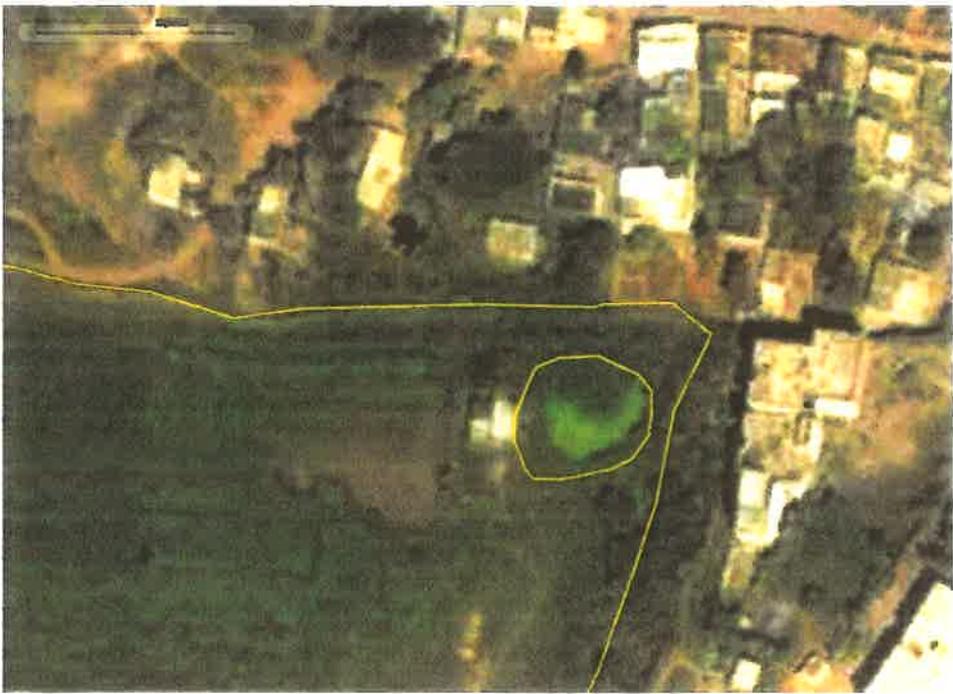
The satellite image of 10-2006 is showing the fresh water well without any sewage channelling

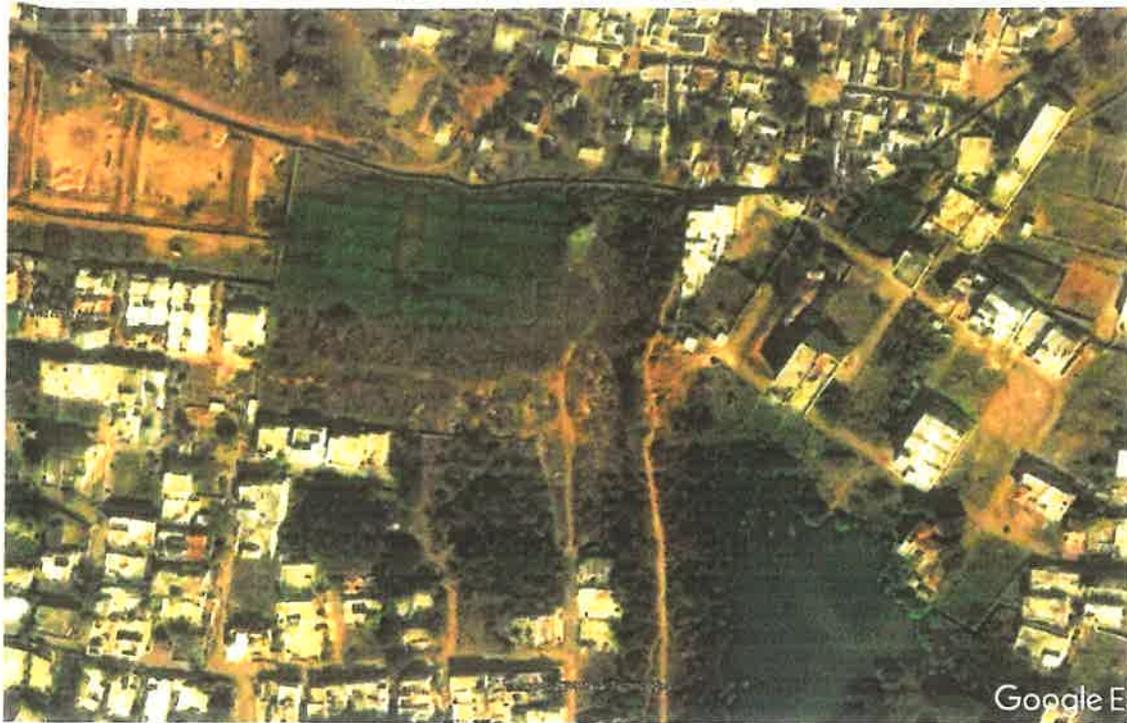
The satellite image of 02-2005 is showing the compound wall constructed surrounding the boundary

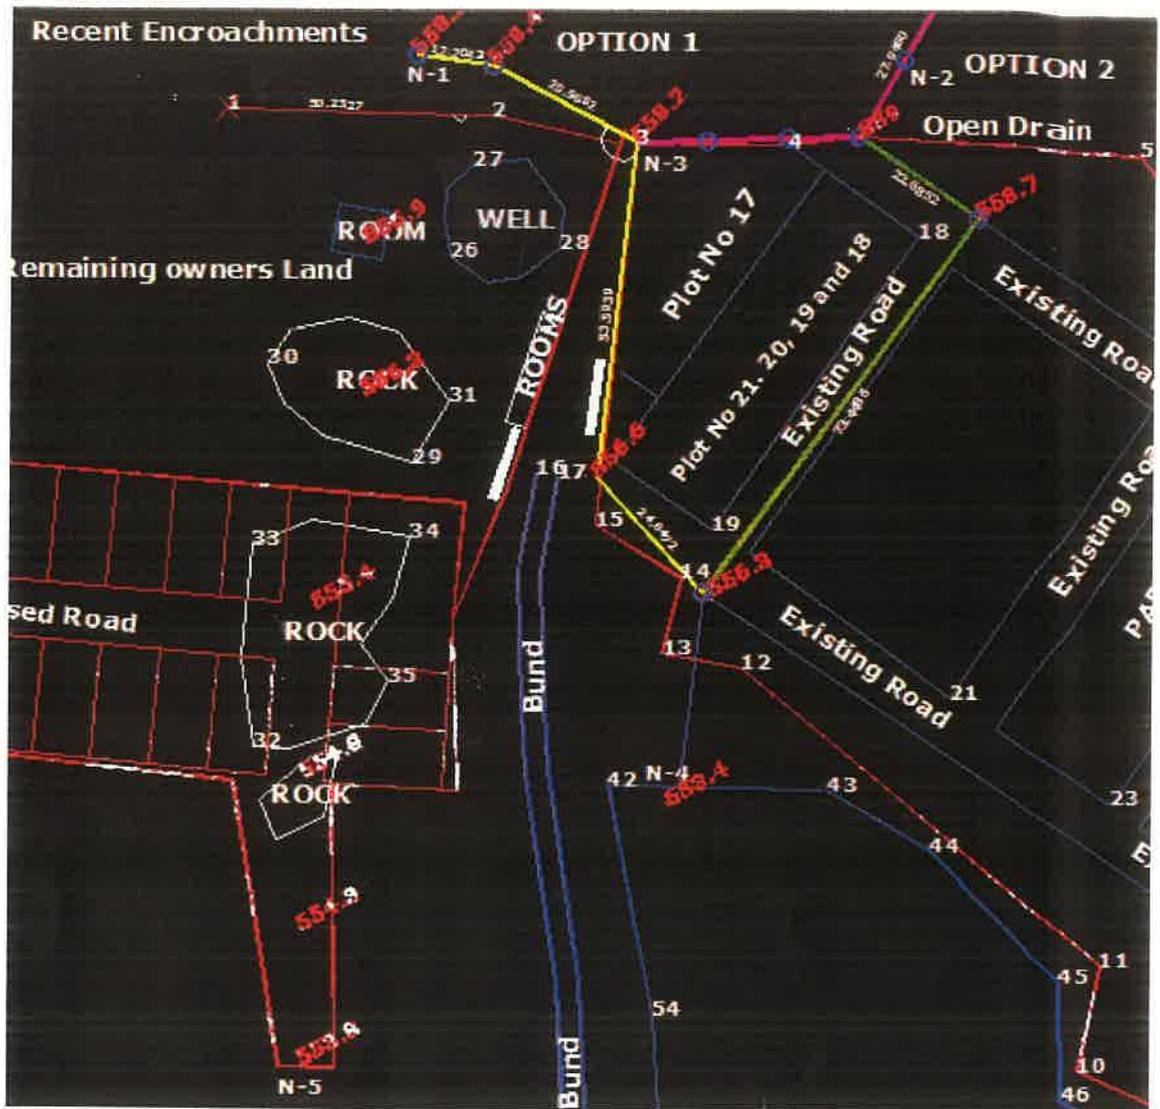
**Society Option 2 is the most feasible and economical one.**

E. The concern about the drainage pipeline taking a steep 120° angle (Option 2) can always be surmounted by constructing appropriately sized manholes. The laying of public drain by creating appropriate gravitational flow is not a technical issue at all as appropriate depth can be assessed.

8. The concern about the drainage pipeline taking a steep  $120^\circ$  angle (Option 2) can always be surmounted by constructing appropriately sized manholes. The laying of public drain by creating appropriate gravitational flow is not a technical issue at all as appropriate depth can be assessed.
9. Therefore, option 1 and option 2 are only feasible and option 2 is most economical.

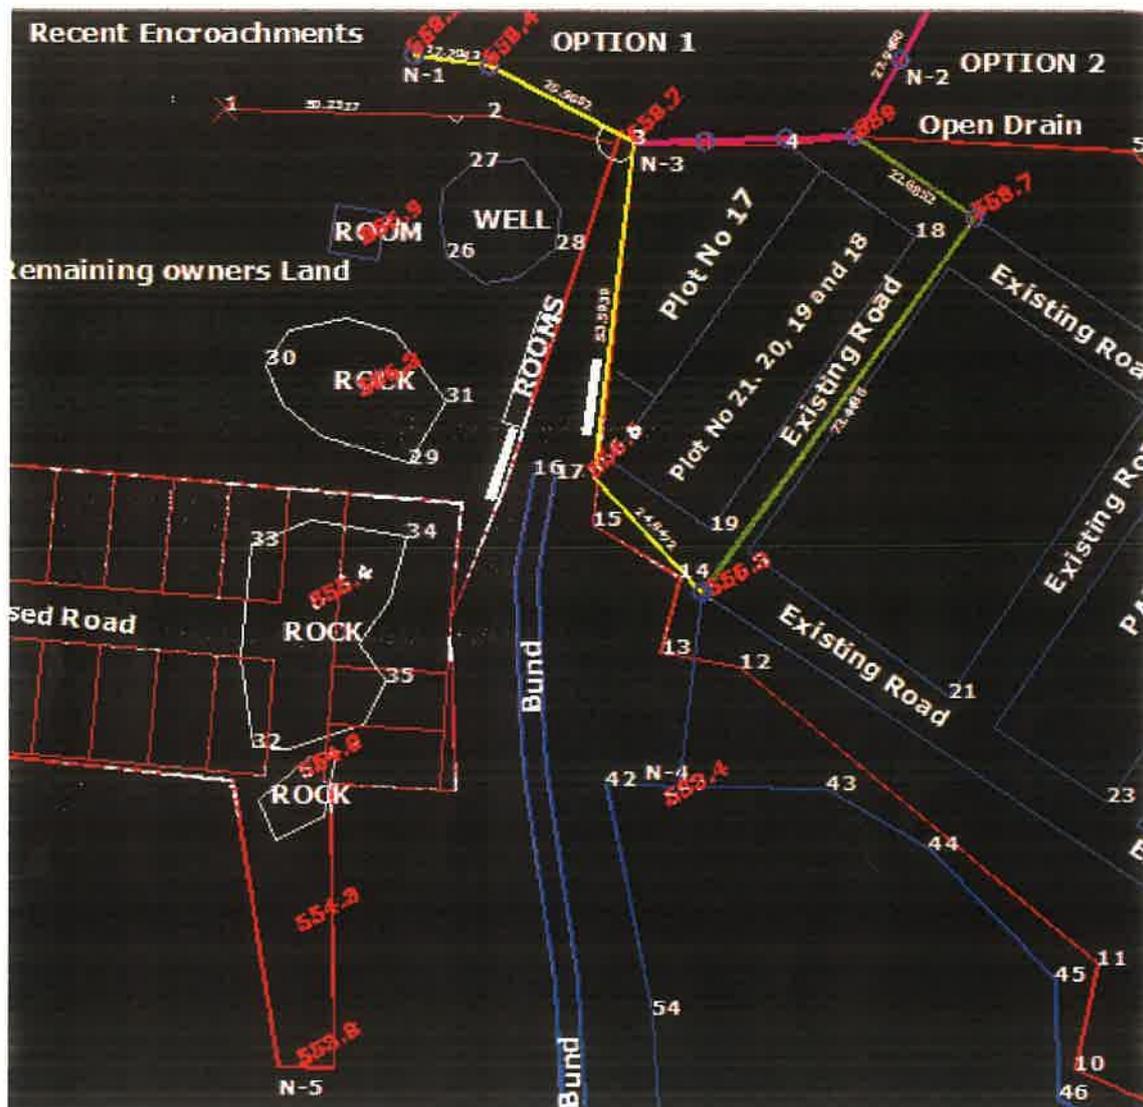
Option 1, (Yellow color) whereas two stretches Node N1 to N3 and node N2 to N3 as shown in the map will merge and dispose to Trimulgherry Lake through N3 to N4 stretch

It's the second most feasible and economical one.

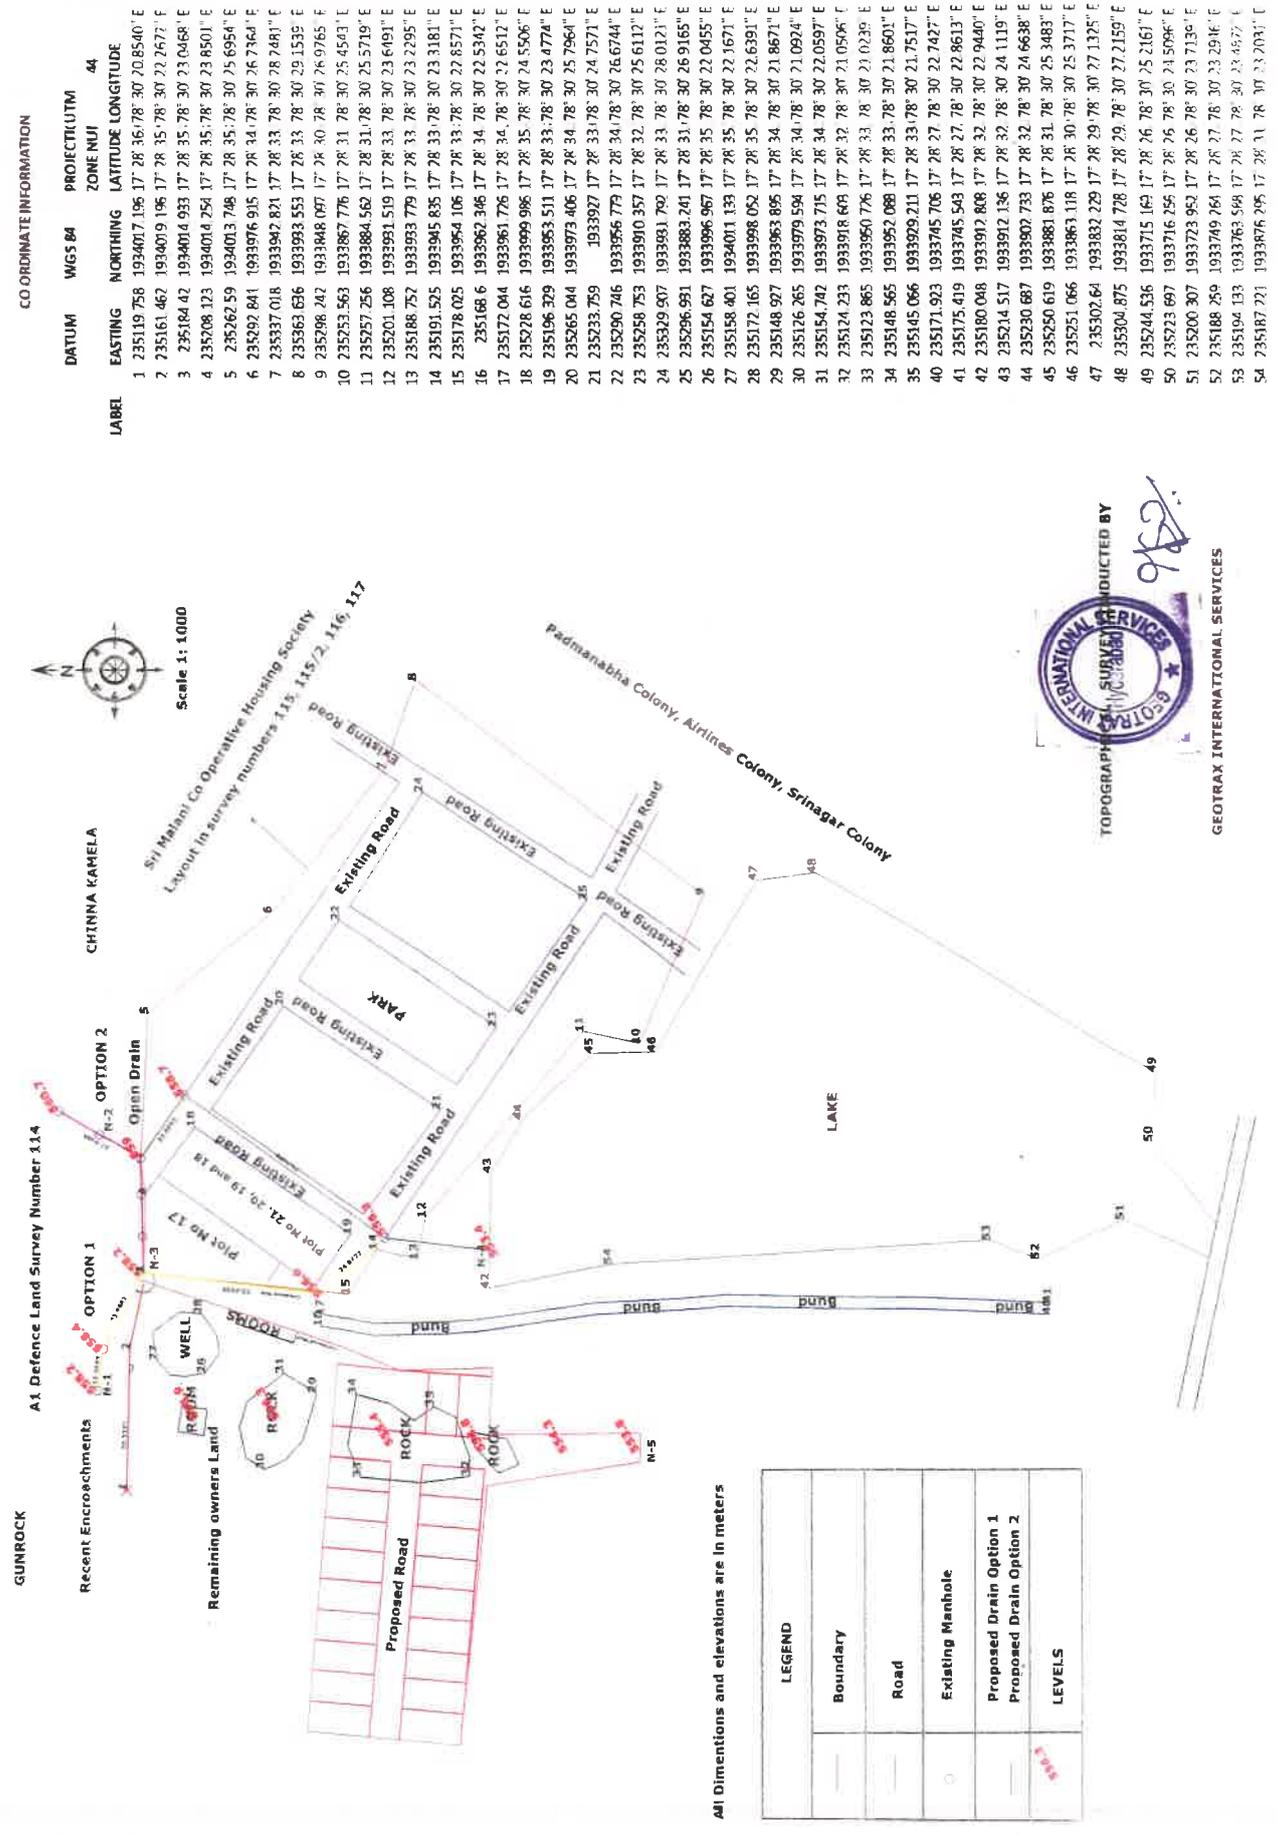
# TOPOGRAPHICAL MAP OF PROPOSED DRAIN AT ENCROACHED A1 DEFENCE LAND, REVENUE SURVEY No. 114, NORTH OF PRIVATE LAND OF SURVEY No. 96 TO 99 PART TIRUMALGIRI LAKE CATCHMENT AREA.

2. The area was surveyed using Dual frequency DGPS (Differential Global Positioning System). The topographical overview of the land has been observed and noted and pointed in the plan prepared.

4. There are cluster of houses north to Private land in Sy. No's 96-99(Part) which appear to be of recent origin upon perusal of Google timeline maps.
5. Presently land in Sy. No's 96-99(Part) of Trimulgherry village lying on the west of the Trimulgherry lake bund is surrounded by compound wall which is broken/demolished in the north eastern side and a huge gaping hole has been made on the northern side of the compound wall to let in the sewage water which is accumulating from recently laid drainage line of the unplanned and unauthorized illegal encroachments. Freshly dug channels inside the compound wall have been made to drain the sewage coming from the northern and north eastern side into the open agricultural well which is now filled to the brim.

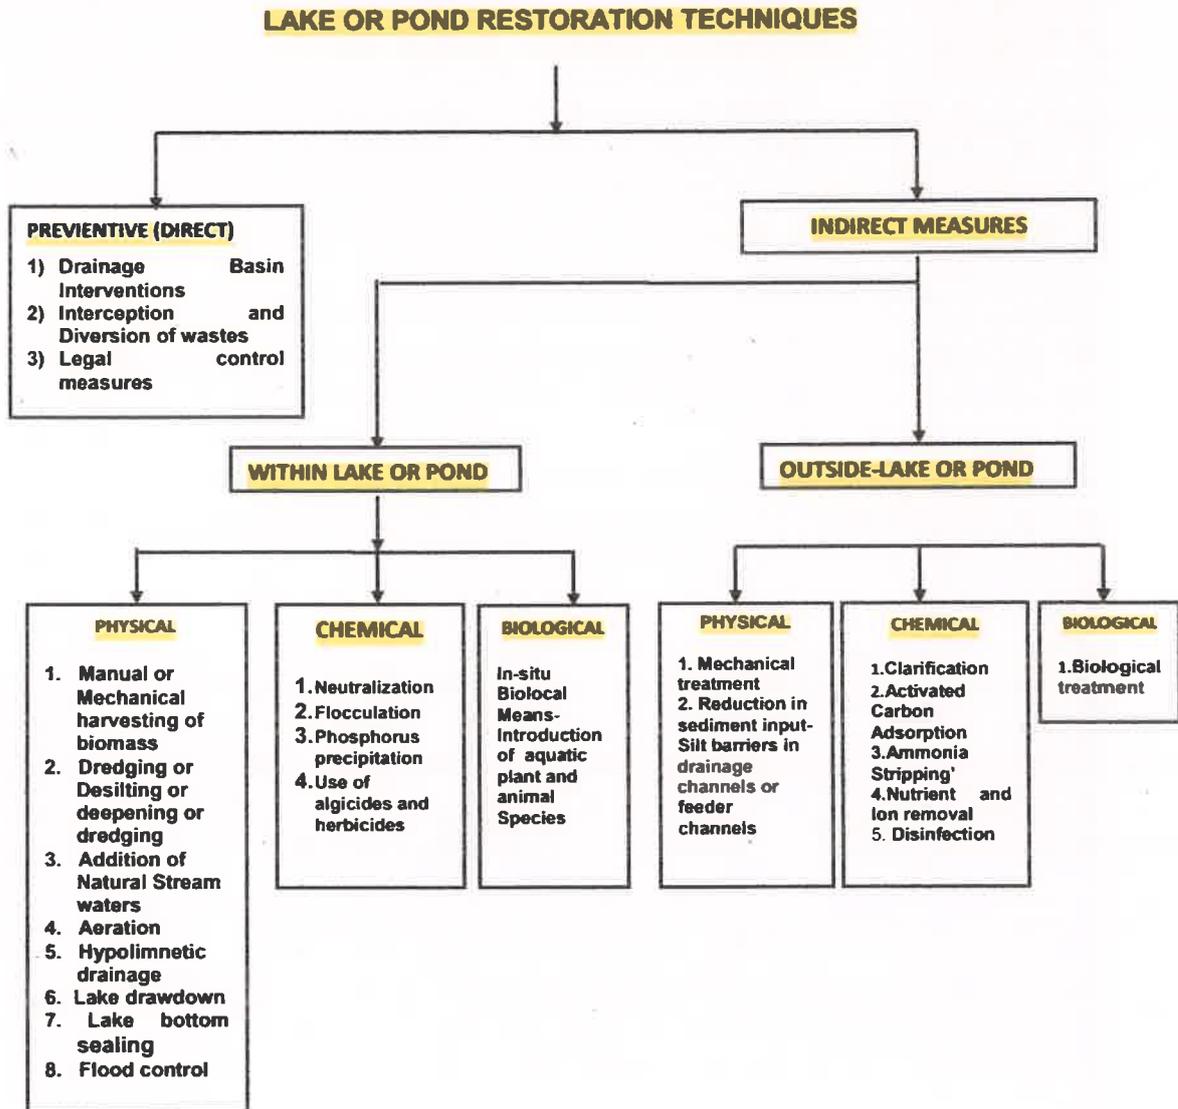
**Figure 1. A Model Lake or Pond Restoration Technique**

- As untreated sewage water is containing bacteriological & chemical contamination dumping into open well needs special attention to restoration.
- As the well is having multiple fracture systems from 40 ft to 120ft up to the maximum depth of well is absorbing the polluted water into the fractures during dry period & transports to longer distance needs to restored.
- To restore the open well, desilting of the open well and removal of sledge is needed.
- To restore the open well, it is needed to extract water continuously & disinfect & dump. It has to be done till the problem is rectified.
- Disinfection outside of the well and adjacent land.
- The time frame to restore the system will be based on the contamination level only. We cannot predict the exact time but it needs some minimum period of one to three years.
