INSPECTION REPORT OF THE JOINT COMMITTEE CONSTITUTED BY THE HON'BLE NATIONAL GREEN TRIBUNAL (SOUTHERN ZONE) IN RESPECT OF O.A. NO. 99 OF 2020 (SZ) SUOMOTU ON THE BASIS OF THE NEWS PAPER REPORT PUBLISHED IN DINAMALAR CHENNAI CITY SUPPLEMENT EDITION DATED, 03.07.2020 UNDER THE CAPTION "WHEN WILL THE SLUICES OF MUDICHUR BIG LAKE BE SET RIGHT"

2. COMPLIANCE OF THE DIRECTION

5. JOINT INSPECTION OF THE COMMITTEE

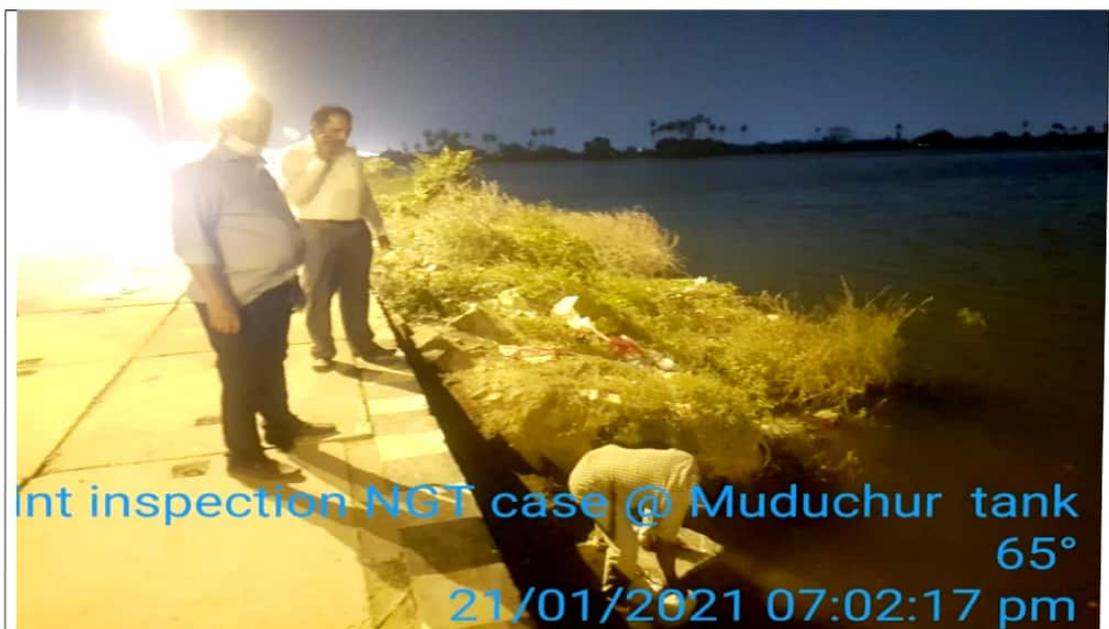
In due compliance of the said Hon'ble National Green Tribunal direction, surface water samples from the Mudichur Lake was collected on 21/01/2021 so as to ascertain the present water quality in the said water body

Collection of water sample to ascertain the quality of water in the Mudichur Lake

The Report of analysis of the water sample collected from the said water body reveals that the Physico chemical parameters analysed satisfy the Inland surface water standards prescribed by the Board. Furthermore the water sample collected from the Mudichur Lake analysed for Bacteriological parameter Total Coliform and Faecal Coliform meets the Primary Water Quality Criteria for Bathing Waters prescribed by Central Pollution Control Board.

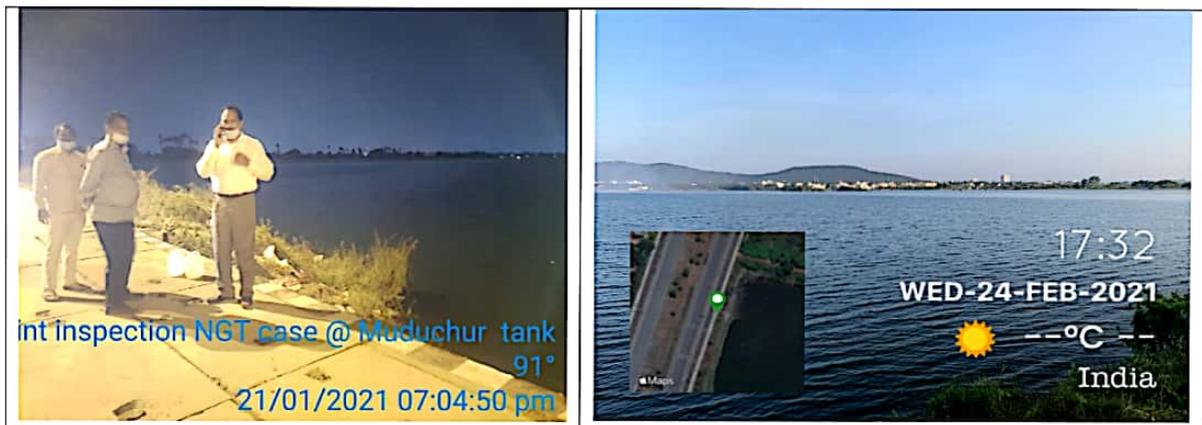
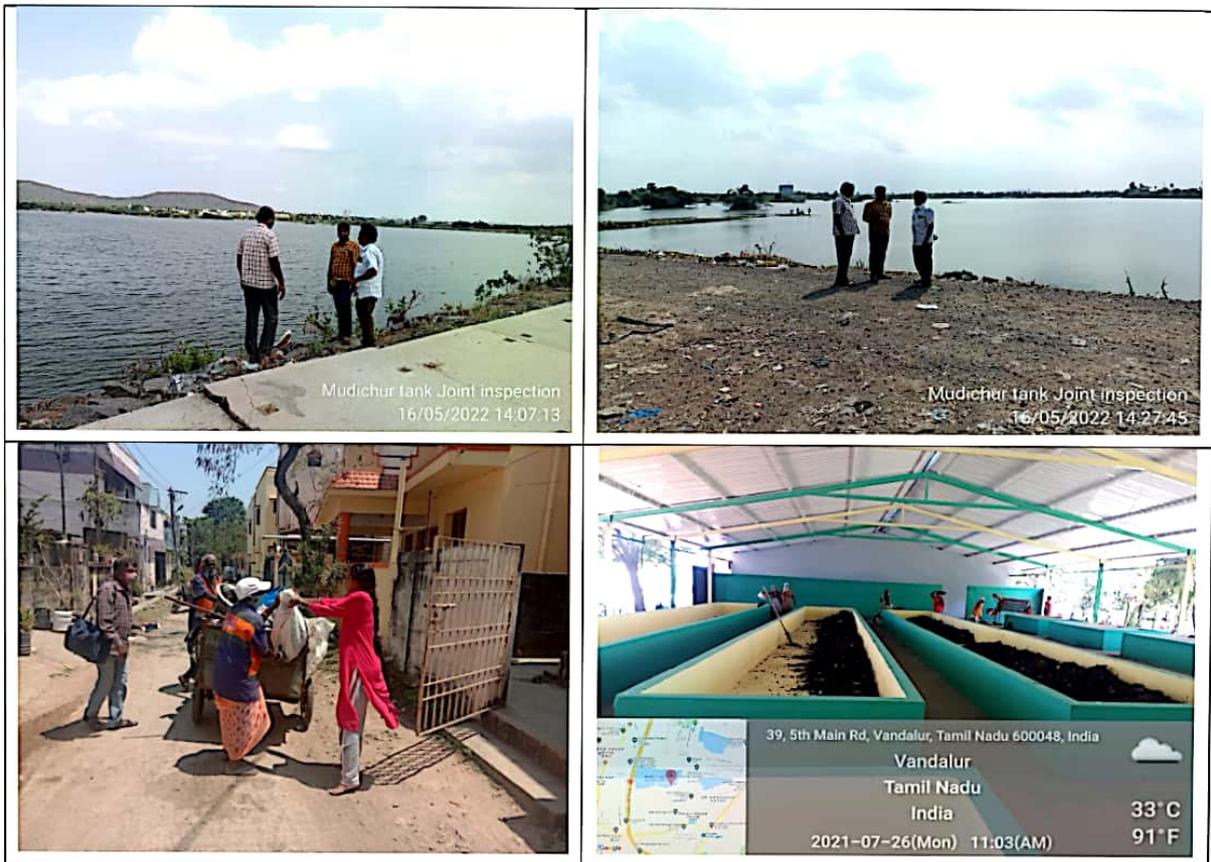
The members of the joint committee have carried out the inspection in the area in question on 21/01/2021, 24/02/2021, 26/07/2021 & 17/05/2022.

6. The overflow of this tank leads to Mudichur Seekana Eri and finally confluence to Adyar River at crossing of Outer Ring Road.
7. There are two sluices in the said water body in which one located at western part of the lake is fully demolished due to the formation of the outer ring road and another one located in the northern side of the lake is in good condition and also sluice is sufficient for the existing irrigation activities and the existing surplus weir is fairly week condition.

8. The households and commercial establishments in the village panchayat area have their own individual septic tank and soak pit arrangements for the treatment and disposal of the sewage. However certain households/ commercial establishments in the southern side of the tank dispose the sewage/sullage through storm water drains which reach Mudichur Lake.

10 Encroachments in the form of residences were noticed in the water spread area and a portion of bund in the western part of the lake.

- 04 The Village panchayat shall identify and provide decentralized community soak pit arrangement at vulnerable locations within three months time to prevent the entry of sewage/sullage to the Mudichur Lake through storm water drain and to intercept sewage entering the lake immediately.

07. The PWD with the help of Revenue Authorities shall make fresh survey to identify the exact number of encroachment and to evict them within six months.

08. The PWD shall revamp the weir and strengthening of the bunds in the said water body for smooth flow of surplus water within six months by obtaining necessary funds from the Government.
