BEFORE THE HON'BLE NATIONAL GREEN TRIBUNAL,
PRINCIPAL BENCH, NEW DELHI

MINISTRY OF ROAD TRANSPORT AND
HIGHWAYS & ORS.

RESPONDENTS NO.11

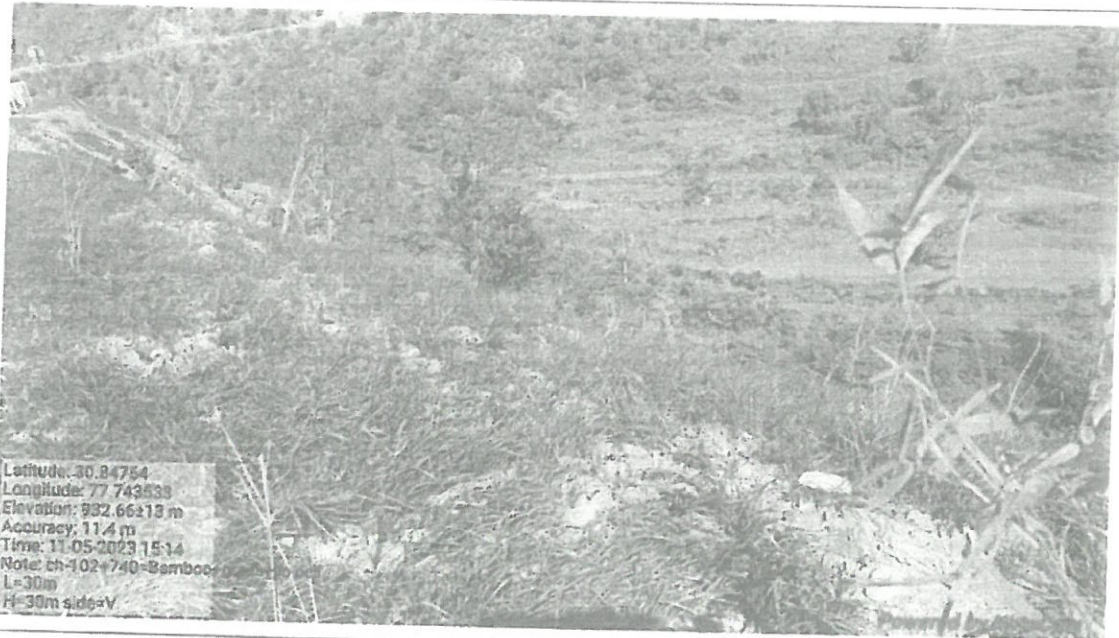
Latitude: 30.84754
 Longitude: 77.749533
 Elevation: 932.66±13 m
 Accuracy: 11.4 m
 Time: 11-05-2023 15:14
 Note: bh-102+740-Bamboo
 L=30m
 H=30m side+V

After flash flood

Time: 22-07-2023 15:26
 Note: 102+760km

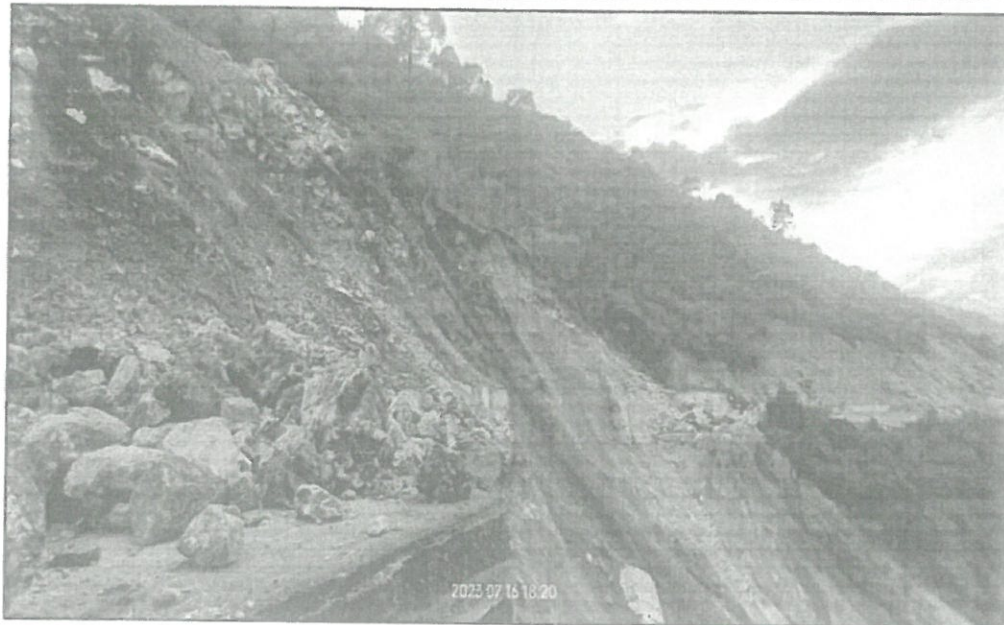
Damage

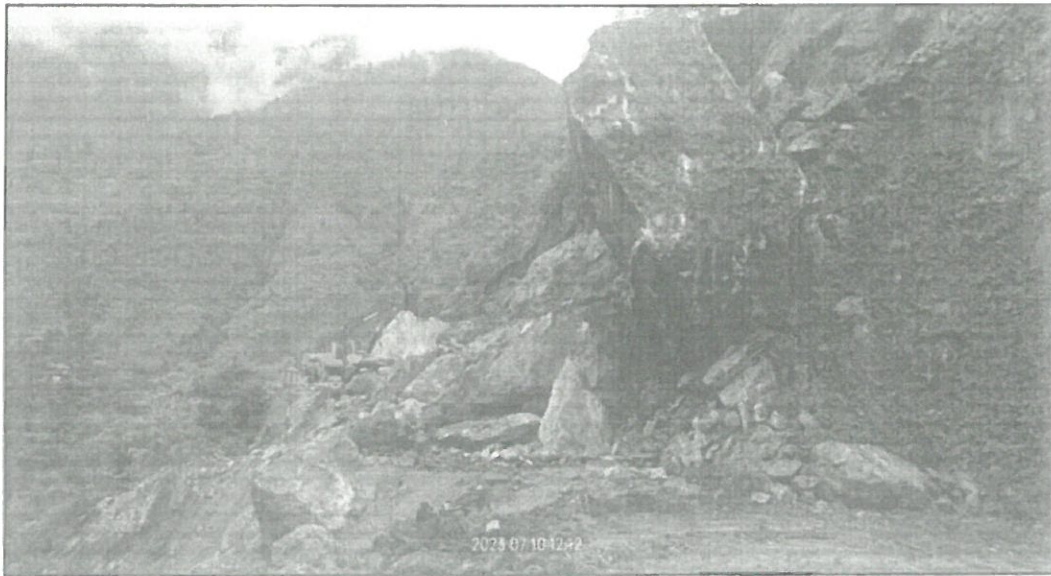
Sr. No.	7
Location No.	RD100/610
Issues	Unauthorized and illegal dumping of debris on forest and private land without any protection measures.
Comment	This location is not a dumping zone and no dumping has been done by the Contractor at this location. However, due to unprecedented rainfall damages occurred. Requisite breast wall have been reconstructed to protect the hill. The road was closed on 09.07.2023 and 12.07.2023 due to a slide at this location. The same information was communicated to the District Disaster Management Authority (DDMA).

Sliding

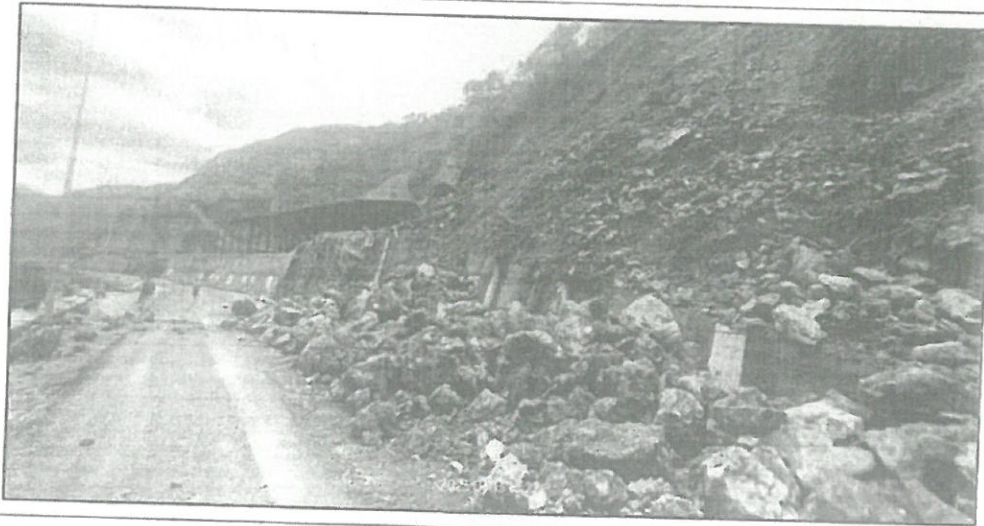
After Sliding

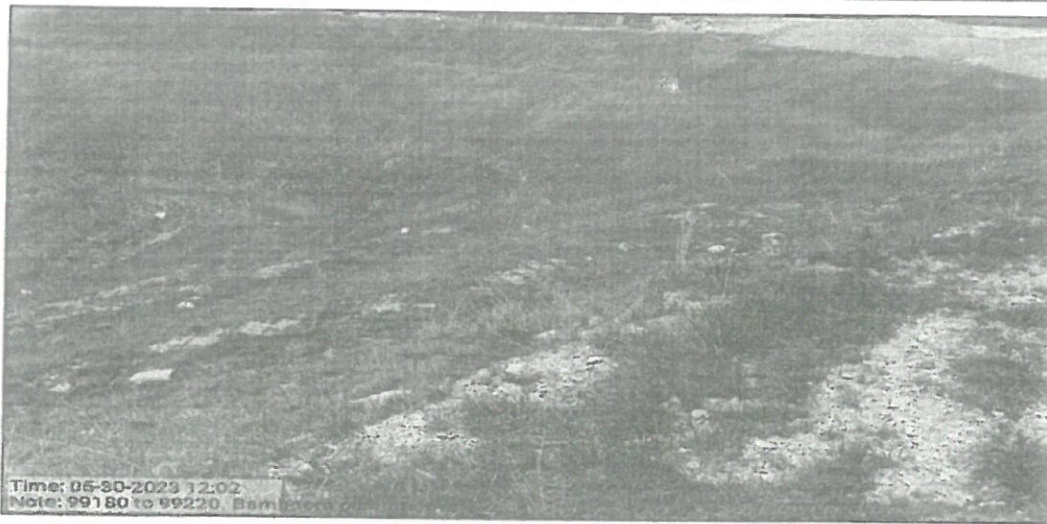
Sr. No.	10
Location No.	RD99/050-99/25 dumping zone-II
Issues	Unauthorized and illegal dumping of debris on forest and private land without any protection measures.
Comment	This is a designated dumping zone. The dumping zone has been protected with gabion wall at the toe. Soil compaction benching, geocell with hydroseeding and bamboo plantation have been provided to control the erosion. A breast wall has also been constructed to support the hillside.

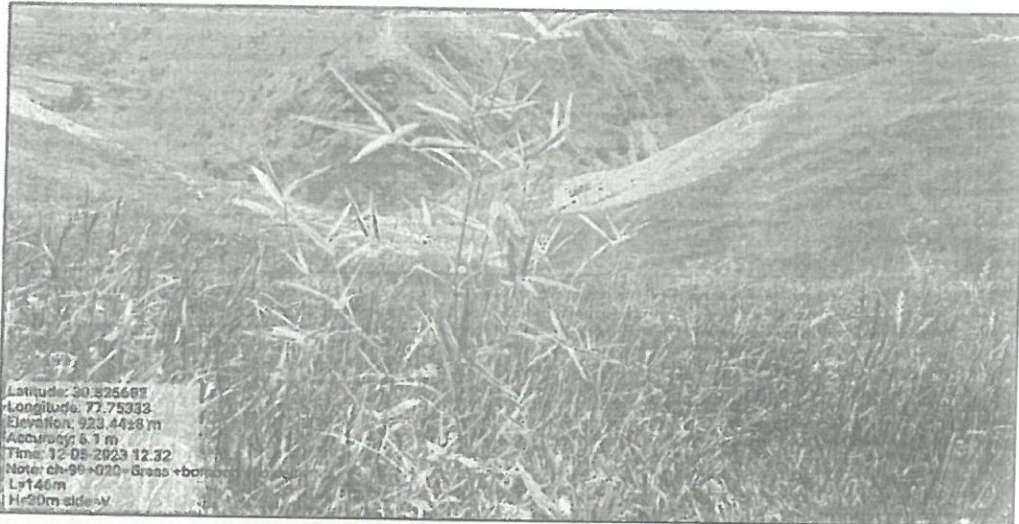
Sr. No.	11
Location No.	RD99/150
Issues	Unauthorized and illegal dumping of debris on forest and private land without any protection measures.
Comment	(Location is already included in Sr. No. 10) This is a designated dumping zone. The dumping zone has been protected with gabion wall at the toe. Soil compaction benching, geocell with hydroseeding and bamboo plantation have been provided to control the erosion. A breast wall has also been constructed to support the hillside.

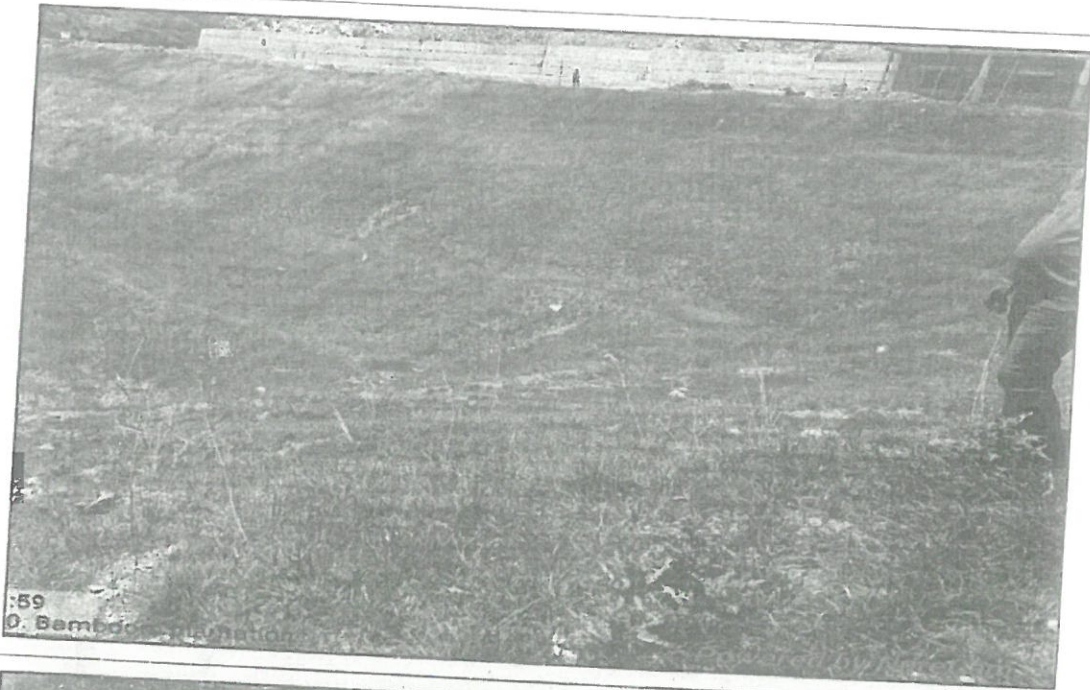
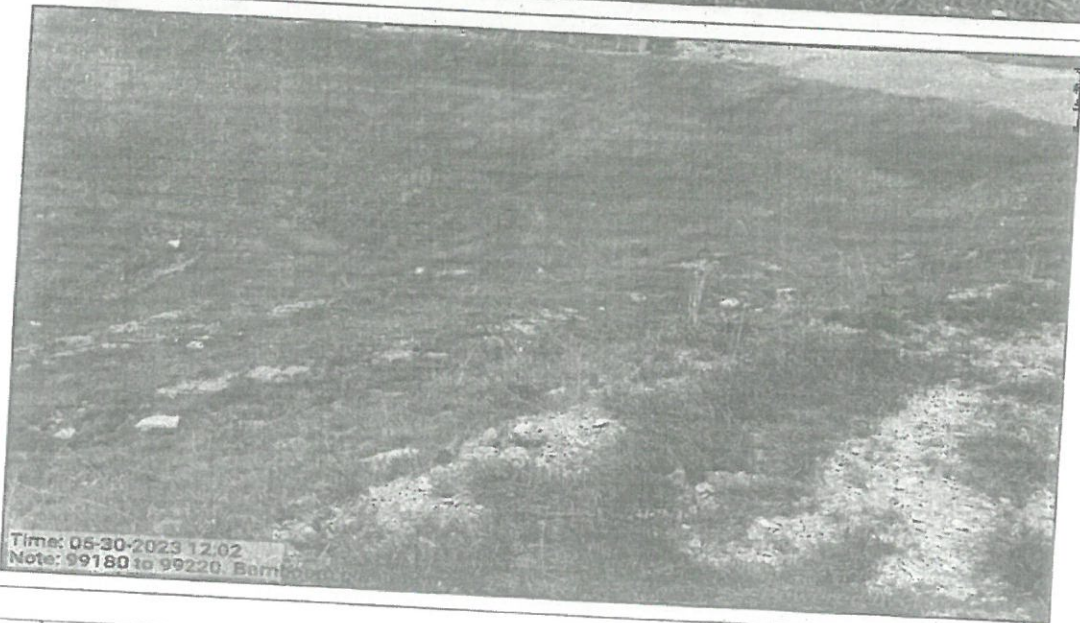
Time: 06-30-2023 12:02
 Note: 99180 to 99220, Bam...

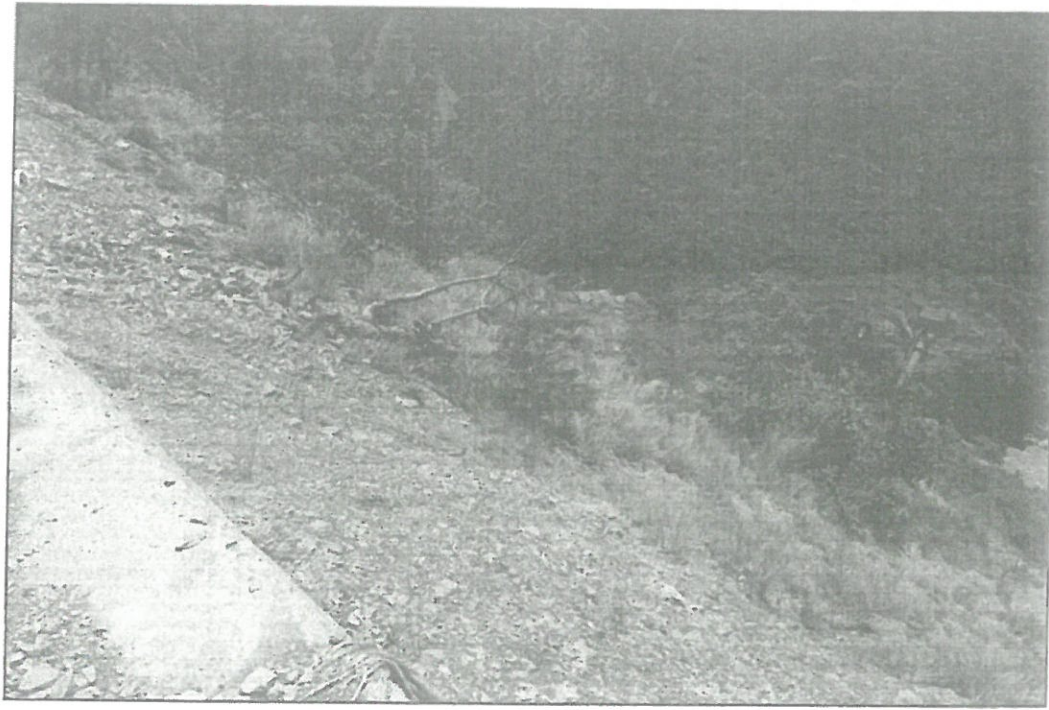
Sr. No.	12
Location No.	RD98/930
Issues	Unauthorized and illegal dumping of debris on forest and private land without any protection measures.
Comment	This location is not a dumping zone and no dumping has been done by the Contractor at this location. Hillside slide and valley-side soil erosion have happened during extreme adverse weather condition of

rainfall in 2023. Bamboo plantation has been done to control the erosion. Detailed report (submitted to insurance company for claim) attached herewith may also be referred in this regard. Further, retaining structures and slope protection measures have been completed and are being maintained by the Contractor.

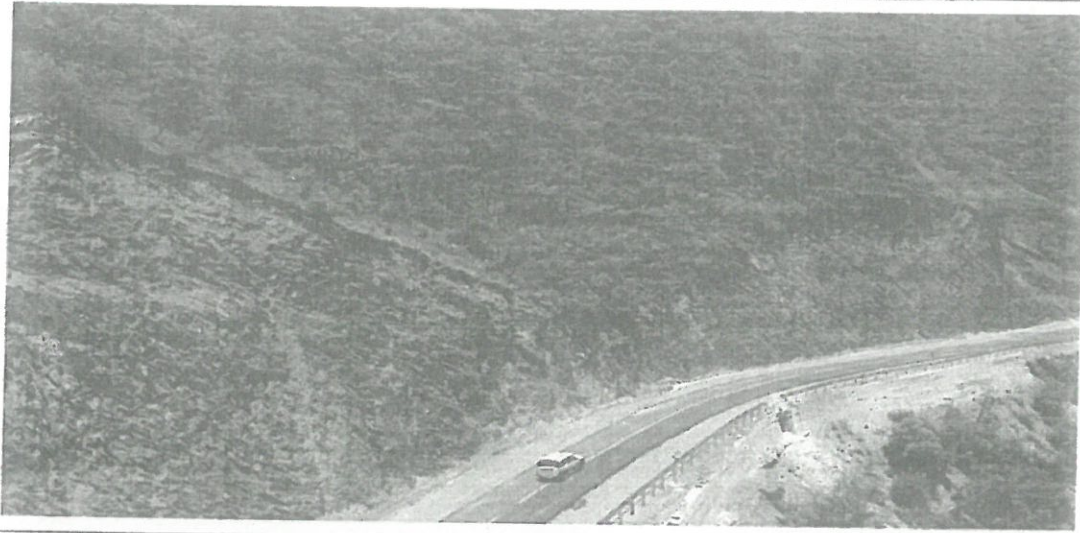
Sr. No.	16
Location No.	RD97/610
Issues	Unauthorized and illegal dumping of debris on forest and private land without any protection measures.
Comment	This location is not a dumping zone and no dumping has been done by the Contractor at this location. The damage is due to extremely adverse weather condition of rainfall. Detailed report (submitted to insurance company for claim) attached herewith may also be referred in this regard. Further, retaining structures on valley side and slope protection measures have been completed and are being maintained by the Contractor.
After restoration

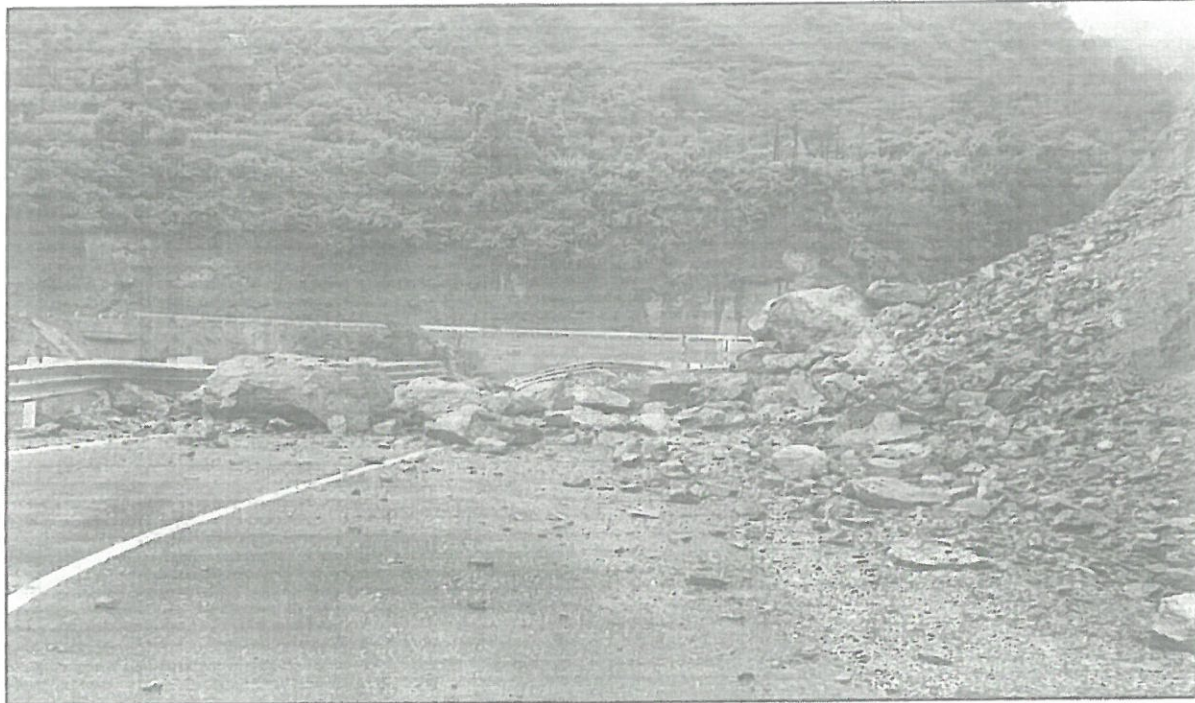
Sr. No.	19
Location No.	RD95/180
Issues	Unauthorized and illegal dumping of debris on forest and private land without any protection measures.
Comment	This location is not a dumping zone and no dumping has been done by the Contractor at this location. The rock fall happened during the rainy season from beyond ROW. The rock debris hit the crash barrier and debris fell in the valley side. Further, geocell with hydroseeding was done in this location to prevent erosion. During the subsequent rainfall, the slope protection measures were also damaged. The stream banks have been cleared for the free flow of water and necessary repair/ restoration works are being ensured by the Contractor.

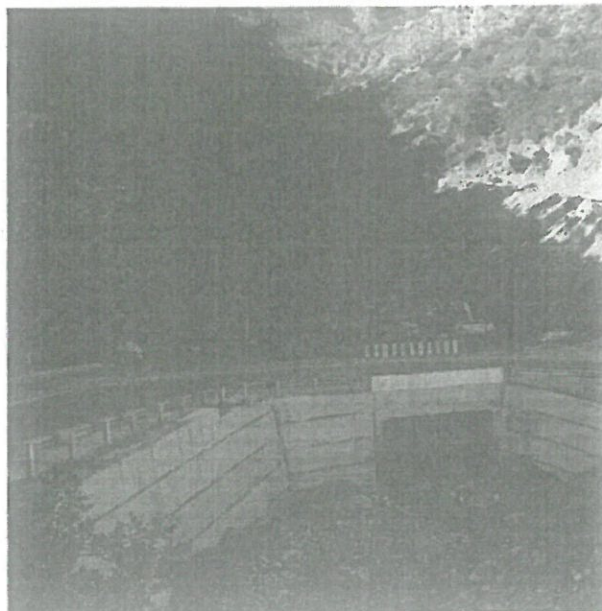
After rectification

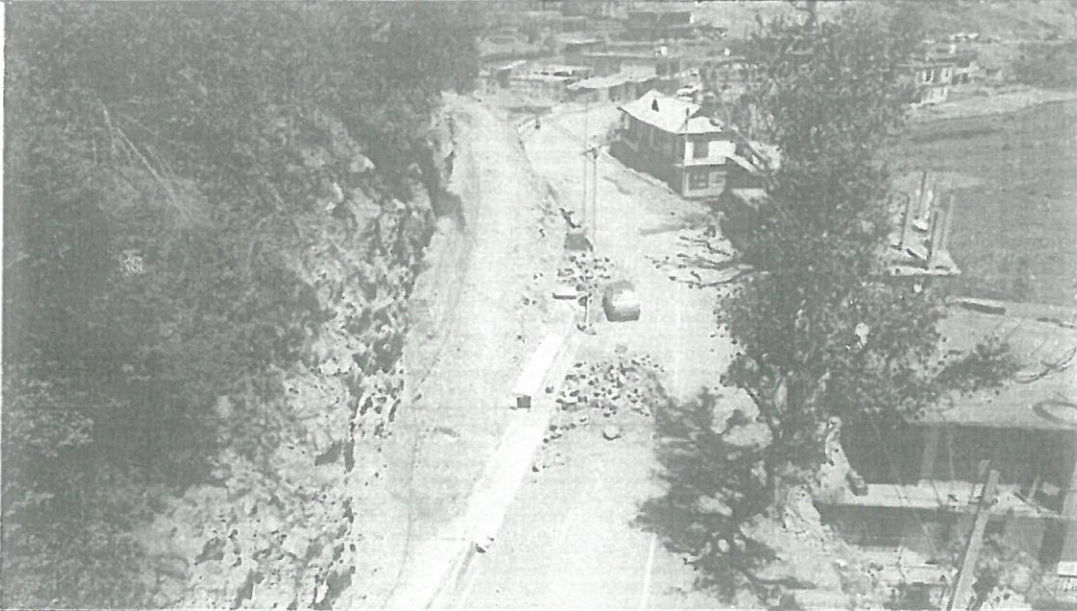
Comment This location is not a dumping zone and no dumping has been done by the Contractor at this location. The location pertains to built up area with structures on both side of the carriageway.

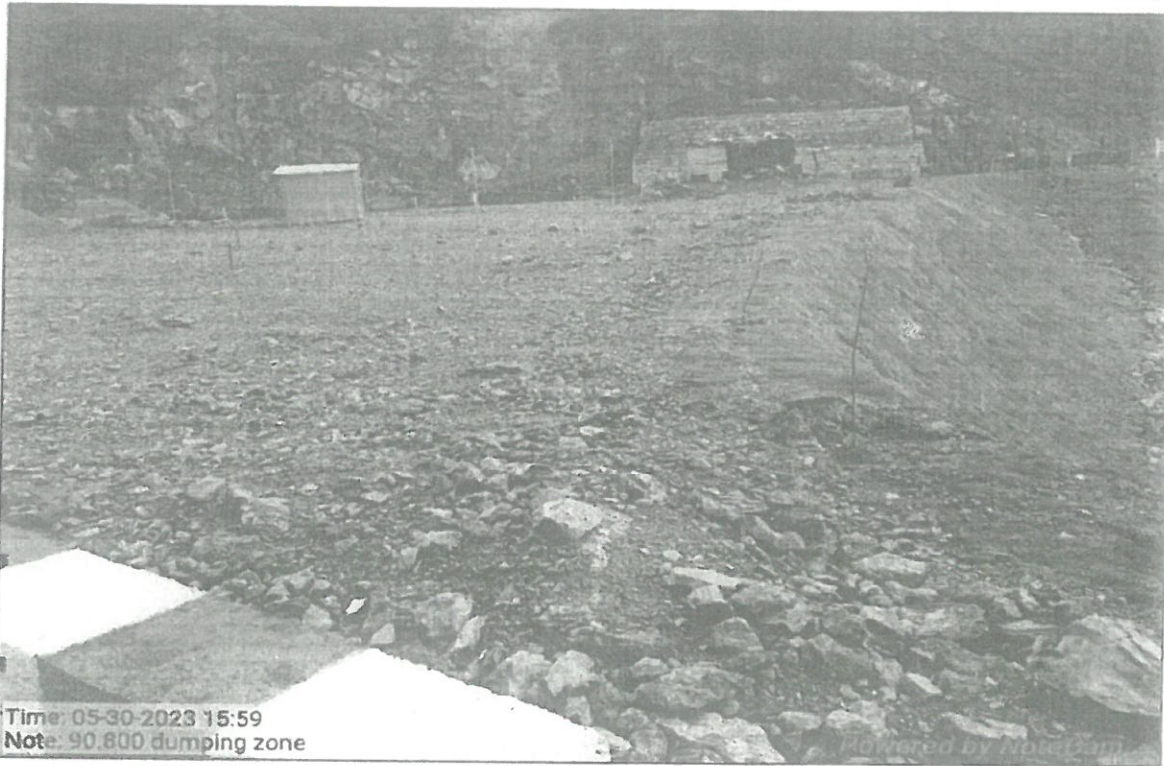
Sr. No.	25
Location No.	RD88/600
Issues	Unauthorized and illegal dumping of debris on forest and private land without any protection measures.
Comment	This location is not a dumping zone and no dumping has been done by the Contractor at this location. The road was closed on 06.02.2023 due to a slide at this location. The same information was communicated to the District Disaster Management Authority (DDMA).

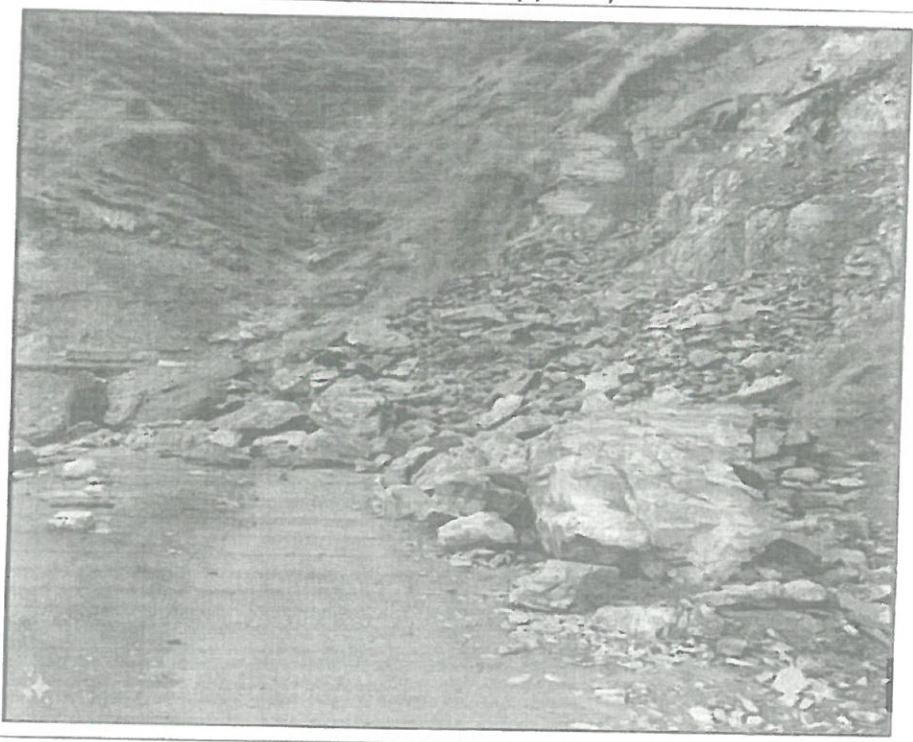
Sr. No	23
Chainage	41+000 to 41+100
Place	Kali Khan
Grievances raised by the applicant	Throwing muck randomly in slope of the hill, due to which debris has been accumulated in the lower parts of the mountains and there is a possibility of tragedy in the rainy season for resident of the villager living in lower part of the hill.
Comment	Owing to the available narrow width of the carriageway and continuous slide resulting in subsequent road closure, the debris from the hillside slid down the slope on the valley side. However, no dumping on the valley side has been done by the Contractor. The road was closed on 29.05.2022, 09.07.2023 and 17.03.2024 due to a slide at this location. The same information was communicated to the District Disaster Management Authority (DDMA).
