Assessment of Encroachment Using Satellite Data in Wild Ass Sanctuary, Little Rann of Kutch, Gujarat

This is a preliminary report prepared by SAC for further discussion and planning course of action by the committee appointed by NGT.

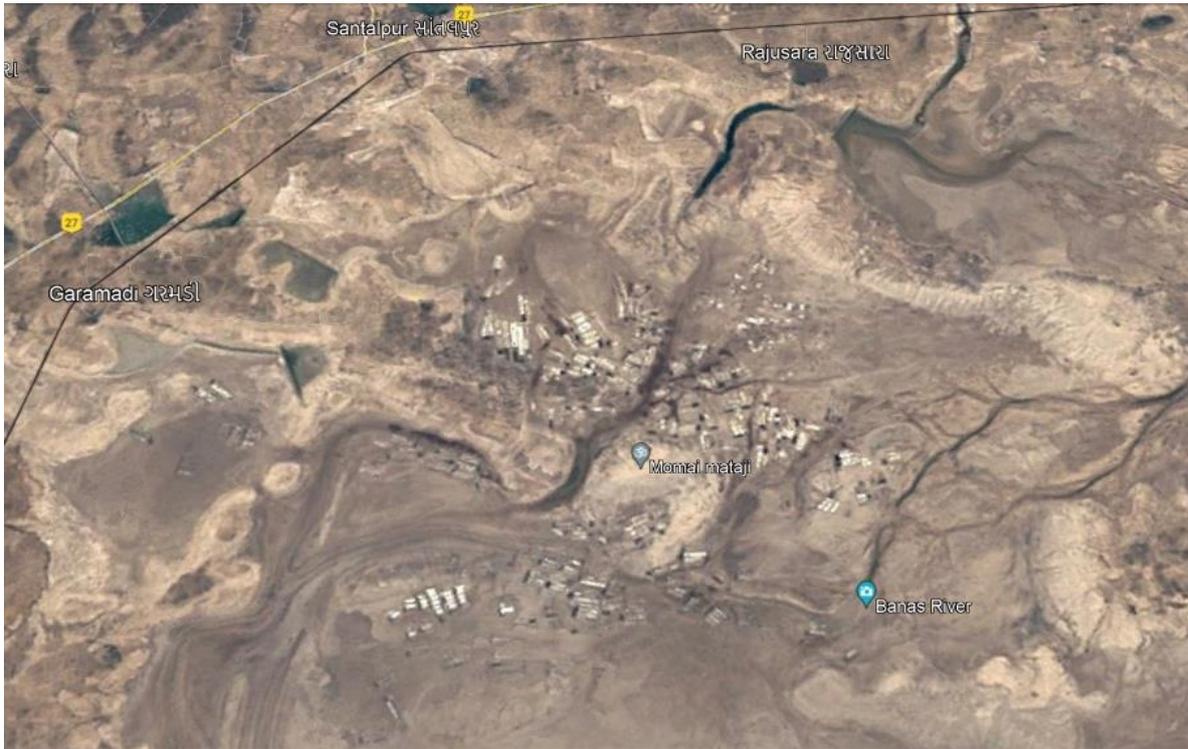
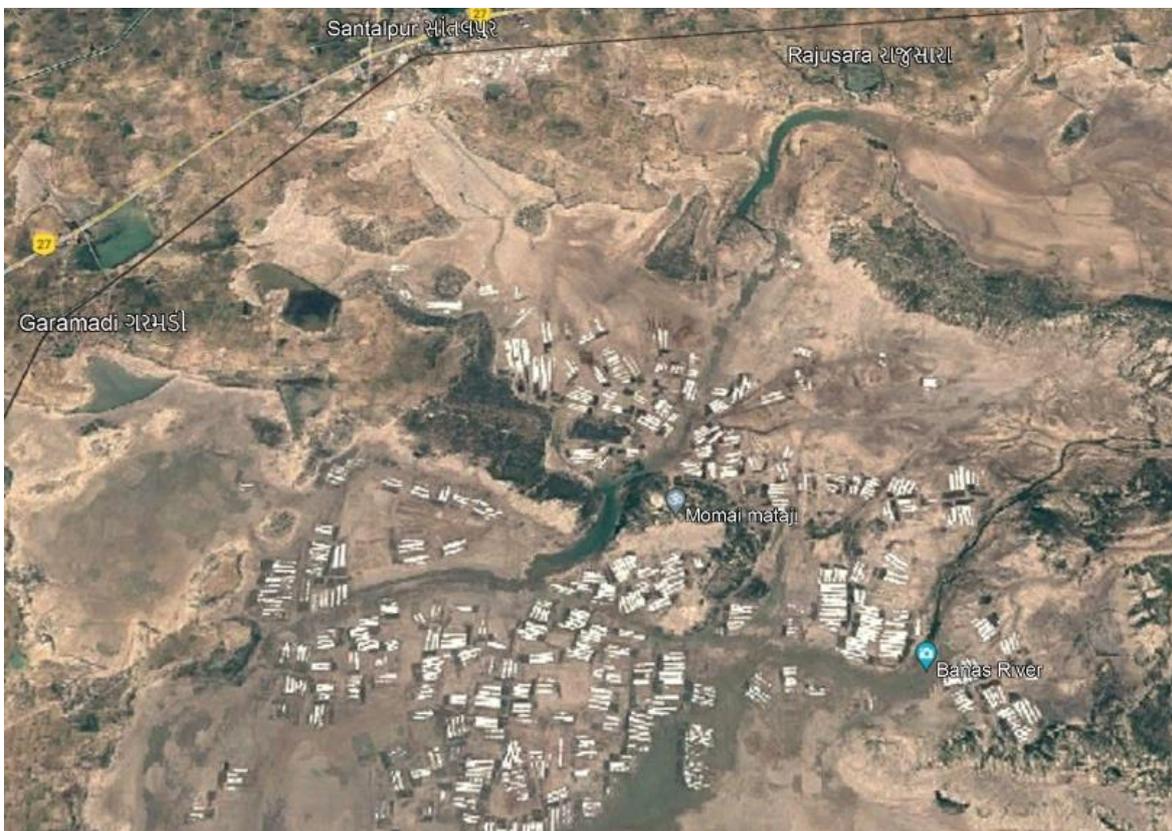
1. **Significant increase in Salt pans:** Salt pan activities increased many folds as shown in the following images of 1985 and 2022 of Little Rann of Kutch near Satalpur.

1985

2022

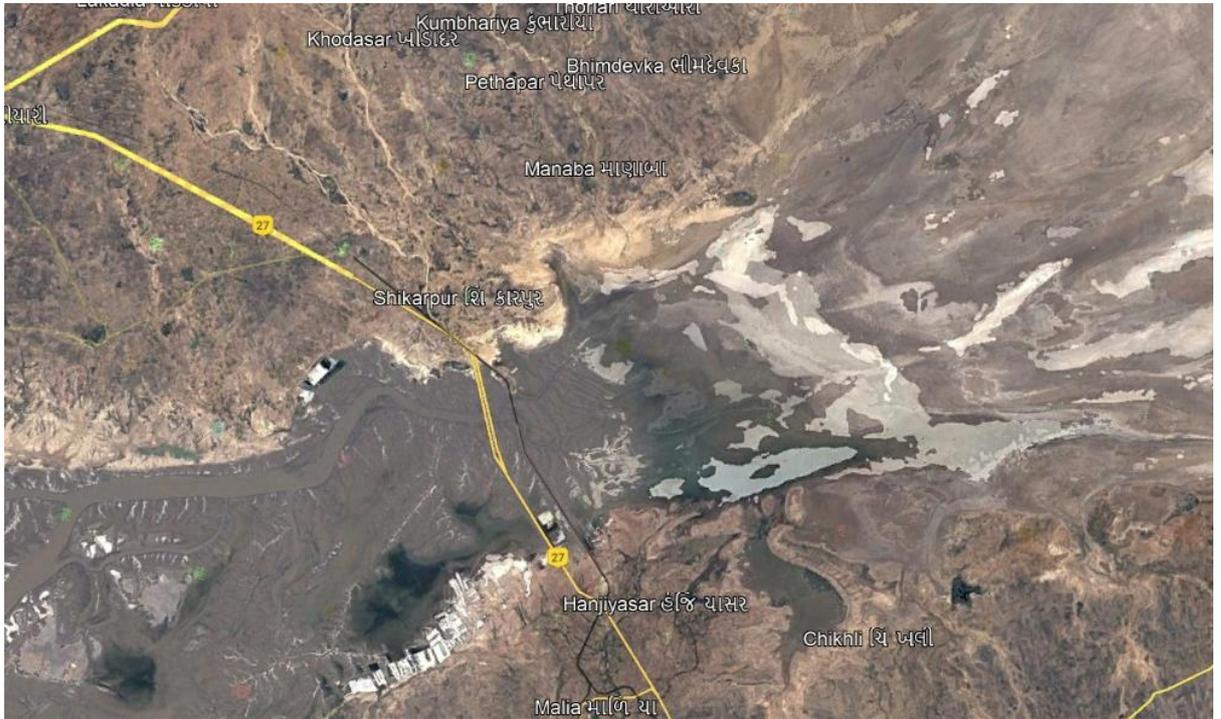
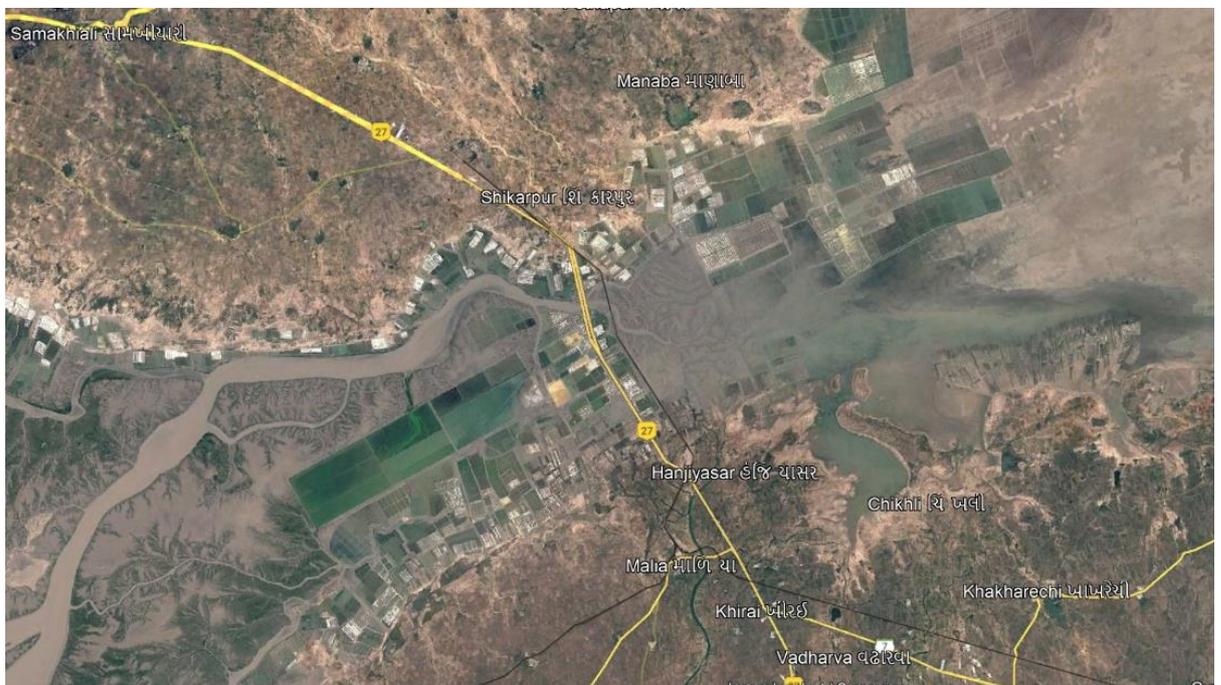
- 2. **Intertidal blockage:** intertidal flow obstructed due to increase in large scale salt pan activities near Malia.

1985

2022

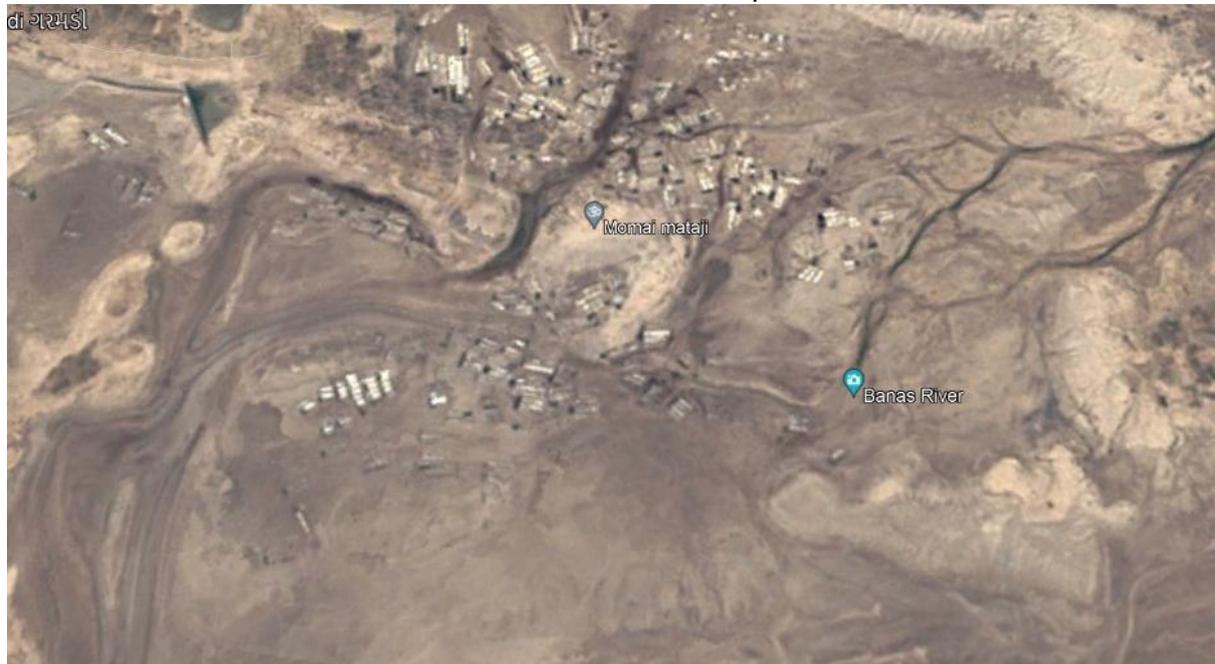
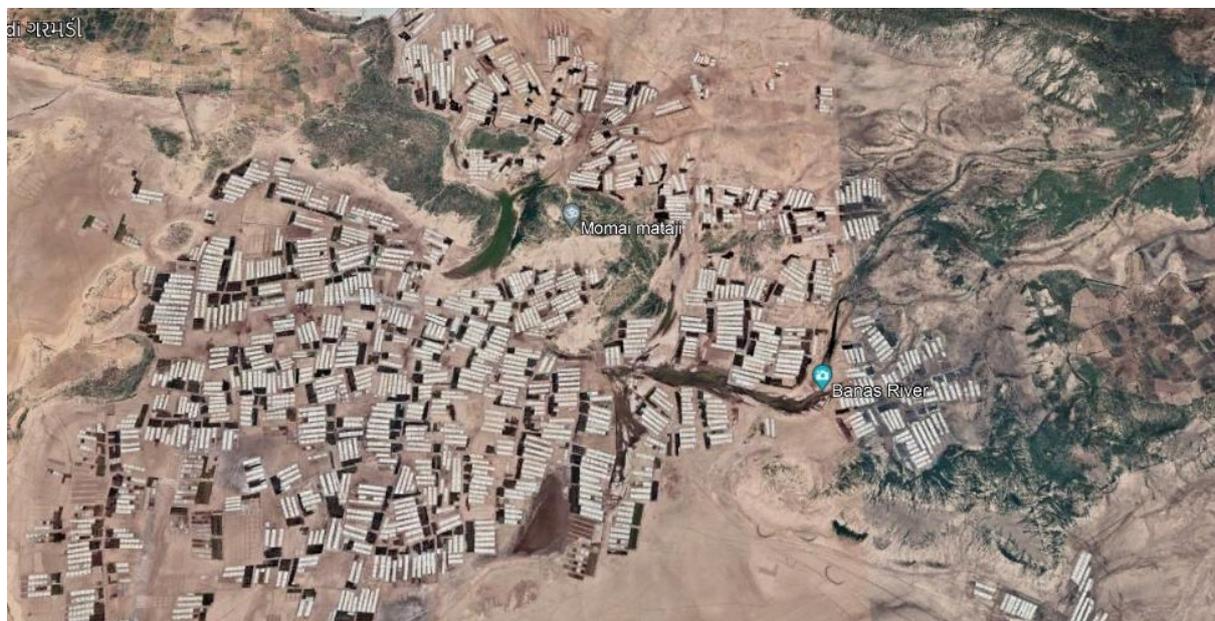
Banas river, near Satalpur

- River channel blockage:** Salt pans are constructed across / near river channel and it is obstructing natural flow of the river. Following examples of Banas and Rupen river shows blockage of river flow in LRK.

1985

2022

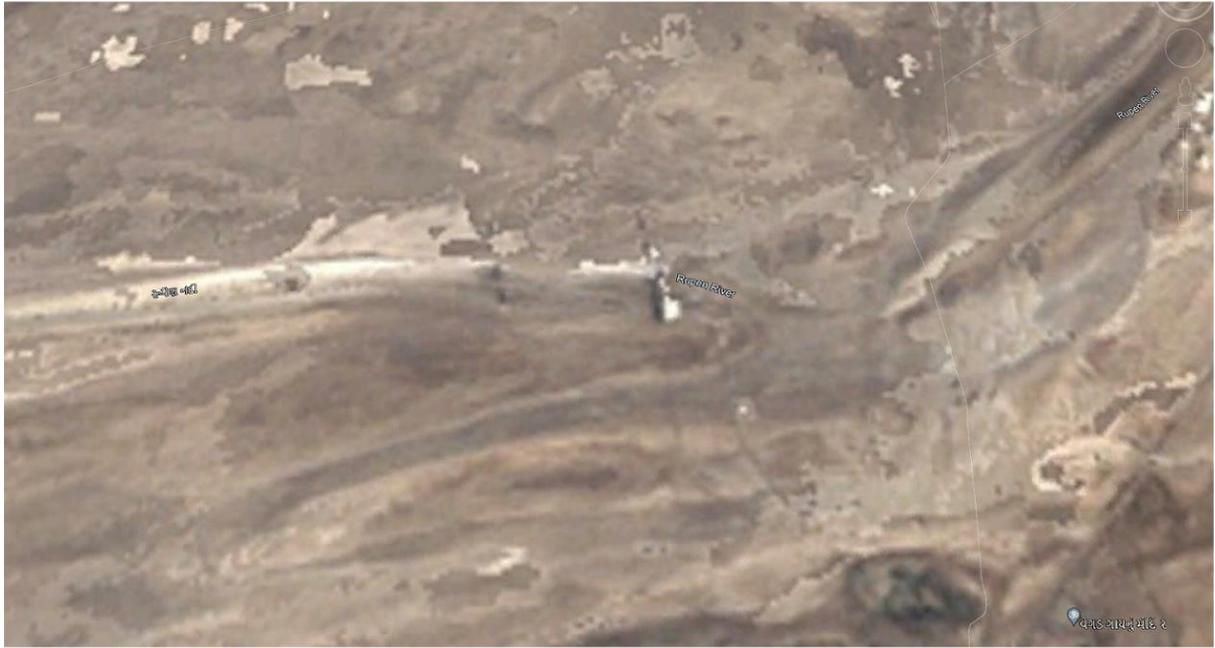
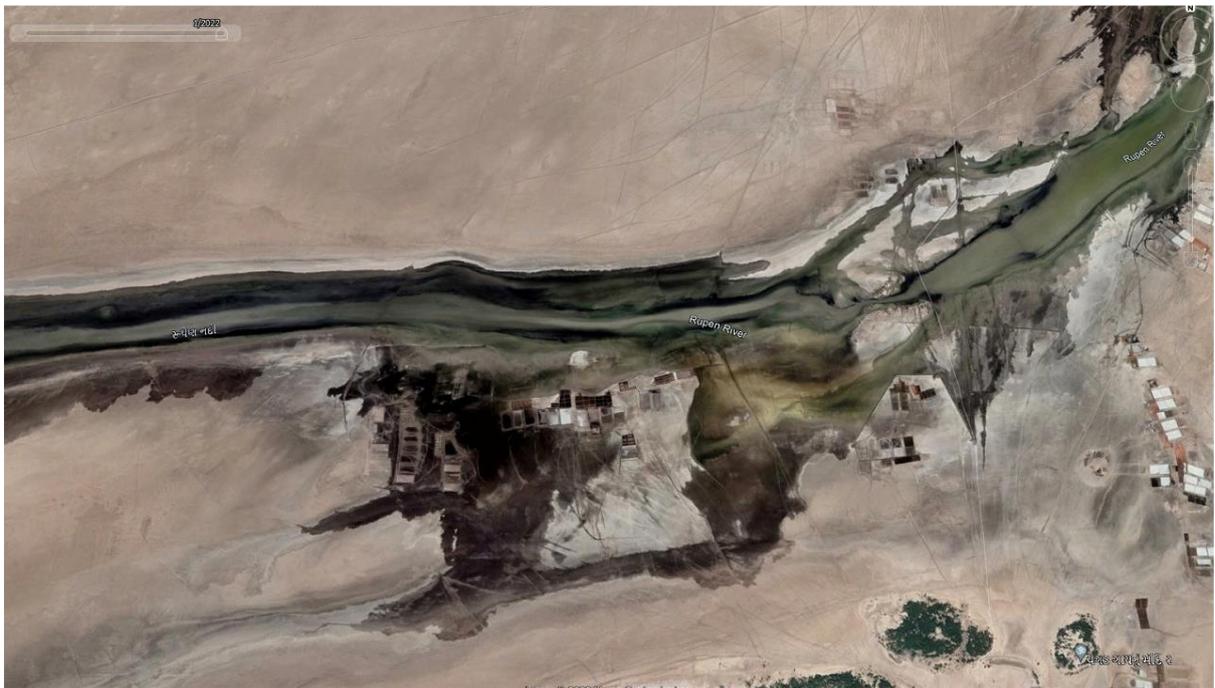
Rupen river, Little Rann of Kutch

1985

2022

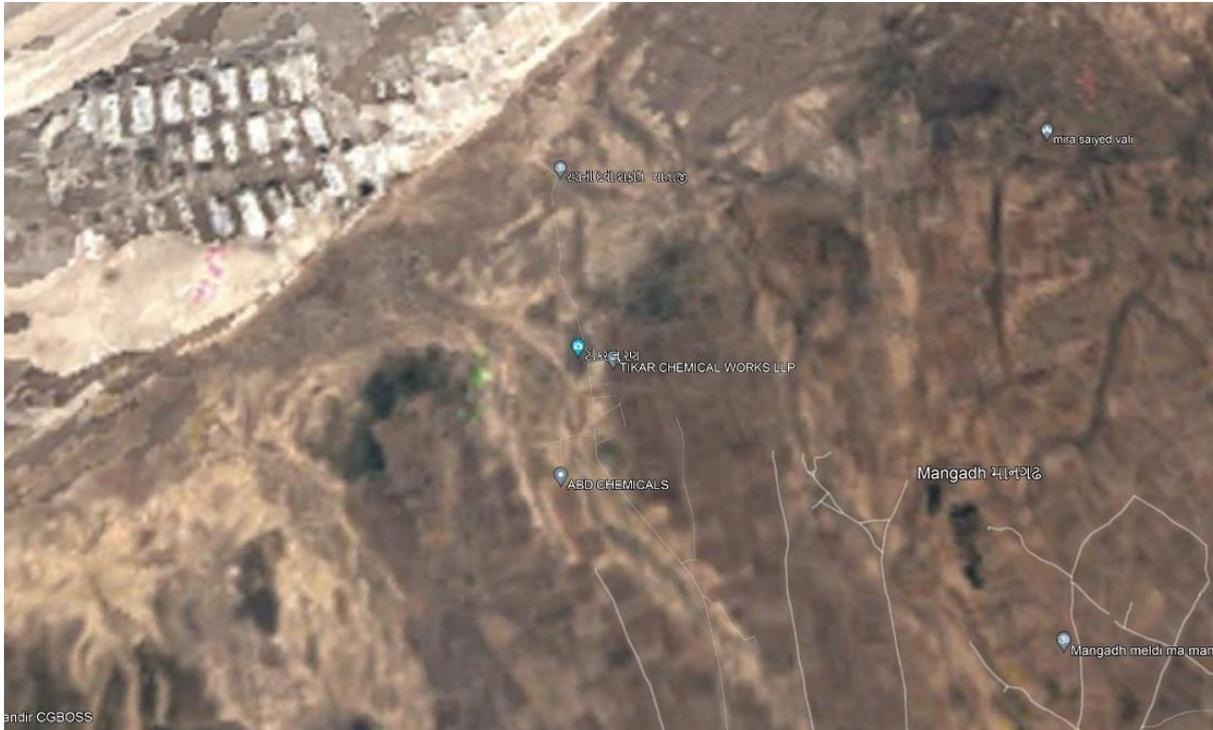
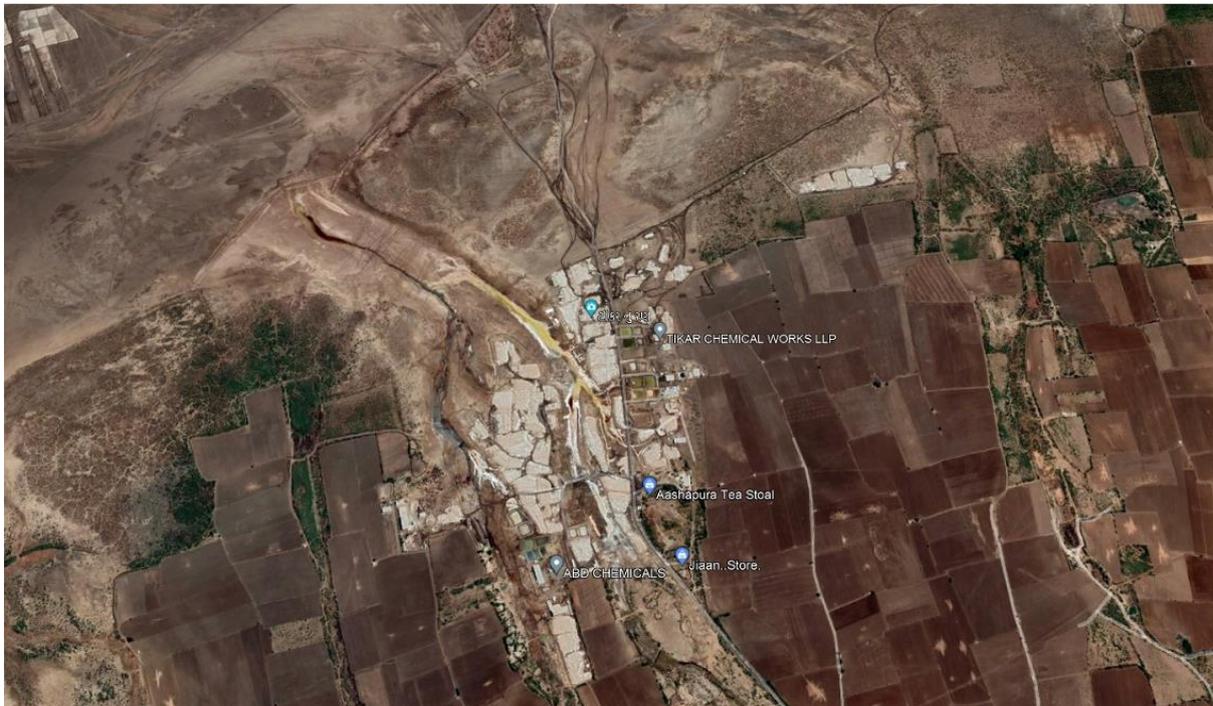
Chemical plant near Tikar

4. **Chemical plants:** Chemical plants are located very near to the sanctuary. River and land pollution may disturb the wild ass habitat, migratory birds breeding ground and overall ecosystems.

1985

2022

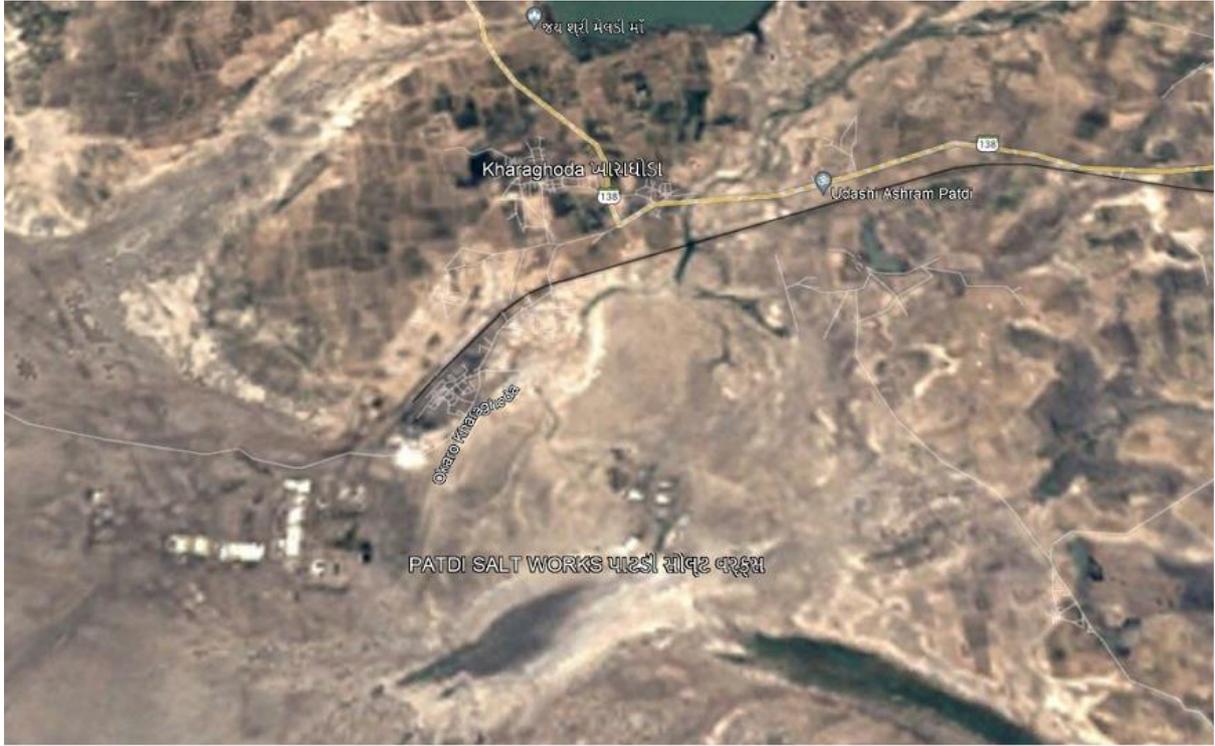
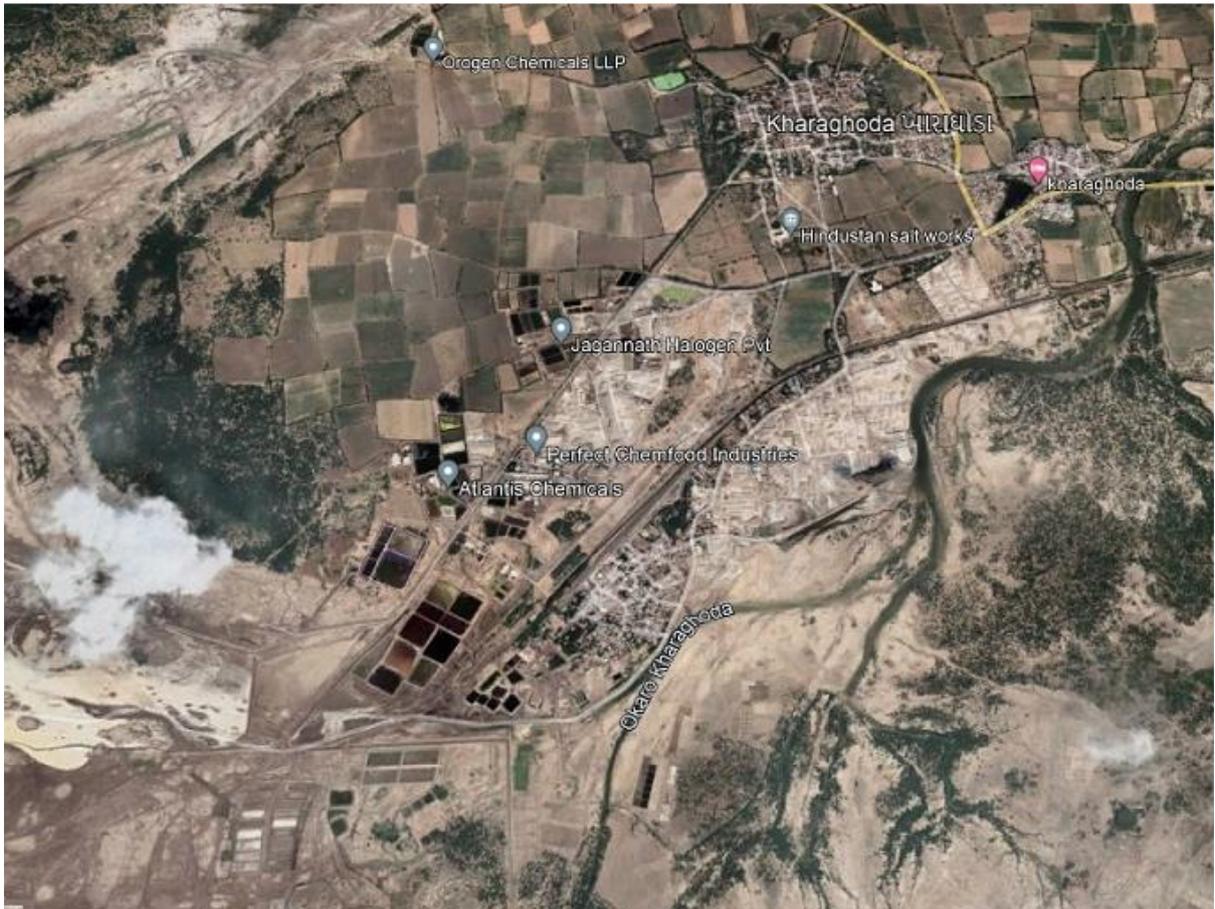
Chemical plant near Kharaghoda

1985

2022
