**Sub: - Action Taken Report w.r.t. Jammu and Kashmir Pollution Control Committee
in O.A No. 706/2022 titled Asgar Ahmad Najar Versus Ministry of
Environment, Forest and Climate Change & Ors**

Action Taken Report of Jammu and Kashmir Pollution Control Committee to the directions of Hon'ble National Green Tribunal Order Dt. 10-11-2023 in O.A No. 706/2022 titled Asgar Ahmad Najar Versus Ministry of Environment, Forest and Climate Change & Ors.

In compliance to the Hon'ble National Green Tribunal order, the J&K Pollution Control Committee carried out the inspection of the site on 12.12.2023 in association with the applicant to verify the compliances made by the Project Proponent M/s ABCI Infrastructure Pvt Ltd. to the remedial measures suggested by the Joint Committee and the Status of Compliance is submitted as under:-

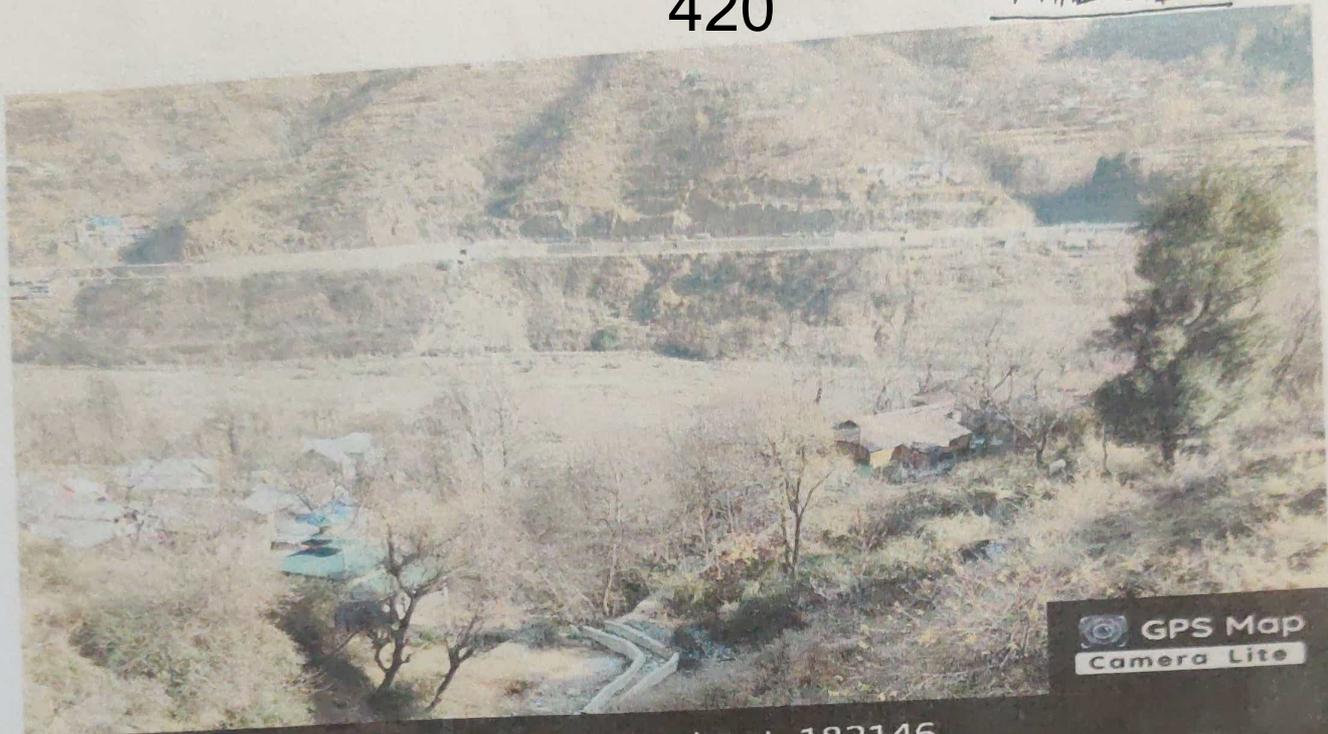
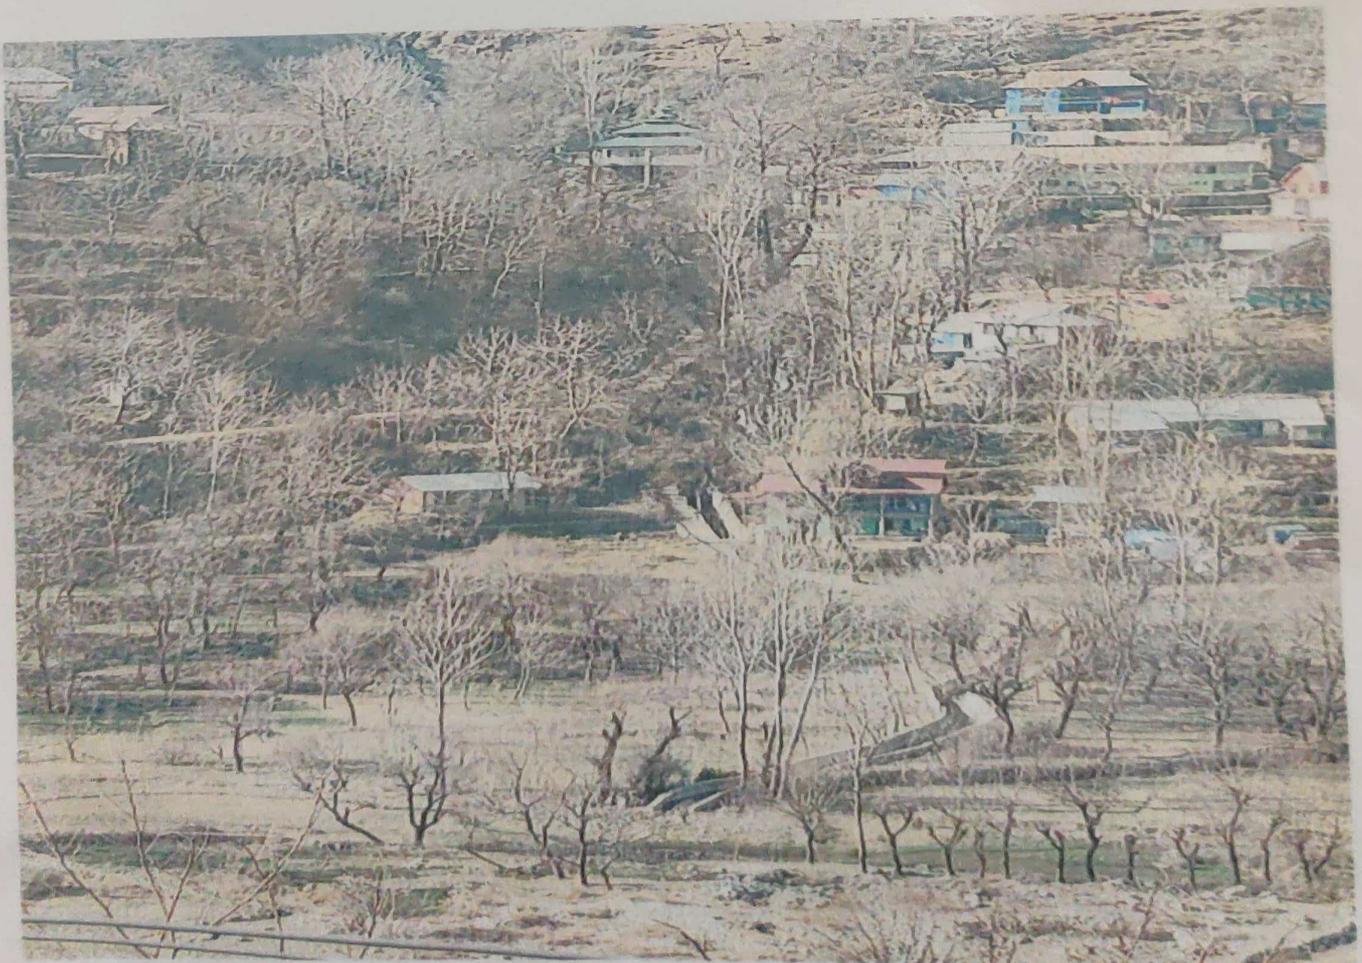
PHOTOGRAPH OF CONCRETE DRAIN PASSING THROUGH VILLAGE

S.No	Recommendations of the Joint Committee during visits to the site.	Status of the compliances done by the Project Proponent to the recommendations of Joint Committee.
1	Visit dated 16.11.2022 Ramps or closed pipes are required to transport the waste	As already reported, pucca/concrete drain passing through one side of the village (natural drainage on down slope) has been

water at the points where waste water is crossing the pathways/crossing points.	constructed by the project proponent and concrete ramps have been laid over the pathways/crossings points of the village over the drain as per the recommendations of the Joint Committee. (Photograph of drain is annexed as Annexure-I)
2	<p><u>Visit dated 16.11.2022</u></p> <p>To construct settling tank of adequate size outside the face of the tunnel so that the slush etc is settled and removed at regular intervals.</p>	The main tunnel T- 77D (now renamed as T-55) seepage water (clean water as the construction activities inside the main tunnel are completed) has been permanently diverted towards the Jammu end through concrete deep drain laid inside the main tunnel and nothing is diverted through the abandoned tunnel T-77A/Village drain. Moreover, the work on the main tunnel has been completed and the trial runs of the train also done through it between Banihal and Khari stations.

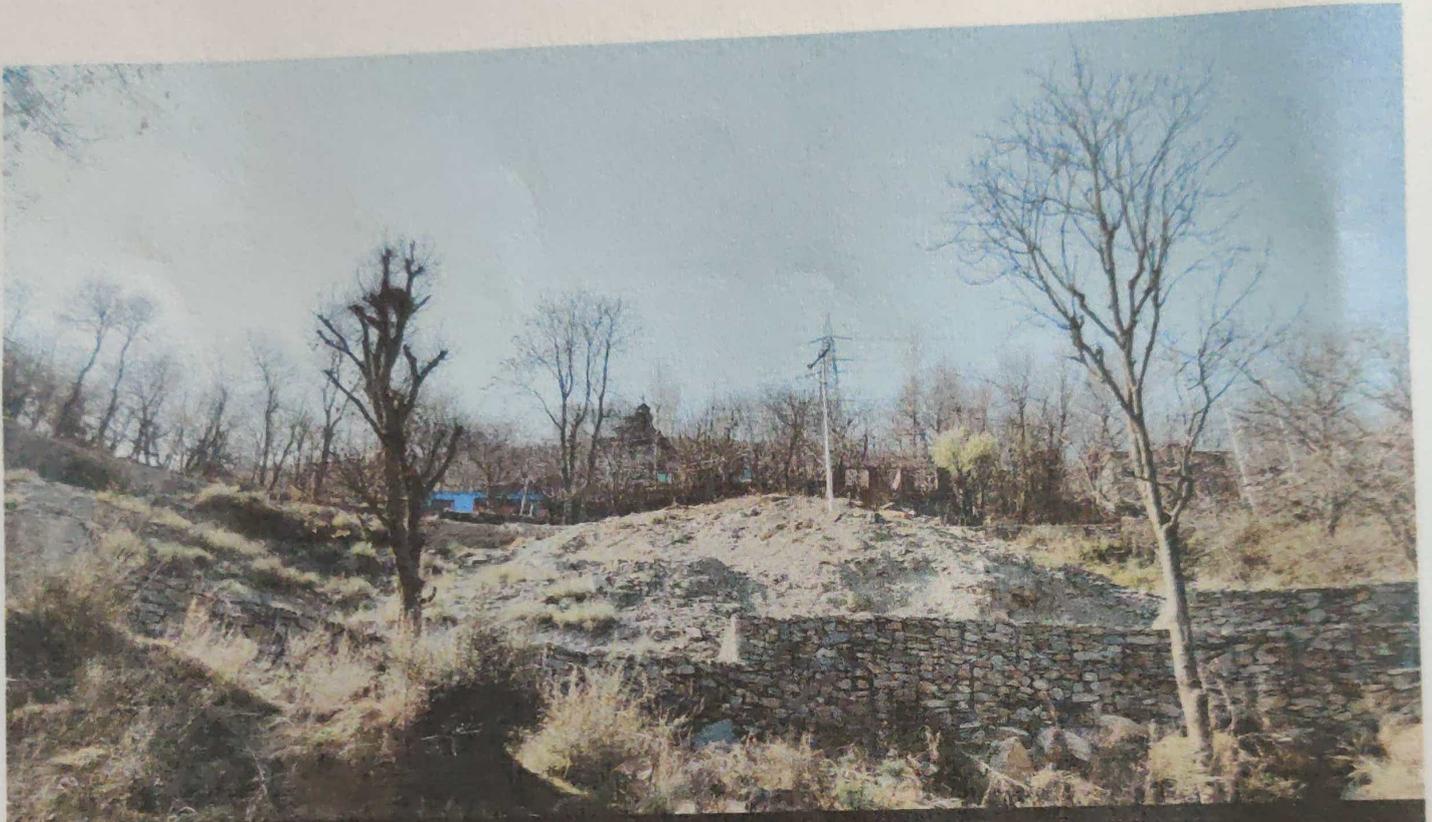
ANNEXURE - III

PHOTOGRAPH SHOWING GRABON/RETAINING WALL AT THE BOTTOM OF THE DUMP

3	<p><u>Visit dated 16.11.2022</u></p> <p>A retaining structure such as gabions/crate wall to retain the muck dumped for construction of approach road on upper side of the village is needed badly to avoid any untoward incident, leading to loss of property or life.</p>	As already reported, a gabion wall to retain the muck dumped for the construction of approach road towards tunnel T-77A has been provided by the project proponent along the bottom of the dump in the railway acquired land as per the recommendations of the Joint Committee and was found intact (Photograph is annexed as Annexure-II)
4	The project proponent is required to collect and store the empty	Store for empty cement bags already provided. It was observed that the

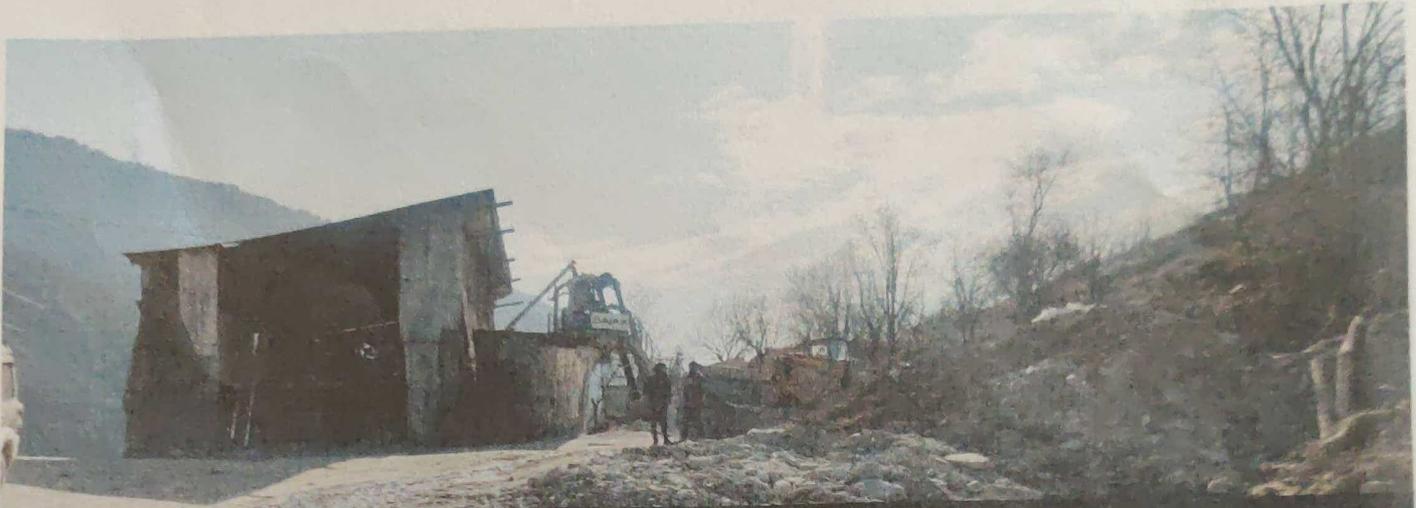
PHOTOGRAPH OF THE CEMENT STORE AND BATCHING PLANT UNDER DISMANTLE

<p>cement bags properly and dispose off the same through supplier or vendor, to avoid contributing towards particulate emissions.</p>	<p>operation of the batching plant has been stopped and the dismantling of same has been started. The underground sedimentation tank of the batching plant has been closed and filled with debris/muck due to completion of the project work.(Photographs is annexed as Annexure- III)</p>
5	<p><u>Visit dated 31.3.2023</u></p> <p>It was observed that a small portion of the soil has started sliding down just below the gabion wall provided by the proponent near Northern face of tunnel T-77A. It was recommended that slope stability is ensured by the proponent before leaving the site.</p>	<p>As already reported, a PCC retaining wall in about 20 M length and 3.0 M above ground in height has been constructed to avoid sliding of the soil near the Northern face of the abandoned tunnel T-77A by the project proponent as per the recommendations of the Joint Committee. (Photograph is annexed as Annexure- IVA)</p>

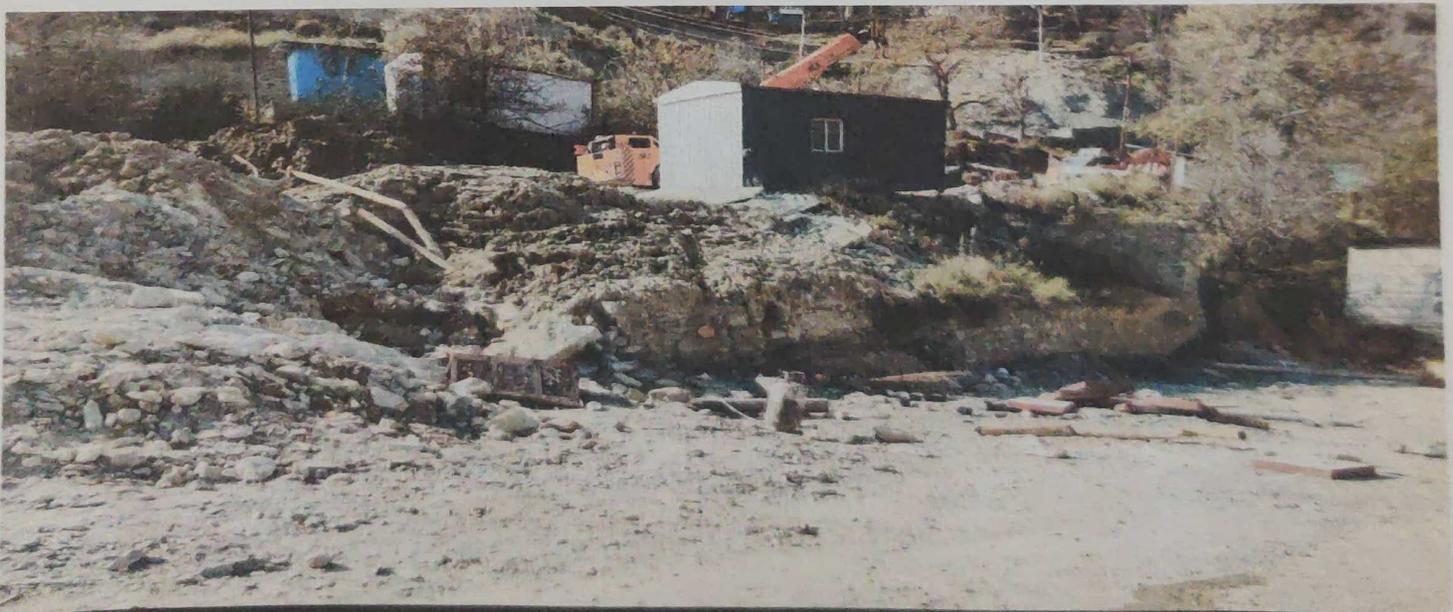
(A)

PHOTOGRAPH SHOWING SITE OF THE SEDIMENTATION TANK OF BATCHING PLANT NOW FILLED WITH DEBRIS/MUCK AFTER COMPLETION OF PROJECT WORK.

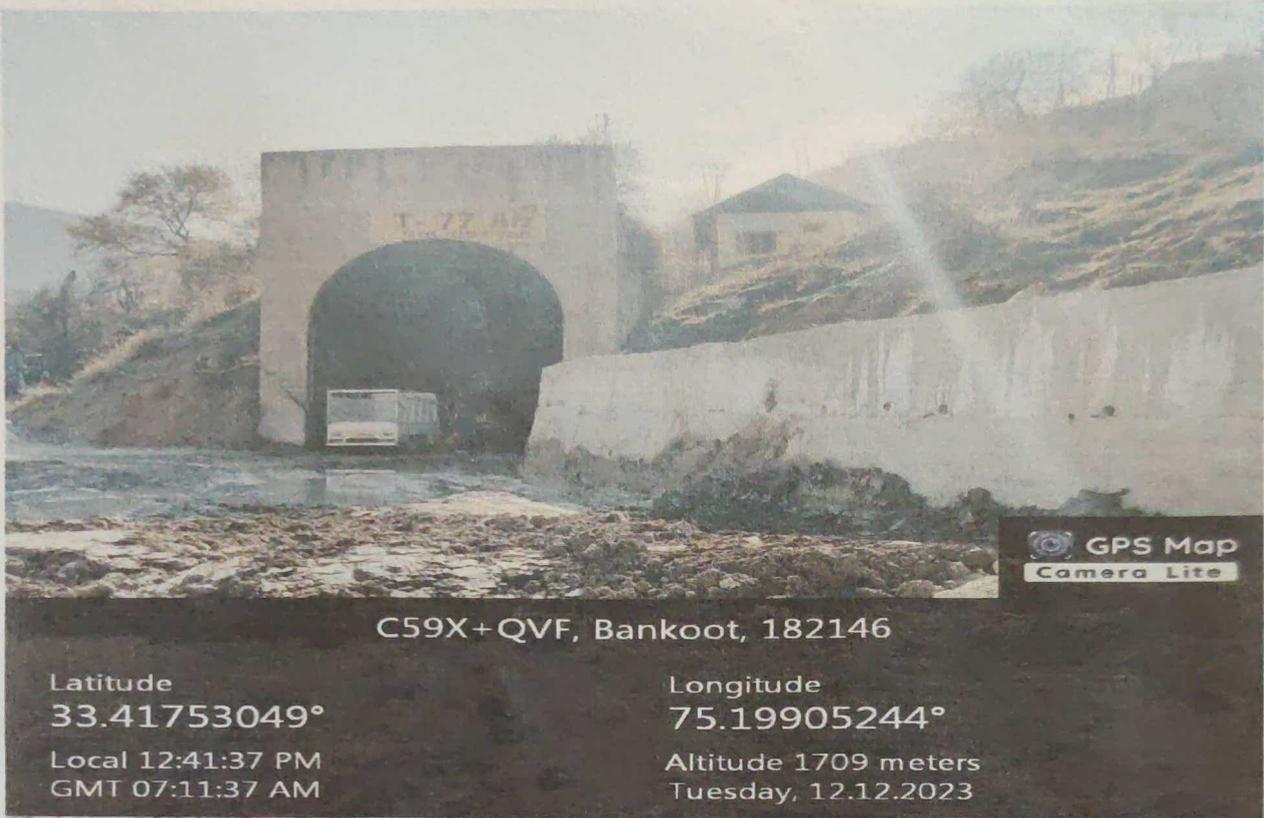
(B)

PHOTOGRAPH SHOWING RCC RETAINING WALL NEAR ABANDONED TUNNEL T-77A

remediation work utilizing the amount is yet to be started.
7.	On spot verbal instructions were issued by the District Magistrate, Ramban during his visit to the site on 11.8.2023 to remove debris in front of the abandoned tunnel T-77A and construct a retaining wall in front of the tunnel.	The project proponent has removed the construction debris lying in front of the tunnel T-77A and has also submitted latest photograph of the ongoing construction work of the retaining wall in front of the tunnel as per the instructions. (Photograph is annexed as Annexture-IVB)

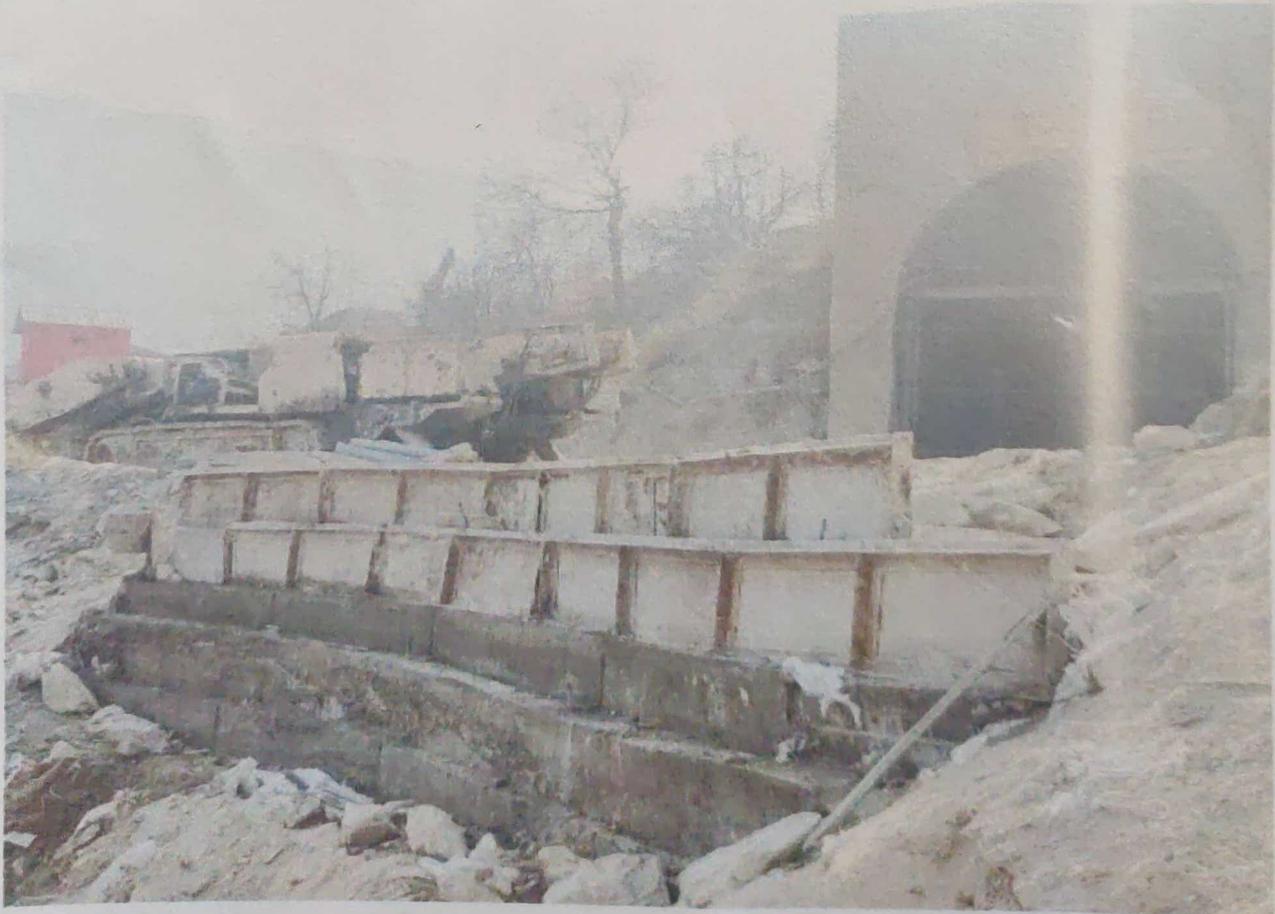
PHOTOGRAPH SHOWING CONSTRUCTION OF RETAINING WALL IN FRONT OF ABANDONED TUNNEL T-77A
