O.A.No.304 OF 2019

ADDITIONAL DOCUMENTS FILED BY POABS GRANTIES PVT. LTD.

NOTE ON THE PRELIMINARY GEOTECHNICAL ASSESSMENT OF MUBARAQ GRANITE QUARRY AND ITS ADJACENT AREAS, PERAKAMANNA VILLAGE, ERNAD TALUK, MALAPPURAM DISTRICT, KERALA.

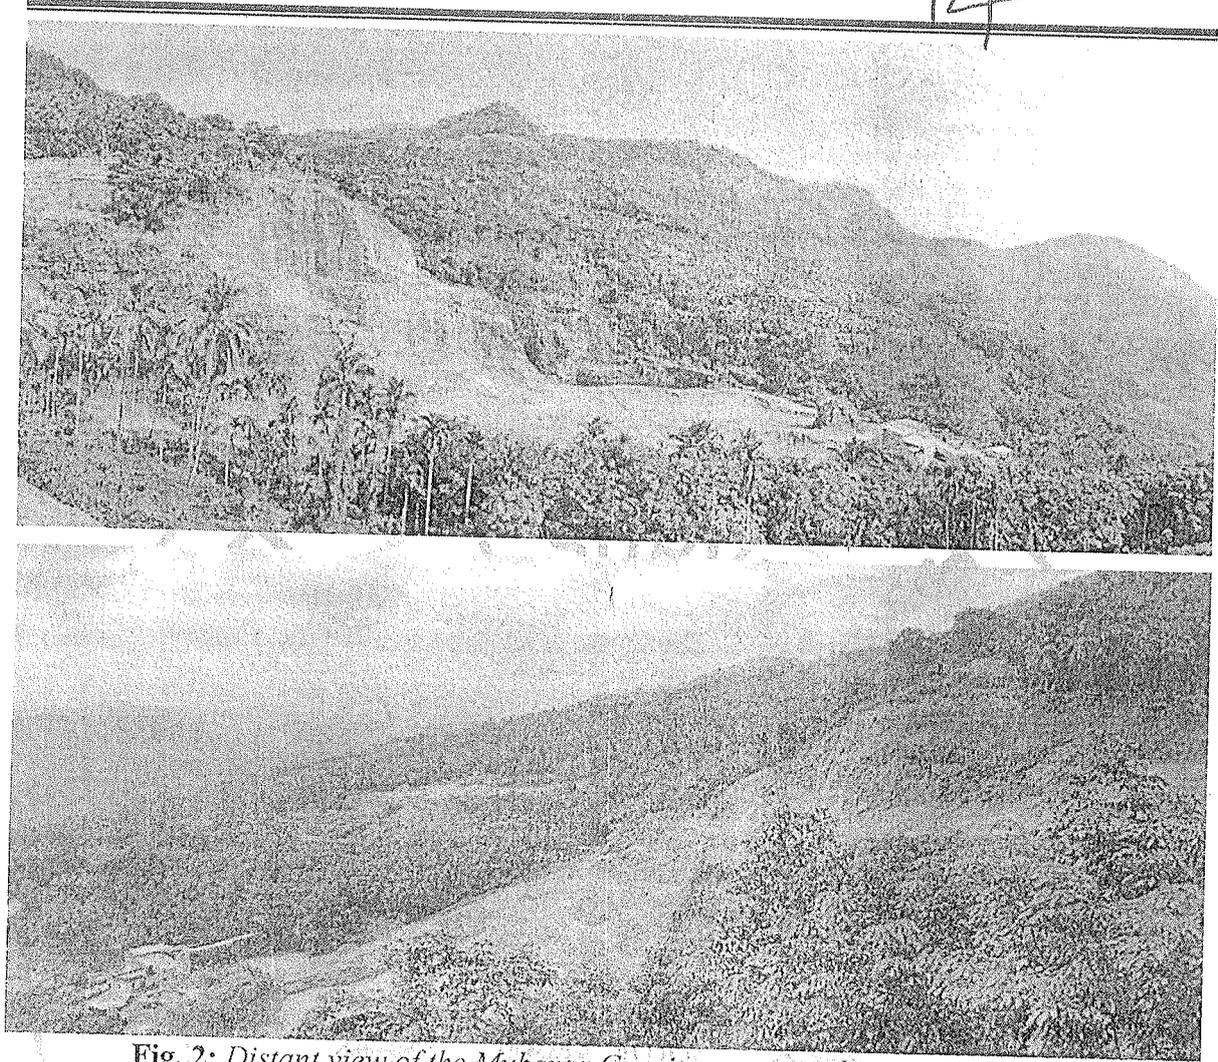
Fig. 2: Distant view of the Mubaraq Granite quarry and its surroundings.

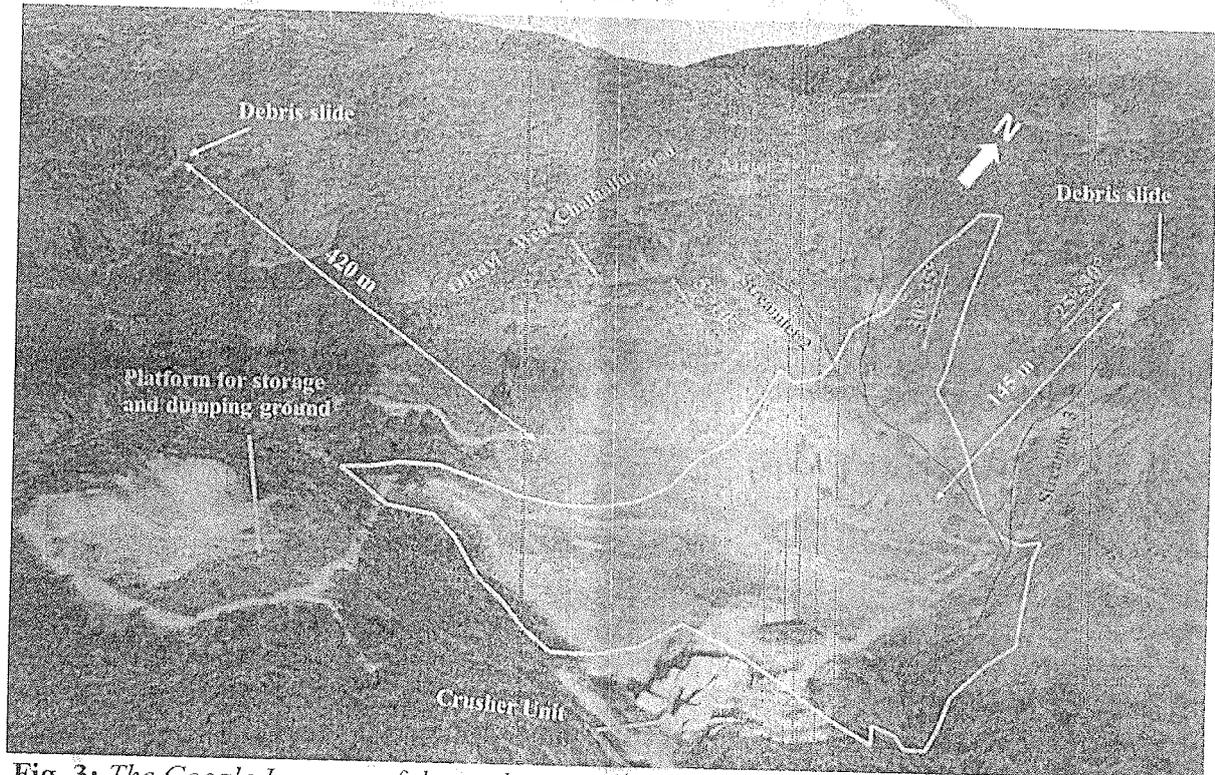
Fig. 3: The Google Imagery of the study area showing the slope gradient upslope, streamlets and the adjacent debris slides.

Two recent landslide incidences were identified nearby the study area. A debris slide (Fig. 3 & 8) occurred about 145 m north from the quarrying area ($76^{\circ} 6'50.67''$ E, $11^{\circ} 15'36.65''$ N) during heavy rains of 2018 southwest monsoon, within the rubber plantation. The slide initiated between the rock – overburden material contact. The slide is having a dimension of 20 m length, 17 m width and 3 m depth.

Another debris slide (Fig. 3 & 9) occurred about 420 m west of the Mubaraq Granite ($76^{\circ} 06' 31.3''$ E, $11^{\circ} 15' 27.5''$ N) during the southwest monsoon of 2019. The slide is having a dimension of about 25 m in length and 12 m width, were the overburden material containing precarious boulders (debris) having a thickness ranging from 0.5 m to 1m slid down. This slide follows a first order stream path for about 150 m. The same streamlet reaches the western part of Mubaraq quarry after travelling 430 m. The failure initiated as a result of increase in pore water pressure and reduction in shear strength of slope forming material due to heavy rainfall.

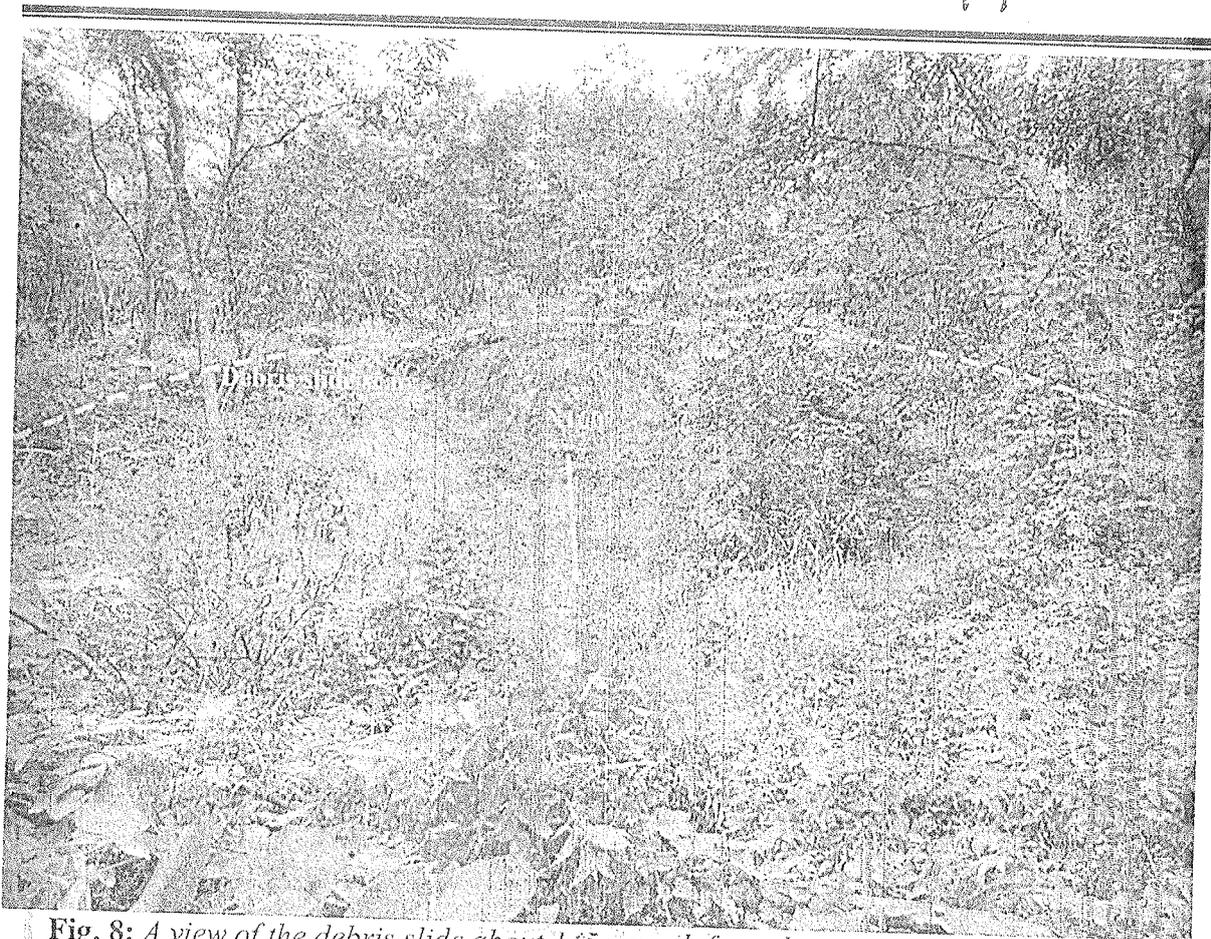
Fig. 8: A view of the debris slide about 145m north from the Mubaraq Granite quarry.

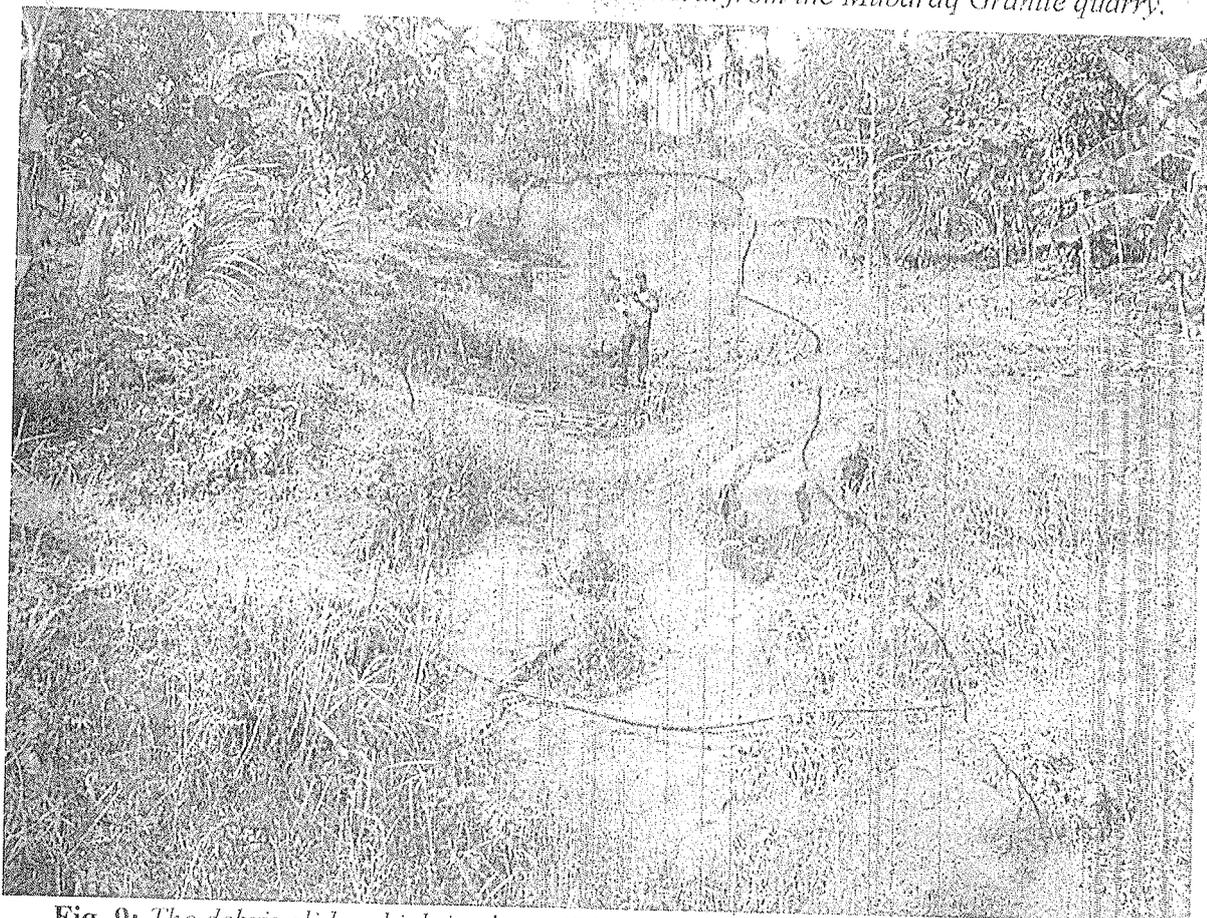
Fig. 9: The debris slide which is about 420 m west from the Mubaraq Granite quarry.

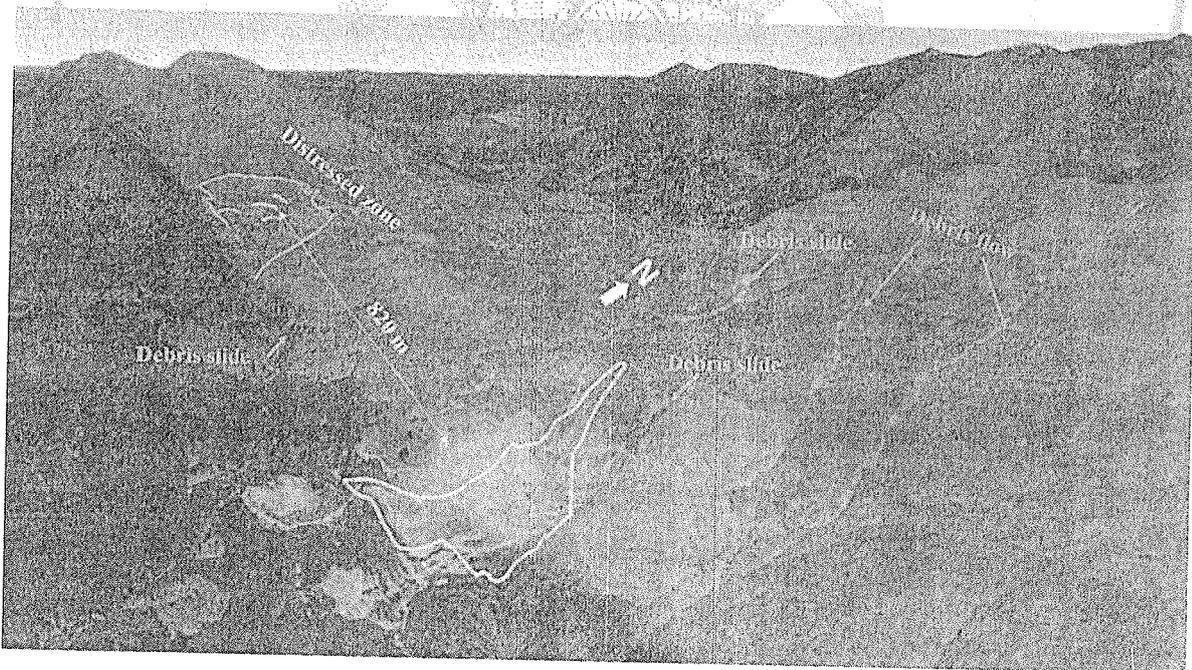
Fig. 10: The Google satellite imagery showing the distressed zone at Chekkunnu mala and slope failures in the adjacent slopes of Mubaraq Granite quarry.

Many debris slides and debris flows were identified either in field or using Google satellite imagery (Fig. 10) in the adjacent slopes of Mubaraq Granite quarry. On investigation it was found that the causative factors for all these failures are natural one mainly due to the type of slope forming material, the depth to the bed rock, slope gradient and the heavy downpour prevailing during the period of initiation of failures. The debris flows in the eastern part initiated as stripping failures which eventually joins the first order stream path and converted to debris flows.

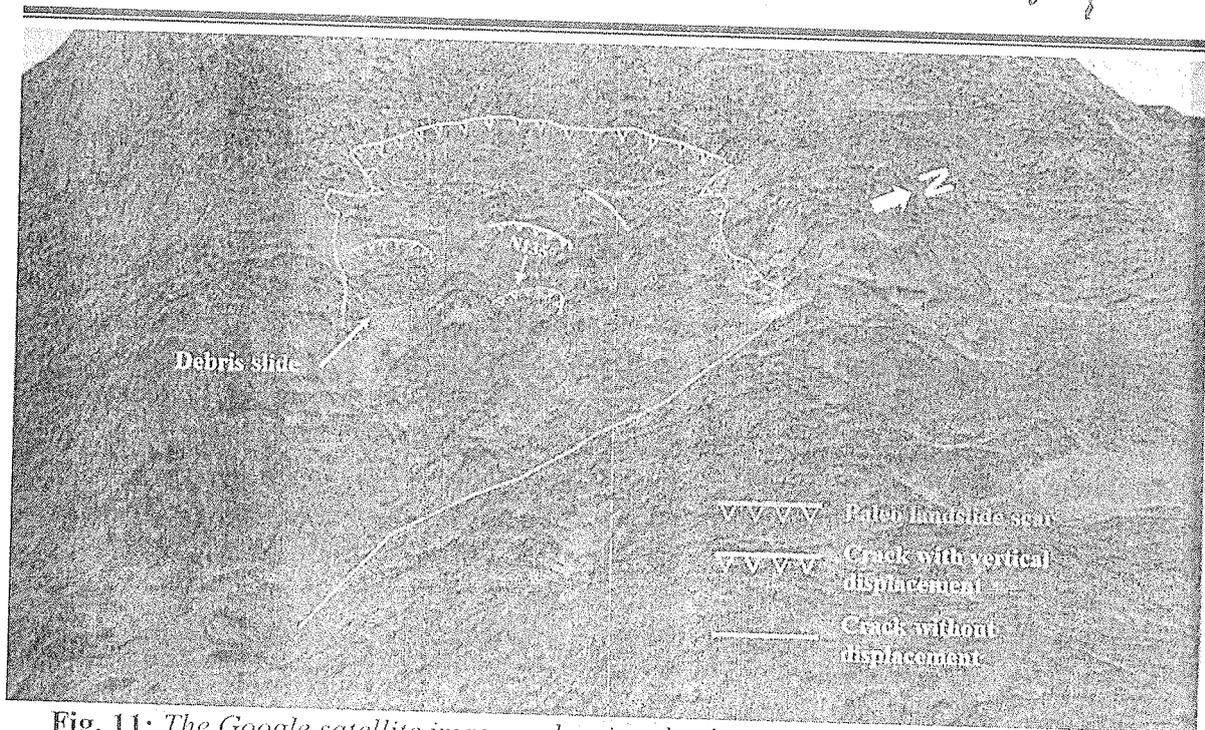
Fig. 12: The photographs showing the distressed zone at Chekkunnu mala.

As informed and mentioned in the petition, the slope at Chekkunnu mala along which two parallel tension cracks (40 m apart) were developed and enlarged during the southwest monsoons of 2018 and 2019 were investigated. In addition to these cracks, a subsidence zone having a dimension of 4 m x 5 m x 3 m is observed at the upslope part. The location is about 820 m aerial distance from the Mubaraq Granite quarry in the WNW direction (Fig. 10). On field investigation it was found that the distressed zone is situated within a paleo landslide scar of past origin. Within this paleo landslide scar, the presence of minor scars of reactivation and a recent debris slide were evident from the Google satellite imagery (Fig. 11). From the site investigation it is clear that the development of these tension cracks (Fig. 12) in this particular slope is the initiation of a major landslide during the southwest monsoons of 2018 and 2019, which got aborted as the development of slip circle terminated due to the break in slope and lesser regolith depth.

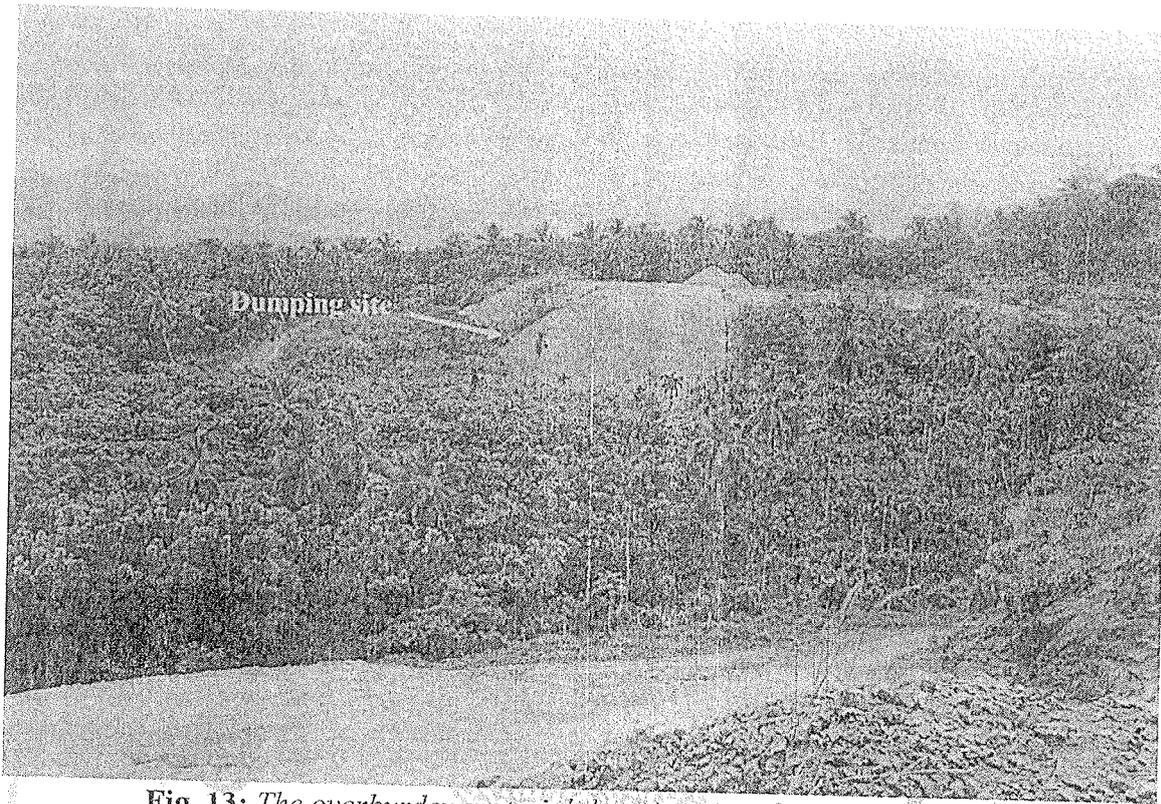
The area occupied by the Mubaraq Granite and its upper and lower reaches were thoroughly investigated and found that the active quarrying area is totally flattened and devoid of any overburden material. The upper reaches of the Mubaraq Granite are occupied with hard compact debris containing isolated large rock blocks with thickness ranging from 0.5 m to 5 m. At the northern reaches where the slope angle varies between 25° - 35° the chances of slope failures are higher which is evident from the recent debris slide. The 2nd order stream flowing along the northern slope is prone to debris flow, so it is recommended to construct a suitable culvert at the stream to quarry – plantation road contact (marked 1 in Fig. 3) and maintain the stream path properly for the free flow of water. The overburden material dumping ground (Fig.

Fig. 13: *The overburden material dumping site of Mubaraq Granite.*

13) in the southern part of the quarry should be stabilized by benching and laying permeable geotextile fabric so as to avoid any slope failures there.

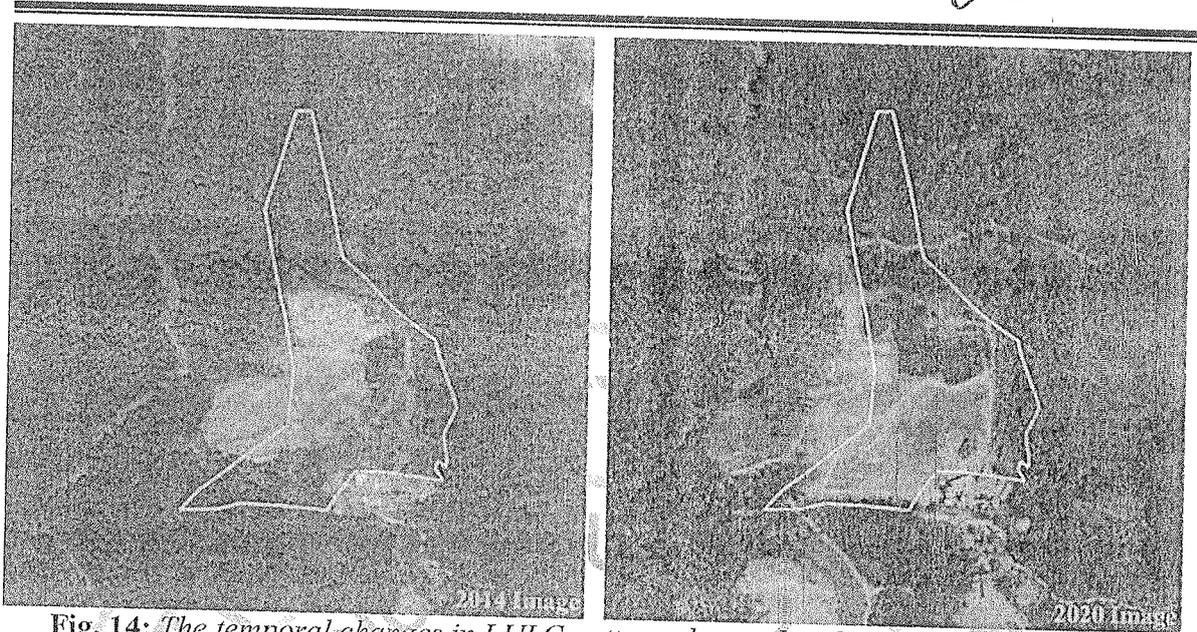
Fig. 14: The temporal changes in LULC pattern observed in Google Satellite imagery.

The landslide susceptibility map from the National Landslide Susceptibility Mapping (NLSM) programme was prepared during the Field Season 2015-16 and changes in land use / landcover pattern and slope morphometry of the study area due to quarrying during the last five years were evident from the Google satellite imagery (Fig. 14). Even the Othayi – West Chathallur road was in the development stage. From this study, it is deduced that the landslide probability is minimum for the area which is flattened and exposed with hard bedrock after quarrying, while the landslide probability is higher in the northern portion where the slope gradient is 25° - 35° with debris as overburden material having a thickness ranging from 0.5 m to 5 m. Hence it is to be concluded that quarrying in the low landslide probability area can be continued using controlled blasting techniques as per the Mining and Geology guidelines after considering the results of ground acceleration monitoring studies. While in the higher landslide probability area it is important to ensure optimum slope design by making benches as per the prevailing mining rules for minimizing slope instability issues and avoid waterlogging conditions on the vulnerable slopes. To minimize any destabilizing effect of quarrying on these slopes, it is advised to use controlled blasting and to avoid mining operations during the monsoon period.

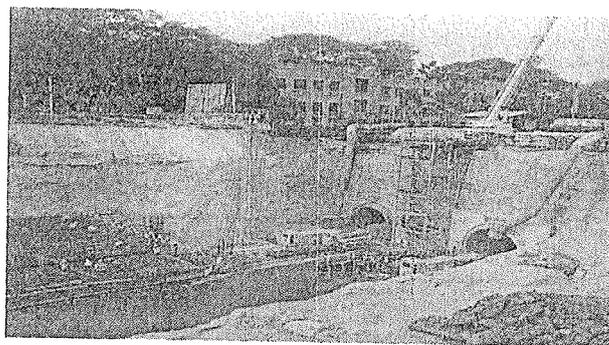
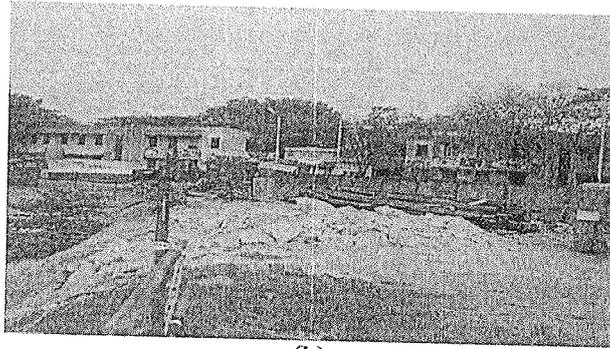
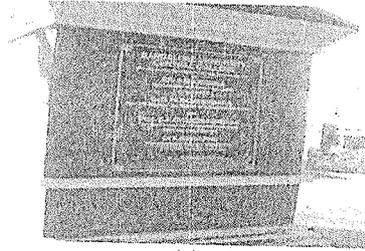
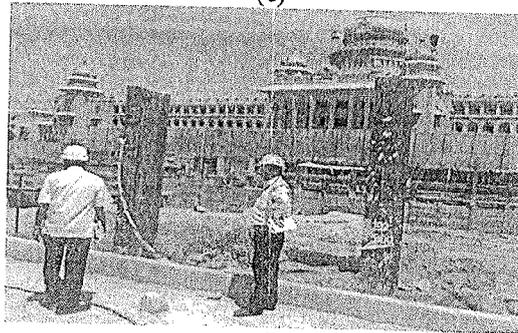
Figure 1: Important structures near the rock excavation site

Fly rock along with ground vibrations is a major concern as a number of important buildings are there in the surroundings and also due to busy public traffic. Heavy muffling arrangement was done using rubber blast mats, each weighing 2.5t (Fig. 3). Each blast was monitored using two units of Minimate Plus blast vibrations monitors, Instantel, Canada, for ground vibrations and noise at specific locations on day to day basis (Fig. 4). Based on the nature of rock mass, condition of the buildings and distance from the buildings to excavation site, controlled blasting methodology was devised.

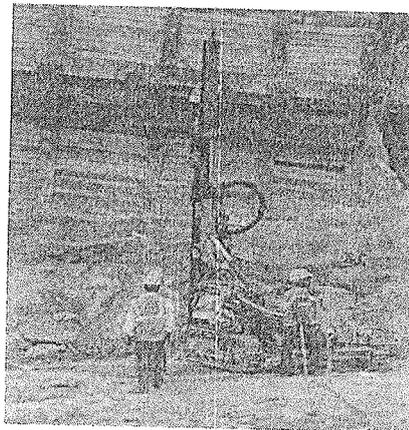
Figure 2: Drilling of blastholes in progress

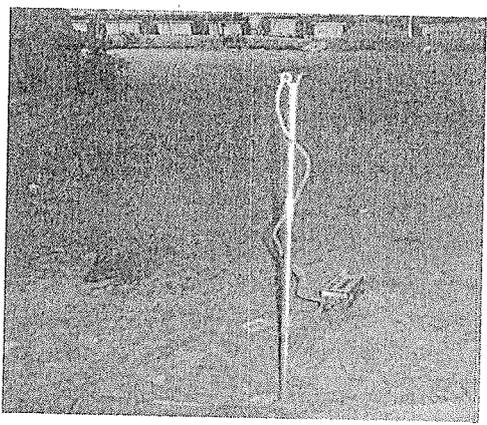
Figure 4: Ground vibrations monitoring near the structures

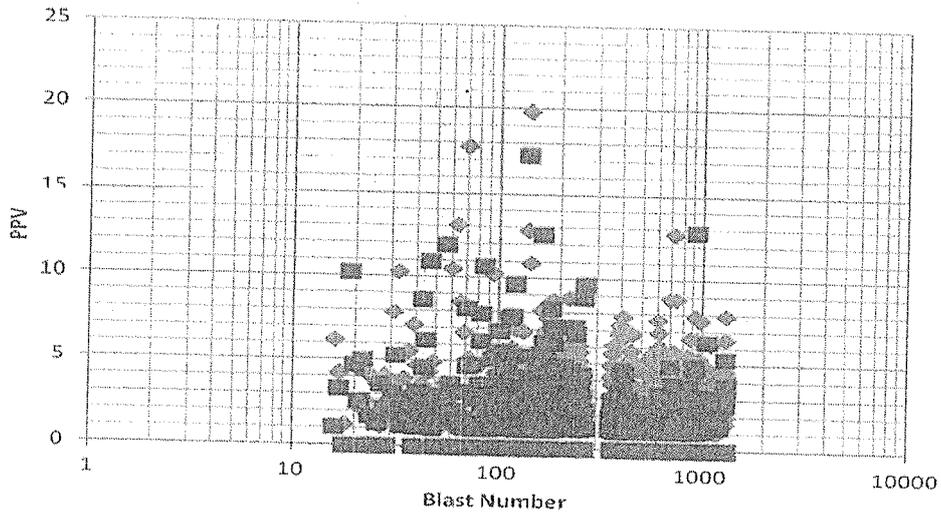
Figure 7: Ground vibrations recorded near the structures of importance

Post-Blast analysis was conducted periodically after every 10 to 15 blasts, by verifying the sample cracks recorded during Pre-Blast analysis. Data generated from more than 1100 blasts conducted at the specific Metro Station is presented in Fig. 5. It was observed that out of more than 1100 blasts conducted, only on 17 occasions the peak particle velocity at different structures exceeded the permissible levels (Fig. 5). The data clearly indicates the implementation of safe blasting methodology by the Metro Rail Corporation.
