BEFORE THE NATIONAL GREEN TRIBUNAL  
WESTERN ZONE BENCH AT  
PUNE.

Original Application No.37/2022

**AFFIDAVIT ON BEHALF OF RESPONDENT NO.2**

## ANNEXURE B

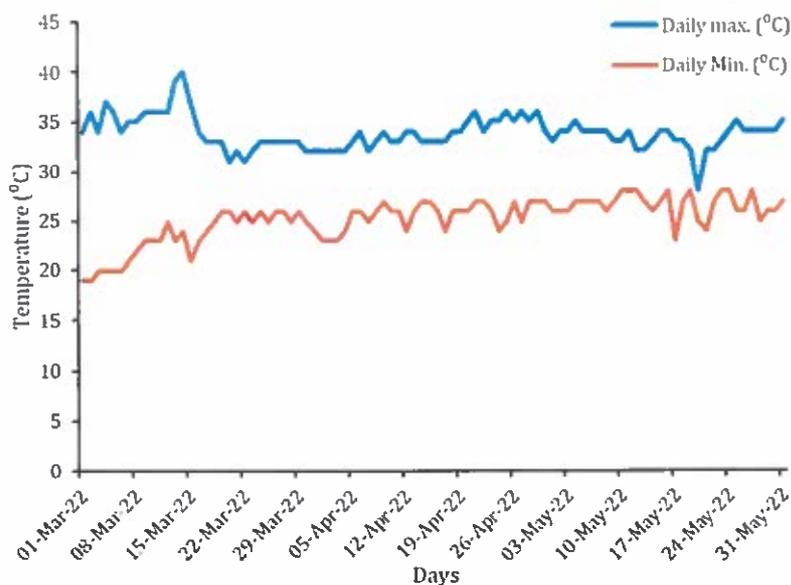
**Figure 3.7 Temperature Profile of Study Area (Summer 2022)**

Months	Mean Daily Max Temp (°C)	Mean Daily Min Temp (°C)	Average Recorded Temp (°C)
January	34	21	27
February	35	21	27
March	35	23	29
April	34	23	30
May	35	24	30
June	33	23	27
July	32	23	27
August	31	24	27
September	32	24	27
October	34	22	28
November	34	22	28
December	33	20	26

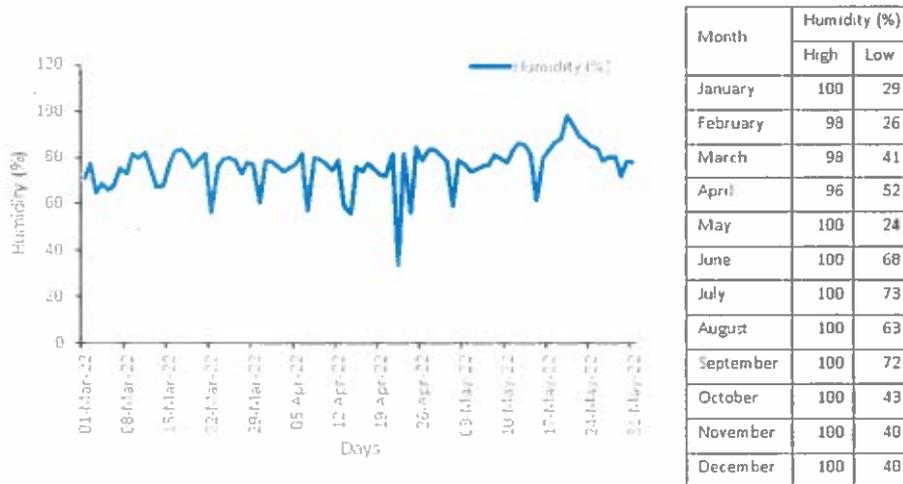
Figure 3.8 Humidity Profile of Study Area (Summer 2022)

Humidity exceeds 98 % throughout the year while as is obvious in table below during the monsoon period (June, July and August, September) it exceeds up to 100%.

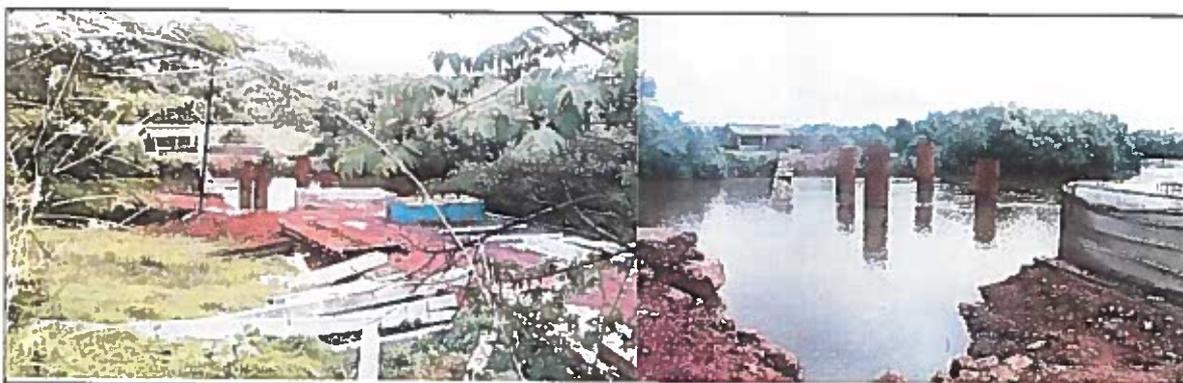
Figure 3.34: Photographic view of site

Platform like structures at both ends of the bridge were observed during site visit, and temporary support structures in the water course.

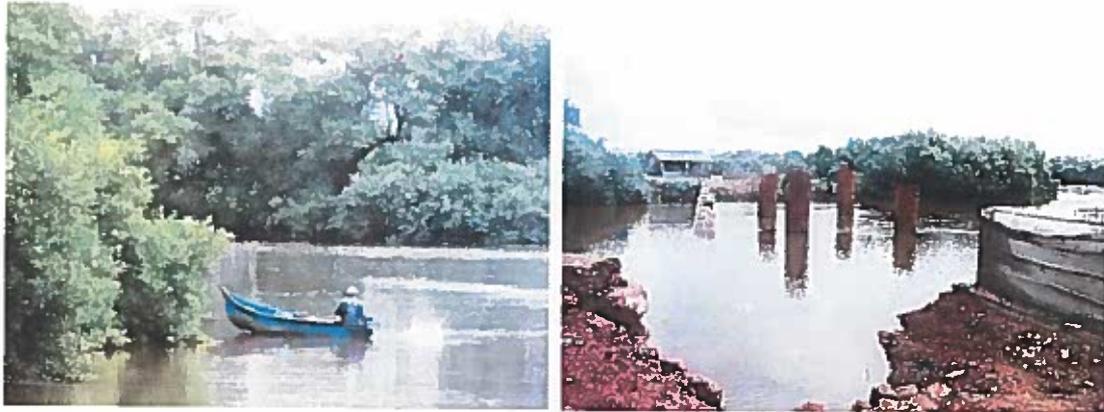
**Figure 3.35: Mangroves on Left & Right of Bridge Location**

The vicinity supports avifauna & healthy aquatic eco-system, with solitary mangroves & few nestlings. While the project location is devoid of mangroves and has solitary growth linearly present along bank & on upstream-downstream sides of the location. Locals were observed fishing in the water course.

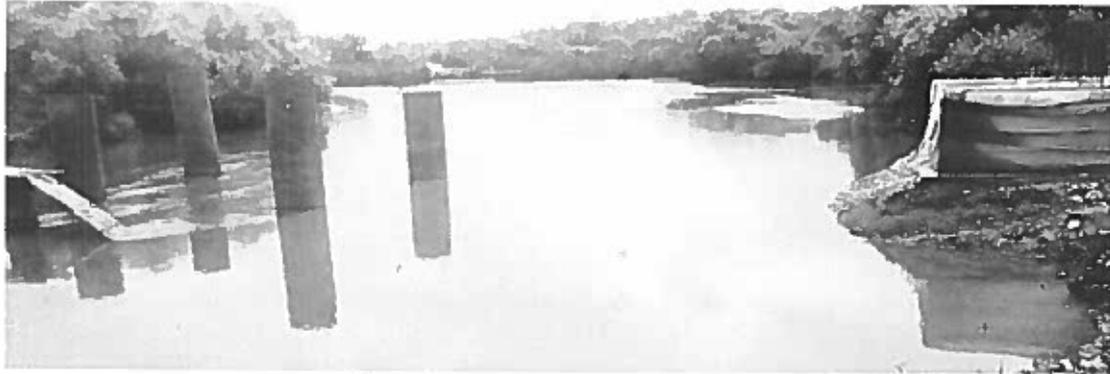
Figure 3.37: Partial View of Site

The site has structure as seen in below figure on bank & it is devoid of any major flora, except solitary mangrove standing at distance of aprox 20 m on left & 4 m on right of south Bank, while 11m on left & 3 m on right of north bank.
