**BEFORE THE HON'BLE NATIONAL GREEN TRIBUNAL
SOUTHERN ZONE, CHENNAI**

APPEAL NO.41 OF 2024

REPLY STATEMENT FILED BY THE 2ND RESPONDENT

INSPECTION REPORT

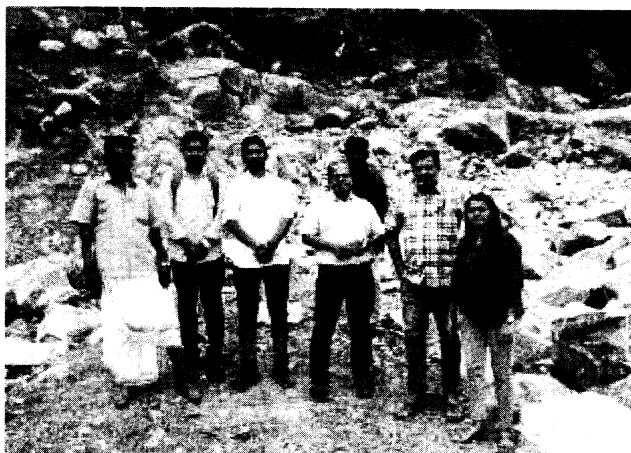
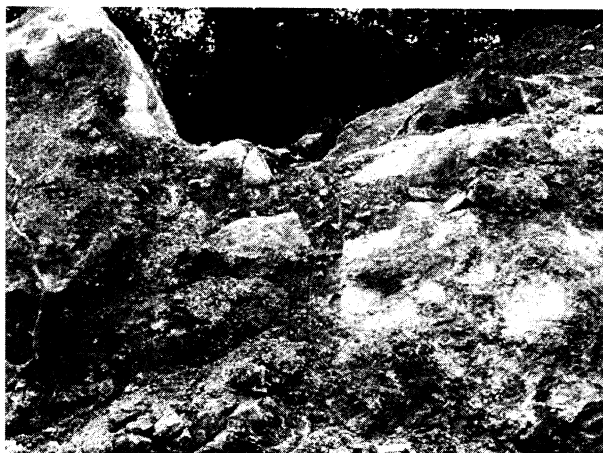
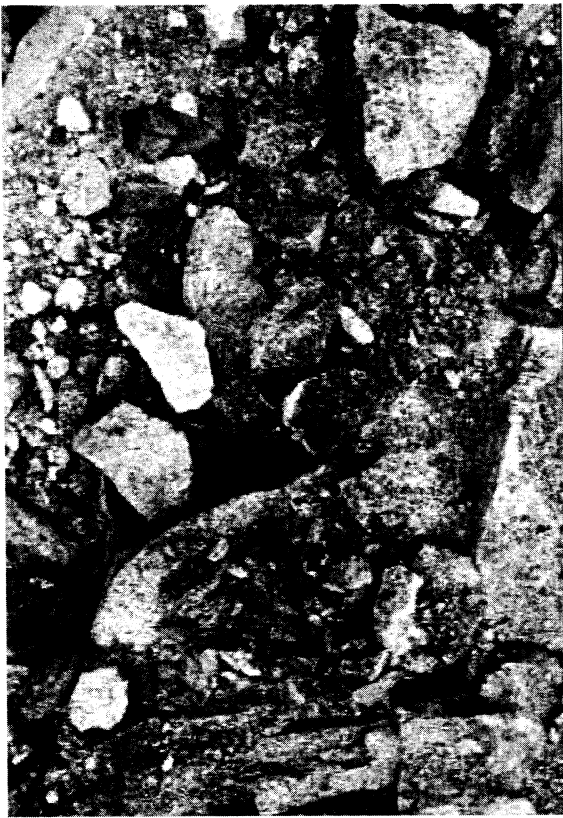
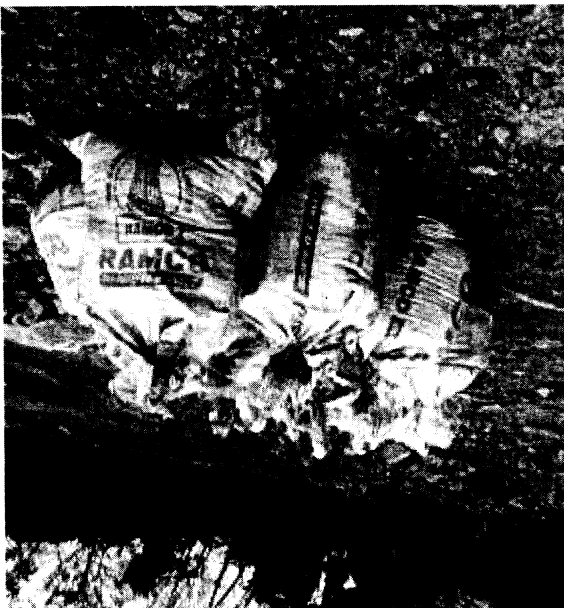
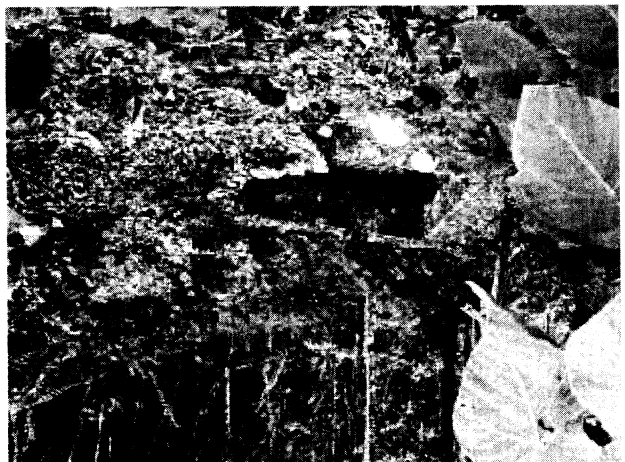
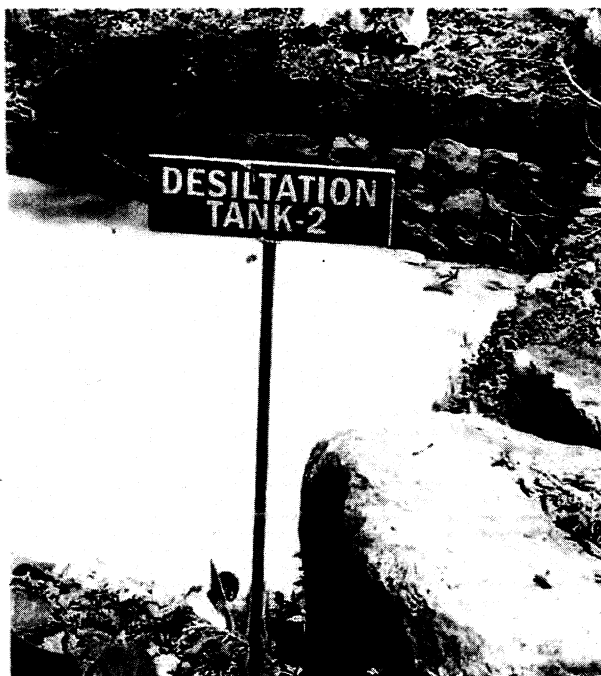
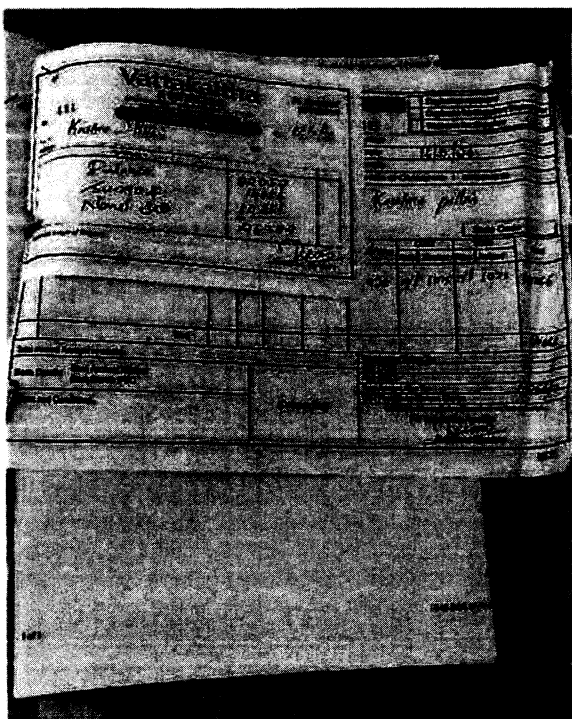
- 1) The quarry was not functioning at the time of the field visit.
- 2) The remnants of NONEL blasting, the hollow flexible plastic tube with NONEL Detonators are seen in the project site (photographs annexed)

- 6) Maximum three blasting rounds are being followed per day.
- 7) Sand bags are observed in the site for the prevention of intensity of blasting.
- 8) Temporary wall of metal sheets are erected along the boundary facing the nearby houses including the house of Appellant.

- 9) Garland drains and drainage channels leading to the desiltation tanks (3 Nos) are not properly constructed to contain the silts.
- 10) During the site visit, the II Class Mines Manager was present and explained the scientific mining activities in the project area particularly with regards to safe and environmental friendly working.

- 11) Planting of trees (Green Belt) as per EMP started; but not maintaining properly.
- 12) Lease area is fenced with barbed wire and the Buffer zones are marked properly with stone pillars but lacked precautionary signboards.

- 14) Top soil and overburden are found more than the quantity projected in the mining plan and is being stacked in the designated dumping area however the retaining boulder wall is not constructed.
- 15) Gates are provided at the entrance to prevent the unauthorized entry of people and cattle.
- 16) Access road to the project area seems concreted.
- 17) Sign boards showing the EC, the blast time, the danger zone, and other information are erected.
- 18) Monitoring Committee was constituted and the minutes of the meeting are documented.

- 1) From the available records and observations, the Project Proponent has been adopting NONEL for blasting.
- 2) Sand bags are used for reducing the impact vibration due to muffle blasting.
- 3) To reduce the dust pollution, the metal sheets are provided along the boundary of the project area.
- 4) If the project proponent follows the specifications for blasting as suggested in the EC, the maximum vibration may be up to 35m from the blasting locations and may not cause any damage to the houses which are at more than 50m from the project boundary.
- 5) The project proponent needs to be more cautious to comply with all the EC conditions and should submit the compliance report with all necessary documentary evidence as per norms.
