**Investigation into Alleged Environmental Violations by
Central Coalfields Ltd in Piparwar OCP:**

**Report of Committee appointed by Hon'ble National Green
Tribunal in *Sanjay Chauhan vs CCL & Ors (OA 39/2020/EZ)*
*vide order dt.22.06.2020***

Date of submission: 14 September 2020

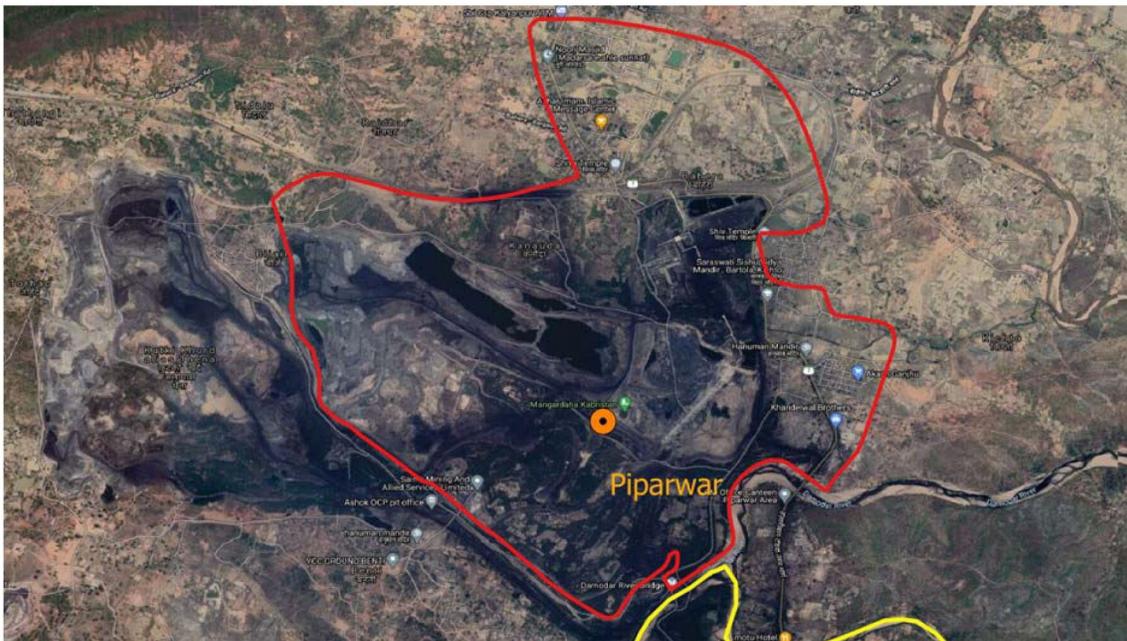
Figure 1. Piparwar OCP as seen from Google Earth (red line is mine lease boundary, yellow line is district boundary)

The Piparwar OCP is located in Tehsil Tandwa of District Chatra of Jharkhand state. The mine lease area is 1120.25 ha (see Figure 1). The OCP was commissioned much before the EIA notification with a normative capacity of 6.5 MTPA, and was subsequently granted an EC for a normative capacity of 10 MTPA (vide EC dt. 11.06.2007). This was later modified to allow for a peak production of 11.5 MTPA (vide EC dt.28.02.2012) and further allowed to expand to a normative capacity of 12.5 MTPA (vide EC dt. 20.05.2014).

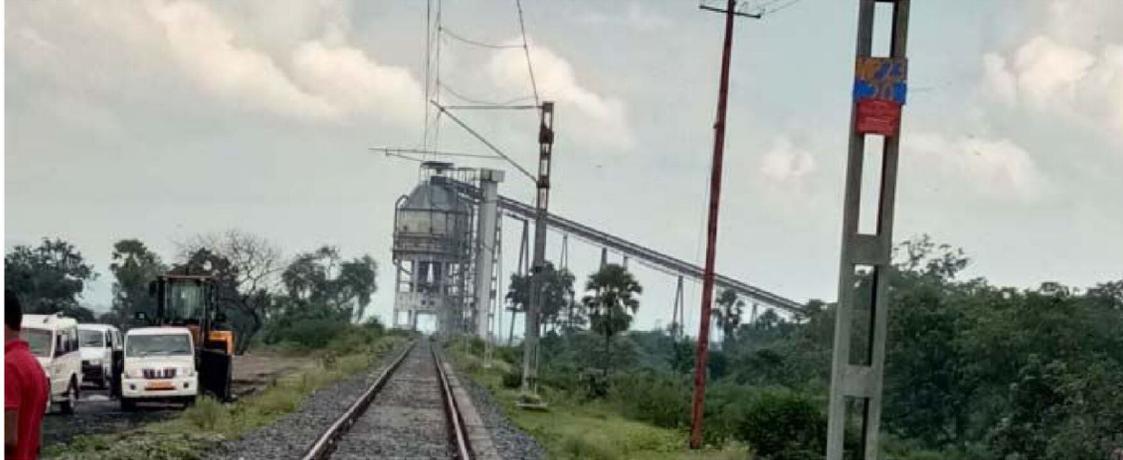
- a) **CHP:** From documents provided by CCL and from the field visit, it is clear that the CHP itself had been constructed many years ago, even before 2007, and is visible today (see Figure 2). As such, the non-construction of the CHP itself is not the issue. **However,** the railway siding linked to this CHP did not get completed by 2014 as committed, but only mid-2017 (see

point c below), and so the Silo was never used between 2007 and mid-2017 (as per information provided by CCL).

Figure 2. Coal Handling Plant with Silo inside Piparwar OCP above tracks of the Piparwar/Rajdhara siding

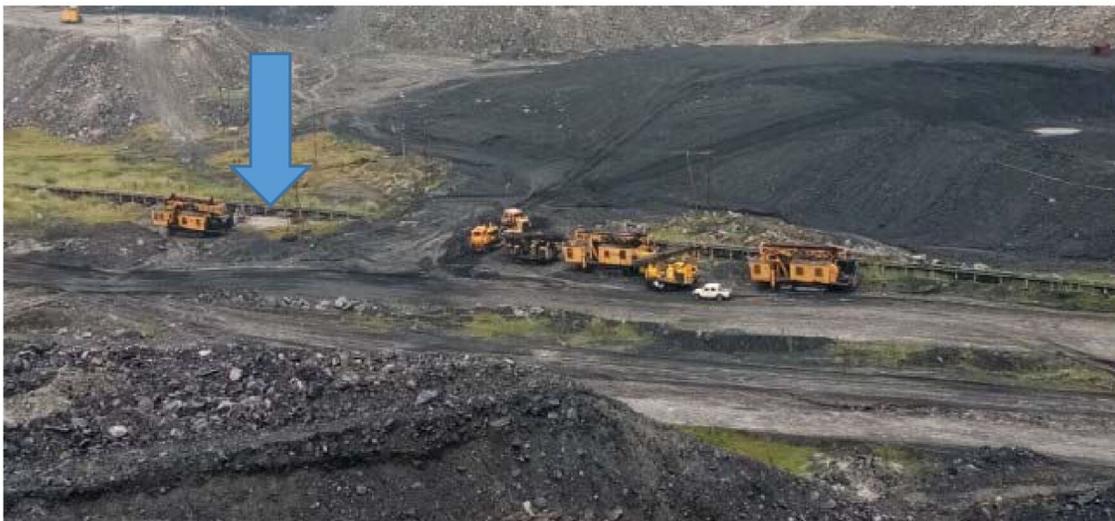
- b) **Conveyor:** A conveyor system is in place from the pit to the CHP (see Figure 3). However, as mining operations had ceased when the Committee visited the mine, it could not be determined whether the conveyor system was actually being used. Since this part of coal transport occurs within the mine lease area, we have not pursued this matter further.

Figure 3. Conveyor belt inside mine (see arrow), now non-operational.

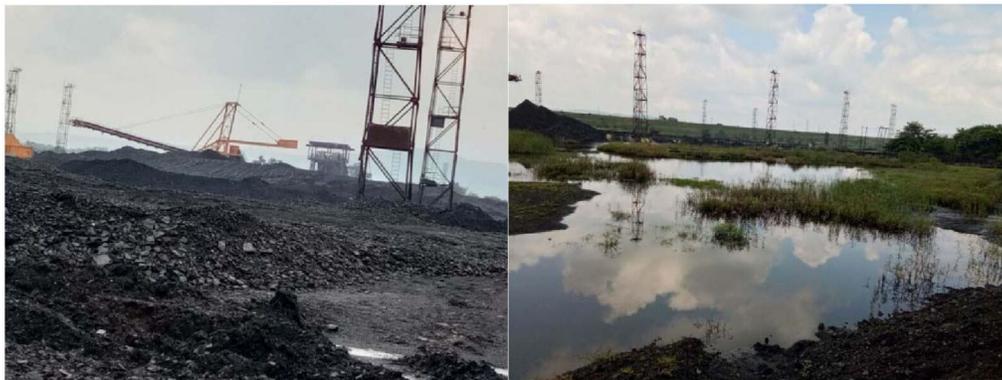
However, the field visit showed that the coal from the mine was being stocked largely on the ground in a coal yard (see Figure 4) near the (mostly unused) CHP and the coal washery (which is also part of the project). The coal yard did contain sprinklers for dust suppression. But the arrangements for containing and treating the runoff water (rain and sprinkler) from the coal yard were inadequate: There was no catch drain around the coal yard, and the runoff was pooling in various low-lying areas (see Figure 4) before reaching the settling tank. (This non-compliance was also pointed out in the MOEFCC report of 15.02.2019).

Figure 4. Status of coal yard near CHP (left) and the poorly managed runoff from the coal yard (right)

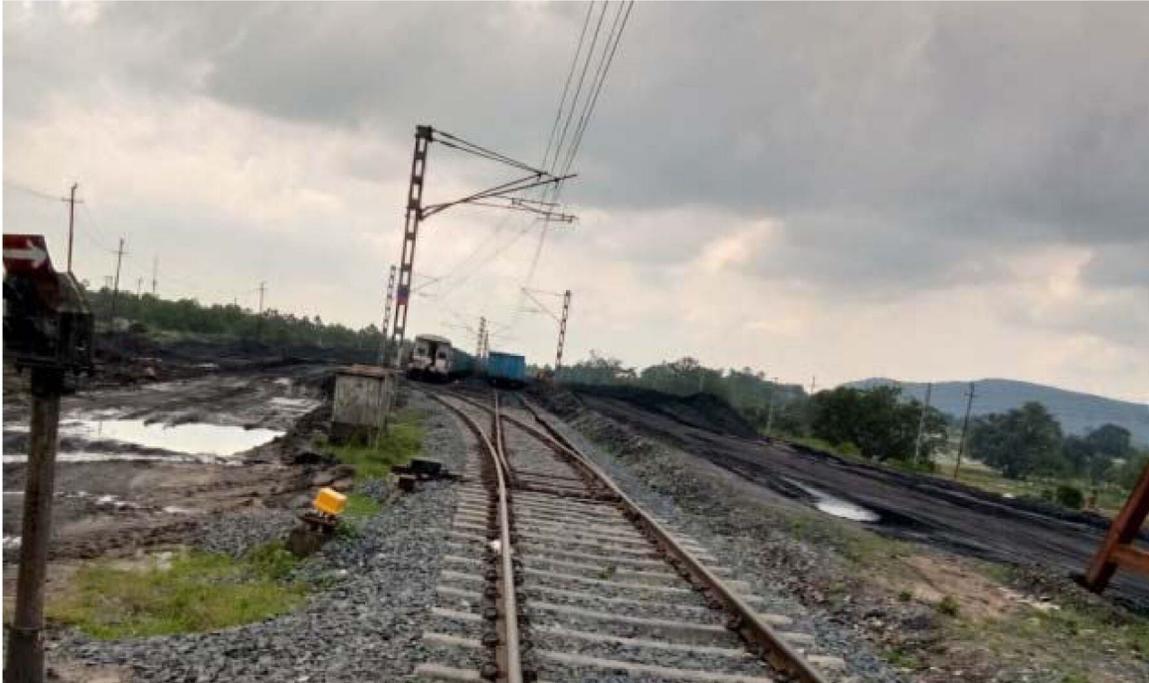
- e) **Status of Piparwar/Rajdhar siding: The arrangements at the siding (where front loaders were being deployed) did not conform to the 2015 CPCB guidelines for railway sidings, viz., there was no screen, no green belt, and no arrangements (drains, settlings or settling tanks) for containing the runoff of contaminated water (see Figure 5).**

Figure 5. The Piparwar/Rajdhar siding inside Piparwar OCP commissioned in 2017, with no screen, 3-tier plantation or runoff collection system

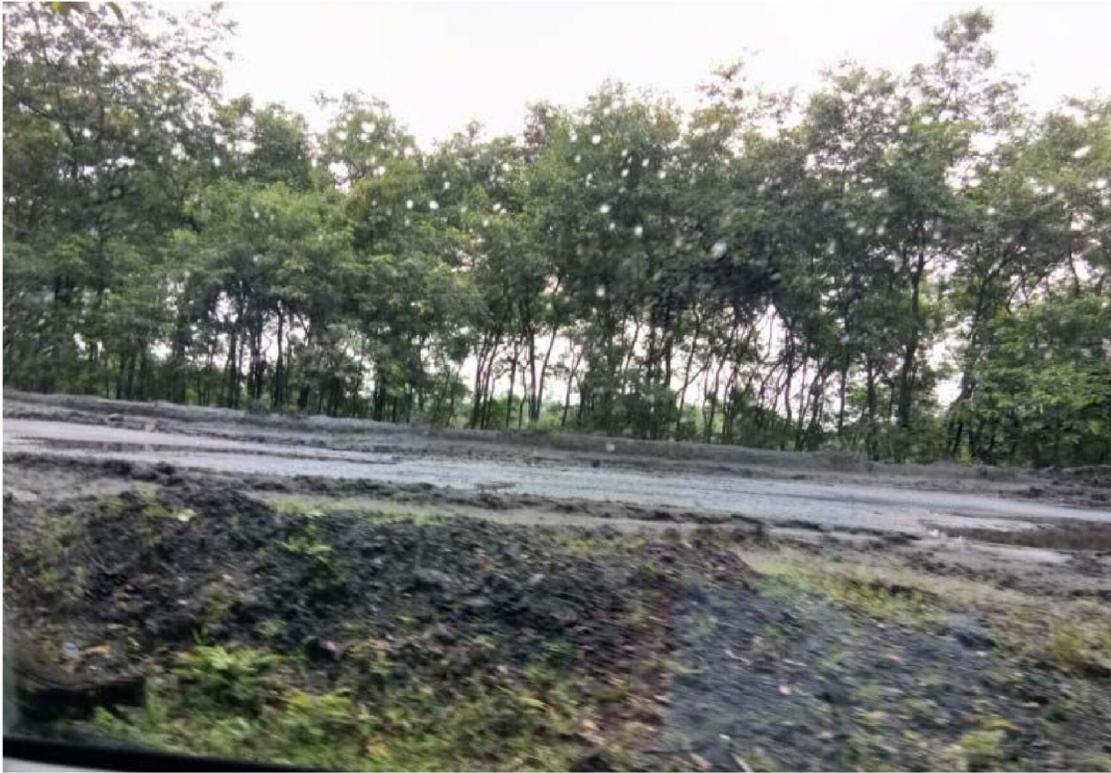
- f) **Further serious violations during coal transport by road to Bachra siding:** Not only is the coal transport to Bachra siding happening in non-compliance of the EC conditions, but further serious violations were noted even in this transportation activity:
- i. Road transport of coal was resulting in much spillage on the road and consequent air and water pollution (see Figure 6).

Figure 6. Road from Piparwar OCP to Bachra siding covered with coal dust

The past environmental harm can neither be condoned nor can it be rectified. Going forward, the obvious recommendation is to completely and immediately cease all coal transport by road outside the mine lease area. Further, the ECs of other mines from

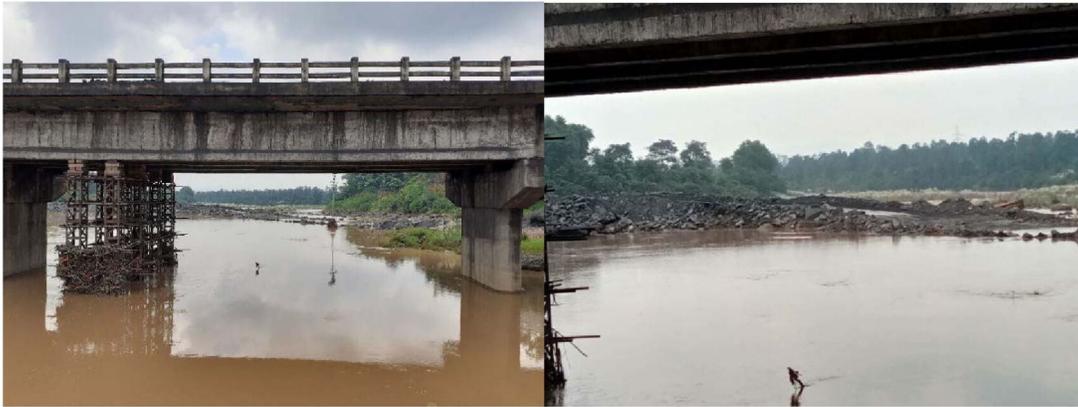
- ii. Following the sinking of the pillars of a bridge on the Damodar river, rather than take a longer route, the truck transporters have dumped debris onto the river to create a temporary crossing in complete violation of rules regarding river protection. Although this crossing was removed by the district authorities once in early 2020, the debris continue to block the Damodar river (see Figure 7), and it seemed that the siding might still have been in use at the time of the NGT Committee's visit.

Figure 7. Bridge on Damodar River under repairs, with temporary crossing created at the back (left) and close-up of temporary crossing (right).

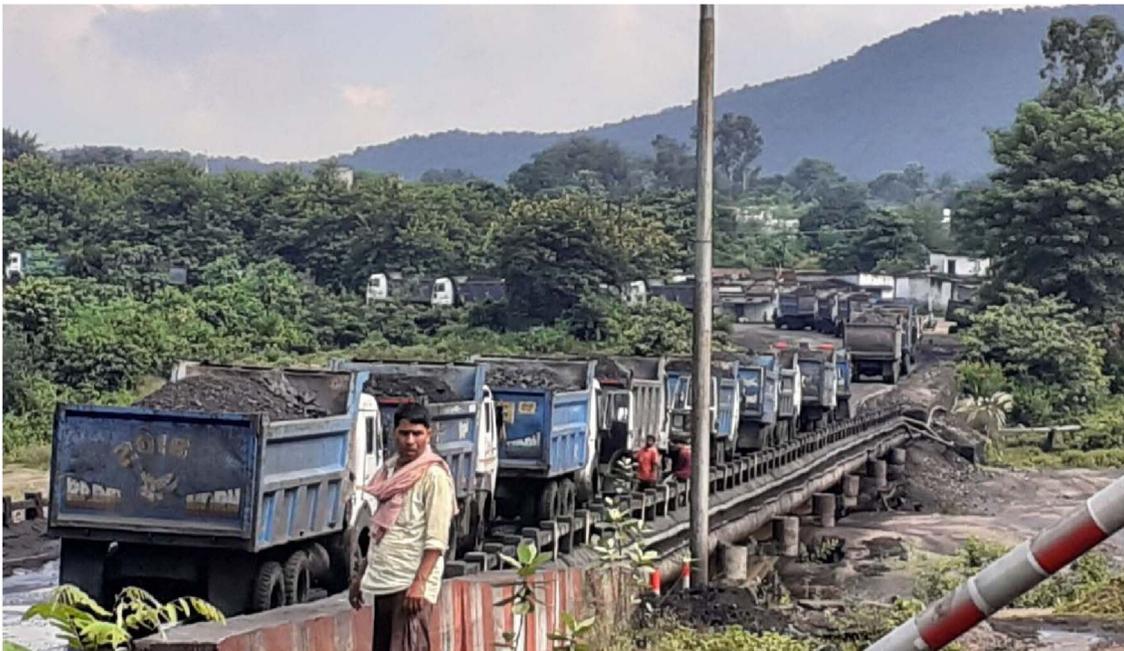
- iii. Finally, the trucks were operating without any tarpaulin covering on the coal (see Figure 8). This is in violation of the EC General Condition to use ‘trucks covered with tarpaulin at all times’, for the obvious reason of reducing spillage and the pollution that follows from it. **This was the most egregious and blatant form of EC non-compliance observed by this Committee.**

Figure 8. Trucks loaded with coal without tarpaulin covering waiting in line outside Bachra settlement

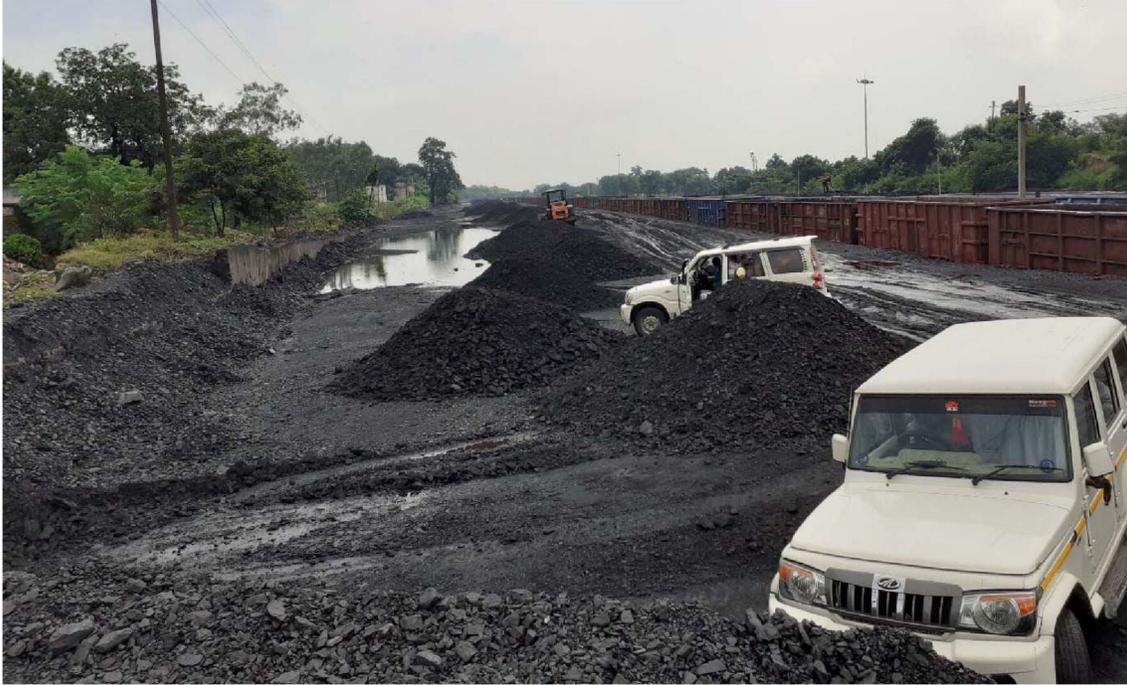
g) **Non-compliance of norms at Bachra railway siding:** Finally, the manner in which the Bachra siding is managed again is in non-compliance with basic norms for such coal sidings (see Figure 9):

It may also be noted that there is a primary school right next to the Bachra siding; therefore, non-compliance with dust pollution control norms at the siding directly endangers the health of the school children.

Figure 9. Status of Bachra rail siding
