Sub:- Compliance Report of Jammu and Kashmir Pollution Control Committee in compliance to Hon'ble National Green Tribunal directions dated 30.05.2024 passed in OA No. 642 of 2024 titled News Item titled "Land Sinking: A new environmental challenge in J&K" appearing in greaterkashmir.com dated 29.04.2024.

News Item titled "Land Sinking: A new environmental challenge in J&K" appearing in greaterkashmir.com dated 29.04.2024.

**A REPORT ON LAND SINKING
AT
PARNOTE-RAMBAN
UT of J&K**

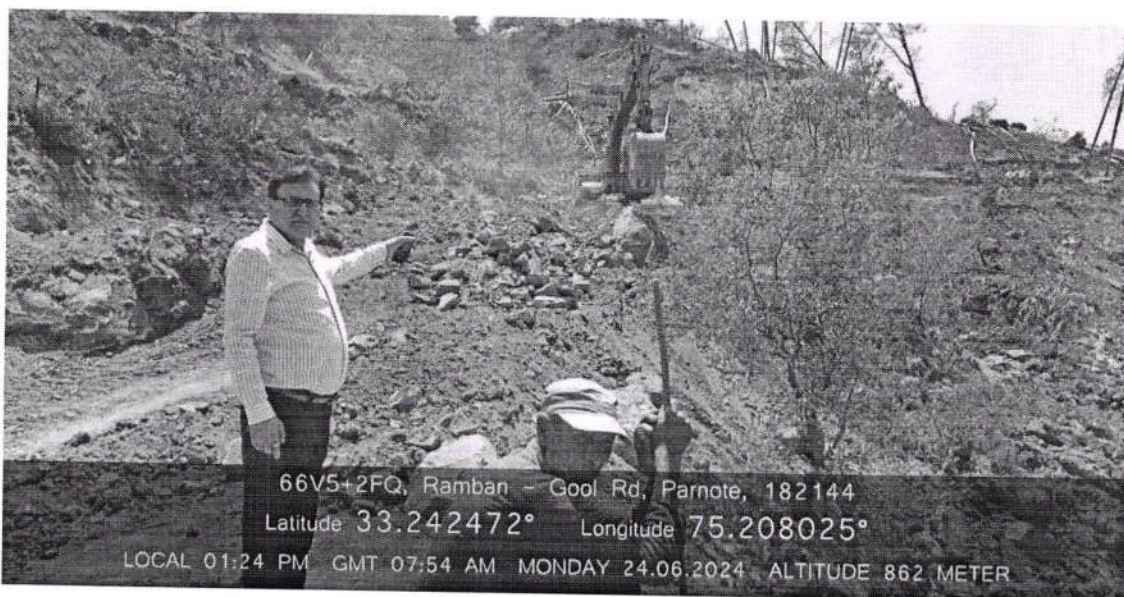
Pic-2 Land Sinking at Ramban-Gool Road at Parnote.

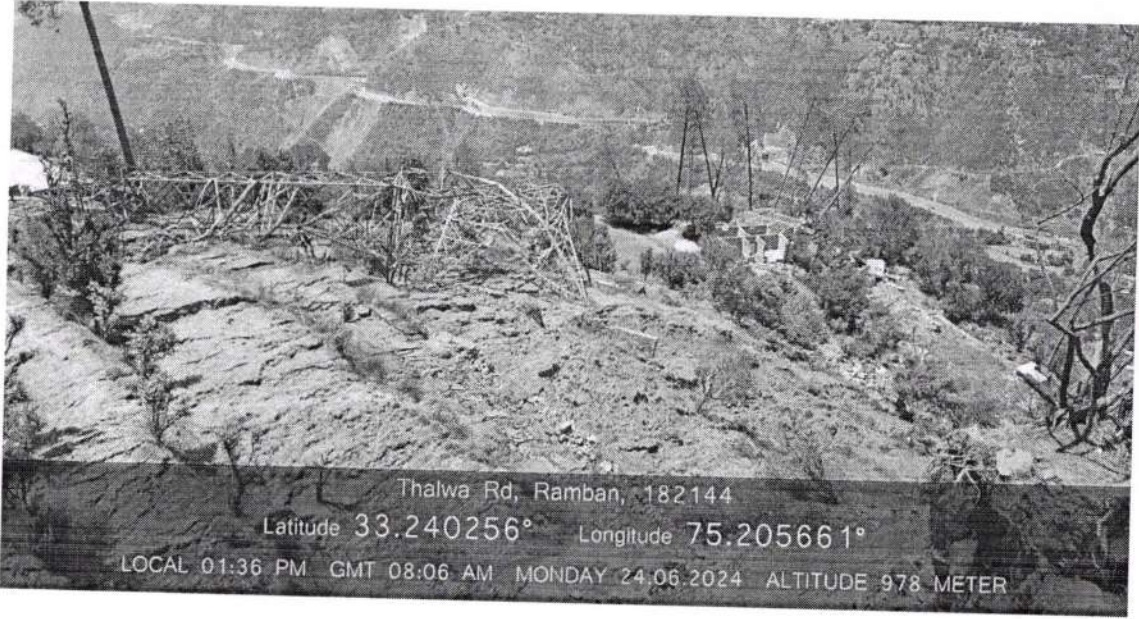
Pic-3 Damaged Transmission line Tower.

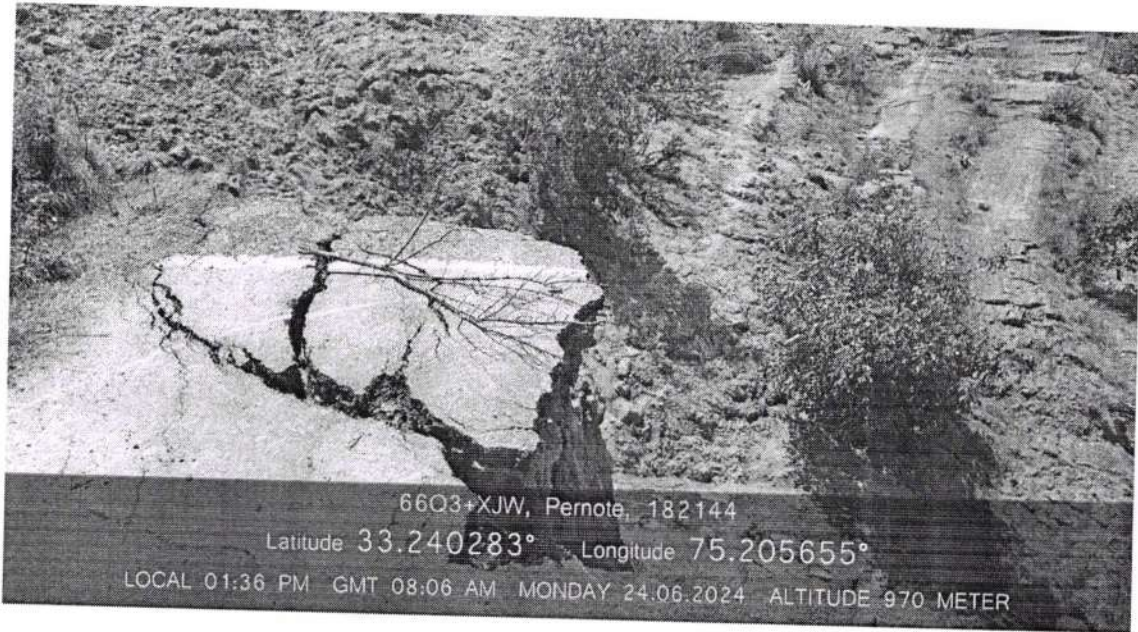
Pic-4: Damaged Parnote-link Road at Parnote.

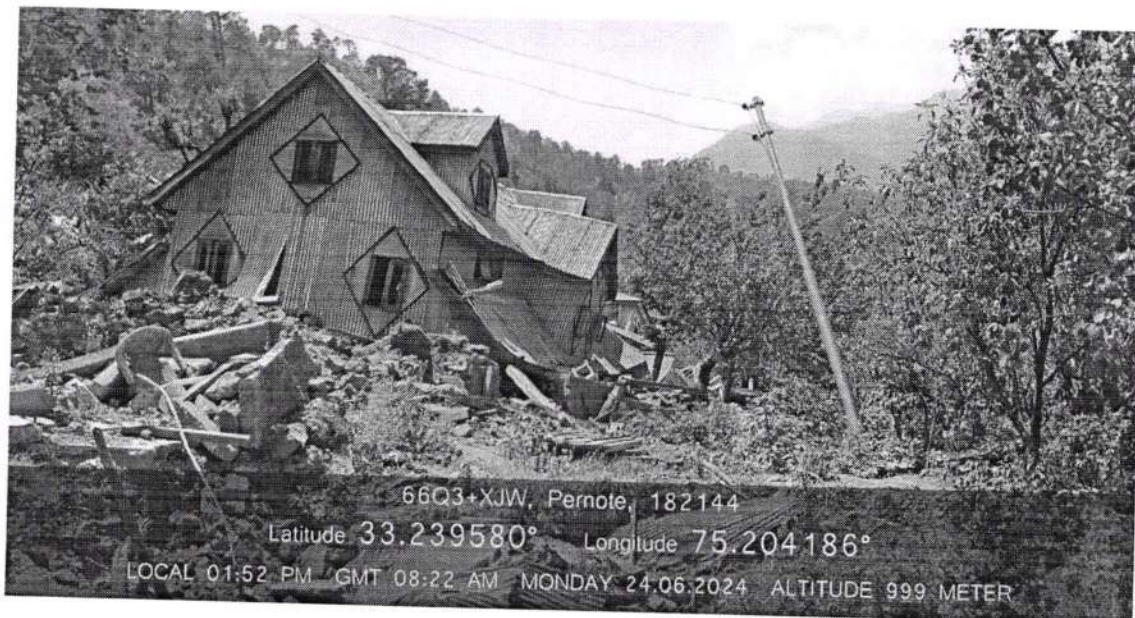
Pic-5: Damaged Houses.

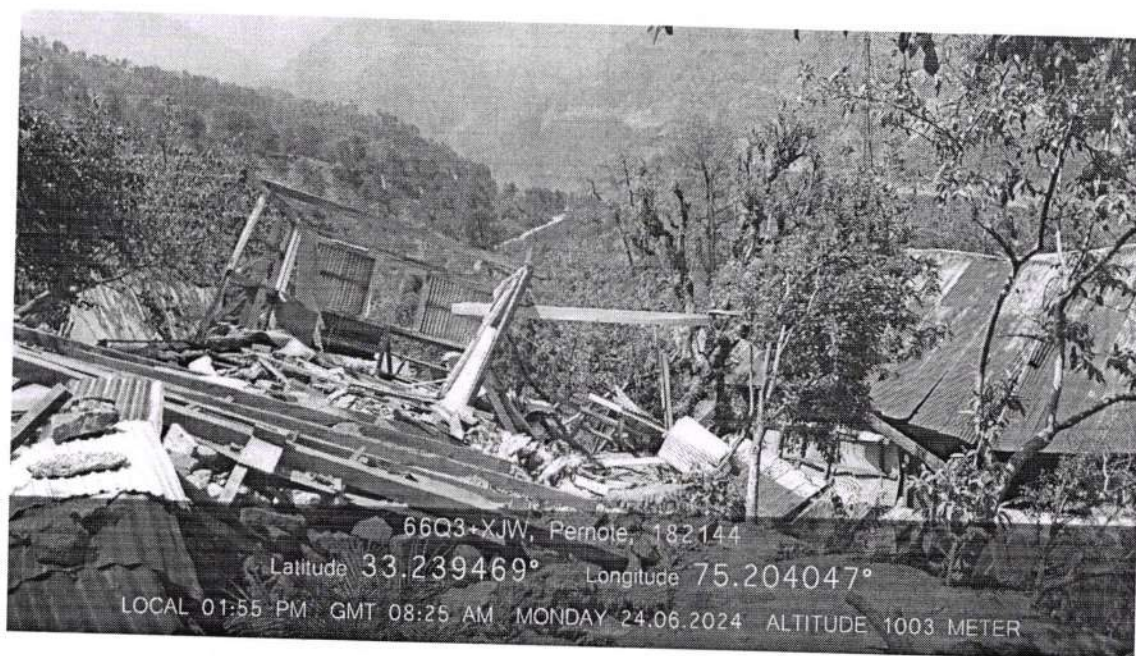
Pic-6: Damaged Houses.

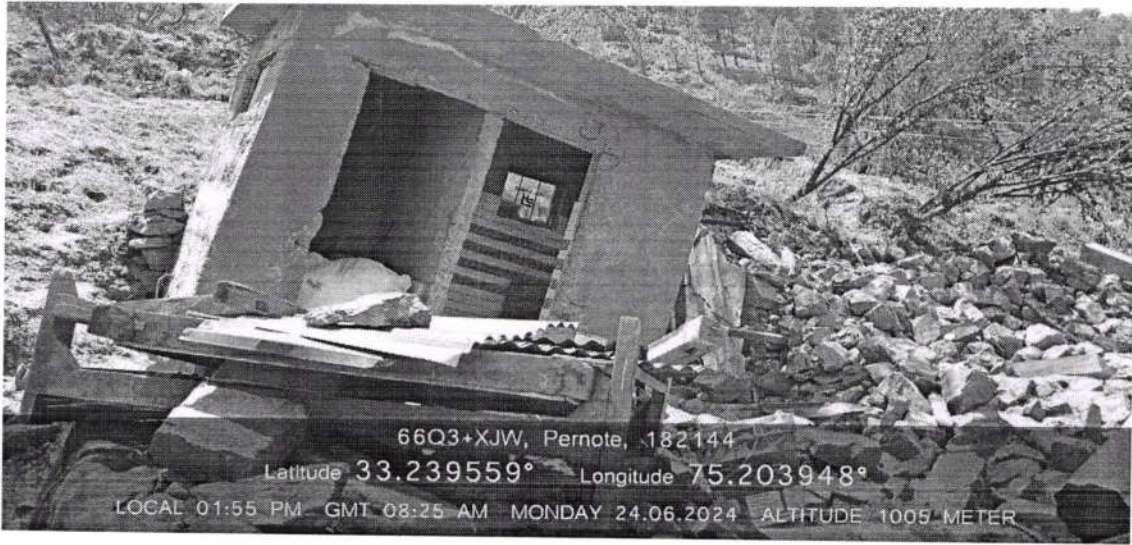
Pic-7: Damaged structures.

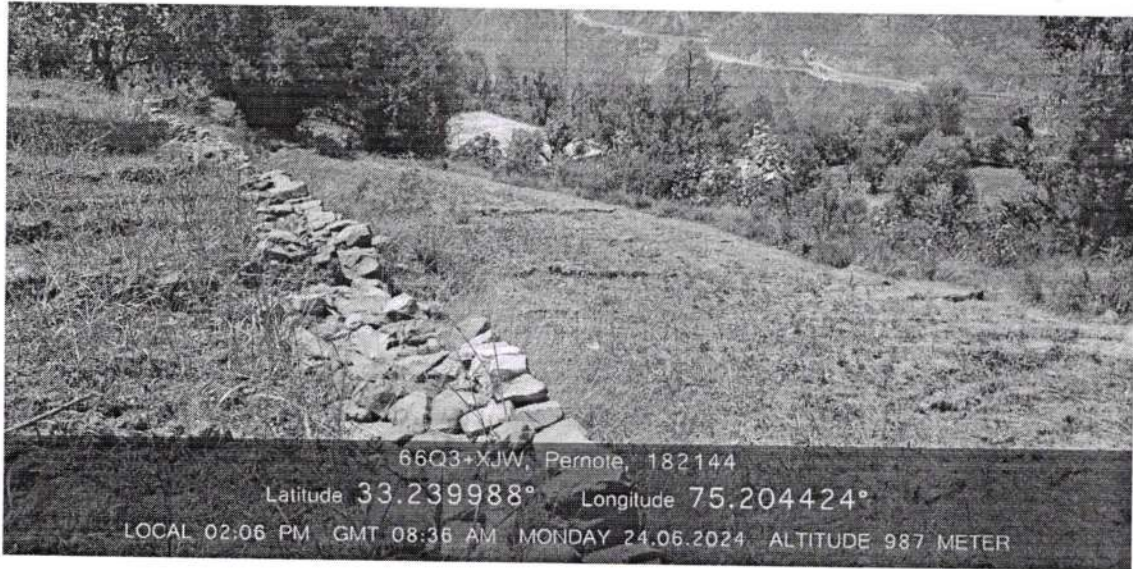
The slopes affected by the landslide are covered with overburden material, primarily consisting of debris from landslides. Several cracks were seen developed in the slope-forming material, further damaging agricultural and forest land. The orientation of these cracks varied across the slope, with transverse cracks striking between NW-SE and E-W, while longitudinal cracks trended NE-SW and N-S. These cracks were observed to vary locally as the slope aspect changed, with dimensions ranging from a few centimetres to 30 centimetres in width and a few meters to tens of meters in length. **It is observed that slopes have sparse vegetation patches. The Committee observed number of natural springs (4-5) oozing water, which were covered by debris and water was seeping down the slopes. Terrace cultivation is also observed during the inspection and found damaged.**

Pic-8: Cracks developed in agricultural fields.

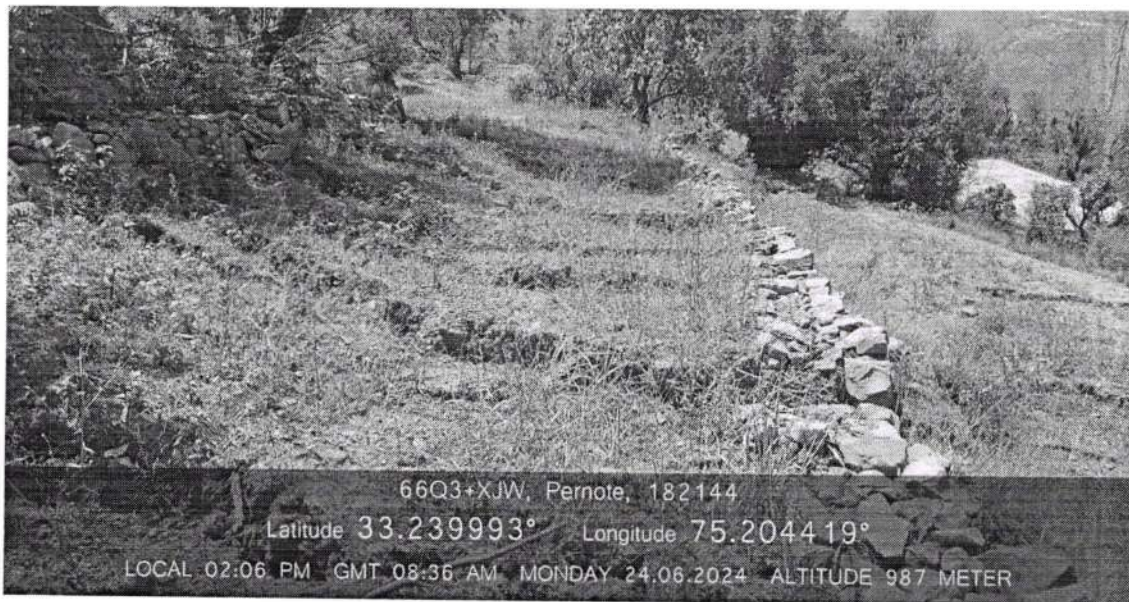
Pic-9: Cracks developed in agricultural fields.

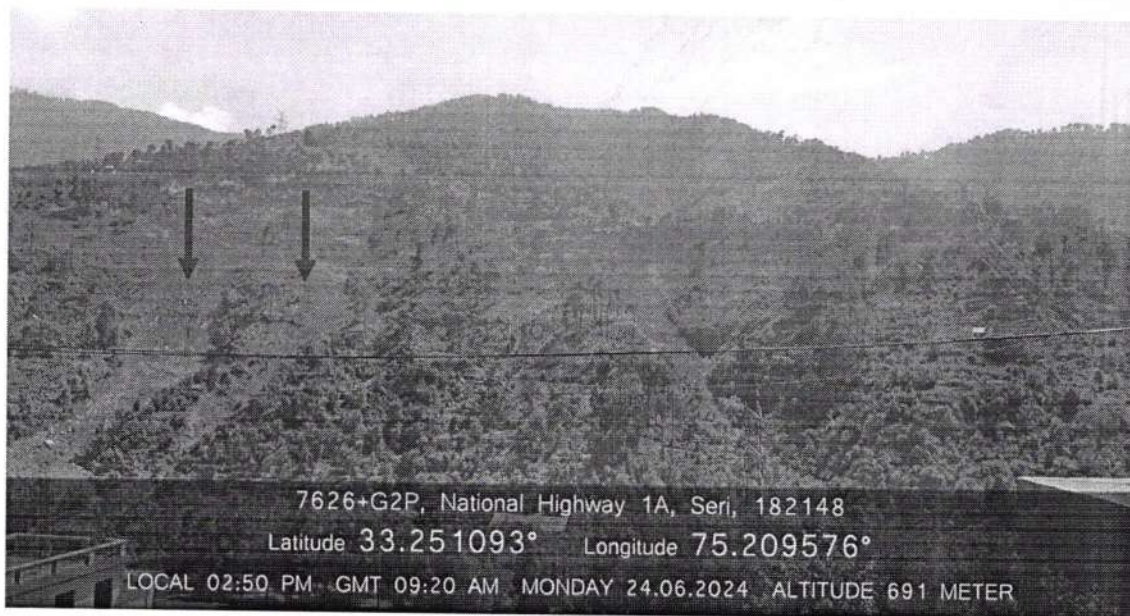
Pic-10: View of Land Sinking site from NH-144 A.

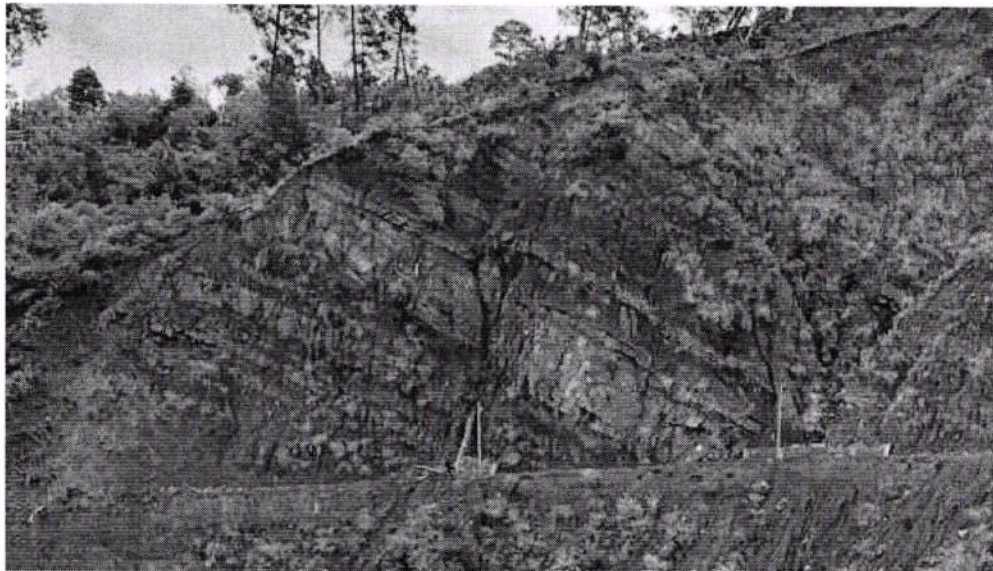
Geologically the area exposes rocks of Lower Murree of Murree Group belonging to Late Eocene to Early Miocene age. The rocks of the Ramban Formation are exposed near the toe part of the slide while the landslide affected area is totally covered with the thick overburden material or debris of the paleo-landslides. The Lower Murree Formation form an alternate sequence of claystone, siltstone and sandstone of which claystone is the dominant lithology (Figure-3 and Figure-4). The discontinuities observed in the study area are given below in table-1

Figure-3: Alternate sequence of claystone, siltstone and sandstone

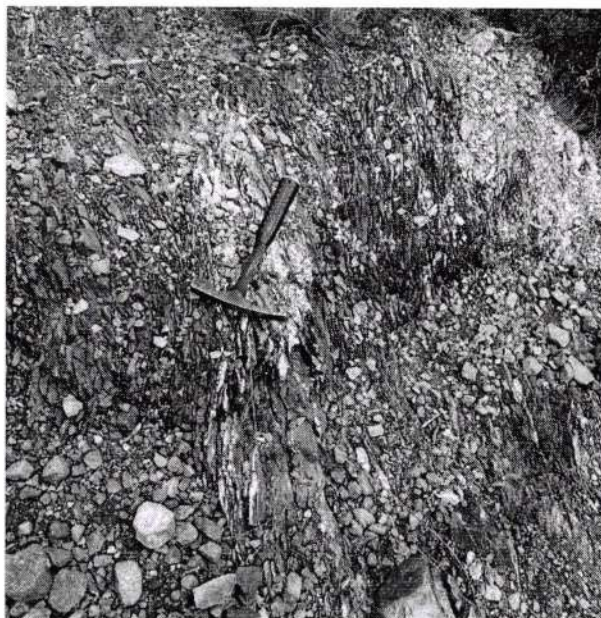
Figure-4: Slates/phyllites of Ramban Formation

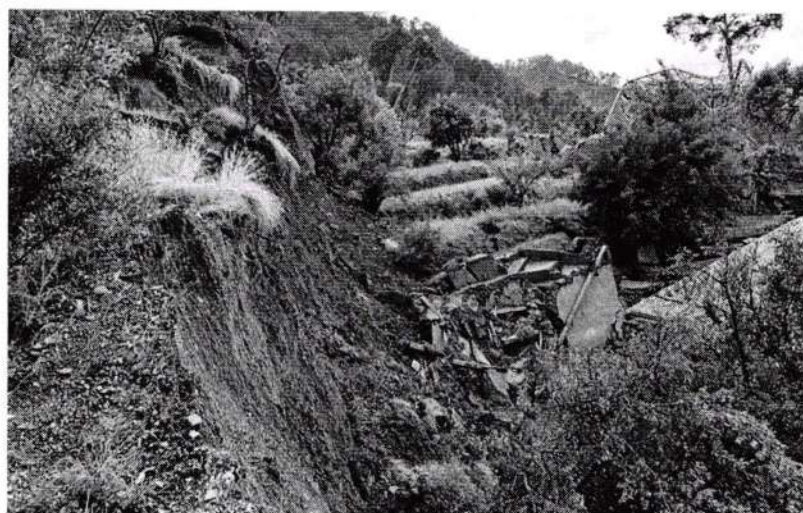
On the evening of April 25th, a landslide struck Pernote village, Ramban district, Jammu and Kashmir. This event caused significant damage to approximately 35 houses located in the central part of the affected slope. Additionally, the landslide impacted infrastructure, damaging an 800-meter section of the Ramban-Gool road, a 300-meter portion of the Pernote link road, electric poles along the 400 KV D/C Kishenpur Wanpoh III & IV transmission line, a power grid station, and a water supply pipeline (as seen in Figure-5 to 9). The slopes affected by the landslide are covered with overburden material, primarily debris from past landslides. The development of several cracks in the slope-forming material further damaged agricultural and forest land.

Figure-5: Showing damaged house

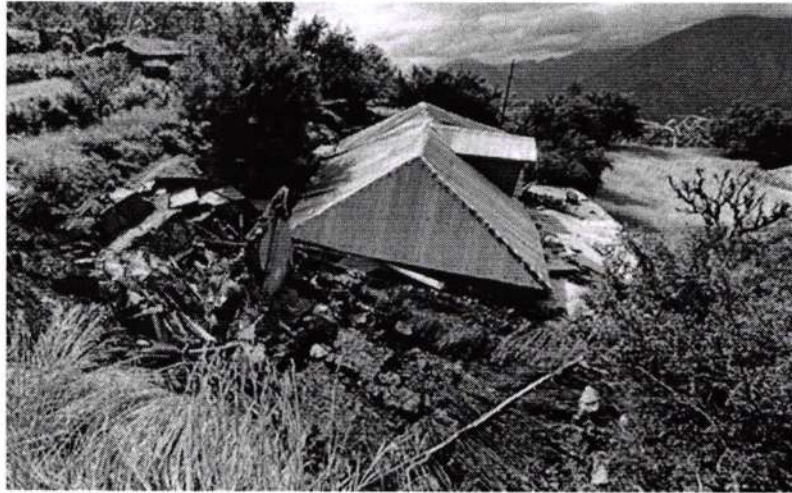
Figure-6: Showing damaged house

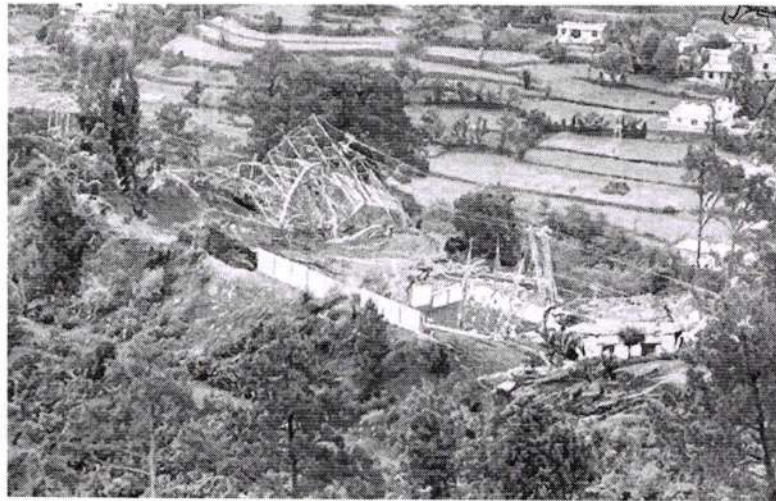
Figure-7: Showing damaged transmission tower and power grid

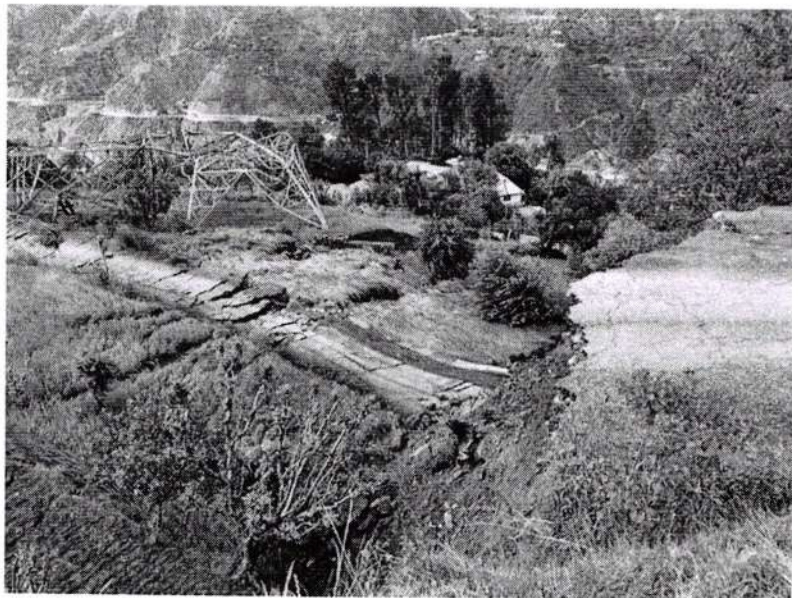
Figure-8: Showing damaged transmission tower and road

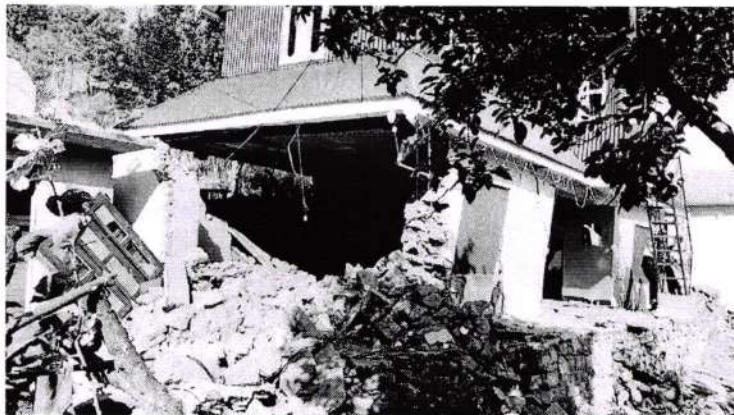
Figure-9: Showing damaged house (Courtesy: <https://www.greaterkashmir.com>)

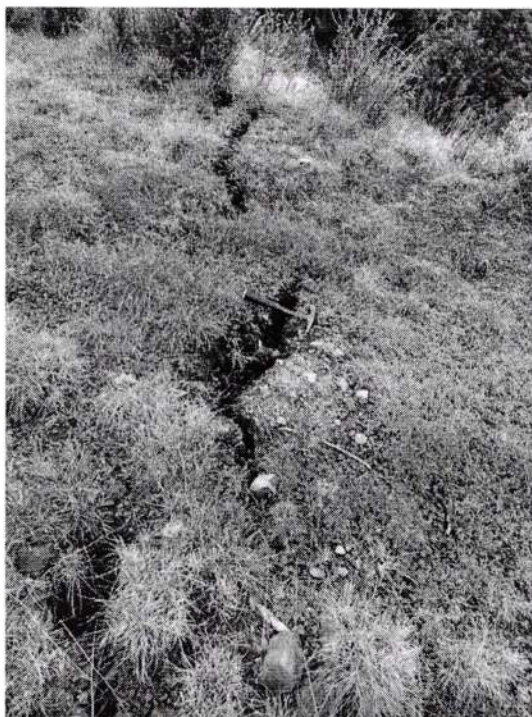
The orientation of the cracks in the slope was observed from multiple locations, with the transverse nature of the cracks varying in strike between NW-SE and E-W (and the longitudinal nature of the cracks varying in trend NE-SW and N-S (Figure-10 and 11). As the slope aspect of the area changes, these cracks are found to be locally varying in the strike. The dimensions of the cracks were observed to vary from a few centimetres to 30 cm in width, a few meters to tens of meters in length.

Figure-10: Showing transverse cracks developed near crown

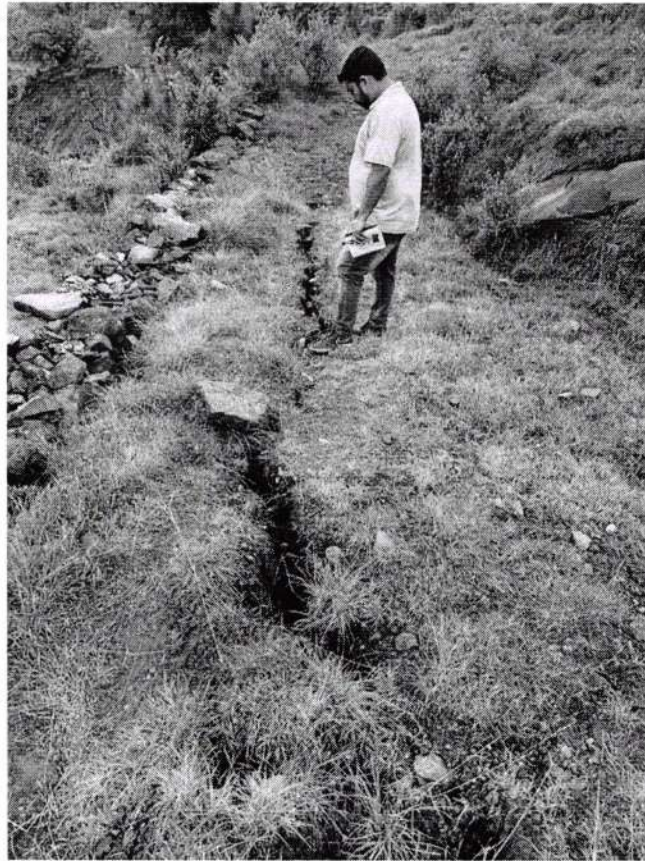
Figure-11: Showing transverse cracks developed near crown

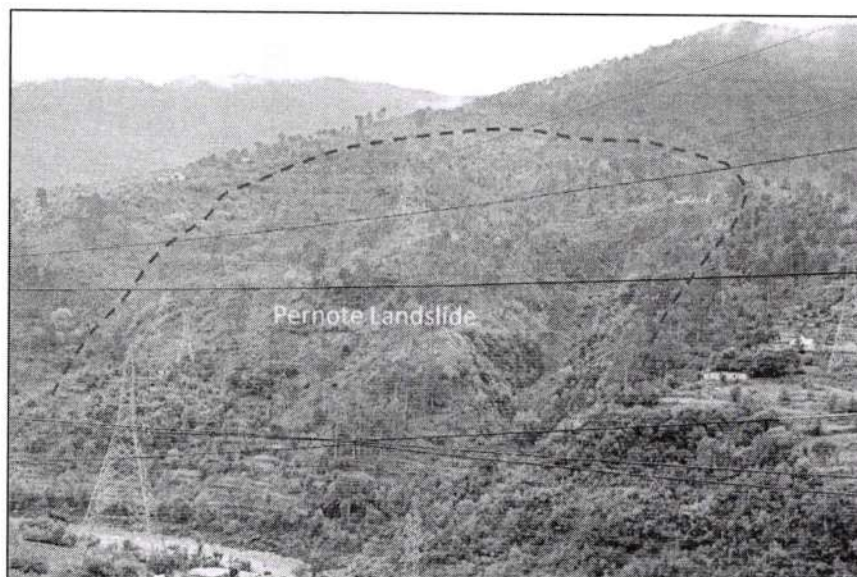
- Demarcation/outlining of the Pernote landslide was done with the help of GPS and from the open source Google imagery. It is estimated that the slide extends in length for ± 1140 m and in width for ± 720 m and having height ± 440 m. Pernote landslide covers an area of approximately 0.51 square kilometres (Figure-12). The central portion may be deeper than 30 meters, although the exact depth is unknown. The crown and toe of the landslide is tentatively inferred at an elevation ± 1110 m and elevation ± 670 m respectively on the basis of geomorphology, distribution of slide debris and other field evidences.

Figure-13: Panoramic view of Pernote landslide

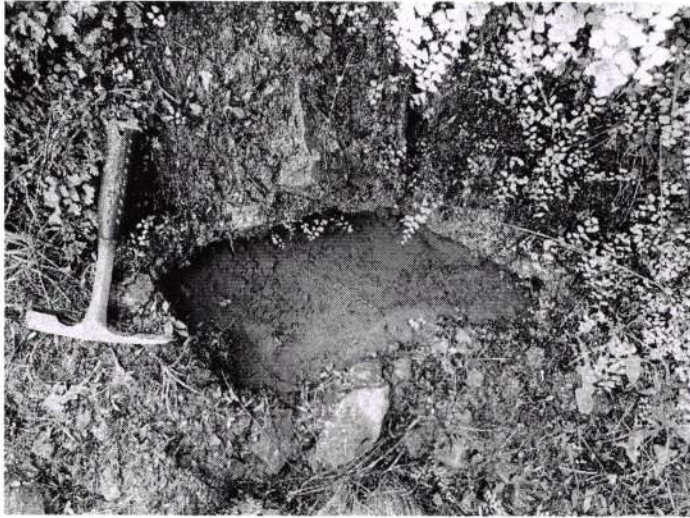
- The water table is shallow in the study area, with water oozing out as springs, seepages, and puddles in several locations (Figure-13 and 14).

Figure-13: Water seepage in the form of spring

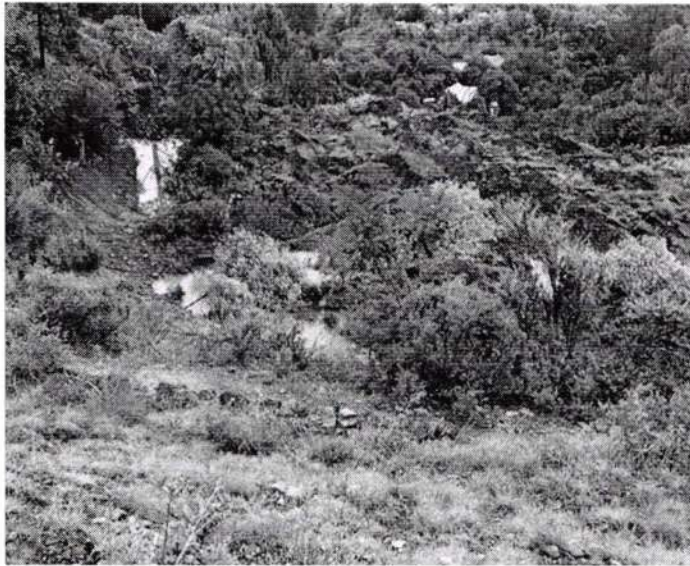
Figure-14: Showing formation of puddles

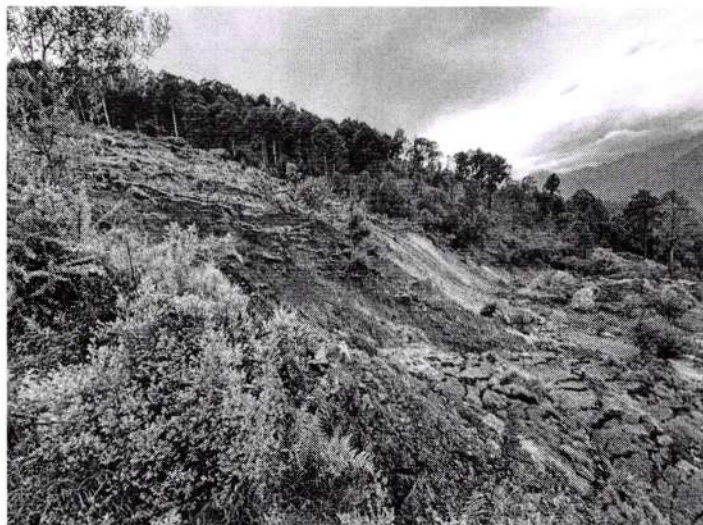
- Field observations** suggest the slip plane originates in the overburden (weathered rock and soil) and extends into the underlying rock mass. This is typical of debris slides, where loose material on the slope initiates the movement (Figure-18). **Multiple surface ruptures** observed on the ground indicate a rotational type of movement. In rotational landslides, the displaced material rotates along a curved surface. Downward movement and thrust of the moving mass formed hummocky structure in the main body of the slide as a result of compression and accumulation of the slope forming material.

Figure-18: Showing slip plane of the landslide

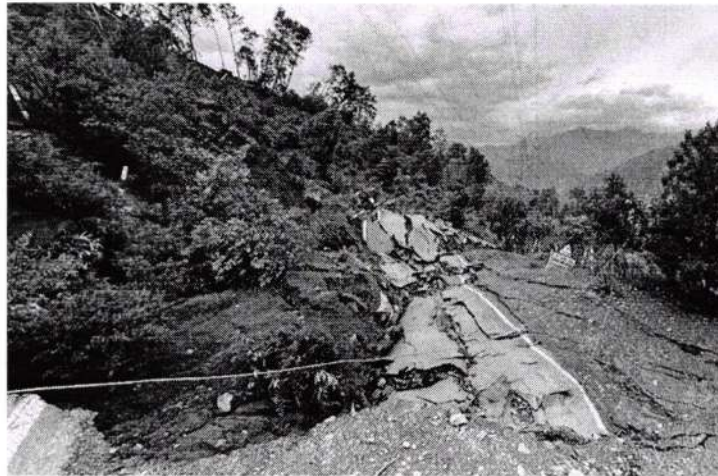
Figure-2: Damaged Ramban-Gool Road due to Pernote Landslide.

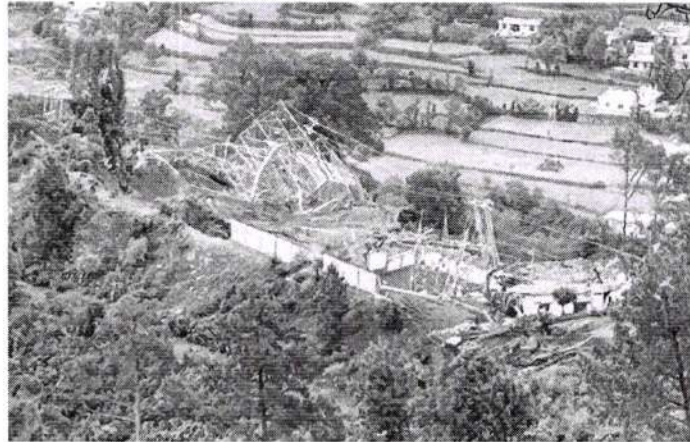
Figure-3: Showing damaged transmission tower and power grid

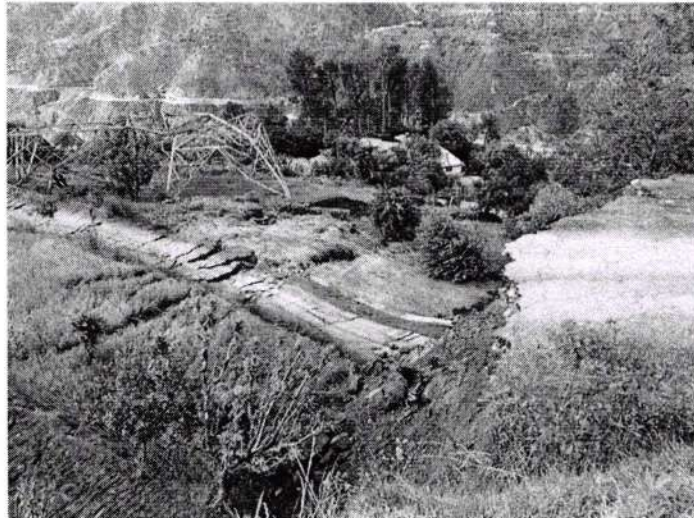
Figure-4: Showing damaged transmission tower and road

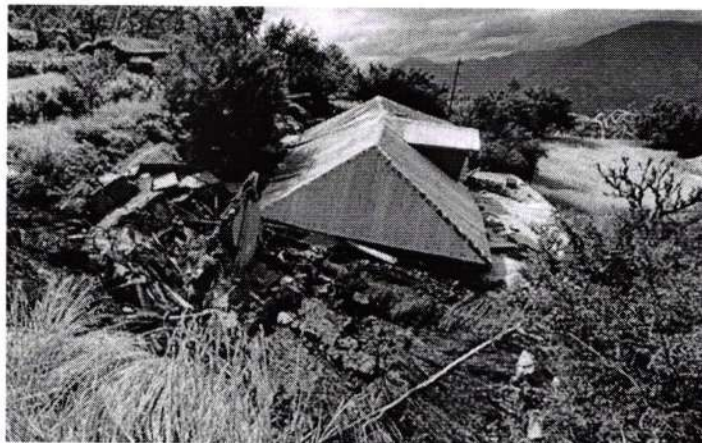
Figure-5: Showing damaged house
