**BEFORE THE HON'BLE NATIONAL GREEN TRIBUNAL, WESTERN
ZONE BENCH AT PUNE**

APPEAL NO. 03 OF 2018

COUNTER AFFIDAVIT OF MATEUS SALDANHA

THE CAUSO CANTRA BUND PHOTOGRAPHS

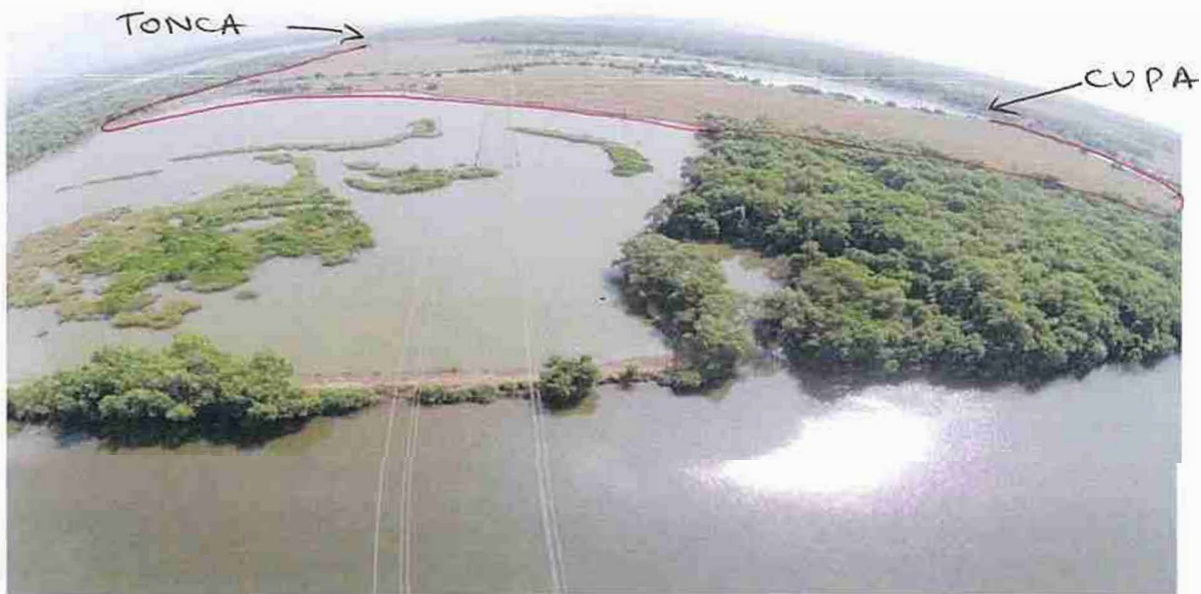
Aerial picture of the intricate system of bunds & sluice gates on Santo Estevam Island which comprises agricultural khazan lands, mangroves, small and large waterbodies and village settlements. The 2,460 m Causo Cantra Bund protects around 100 hectates of khazan paddy fields. To the right is Cupa village and to the left is Tonca. The island is surrounded by the River Mandovi.

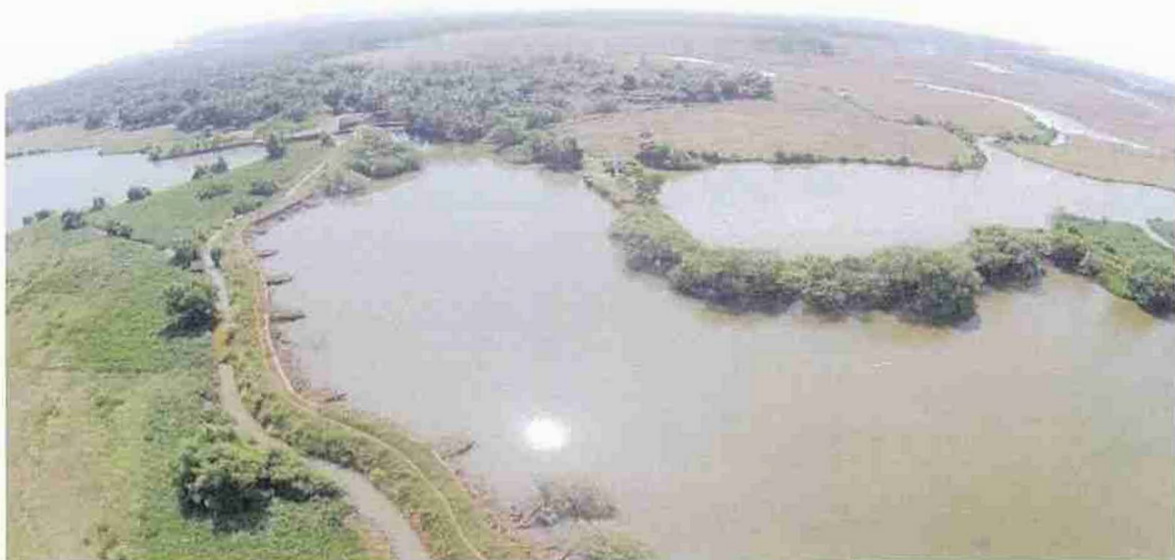
Close-up of Cupa side. The entire stretch mangroves has been destroyed all along the bund. Only few mangroves are seen alongside the bund.

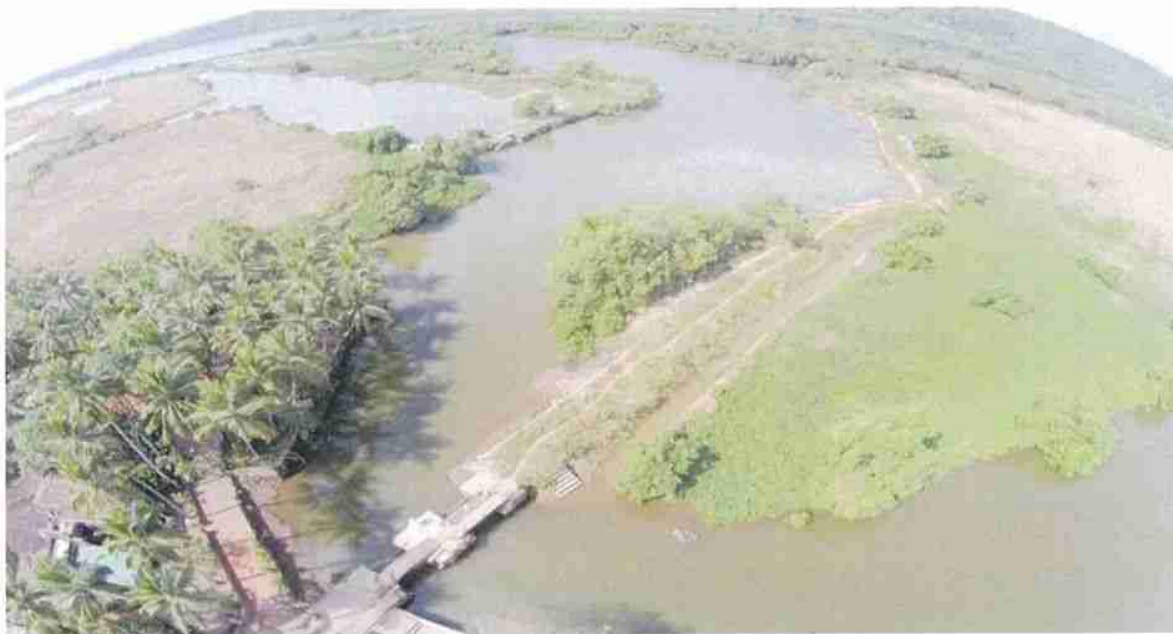
The Cupa settlement on the left. Next to it is the sluice gate from where the Causo Cantra bund starts.

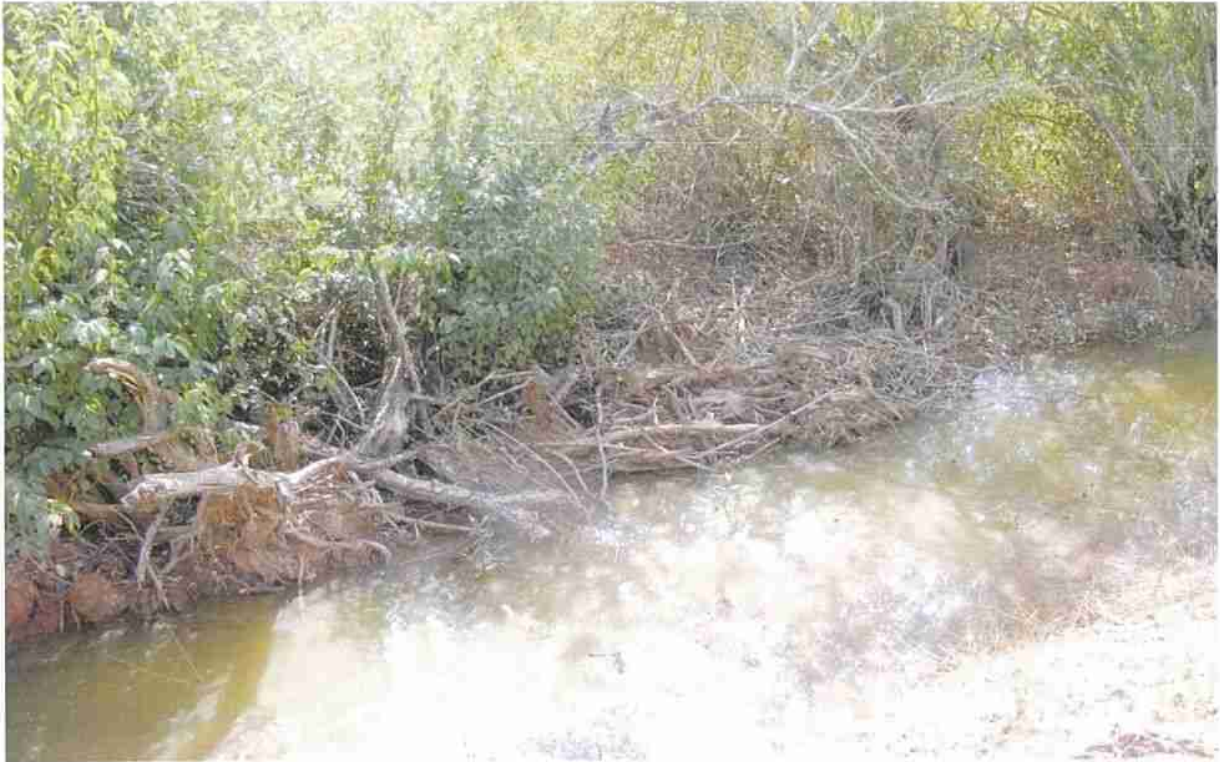
Mangroves uprooted along the bund

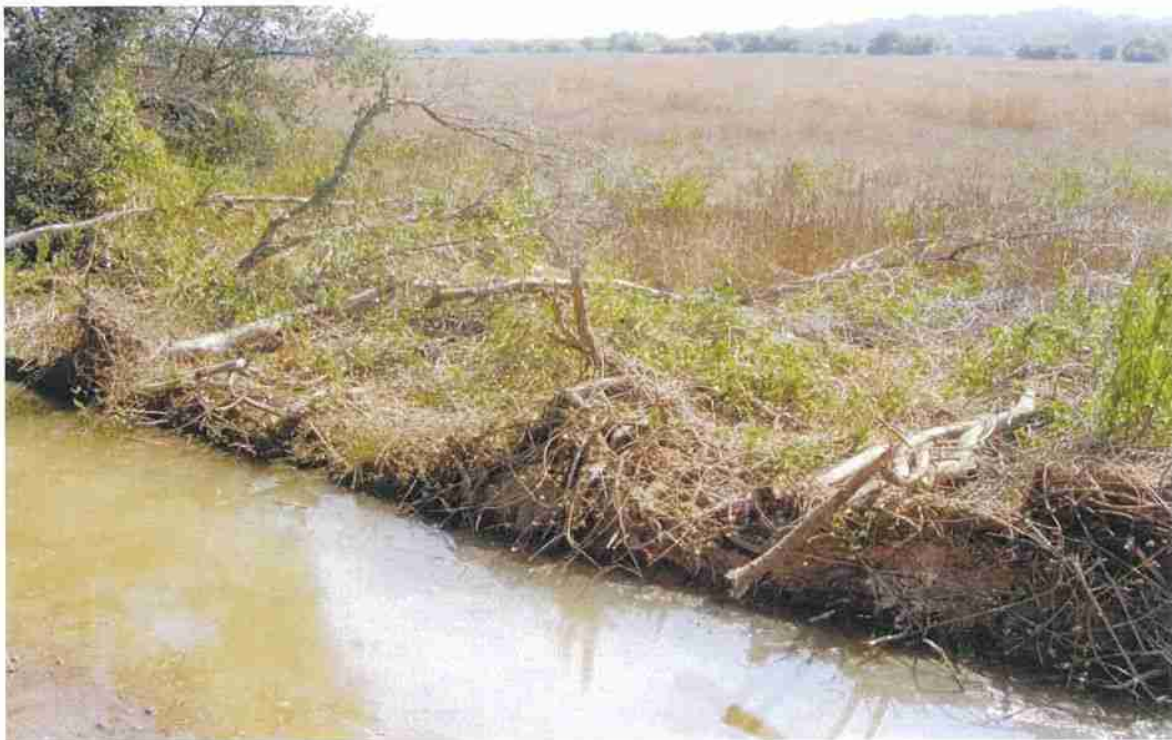
Mangroves uprooted along the khazans

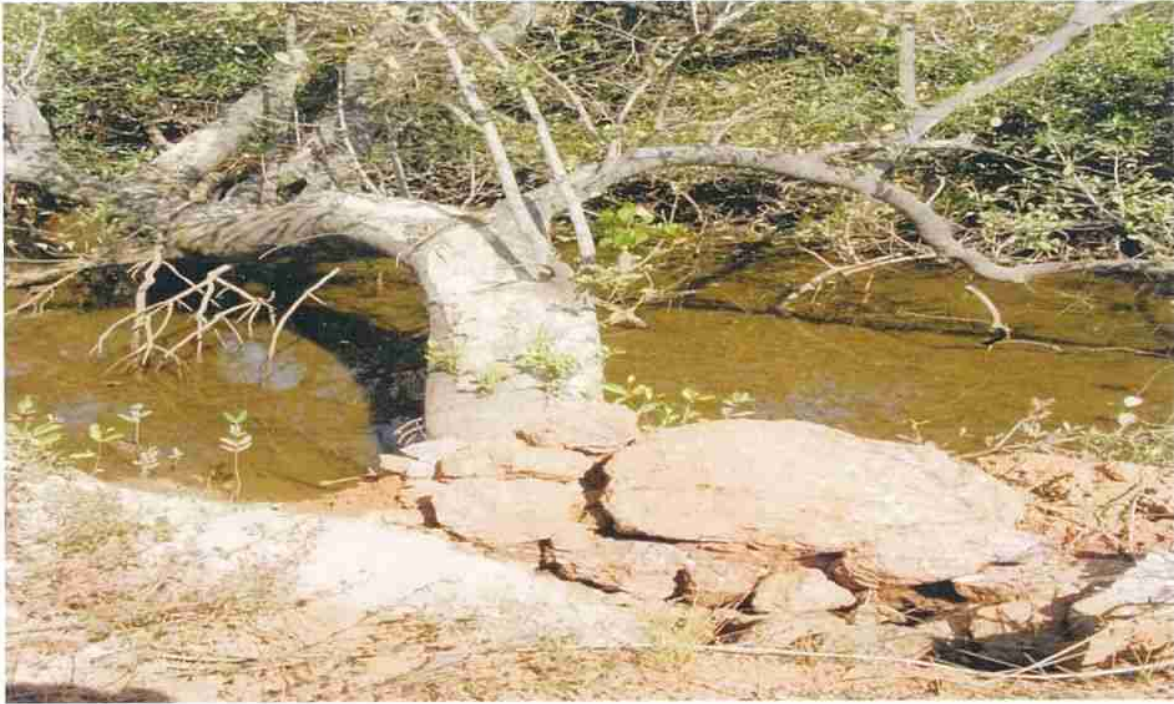
The laterite masonry base of the bund on the riverside has caused slow death of mangroves due to use of cement.

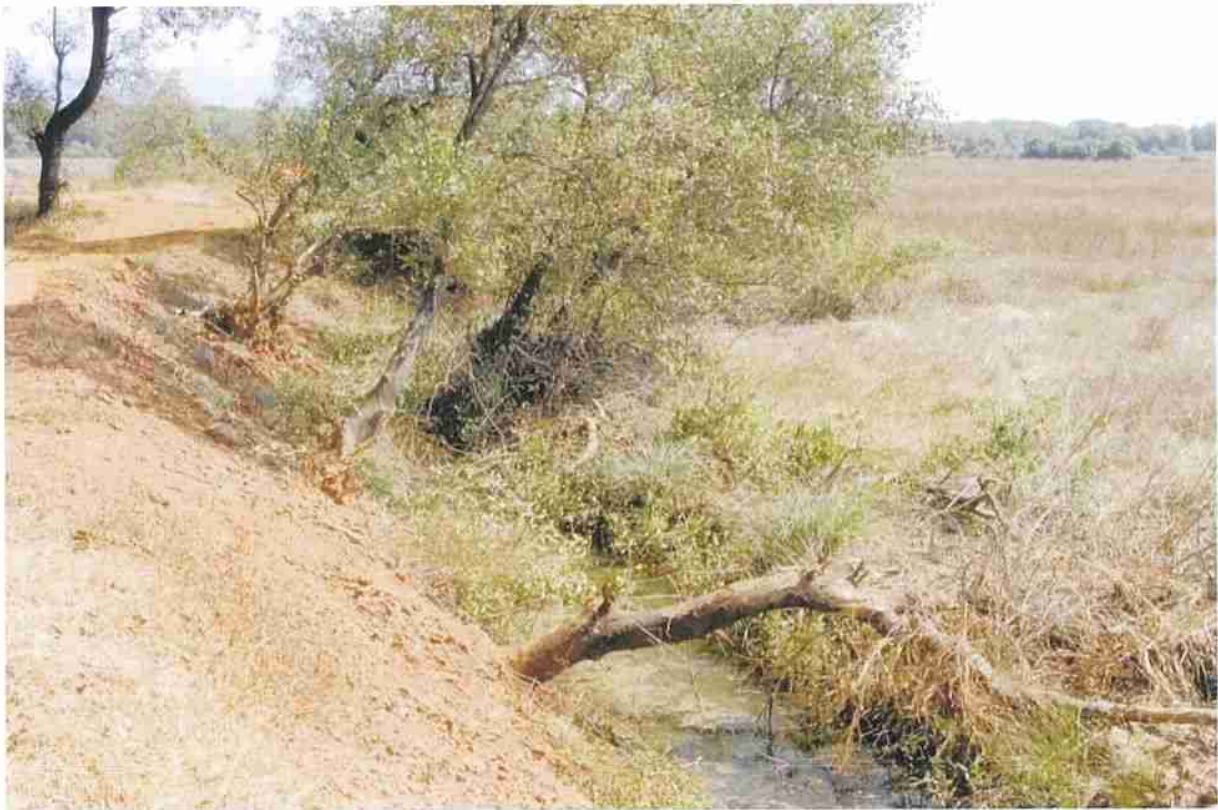
The bund slopes towards the agriculture fields

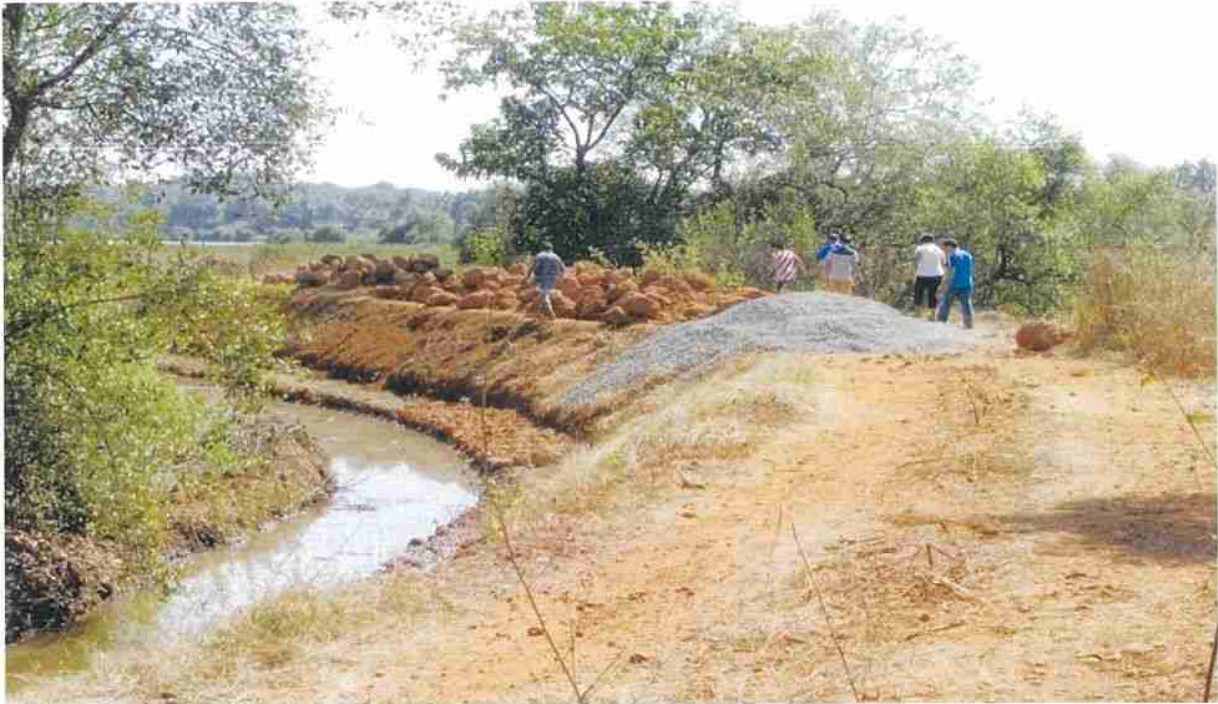
Work of constructing the base of the bund of laterite boulders commencing on the side of the agricultural fields. Material for construction brought to the site.

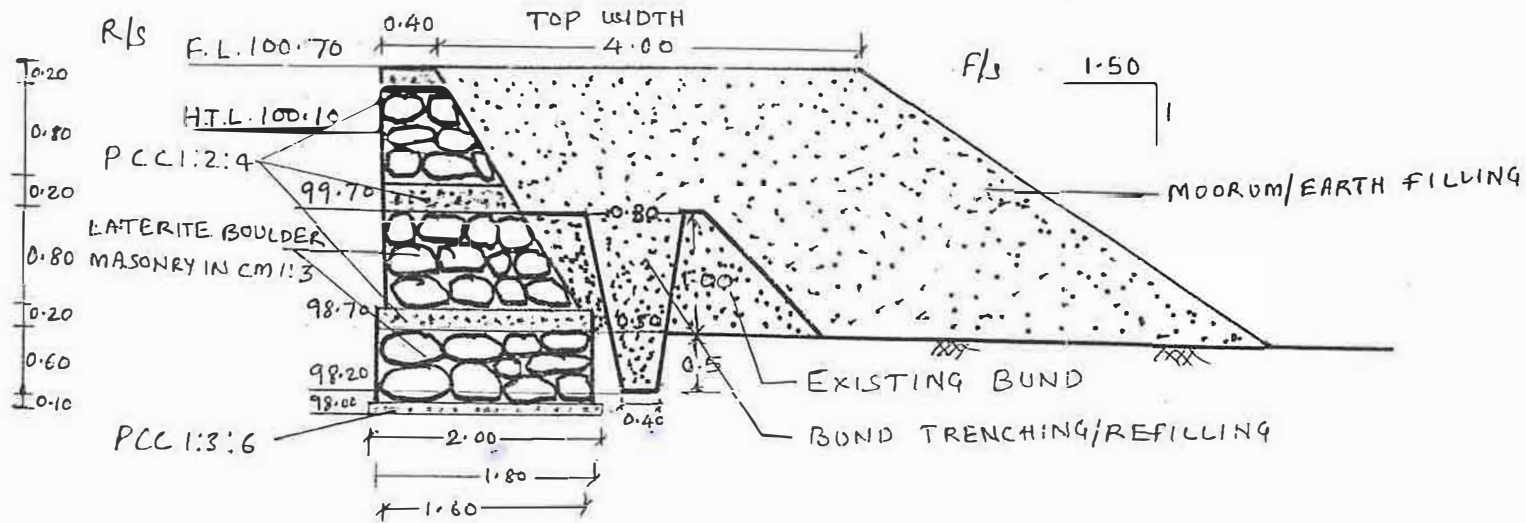
TYPICAL CROSS-SECTION OF BUND

that the original Bund of 2.5 mts width was proposed to be extended to 4 mts only. A copy of the report dated 17.05.2012 along with the design drawing submitted by the Soil Conservation Division is attached herewith as **Annexure R-4 Colly**.

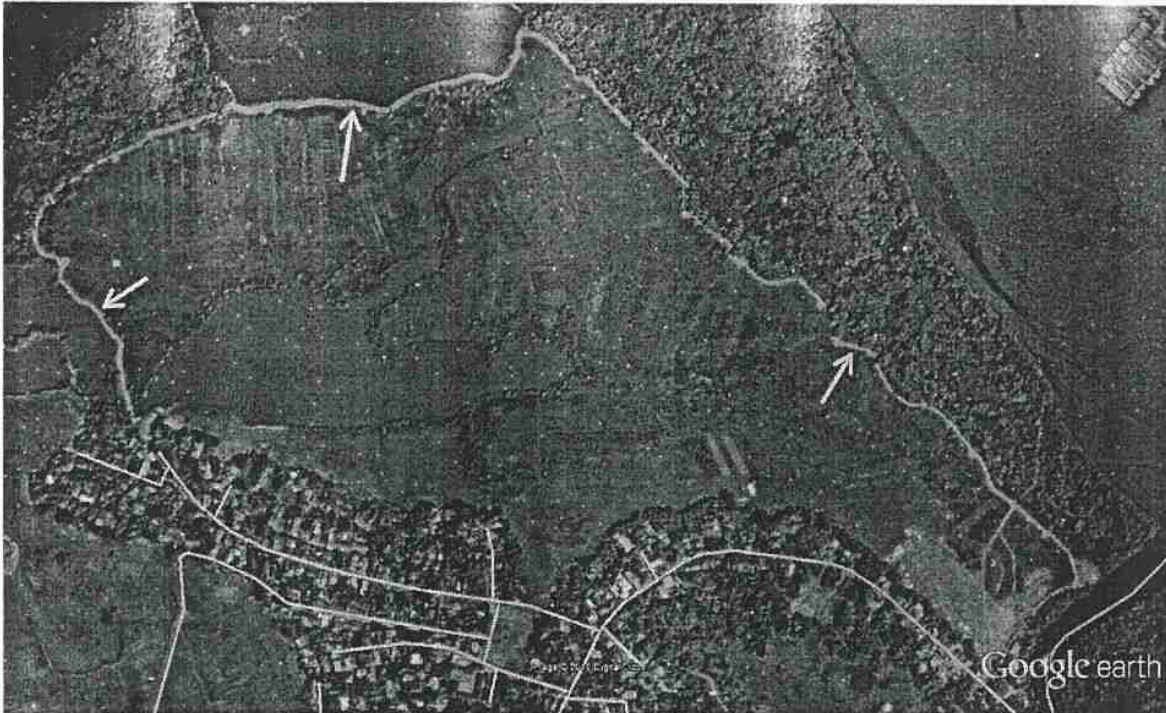
GE image 03/2015: Human interference along the Cavso Cantor embankment; the entire 2.6 km long 'bundh' has been reclaimed / filled with fresh lateritic mud (shown by arrows in yellow); dense mangrove strip along the Mandovi River is seen in the East and North.

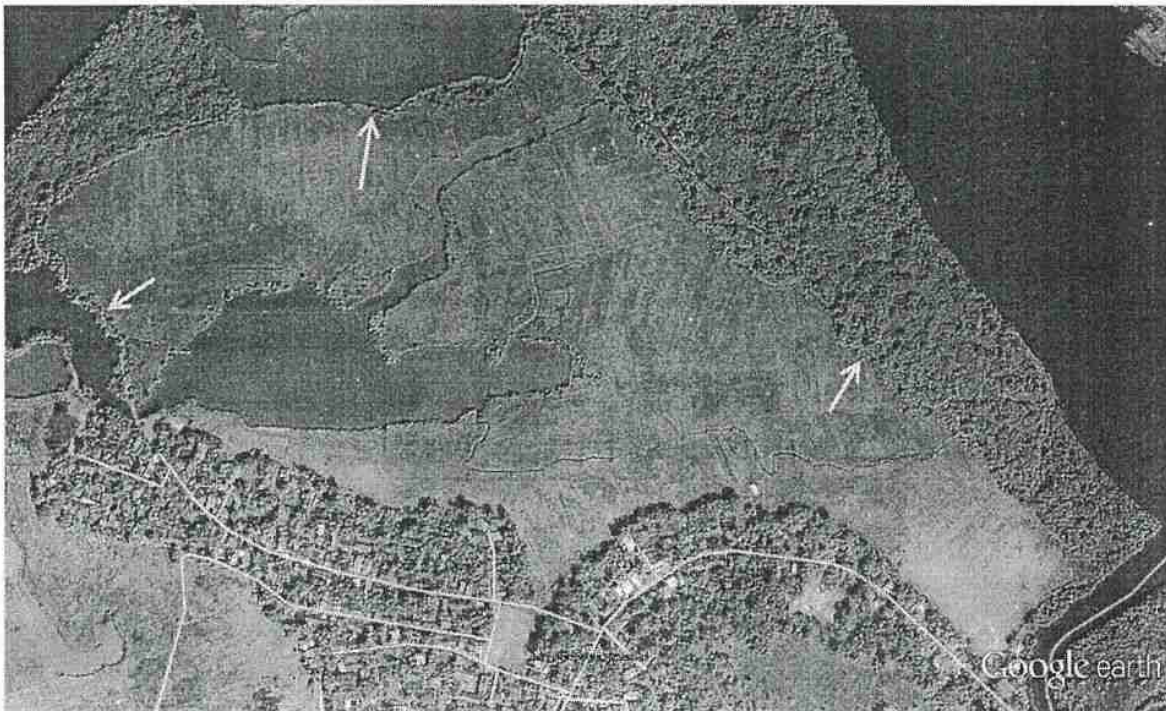
GE image 12/2013: The Cavso Cantor bundh as it appeared before the embankment was reclaimed; the entire wetland complex presents a natural landscape; the embankment marked by a continuous mangrove fringe can be faintly seen (shown by arrows in yellow).

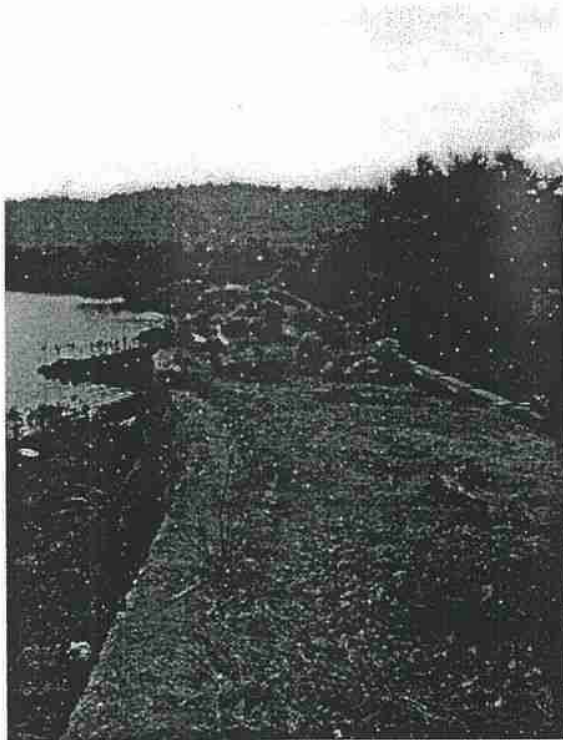
Left: A view from Cupa sluice gate; large boulders seen dumped for the on-going reclamation work. Right: Starting point of the new wall; smaller mangroves seen in the background; Mandovi River lies in the far background.

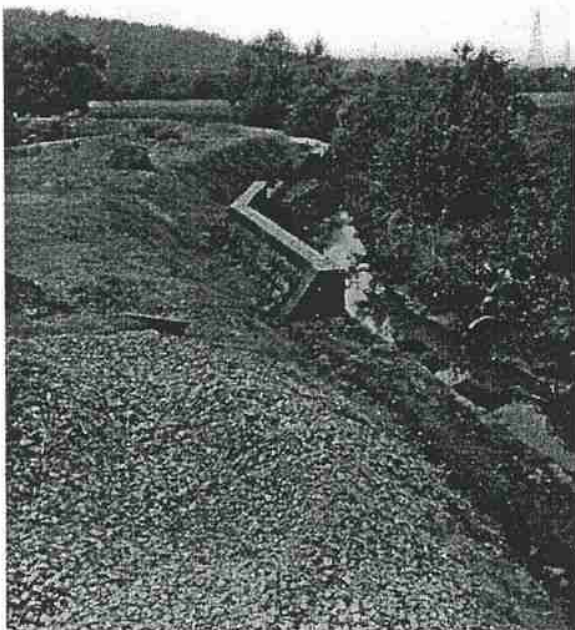
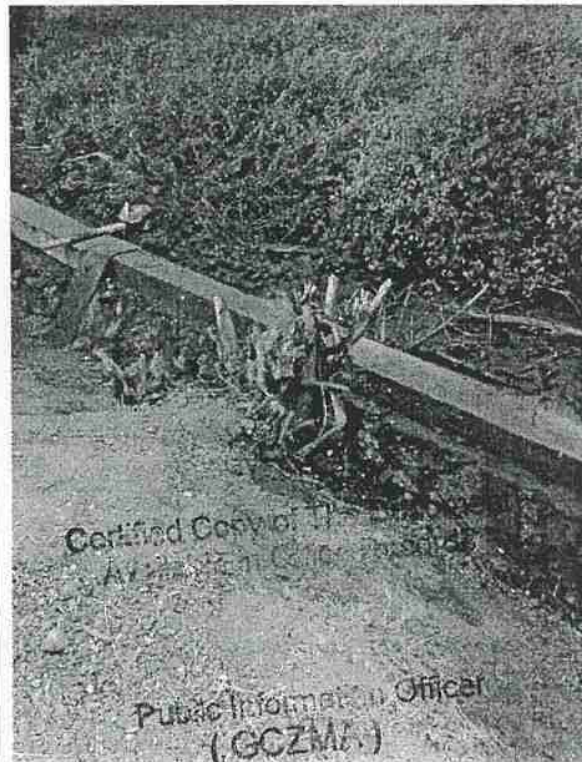
Left: About 100 metres from Cupa sluice gate; work on the rubble – concrete wall along the widened embankment; here, the embankment would be 6-7 metres wide, and about one metre above high tide level; mangrove fringe is still seen. Right: The trunk of a mangrove that is cut; smaller mangroves seen in the background.

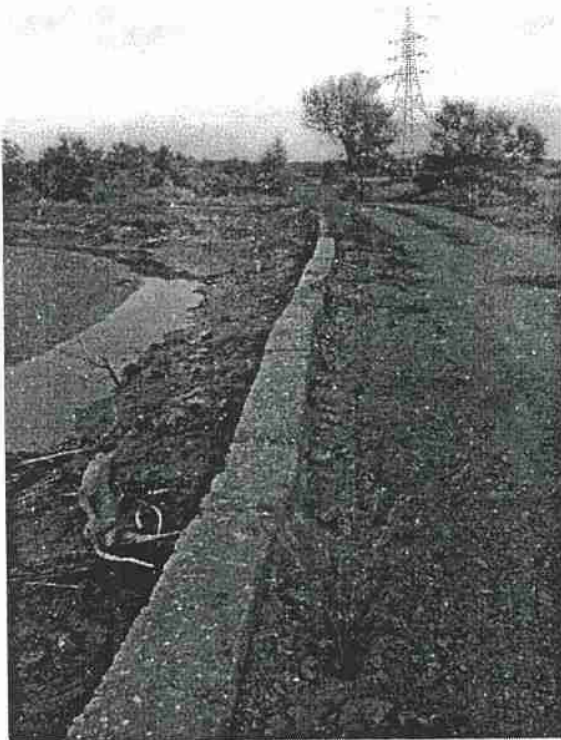
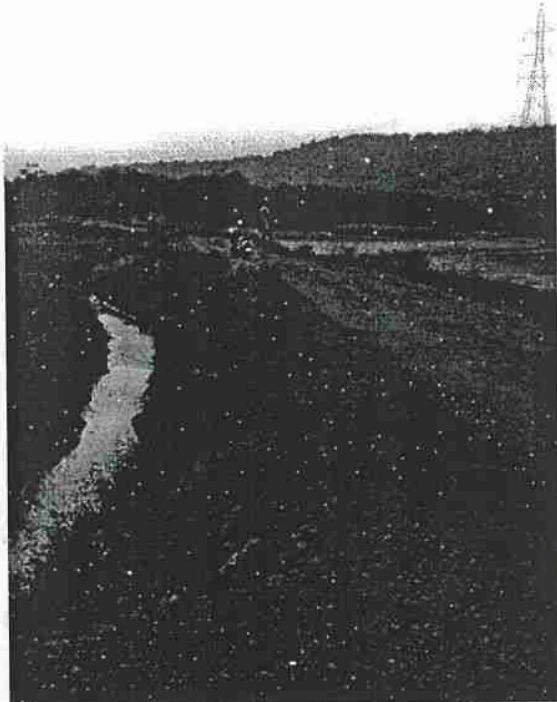
Left: Northern part of the embankment closer to the river; the wall all along the outer periphery of Cavso Cantor bundh is already built some years back. Right: The trench is dug for the foundation of the proposed works; the original embankment is completely buried by red mud.
