**Original Application No. 142 of 2020**

**JOINT COMMITTEE REPORT FILED AS PER ORDER DATED 7.8.2020, BEFORE  
THE HONOURABLE NGT(SZ) IN OA NO.142/2020**

Annexure -9**ENVIRONMENTAL DAMAGE ASSESSMENT AS PER 142/20 NGT****1. Background of the Damaging Activity**

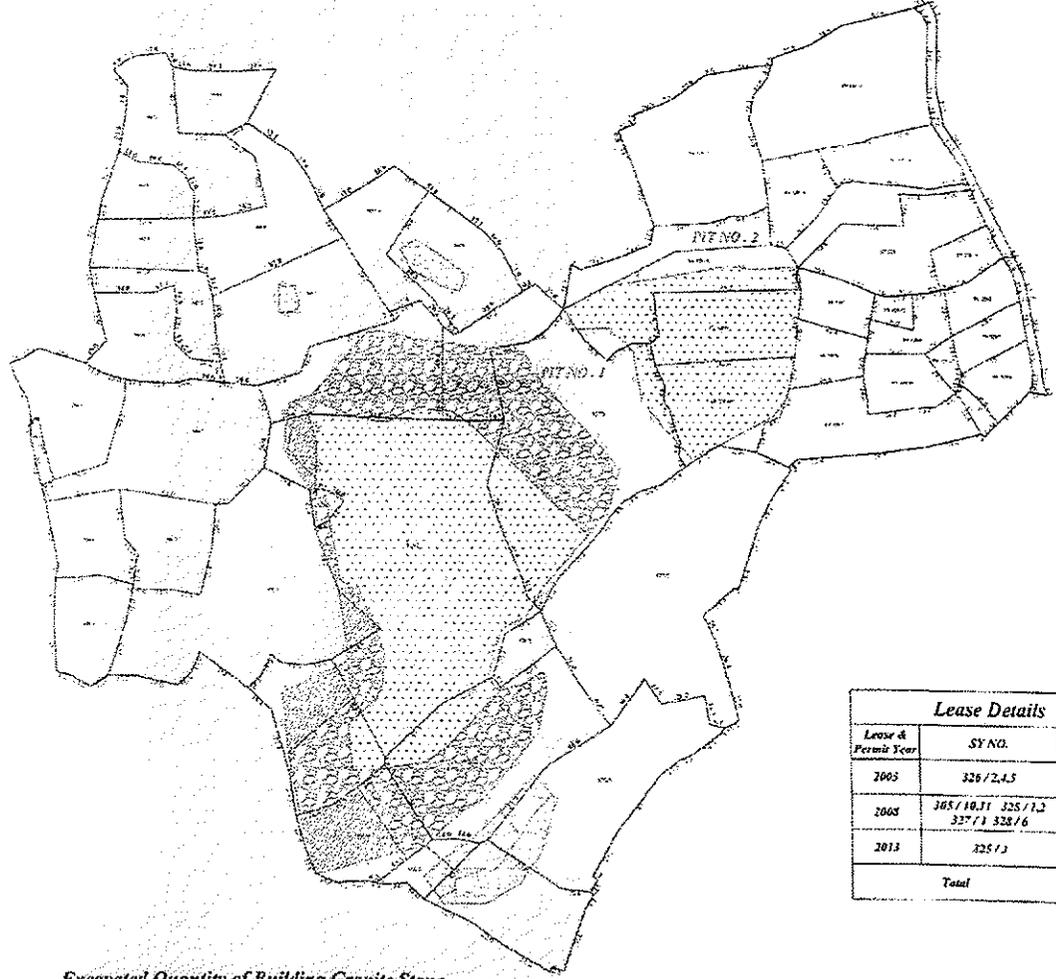
- LEGEND**
- Lease Area (2005,2008) and Permit Area (2013) - 6.4398 Ha
  - Excavated Area seen Water Logged in Lease Area (Pit 1 & 2) - 3.0480 Ha
  - Balance Excavated Area from Lease Area excluding Water Logged Area - 1.6210 Ha
  - Excess Area Excavated from outside of Lease Area - 0.3740 Ha
  - Total Excavated Area of Granite Building Stone from Quarry - 5.0430 Ha
  - Excavated Area of Ordinary Earth - 0.3570 Ha

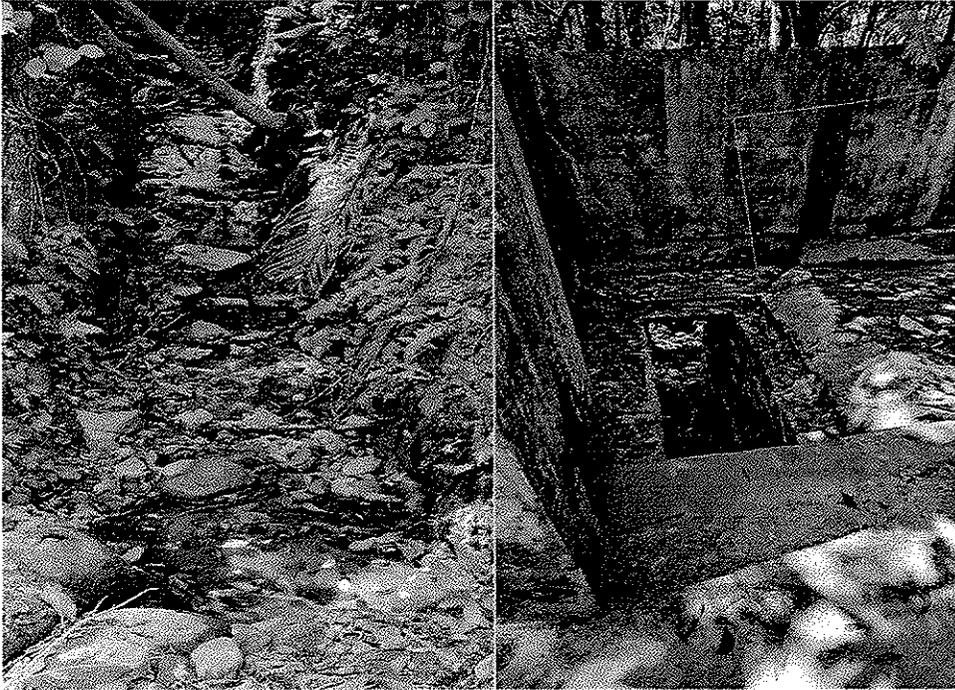
4. There was no water in the Mannathuthodu during the time of inspection. It is a natural drain starting from somewhere in the upper side of the locality and flowing through the front side boundary of the 8<sup>th</sup> respondent towards the downward direction. The 8<sup>th</sup> respondent has provided protection walls to the thodu in front of their boundary to some extent . The runoff from the area and overflow from the quarry pond during the rainy season may reach the canal. During the time of inspection time any deposit of quarry waste in the thodu was seen.

**Mannathodu & drainage built by the unit**

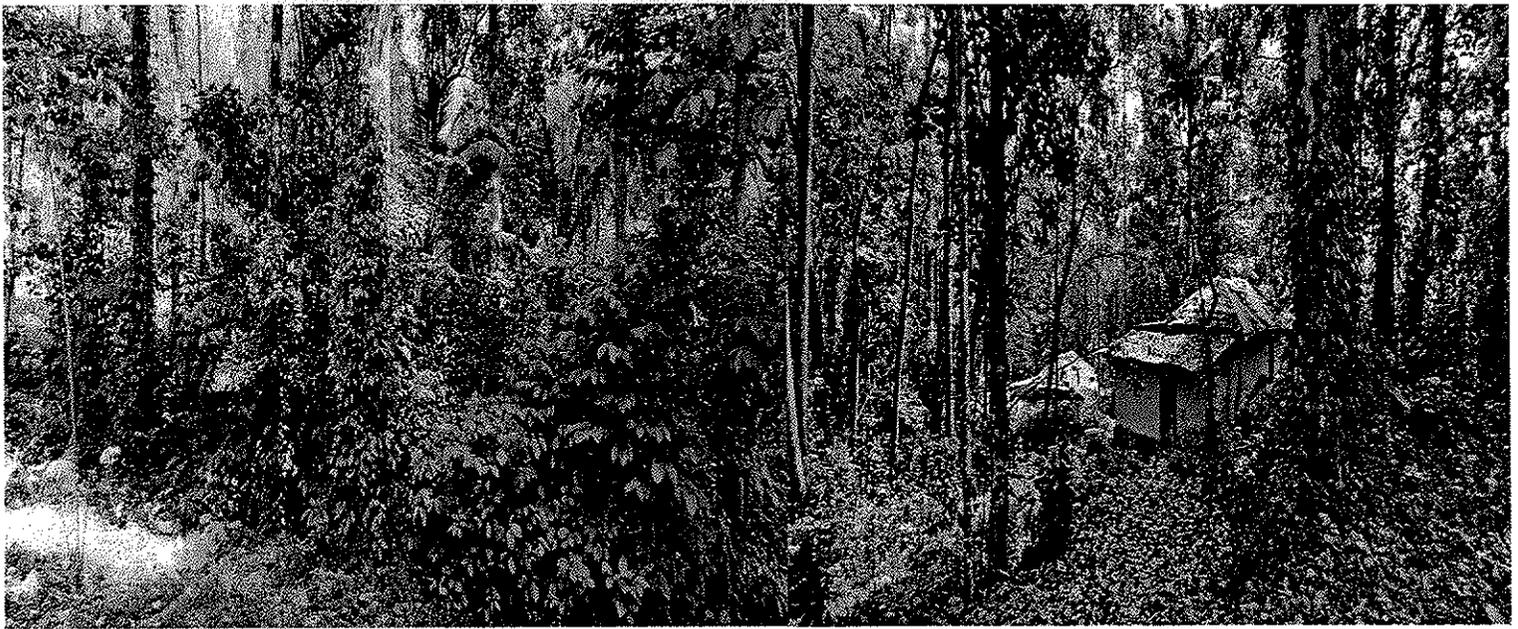
**Plantations in the property of 8<sup>th</sup> respondent**

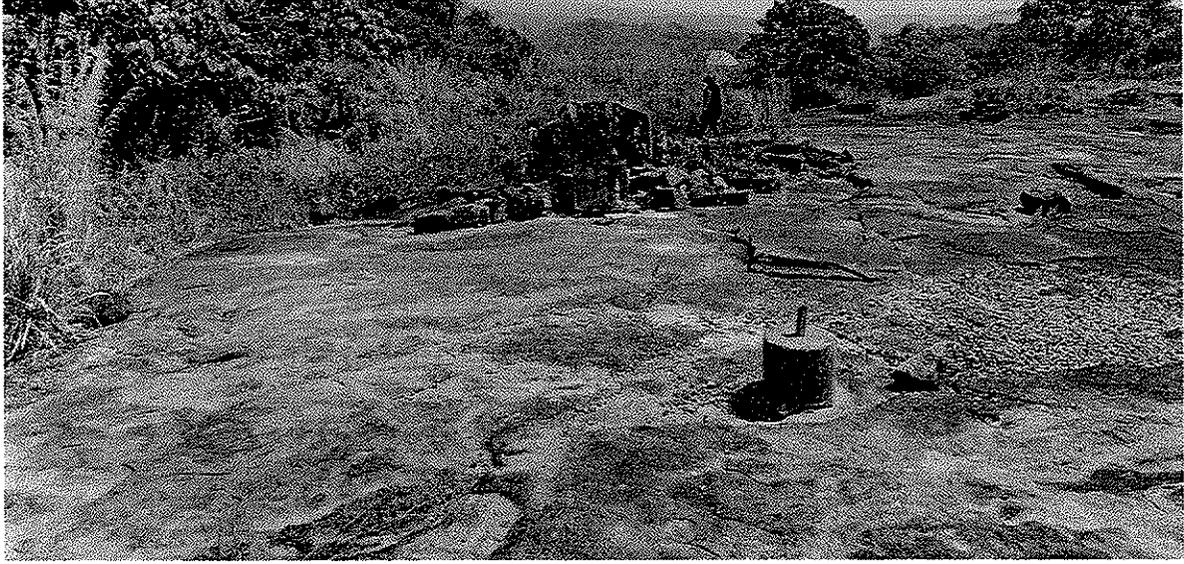
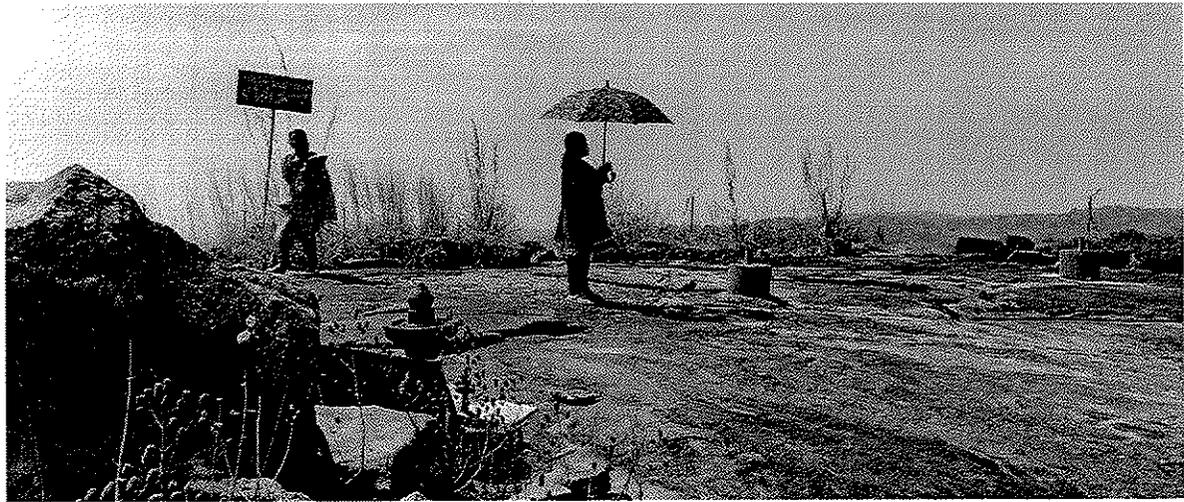
5. The Malankottukara Devasthanam tribal temple is situated towards eastern side of the quarry pit 1 and at a distance of 10 m from the boundary. The temple has no permanent structure. A stone in place of idol and lamp made of stone is placed on the top of the rock. There is no daily pooja in the temple. Any damage to the temple due to mining activities were not noticed. A name board is displayed in the premises.

**Malankottukara Devasthanam tribal temple**
