BAGHJAN WELL # 5 BLOWOUT

Damage Assessment and Restoration Plan of Dibru Saikhowa National Park

Maguri-Motapung Wetlands

**FINAL REPORT OF EXPERT COMMITTEE
TO THE HON'BLE SUPREME COURT OF INDIA**

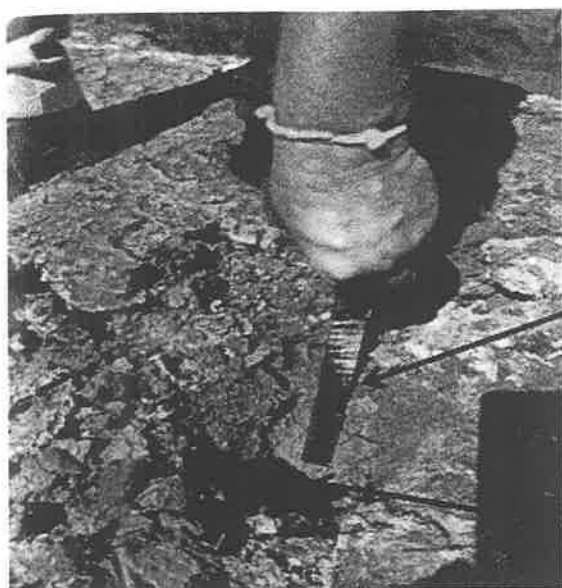
Contaminated Soil at top layer

Clean Soil in bottom of pit

Soil profile view

Figure 10: Soil profile photographs received from OIL on Dec 4, 2021 based on soil sampling on Nov 30-Dec 3, 2021. Soil probes were injected to depth upto 25 cm and visually contaminated soil were encountered at depths of 7 cm to 13 cm

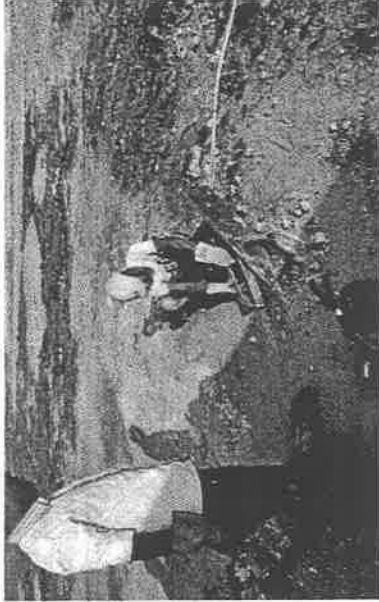
Redundant pipes etc.	Anchor plates and exposed pipes were left on site which can cause potential slipping/tripping hazard	Anchor plates and exposed pipes have been cut and removed.

A final scanning of the area for any other underground redundant pipes needs to be carried out.

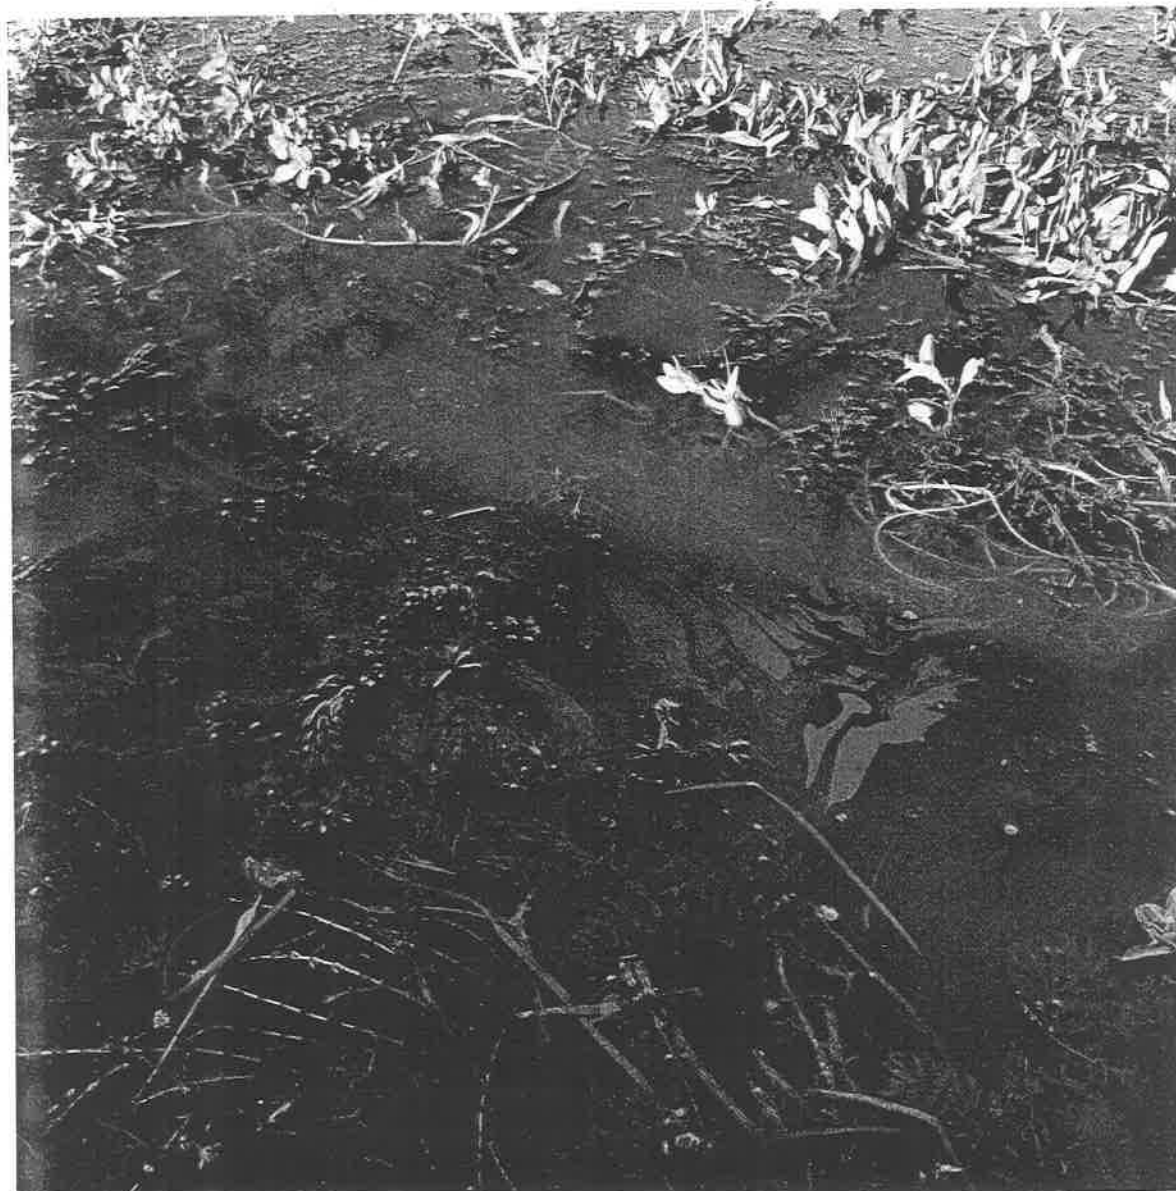
Figure 24: A patch of oil on the surface of Maguri - Motapung Beel (November 17, 2021 observed by Committee)
