Original Application No. 448 of 2022

**In re: News item published in Hindustan Times dated 03.06.2022 titled
"178 Women workers fall ill after gas leak in Andhra's
Visakhapatnam"**

**2nd Interim Report
of the Joint Committee
Appointed by the National Green Tribunal
in the matter of
O.A. No.448 of 2022**

2nd Interim Report on the Incidents occurred on 03.06.2022 and 02.08.2022 at M/s Brandix Intimate India Pvt. Ltd., (formerly M/s Seeds Intimate Apparel India Pvt. Ltd.) located in the premises of M/s. Brandix India Apparel City Pvt., Ltd, SEZ, Atchuthapuram, Anakapalli District, Andhra Pradesh.

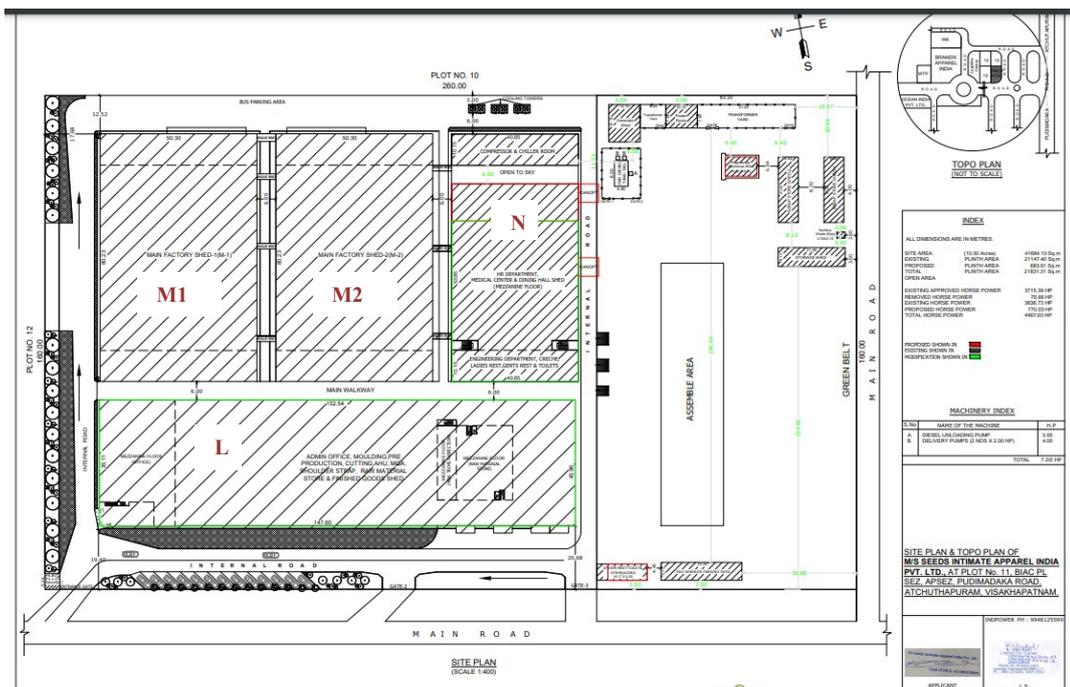
Figure 1: The layout of the M/s. Brandix Intimate India (P) Ltd., Unit in Brandix India Apparel City (P) Ltd.,

M/s. BIIL has four building blocks namely M1, M2, L and N blocks and open space /areas. The layout of the unit is shown in Figure 1.

The two manufacturing blocks are designated as M1 and M2, whereas the L block houses the administration office, moulding, preproduction, cutting, and warehouse for storage of raw material and finished apparel product. The Block N is meant for utilities including a medical room and canteen. There is a separate room in N block, which is designated as

compressor and chiller room. There are three cooling towers behind the N block at a distance of 6 m from the N block as shown in Figure 1. The bus parking area is at the rear side (*north side*) of the M1 and M2 blocks. The rest rooms or washrooms were provided at the backside (north side) of M1 and M2 blocks. There is a chemical storage unit, which stores chemicals necessary for the chilling unit. A Diesel Generator set with a capacity of 1010 KVA (2 Nos) is installed and a diesel storage tank of capacity 15 KL exists.

The corridor between M1 and M2 is 6 meters wide and it is open to sky. The width of the open space on North side of M1 block is 15 m North side M1 to North compound wall) as shown in Figure 1.

The Air conditioning facility provided is chilled water HVAC system consists of a central chilling unit outside the building as shown in Figure 1. There are total eight Air Handling Units (AHU) catering the air – conditioning needs of both M1 (4 AHUs for M1) and M2 (4 AHUs for M2) blocks. The AHUs are located on the roof top of M1 and M2 buildings. The each of the AHUs provide fresh air inlet to draw outside air. The fresh air drawn through these inlets is mixed with the chilled air and circulated in the air conditioning system.

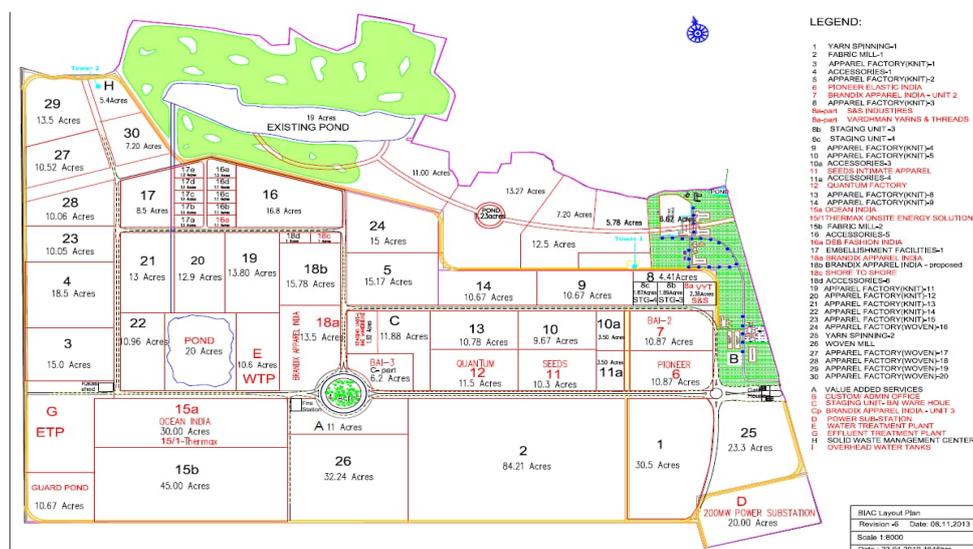
Atchuthapuram, Anakapalli District.

The Layout of M/s Brandix India Apparel City Pvt., Ltd, and the Google map indicating location of BIIL are shown in figure 2 & 3 respectively.

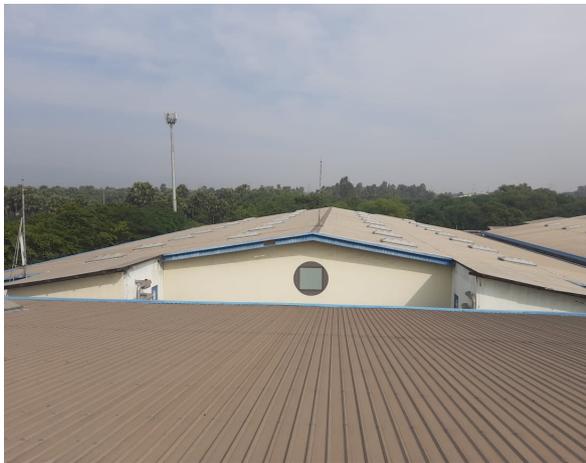
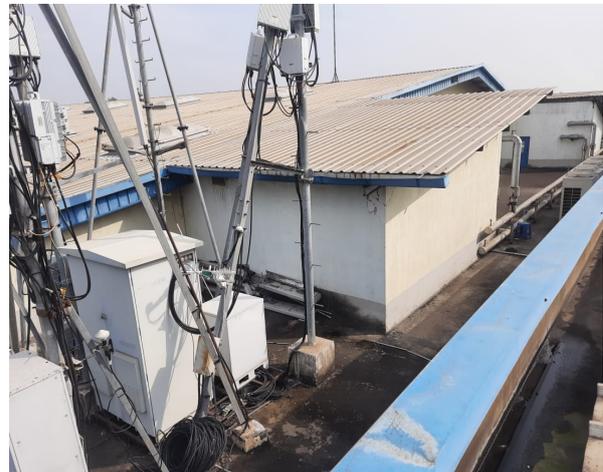
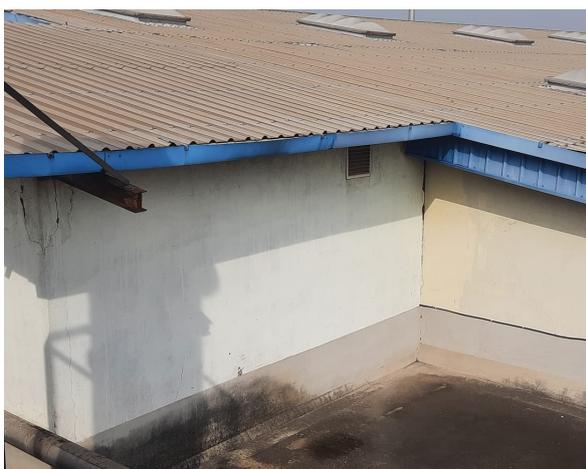
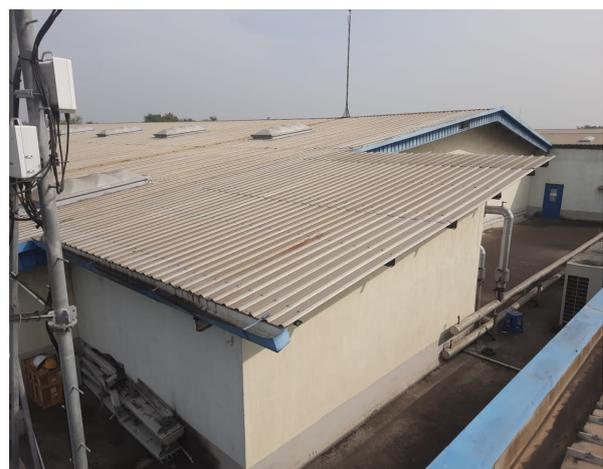
- Chilling room has one chilling plant and three No. of compressors in N block.
- 4 number of Air Handling Units (AHUs) are provided for each of the M1 and M2 blocks (two 75 TR AHUs are located at North side and the other two 80 TR AHUs are at south side of the blocks).
- Capacity of AHUs for each block is 80 TR AHUs (2 Nos.) – 34,400 CFM; 70TR AHUs (2 Nos) – 28,000 CFM.
- The lines numbered as 1,3,5,7,9,11,21,22 in the manufacturing blocks are connected to AHUs – 3 at South West side of M1.

- The lines bearing numbers 2,4,6,8,10,12 are connected to AHU – 4 at South East side of M1.
- The lines 13,15,17,19,23 are connected to AHU-2 at North East side of M1.
- The lines 14,16,18,20,24 are connected to AHU- 1 at North West side of M1.
- The AHU room size is 20.9ft x 16 ft.
- Fresh air damper of AHU size is 20 inch x 16 inch.
- AHU No.3 & 4 were installed on terrace slab of M1 building at South side at a distance of 5m from corridor lean to roof.

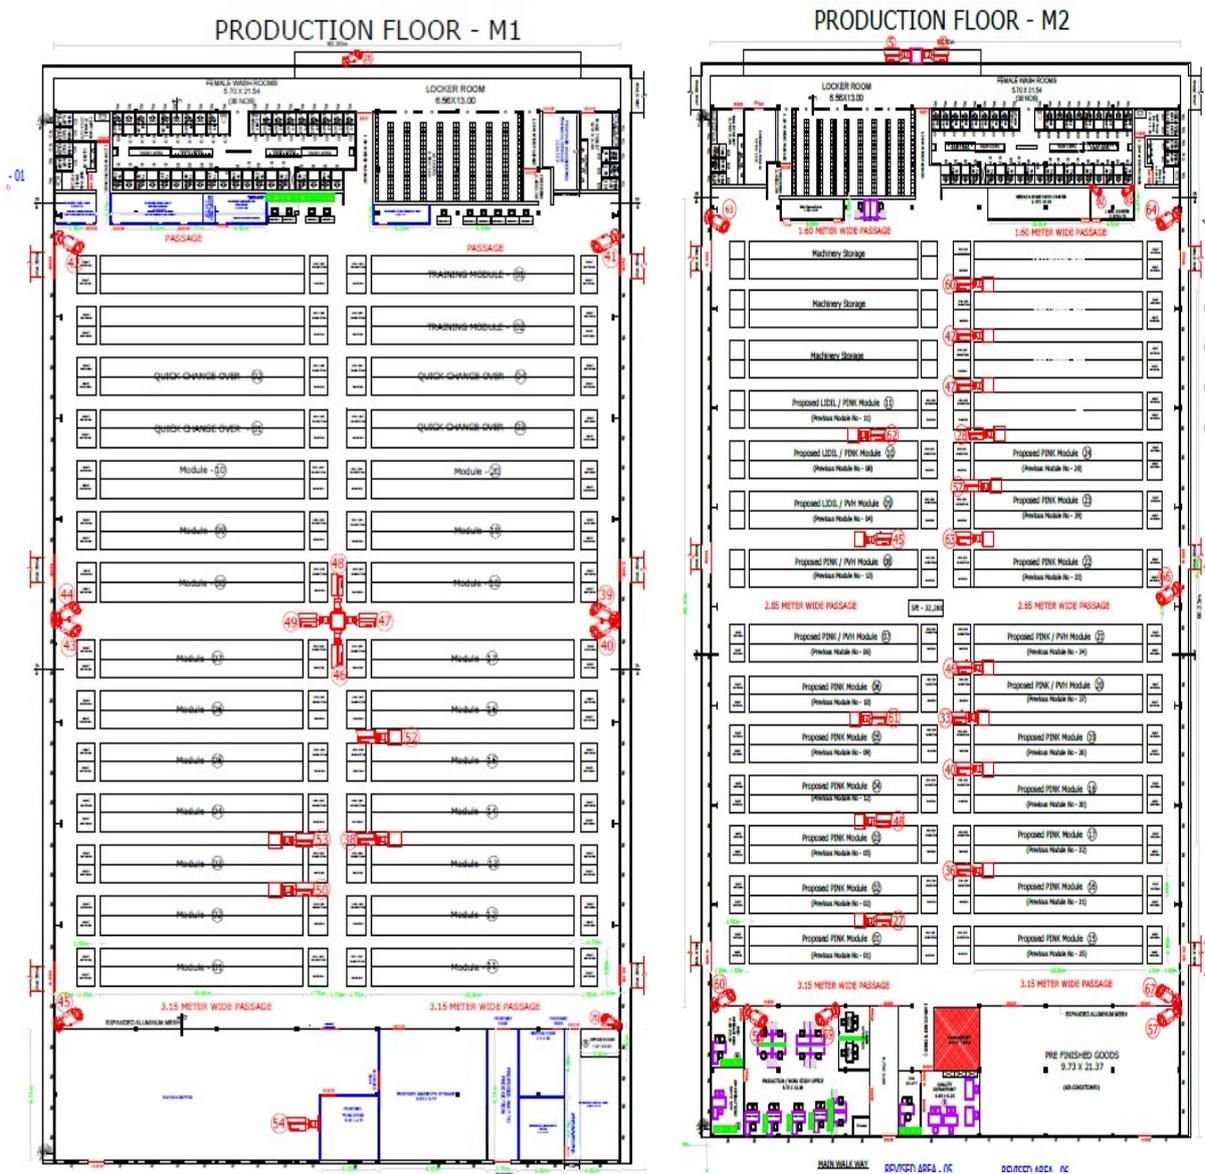
Figure 2: Production floor layout of the M1 and M2 blocks

M/s. Brandix Intimate India (P) Ltd. is an apparel factory producing the apparels. It is engaged in manufacturing or knitting of Bras upto 39,800 numbers/day and Bralets upto 10,200 numbers/day. The factory receives fabric, elastic, hooks, PU cups, rings and slides, stickers, tags etc. as raw materials. Initially, as per the designs, the cutting of the fabric takes place in the L block. Then it is supplied to the M1 and M2 blocks where the workers stitch the fabric to make the final product and pack it. The packed product is sent to designated storage in L block. The major activity in the M1 and M2 blocks is tailoring. The approximate dimensions of the each of the M1 and M2 blocks are 80 m x 50 m. The ceiling is at a height of 5m at

eaves. The M1 and M2 blocks are centrally air-conditioned blocks where the temperature and humidity are maintained in the range of 25° C – 26° C and 55% - 60% respectively. The noise levels are measured during the field visit and the average noise level is 65 dB. The staff working in these blocks is exposed to these conditions for duration of approximately 7.5 hours in a working day. The production floor layout of the M1 and M2 blocks is shown in Figure 2.
