**BEFORE THE NATIONAL GREEN TRIBUNAL
PRINCIPAL BENCH, NEW DELHI**

Original Application No. 448/2022

In re: News item published in Hindustan Times dated 03.06.2022 titled
**“178 women workers fall ill after gas leak in Andhra’s
Visakhapatnam”**

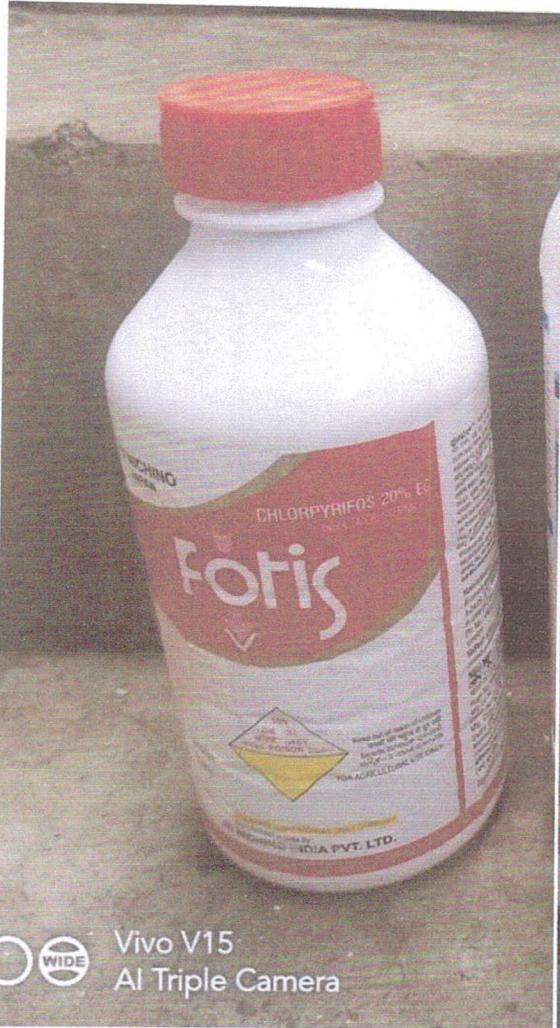
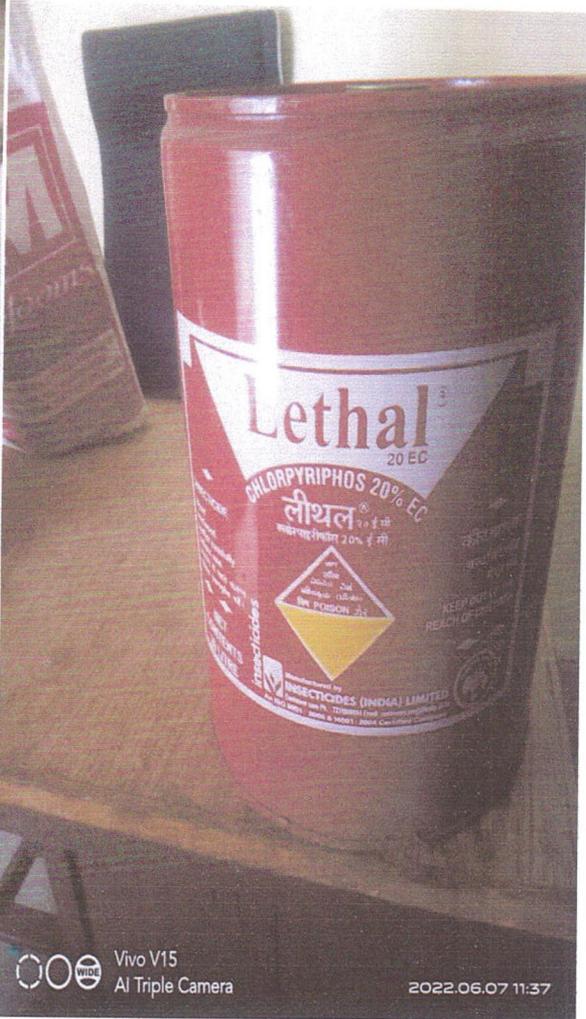
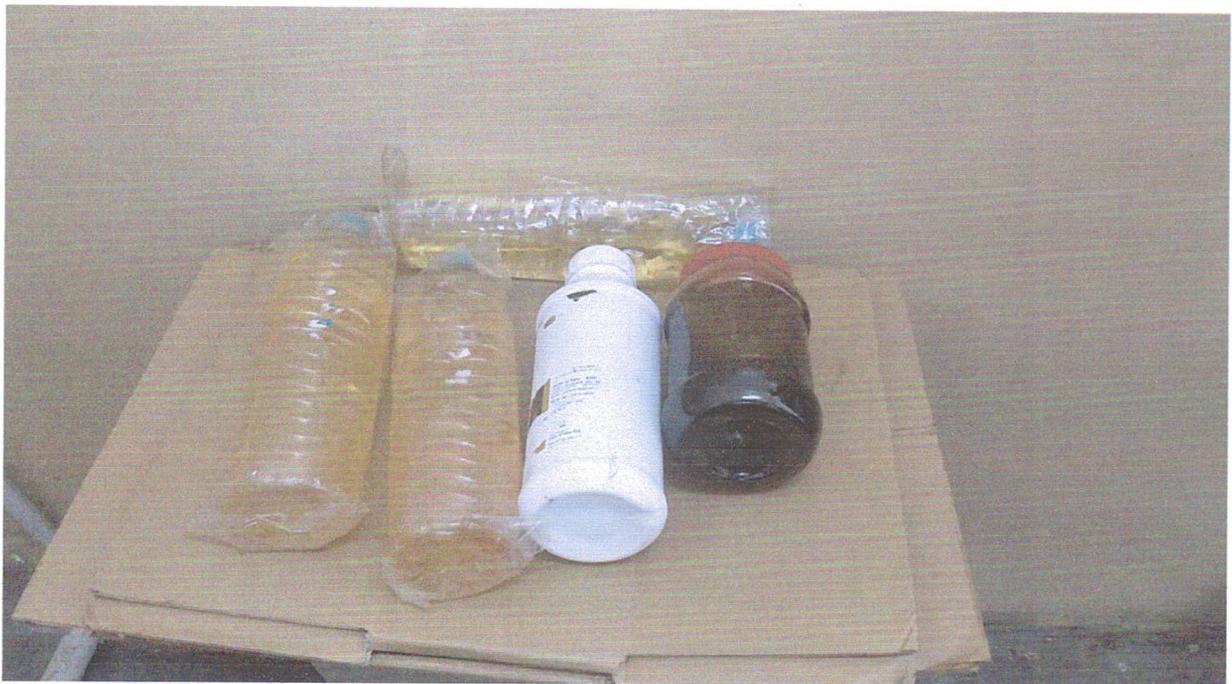
Pest Control chemicals

5. As per the composition solubility of chlorpyrifos 20% EC in water is 2mg/L and at the time of spraying at the incident site the final concentrated residue may have settle down in the sprayer due to improper mixing and the concentrated chemical might have been sprayed at the site leading to the occurrence of the incident.

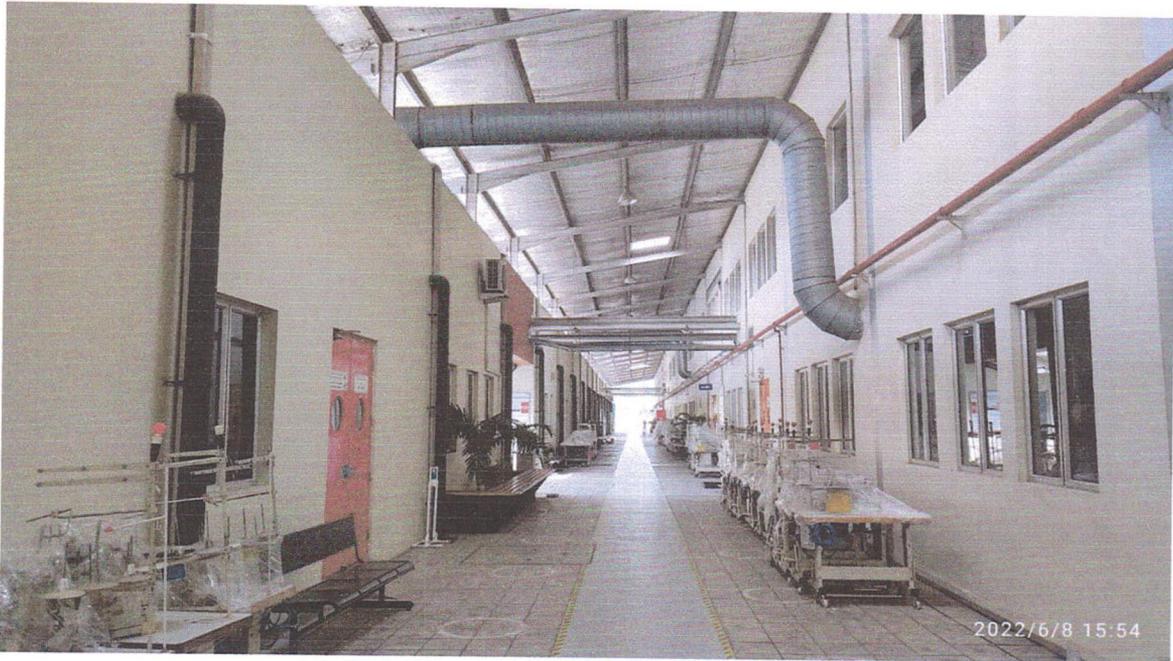
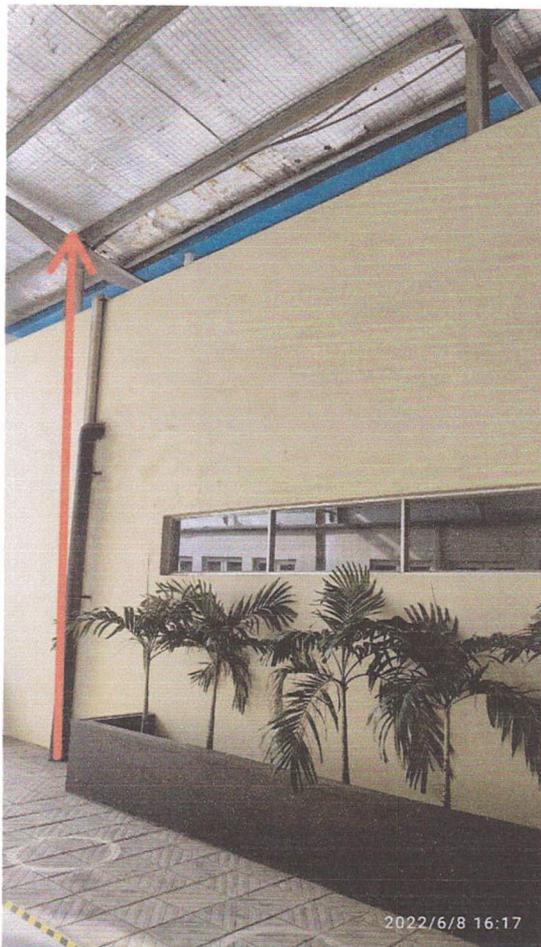
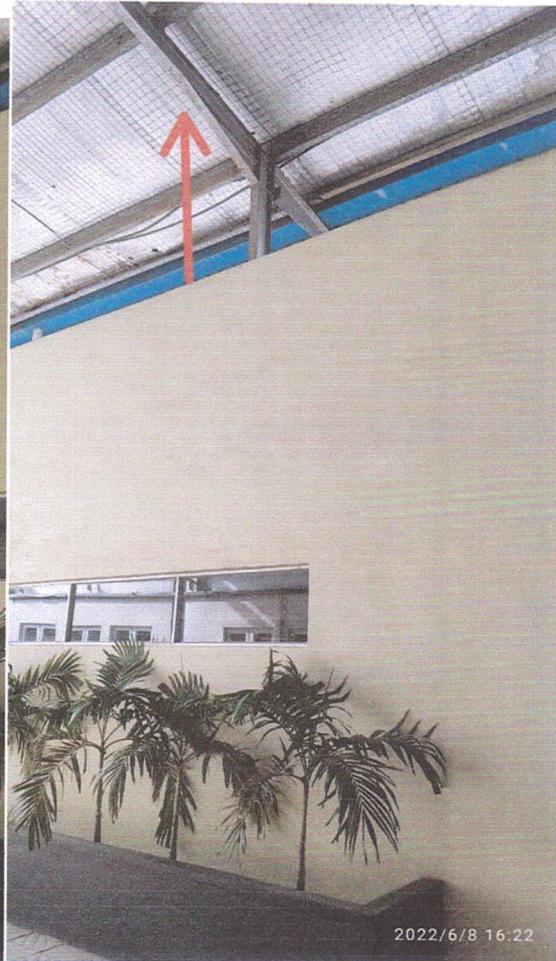
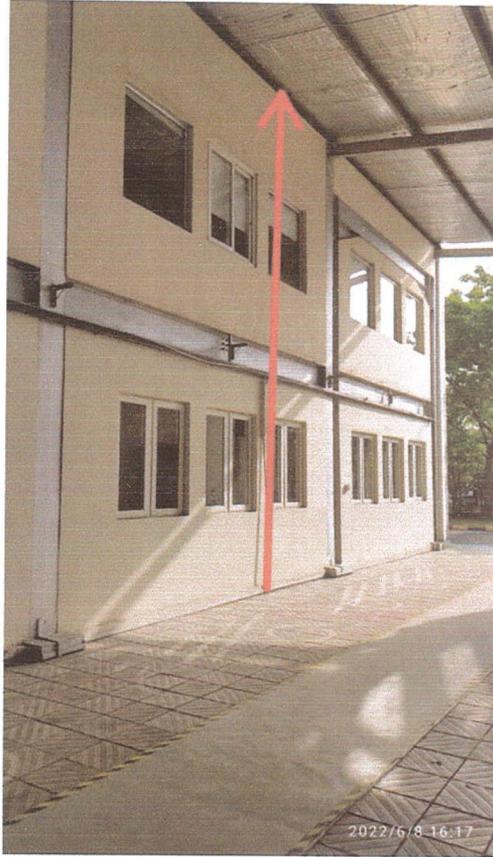
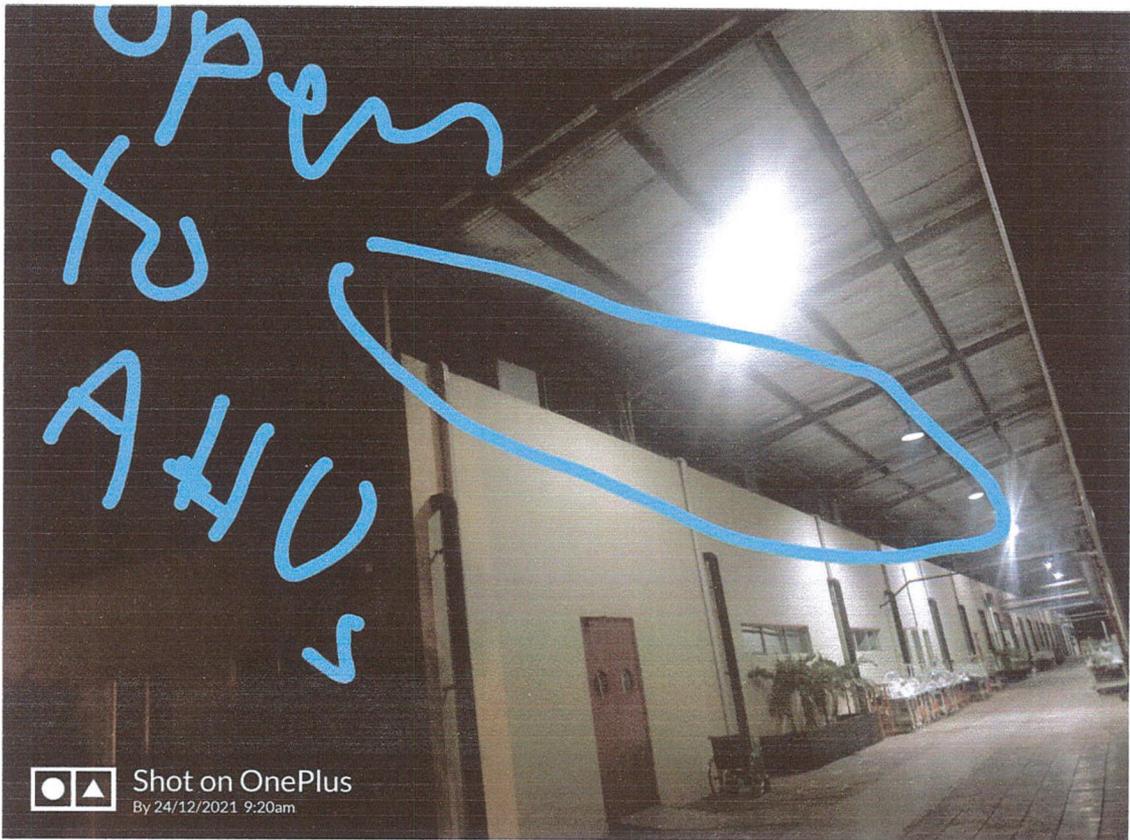
8. There is a lean to roof of GI Sheet found on the the slabs of M1, M2 & N blocks L block .there is 6m wide corridor between M1, M2 & N blocks and L building .The pest control operator usually spraying along the walls of L Block and return along the walls of M1, M2 & N blocks. As the 6 meters corridor with the length of about 150 meters is sprayed twice and the entire gases/vapour generated from the spray is accumulated at lean to roof, from there the accumulated gases passed through the gap between the roof and walls of M1, M2 & N blocks.

Lean to roof of GI Sheet found that the eaves are on M1, M2 & N blocks and leading from L (Admin. Building), leaving a gap of 6 meters between M1, M2 & N blocks and L (Admin Building).

A show cause notice is being issued to the management for constructing the lean to roof galvalume sheet covering the corridor of 6 m wide and 150 m length between L block and M1,M2 and N block without obtaining a previous permission in writing approving the plans from DOF, AP.

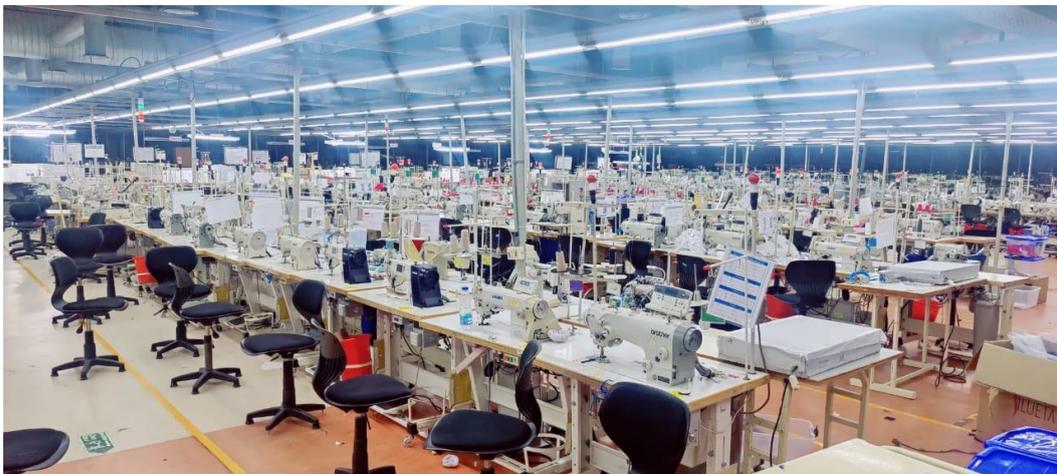
Figure 3: M1 Block of M/s. Seeds Intimate Apparel-place of incident

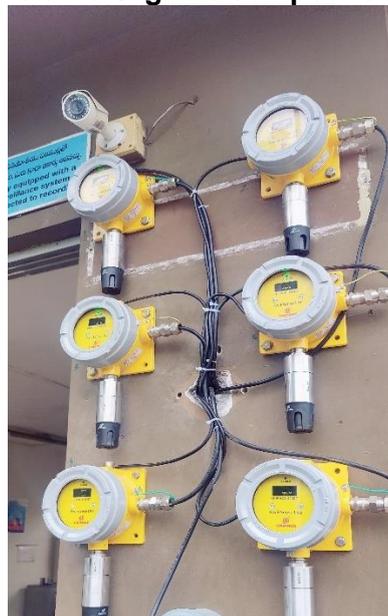
Figure 6: Monitoring the Gas Alarms for Carbon Monoxide, Formaldehyde, Ammonia, Chlorine, Methyl Mercaptan and VOC (Volatile Organic compounds) at the entrance of M1 Block

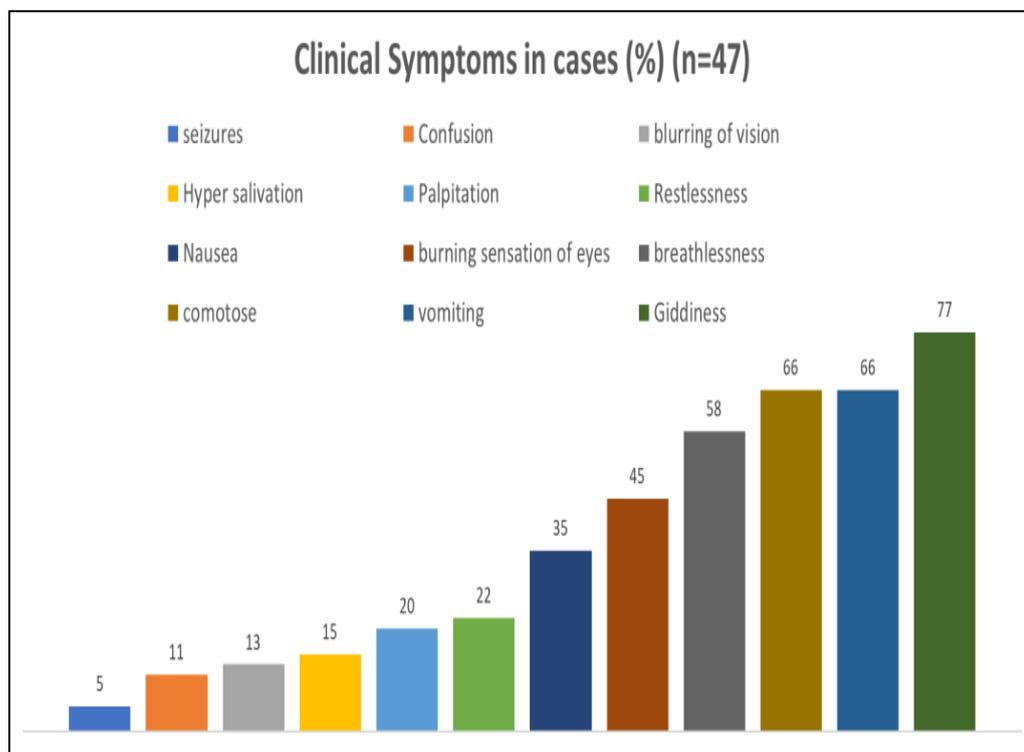
Figure 7: Distribution of clinical symptoms in cases

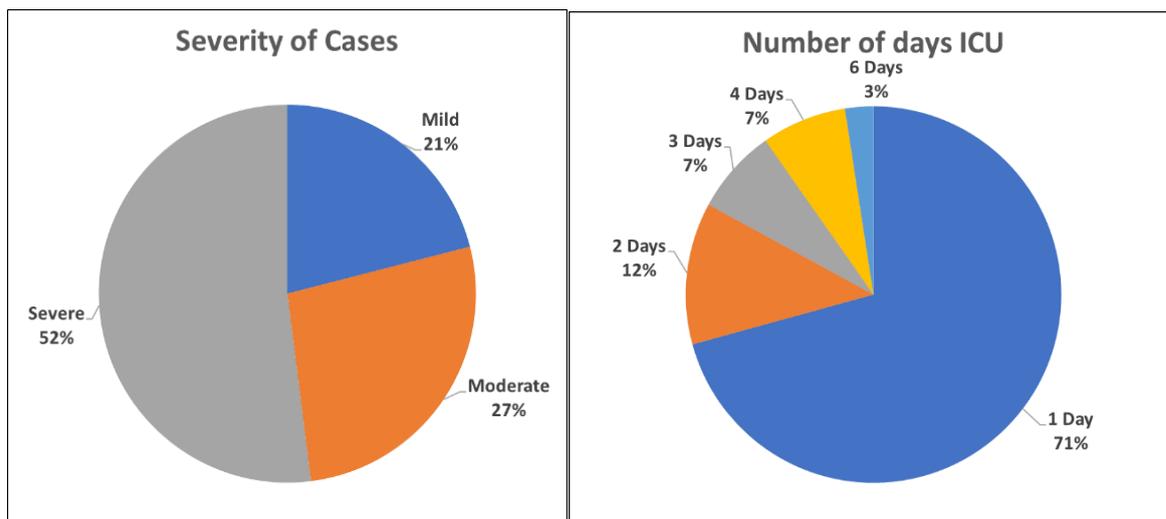
Figure 8: Severity of Cases and Number of Days in ICU

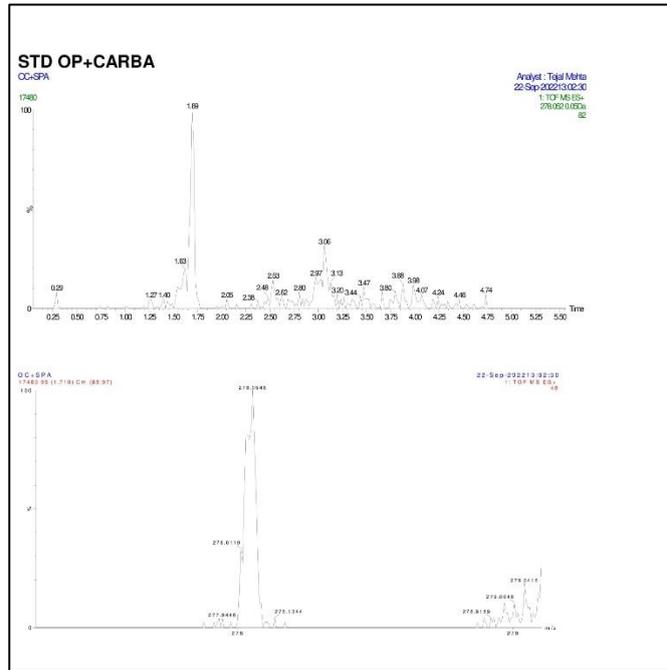
Figure 9: Standard chromatogram for Organo Phosphorous compound (standard)

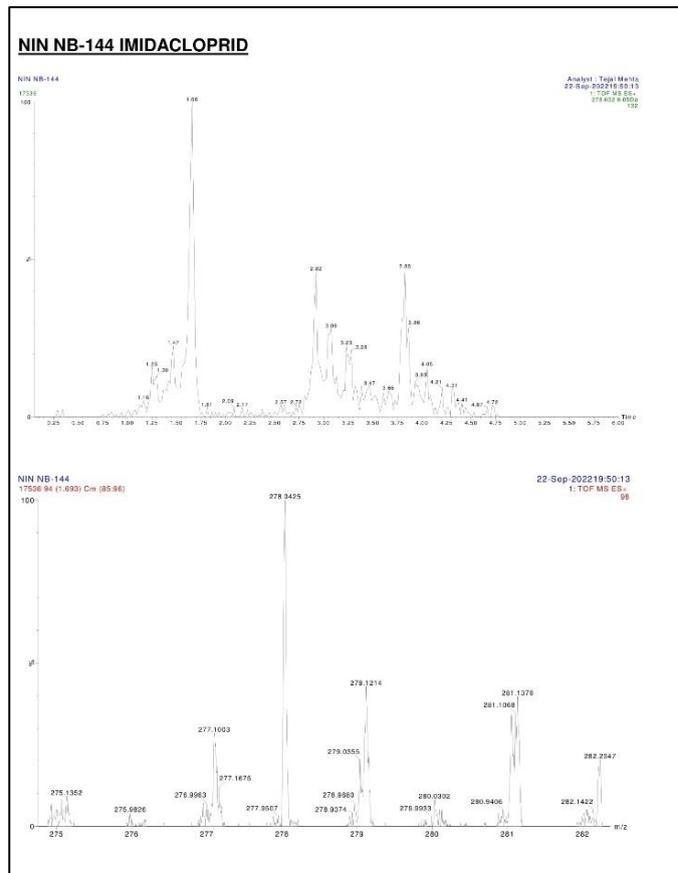
Figure 10: chromatogram of Imidacloprid In Blood sample of Case

The clinical picture and epidemic pattern are characteristic of a single exposure outbreak. The acute clinical signs and symptoms were suggestive of inhalation of organophosphate insecticide. The biomarker of Imidacloprid, an Insecticide, were found in four samples among the exposed.
