BEFORE THE HON'BLE NATIONAL GREEN TRIBUNAL

Original Application No. 274 / 2020

News item published in the "Indian Express" dated 23/11/2020 entitled
'Maharashtra : Two Killed, eight injured in methane gas leak in sugar factory'

INTERIM REPORT BY THE EXPERT COMMITTEE IN O.A. 274/2020 ON EXTENT OF DAMAGE TO ENVIRONMENT AND STEPS TO BE TAKEN FOR RESTITUTION OF DAMAGED ENVIRONMENT

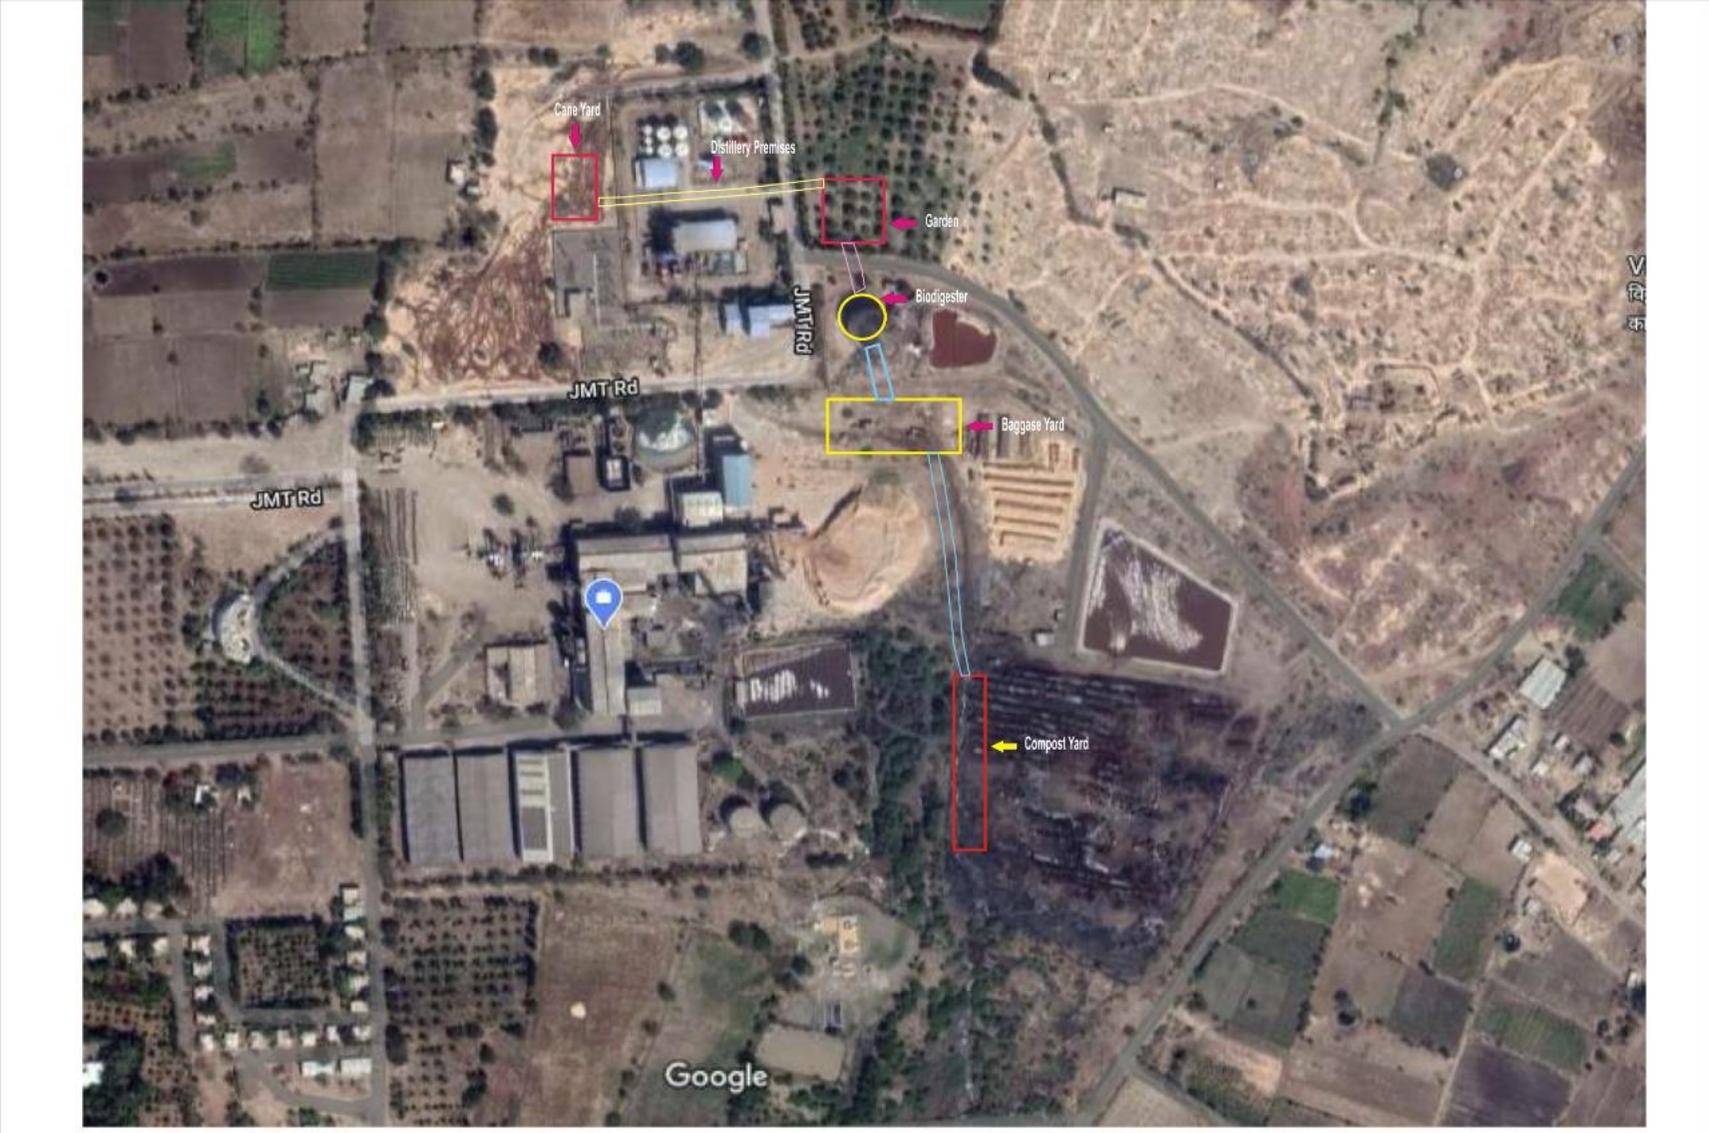
Further, the industry had also scrapped ~1,050 MT spent wash contaminated soil from the nalah and stored in the existing bio-compost preparation yard. In total, the industry had scrapped out ~5,750 MT of spent wash contaminated soil within the unit premises. The industry has supplemented the details of no. of vehicles utilized, date and no. of trips covered regarding quantification for collection of spent wash and contaminated soil. The details of the same is provided at **Annexure-I**. The spent wash spread areas is delineated in the below Google image (Figure 1).

Figure 1: Google imagery indicating the spread of spent wash within the industry premises.

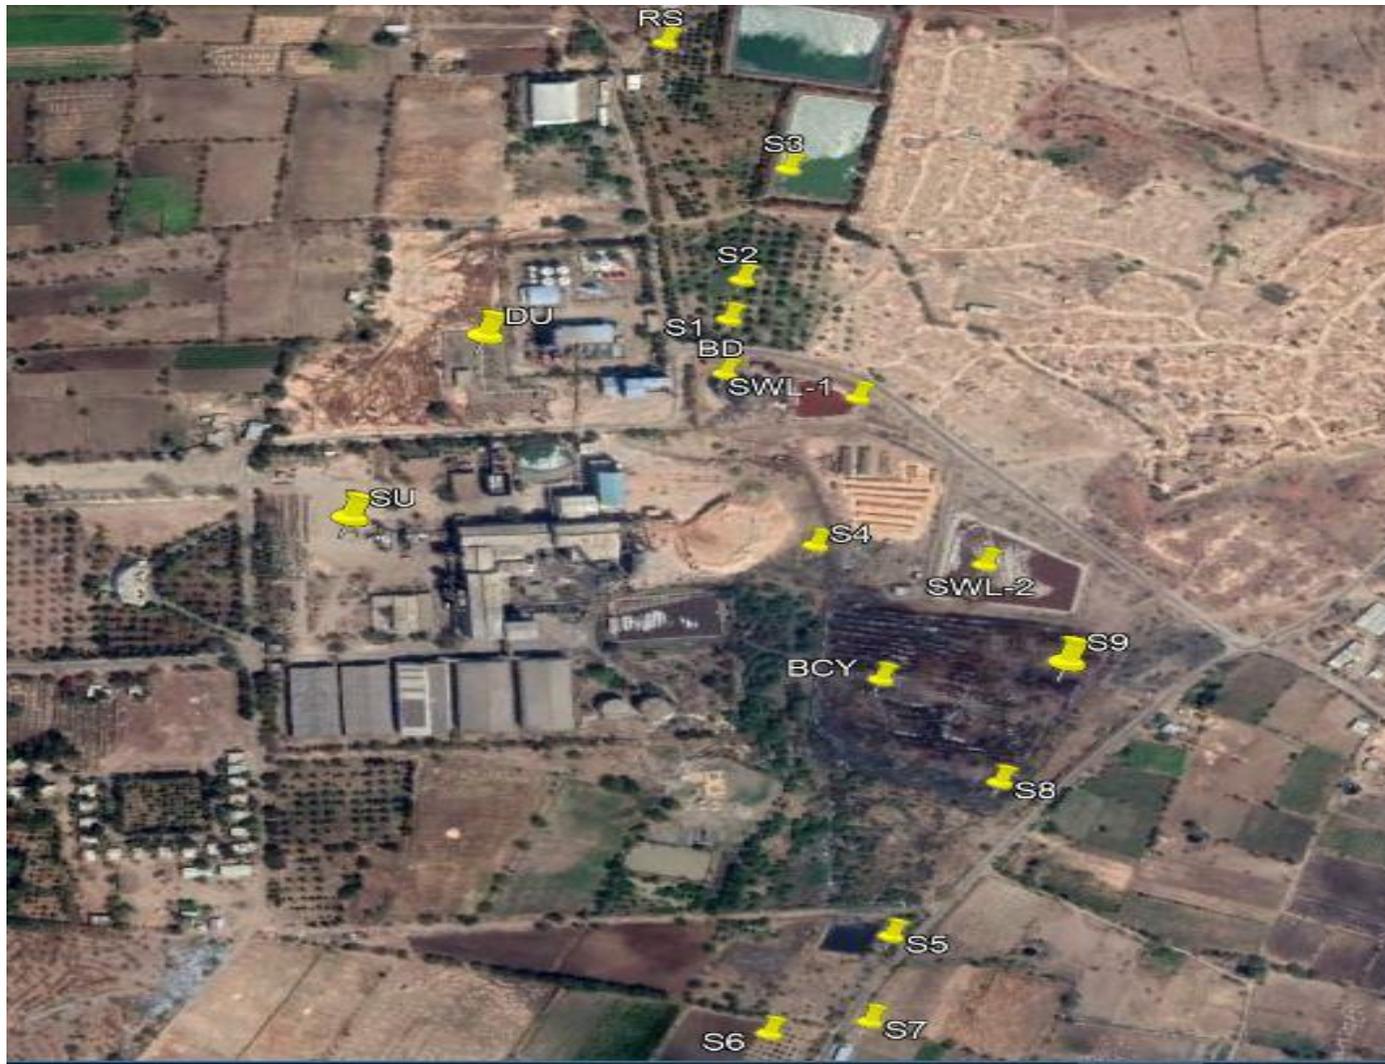
The soil sampling locations are depicted in following Google earth image. As it is evident from the Google earth image (Figure 2), soil sampling locations S-1, S-2, S-3 and reference soil sampling location are towards the Northern side of biodigester and well within 1 km radius from the biodigester. The locations S-4, S-5, S-6, S-7, S-8 and S-9 are towards the Southern side of the biodigester and also located within 1 km radius from the biodigester. The maximum spent wash was found towards the Southern side of the biodigester and the industry had contained the spent wash by excavating temporary pits and re-collected the spilled spent wash into 30 days impervious (concrete) lagoon.

Figure 2: Google imagery of the soil sampling locations in and around the industry and other environmental infrastructure provided.

The committee, during its visit on 09.02.2021 collected samples of soil from 08 different locations covering the entire impacted area due to the accident and also from one area not having any impact due to accident as reference/background soil sample. The impact area was delineated based on the spill occurred during the accident. Initially, the committee collected the location map and made a reconnaissance survey of the impact area. Based on the discussion and spill profile of spent wash in the area, the committee decided to collect the soil samples at various depths ranging from the surface level, at 20 cm depth and at 40 cm depth.

Sampling location	Geographic location, Degree decimals		Details of sampling locations
	Latitude	Longitude	
S1	17.87411 N	75.59058 E	Top soil sample taken from the mango orchard (Northern side of biodigester)
			Soil sample taken at 20 cm depth from the mango orchard (Northern side of biodigester)
S2	17.87448 N	75.59066 E	Top soil sample taken from the mango orchard (Northern side of biodigester, middle of mango orchard)
			Soil sample taken at 20 cm depth from the mango orchard (Northern side of biodigester, middle of mango orchard)
S3	17.87552 N	75.59095 E	Top soil sample taken from the area, opp. distillery gate (North-eastern side of biodigester)
			Soil sample taken at 20 cm depth from the area, opp. distillery gate (North-eastern side of biodigester)
			Soil sample taken at 40 cm depth from the area, opp. distillery gate (North-eastern side of biodigester)
