**BEFORE THE NATIONAL GREEN TRIBUNAL
SOUTHERN ZONE, CHENNAI**

Original Application No. 251 of 2024 (SZ)
Earlier O.A. No. 777 of 2024 (PB)

Suo Moto matter in respect of news item
appearing in The Times of India dated
14.06.2024 titled **“The great beach robbery:
Chennai’s Coastal Zone marred by
Encroachment, digging of borewells.”**

SITE INSPECTION REPORT

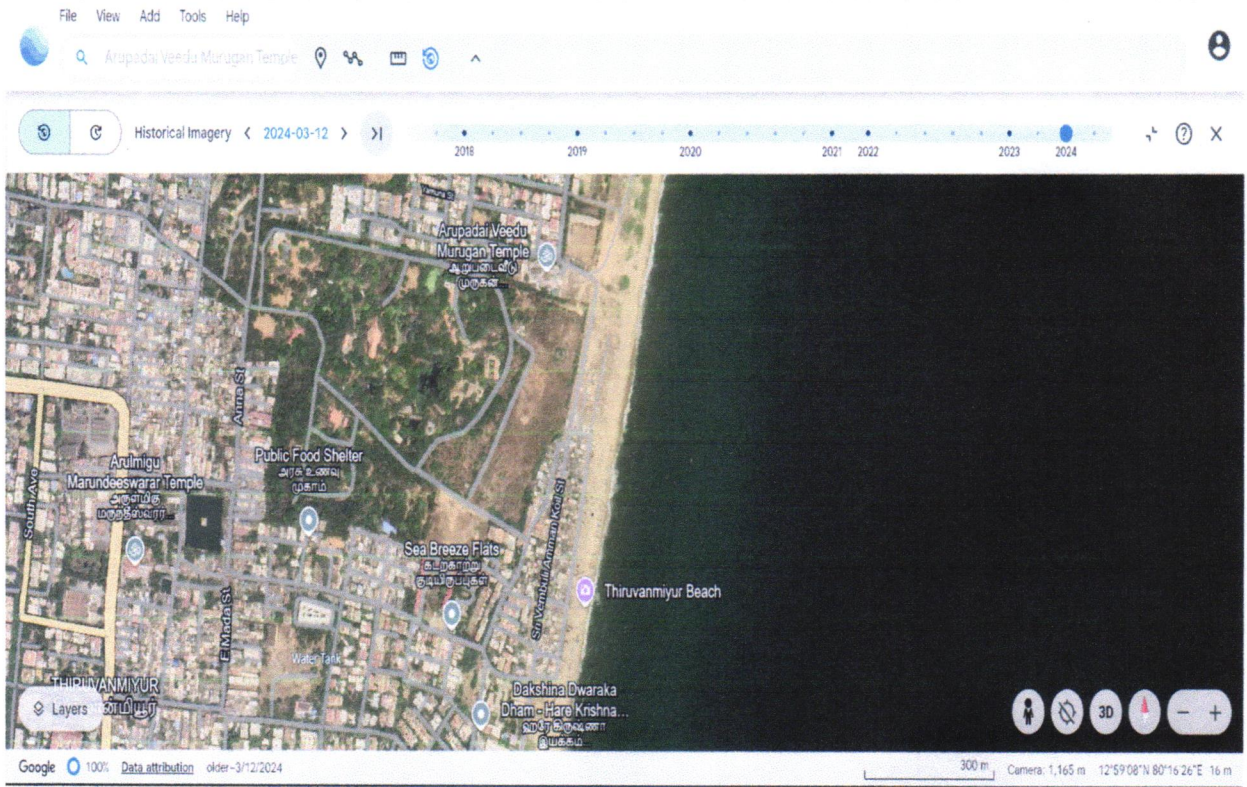
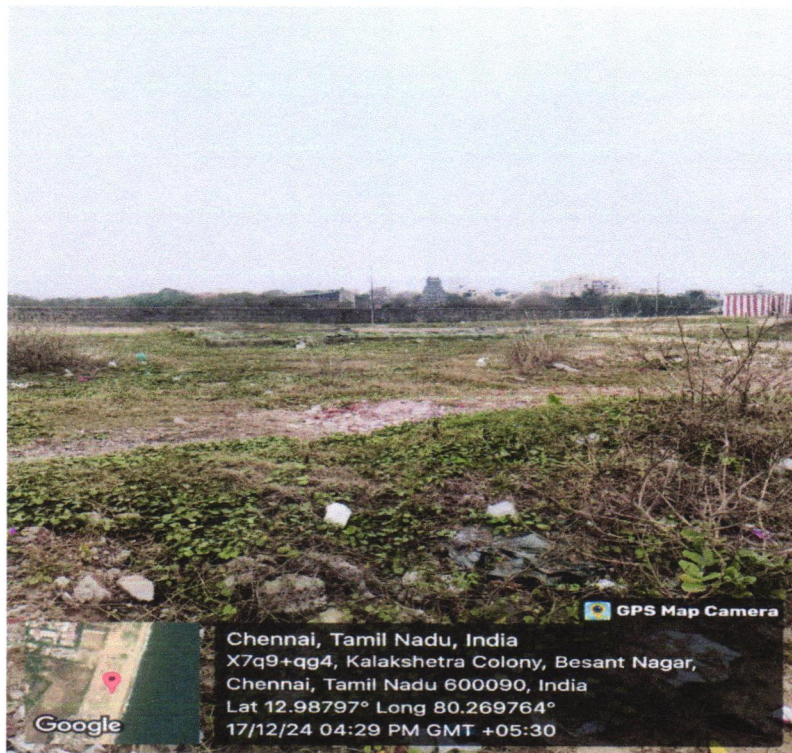
Fig 1. Location near to the Arupadai Veedu Murugan Temple in Besant Nagar’s Kalakshetra Colony in Chennai (Tamil Nadu)

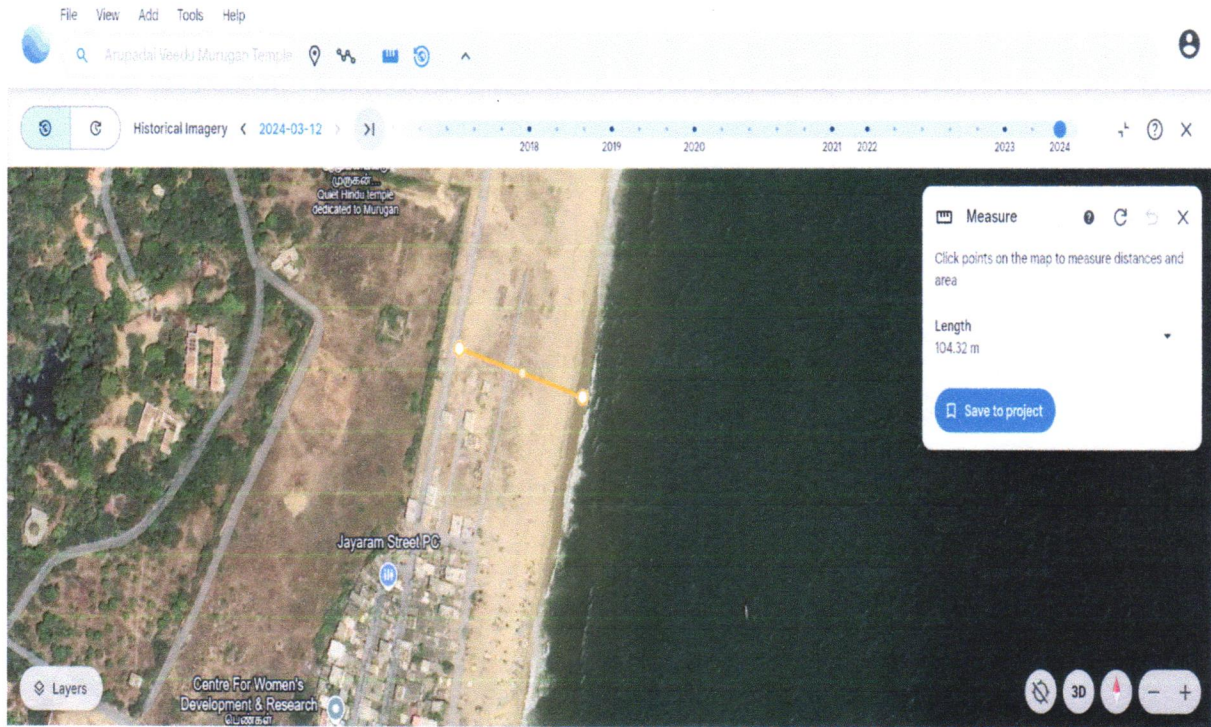
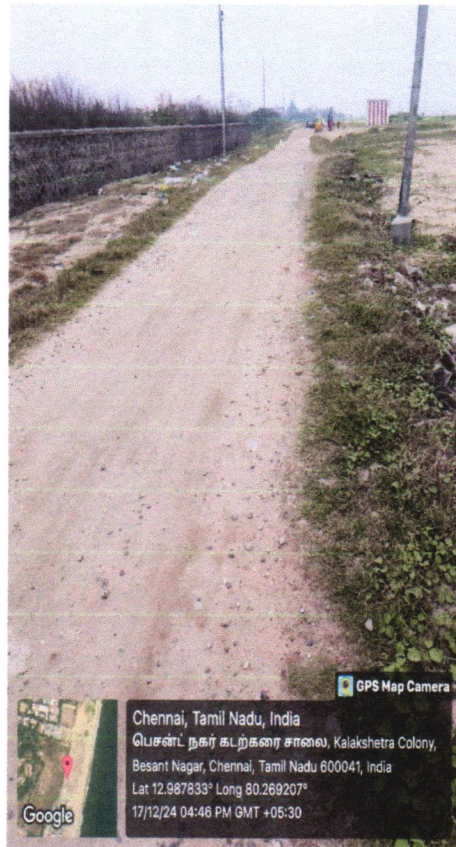
Fig 2. Sand Pathway constructed near to the Arupadai Veedu Murugan Temple in Besant Nagar's Kalakshetra Colony in Chennai (Tamil Nadu)

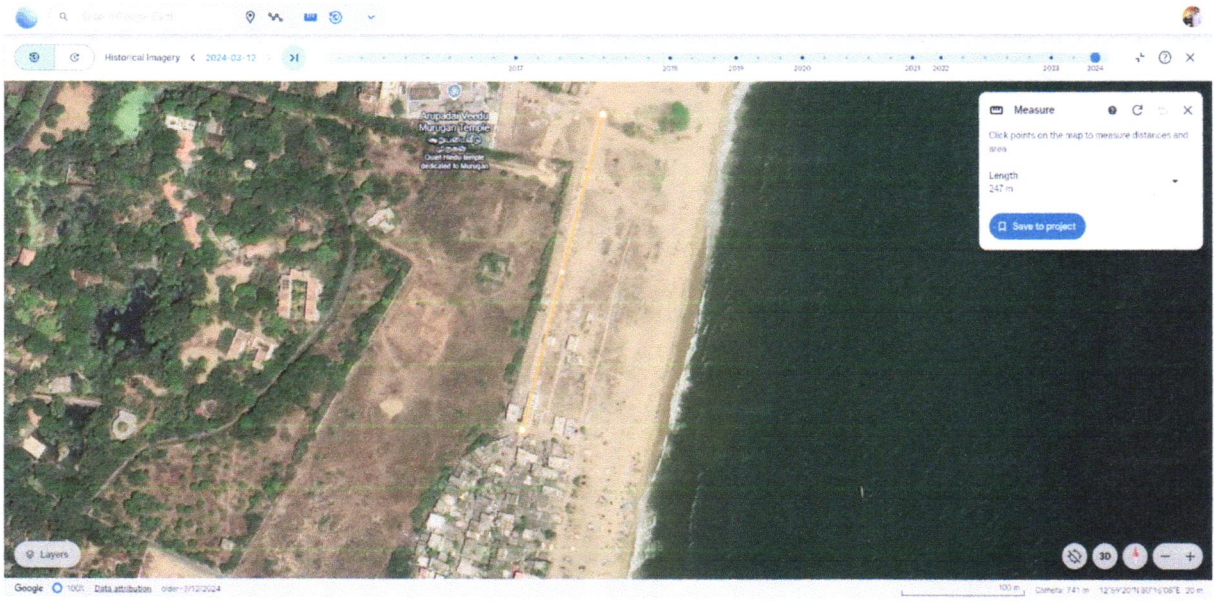
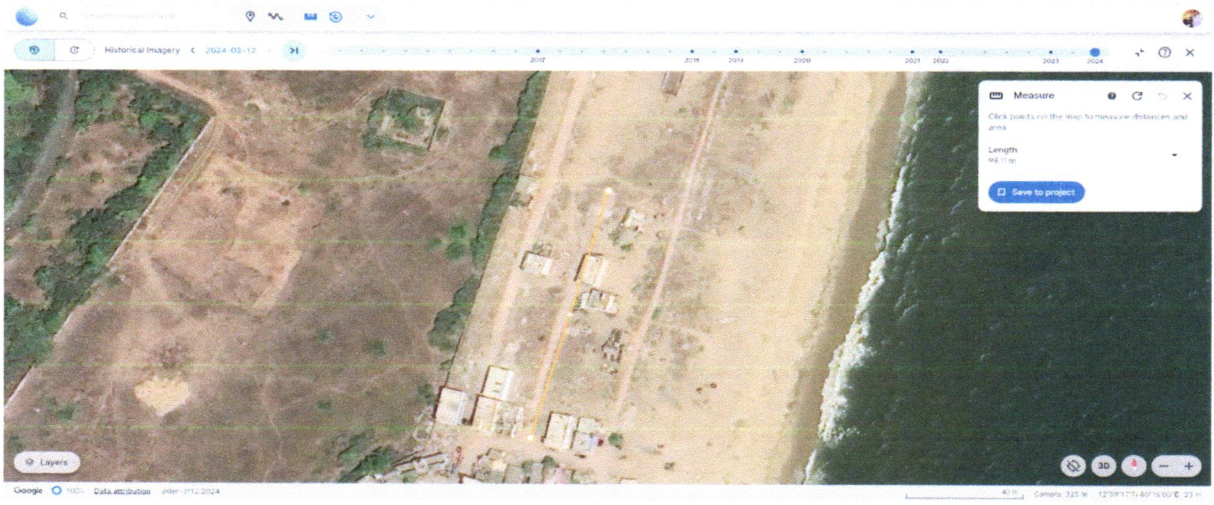
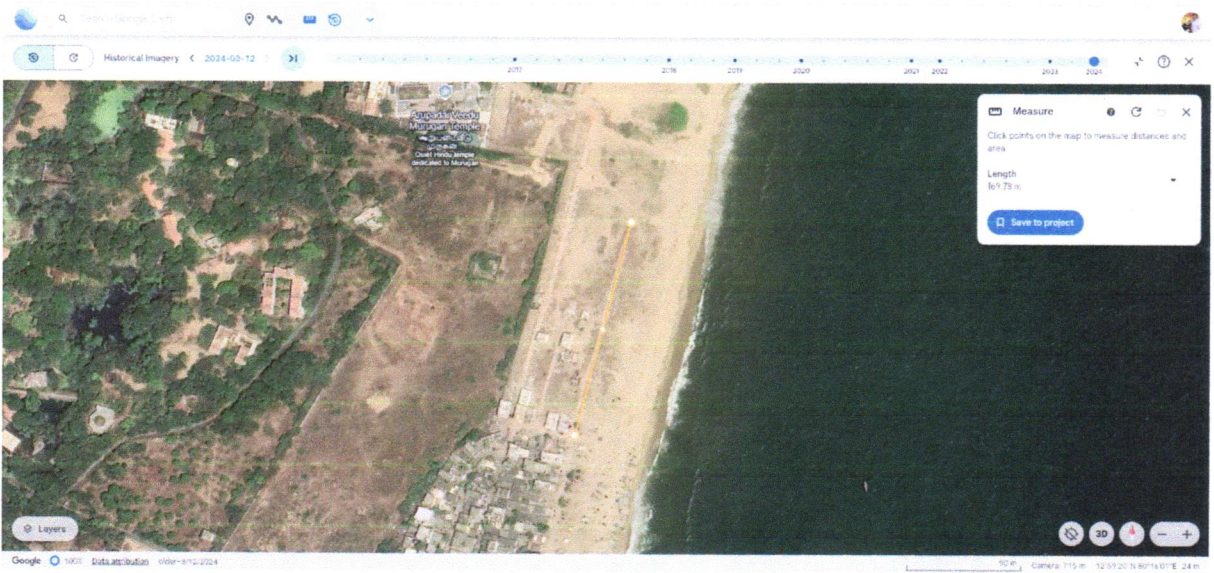
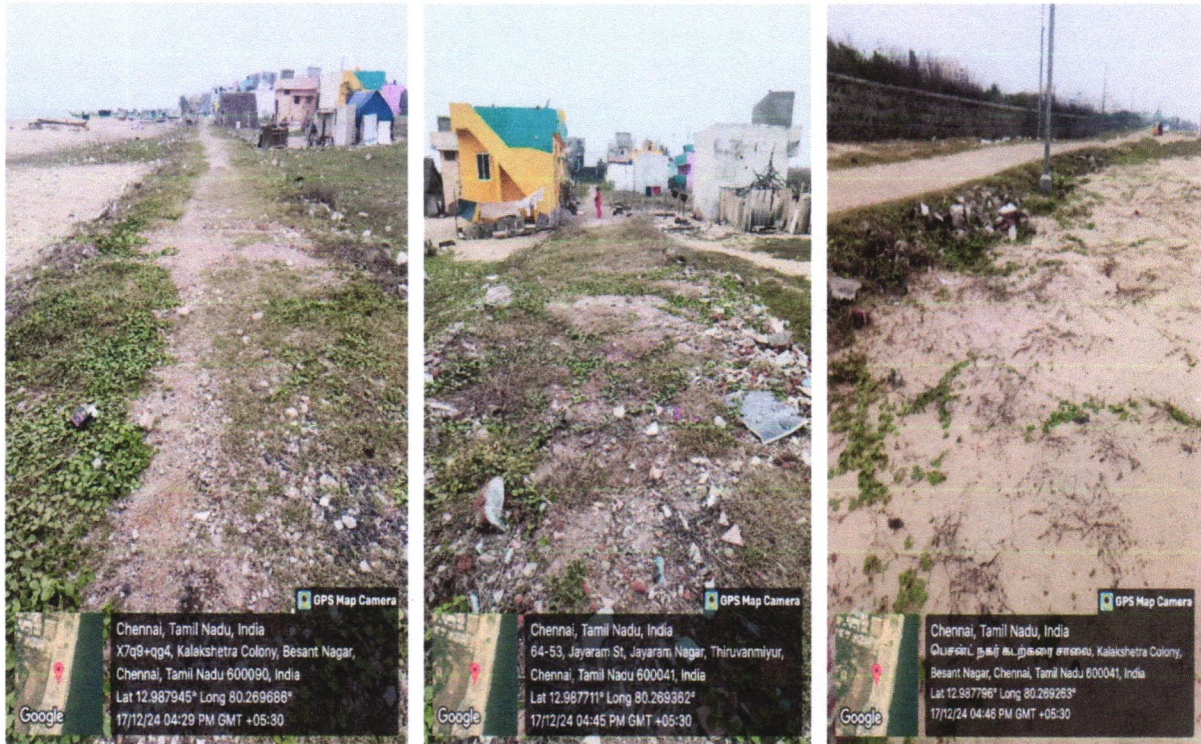
3. Three sand roads were laid at the location near to Arupadai Veedu Murugan Temple in Besant Nagar's Kalakshetra Colony in Chennai (Tamil Nadu). The first, second and third sand roads which are approximately 247m, 98.11m and 169.78m lengths from Arupadai Veedu Murugan Temple in Besant Nagar's Kalakshetra Colony in Chennai (Tamil Nadu) respectively (Photographs attached at Annexuer-1).

Fig 3. Three sand roads constructed near to the Arupadai Veedu Murugan Temple in Besant Nagar's Kalakshetra Colony in Chennai (Tamil Nadu)

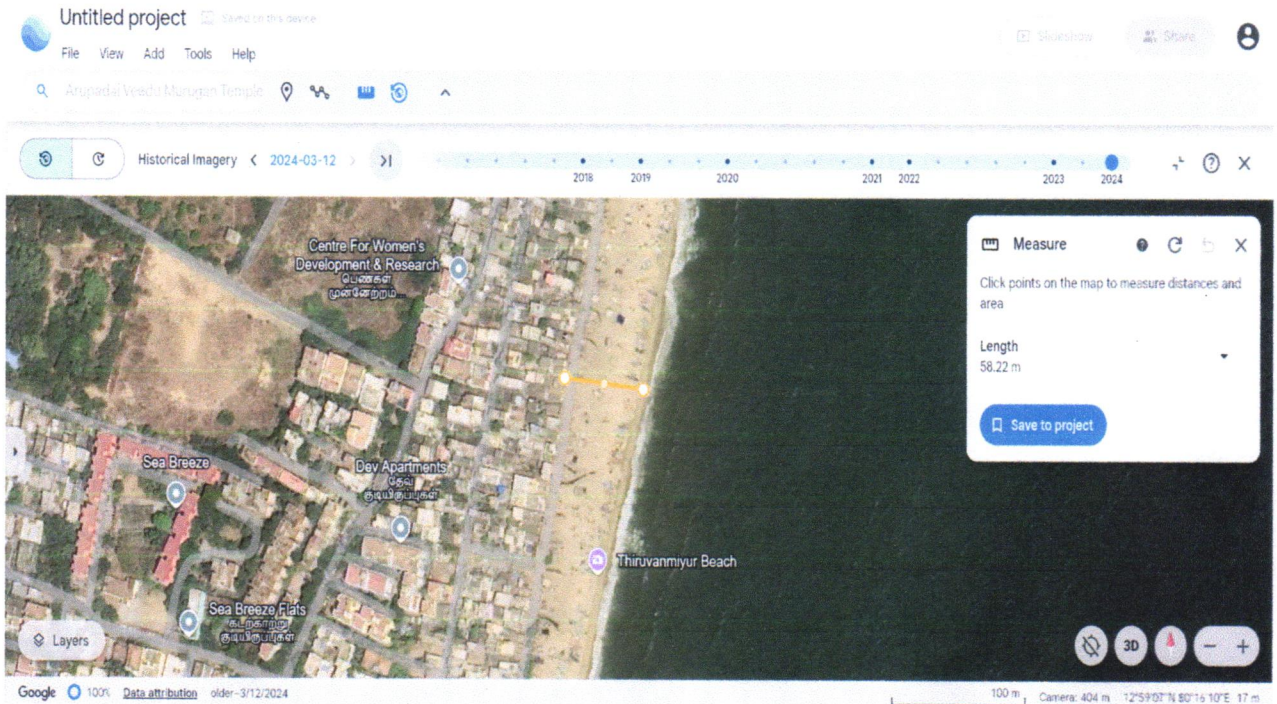
4. Construction of dwelling structures were observed near to the Arupadai Veedu Murugan Temple in Besant Nagar's Kalakshetra Colony in Chennai (Tamil Nadu) which are of approximately located 58.22m, 103.94m and 195.7m from High Tide Line (HTL) (Photographs attached at Annexuer-1).

Fig 4. Construction of Dwelling places near to the Arupadai Veedu Murugan Temple in Besant Nagar's Kalakshetra Colony in Chennai (Tamil Nadu) which is of approximately 58.22m from High Tide Line (HTL)

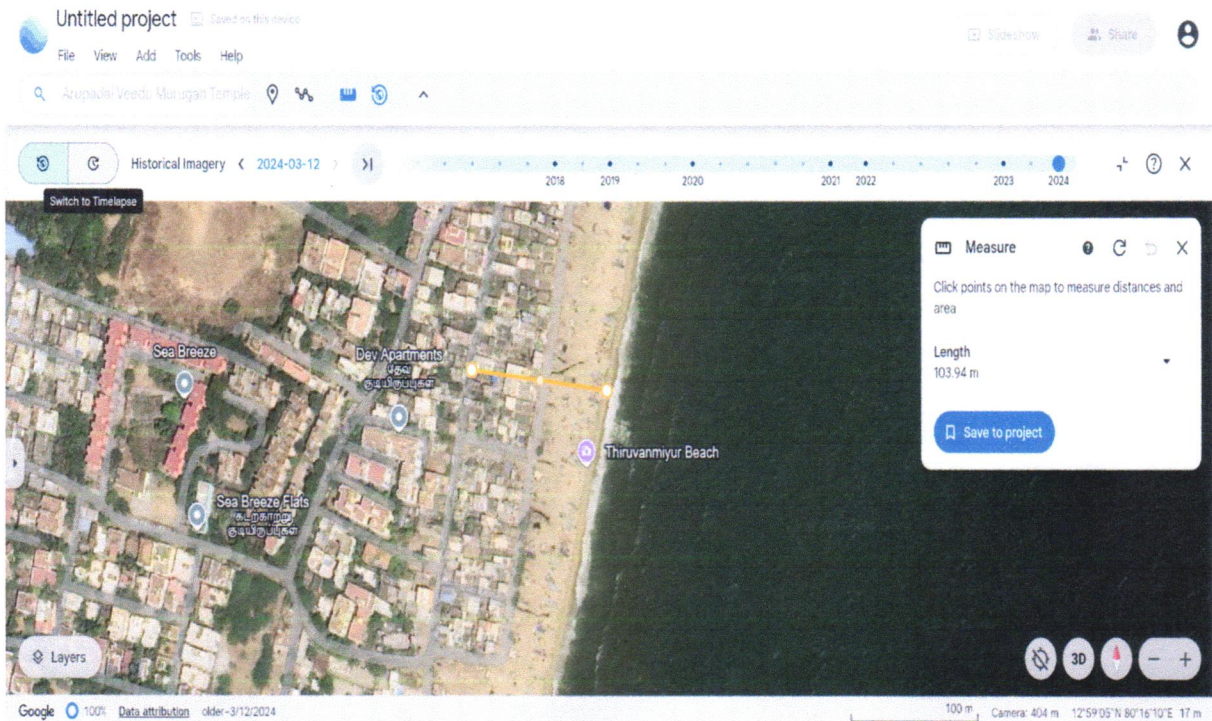
Fig 5. Construction of Dwelling places near to the Arupadai Veedu Murugan Temple in Besant Nagar's Kalakshetra Colony in Chennai (Tamil Nadu) which is of approximately 103.94m from High Tide Line (HTL)

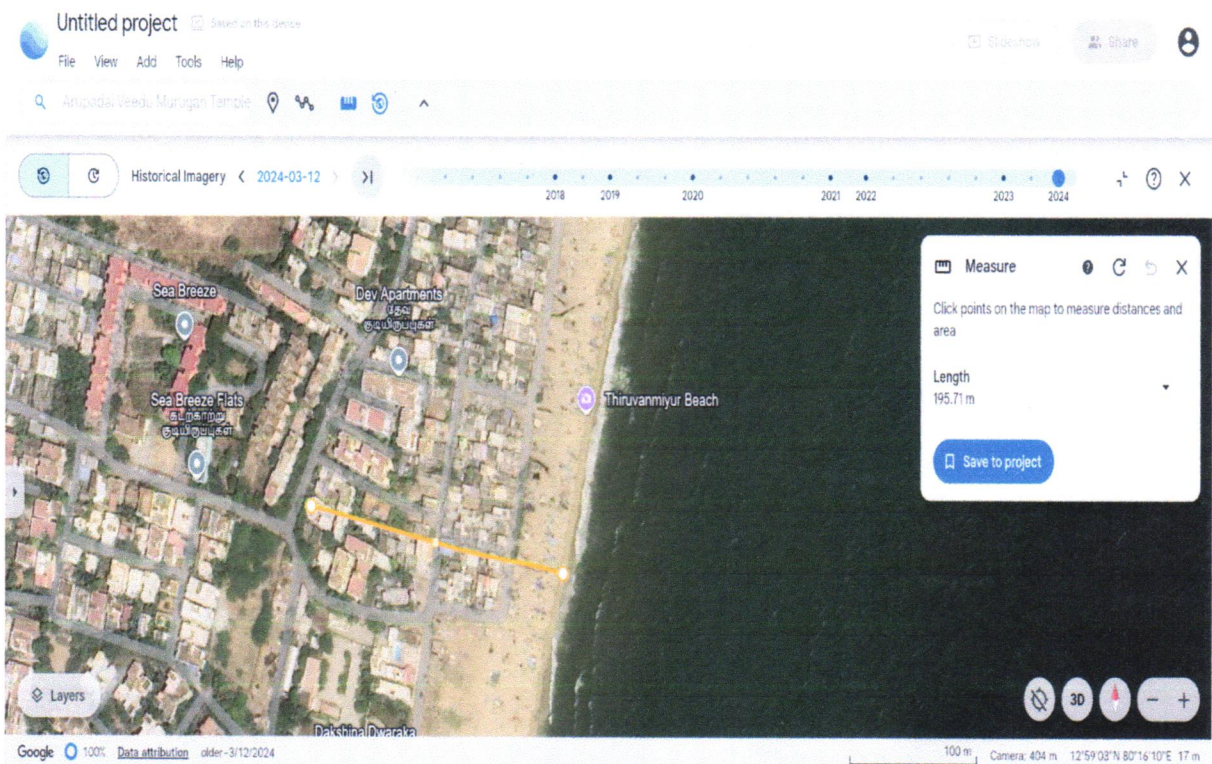
Fig 6. Construction of Dwelling places near to the Arupadai Veedu Murugan Temple in Besant Nagar's Kalakshetra Colony in Chennai (Tamil Nadu) which is of approximately 195.71m from High Tide Line (HTL)

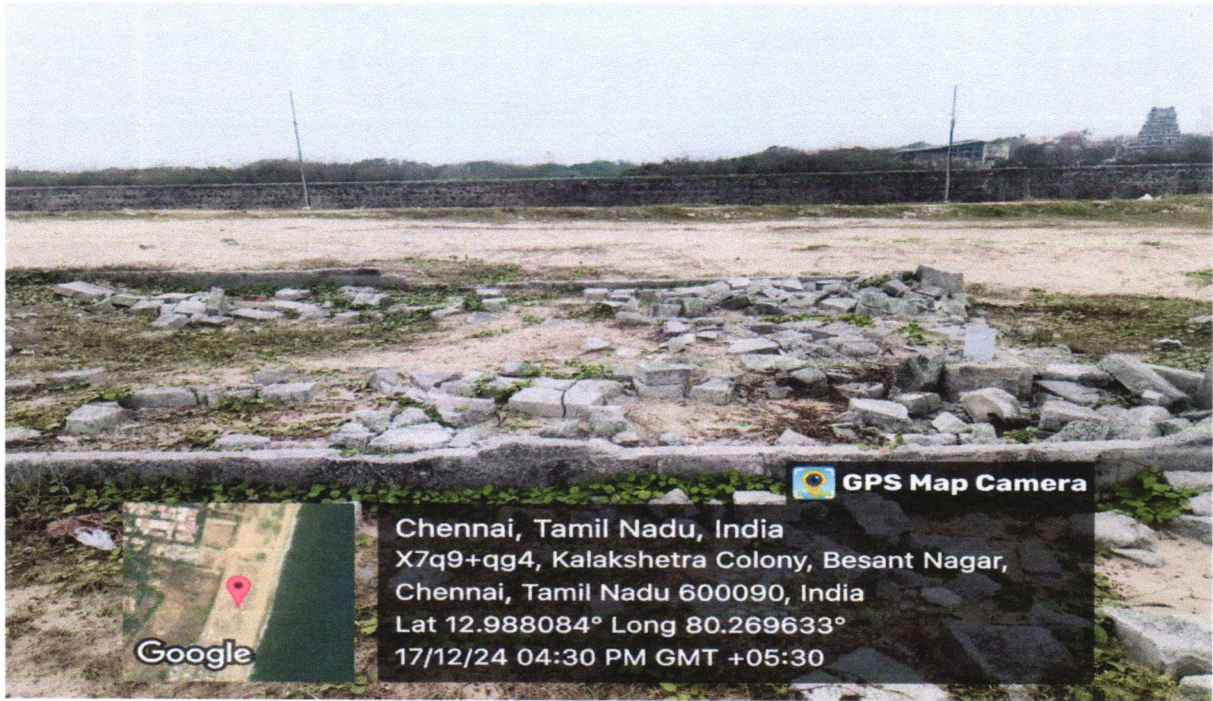
2. Presently, the construction works as mentioned in the News items dated 14/06/2024 in relation to the subject matter was stopped and seems to be demolished (Photographs attached at Annexuer-1).

Fig 7. Dilapidated Construction near to the Arupadai Veedu Murugan Temple in Besant Nagar's Kalakshetra Colony in Chennai (Tamil Nadu)

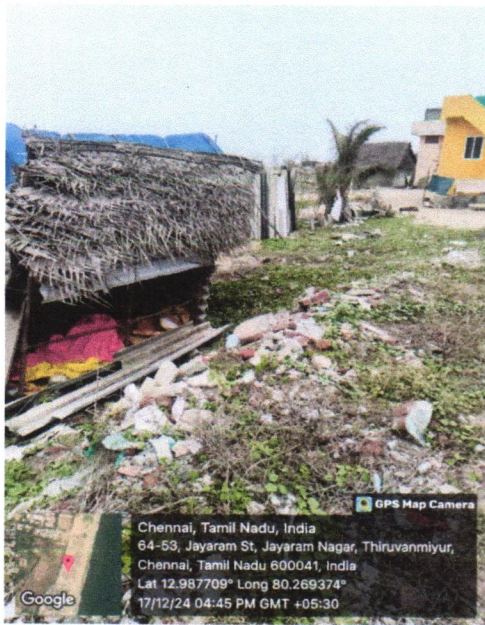
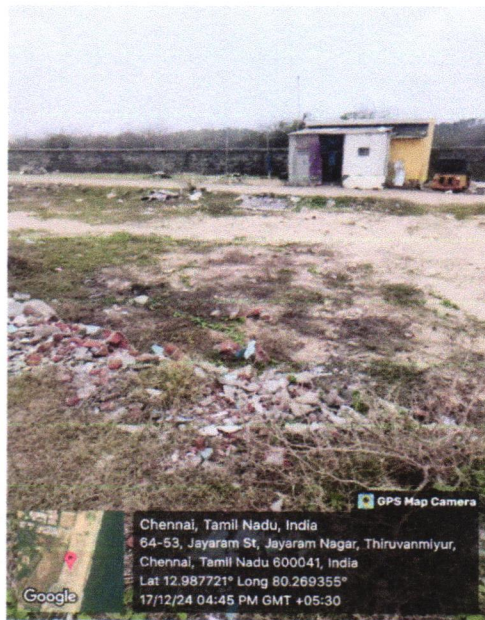
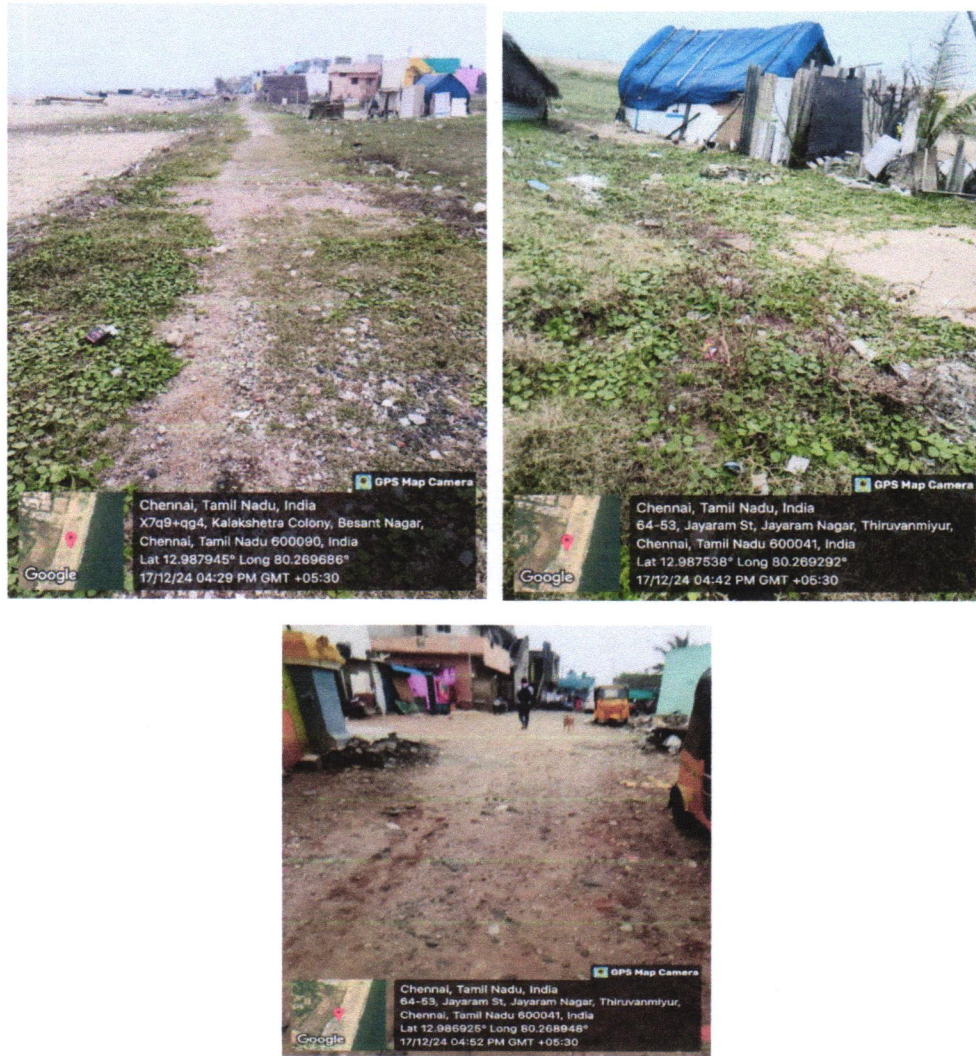
Fig 8. Construction of small sheds, thatched roofs and concrete dwelling places near to the Arupadai Veedu Murugan Temple in Besant Nagar's Kalakshetra Colony in Chennai (Tamil Nadu)

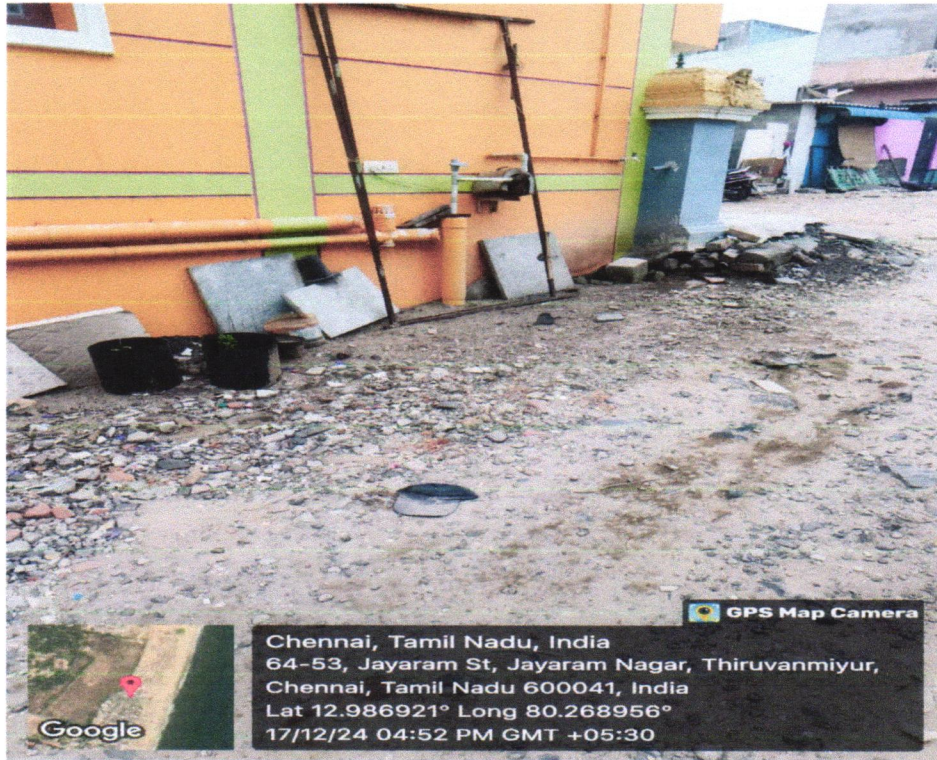
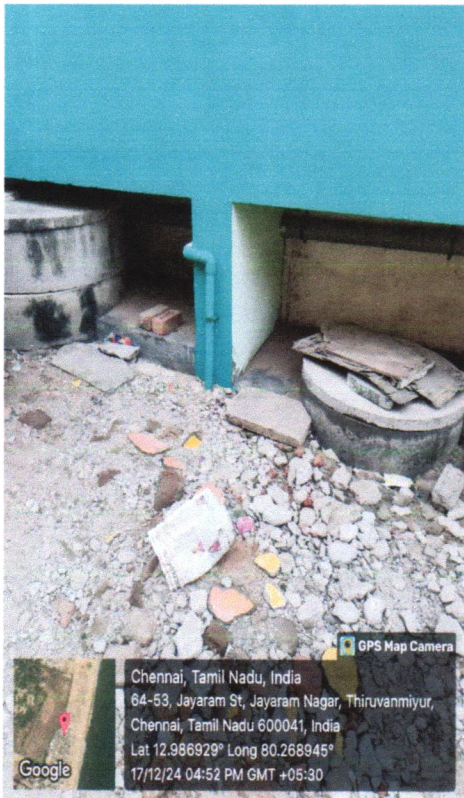
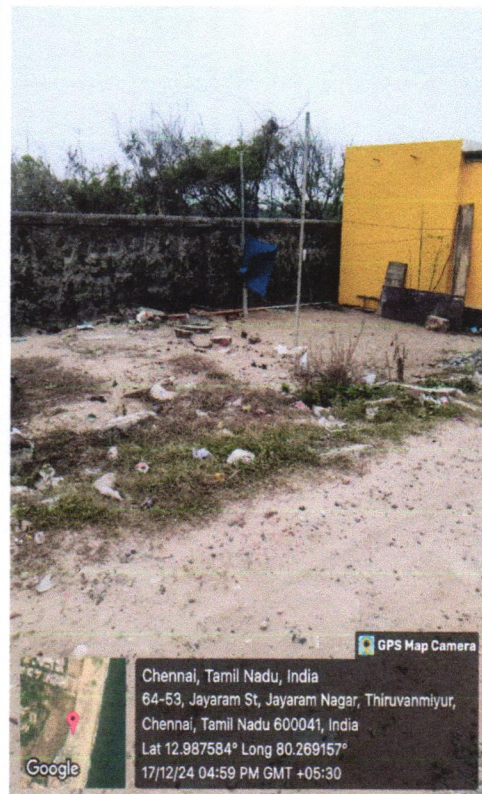
5. Boreholes with pumps were installed adjacent to the dwelling places for the withdrawal of Ground water (Photographs attached at Annexuer-1).
6. Natural storm water drain was located near to the Arupadai Veedu Murugan Temple in Besant Nagar's Kalakshetra Colony in Chennai (Tamil Nadu) which is connecting the Kalakshetra Colony road and the Thiruvanmiyur sea (Photographs attached at Annexuer-1).

Fig 8. Boreholes were constructed in the dwelling houses near to the Arupadai Veedu Murugan Temple in Besant Nagar's Kalakshetra Colony in Chennai (Tamil Nadu)

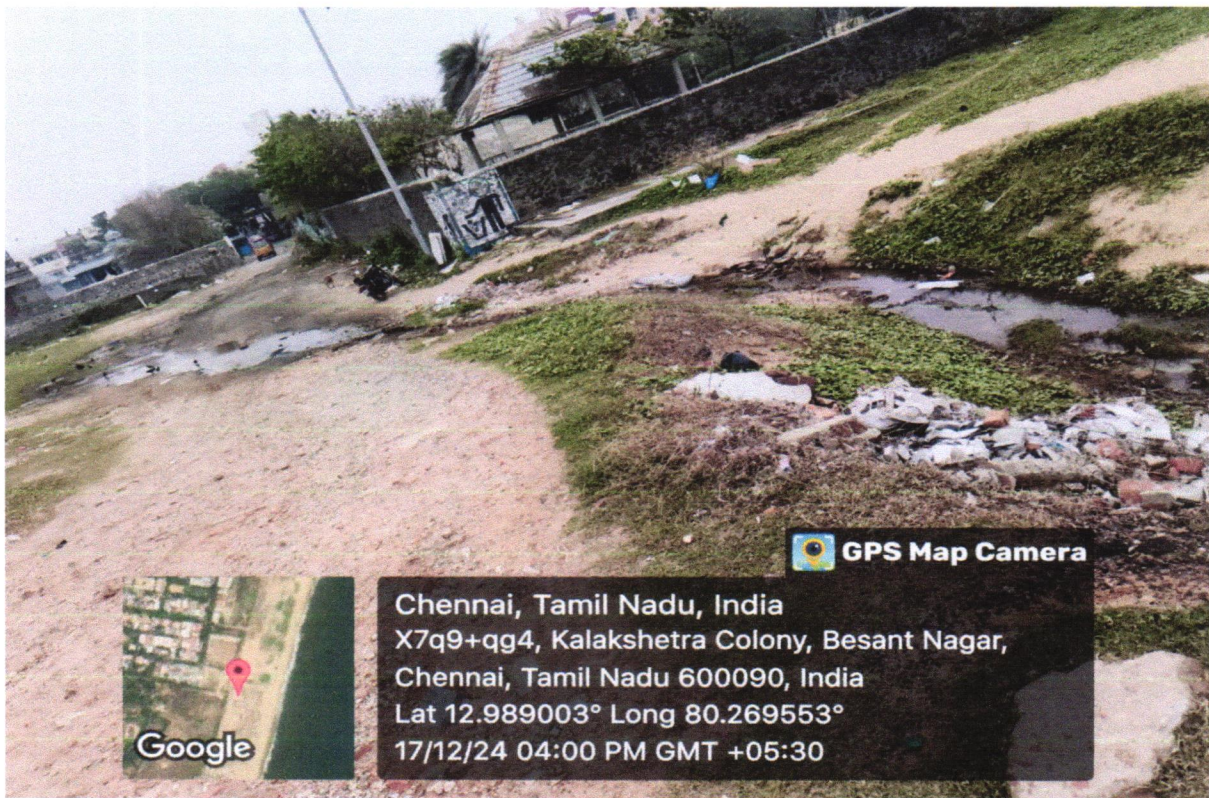
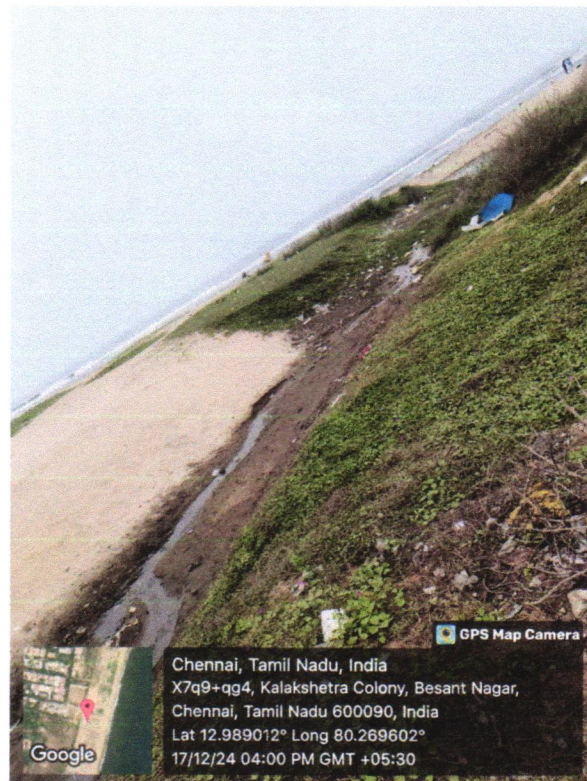
7. Minimal plastic debris were observed in the natural storm water drain (Photographs attached at Annexuer-1).
8. Recently surveillance cameras were installed near to the Arupadai Veedu Murugan Temple in Besant Nagar's Kalakshetra Colony in Chennai (Tamil Nadu) (Photographs attached at Annexuer-1).

Fig 9. Natural Drian for rain water was observed near to the Arupadai Veedu Murugan Temple in Besant Nagar's Kalakshetra Colony in Chennai (Tamil Nadu)

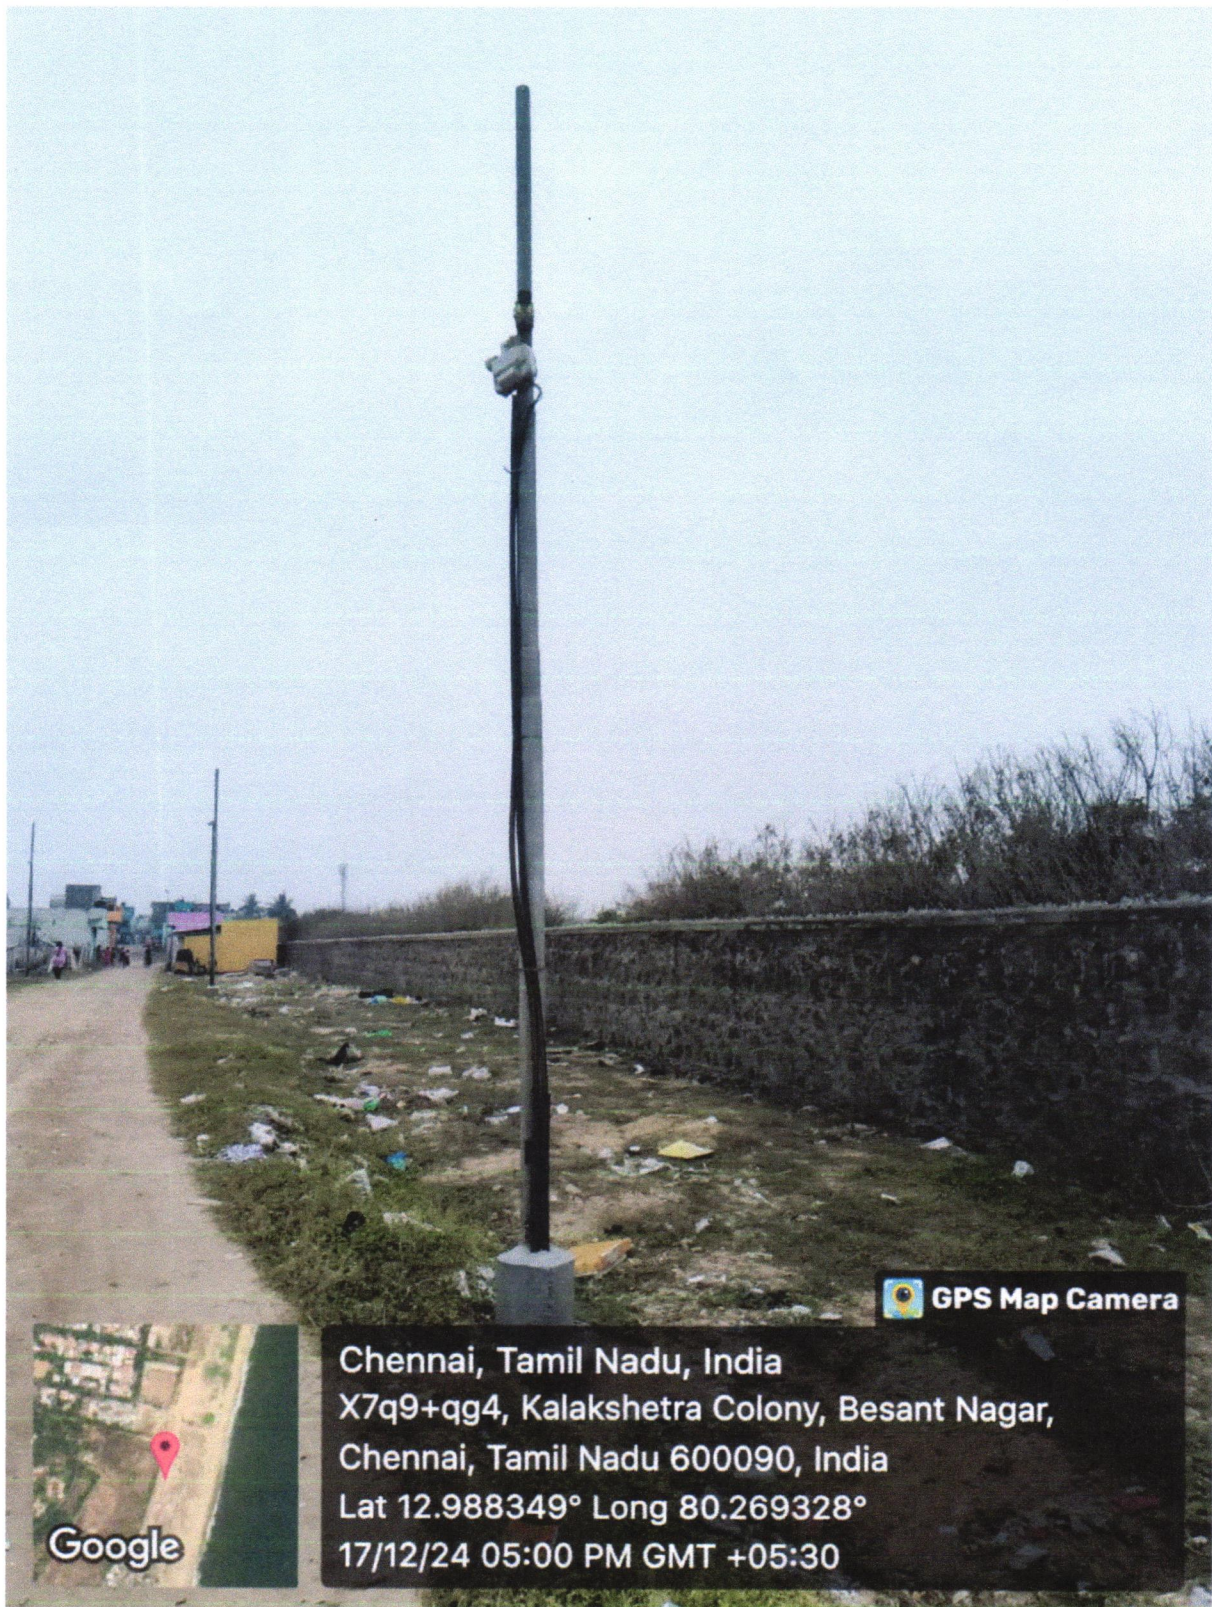
Fig 10. Camera Poles were erected recently to observe the activity near to the Arupadai Veedu Murugan Temple in Besant Nagar's Kalakshetra Colony in Chennai (Tamil Nadu)

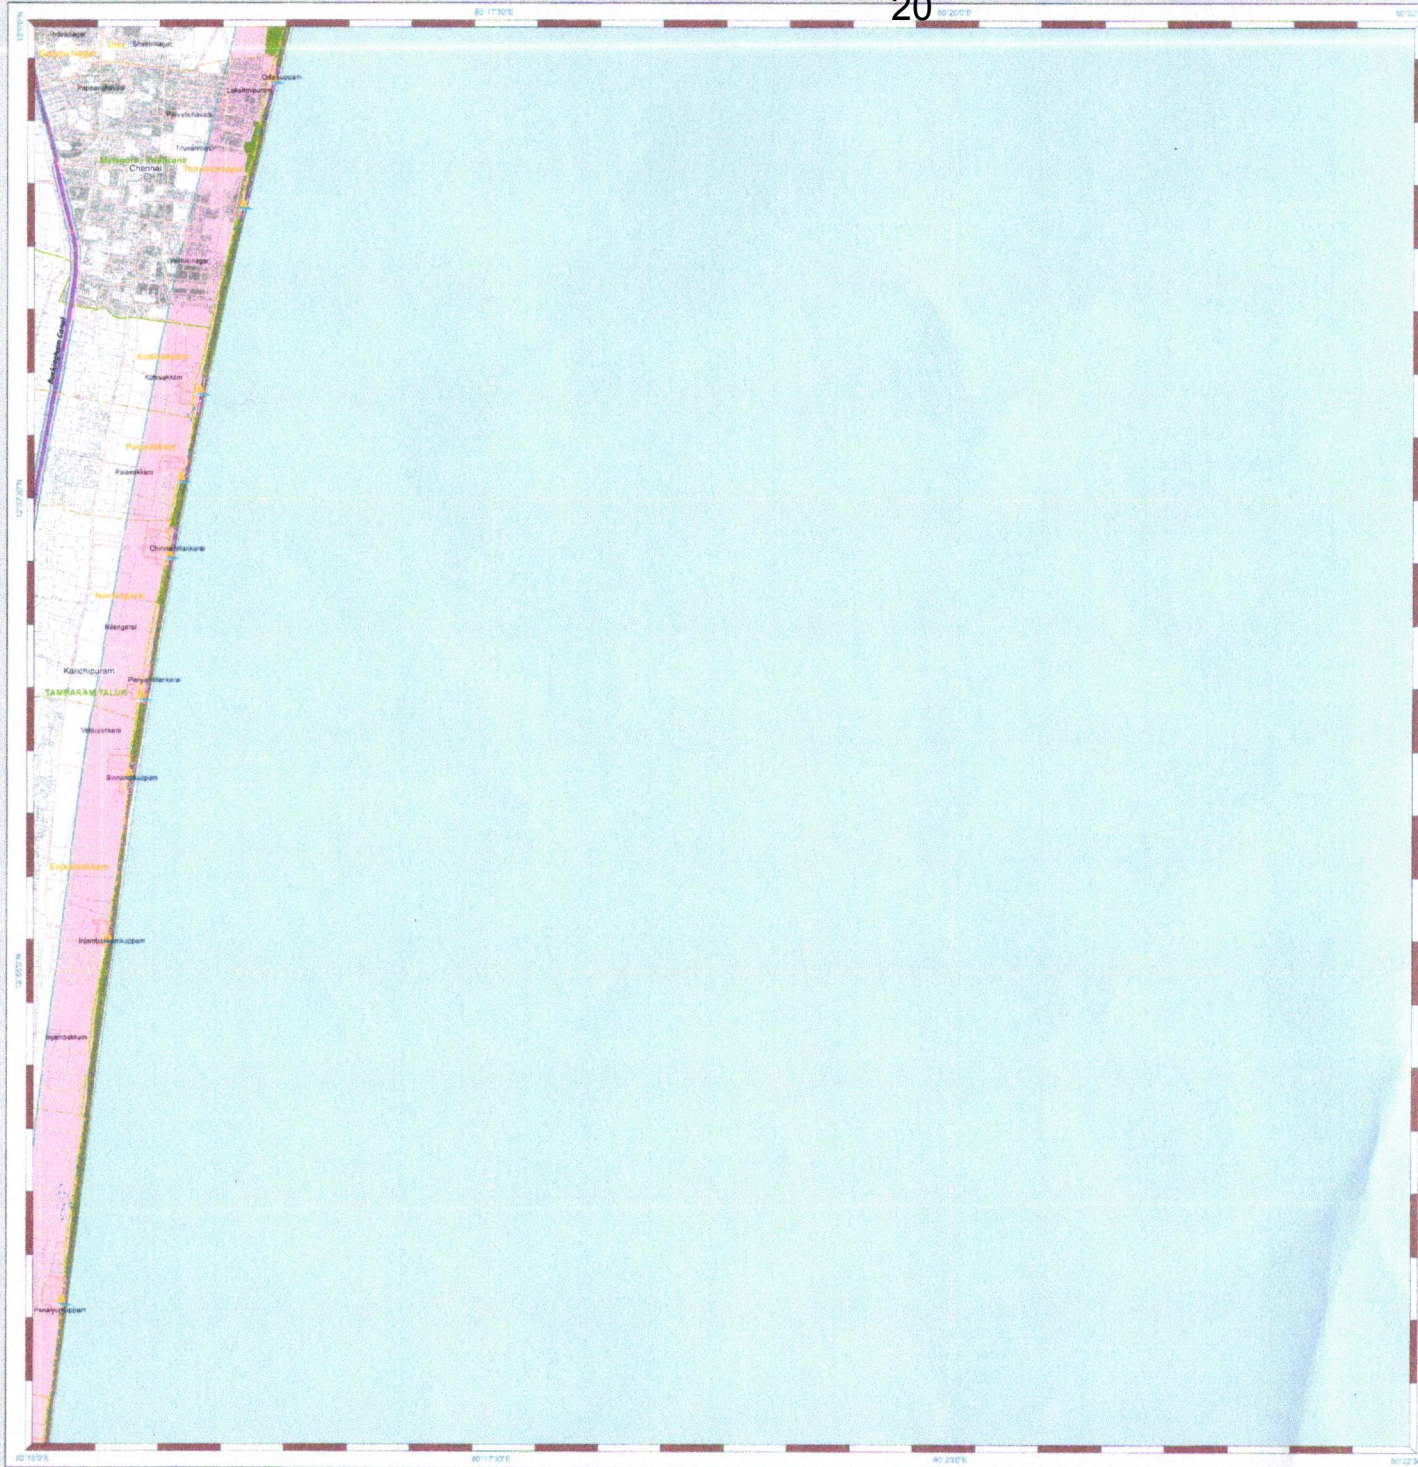
Sheet No: D 44 U 5 / NW

2. The location mentioned in the News Item titled "The great beach robbery Chennai's coastal zone marred by encroachment digging of borewells" appearing in The Times of India dated 14.06.2024 seems to fall under the Category CRZ-II of Costal Regulation Zone Notification 2011 (**Approved Map which was downloaded from the TNCZMA website having Number of TN 107 is attached at Annexure-4**).
3. In light of these considerations, it is respectfully requested that the Honourable Tribunal may take the appropriate decision as it sees fit.

COASTAL ZONE MANAGEMENT PLAN
