SUB: SUBMISSION OF REPORT BY THE JOINT COMMITTEE IN THE MATTER OF OA NO. 205/2023 IN THE HON'BLE NGT (PRINCIPAL BENCH), NEW DELHI.

Ref: NGT Order dated 28/03/2023 in OA No. 205/2023 regarding the Oil Spill reported at Thethi Nagar Beach, Nagore Coast, Nagapattinam, Tamil Nadu.

**Report of the Joint Committee on “Assessment of the M/s Chennai Petroleum Corporation Limited-Cauvery Basin Refinery (CPCL CBR) - Nagapattinum Crude Oil Pipeline Leak near Nagore Coast, Nagapattinam, Tamil Nadu”.**

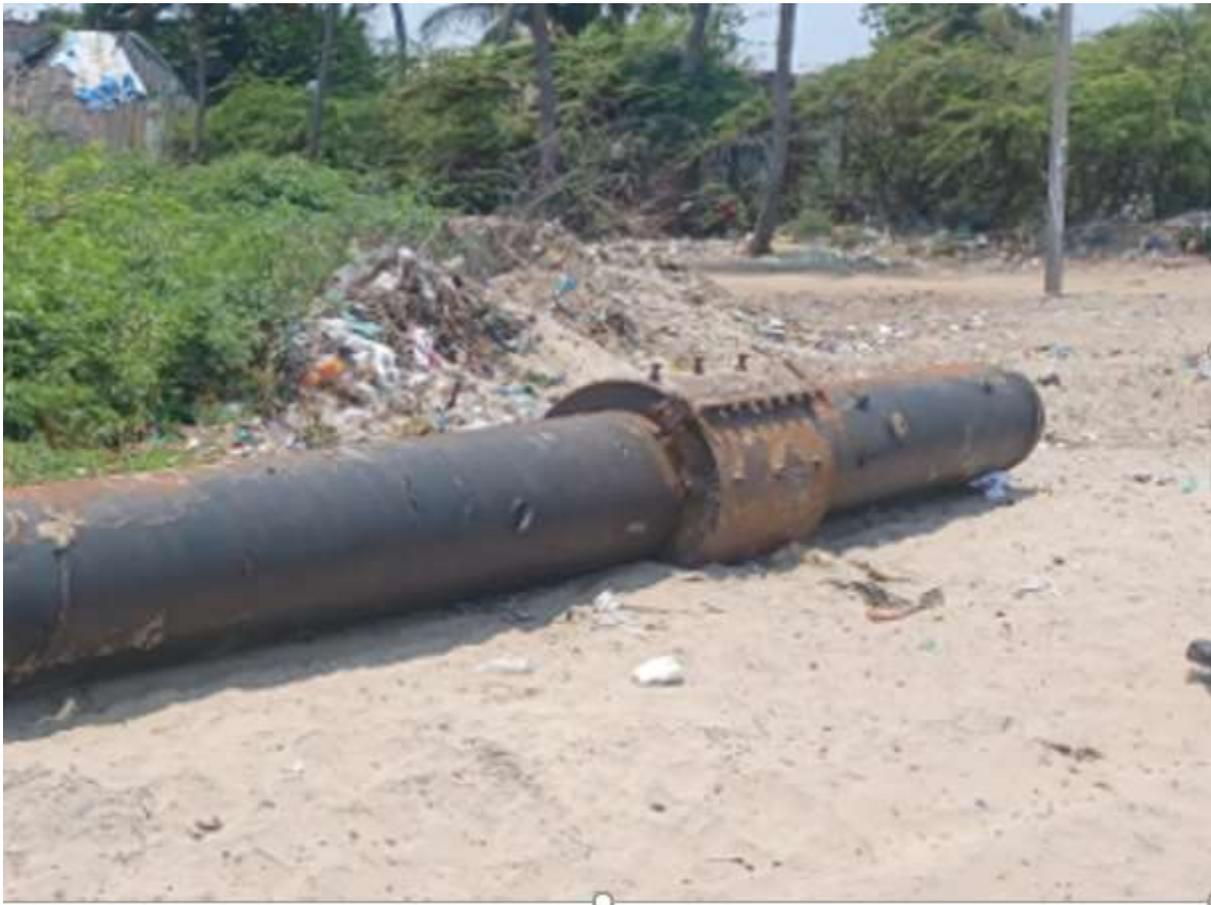
During the committee site visit on April 18, 2023, the committee observed that the leaky portion of the pipeline was removed and kept aside. The clamp provided in the pipeline was not removed. The remaining portion of the base pipeline was found intact with very little damage to the external coating of the pipeline. CPCL officials explained that the damage to the coating material happened

during the removal and shifting of the pipeline by crane and sling. The visual inspection inside the pipeline found normal and healthy condition. The thickness measured at the leaky portion of the pipeline is at permissible levels of 6.1 mm, against the design thickness of 6.35 mm. There was no corrosion or erosion observed in the pipeline and the cause of the leak may be due to an external impact.

During the site visit, CPCL Officials explained that the line was laid at about 1.5 Meters depth in the land area at a distance of 40 meters from the sea. Due to the gradual shifting of the inter-tidal zone and other developments like the Construction of Breakwater at Karaikal Port, and natural calamities such as cyclones etc., the inter-tidal zone has come into contact with the pipeline. However, the exposure of the pipeline to seawater is a recent phenomenon, and hence, corrosion and a reduction in the thickness of the pipeline did not take place.

Figure 3: Photograph of the removed portion of the pipeline with metal clamp

Industrial Research (CSIR) to carry out the metallurgical analysis of crude pipeline to identify the root cause of the failure. The CMERI metallurgical analysis report has concluded that the pipeline failed primarily due to external object impact force. The CMERI conclusion is furnished below. The CMERI Report is enclosed as Annexure: 6.

- 1) The crack was initiated only on the outside diameter (OD) pipe wall surface of the pipeline
- 2) The plastic collapse on the pipeline was due to the impact of external or foreign objects
- 3) The plastic deformation-induced deformation texture bands within the metal matrix microstructure are evidenced by electron microscopy and optical microscopy.
- 4) The crack morphology on the failed pipeline was predominantly dominated by a brittle fracture due to sudden impact, while a mixed (brittle and ductile) mode of crack propagation was also evidenced.
