JOINT INSPECTION REPORT OF COMMITTEE CONSTITUTED BY HON'BLE NATIONAL GREEN TRIBUNAL, SOUTHERN BENCH, CHENNAI VIDE ORDER DATED 08.09.2020 IN THE MATTER OF OA NO. 175 OF 2020 (VENKATAPATHI RAJA YENUMALA VS UNION OF INDIA & ORS)

Inspection Report in the matter of OA 175/2020 (SZ)

3.0 About M/s ONGC, Rajahmundry Asset

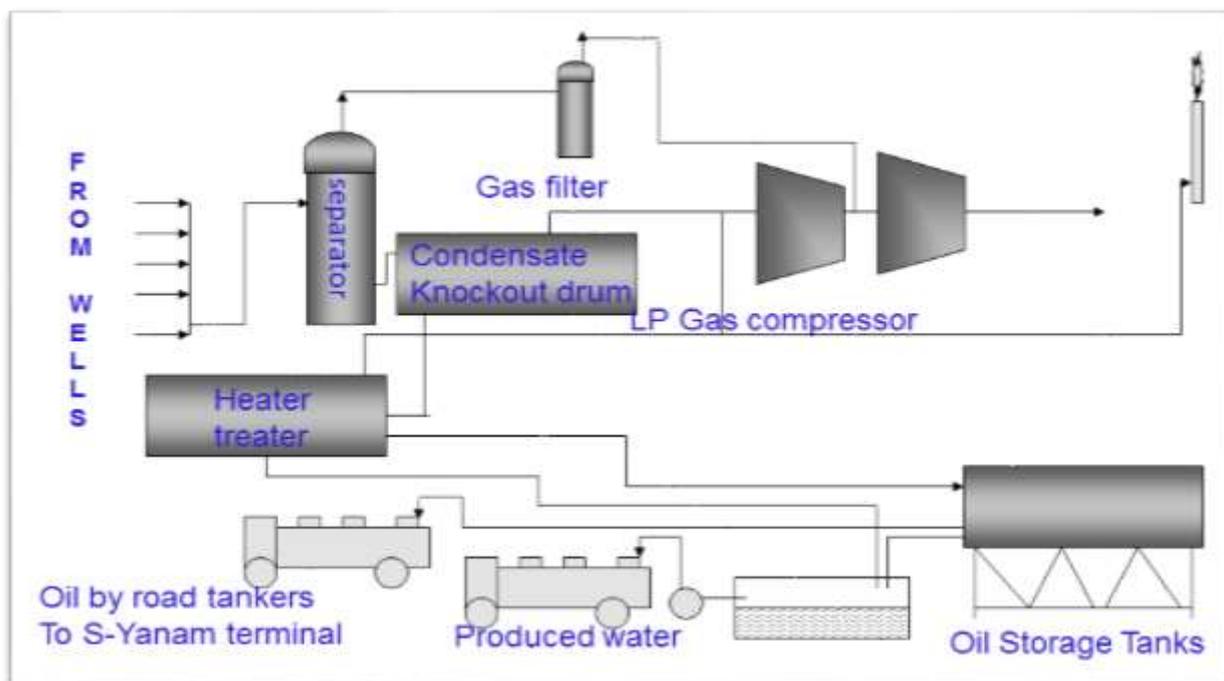
Fig: crude oil processing at ONGC Rajahmundry asset

Well fluid comprising of oil, water and gas is transferred from well head to installation via flow lines and are separated into three phases: oil, water and gas. The high pressure gas is compressed, dehydrated by glycol dehydration, filtered into cartridge filters to scrub out any entrained liquid from the gas and gas at high pressure is fed to GAIL trunk line after treatment. If well delivers low pressure gas, the gas compressors will boost the gas to required pressure to push the gas in Gas grid.

The liquid in the form of emulsion containing oil water mix is further stabilized in the heater treater along with demulsified chemicals for separating oil from water. After stabilization in heater treater, oil is stored into oil storage tanks. The drained out water after further treatment is disposed as per conditions stipulated in CFO. Purified oil is transported either to Tatipaka Refinery or to S-Yanam/EIPL Vizag for further transportation to HPCL Vizag through Cairn India limited. The quantity of producer water generated from the extraction well varies from well to well and depends mainly on age of the well. When the well fluid contains more than

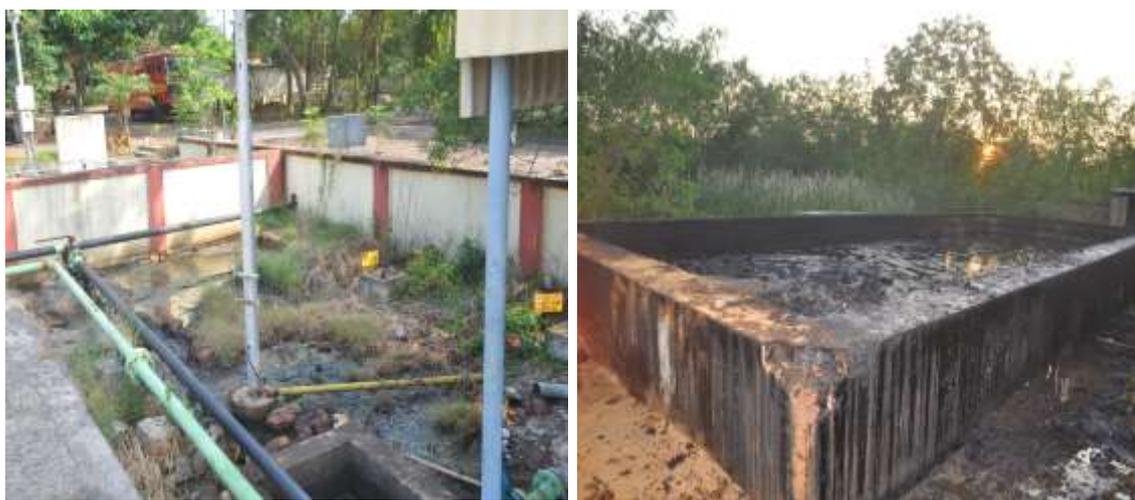
- c. TVOC levels measured using handheld PID analyzer in the ETP area is varying from 2.2ppm to 4.0ppm.
- d. There is no dedicated hazardous waste storage shed. ETP sludge, empty barrels, slop oil are stored haphazardly within the unit premises.
- e. In old GCS plant drain effluent is joining storm water drains and pH of drain effluent was 14 and same was joining storm water drain.
- f. LDAR of refinery is not carried out. TVOC levels near the valves of distillation column is around 5ppm and near sampling point is 70ppm.
- g. In the gas dehydration unit in the re-boiler system, rich glycol (containing moisture) is heated to 200⁰C and moisture is knocked out into the atmosphere. During knocking out some glycol vapors is carried along with moisture. There was odor nuisance in the area.

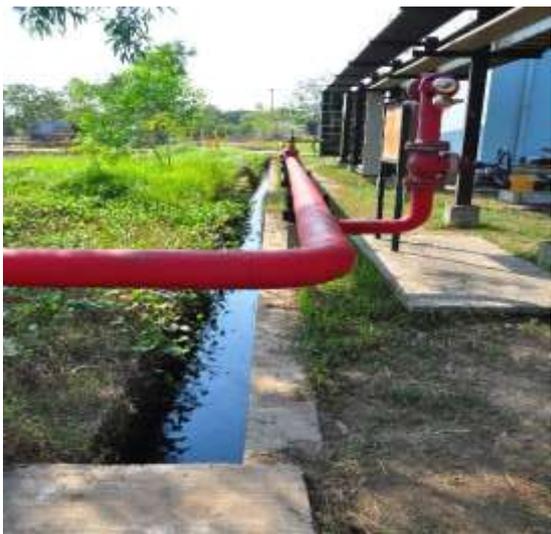
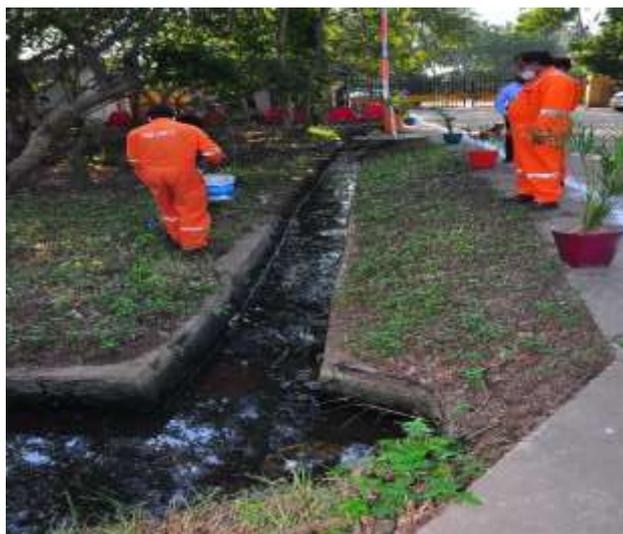
1. Effluent is getting mixed with storm water and storm water is discharged into main drain outside the unit premises. pH of the storm water was 12. In addition the leaves and garden waste is in the drain and getting putrefied in the drain itself.
2. The effluent stored in treated effluent sump was red in color and ph was more than 12.

Storm water drains

- xii. During visit the committee observed that the storm water drains are clogged, filled with effluent, oily sludge is deposited in the drains in ETP area. Firstly the units shall ensure that the entire storm water from the unit shall be collected and reused within the unit premises and it shall not be sent outside the unit premises. The committee submits to Hon'ble NGT to direct APPCB to impose this as one of the consent conditions as not to discharge any storm water outside the unit premises. The unit shall have a fixed frequency for cleaning the drains and oily sludge settled in the drains shall be sent to TSDF or as directed by APPCB.

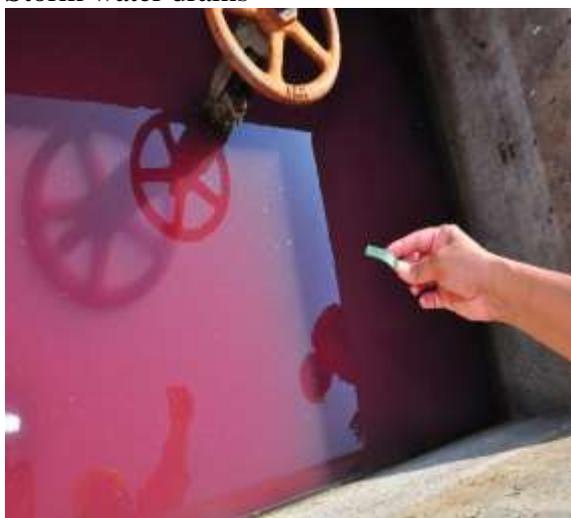
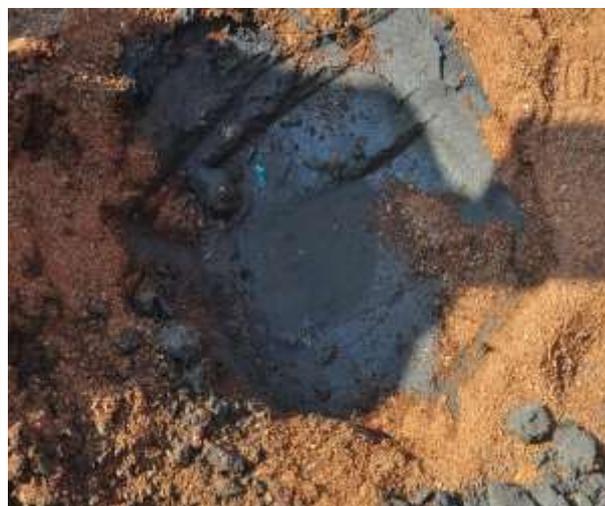
treated effluent sump

ETP area where oil spill is covered by fresh soil

- x. The committee observed during both the visits that the treatment plants are not properly operated and storm water drains are filled with sludge. Records on hazardous waste disposal was not shown to the committee. The ETP sludge and oily sludge from slop oil tank is stored in open. The unit has not taken any measures for the cleanup of sludge and storm water drains under the supervision of APPCB. The units shall ensure that the hazardous waste generated shall be disposed as per the conditions stipulated in CFO and in compliance with Hazardous Waste Management Rules, 2016.

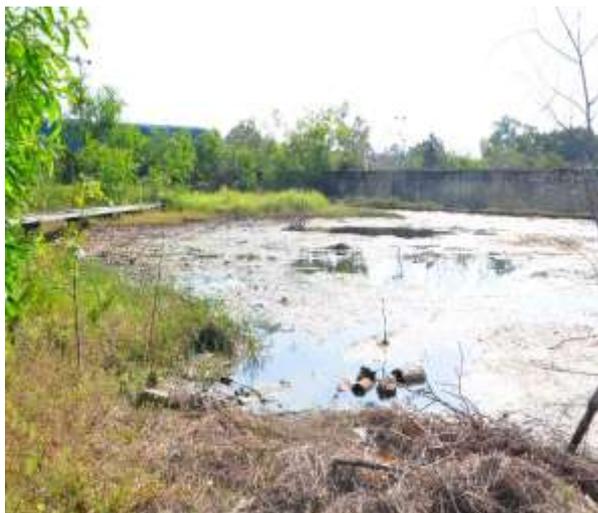
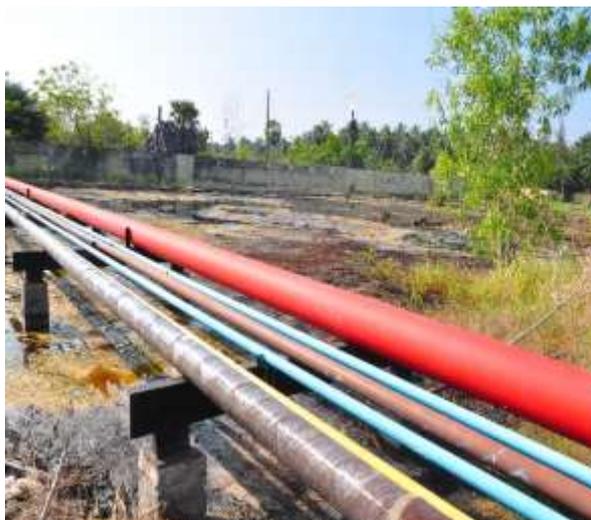
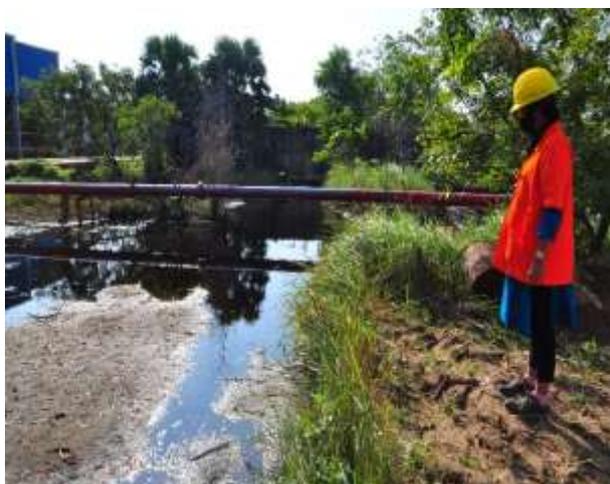
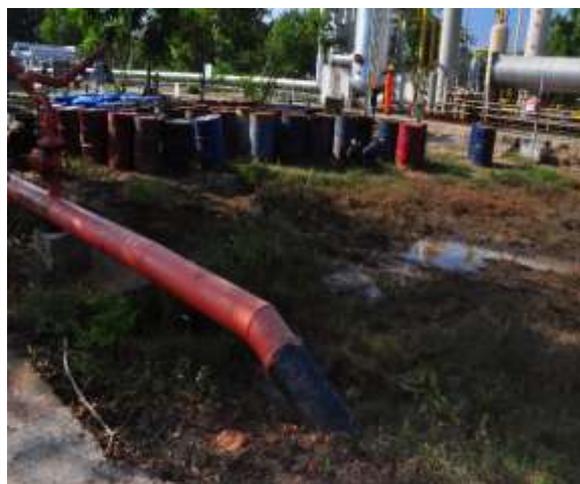
3. There is no dedicated hazardous waste storage sheds
4. The unit was disposing the effluent by means of marine disposal but however the unit has not obtained necessary permissions from APPCB for marine disposal. Further, part of the pipeline used for deep sea disposal (1000m stretch of pipeline taking deep sea) is broken and washed away. presently the unit is disposing the effluent in the coast. The unit had obtained CRZ clearance for laying of pipelines.
5. Water logging observed at the entrance of the unit.
6. In the ETP area, the unit had covered with fresh soil. The committee excavated the portion of the soil and found that black oily soil was present below upto depth of 1m. On enquiring it was informed that there was oil spill and the unit had covered with fresh soil.
7. Opposite to new ETP boundary wall, waste oil & sludge is dumped on land to an extent of two to three acres.

Two to three acres of Area opposite to ETP likely to be contaminated

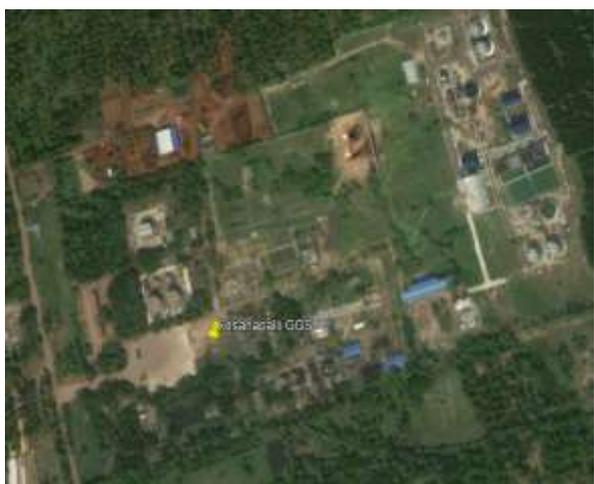
Satellite image 10/2018

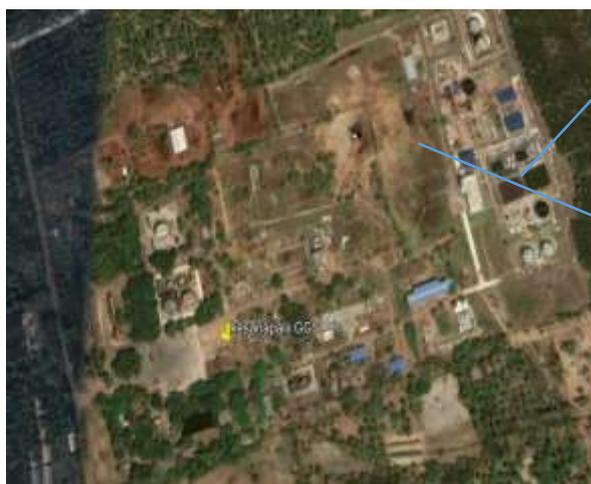
satellite image 12/2020

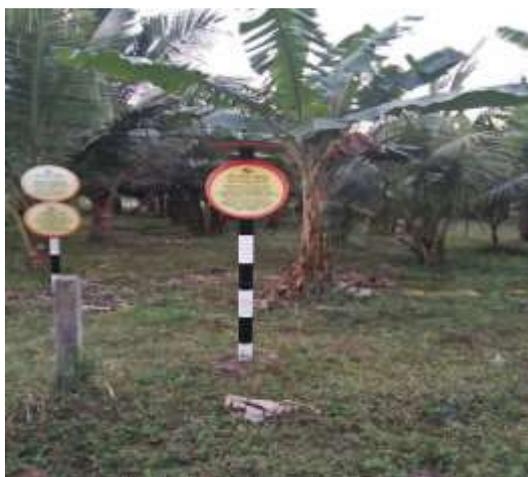
The committee visited two sites where previously accidental leakage has took place. One is Kesanadasipalem and the other is Nagaram. It was observed during committee inspection that area where previously accident has took place is completely restored. The soil was excavated till the pipeline is visible. No leakage was observed. There was no odour nuisance and VOC was monitored using handheld PID analyser and it measured 0ppm in both sites. Sediment samples were collected at locations where the leakages have occurred and on comparison of the results with MOEFCC screening values for identification of hazardous waste contaminated soil it is found that the soil in both the locations are not contaminated. This implies that the unit has completely restored the nagaram area and Kesanadasipalem area where previously accident had took place.

Photo: Nagaram

The sediment samples collected at accident sites Nagaram and Kesaadasipalem were compared with the soil screening values for agricultural purposes as per the Guidance document for assessment and remediation of contaminated sites and it is found that the sites are not contaminated. During visit also it was observed that normal plantation has come up in the area and area is restored.

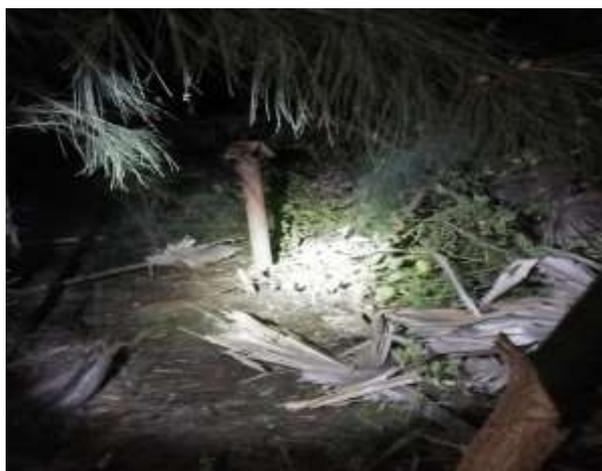
Kesanadasipalem
