FACTUAL REPORT

JOINT COMMITTEE

APPLICATION NO.57/2022 (CZ)

Joint Committee Report

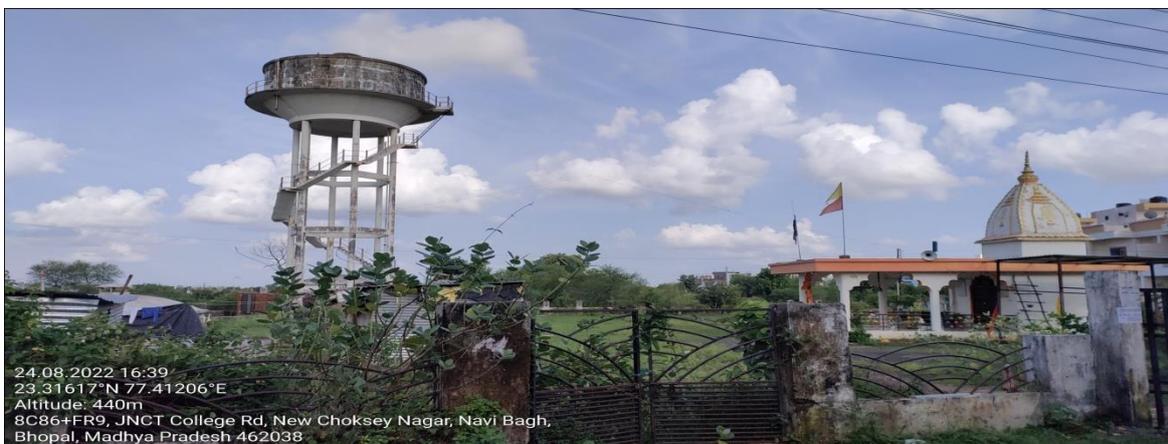
8. One overhead tank and a sump well of approx 150 KLD storage capacity is provided within the colony at a park for water supply in the colony.
9. Residents informed that the water supply system is not operative.

Water supply tank situated in the colony

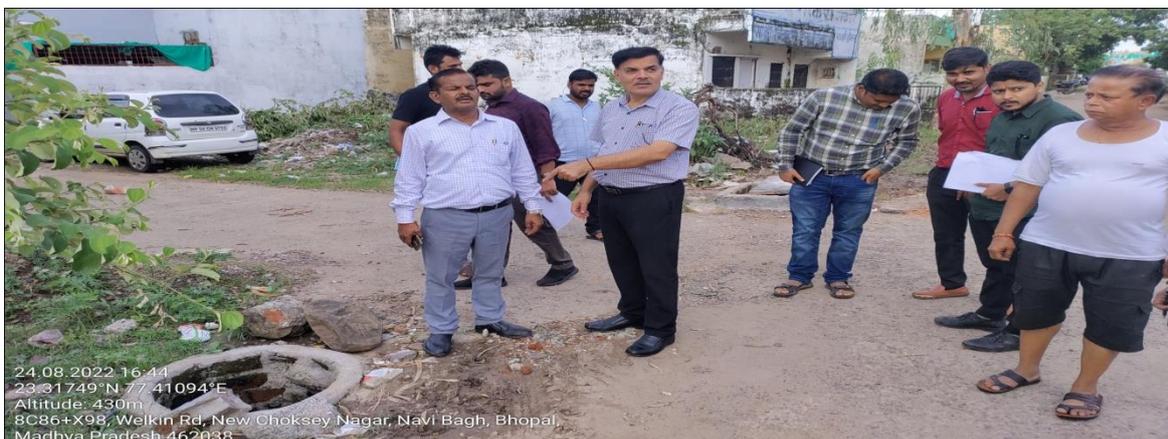
Inspection sewage Chamber inside the society premises

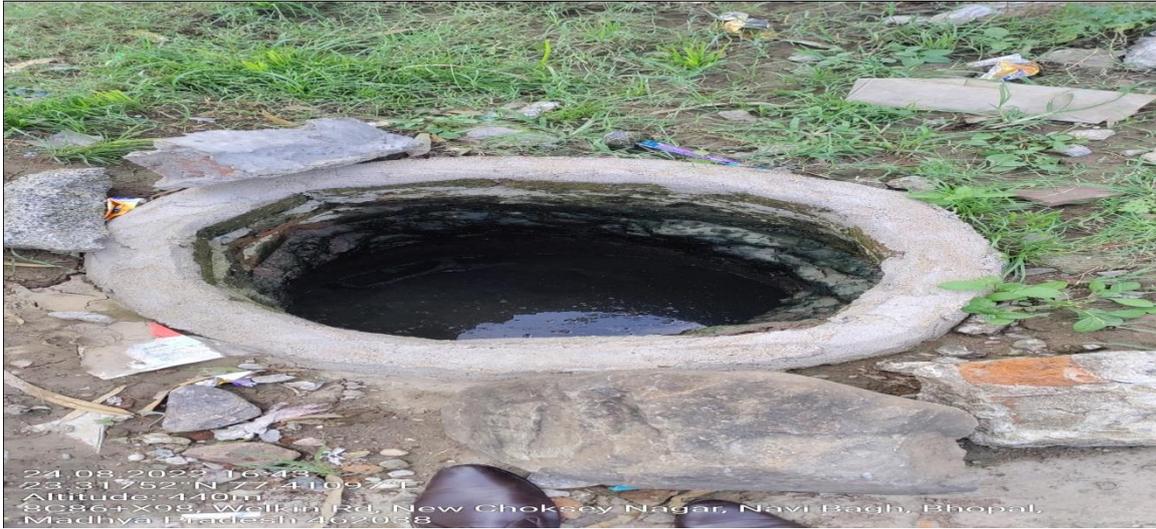
The flow of Sewage observed in the sewage chamber

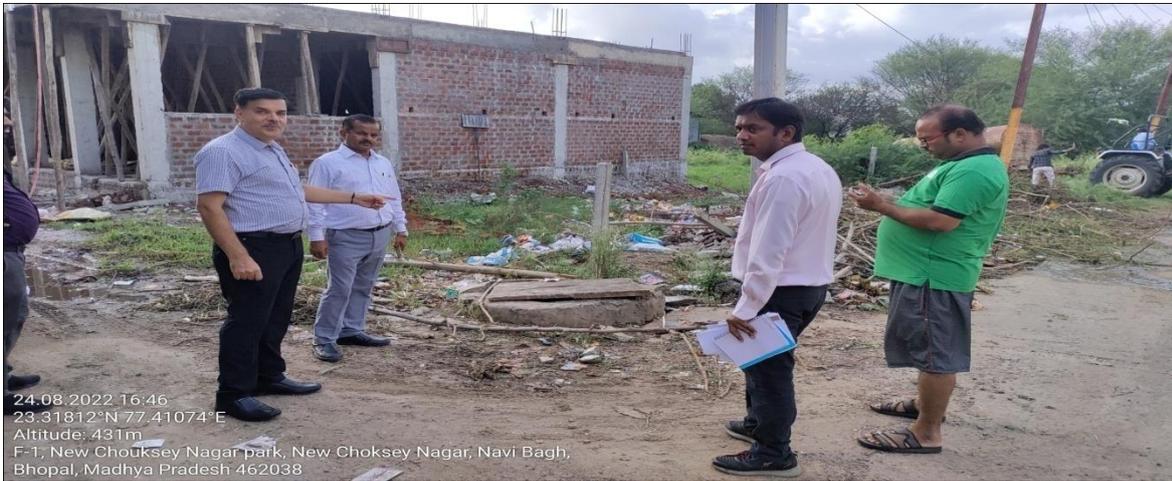
No overflow observed from sewage chamber

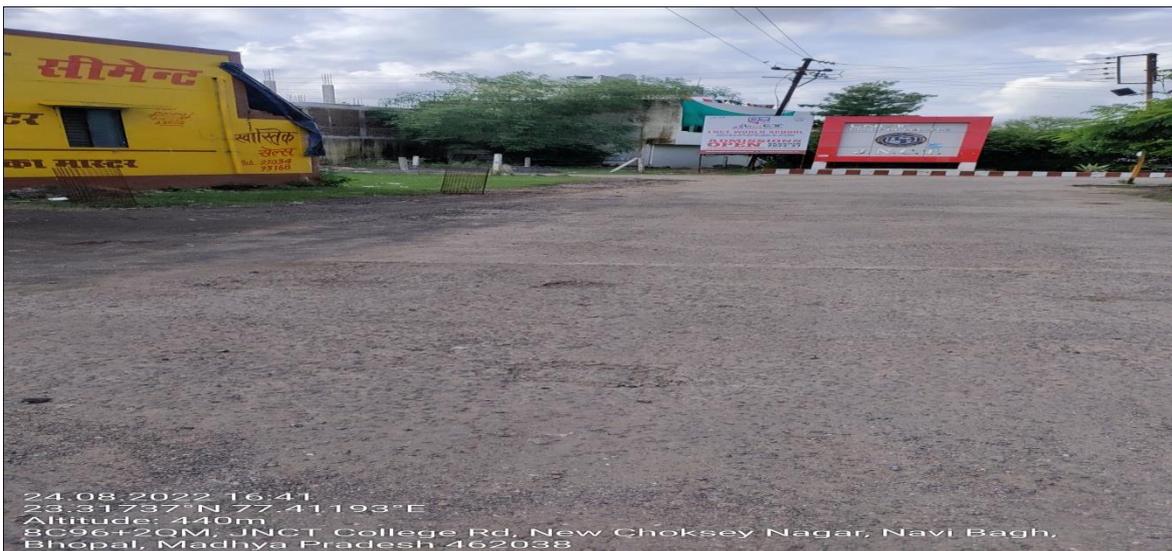
3. The approx area of the colony is 27 Acre and as per petition colony is consisting approx 500 plots.
4. The approach road from main road to the colony is made of cement concrete. The internal roads of the colony are made of cement concrete having width of approx. 15 feet. The roads are found clean and in good condition.

Cement concrete Pavement road inside colony premises

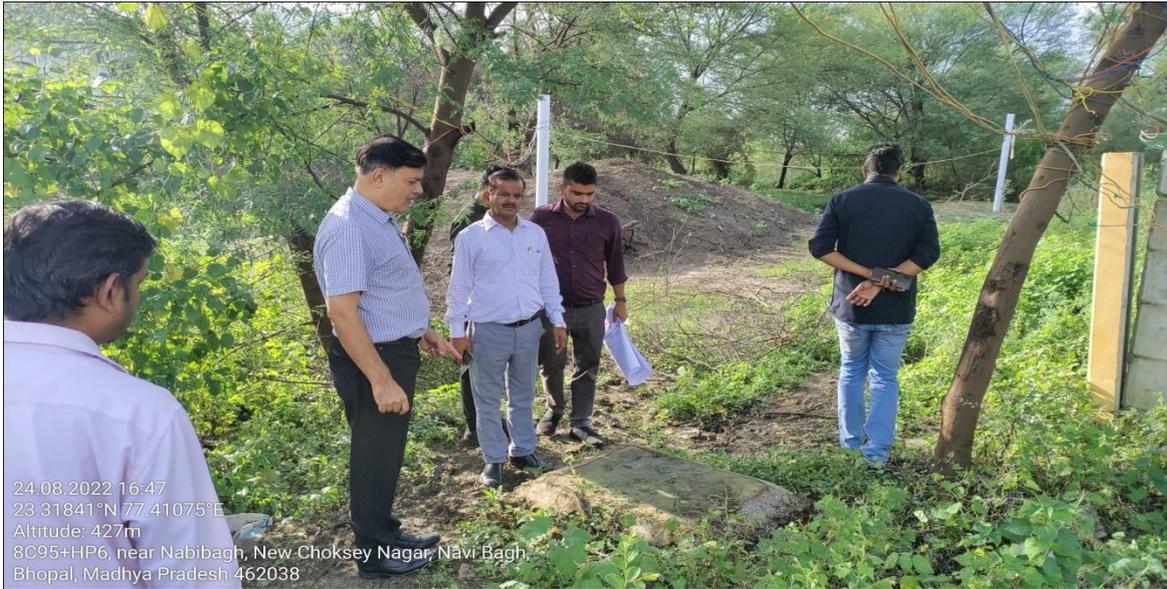
24.08.2022 16:47
23.31841°N 77.41075°E
Altitude: 427m
8C95+HP6, near Nabibagh, New Choksey Nagar, Navi Bagh,
Bhopal, Madhya Pradesh 462038

Sewage chamber located before the septic tank

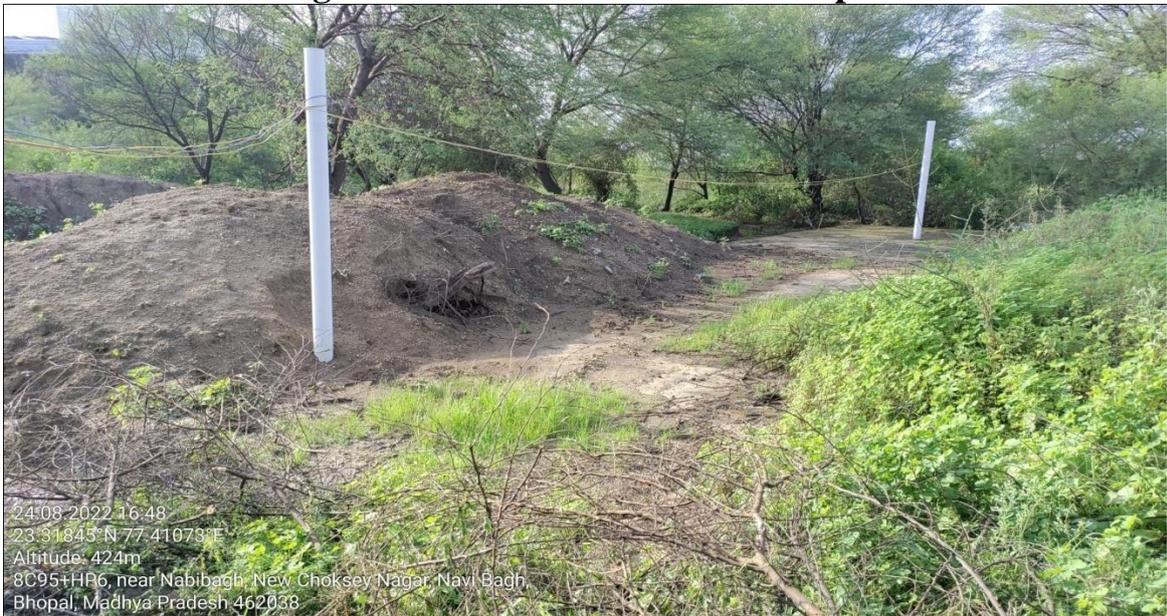
24.08.2022 16:48
23.31843°N 77.41079°E
Altitude: 424m
8C95+HP6, near Nabibagh, New Choksey Nagar, Navi Bagh,
Bhopal, Madhya Pradesh 462038

11. The manholes and chambers are located at suitable places and are in working conditions.
12. A septic tank of approx 450 cubic meter capacity is provided on north-east corner of the colony for the sewage treatment. The location is marked on

Google map. The sewage line is connected with the septic tank. Septic was found in operational condition.

Septic Tank with air vent pipes

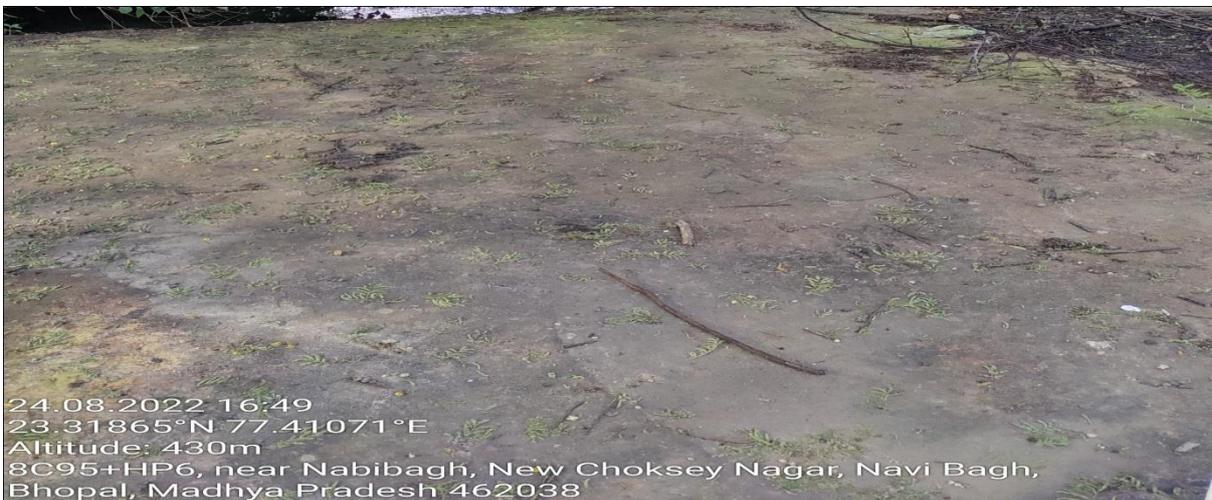
24.08.2022 16:49
23.31865°N 77.41071°E
Altitude: 430m
8C95+HP6, near Nabibagh, New Choksey Nagar, Navi Bagh,
Bhopal, Madhya Pradesh 462038

Concrete top of Septic Tank

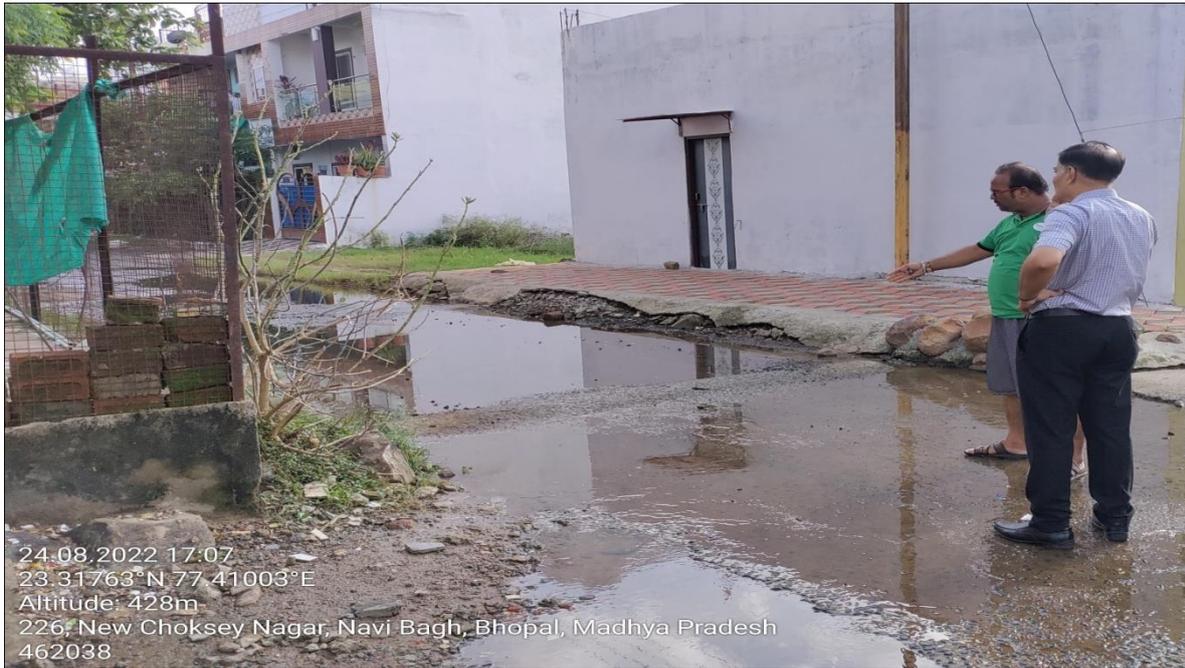
13. Water logging is observed in some vacant plots. The water is seems like rain water as there was a heavy rains in the area in previous day.
14. Residents informed the committee that sewage overflows from some manhole is collected in to a vacant plot. MPPCB has collects water samples from the stagnated water for analysis.

Water logging above the road

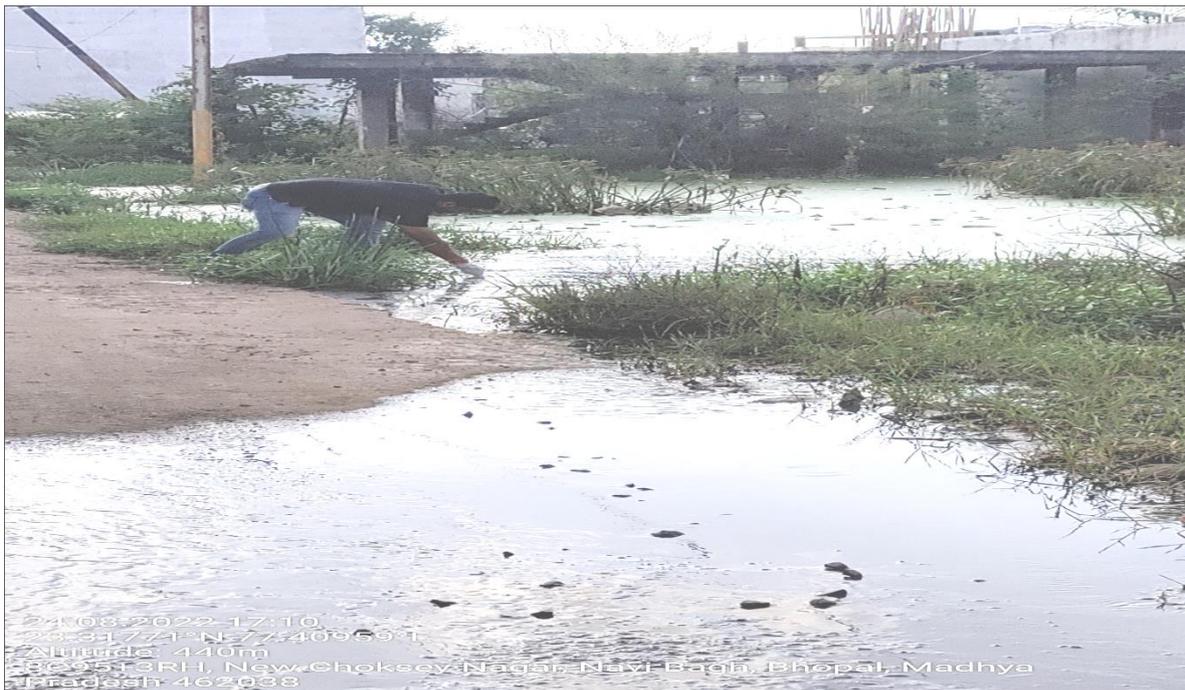
Water logging in the low laying area within the colony

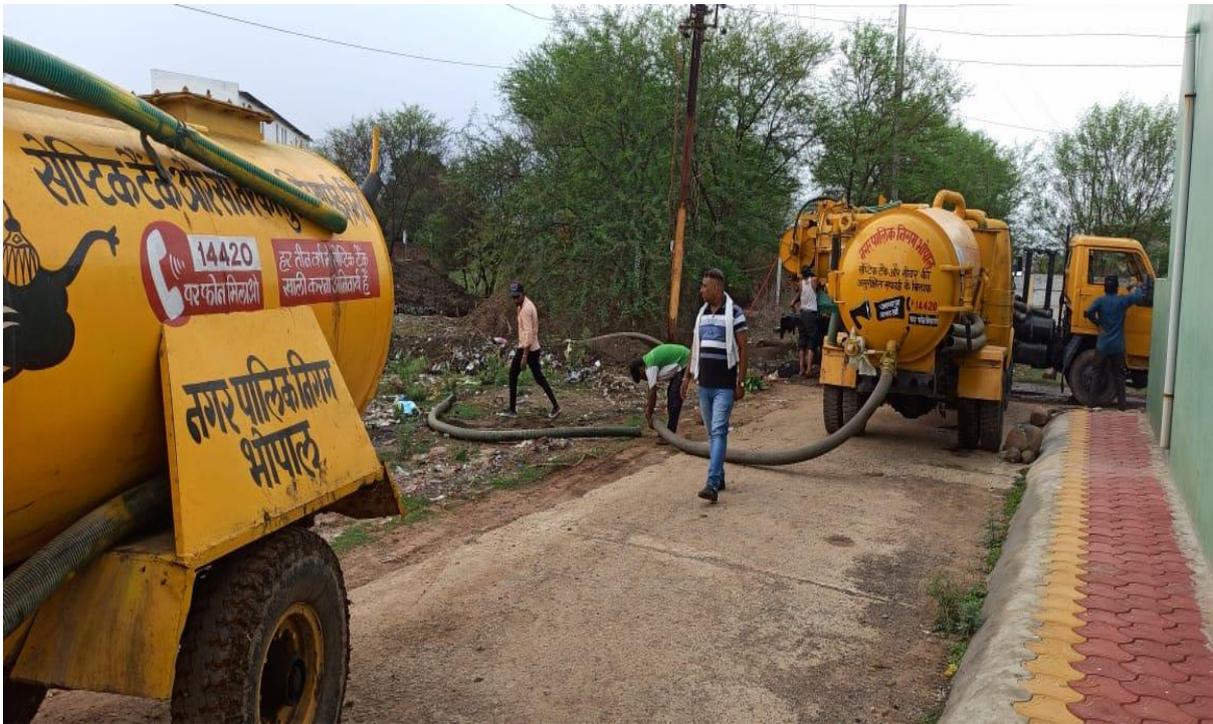
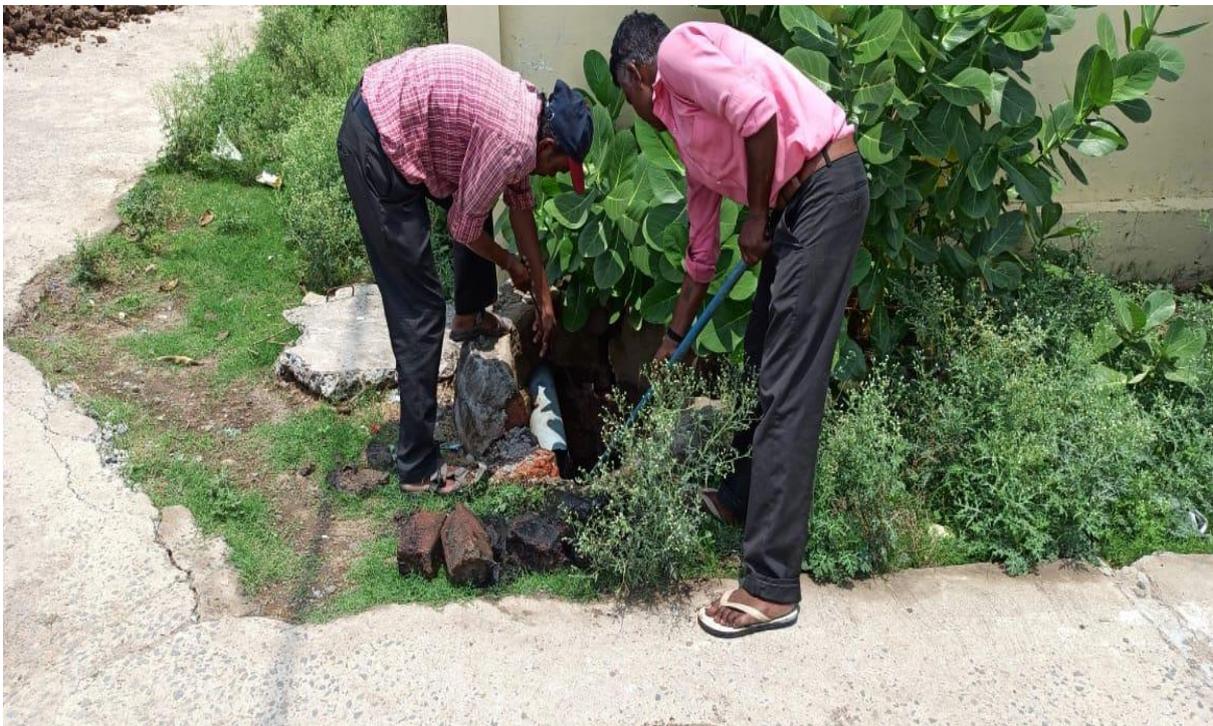
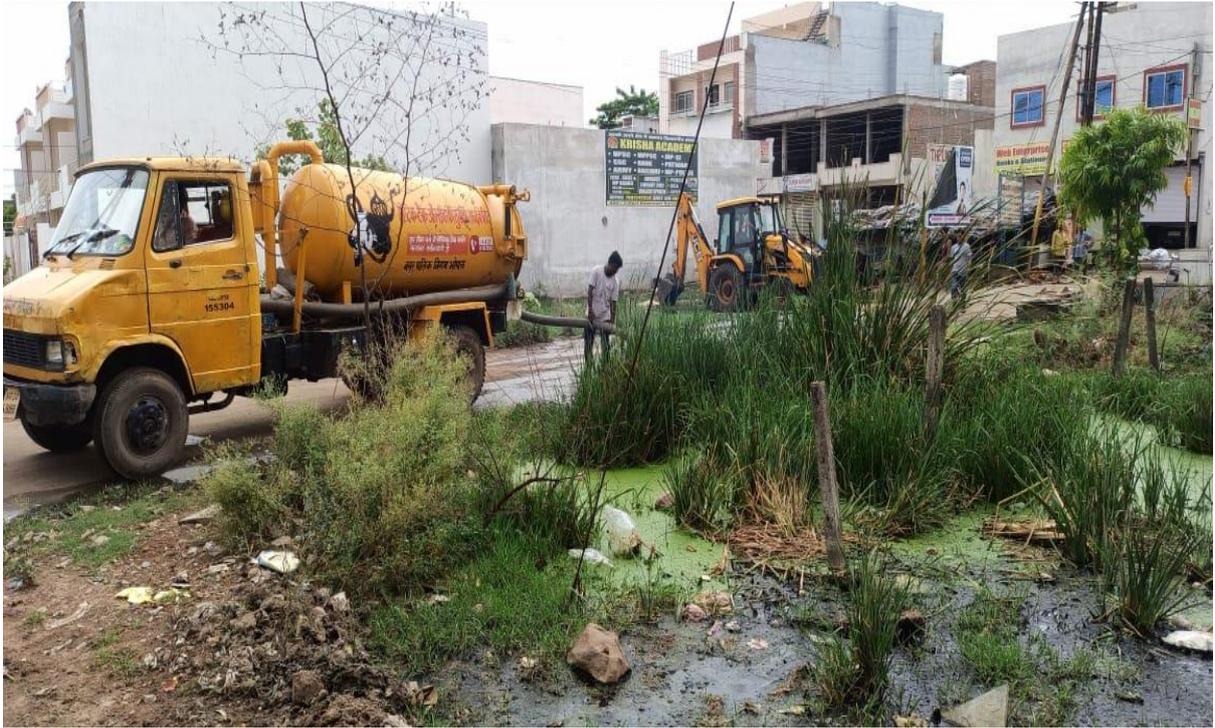
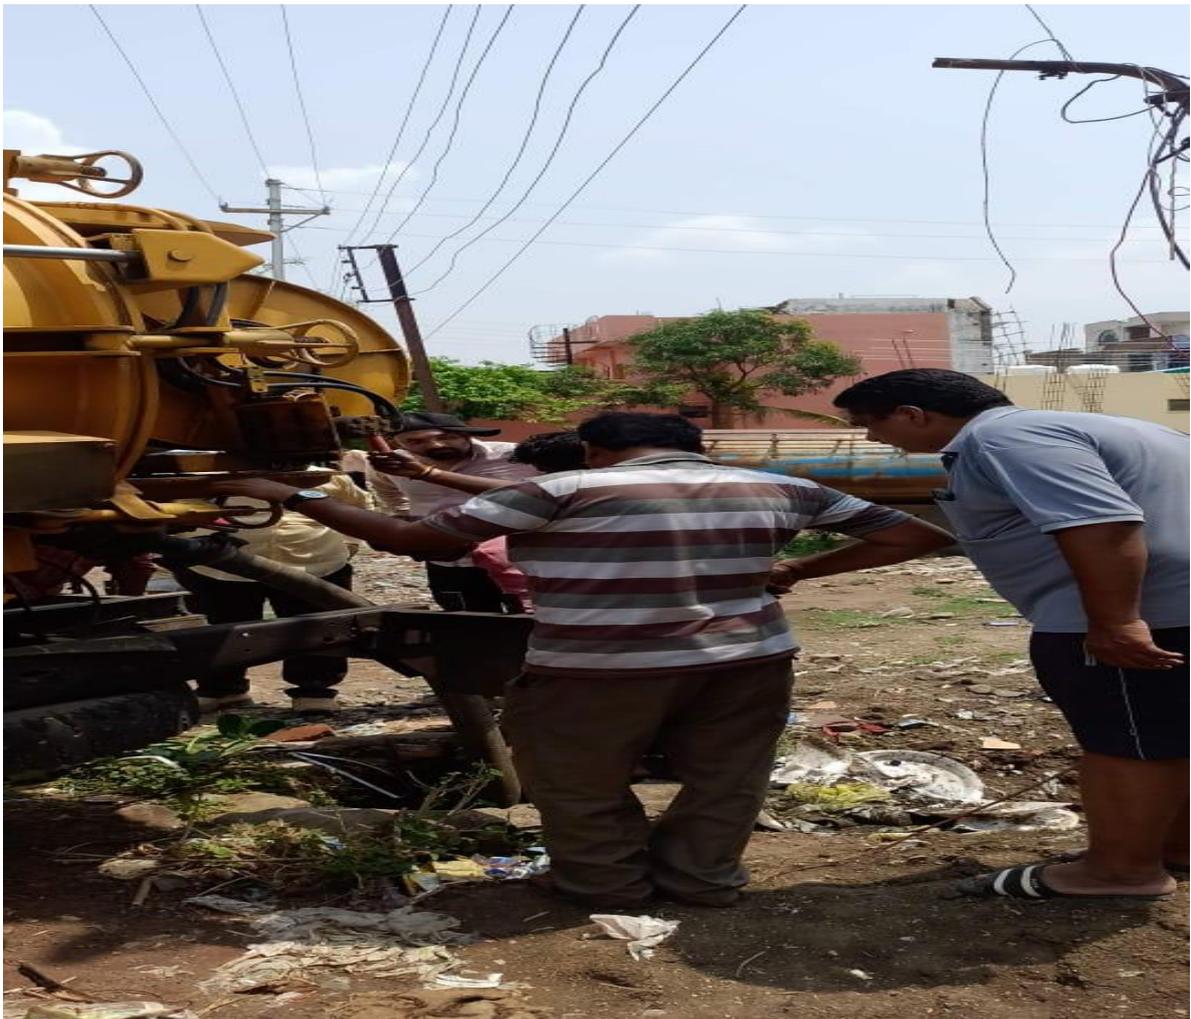
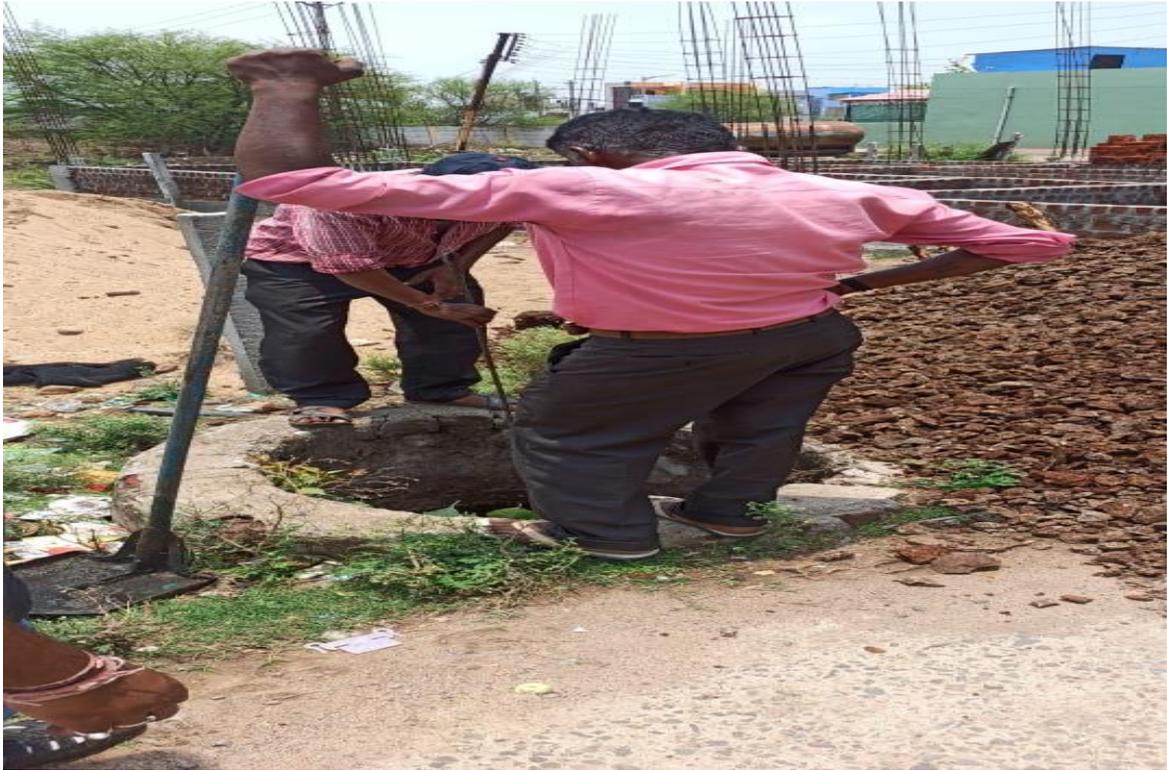
Photographs Taken during Cleaning of sewer line of New chowksey Nagar colony

2. For instant relief Bhopal Municipal Corporation has cleaned the sewer line of the New Chowksey Nagar colony. Photographs taken during the cleaning of sewer line in New Chowksey Nagar colony are enclosed as **Annexure-IV**

1. The sewer line is required regular cleaning and maintenance so that sewage overflow from manhole should not take place.
2. For regular operation and maintenance of sewage line, street light, water supply, internal roads of colony New Chouksey Nagar Colony residents should developed a society of residents and create a financial support based on sharing basis of each resident.
3. The funds should be used for regular operation and maintenance of colony.
