Original Application No. 119 of 2021

**REPORT FILED ON BEHALF OF THE FOURTH RESPONDENT -
TAMIL NADU POLLUTION CONTROL BOARD.**

Assessment of Environmental Compensation for the Brick Kiln Units Located in Thadagam valley

*as per the orders of the Hon'ble High Court of Madras dated 27.04.2023 in WP No.
34793 of 2022*

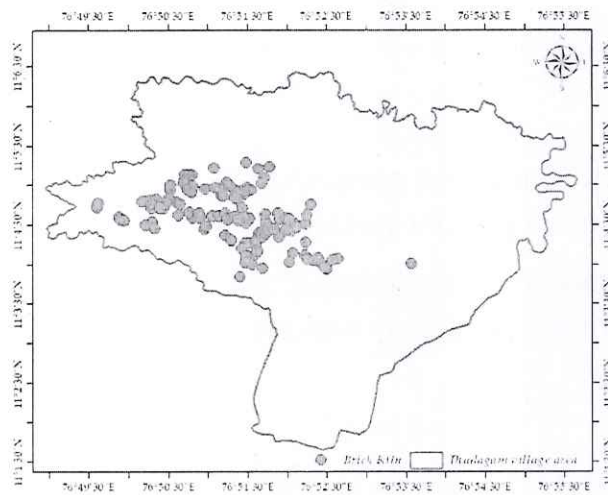
Figure 1 Brick kilns in Thadagam village area.

183 brick kilns in the Thadagam valley area were mapped based on the survey data of the TNPCB.

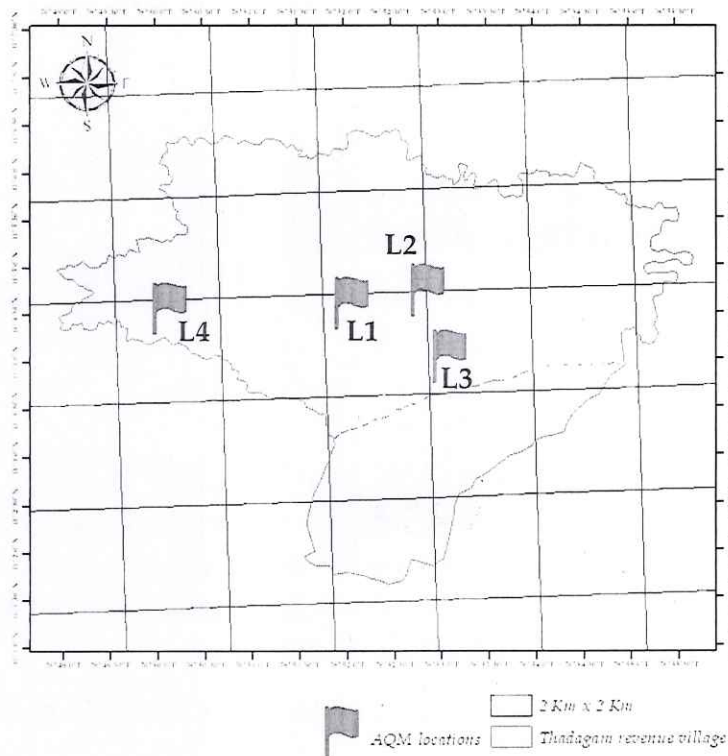
Figure 2 AQM locations in Thadagam revenue village area.

Four locations namely i) Chinna Thadagam (L1), ii) Madathur (L2), iii) Mangrai (L3) and iv) Kalainur (L4) were selected to measure the air quality (PM_{10} and $PM_{2.5}$) of the Thadagam valley area. These locations were selected based on the prevailing wind directions, landuse pattern, and feasibility of operating the instruments.

L1: Chinna Thadagam; L2: Madathur; L3: Kalainur; L4: Mangarai

Again, the 24-hour average ambient PM_{2.5} concentration varied between 5 and 51 µg/m³ across the air quality measurement locations. The highest mean PM_{2.5} concentration was recorded at L2: Madathur (15 µg/m³) and L3: Mangarai (15 µg/m³) during the monitoring period. The daily average PM_{2.5} concentration was recorded well within the 24-hour average NAAQS limit of 60 µg/m³ for ecologically sensitive areas (Figure 2).

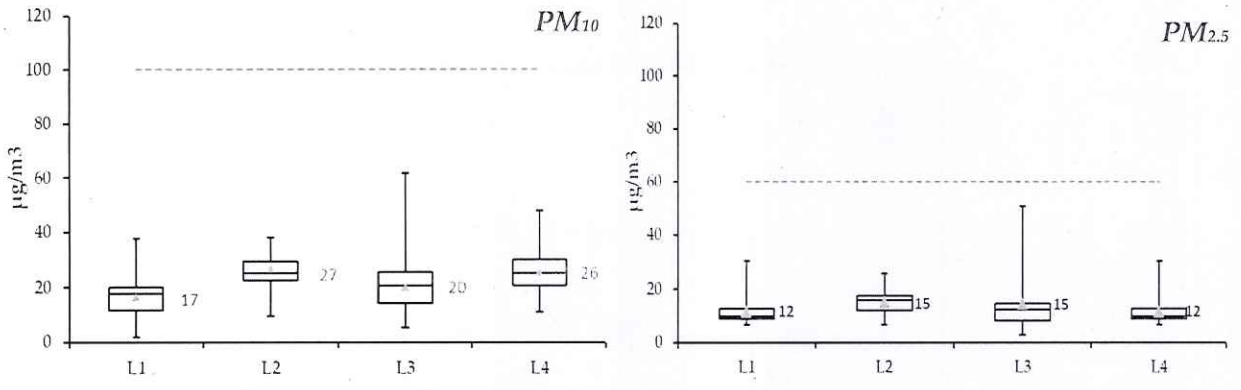
Figure 3 15-days atmospheric PM_{10} and $PM_{2.5}$ concentrations at the AQM locations.
 L1: Chinna Thadagam; L2: Madathur; L3: Kalainur; L4: Mangarai

PM₁₀/PM_{2.5} sampler (Make: Envirotech Model: APM 550M) was used to collect air samples at an average flow rate of 16.67 L/minute. Preconditioned and pre-weighed microfibre filter papers (Whatman, UK) were used for particulate sampling during ambient air quality monitoring. Monitoring and sampling followed the guidelines set by the Central Pollution Control Board (CPCB) and the Bureau of Indian Standards (BIS). A 15-day measurement was conducted to collect air quality samples using Whatman microfibre filter papers to determine the PM mass. PM₁₀ and PM_{2.5} samples collected on the Teflon filter media were used to calculate the atmospheric PM₁₀ and PM_{2.5} concentrations in the Thadagam region following the gravimetric method.

24-hour mean atmospheric PM₁₀ concentration varied between 5 and 62 µg/m³ across the air quality measurement locations at the Thadagam Valley. The highest mean PM₁₀ concentration (27 µg/m³) was recorded at the L2 (Madathur) location and the lowest mean PM₁₀ concentration was recorded at L1: Chinna Thadagam (17 µg/m³) during the measurement period. The daily average PM₁₀ concentration was recorded well within the 24-hour average NAAQS limit of 100 µg/m³ for ecologically sensitive areas.

The ratio of $PM_{2.5}/PM_{10}$ varied from 0.46 to 0.75 (Table 2) across the air quality measurement locations. A higher $PM_{2.5}/PM_{10}$ ratio indicates that the contribution from combustion sources is more prevalent than the dusty sources in the study area. This can be attributed to the release of fine particulate fractions from locally polluting activities such as tailpipe emission, biomass burning, etc.

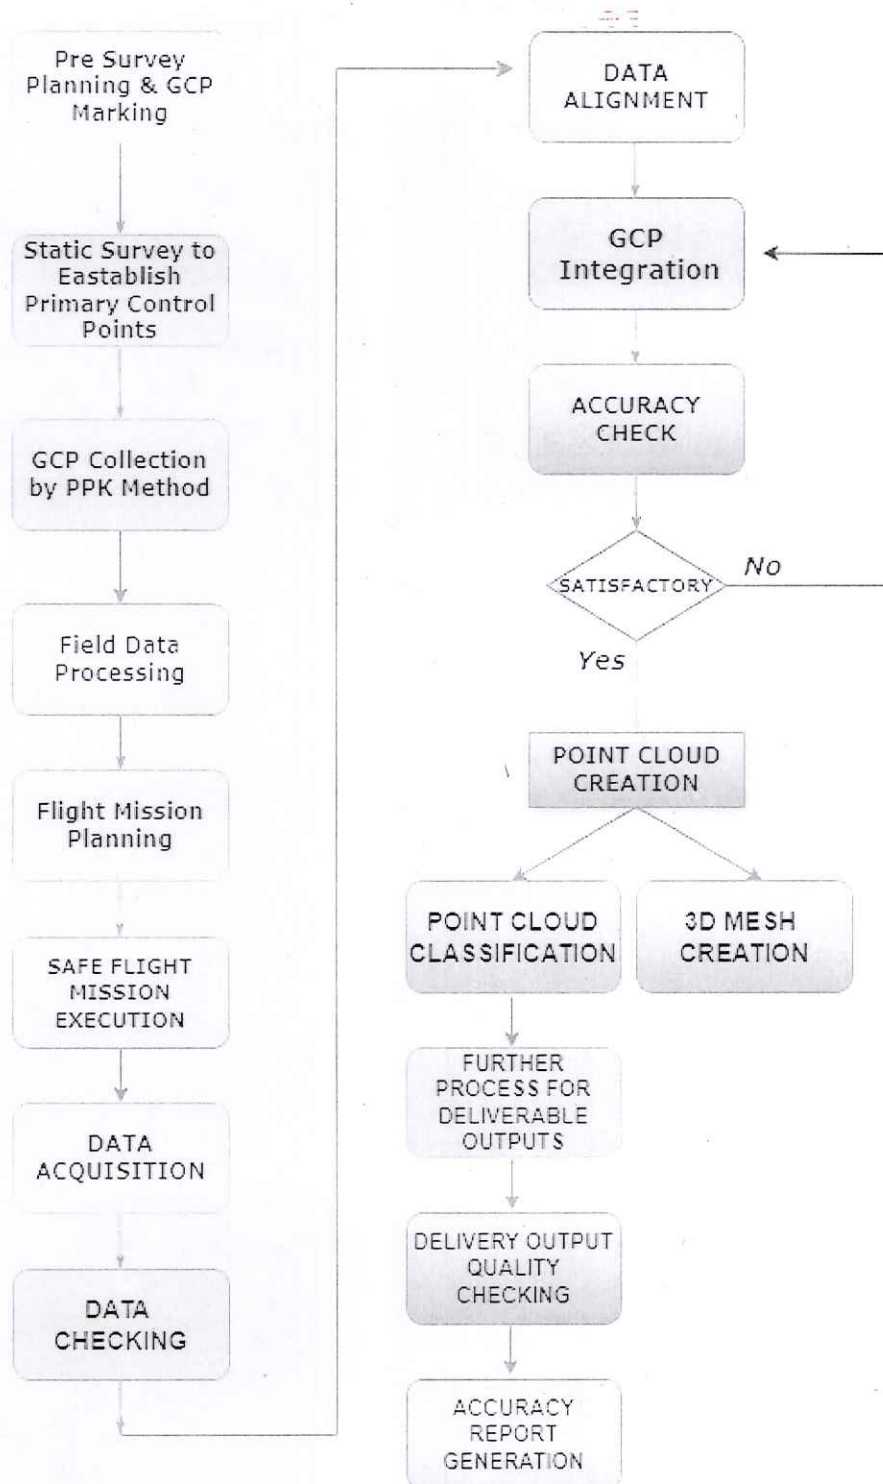
Figure 4 Flow chart of methodology of the UAV survey at Thadagam revenue village area.

The survey was conducted following the methodology flow chart below,

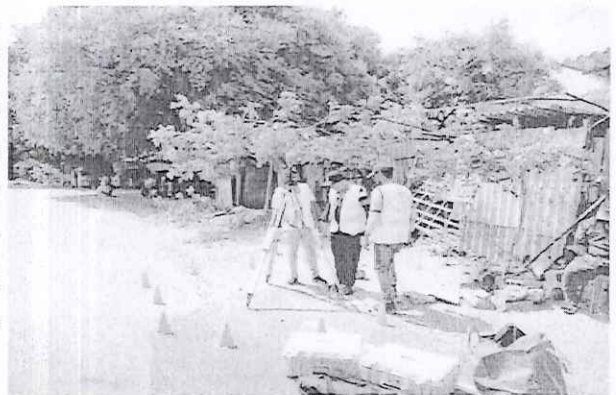
The base was established at 02 suitable locations. Trimble R12i GNSS receiver (S/N: 6407714596) was connected in rover mode and observations were taken in Static Survey Style for 04 hours & 06 hours 35 minutes respectively. The resulting files were uploaded to Trimble Inc's online post-processing service (Trimble CenterPoint RTX Post Processing) and the global co-ordinates were extracted

Table 1.1 Geographic coordinates of primary control Establishment of a base station point

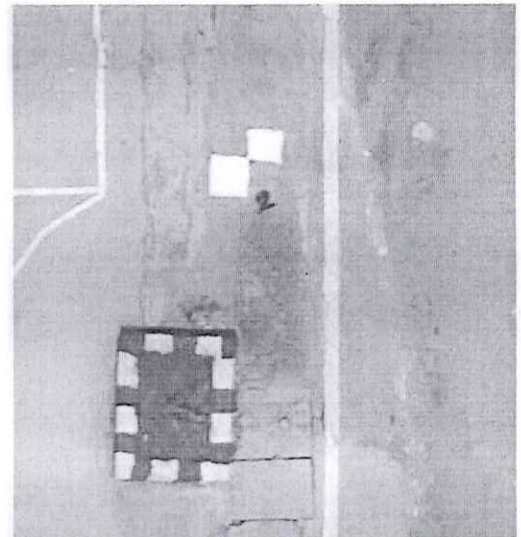
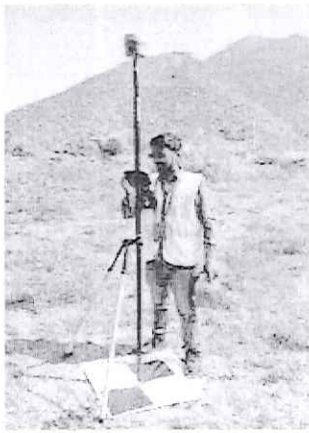
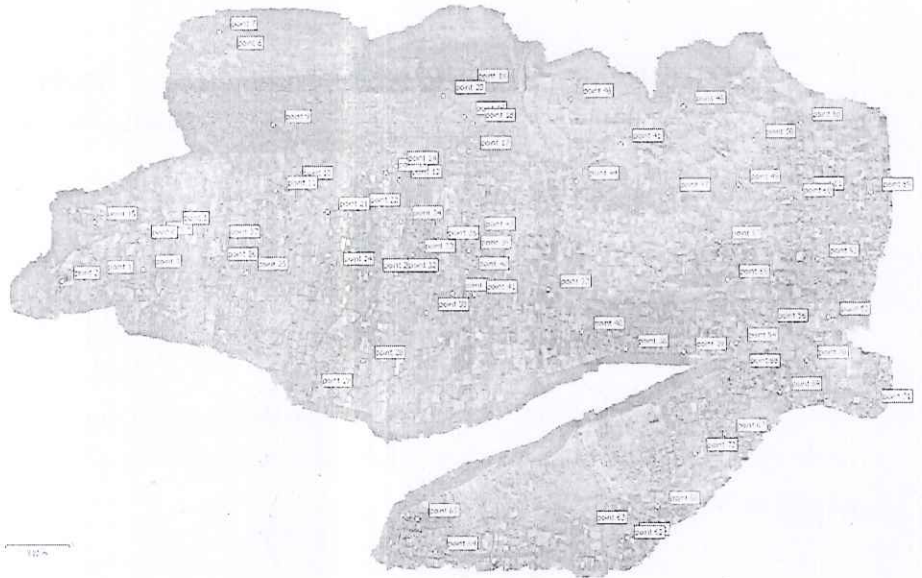
Figure 5 GCP marking in the Thadagam revenew village area.

After completion of the above-mentioned surveys, seventy-two Ground Control Points were marked in such a way that they are well distributed over the study area.

The markings were done in such a way that they were visible in the images captured by the UAV

To conduct a Ground Control Point (GCP) survey, both the Trimble receivers were used. The point collected on the previous day was used as base and the receiver with s/n 6407714596 was connected with the TSC5 Controller and started in the base mode.

Next receiver bearing s/n 6408714873 was connected with the controller in rover mode and the ground control points were observed. For each point, a minimum of 05 minutes of observation time was used (Figure 5). The global UTM co-ordinates of the points are listed in the table below.

Intermittent checks were carried out to see whether the GCPs that were painted on the ground were still visible or not. Re-painting was done as and when needed.

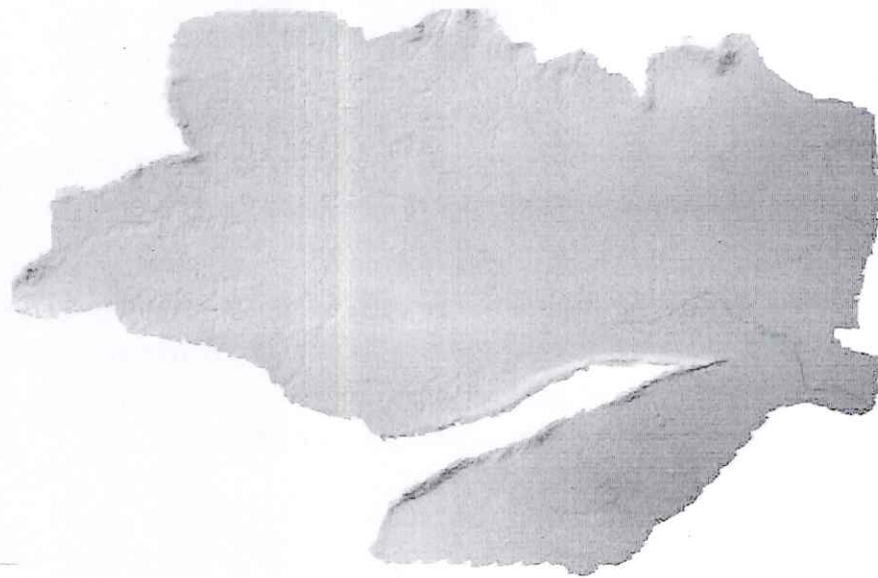
Figure 6 Digital elevation model of Thdagam village area

A Digital Elevation Model (DEM) is the simulation of the bare ground (bare earth) topographic surface of the Earth excluding trees, buildings, & any other surface objects. It is often used in geographic information systems (GIS) and other geospatial analysis applications such as land use planning, environmental assessment, disaster management, & urban planning.

The DEM and the DSM were used for the contour analysis and analysis of the earth mining in the Thadagam revenue village area.

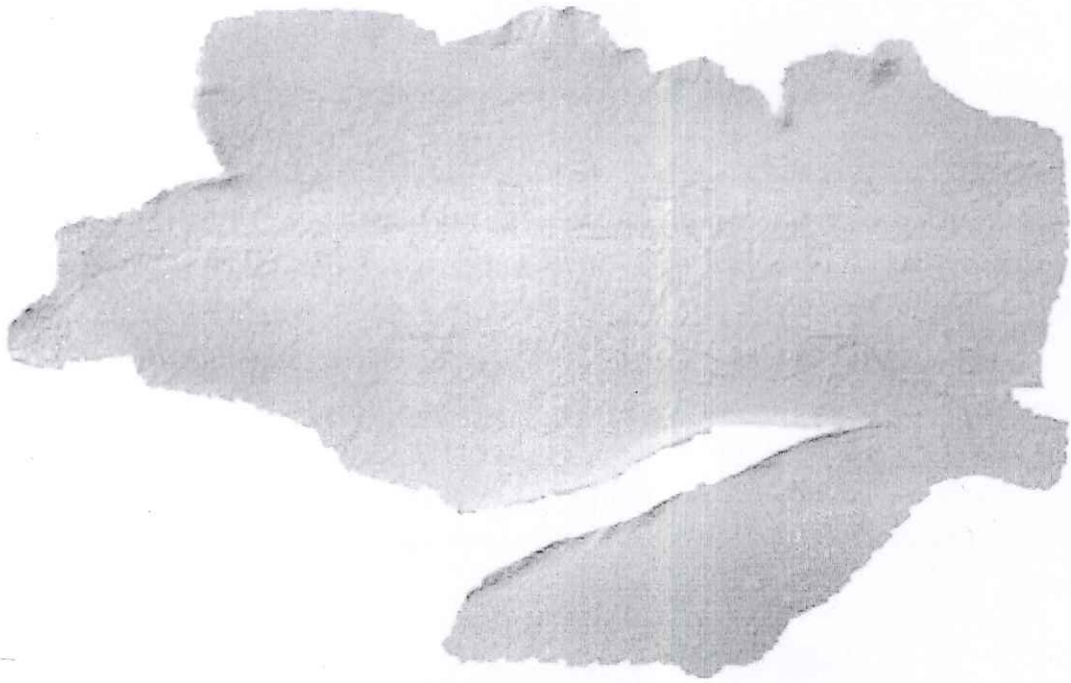
Figure 7 Digital surface model of Thadagam village area

A Digital Surface Model (DSM) is a digital representation of the Earth's surface, including all objects on it, such as trees, buildings, & other structures. DSMs are created by processing drone images & generating a point cloud that includes all surface features.

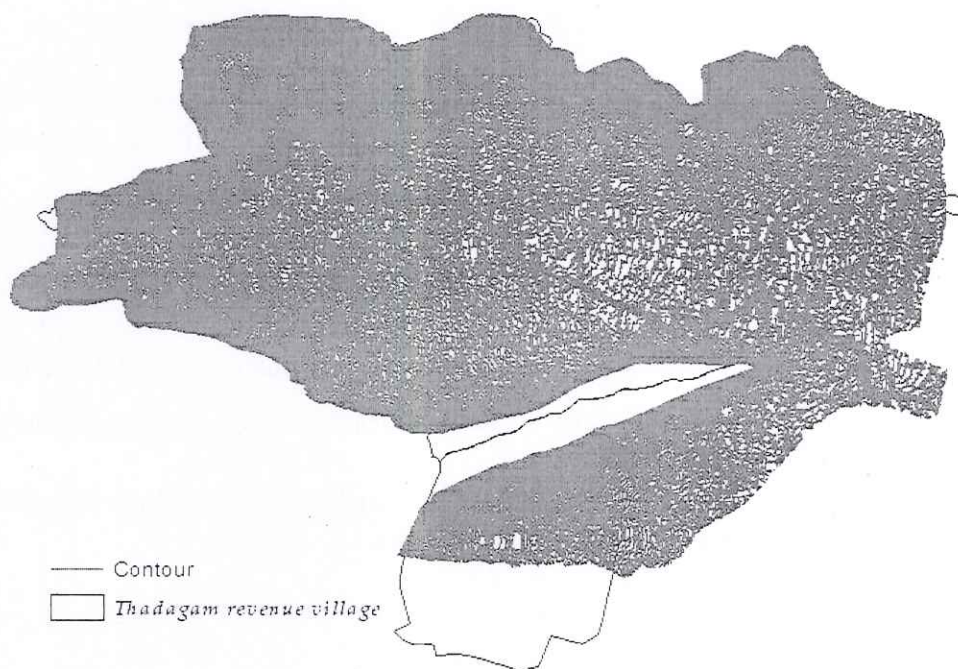
Figure 9 Contour mapping of Thadagam revenue village area.

The analysis of the contour map suggests that the average elevation of the surveyed area of the Thadagam revenue villages is 532 m with a range between 456m and 758m (MSL).

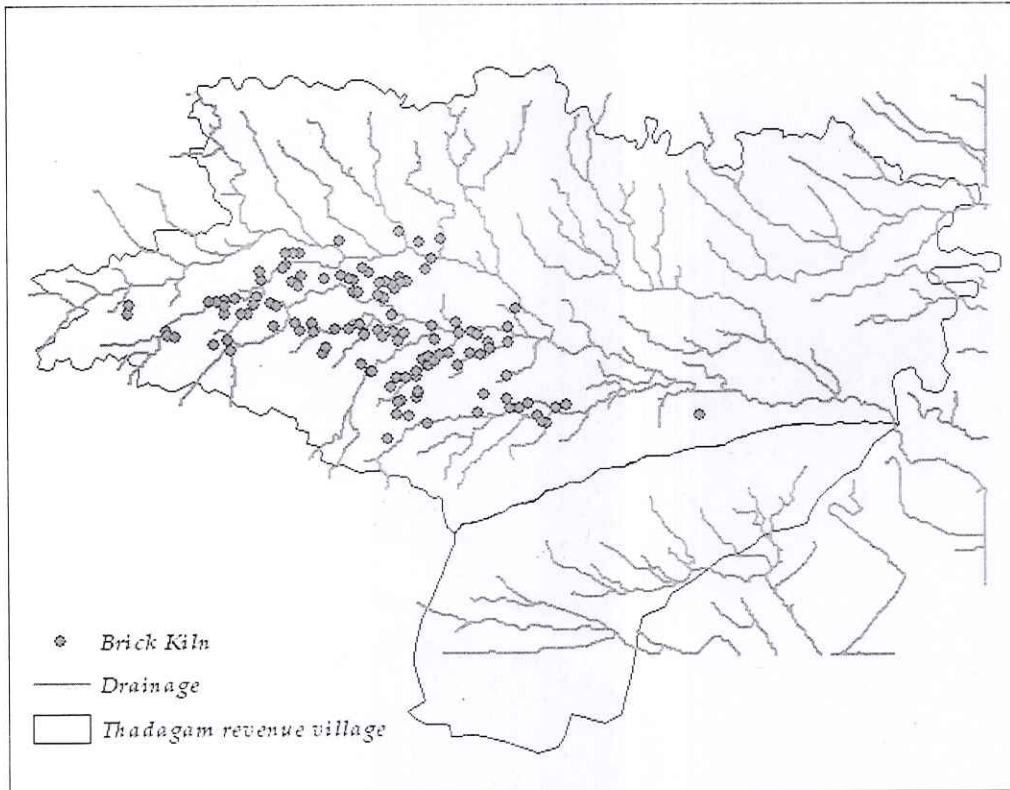
Figure 10 Drainage mapping and brick kilns in the Thadagam revenue village area

The analysis of the drainage network and the location of brick kilns indicates that the brick kilns were mostly built up at the side of the river channels. However, part of the brick kiln area might have overlapped the drainage channels in some cases.
