**BEFORE THE NATIONAL GREEN TRIBUNAL (SZ), CHENNAI**

**O.A. 136 of 2024**

**TYPED SET FILED BY THE APPLICANT**

# COMPREHENSIVE SHORELINE PROTECTION MANAGEMENT PLAN FOR ENTIRE TAMILNADU COAST

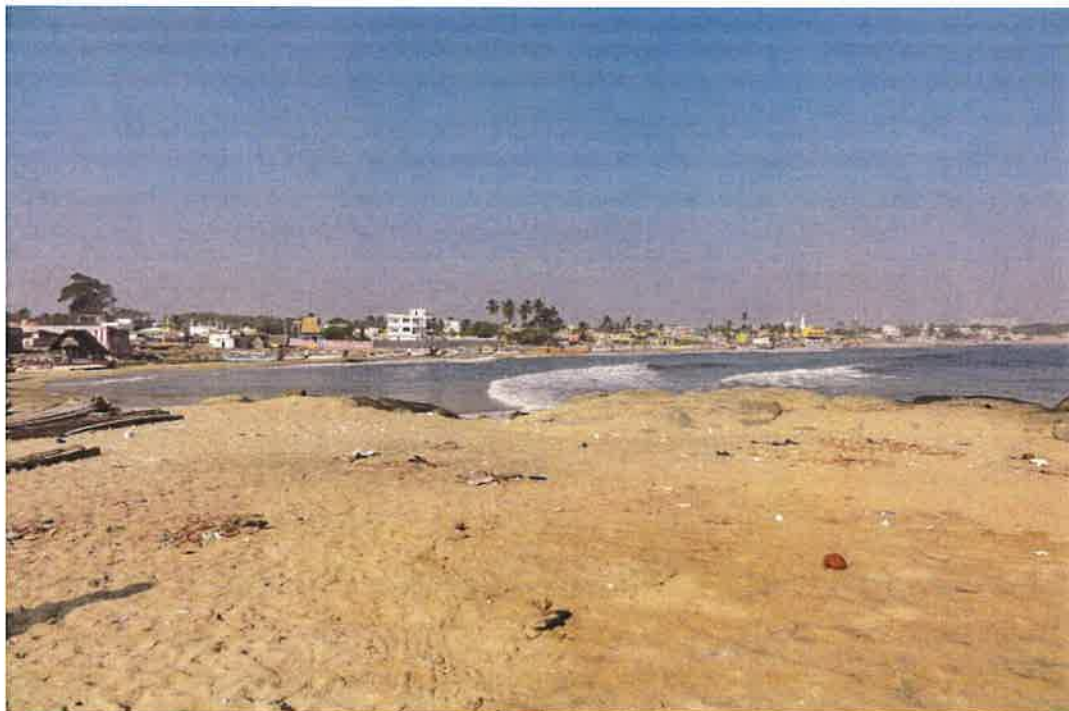
**Fig.10.3a** Beach profile Left (North) of yellow temple

The stretch of the coast off Kovalam is shown in **Fig. 10.3a**. A bay like formation, from north of the above location has formed and this formation as per the local public appears to be eroding since 2007 at a rate of about 5m/year. This bay formation is likely due to the outcrops on its south acting as a natural littoral barrier. As regard to the coastal protection, it is suggested to tame the waves and the sediment transport by providing groins as tentatively shown in the above figure. The solution suggested can prove to serve as an efficient coastal protection as well as allow the local fishermen to use the bay on the left side to the southern groin as a mini harbour. A perfect road is also available up to this beach, which may be quite suitable for the development of a fish landing centre and also prevent further coastal erosion. However, this needs further assessment as regard to the Cost – Benefit analysis. A detailed numerical modelling is absolutely essential to conclude the protection measure.

**Solution suggested:** *A field of short groins designed through detailed scientific studies with existing bathymetry and shoreline morphology would serve the purpose. It is recommended to provide a pair of training walls for training the mouth of Mutukadu backwater.*

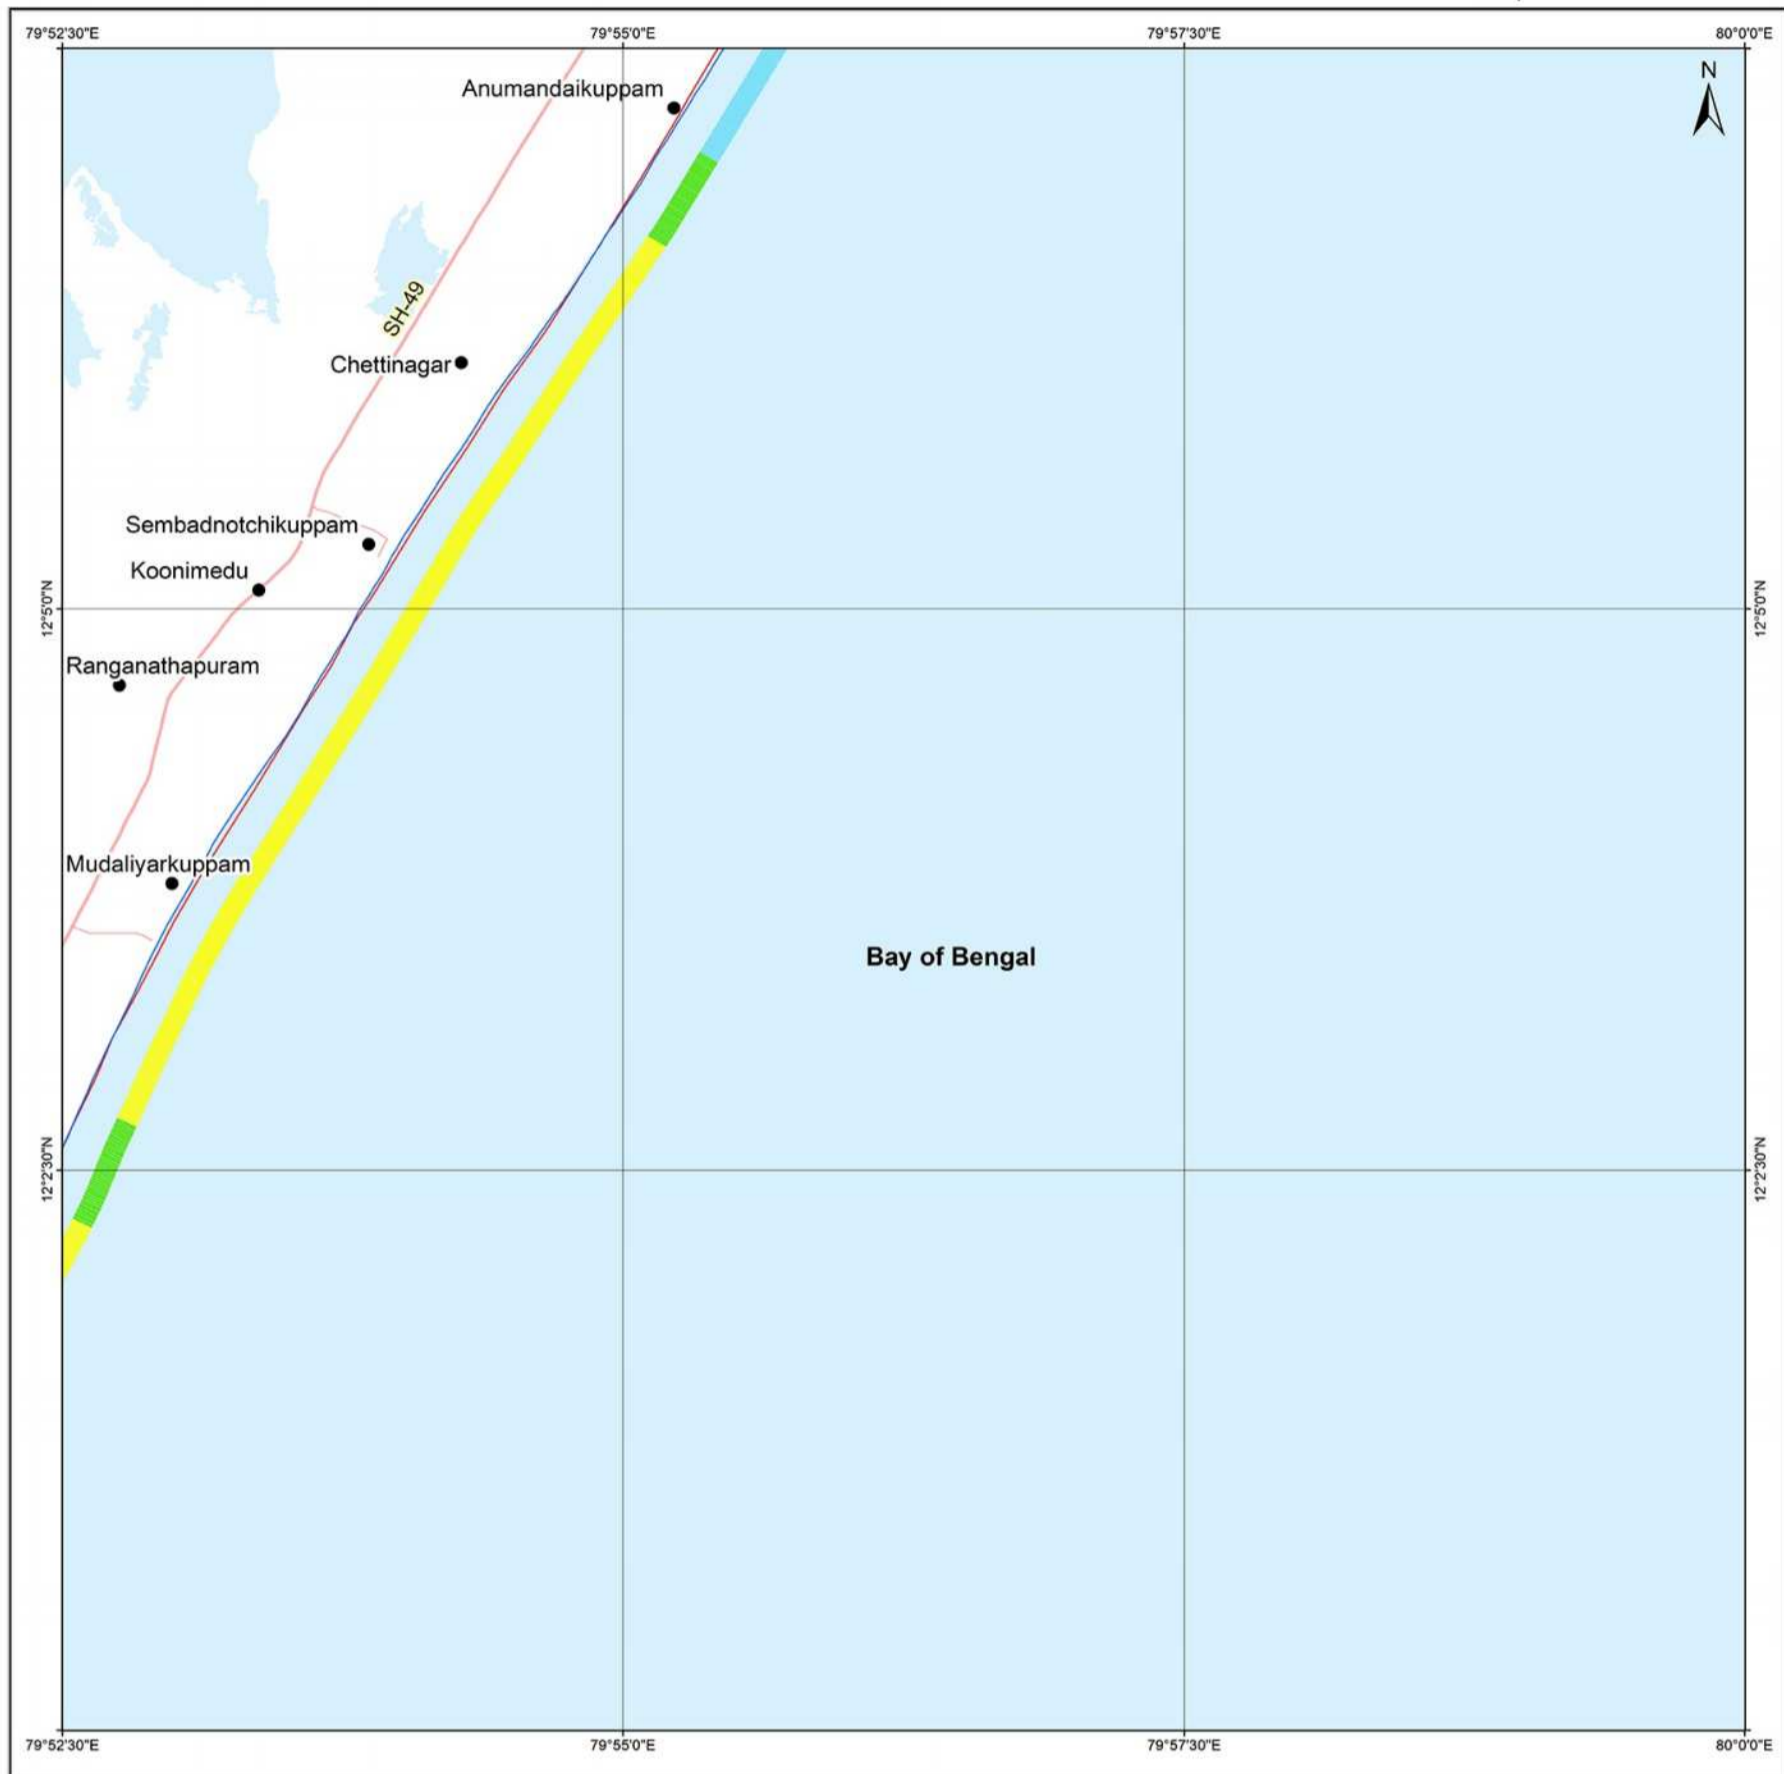
Restricted Use  
57 P / 16 / SE  
Map No. : NCCR/SCM/348

**Shoreline Change Trend for Period 1990 - 2018**

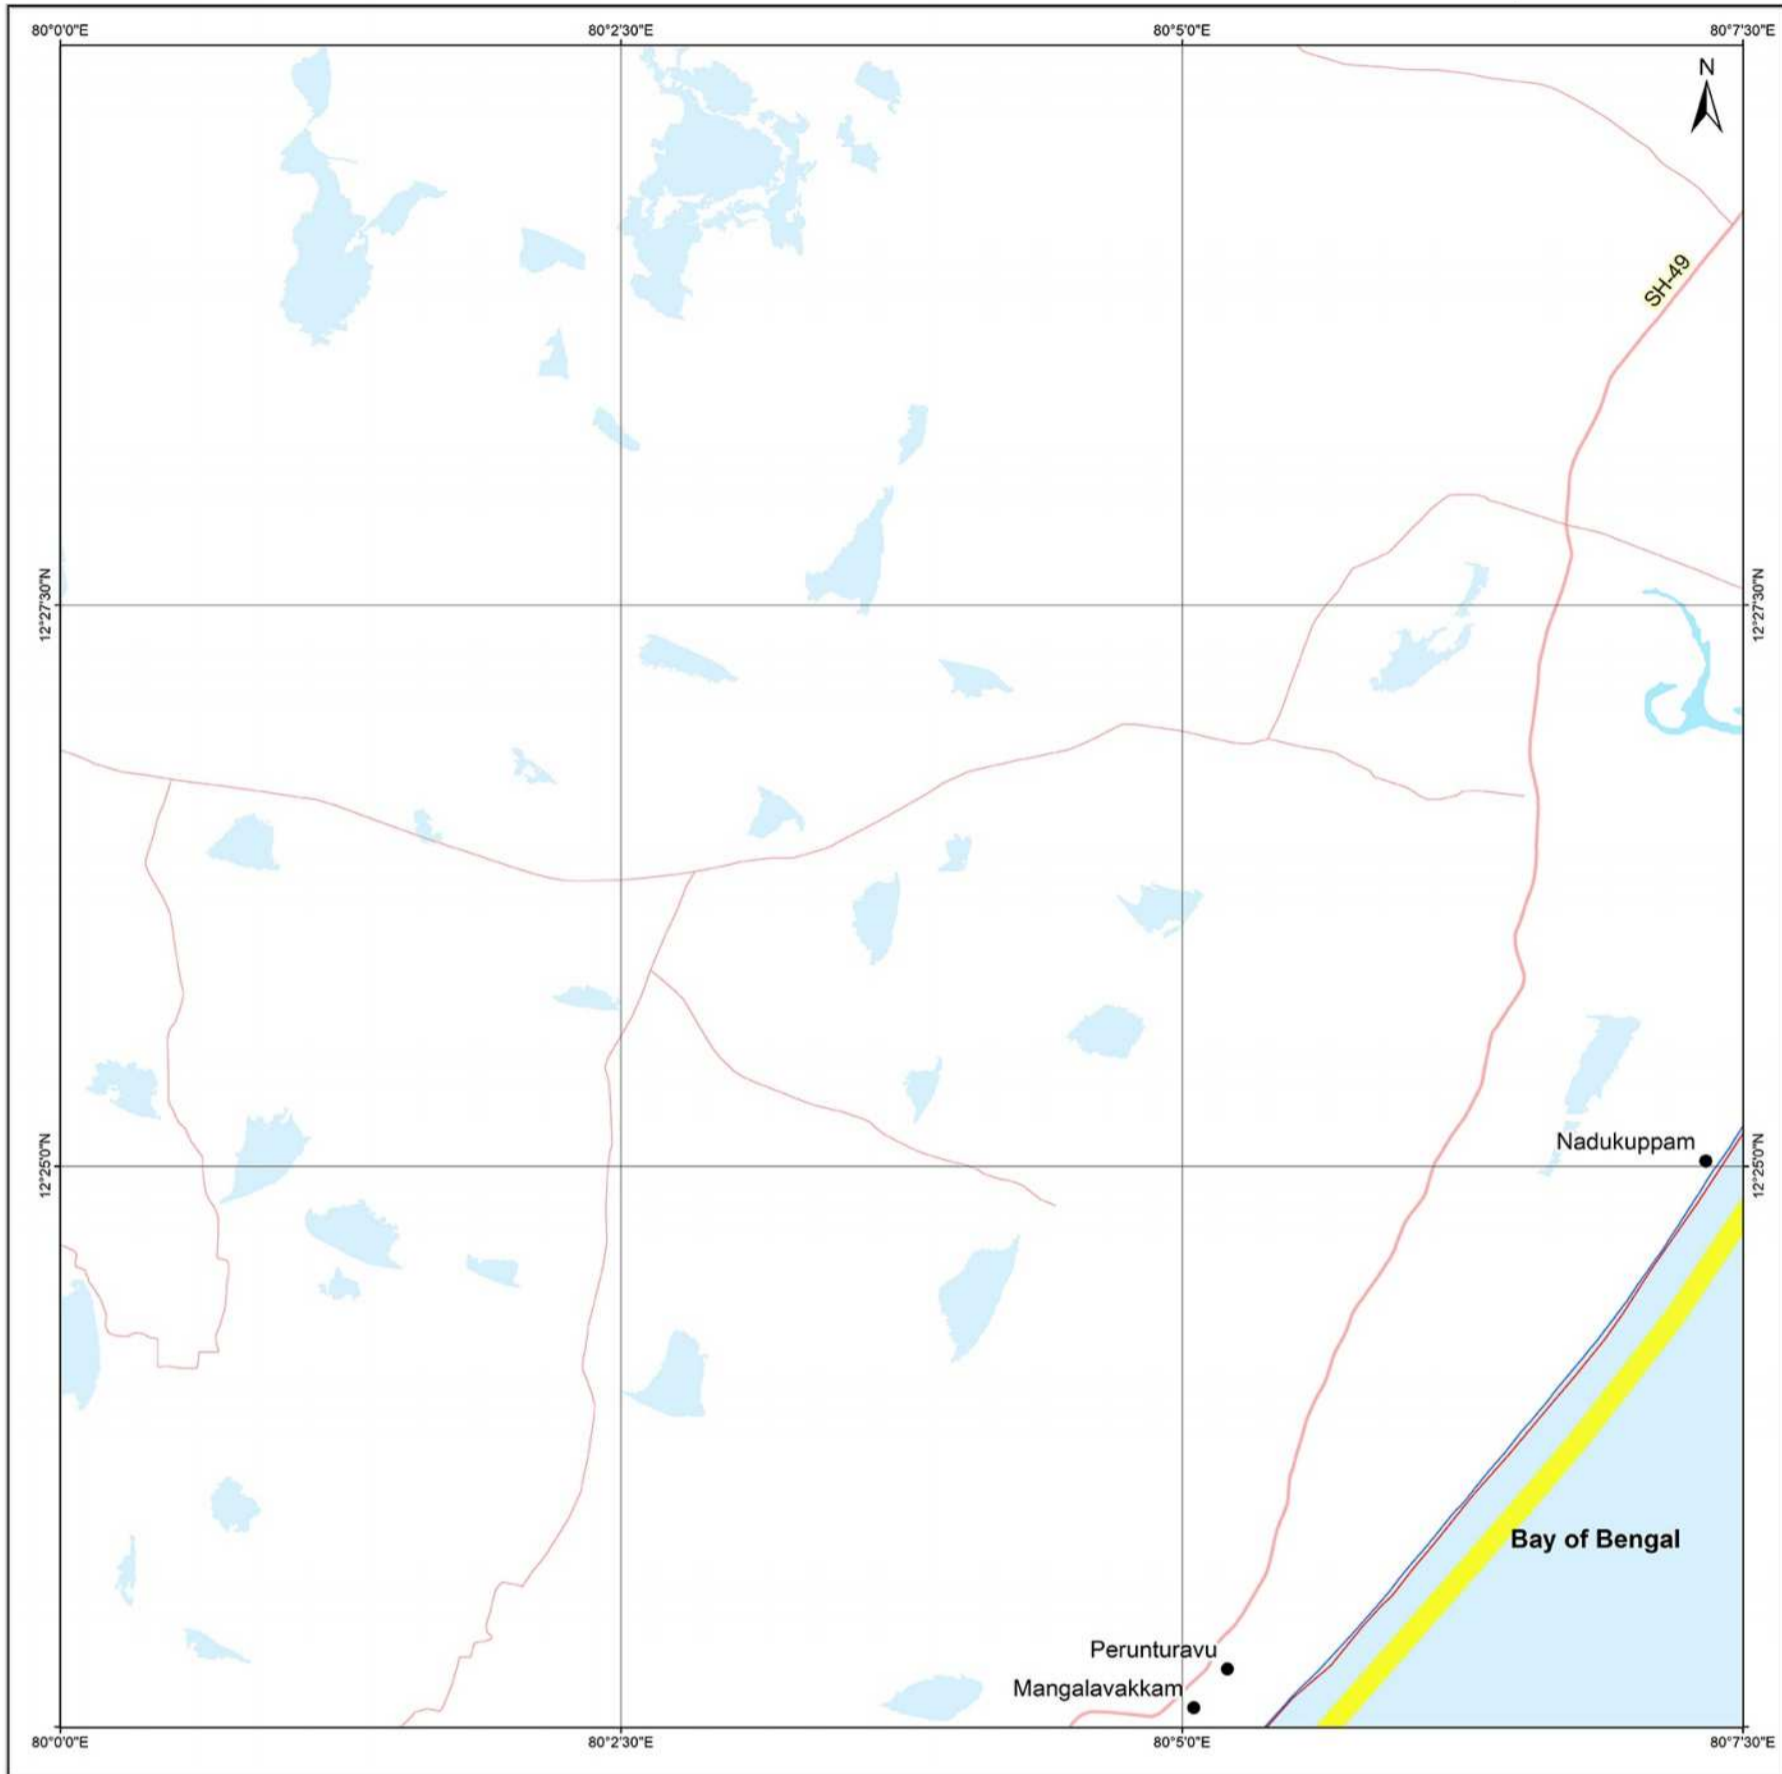
Restricted Use  
66 D / 3 / NW  
Map No. : NCCR/SCM/352

**Shoreline Change Trend for Period 1990 - 2018**

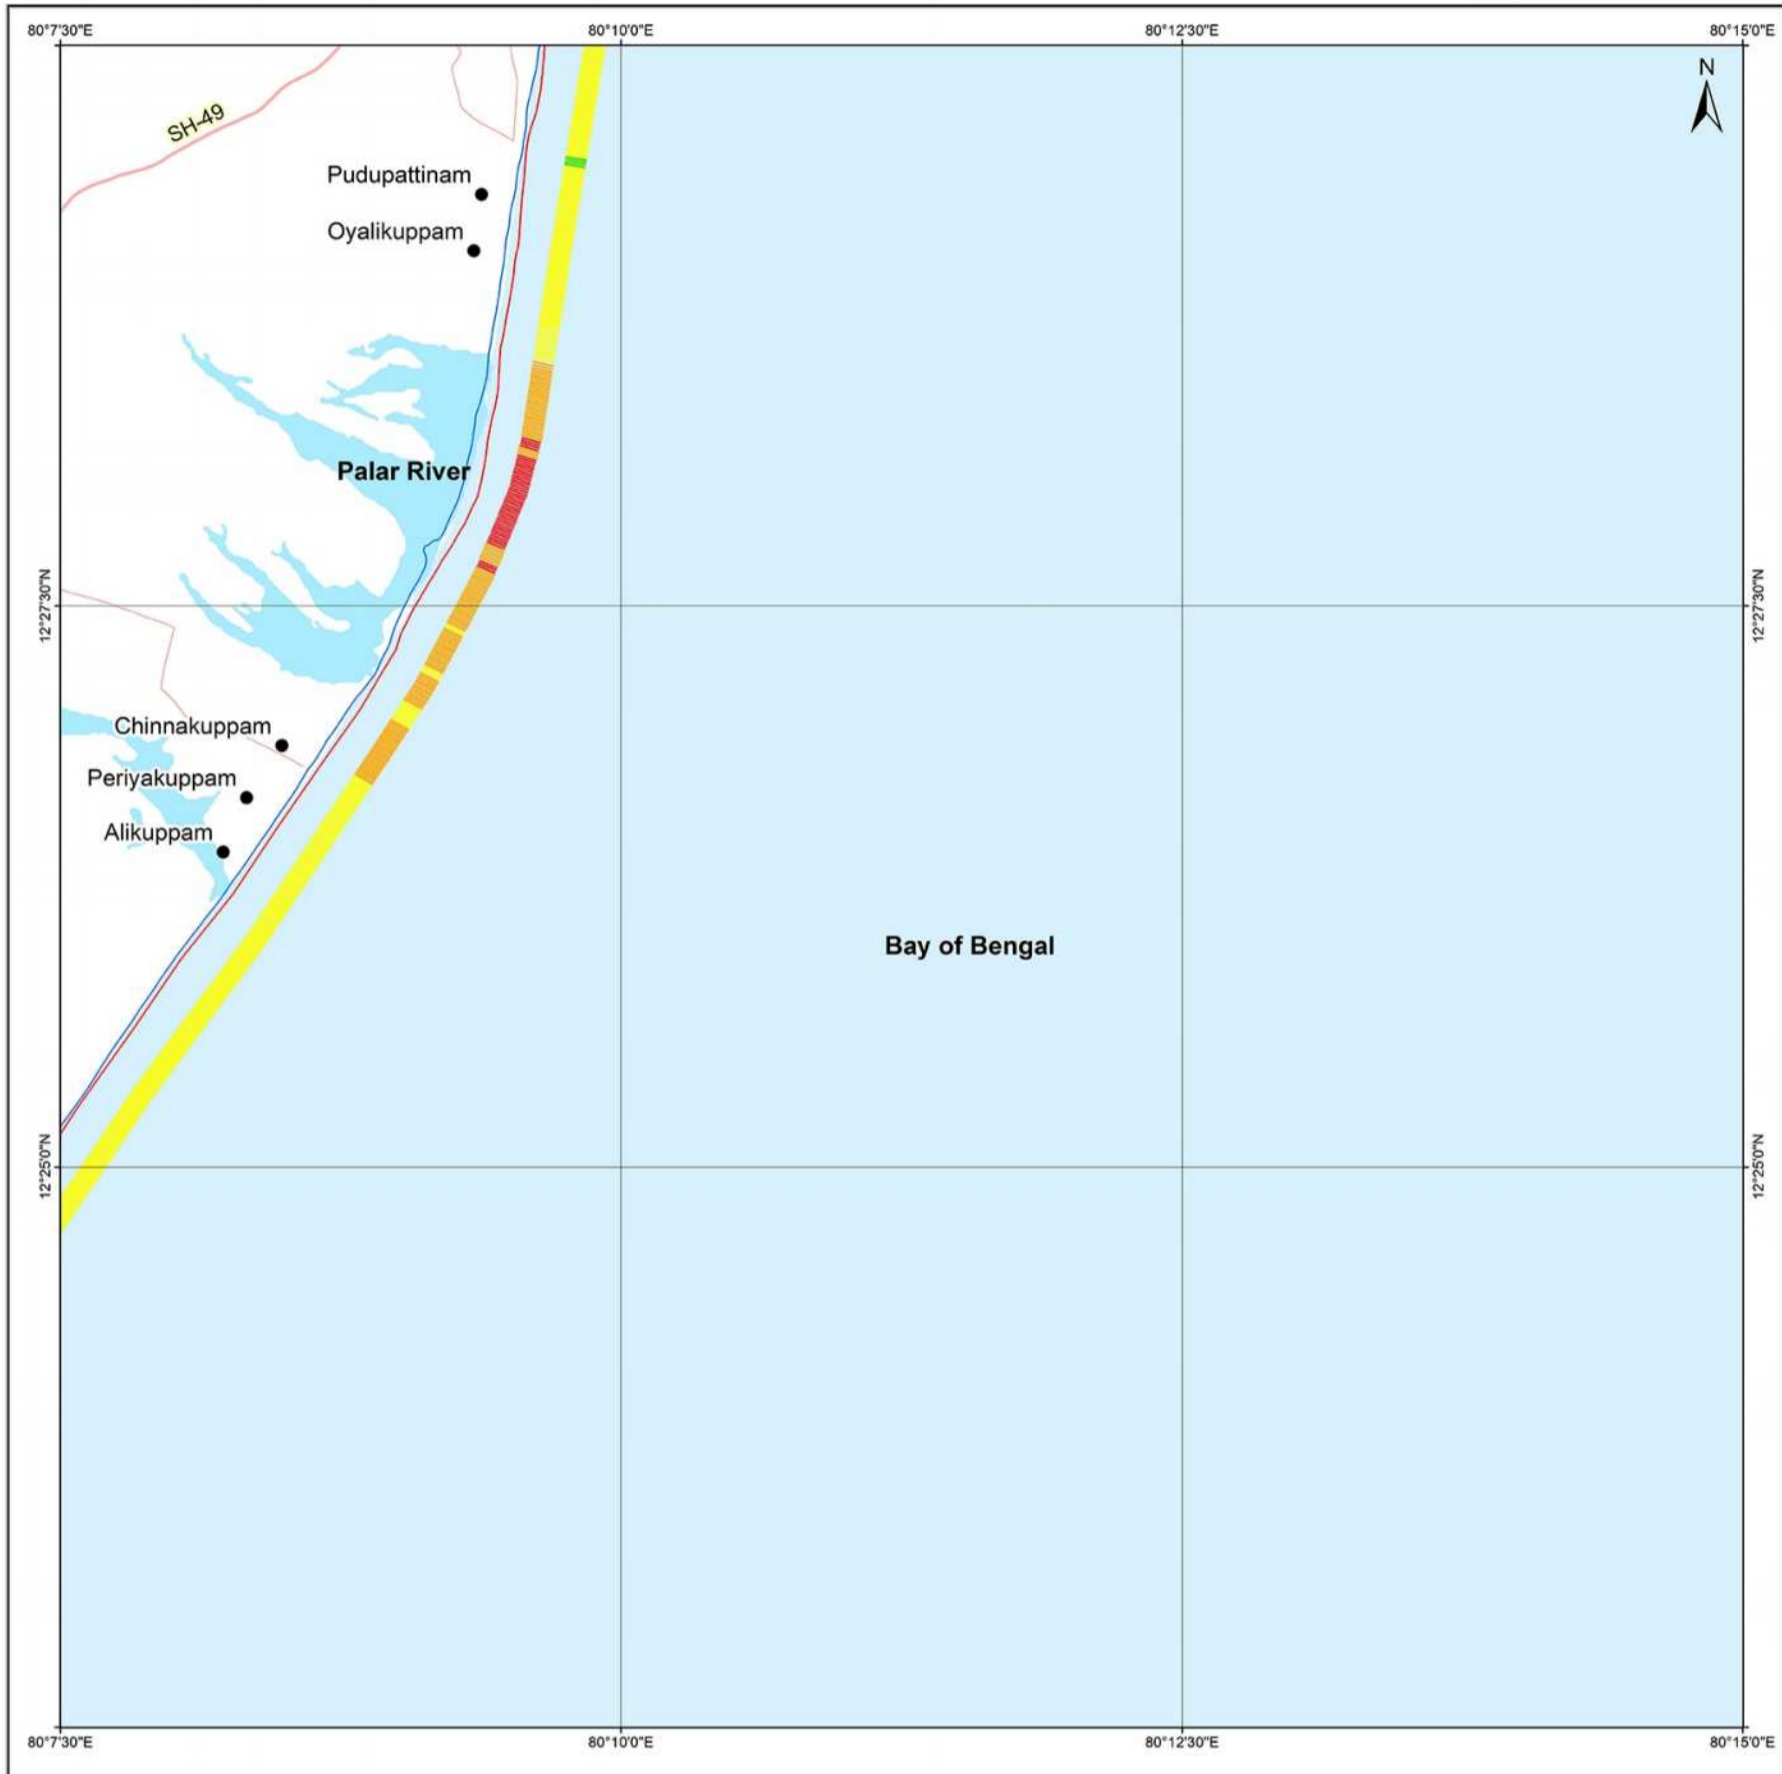
Restricted Use  
66 D / 3 / NE  
Map No. : NCCR/SCM/353

**Shoreline Change Trend for Period 1990 - 2018**
