BEFORE THE NATIONAL GREEN TRIBUNAL

Original Application No. 146 of 2024 (SZ)

**REPORT FILED BY 1<sup>ST</sup> RESPONDENT - THE TAMIL NADU COASTAL ZONE MANAGEMENT  
AUTHORITY.**

**Environment Engineering Division**  
**Department of Civil Engineering**  
**Indian Institute of Technology Madras, Chennai – 600036**

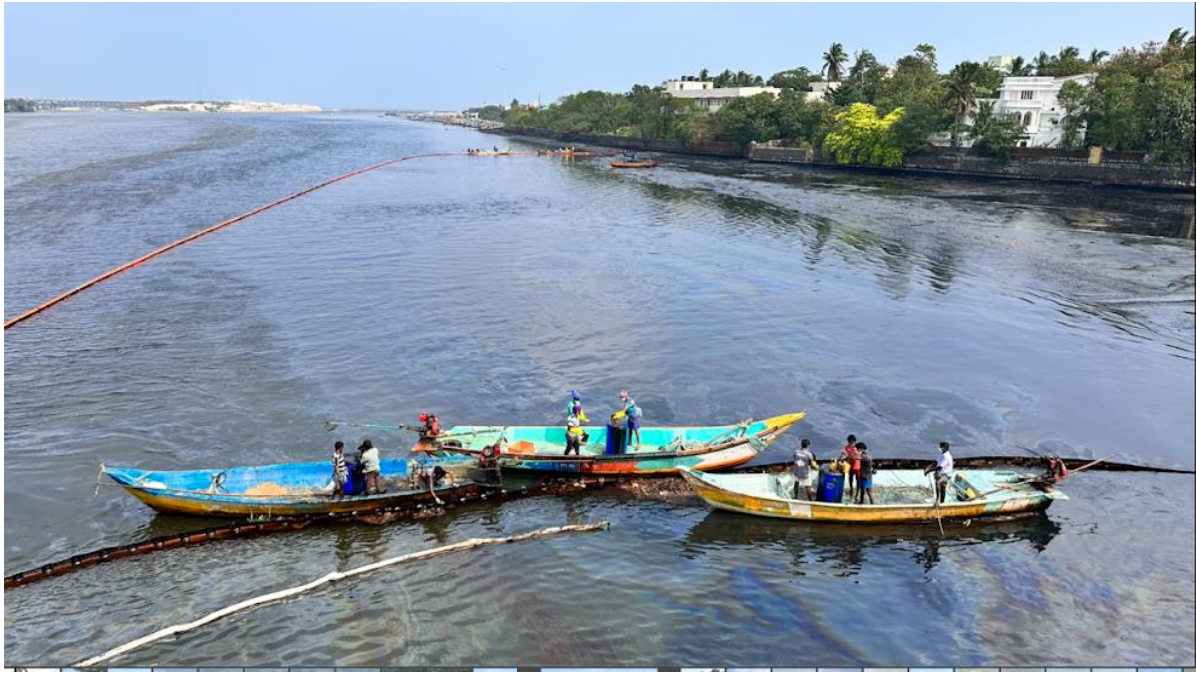
**Figure 1:** Oil spread near Ennore railway bridge

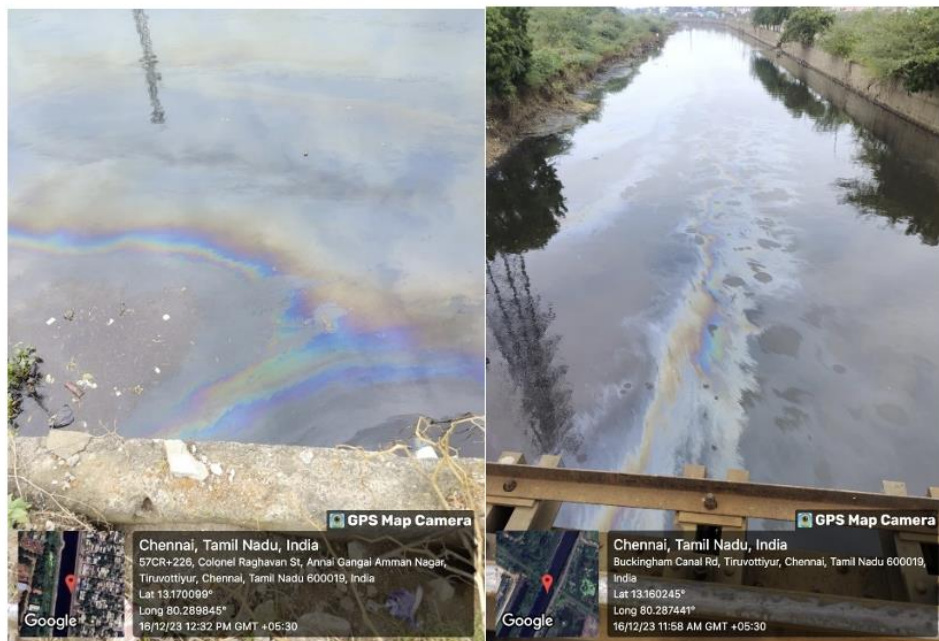
**Figure 2:** Oil contamination in Buckingham Canal

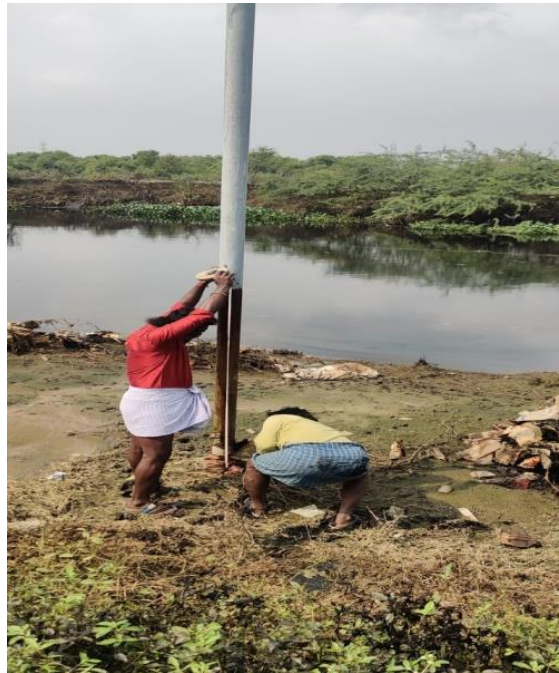
During the flood event, B Canal experienced overflow of oil mixed water, inundating the residential areas of Ernavoor (Zone 11). Lamp posts positioned within the residential vicinity along the B Canal exhibited signs of oil spillage, while flood-affected houses showed oil stains on their walls, reaching heights of 5 to 6 feet. The overflowing oil mixed water adversely affected vegetation, residential buildings, vehicles, and the open wells that serve as sources of groundwater. The field images below provide visual representation of the extent of oil contamination within the residential zones of Ernavoor.

**Figure 5:** Highest oil mixed water level 7.5 feet above normal water level during the cyclone

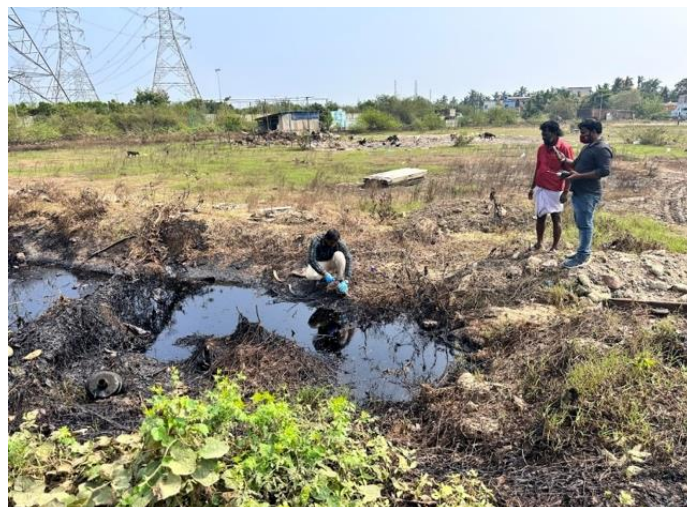
**Figure 6:** Collection of samples from the oil overflow along the banks of B Canal.

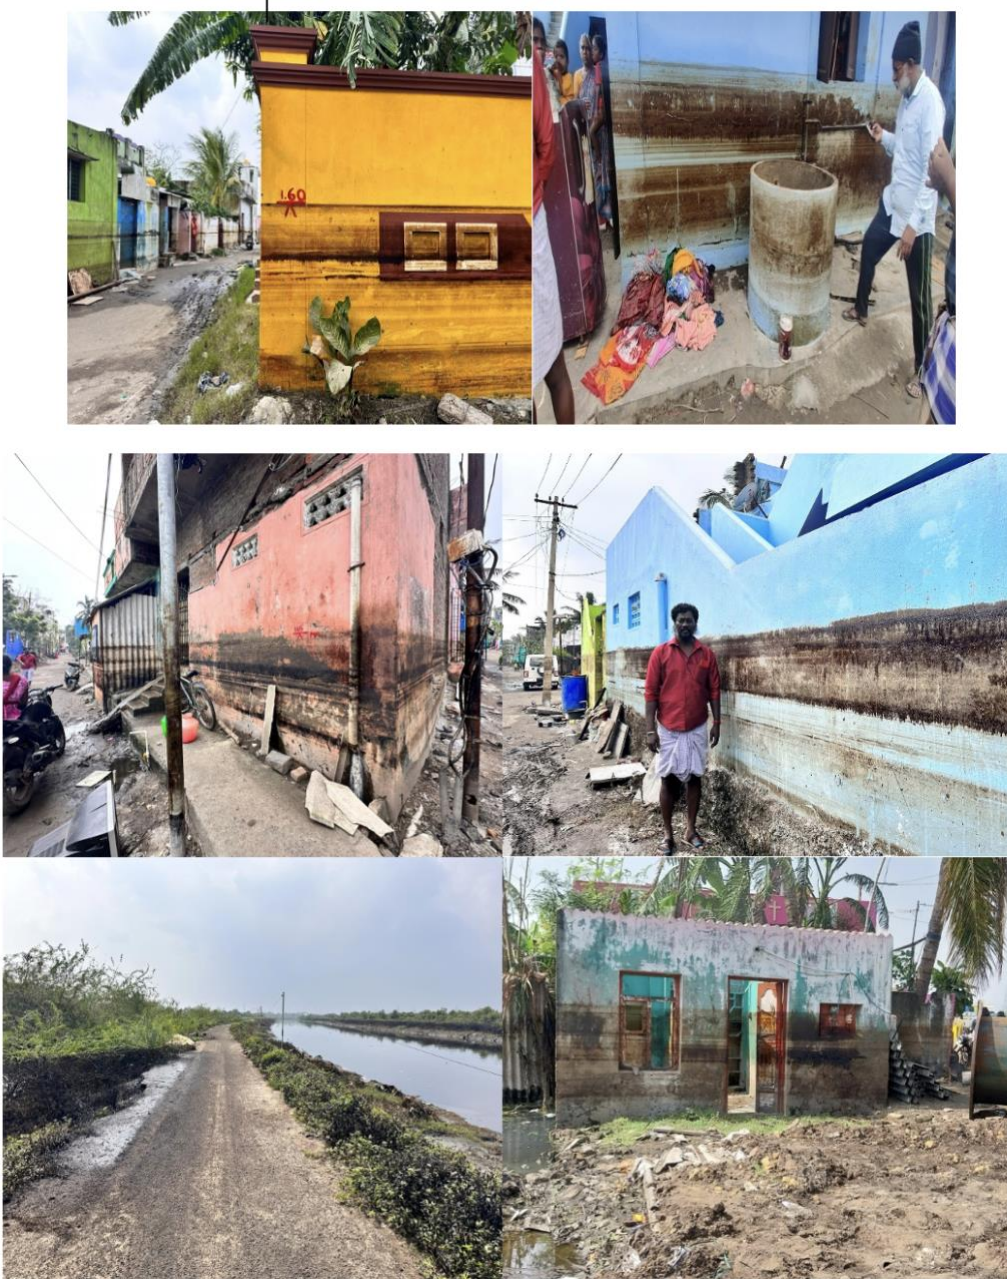
**Figure 7:** Oil marks observed in the residential localities of Ernavoor.

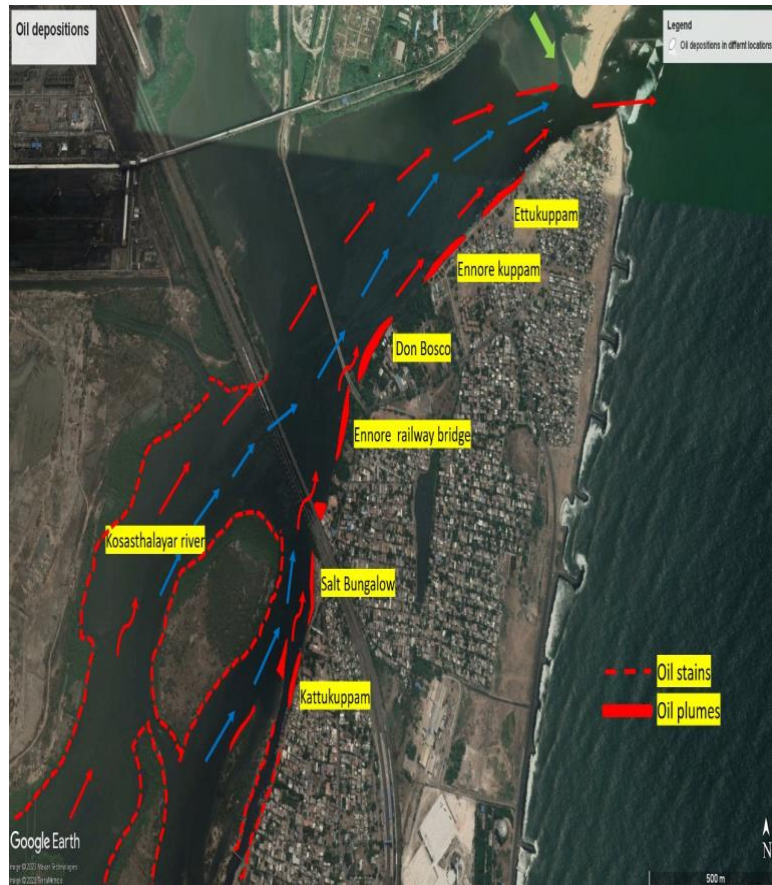
**Figure 8:** Assessment Region 1 - Downstream from ETPS to Creek Area

The depicted figure illustrates the flow of oil, represented by red arrows, along the B Canal and K River after the floodwaters receded. Dotted lines signify the presence of oil stains along all banks of these water bodies and islands. Hotspots, where substantial oil deposits occurred, are highlighted as red patches along the eastern banks of the Creek, extending from Kattukuppam to Nettukuppam.

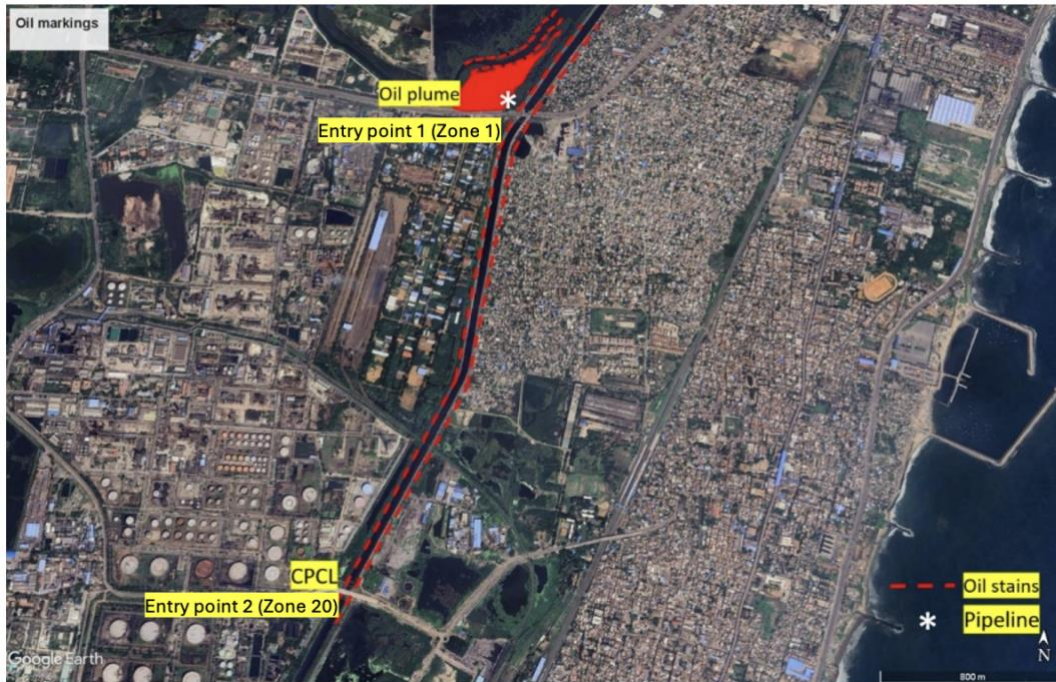
Two oil discharges from the M/s CPCL stormwater drain have occurred in the locations: one in the south (entry point 2), directly into the B Canal, and another in the north (entry point 1), flowing through the stormwater drain adjacent to India Additives, into the flood plains of K river (Zone 1 indicated by the large red patch). Stormwater drains within M/s CPCL were tracked, revealing breaches in the outlet and walls, with all drains and tanks heavily stained with oil. Numerous open oil-water collection tanks were present at ground level, lacking preventive measures to contain oil during flooding or to prevent its escape from the premises.

**Figure 10:** Assessment Region 3 - Upstream of B Canal from Manali High Road to Kodungaiyur showing the entry point of oil into the Buckingham Canal and Kosasthalaiyar River

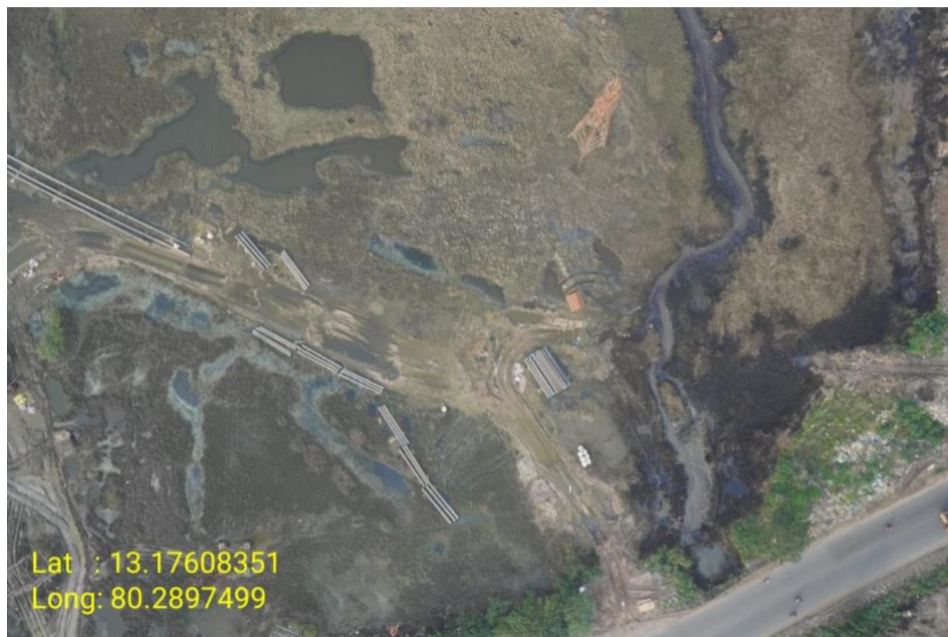
The soil samples collected at Zone 1 had oil markings present up to 2m (max.) depth from the surface. This may have long-term impacts on the region as it is mostly an unconfined aquifer where there are possibilities of contamination of the ground water.

**Figure 11:** Drone image of Zone 1

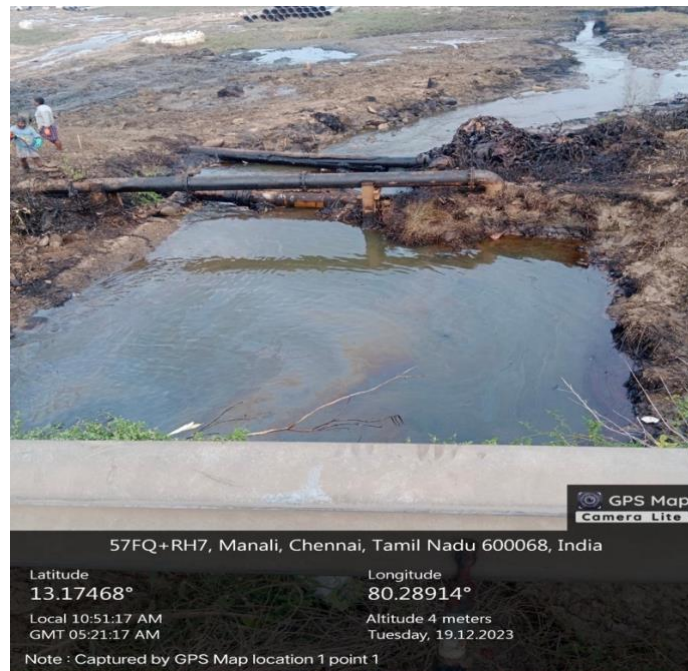
**Figure 12:** Close up view of Zone 1

Verified through drone camera images, the dark patches in the above image signify the presence of oil pools surrounding the stormwater outlets flowing towards the K River. Extensive sampling of soil and water at this contaminated site revealed high oil content. Upstream from this contaminated site, deposits of oil-contaminated sludge are still present, likely resulting from backflow from this leakage point. However, no significant oil spill or sludge deposition was observed beyond 100 meters from this location, indicating that Zone 1 is likely the initial point of oil spillage or the source itself.

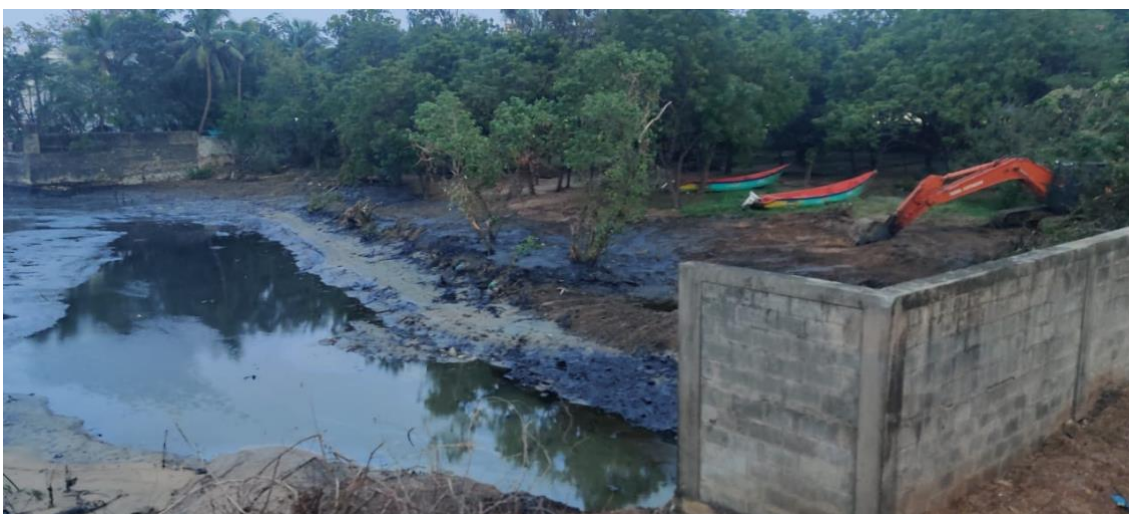
**Figure 13:** Earth moving machinery at the oil spill site

Numerous earthmoving machines were on-site (Figure 13), along with several laborers tasked with covering the oil stains in the floodplain. Arrows pointing towards the two locations in the Buckingham Canal (Figure 14) distinctly indicate that the bund has been reworked following the oil spill, with one section appearing clean and the other section visibly stained with oil.

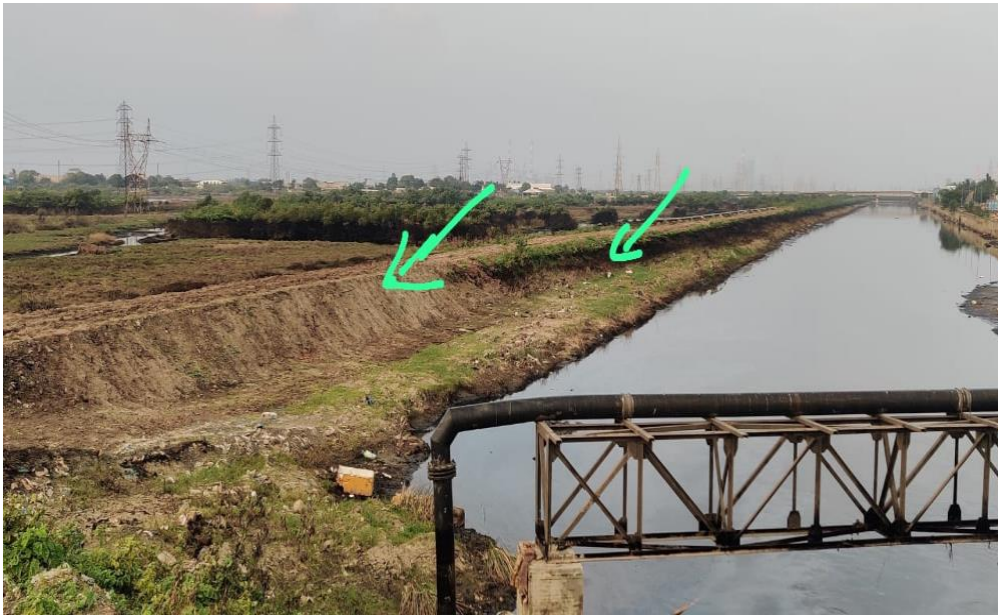
**Figure 14:** B canal possibly breached and oil stain covered.

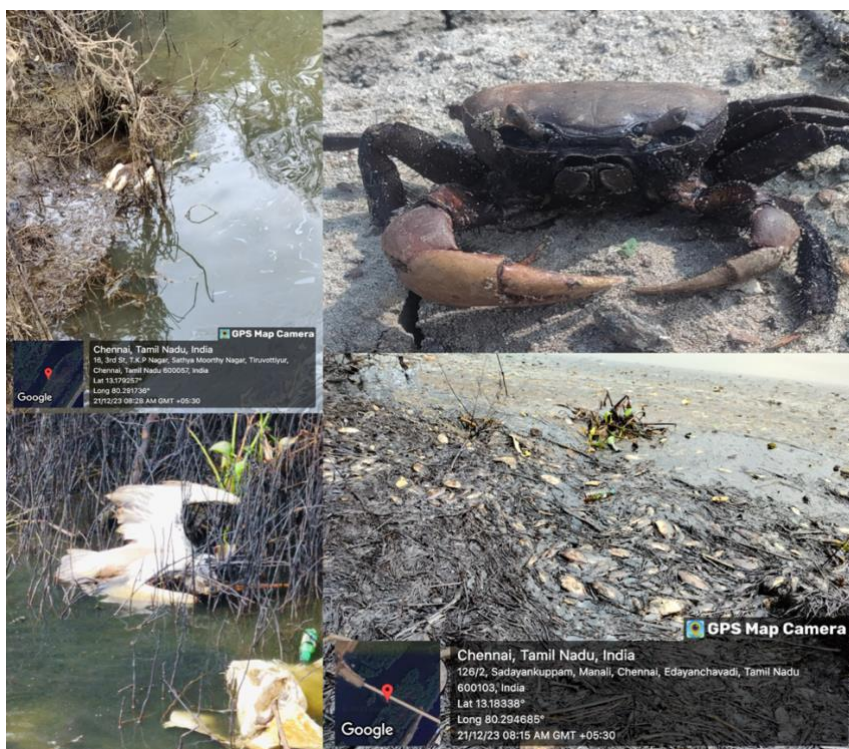
**Figure 16:** Dead birds, crabs, and fishes found in the contaminated site

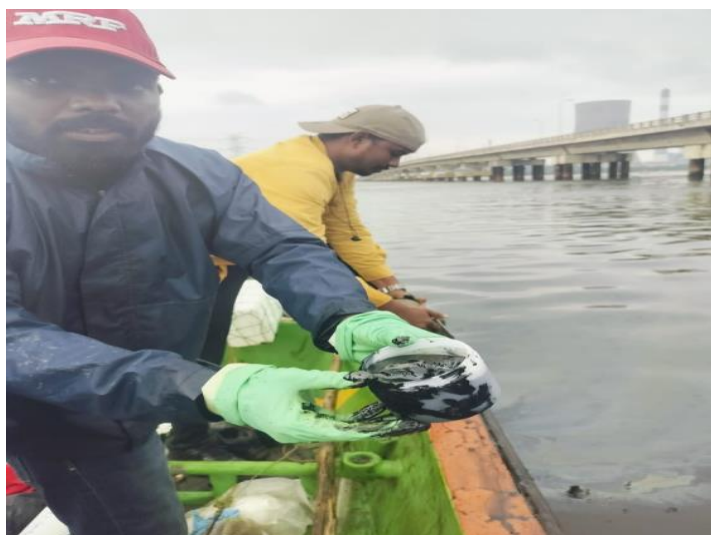
**Figure 19:** Sediment sample collection from midstream and banks

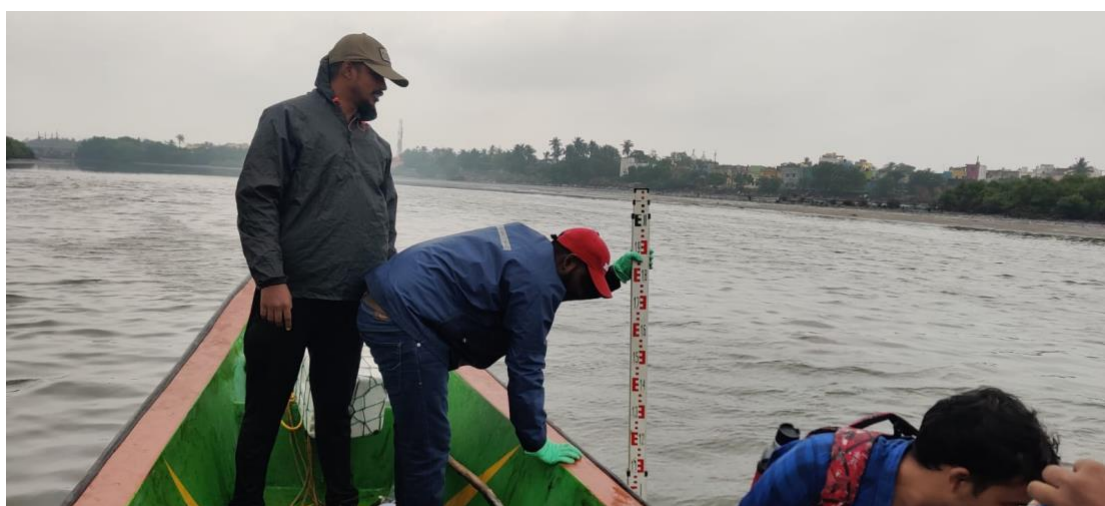
**Figure 20:** Depth measurement

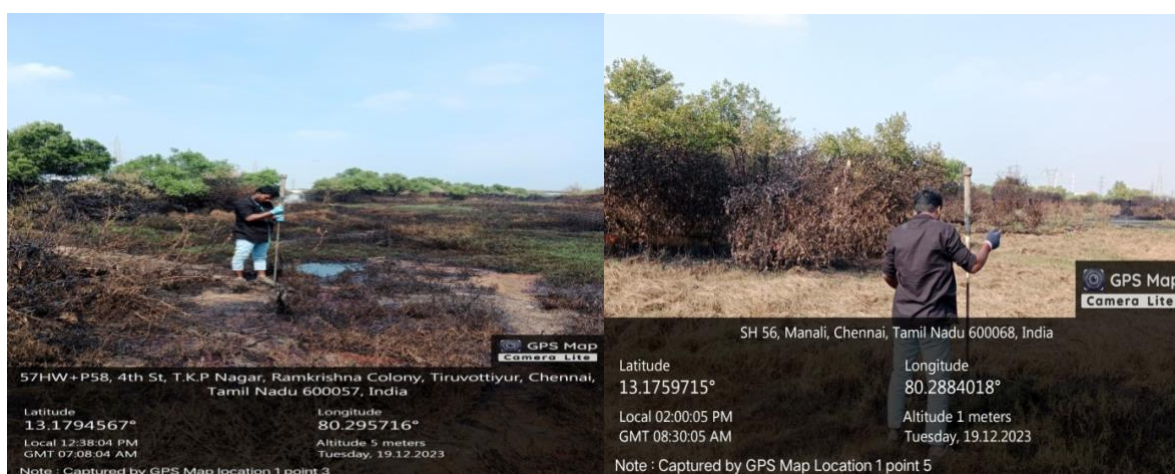
**Figure 21:** Sampling of soil cores

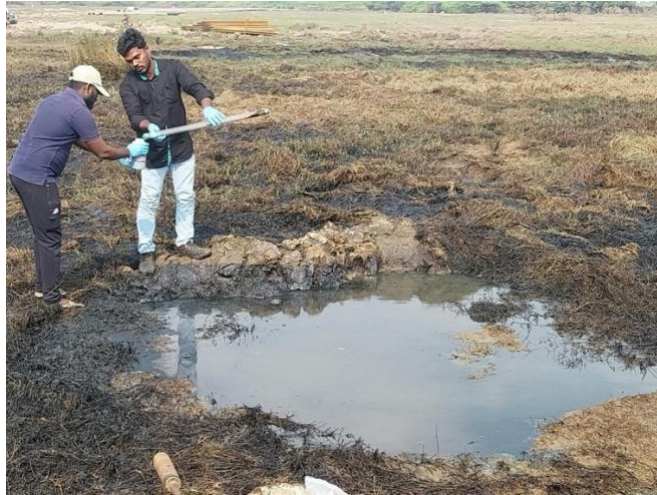
**Figure 22:** Collecting water samples using a bailer

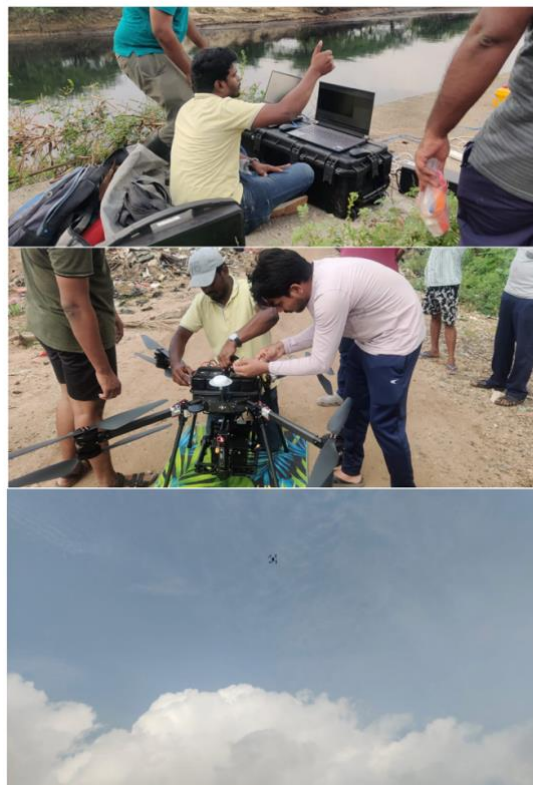
A drone survey was carried out to quantify the oil contamination spatially. Drones were employed to capture the hyper-spectral aerial images, that will help us differentiate water from oil. The drone images captured (Figure 24) show the oil sheen floating on B canal and K River.

**Figure 23:** Capturing high-resolution images using drone survey

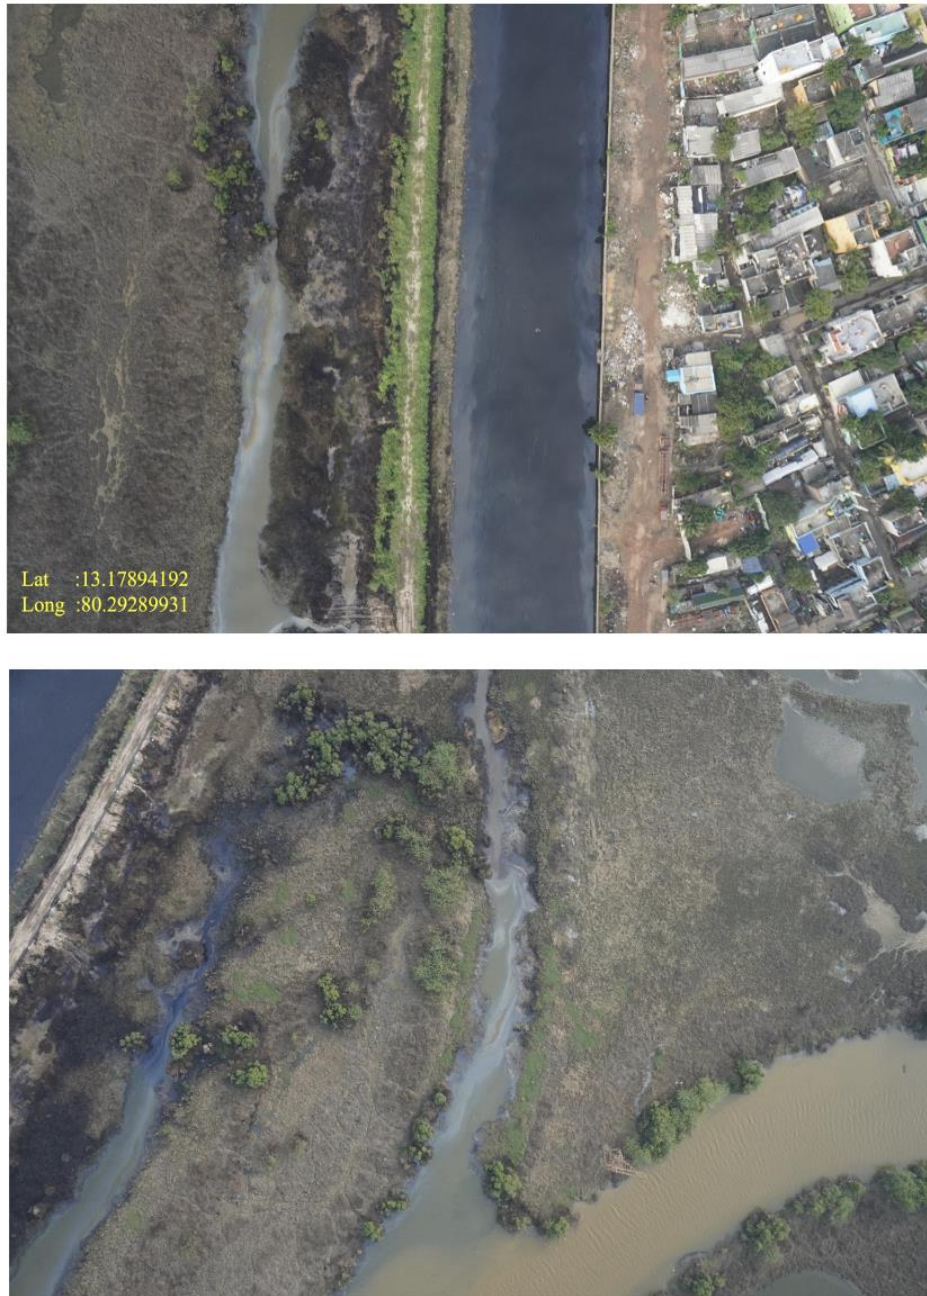
**Figure 24:** Drone images showing oil contamination in B Canal and K River

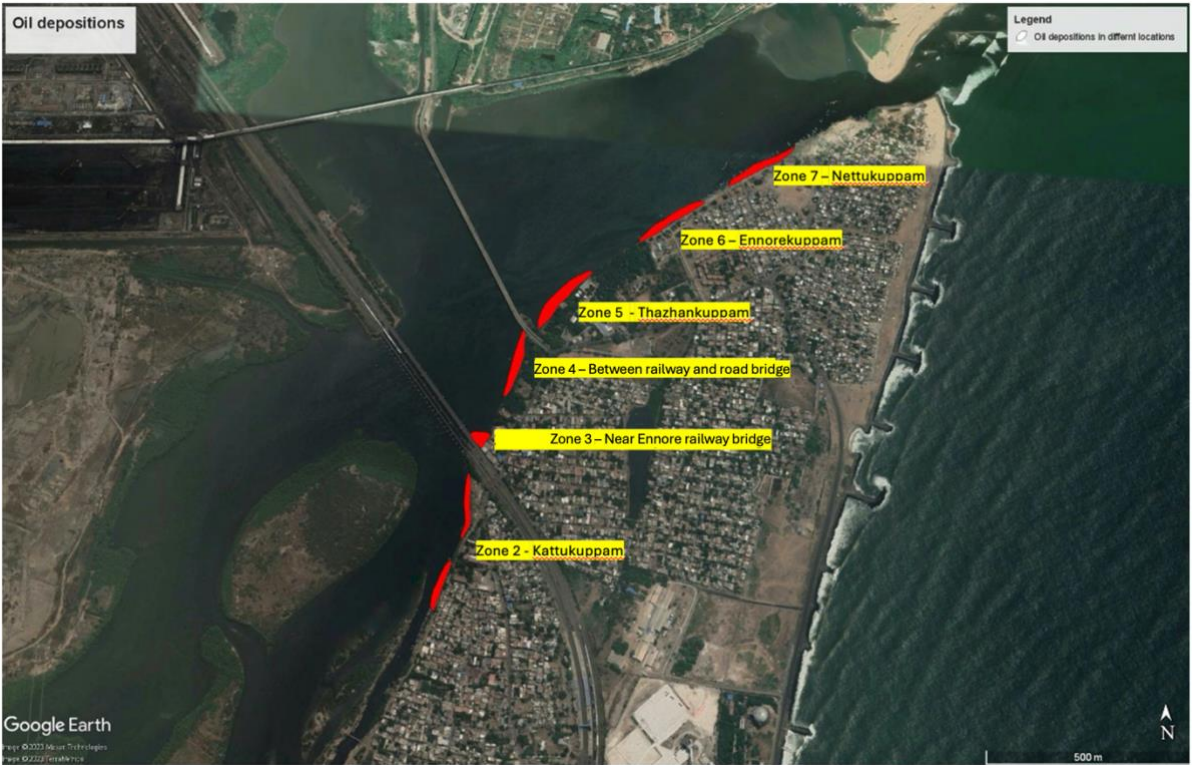
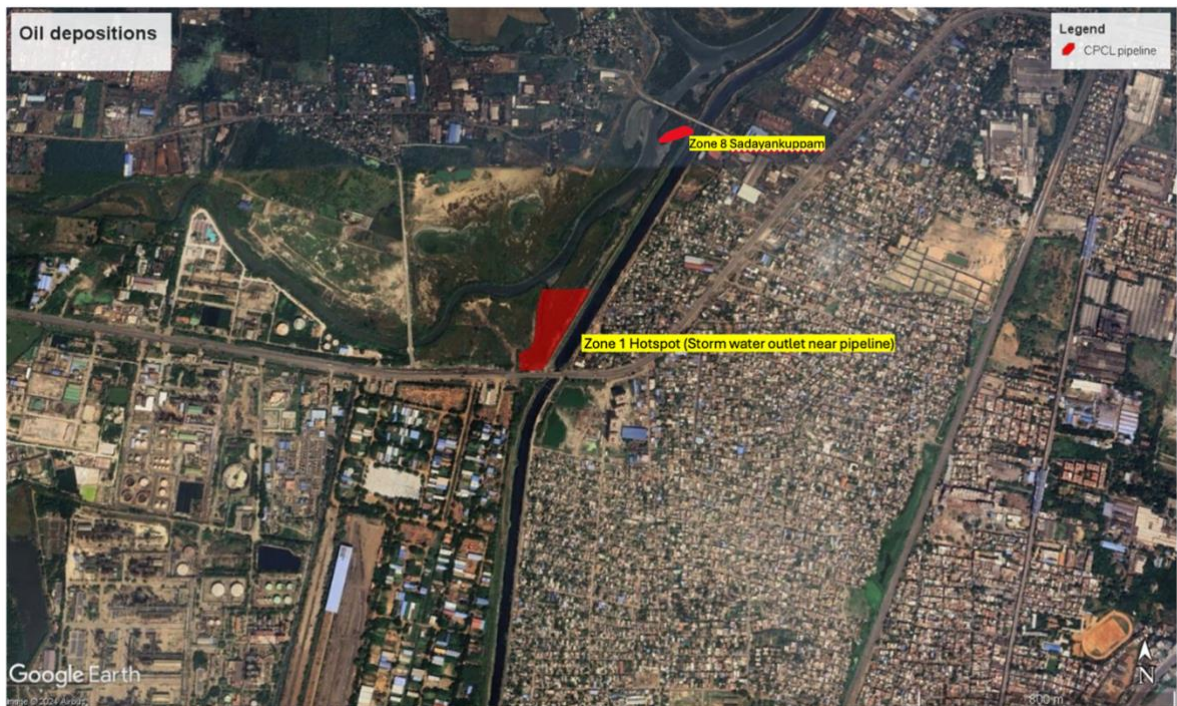
Figure 28: Soil Contamination Zones

Figure 29: Soil Contamination Zones

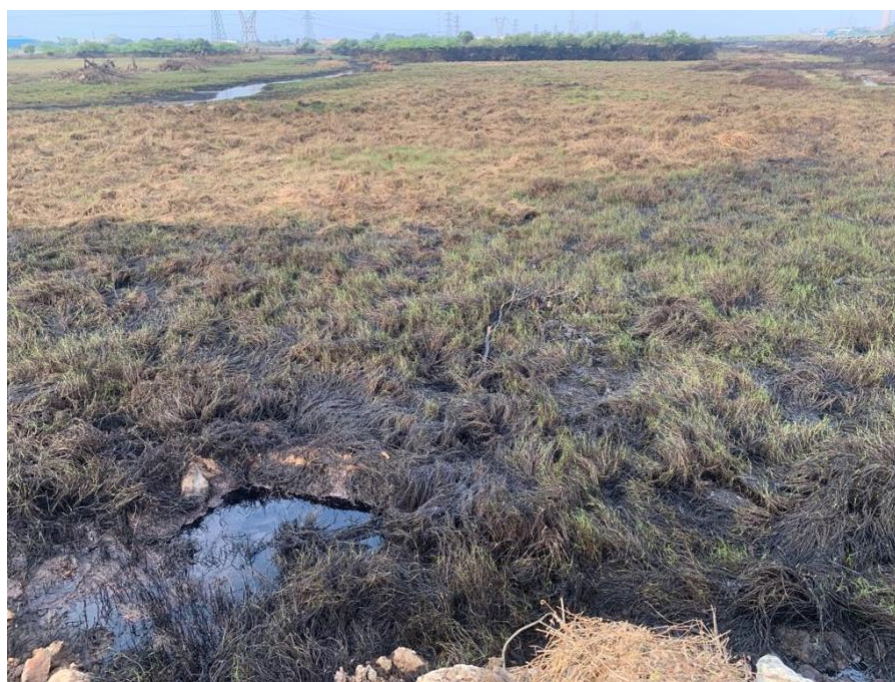
Oil was found ponding along the B Canal in the upstream stretch where maximum flood levels had taken the oil above the bank of the canal and into the eastern residential and industrial areas. Oil was also found ponding within the mangrove islands after the flood water receded. Largest oil ponding was observed in Zone 1. Area of the contamination zones for oil pools were estimated using Google Earth Pro. The volume of oil ponded could be anywhere between 31.4 cu.m. to 314 cu.m.

**Figure 30:** Oil pools on K river flood plain

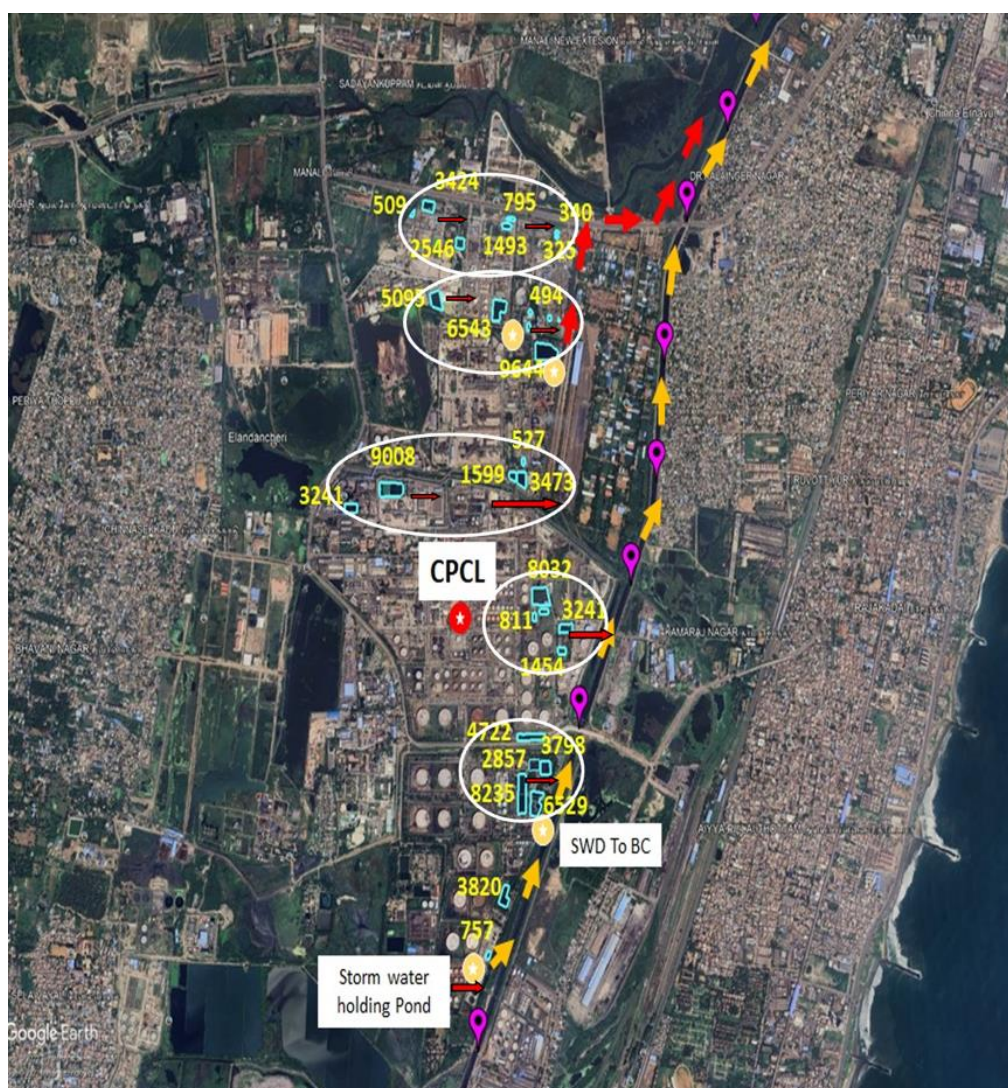
Google Earth images were used to assess the open tanks in M/s CPCL close to the two storm water outlets. The total area of these open tanks are worked out as 95,058 sq.m.

**Figure 34:** Open tank locations and area in sq.m.
