**BEFORE THE NATIONAL GREEN TRIBUNAL SOUTHERN ZONE AT  
CHENNAI**

Original Application No. 152 of 2023

**MEMO FILED BY APPLICANT**

Fisher Bathymetry at 1700m dredging section of Kosasthalaiyar dated 24.06.2025

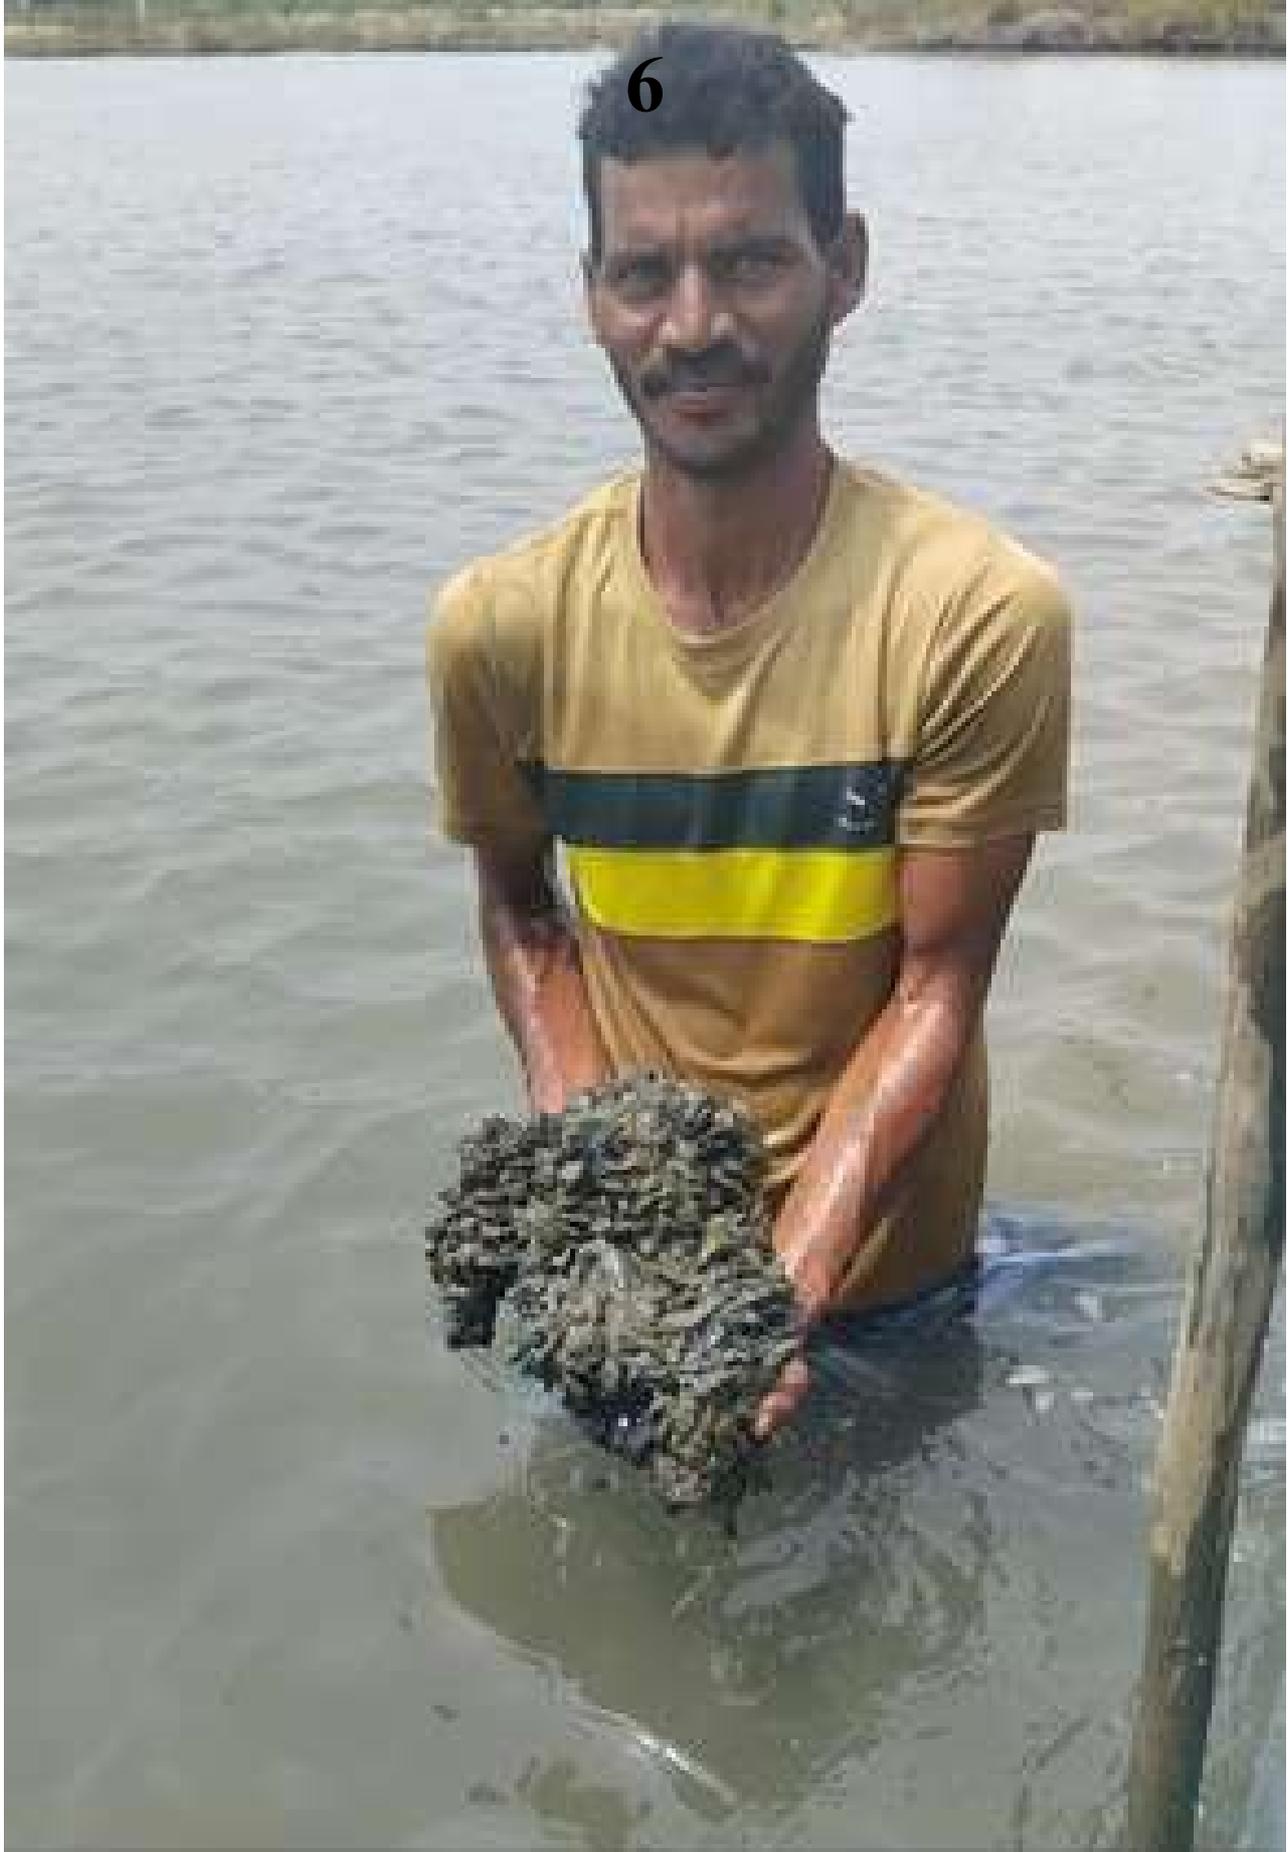
Kattupalli Road, Puzhuthivakkam,  
Kattupalli, Tamil Nadu 600120,

Lat: 13.291210, Long: 80.329549

10 Jun, 25, 01:09 pm, Tuesday

4. The spread of the kaakka aazhi has only increased with the passage of time, and the livelihood of fishers in the Ennore-Pulicat wetlands is being adversely affected with every passing day.

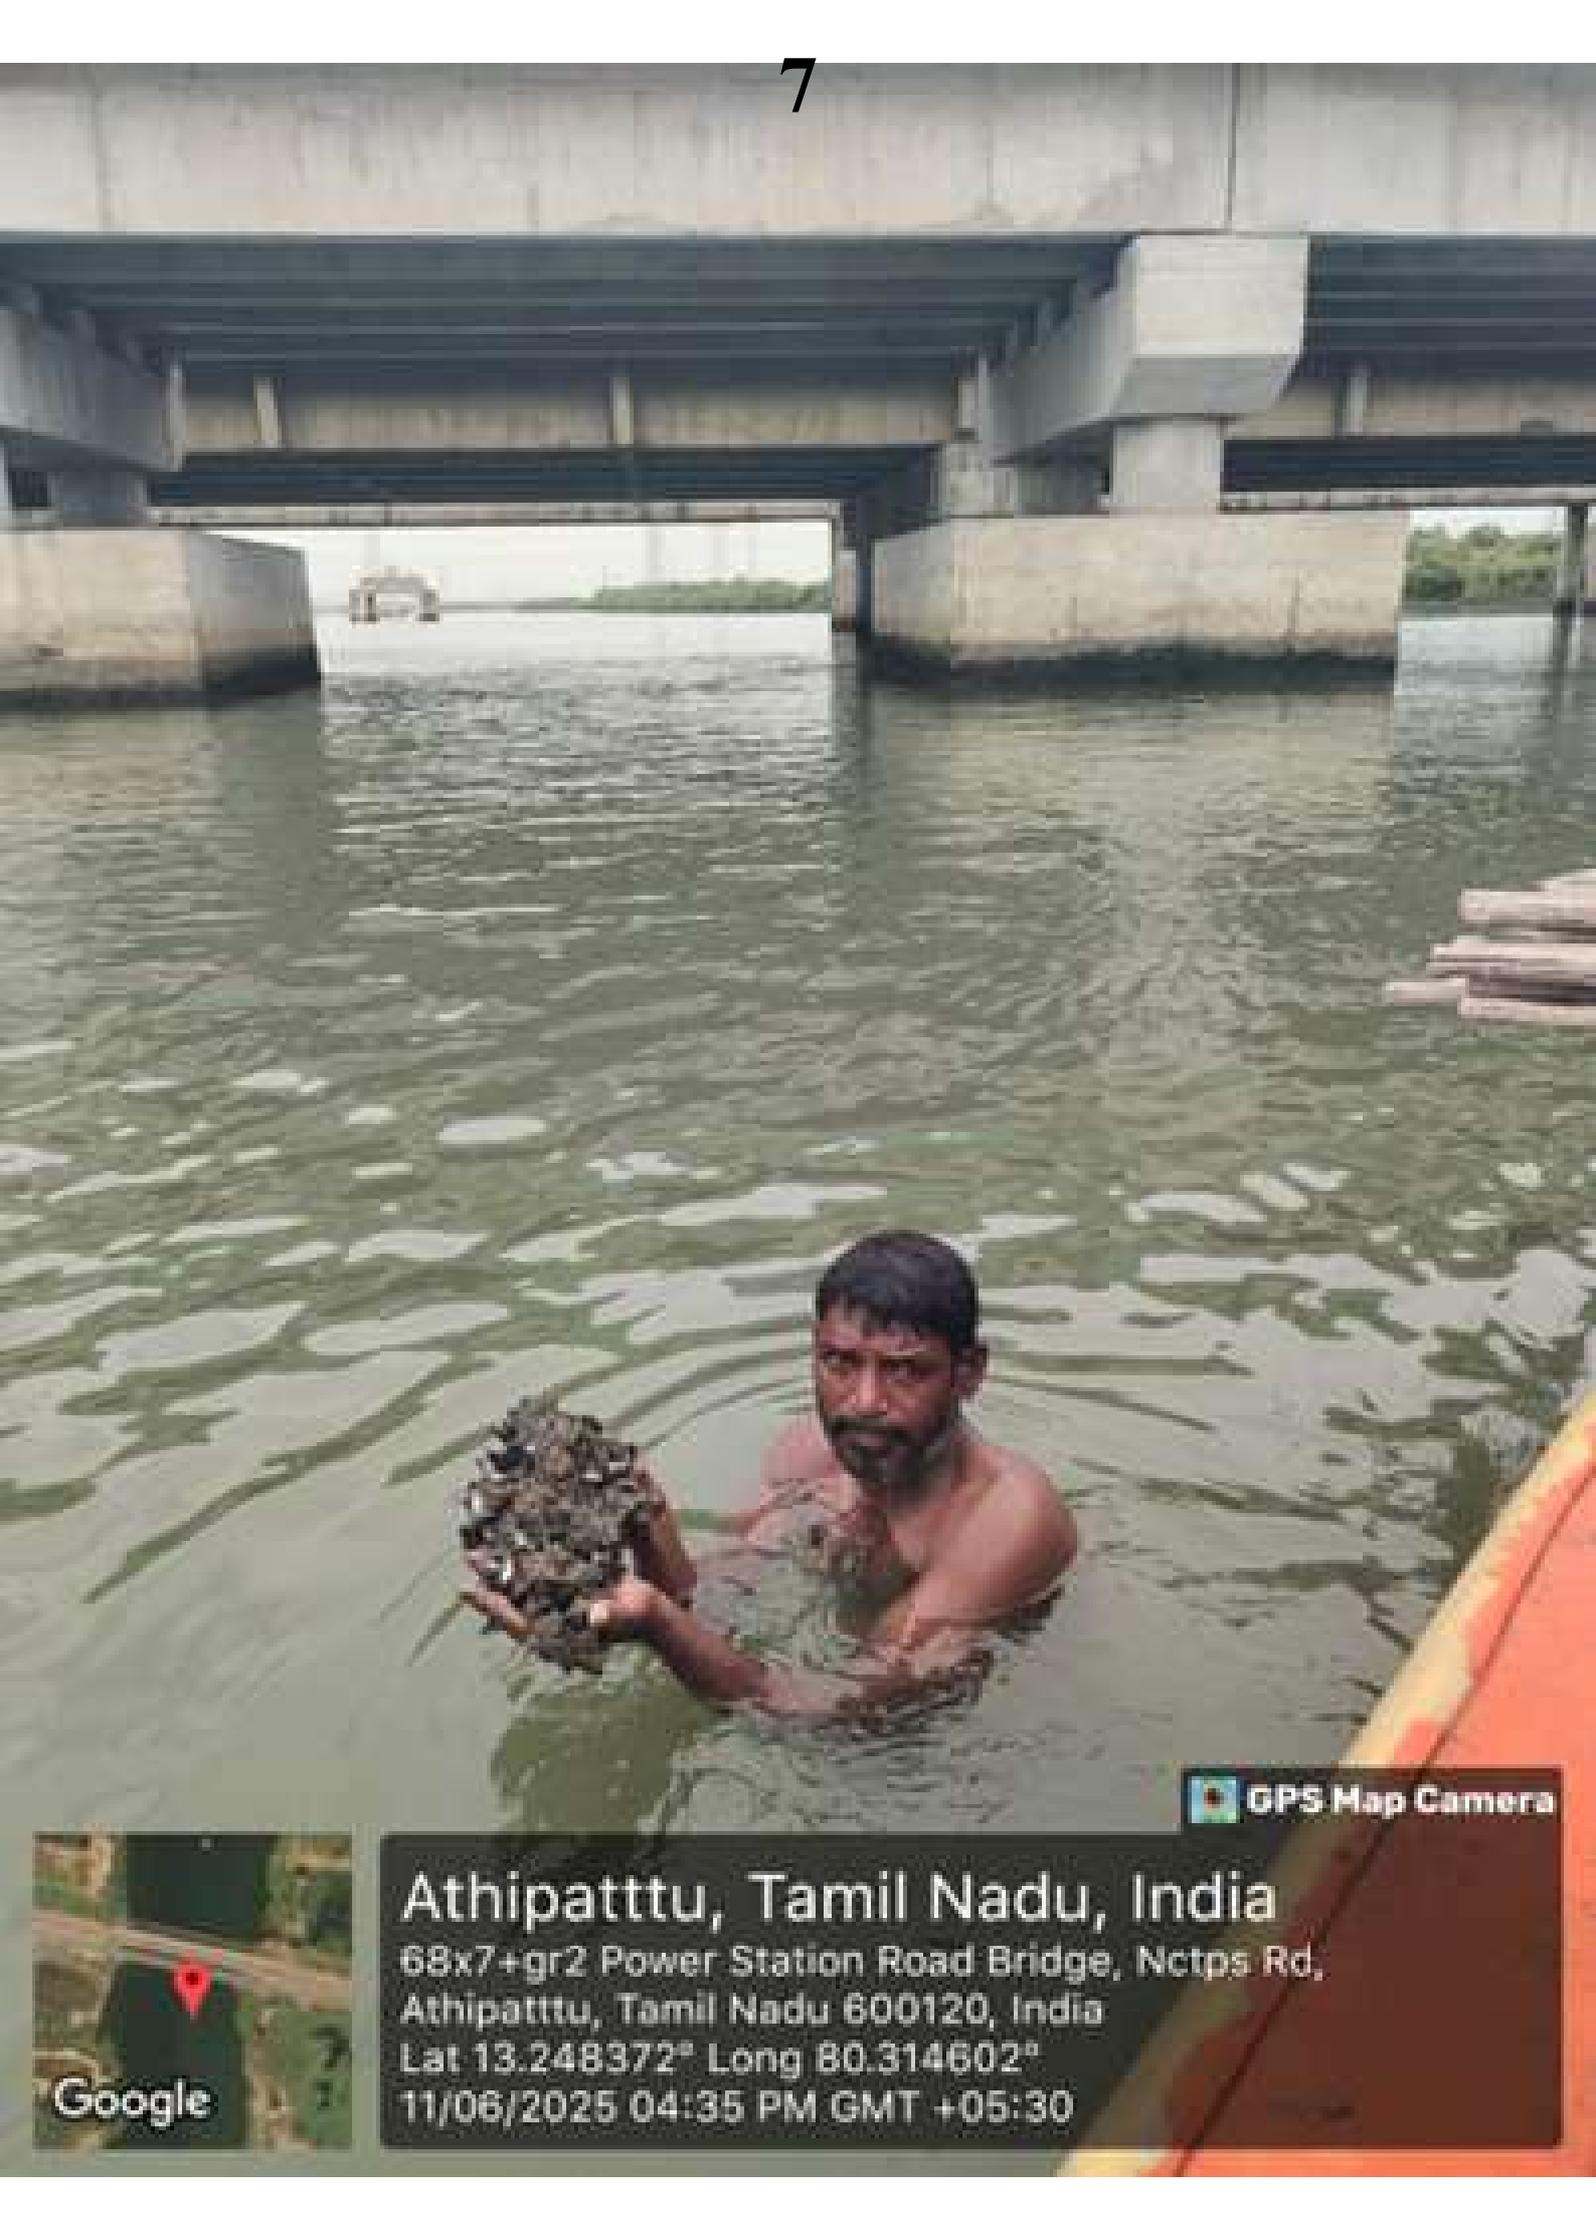
### Athipattu, Tamil Nadu, India

68x7+gr2 Power Station Road Bridge, Nctps Rd,  
Athipattu, Tamil Nadu 600120, India

Lat 13.248372° Long 80.314602°

11/06/2025 04:35 PM GMT +05:30

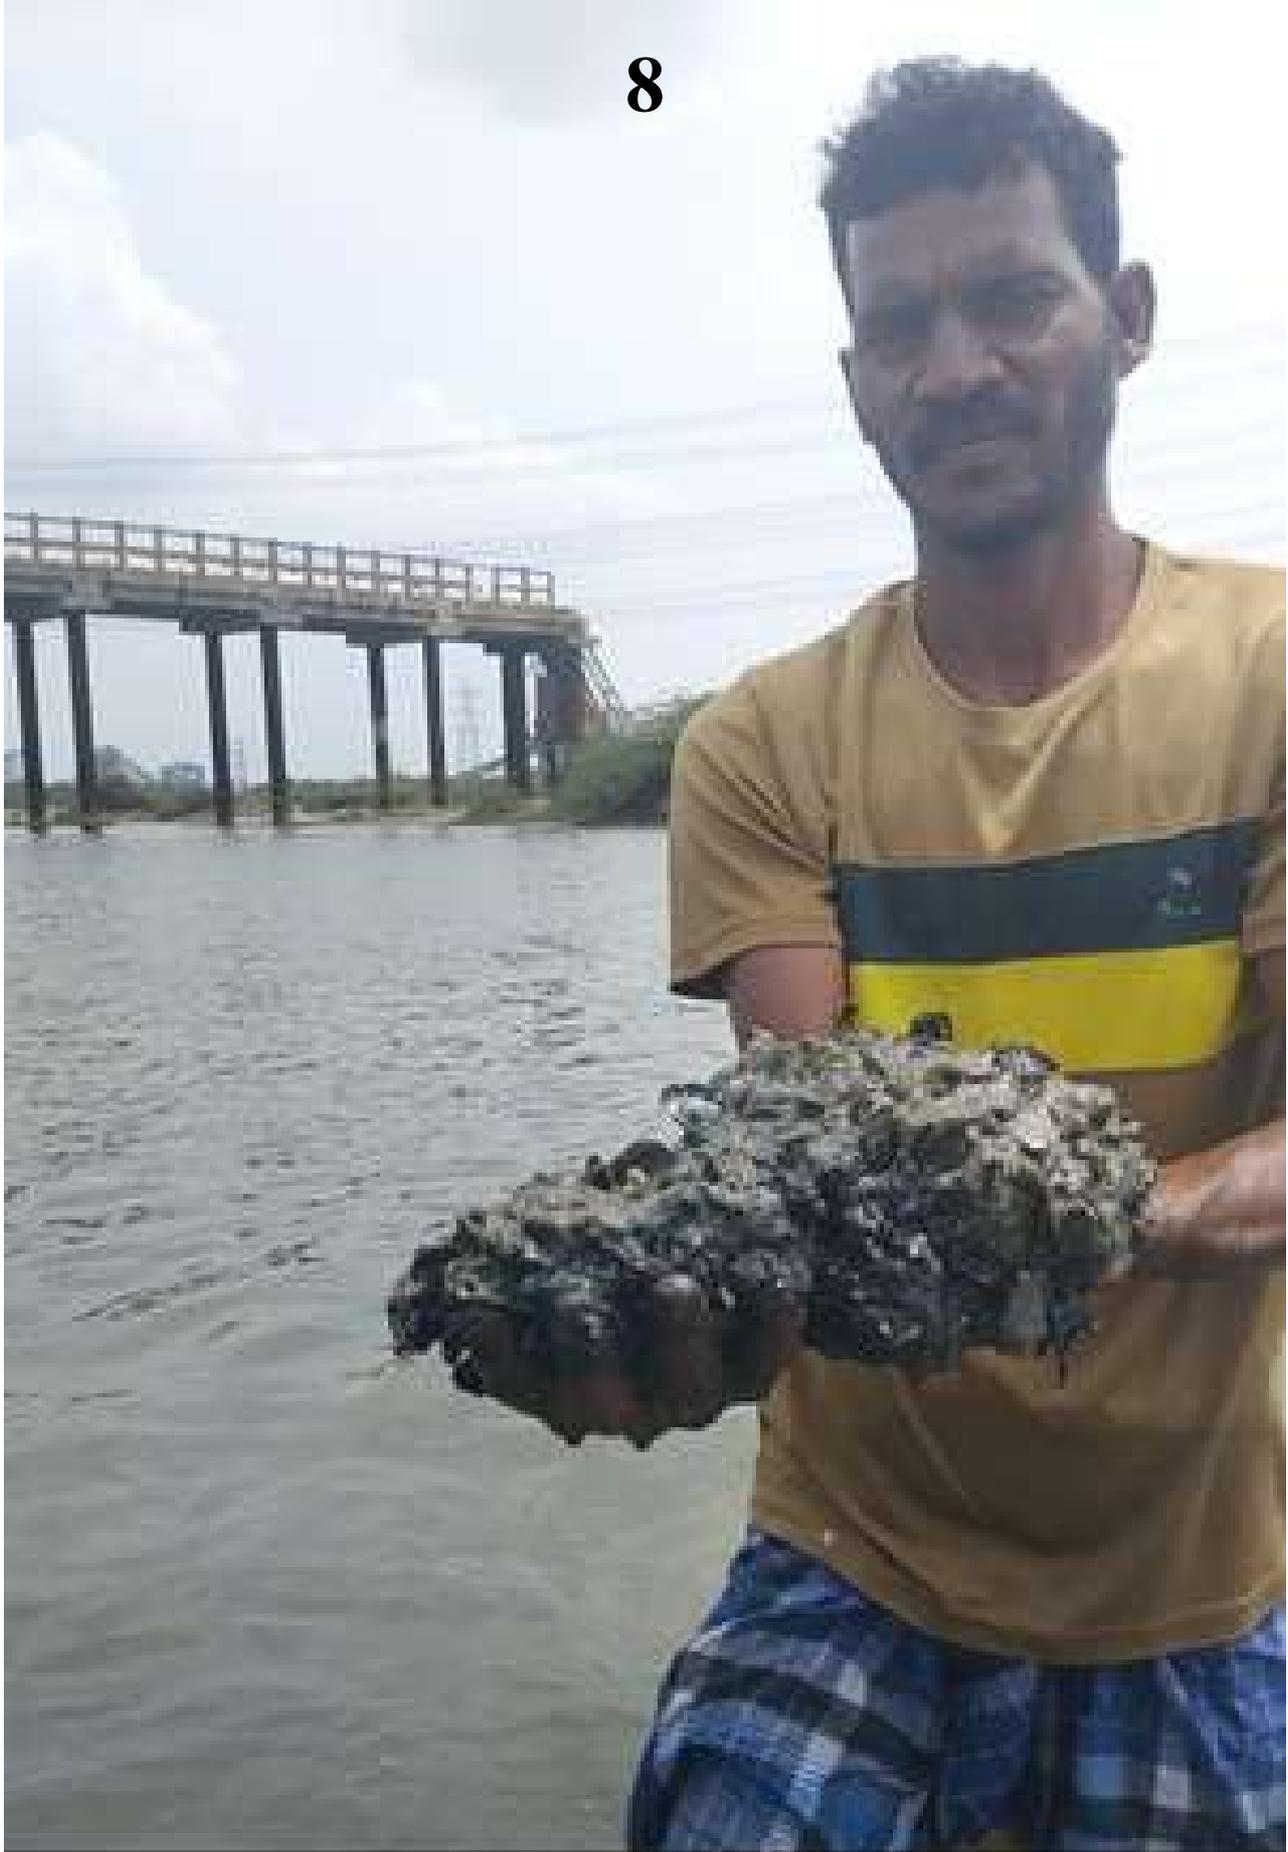
Kattupalli Road, Kattupalli, Tamil  
Nadu 600120, India,

Lat: 13.295655, Long: 80.328467

10 Jun, 25, 01:20 pm, Tuesday

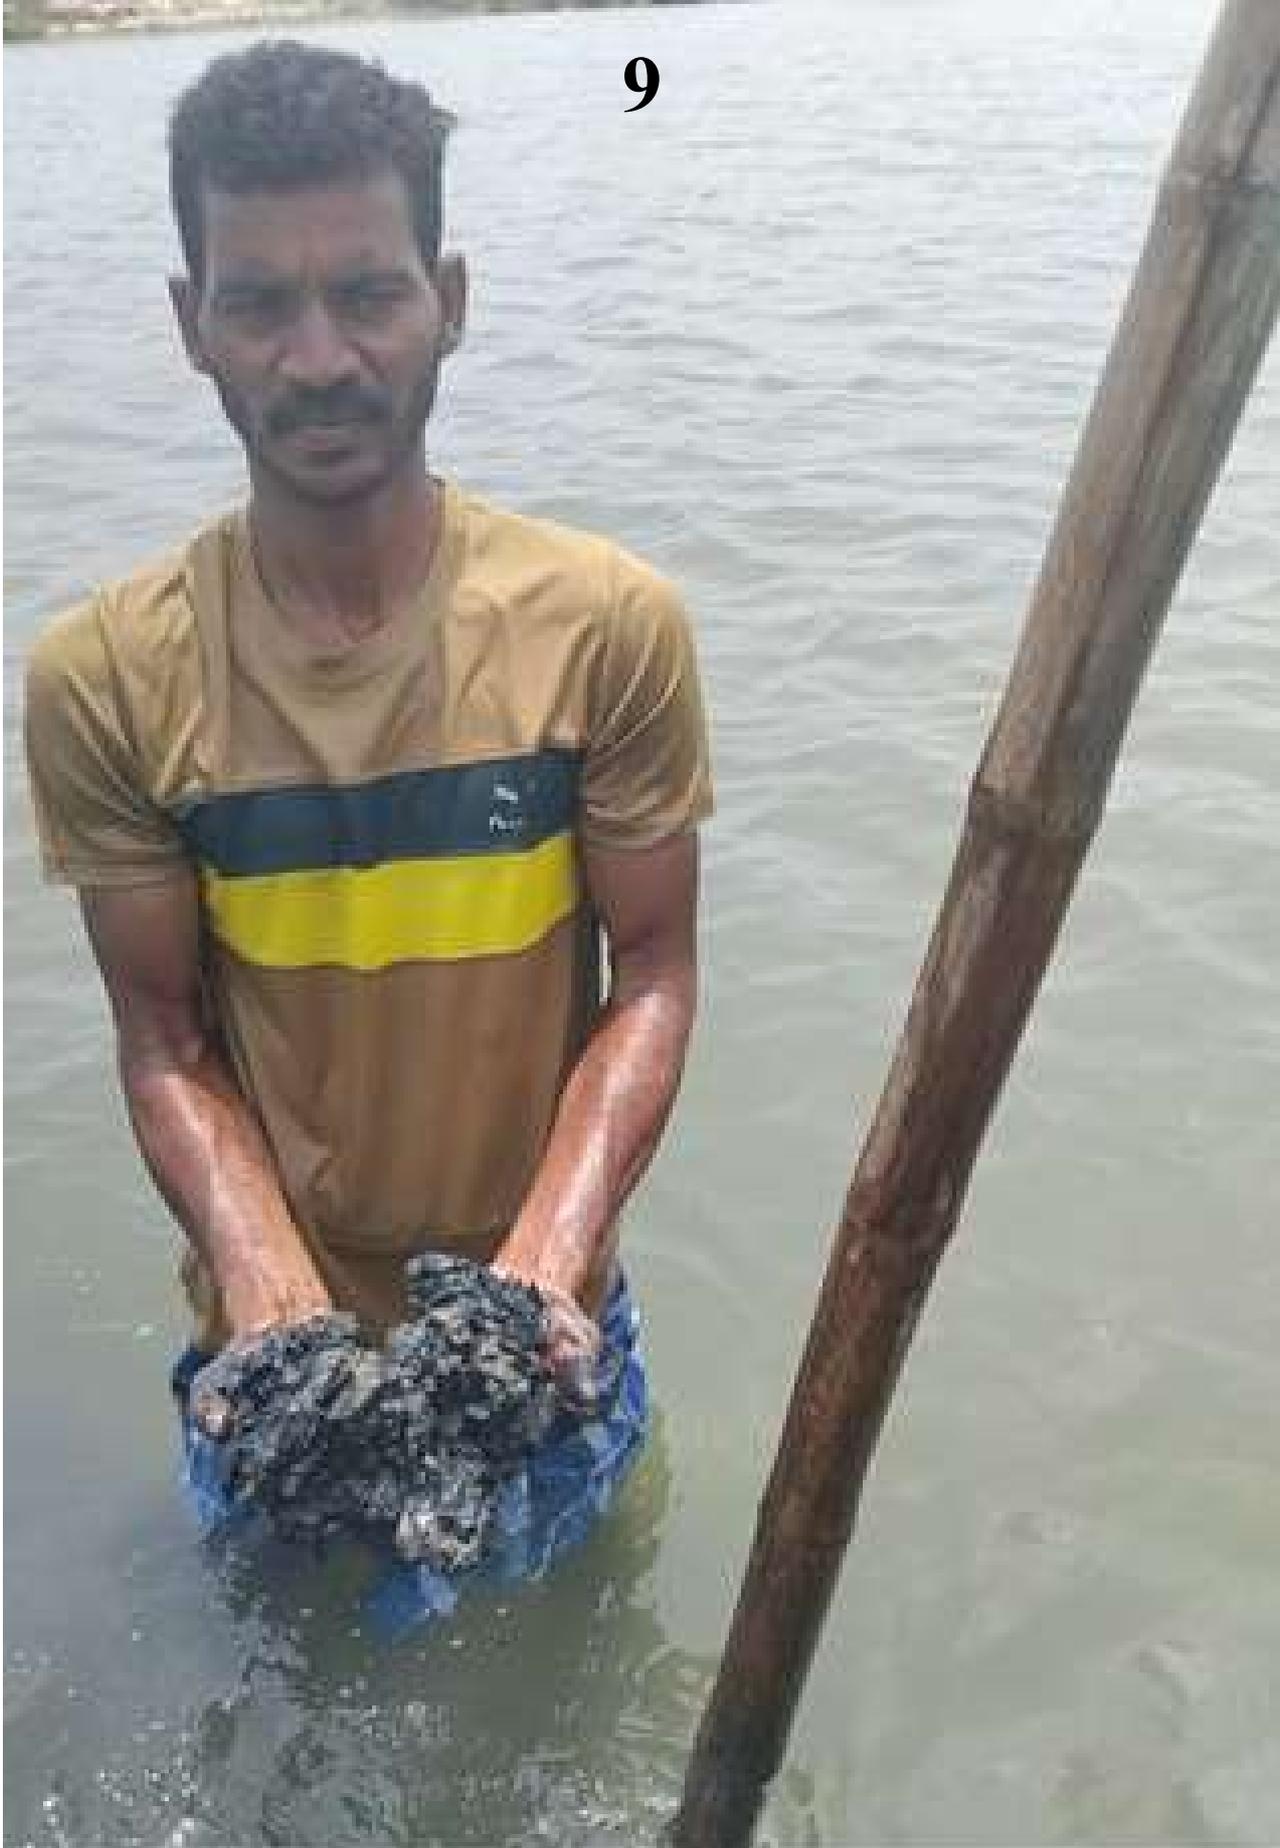
Puzhuthiyakkam, Tamil Nadu,  
India,

Lat: 13.262656, Long: 80.320881

10 Jun, 25, 12:29 pm, Tuesday

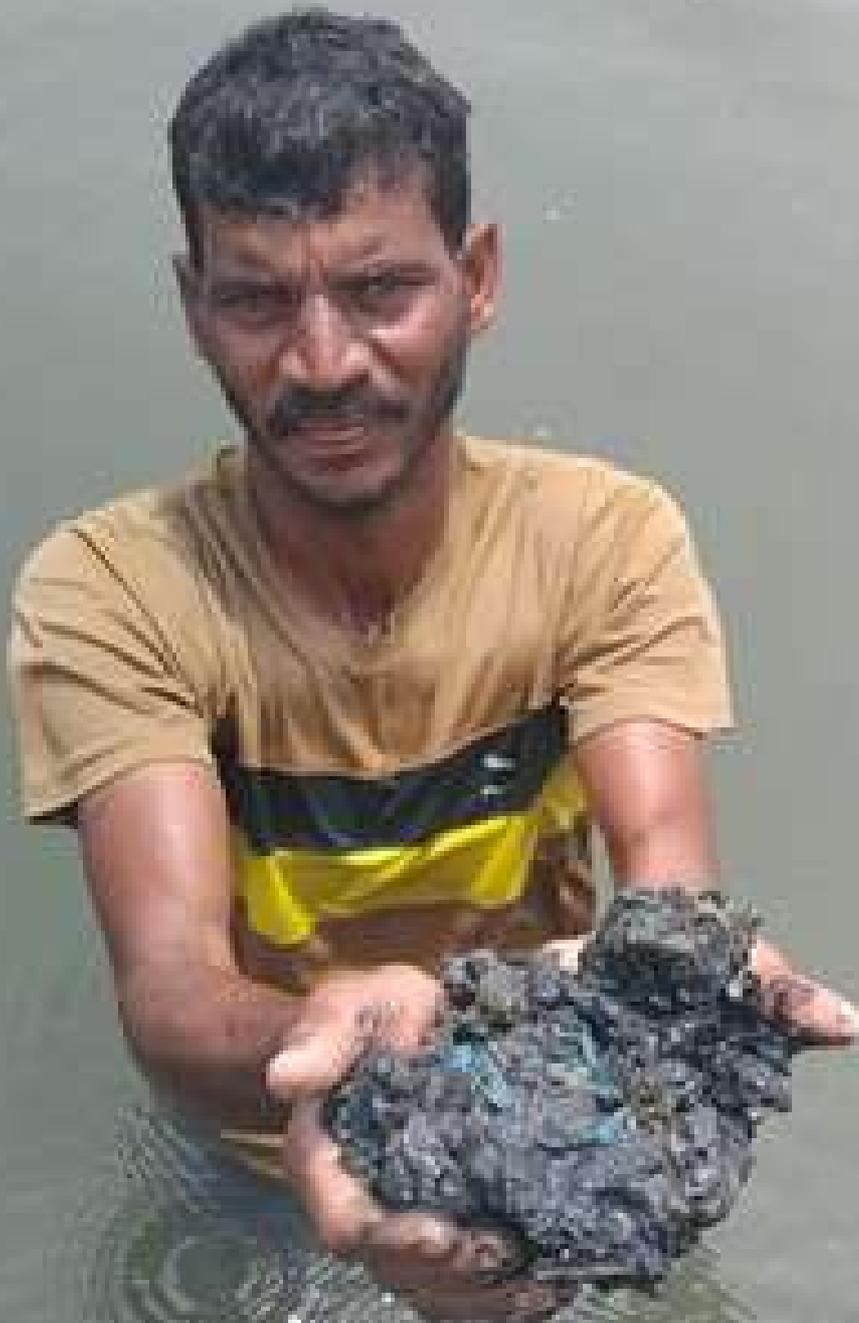
Ash Pipeline Rd, Puzhuthivakkam,  
Tamil Nadu 600120, India,

Lat: 13.267342, Long: 80.324074

10 Jun, 25, 12:45 pm, Tuesday

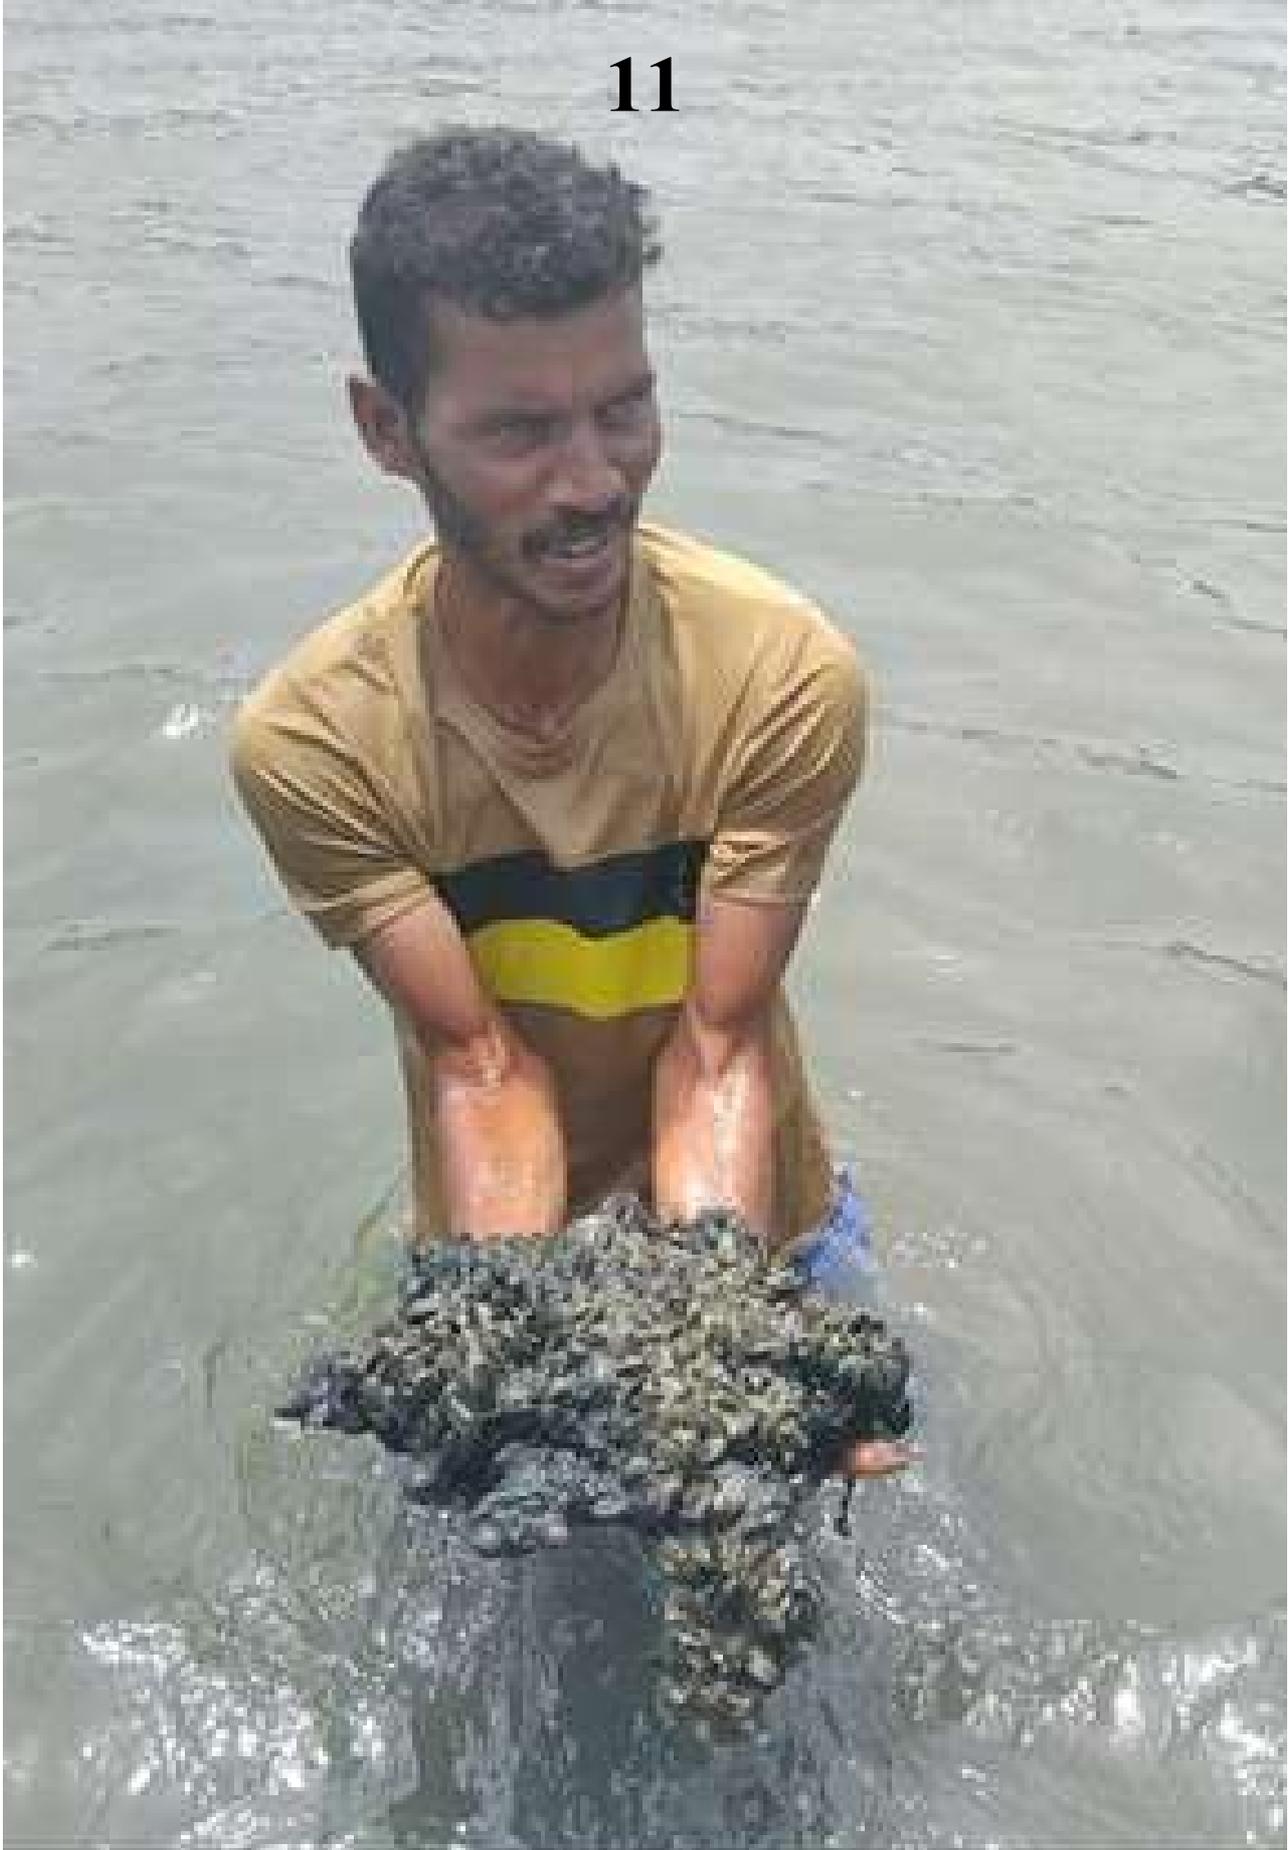
Ash Pipeline Rd, Puzhuthivakkam,  
Tamil Nadu 600120, India,

Lat: 13.258983, Long: 80.318497

10 Jun, 25, 12:24 pm, Tuesday

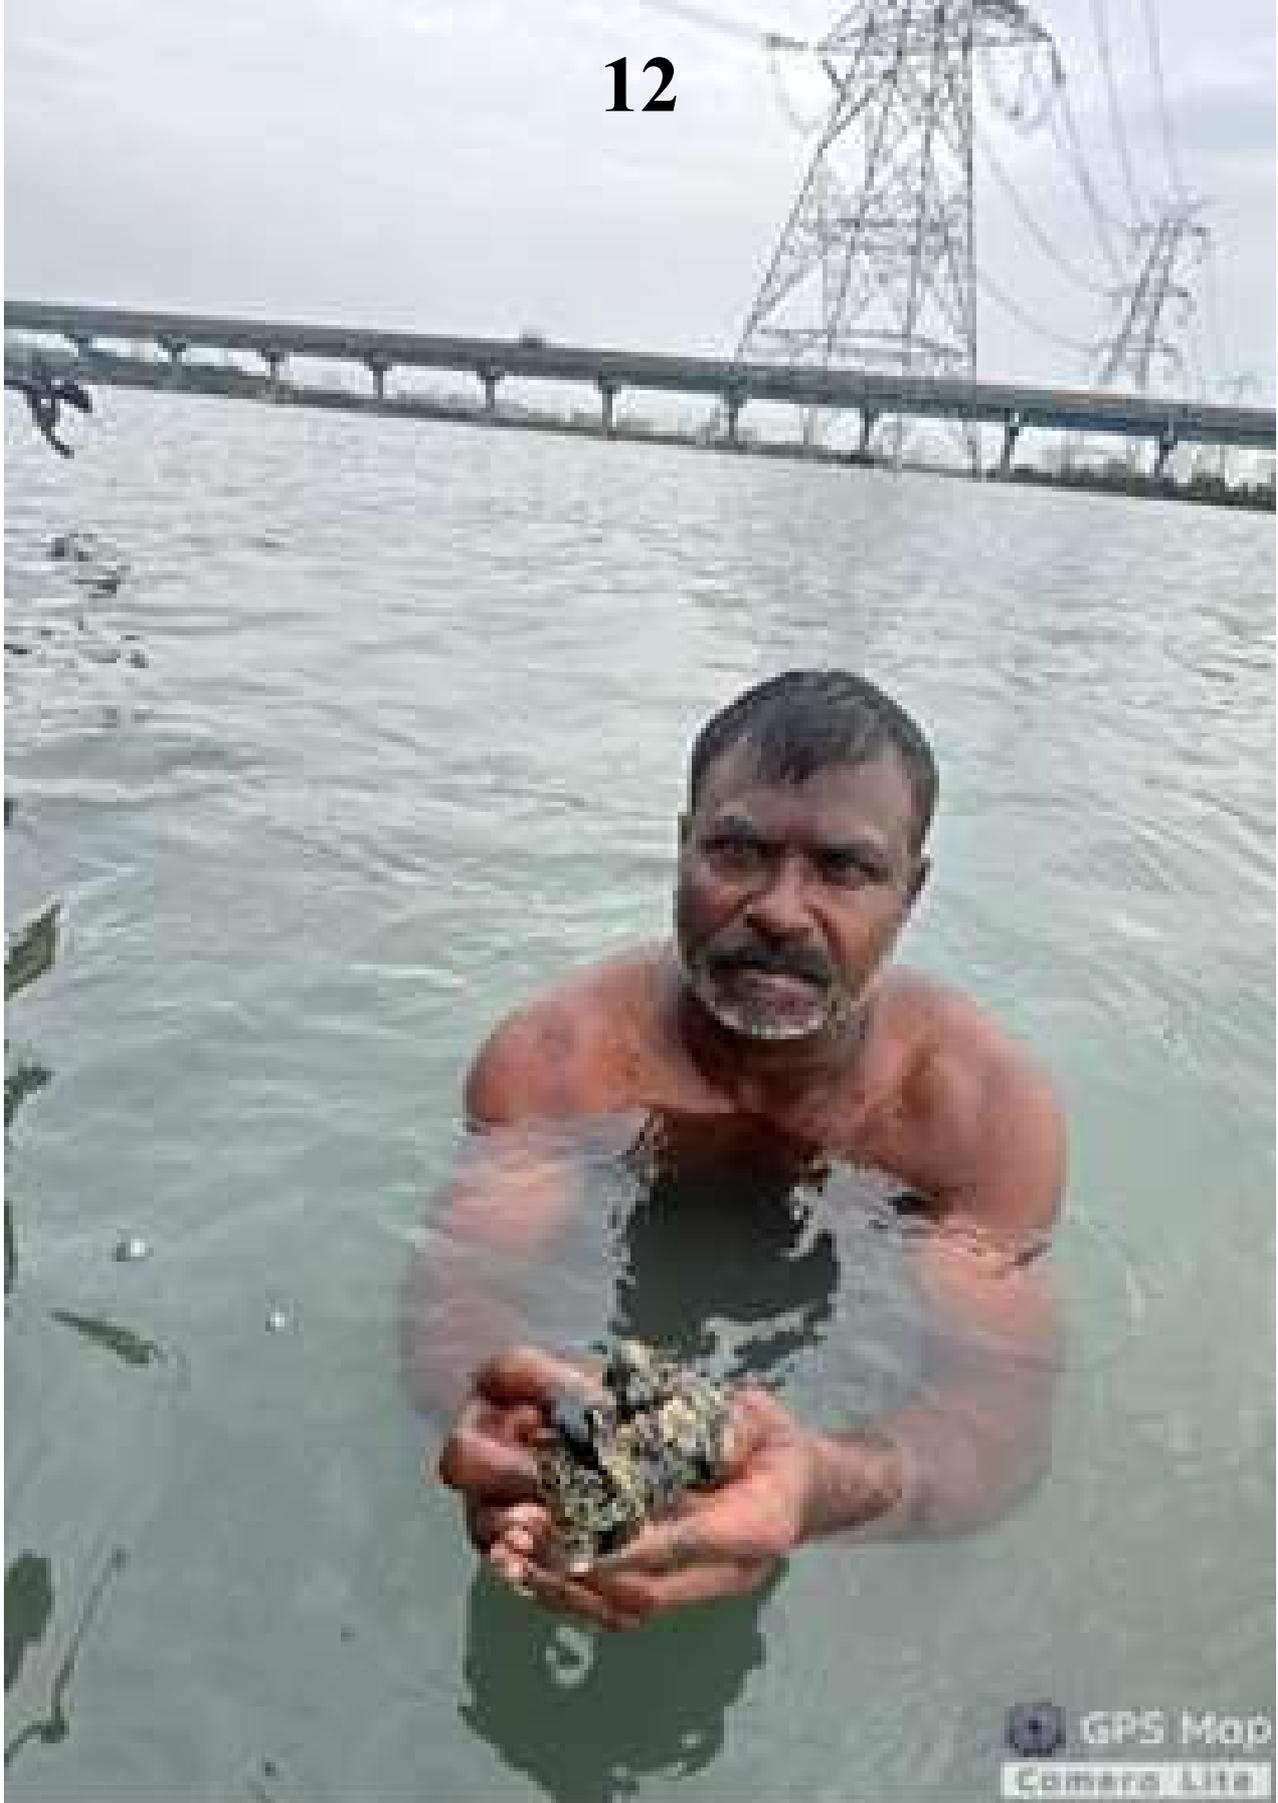
Ennore, Chennai, Tamil Nadu, India

Latitude  
13.229974°

Longitude  
80.317180°

Altitude 3.6 meters  
Tuesday, 06/24/2025

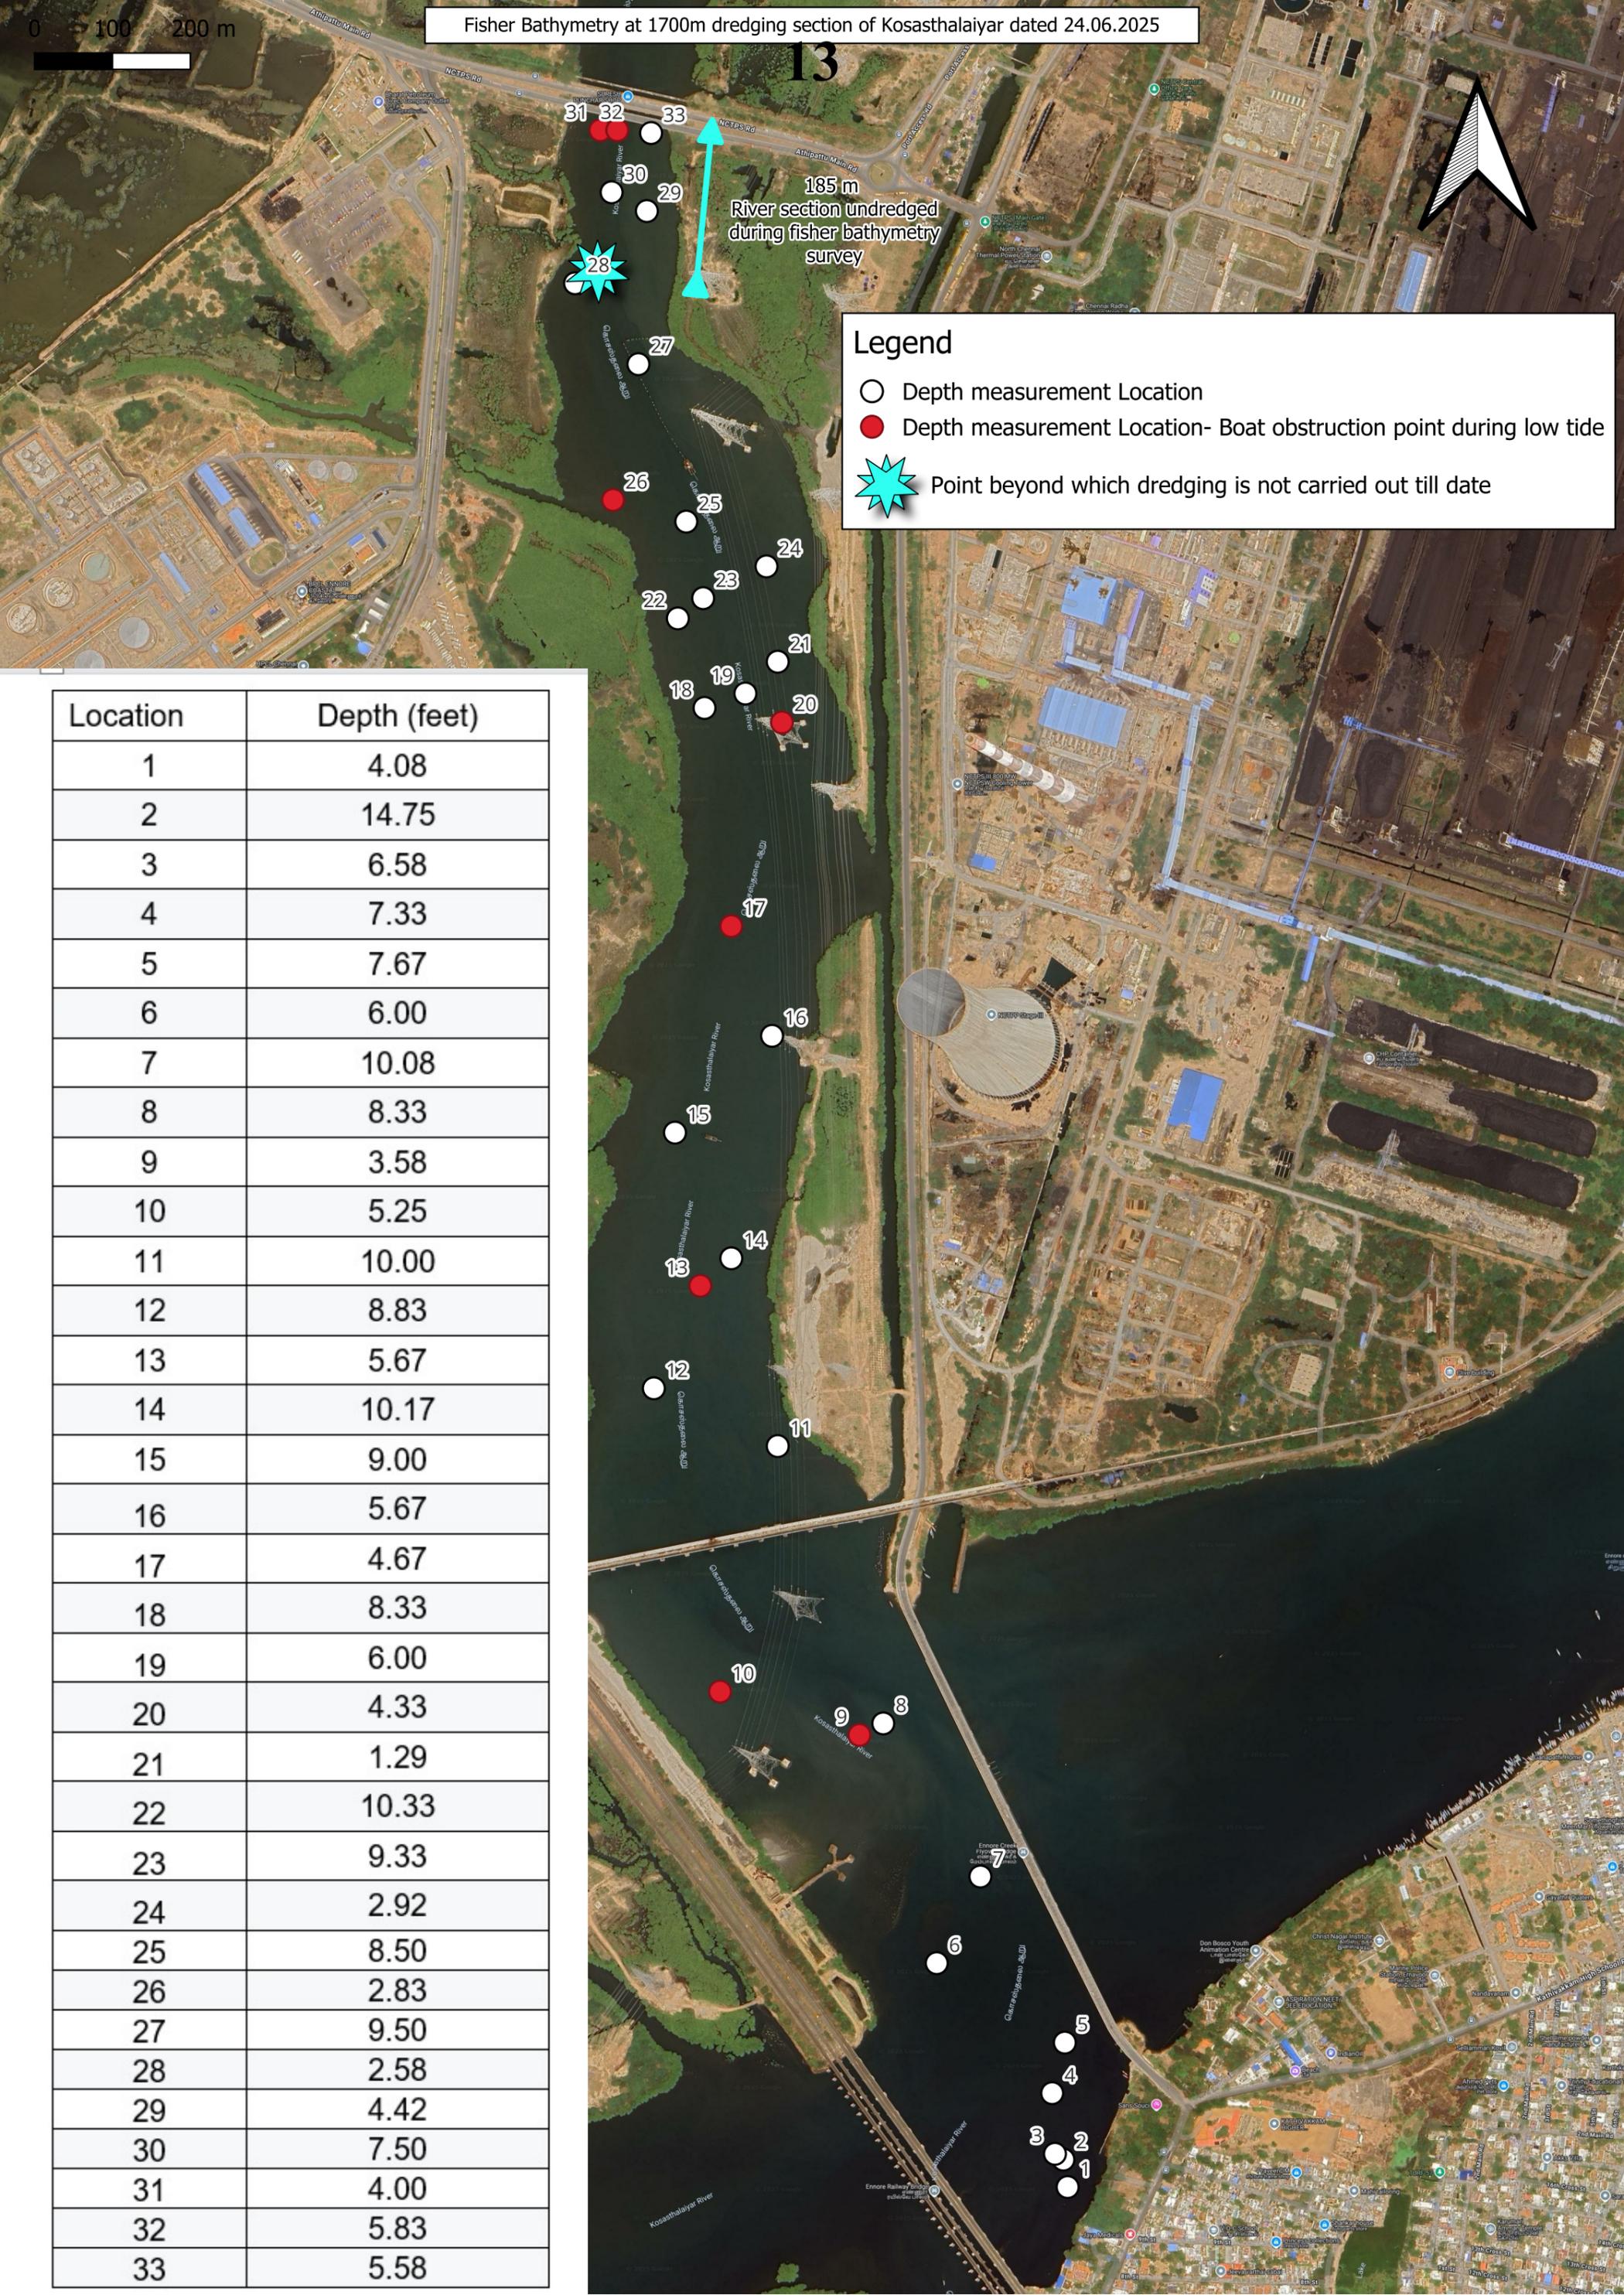
- Depth measurement Location
- Depth measurement Location- Boat obstruction point during low tide
- ★ Point beyond which dredging is not carried out till date

Location	Depth (feet)
1	4.08
2	14.75
3	6.58
4	7.33
5	7.67
6	6.00
7	10.08
8	8.33
9	3.58
10	5.25
11	10.00
12	8.83
13	5.67
14	10.17
15	9.00
16	5.67
17	4.67
18	8.33
19	6.00
20	4.33
21	1.29
22	10.33
23	9.33
24	2.92
25	8.50
26	2.83
27	9.50
28	2.58
29	4.42
30	7.50
31	4.00
32	5.83
33	5.58

7. Even the dredging that is currently taking place is happening in a completely unsystematic manner, which has led to different points of the subject area being dredged to different extents. The ideal depth for fishing grounds in this area is 3.2 – 5 ft. However, the ongoing dredging work has led to vast differences in the depth of the waterbody in the very

same area, ranging from 14.75 feet to 1.29 ft. As a result of this, the boats of artisanal fishers are not able to pass through large stretches of the waterbody, particularly during the low tide. It is submitted that dredging conducted without any consultation of the fishers has seriously damaged their fishing grounds or paadu.

8. A tabulation of the depth of various points in this area and the uneven dredging taking place, as recorded on 24.06.2025, is produced below for convenience:
